**Agricultural Buildings
76 MAIN STREET
Great Gidding, Cambs.**

**ARCHAEOLOGICAL
EVALUATION REPORT**

AGRICULTURAL BUILDINGS, 76 Main Street, Great Gidding, Cambridgeshire

Project ref.: HN1328
Planning Ref.: 16/01874/FUL
HER Event No.: ECB 4960

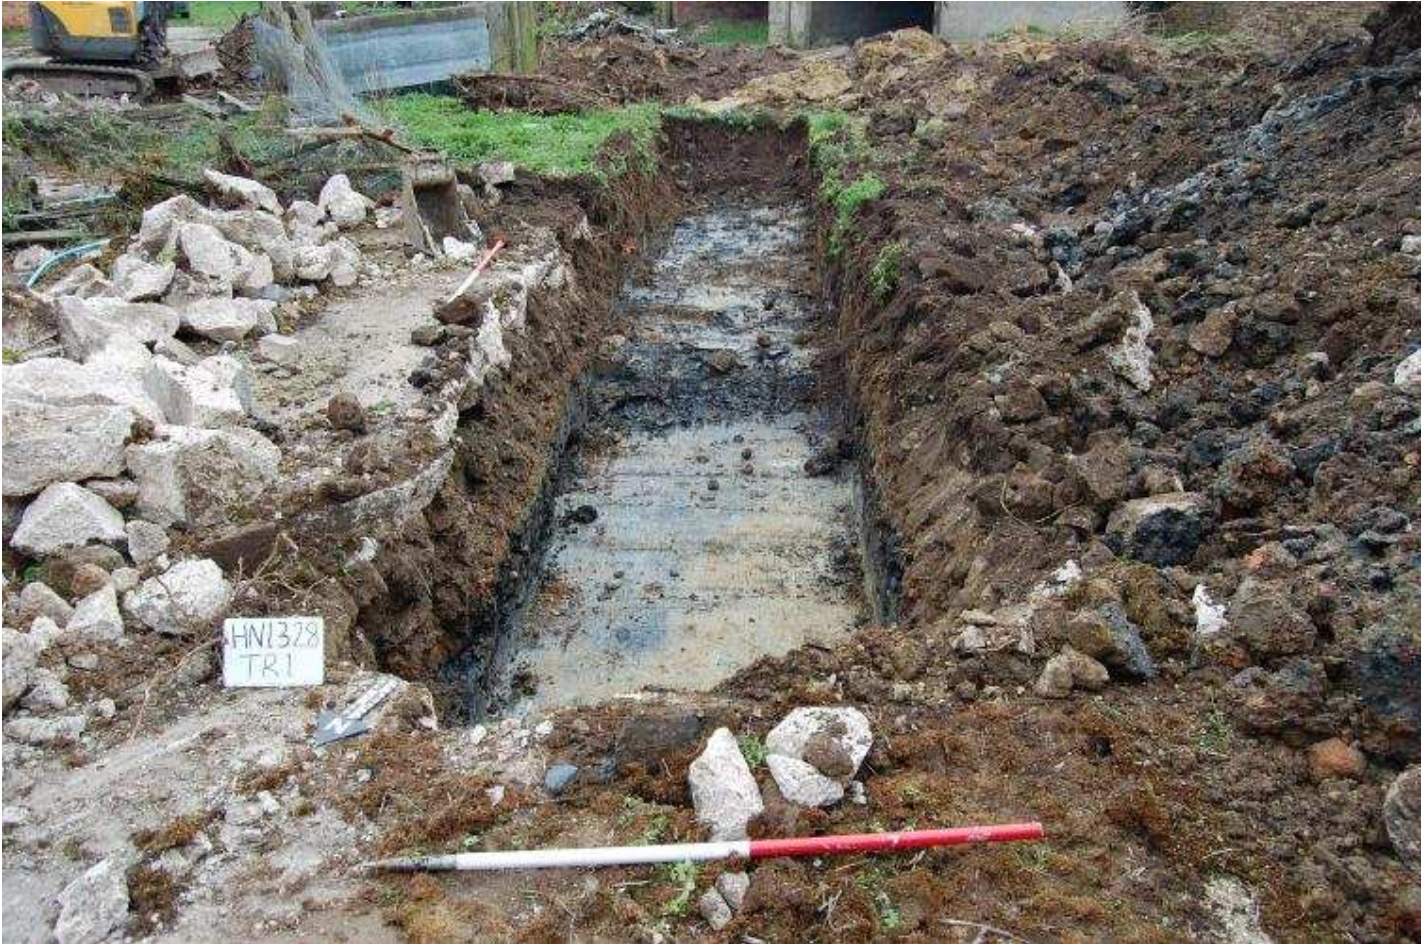
Plate 01 - Trench 1, looking SE

2.15 Trench 1 was located at the north-western end of the site (Figure 2). It was aligned north-west to south-east and measured 10m in length, 1.60m in width and was excavated to a maximum depth of 1.60m (Figure 3, Plate 1).

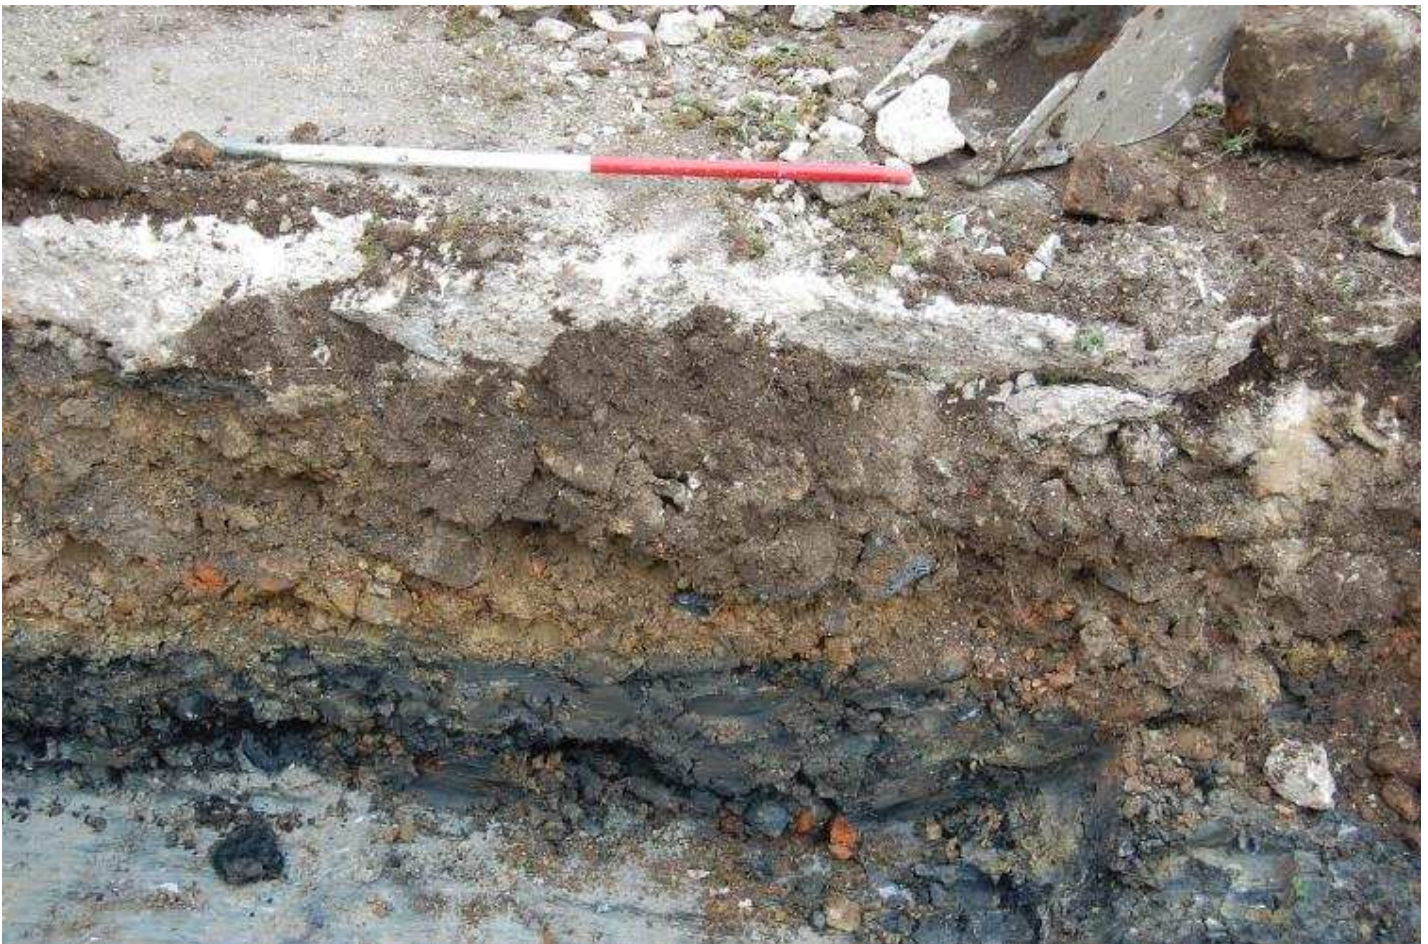
Plate 02 - Trench 1, indicative section at NW end

2.16 The stratigraphy in Trench 1 varied slightly from north-west to south-east. At its north-western end it comprised a modern concrete yard surface, approximately 3m in length and 0.08m in depth, above a rubble bedding layer, 0.17m in depth (Figure 3, Plate 2). This changed to a grassed area at approximately 3m from the north-western end. The turf overlay dark greyish brown friable silty clay topsoil, containing frequent roots and moderate amounts of small stones.

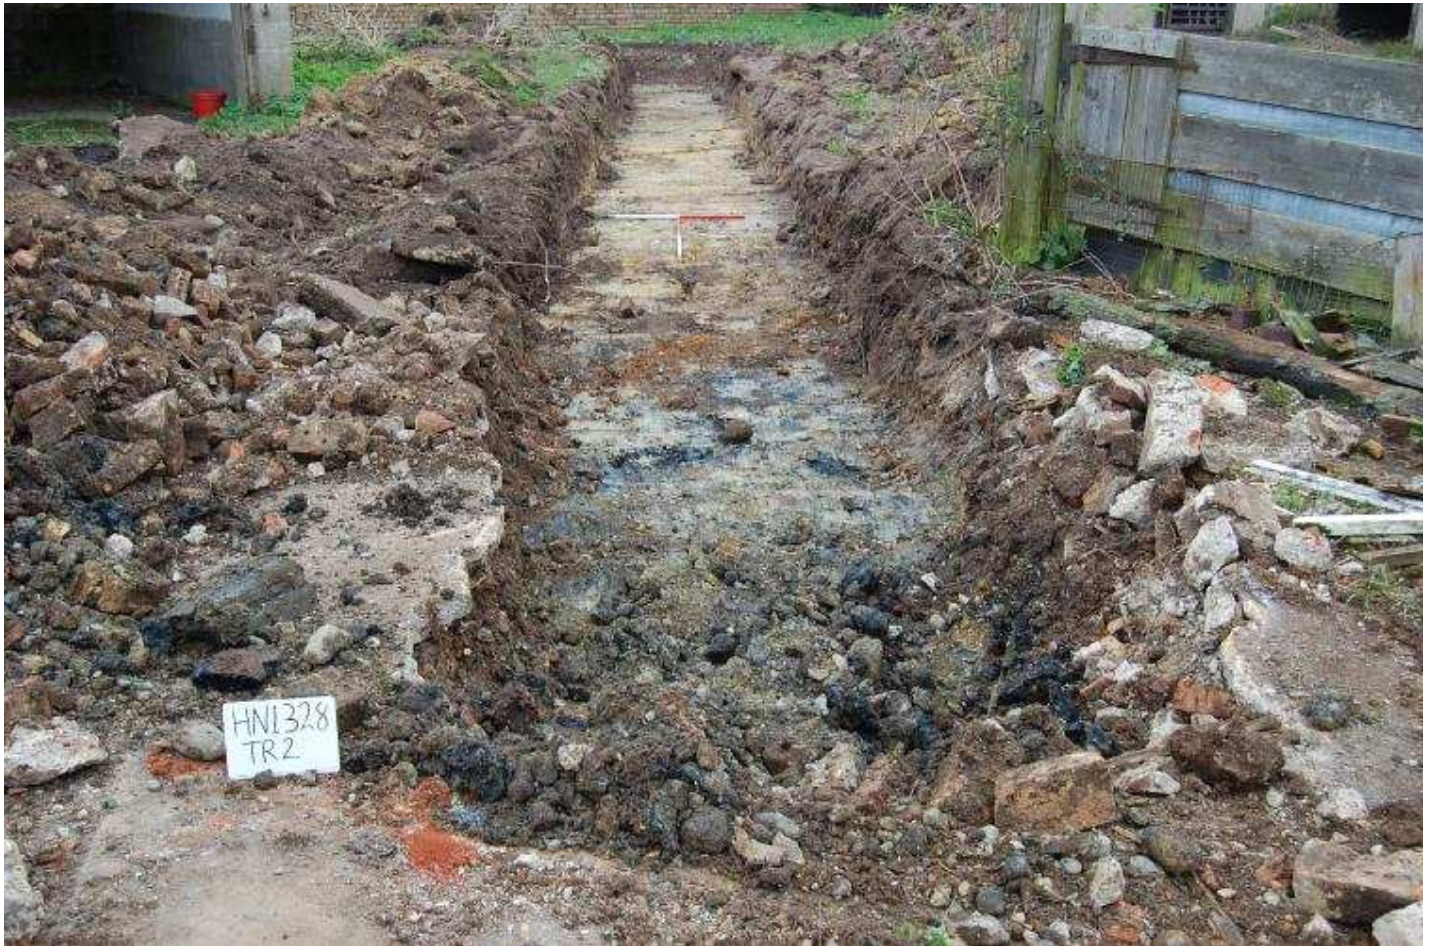
Plate 03 - Trench 2, looking SW

2.20 Trench 2 was located to the south of Trench 1. It was aligned north–east to south-west and measured 20m in length, 1.60m in width and was excavated to a maximum depth of 0.80m (Figure 2, Plate 3).

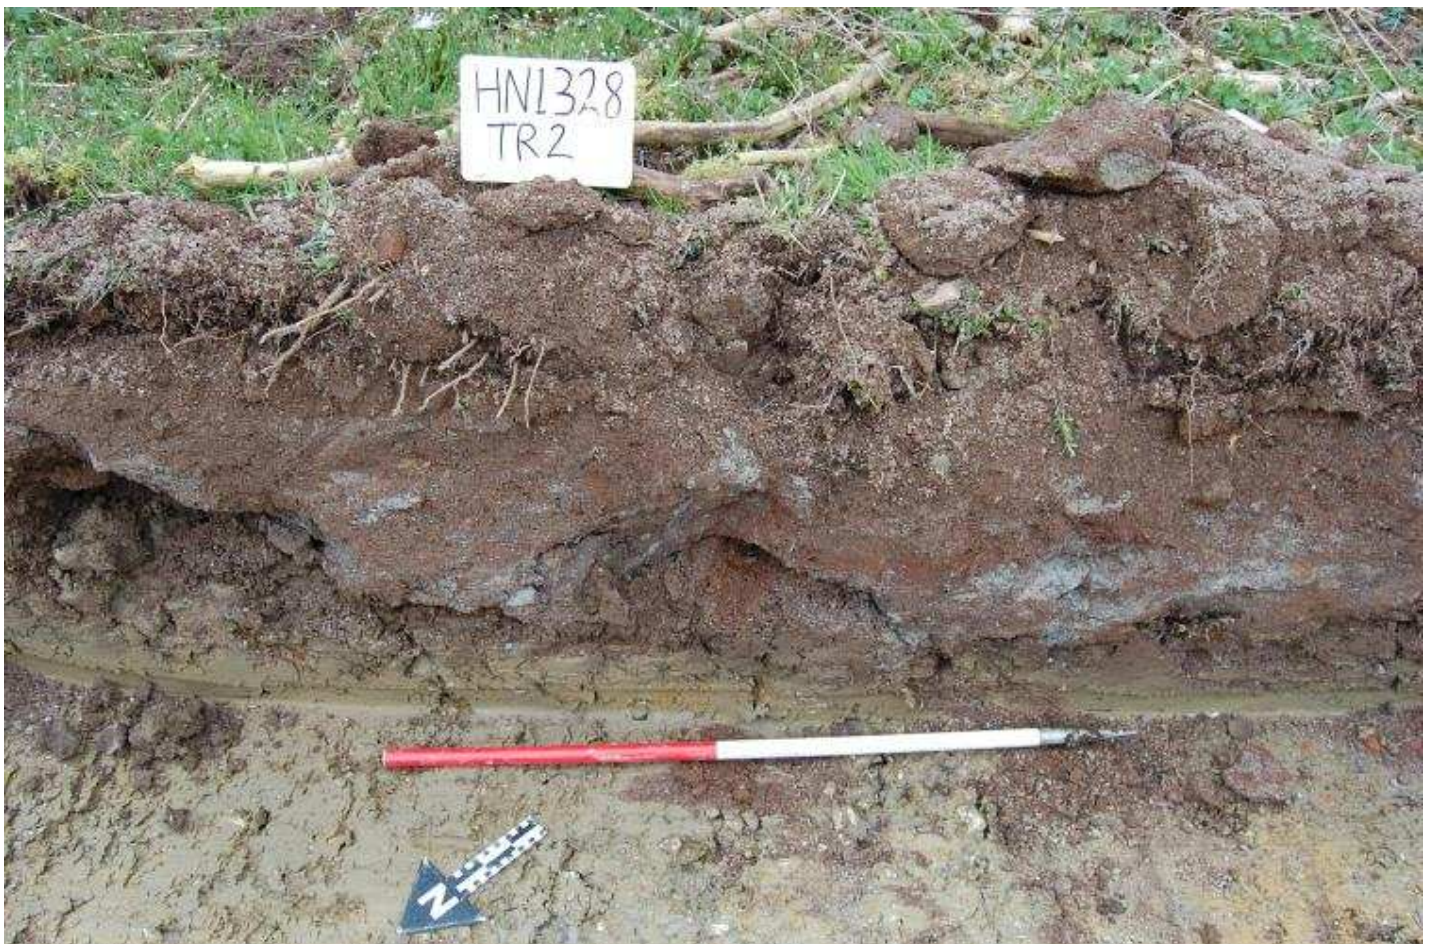
Plate 04 - Trench 2, indicative section, looking SE

2.21 The stratigraphy in Trench 2 comprised a topsoil of dark greyish brown friable silty clay, 0.10m in depth, above a modern Type 1 aggregate (Figure 4, Plate 4). The mixed blueish grey and black clay layer, observed in Trench 1, was encountered below the aggregate at the north-eastern end of the trench. This was separated from the clean natural substrate by a narrow band of orange – red gravel.

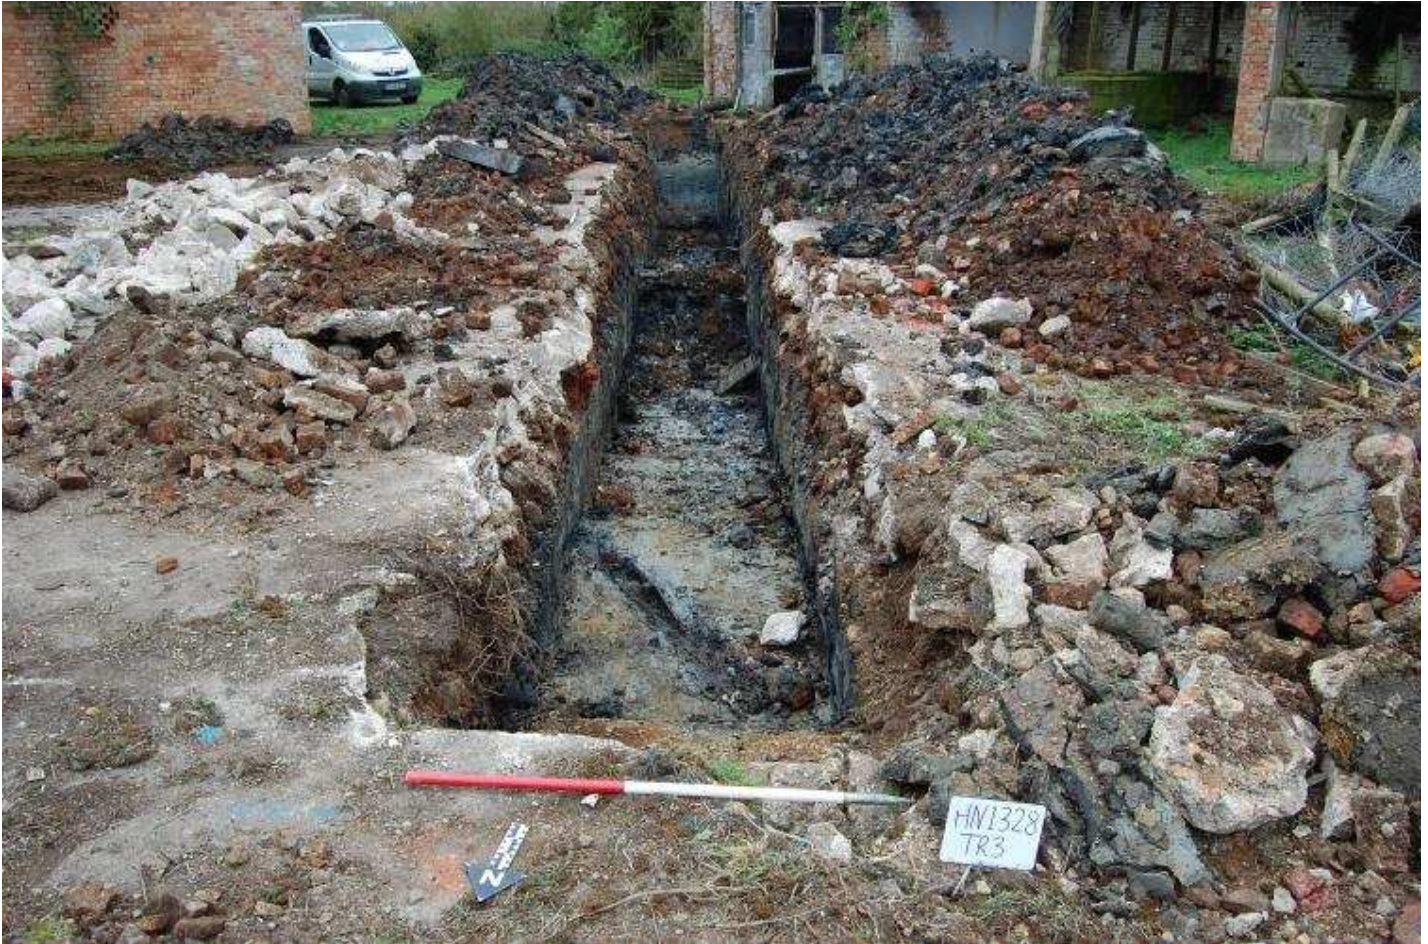
Plate 05 - Trench 3, looking SE

2.24 Trench 3 was located in the centre of the site, to the east of Trench 2. It was aligned north-west to south-east and measured 20m in length, 1.40m in width and was excavated to depths of between 1.20m at the north-western end and 2.20m at the south-eastern end (Figure 2, Plate 5).

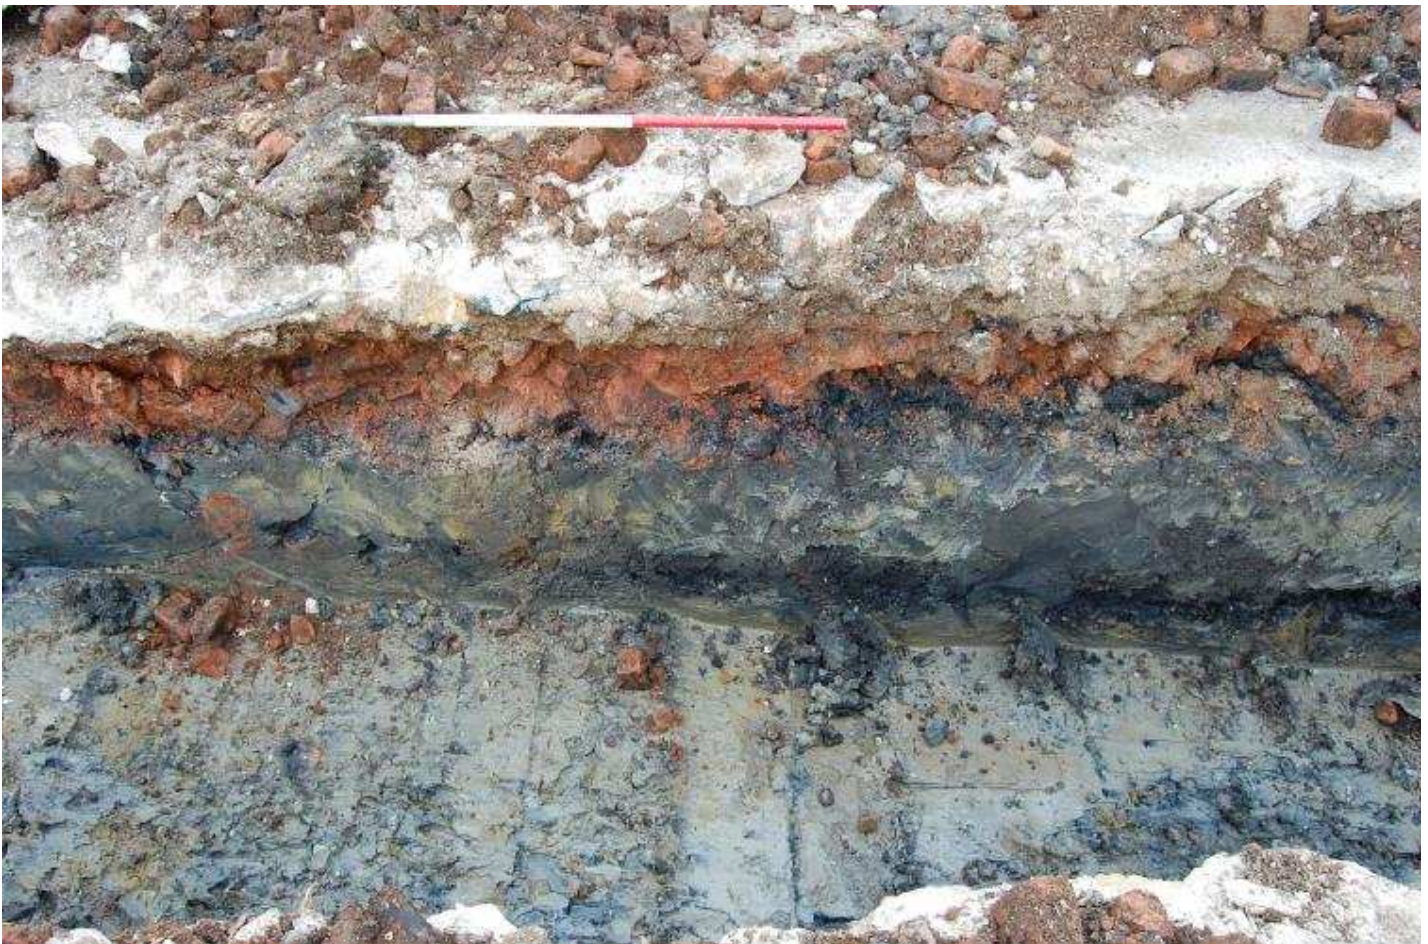
Plate 06 - Trench 3, indicative section showing cobbles

2.25 The stratigraphy in Trench 3 comprised a concrete yard surface, 0.22m in depth, above a rubble bedding layer, 0.10m in depth. This overlay a deposit of red brick rubble, 0.20m in depth (Figure 5, Plate 6).

2.26 Part of a former cobbled yard surface, 0.10m in depth, was noted below the brick rubble at various points along the east facing section (Plate 6). This consisted of large rounded stones in a soil matrix. Where the cobbles had not survived they were replaced by a layer of yellowish brown hoggin, 0.10m in depth, consisting of mixed gravel, sand and medium sized stones, which contained occasional brick and tile fragments (Plate 7).

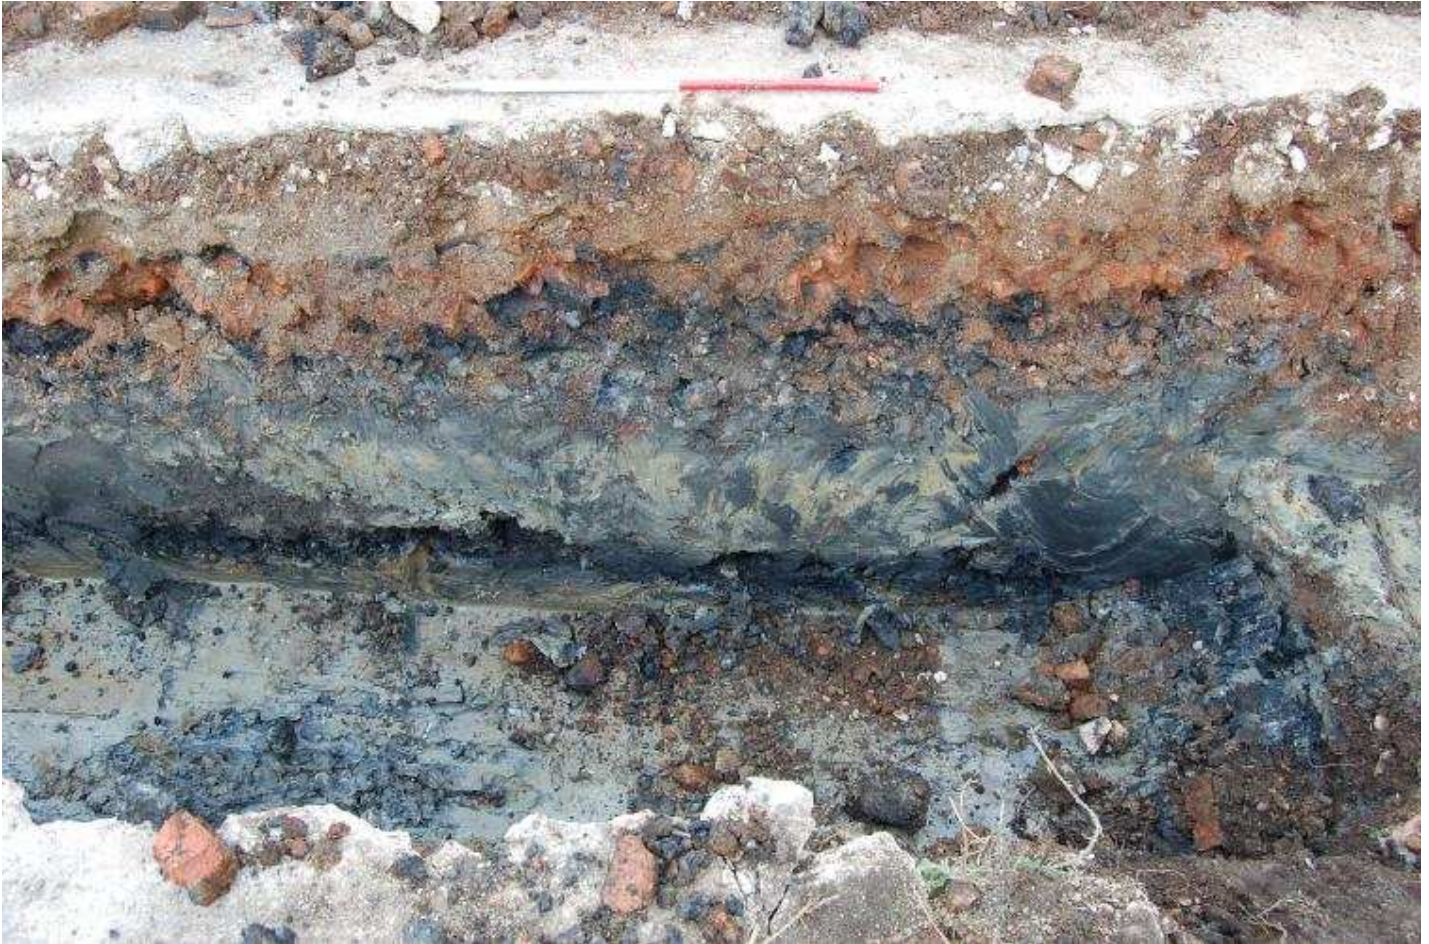
Plate 07 - Tr.3, indicative section, showing hoggin layer

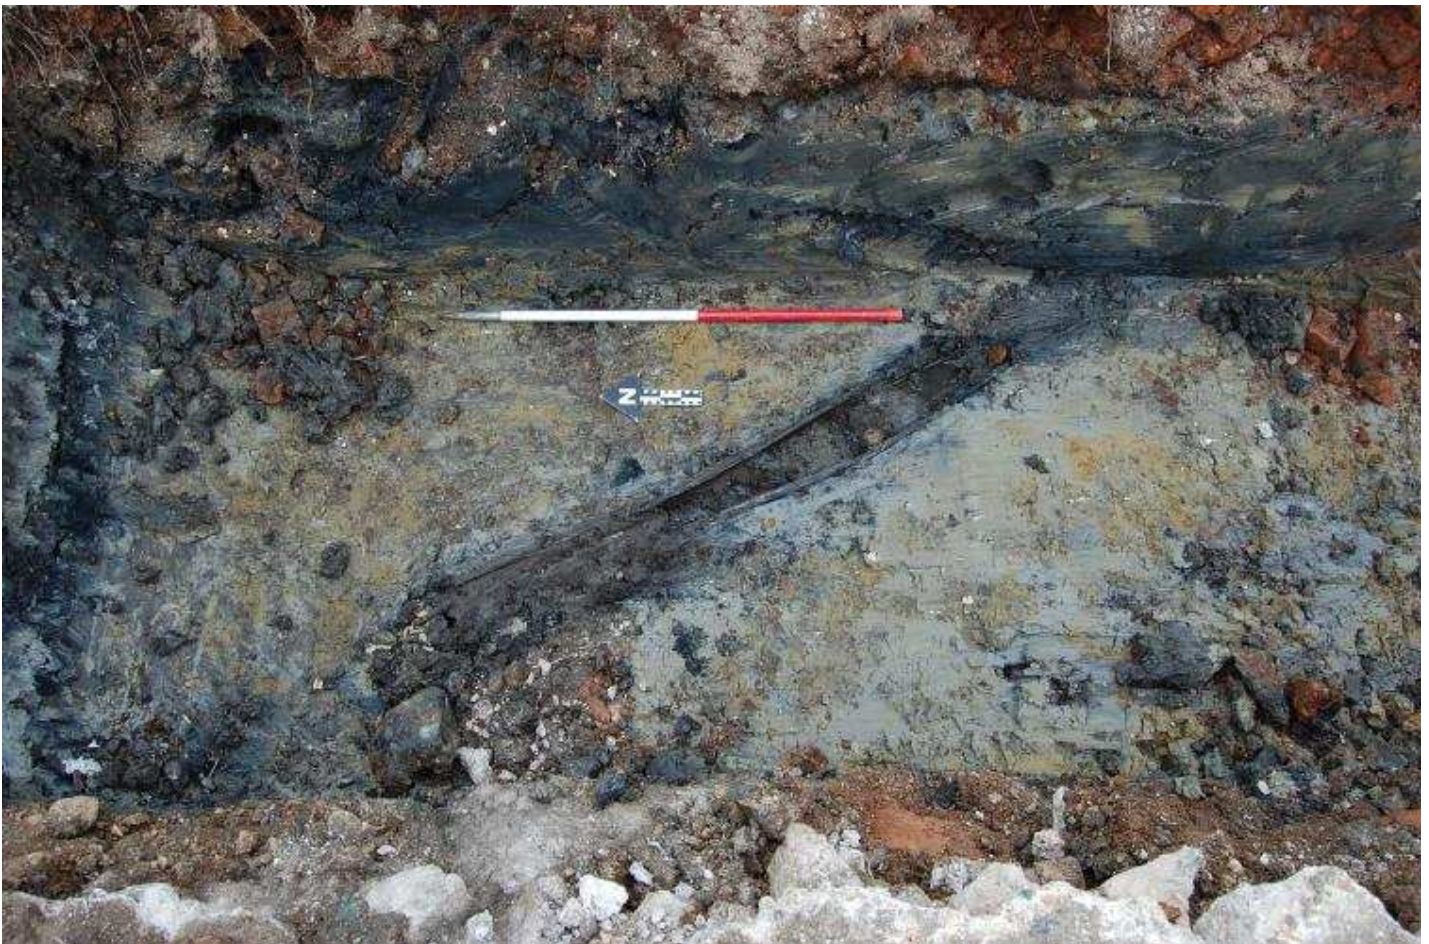
Plate 08 - Trench 3, wooden drain, looking W

2.29 An open wooden drain, [303] was cut into the natural clay below the organic layer at the north-western end of the trench. This ran on a north-west to south-east alignment in the centre of the farmyard and parallel (Figure 5) with the site boundaries. Its exposed area

measured approximately 2.10m in length, 0.25m in depth and 0.32m in width (Plate 8). The wooden sides varied in width between 0.04m and 0.02m. A wooden stake, 0.06m in diameter and 0.23m in height, was observed on the interior of the western side.

2.30 The drain contained fill (304), organic material, possibly animal manure. It was aligned with the axis of the farmyard and may run down the track dividing the two earlier tofts shown on the 1851 Tithe map.

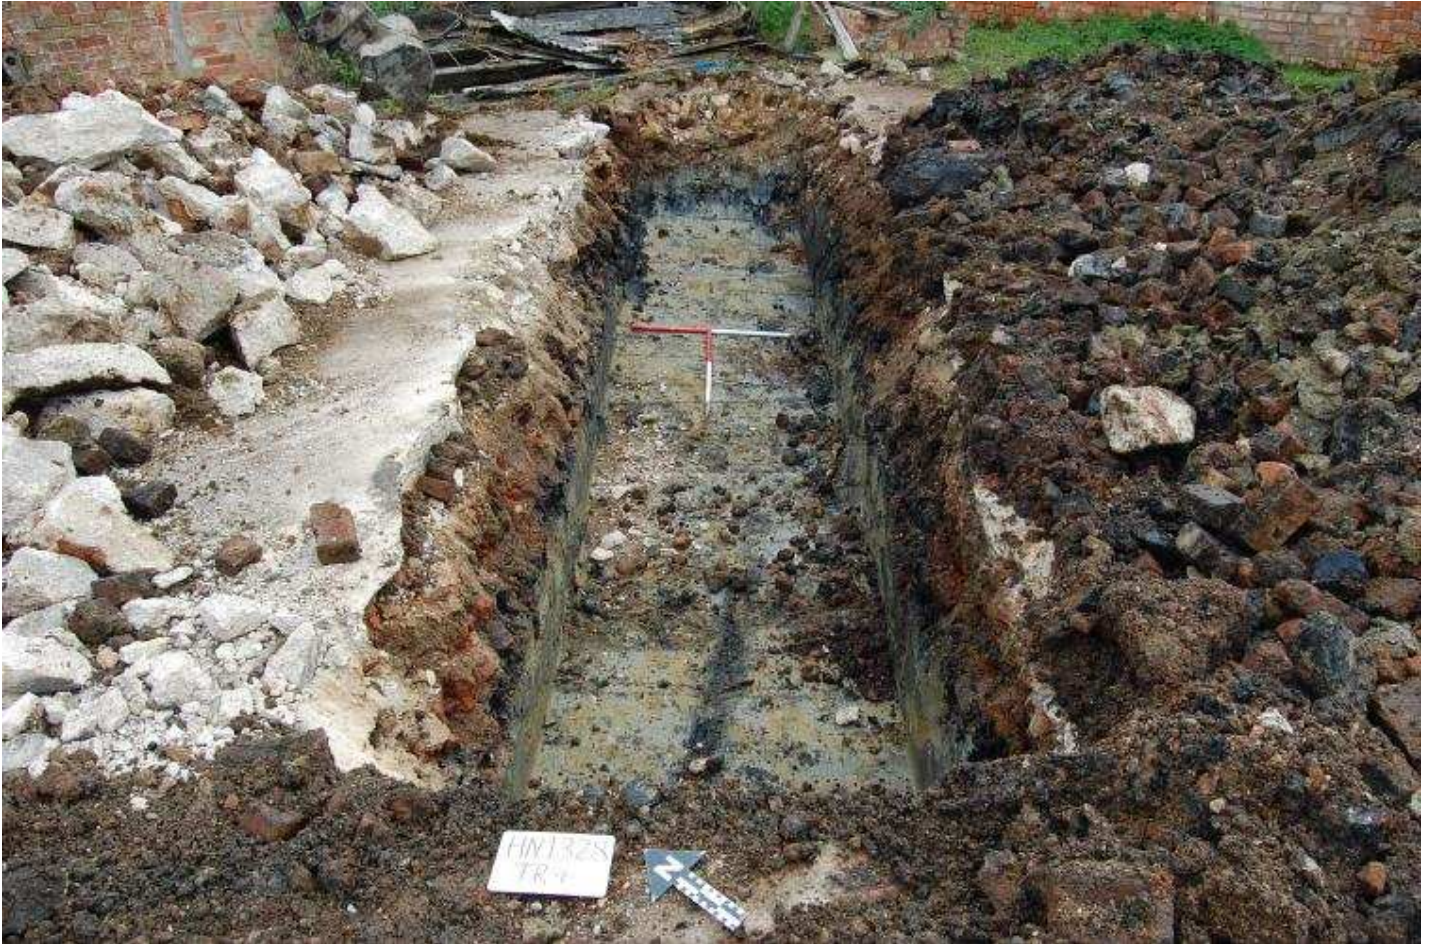
Plate 09 - Trench 4, looking NE

2.33 Trench 4 was located in the north-eastern corner of the site, to the east of Trench 3, and was oriented north-east to south-west (Figure 2). It measured 10m in length, 1.60m in width and was excavated to a maximum depth of 1.30m (Plate 9).

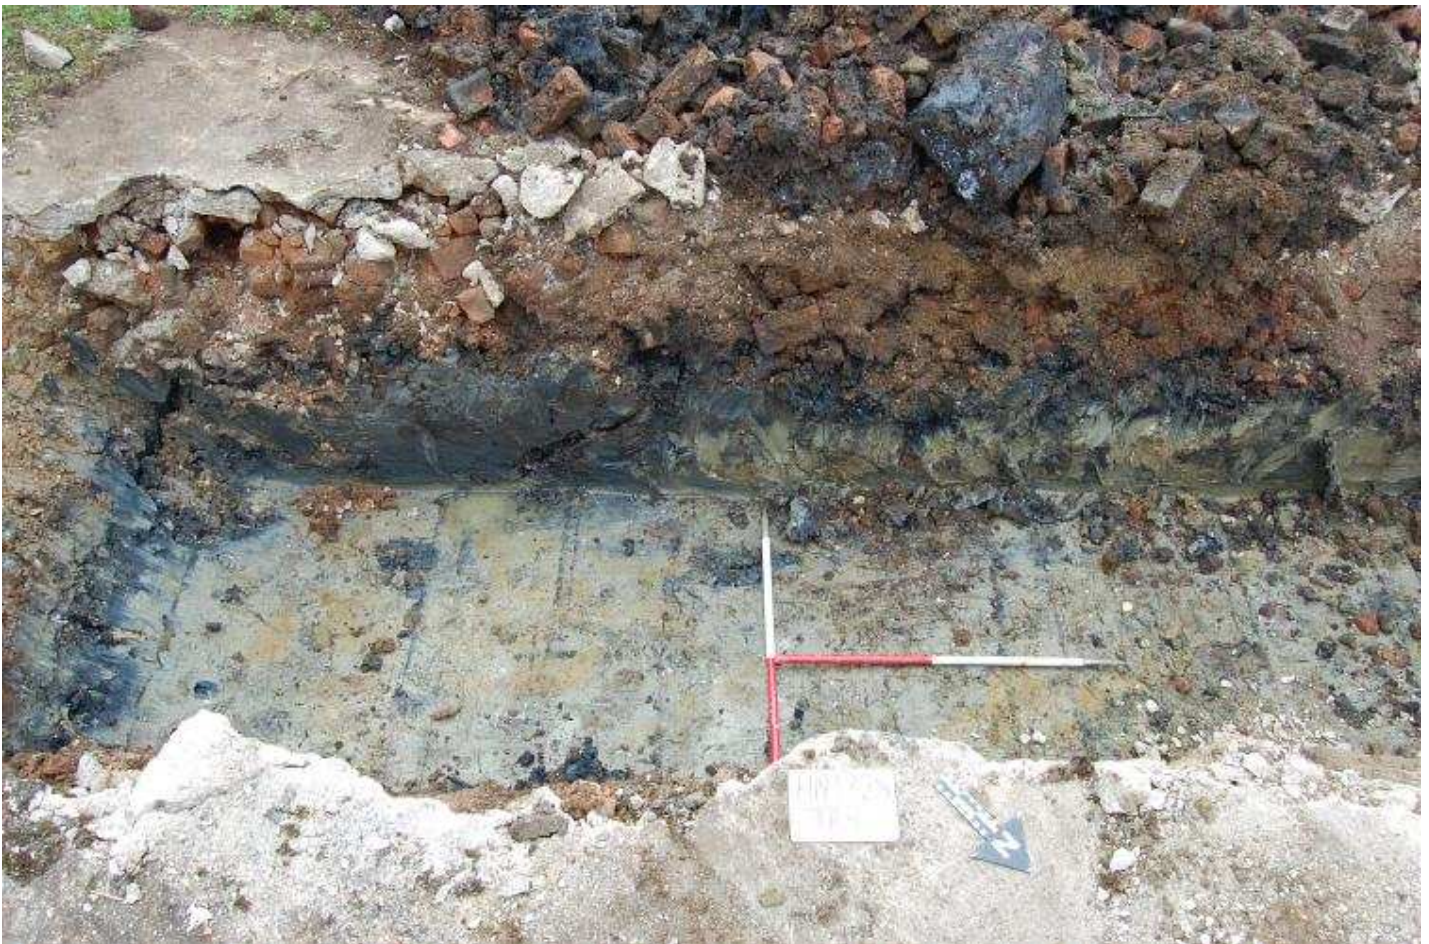
Plate 10 - Trench 4, indicative section, looking SW

2.34 The stratigraphy in Trench 4 comprised concrete yard surface, 0.20m in depth, above a layer of red brick rubble, 0.32m in depth (Figure 6, Plate 10). Below this was thin layer of gravel hoggin, 0.08m in depth, which overlay the dirty blueish grey redeposited clay, 0.50m in depth, seen elsewhere on the site.

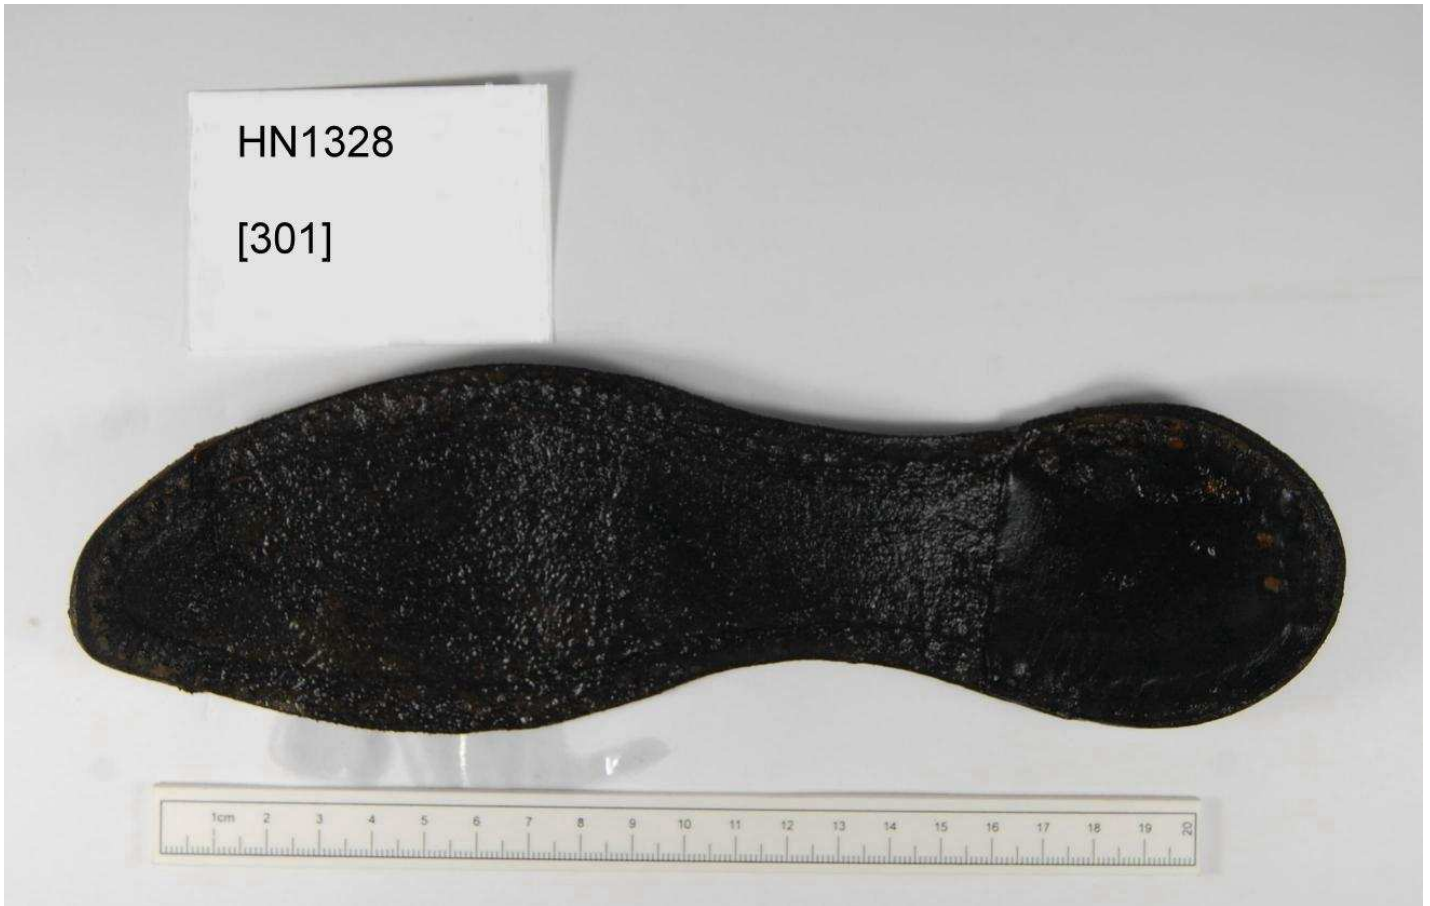
Plate 11 - Leather sole from [301]

2.37 One leather shoe sole was recovered from layer (301) in Trench 3. The sole, which is in good condition, measures 240mm in length, 2mm in depth and varies in width, measuring 60mm at the heel, narrowing to 38mm for the waist, before widening to 68mm for the instep, then narrowing to 20mm at the toes (Plates 11 & 12). It is made of two pieces of leather, one for the sole and a second piece at the heel, possibly as an insole. The footbed appears to have been cut out, of the main leaving a band approximately 7mm in width and 0.5mm in height, standing proud around the sole for the welt. This appears to have small holes, presumably from where the upper was stitched to the sole.

2.38 It has been dated to the mid 19th century at the earliest, and is likely to post-date the rebuilding of the farm after the fire (Quita Mould, pers. com.). Its shape shows that it was for the right foot, but from not a work boot. The size indicates that it was either a woman's or a youth's shoe, possibly worn as "Sunday best".
