LANDS OF HADDENHAM AIRFIELD, (ZONE 5) Haddenham, Buckinghamshire

***ARCHAEOLOGICAL
MONITORING REPORT***

Project ref.: HN1339
Planning ref.: 14/03289/AOP (Outline)
Accession number: AYBCM 2017.133

Archaeological Monitoring Report

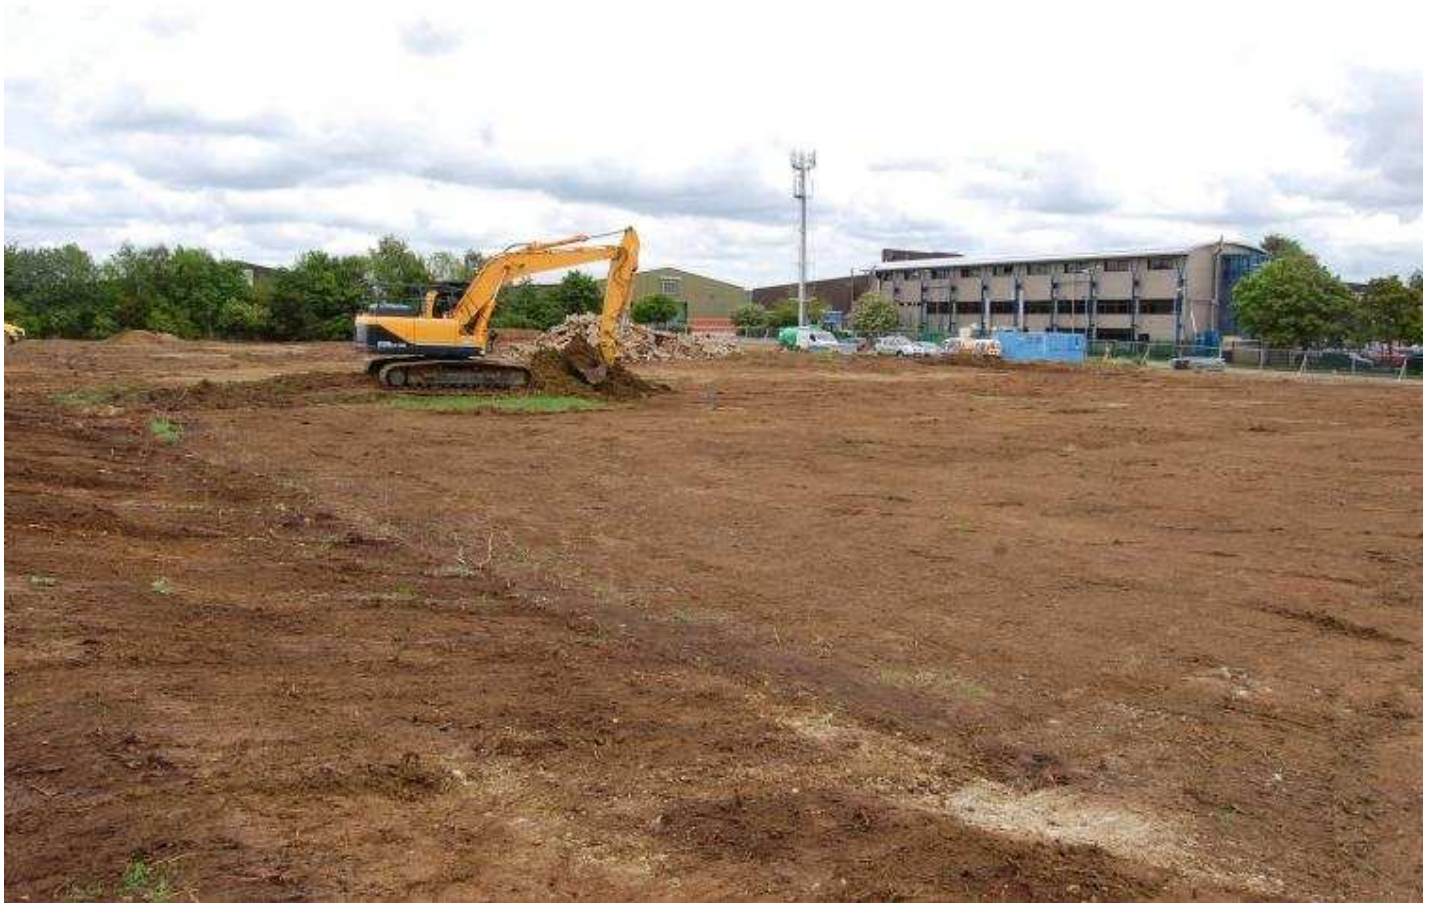
Plate 01 - Zone 5 during the vegetation strip, looking SE

2.13 The Phase 1 works involved a vegetation strip, to a maximum depth of 0.10m, across the entire site (Figure 2, Plate 1). This work did not breach the dark brown sandy silt topsoil.

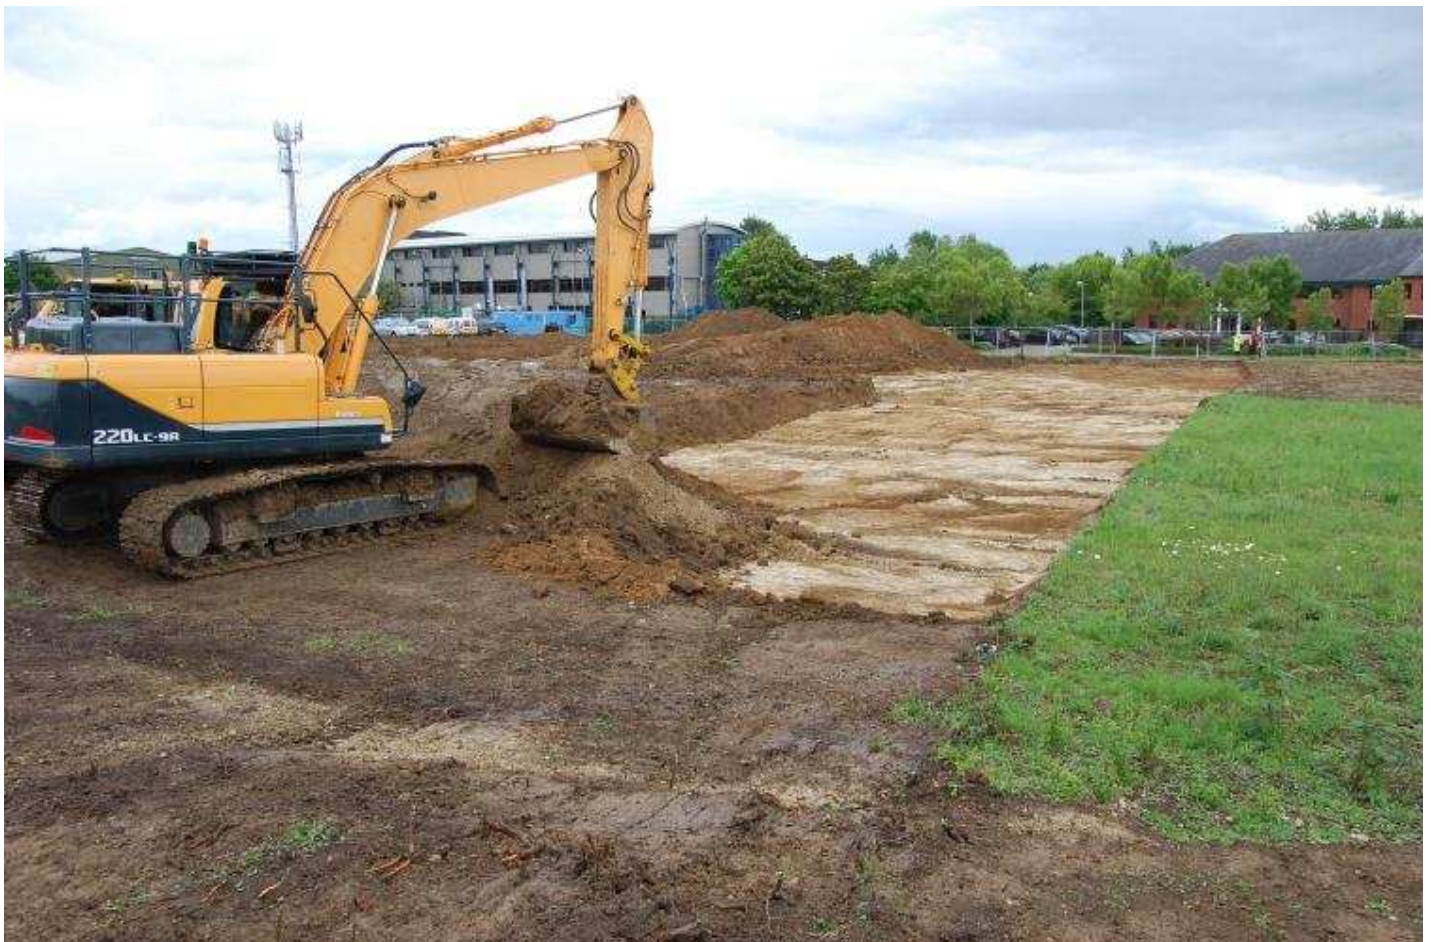
Plate 02 - Access road during ground reduction, looking SE

2.16 The access road was located at the south-western end of Zone 5, within the area of archaeological potential. It crossed the zone on a north-west to south-east alignment and covered an area of approximately 1519m². The ground level across the access road was reduced by approximately 0.50m (Plate 2).

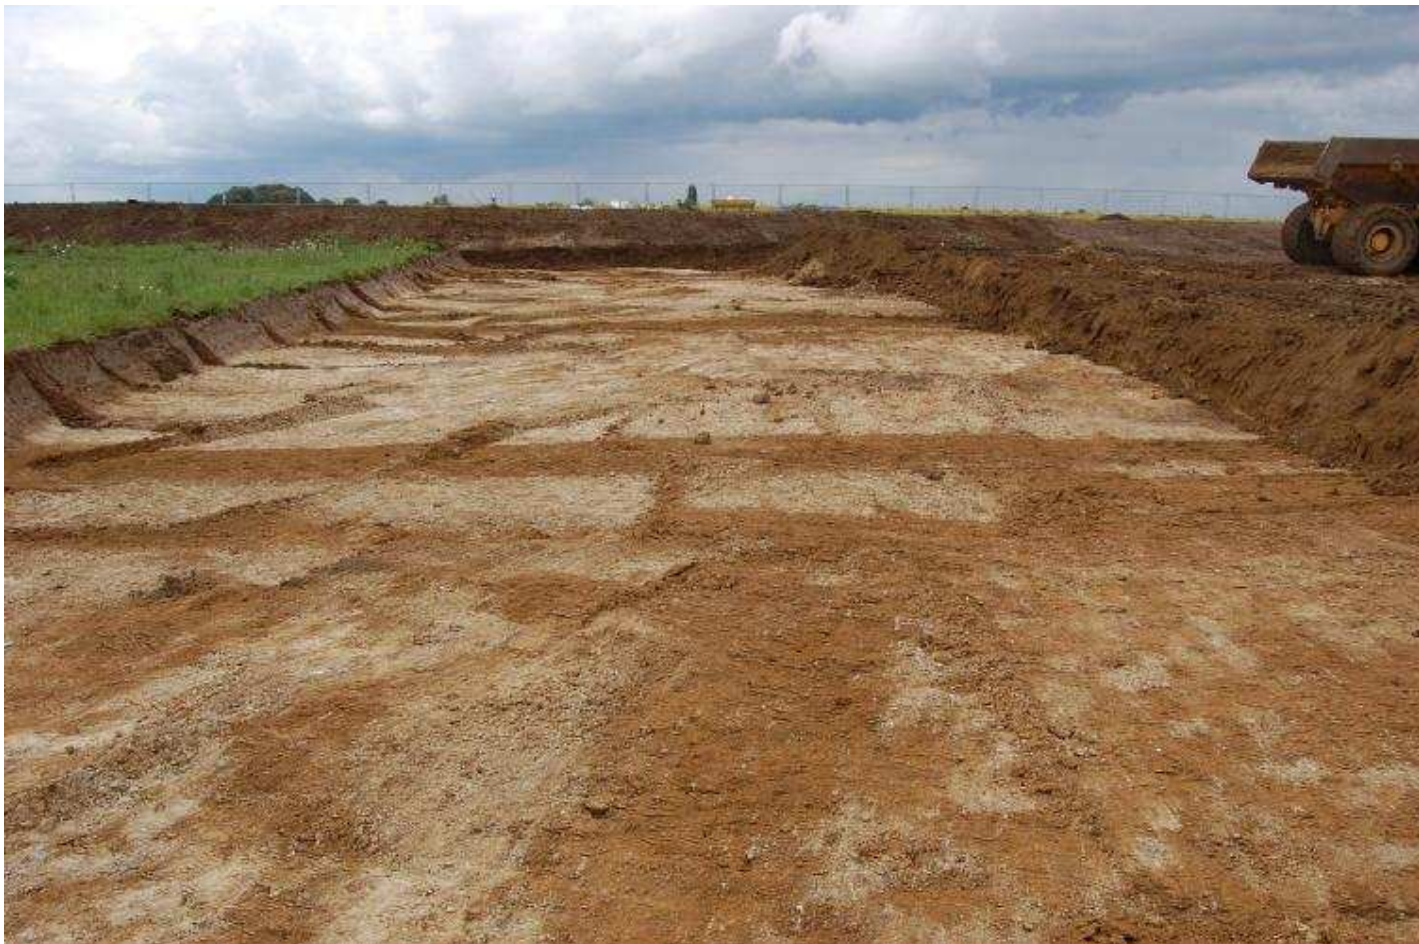
Plate 03 - Access road following ground reduction, looking NW

2.17 A number of roughly parallel linear features were revealed cutting the natural sand towards the north-western end of the access road (Plate 3). Linear R[101] was located between R[111], to the south-east, and R[103]/[105] to the north-west (Figure 2). It ran north-east to south-west and measured over 10m in length, 0.95m in width and 0.30m in depth, with steep sides and a flat base (Figure 3). The fill, R(102), consisted of friable mid reddish brown silty clay, with occasional small to medium chalk inclusions (Plate 4). A small abraded sherd of undateable pottery was recovered from the fill. This feature appeared to represent the south-eastern continuation of linear [2901], recorded in Trench 29 during the evaluation in 2014 (Ashworth, Hillelson & Jones 2014).

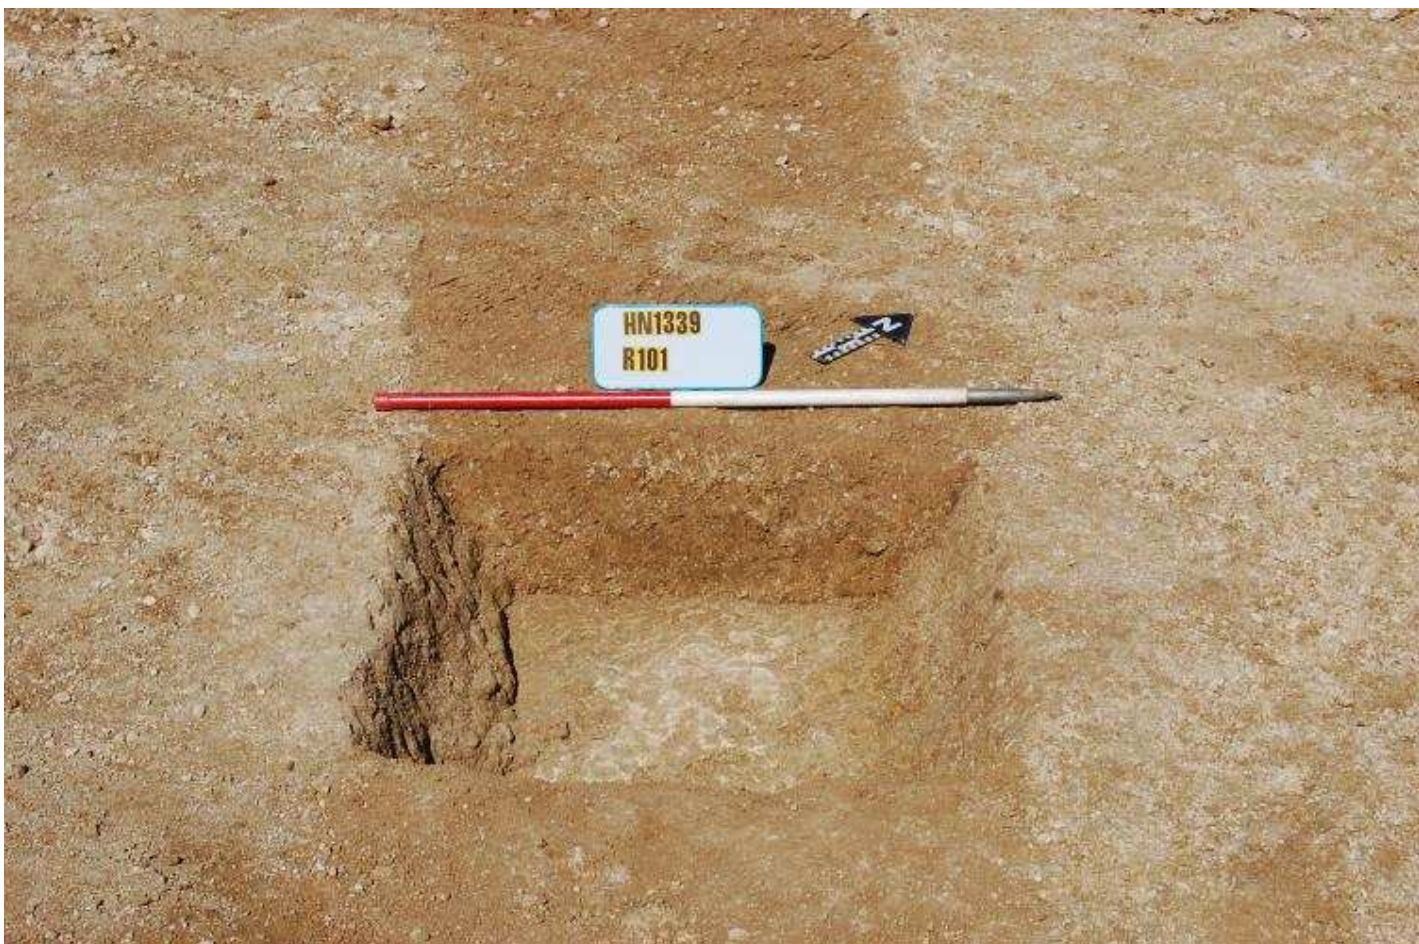
Plate 04 - Section through linear R[101], looking N

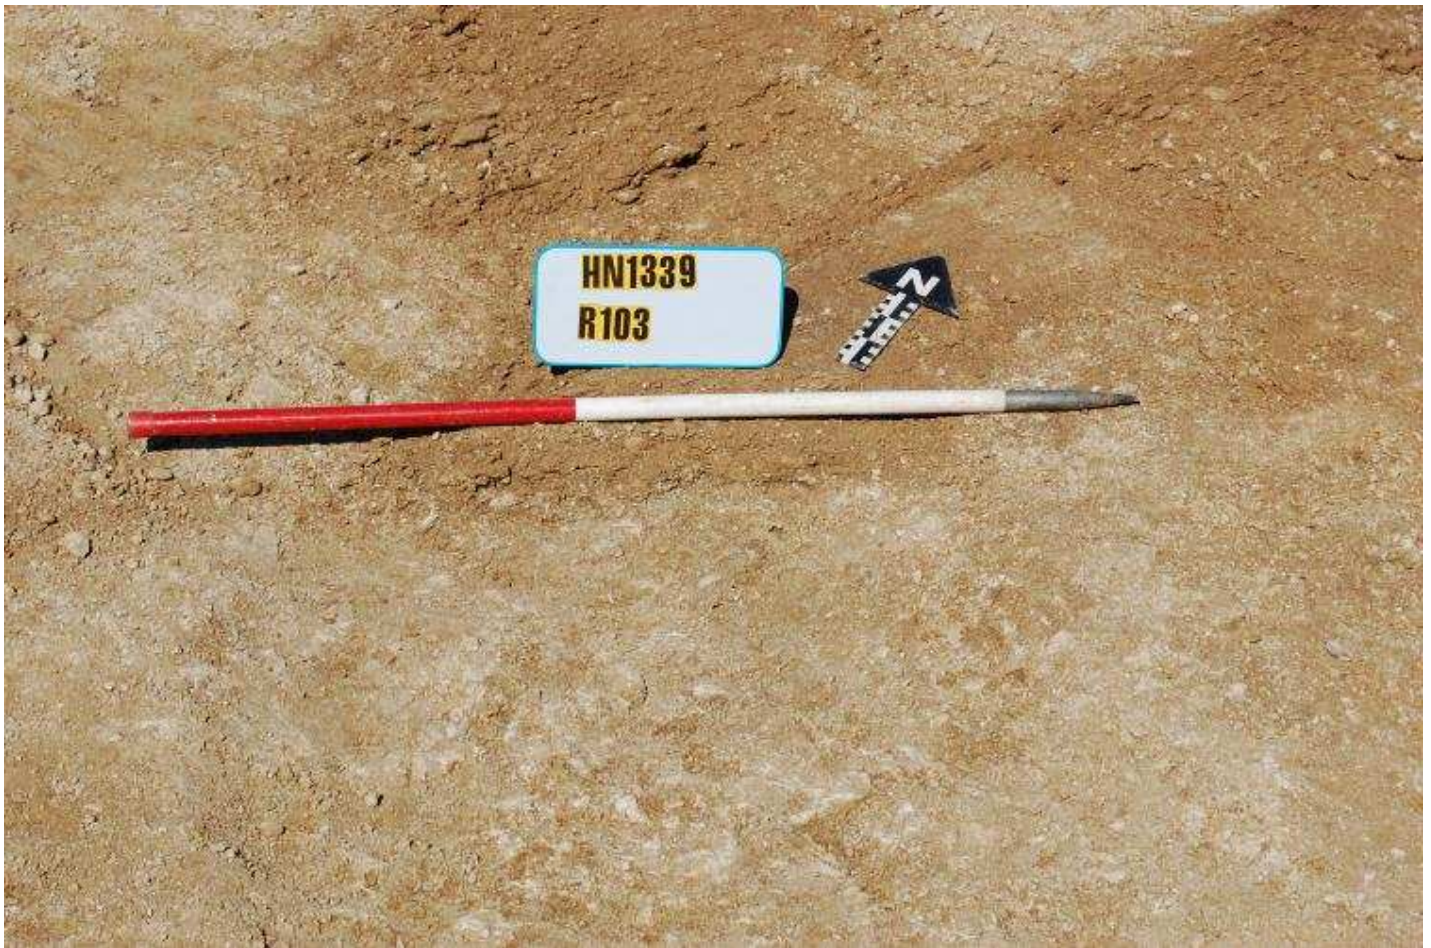
Plate 05 - Section R[103], looking NW

2.18 Linear R[103] lay approximately 7m to the north-west of R[101]. It ran north-east to south-west and measured over 10m in length, 0.84m in width and 0.07m in depth, with shallow sides and a concave base (Figure 3). The fill R(104) consisted of friable mid reddish brown silty clay with occasional small to medium chalk inclusions. No finds were uncovered from within the fill and it was not encountered in Trench 29 (Plate 5).

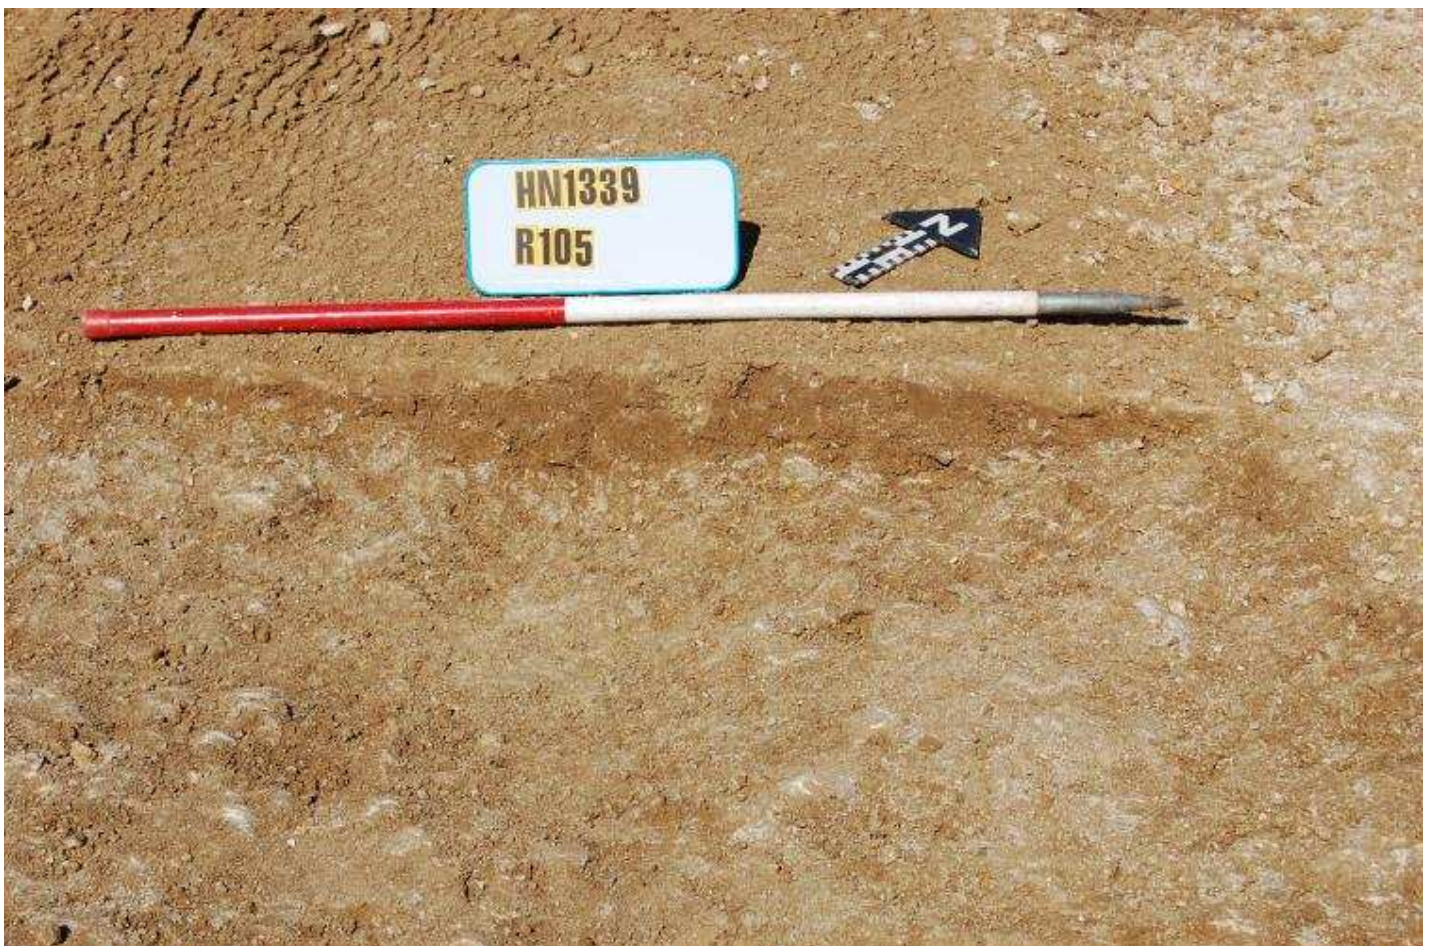
Plate 06 - Section R[105], looking NW

2.19 A second section, R[105], was excavated to the NW, across the same linear. This revealed a slightly different profile which measured 1.2m in width and 0.10m in depth, with a shallow concave base. The fill R(106), consisted of friable mid reddish brown silty clay with occasional small to medium chalk inclusions (Plate 6). Four sherds of medieval pottery were recovered from the fill.

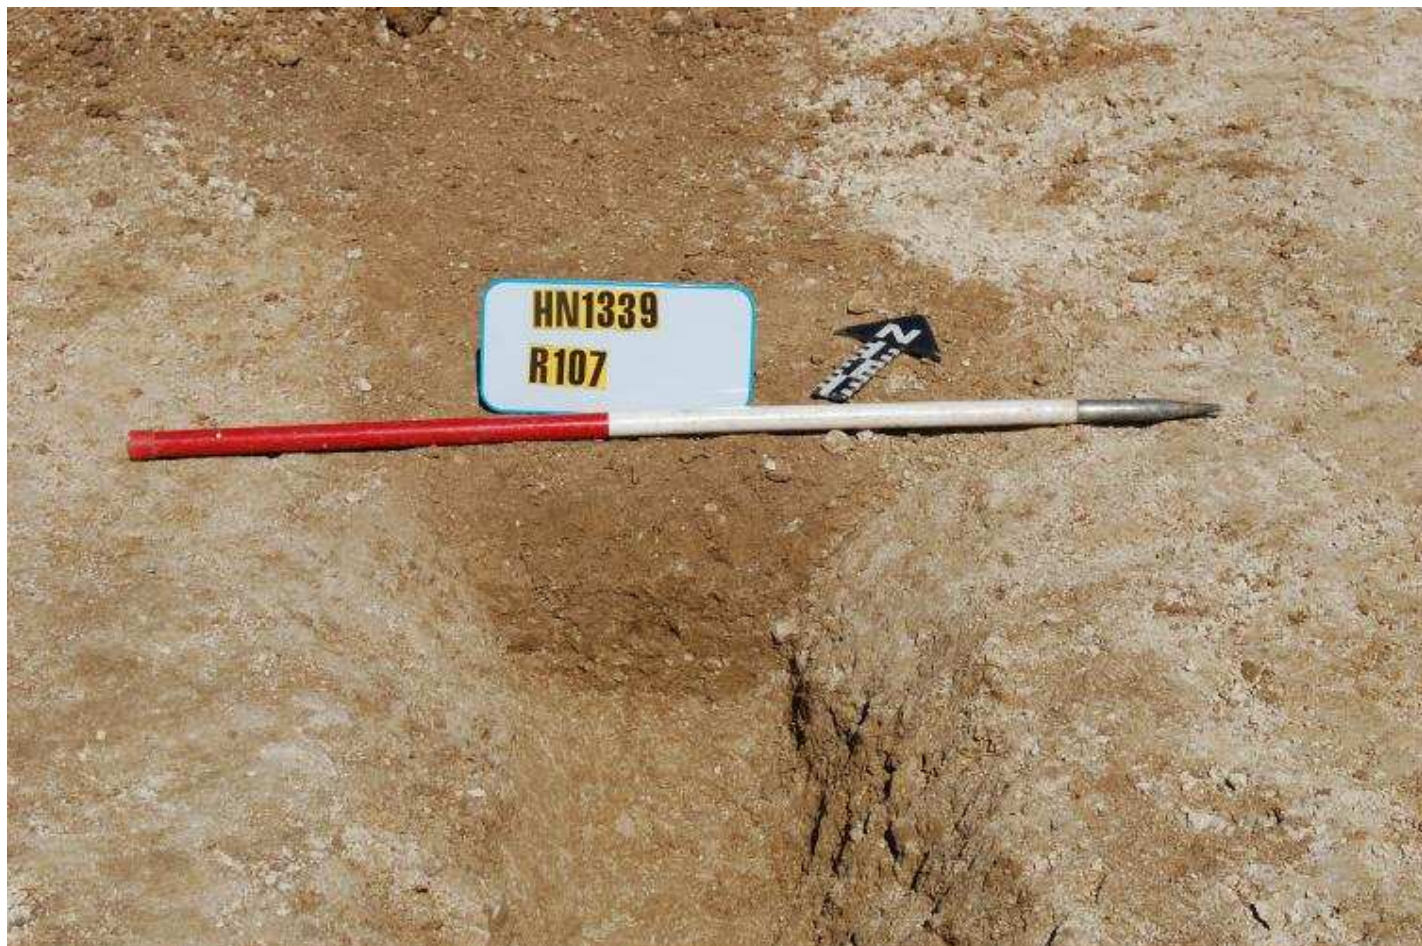
Plate 07 - Section R[107], looking NW

2.20 Linear R[107] was located approximately 8m to the north-west of R[103]/[105]. It was aligned ENE-SSW and measured over 11m in length, 0.52m in width and 0.28m in depth, with steep sides and a concave base. The fill R(108) consisted of friable mid brown silty clay with occasional small to medium chalk inclusions (Plate 7). A small sherd, possibly intrusive, sherd of modern pottery was recovered from the fill.

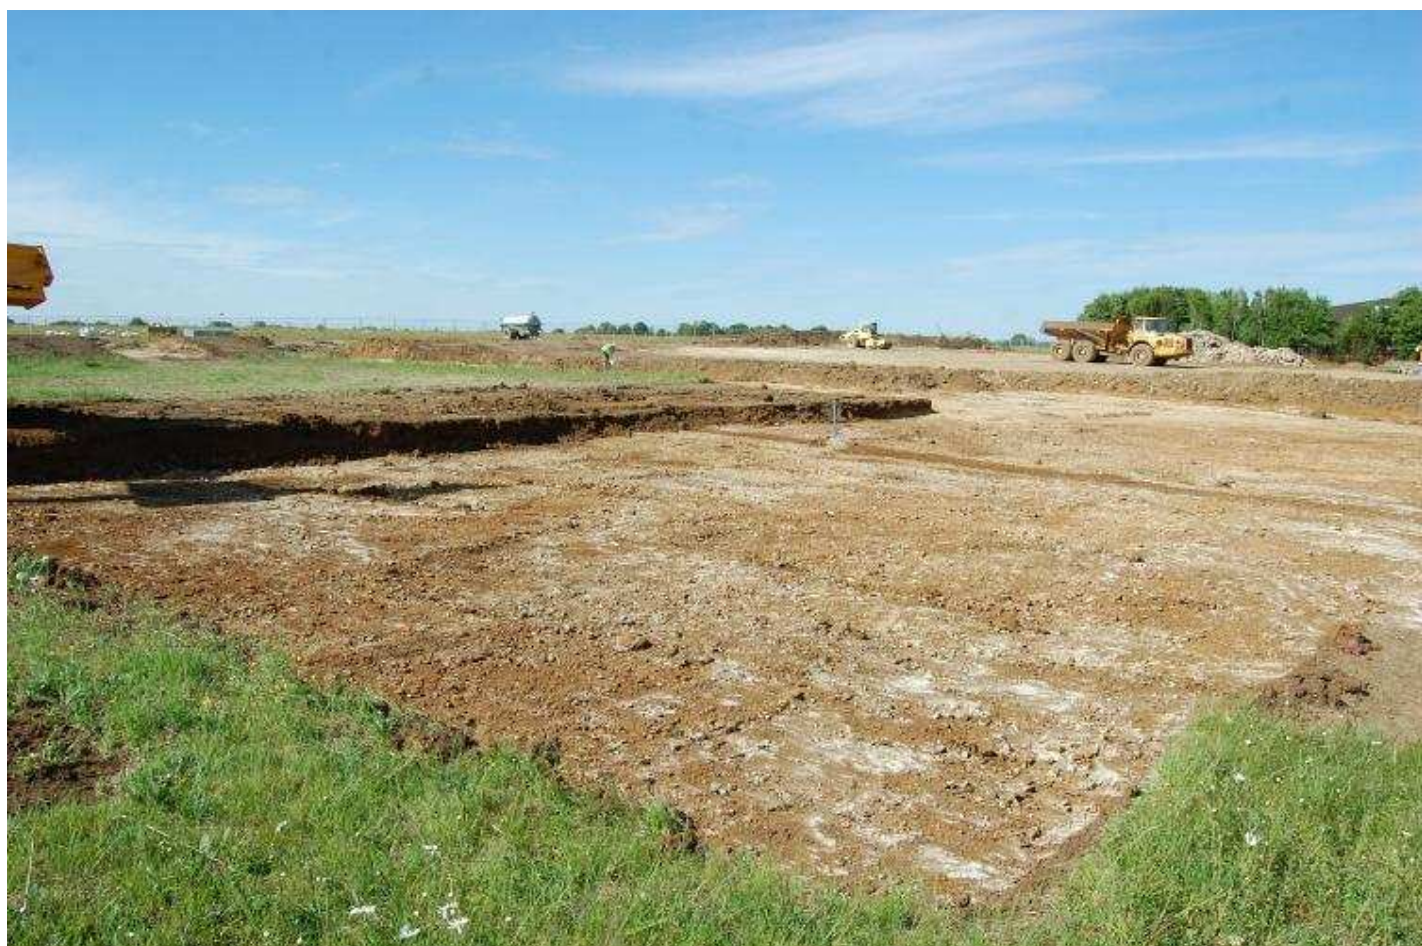
Plate 08 - Area of the attenuation tank after ground reduction, looking N

2.24 The area reduced for the attenuation tank was located immediately adjacent to the south-eastern end of the access road (Figure 2). It formed an irregular rectangle, with a maximum length of 45m and a maximum width of 36.50m. The ground level across this area was reduced by approximately 0.50m (Plate 8).

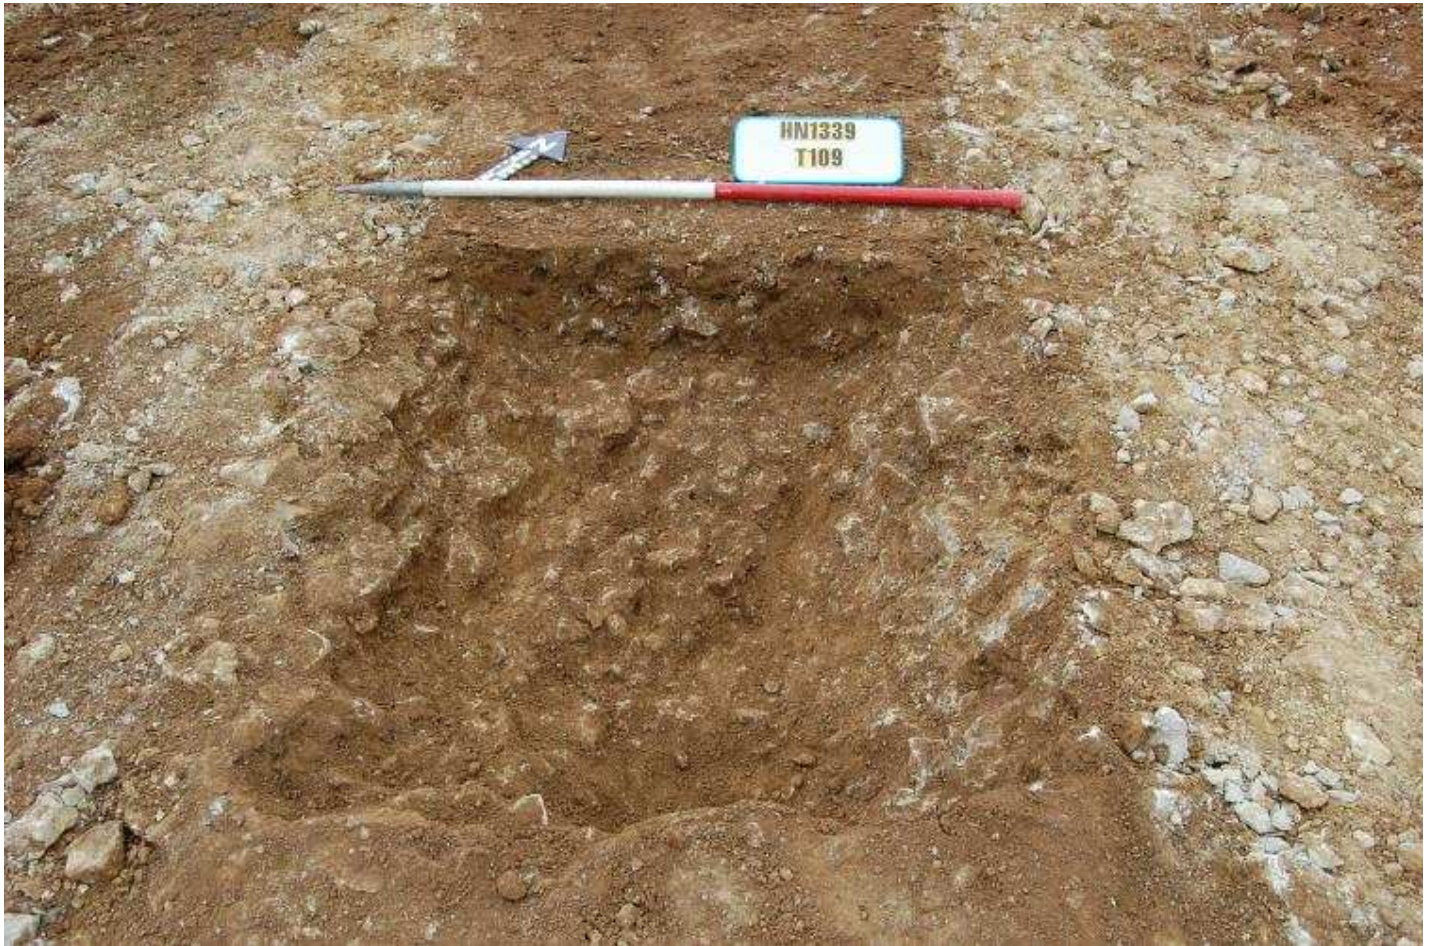
Plate 09 - Section T[109], looking NW

2.25 One linear feature, T[1009], was revealed in this area. It was aligned approximately north-west to south-east and measured over 24m in length, approximately 0.95m in width and c.0.16m in depth, with irregular sides and a flattish base (Figure 3). The fill, T(110), consisted of friable mid orangey brown clayey sandy silt, with frequent angular chalk fragments over 0.15m in diameter (Plate 9) . No finds were uncovered from within the fill.

2.26 The geophysical survey shows that this feature continues beyond the reduced area. Cartographic evidence suggests that it may form part of a boundary shown between furlongs in the common field and which had survived into the post-enclosure landscape, but which had disappeared by 1879 (Ashworth et al 2014, Figures 5 – 8).

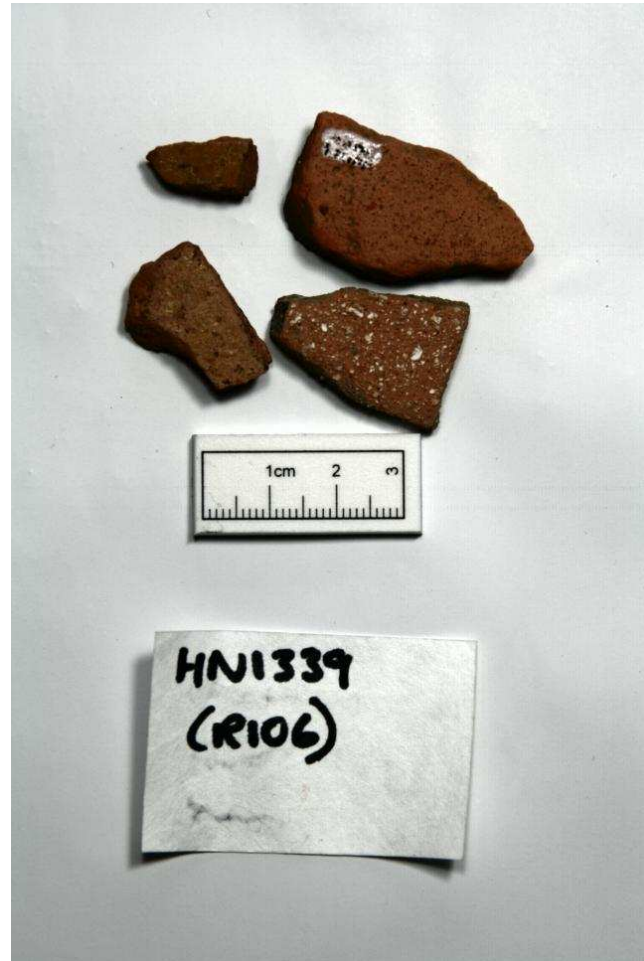
Plate 10 - Medieval pottery sherds from R(106)

2.29 The earliest pottery was recovered from R(106), the fill of section R[105]. A small group of four sherds of medieval, or probable medieval, date were collected from this context (Plate 10).

- One of the sherds was shell-tempered, indicating a date between the 10th and 12th centuries.
- A further two sherds are likely to be from the same vessel. These are in a fine oxidised fabric, sparsely tempered with fine sand and quartz, possibly from the kiln site at Boarstall. Both sherds have a yellowish green glaze on the exterior. They have been dated to the period between the 12th – 14th centuries.
- The fourth sherd is unglazed. It has a thicker section, but is in a similar fabric, with a reduced core. This may also be from Boarstall, with a date between the 12th and 14th centuries.
