RED BRICK COTTAGE

The Street, Kelshall, Hertfordshire

HN1353

Report No. 1091

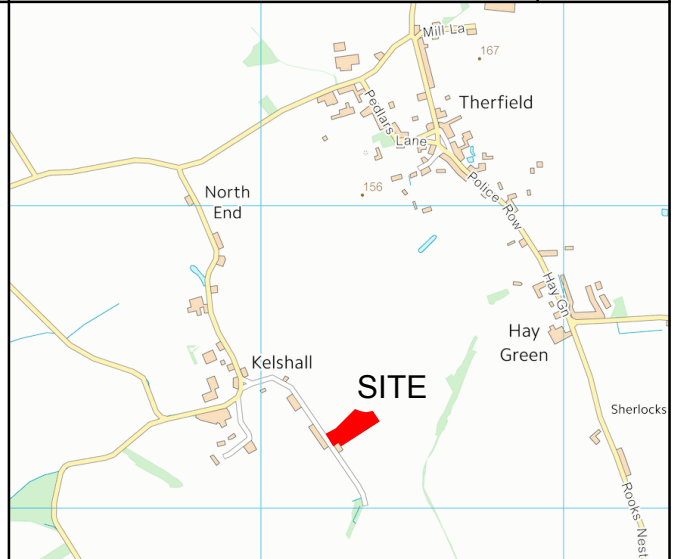
Site location and layout

The footprint of the new barn was reduced down to the top of the subsoil, using a 1 tonne tracked mini-digger fitted with a 0.6m wide ditching bucket, or a 0.6m wide toothed bucket where appropriate. No archaeological features, deposits or finds were revealed during this phase of the work (Figure 2, Plates 9 & 10).

Pad footings were excavated in eight places around the perimeter of the building footprint. The pits measured between 0.8m and 1.3m in length, 0.5m in width, and were excavated to a depth of between 0.65m and 0.8m. No archaeological features, deposits or finds were encountered during this phase of the work (Figures 2 & 3, Plates 1-8).

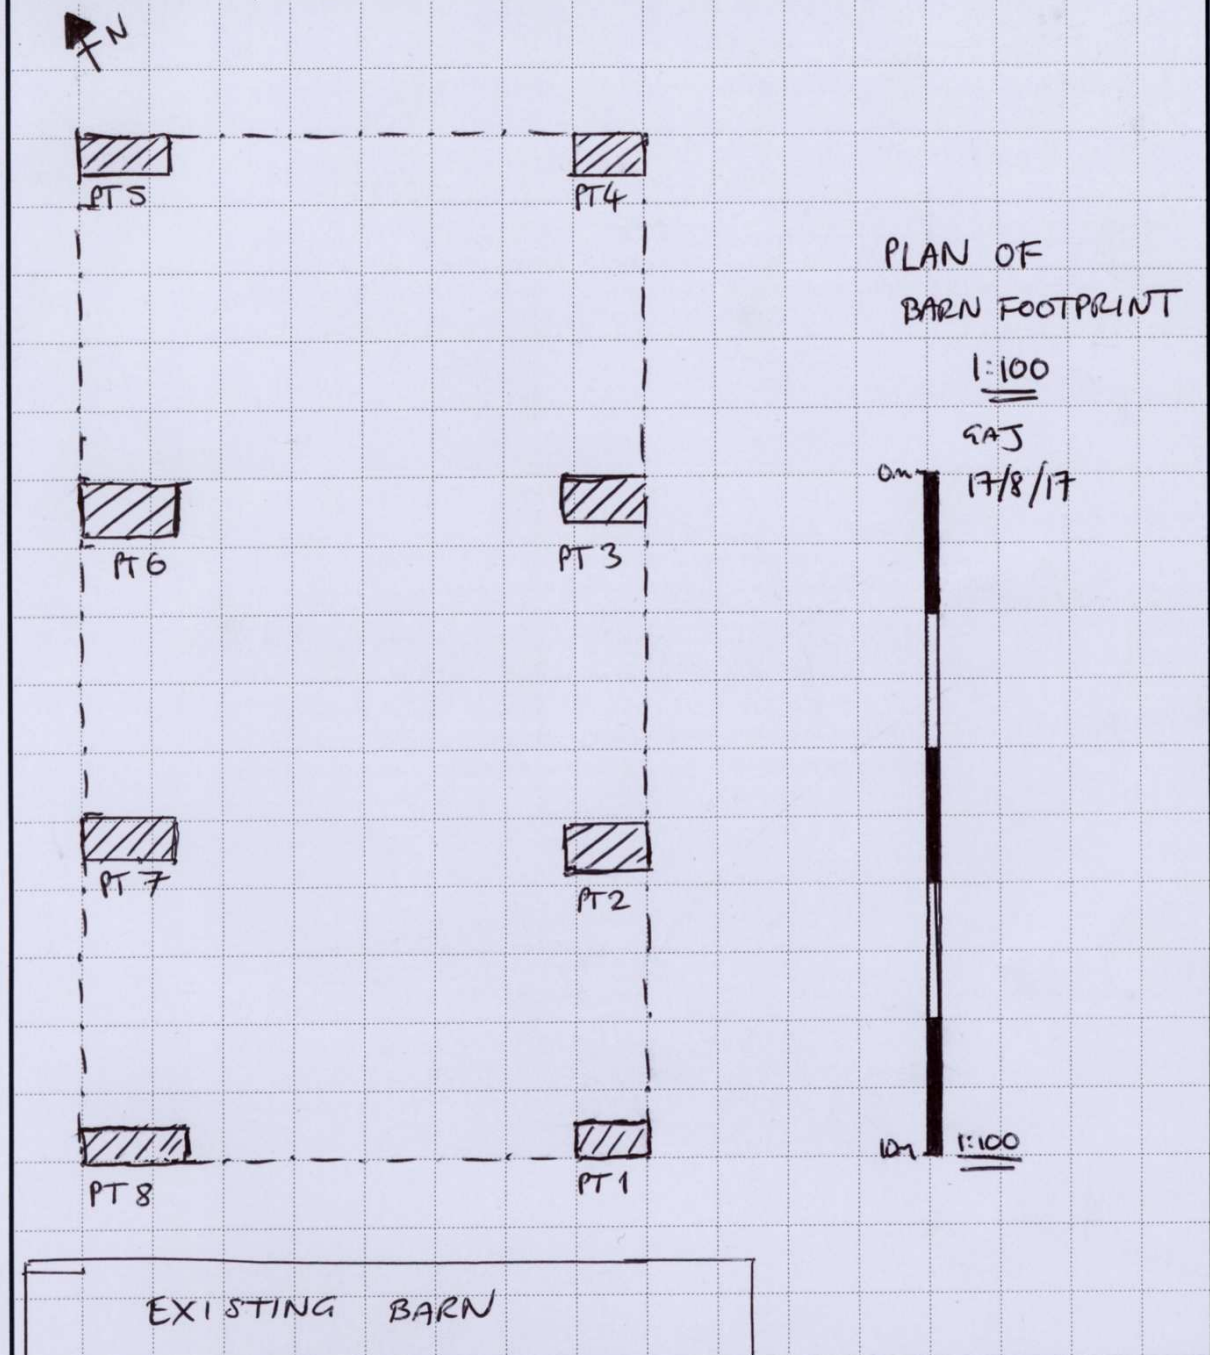
Monitored excavation of 8 pad trenches - All blank.
 Monitored topsoil strip of barn footprint - No archaeology observed at this level.

PLAN OF BARN FOOTPRINT, SHOWING TOPSOIL STRIPPED AREA (DOWN TO TOP OF SUBSOIL) & THE LOCATION OF THE PAD FOUNDATIONS TRENCHES.
