**Land r/o 23 Edward Street, Dunstable, Bedfordshire.**

HN1362

Report No.1083

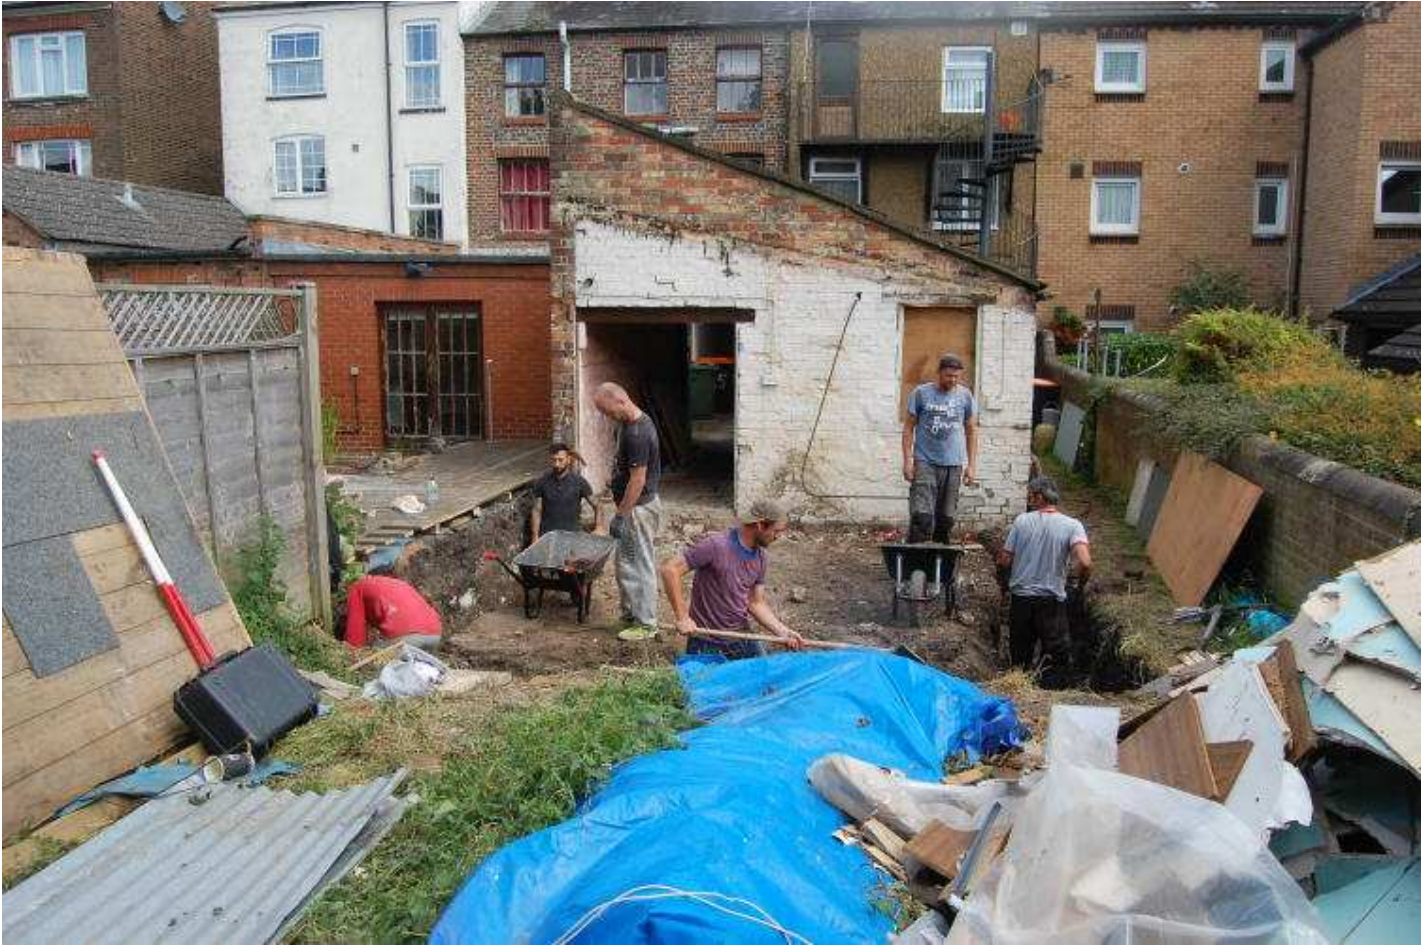
Three footings trenches (Trenches 1, 2 & 3), forming a 'U' shape in plan, were excavated adjacent to the south-west elevation of the existing outbuilding (Figure 2, Plate 1). Due to the confined access to the site, the excavation was undertaken by hand. Trenches 1 and 3 measured 3.89m in length, while Trench 2 measured 4.8m in length. All trenches measured 0.6m in width and were excavated to a maximum depth of 1m (Plate 2).

Plate 01 - working shot of footing trenches, looking NE

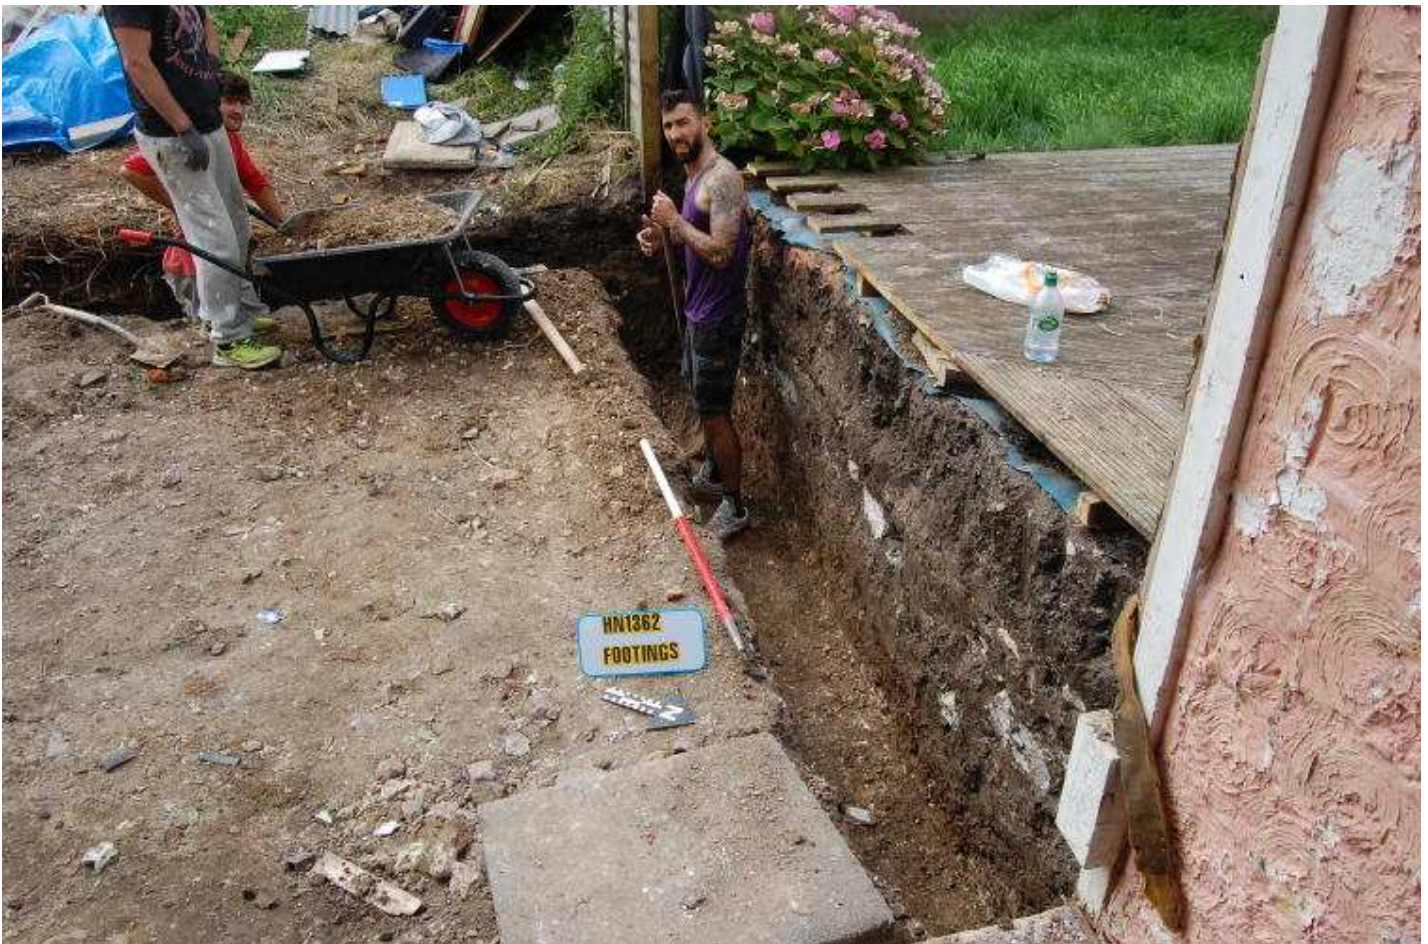
Plate 02 - Footing trench, looking SW

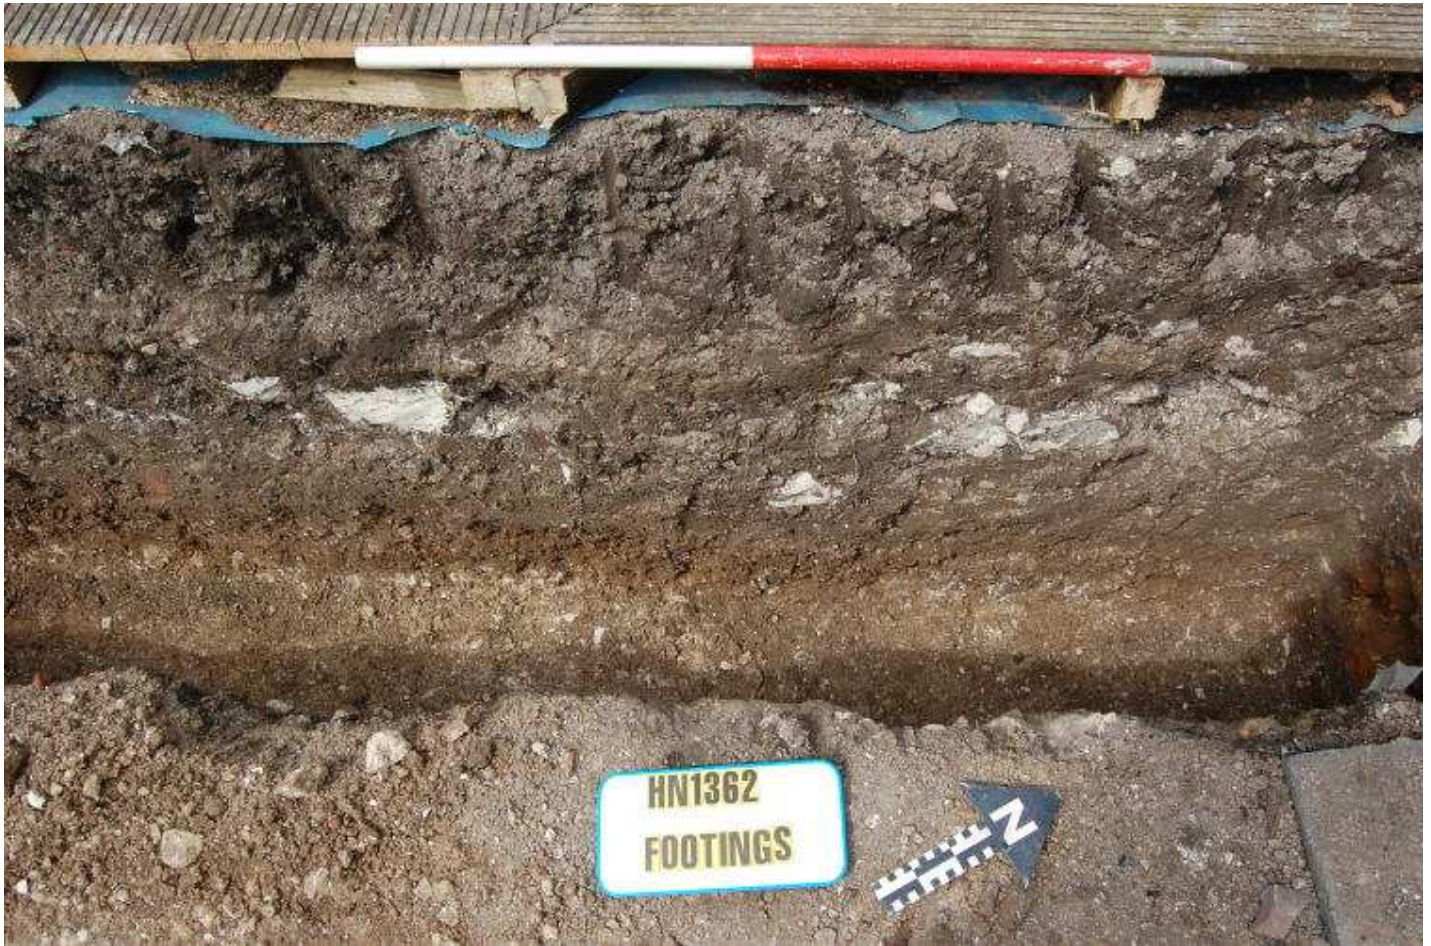
The sections in all three trenches revealed a similar stratigraphy, consisting of dark greyish brown, friable, silty clay topsoil, which measured 0.15m in depth after the removal of the concrete raft, containing occasional small rounded stones. The original depth of topsoil, which measured 0.28m, was exposed in the south-east facing section of Trench 1 (Figure 2, Plate 3). Below this was a layer of made ground, consisting of mid-olive brown, friable silty clay, 0.5m thick, containing frequent large chalk fragments, crushed chalk, red brick, slate and glass. This in turn overlay a mid-brown, friable silty clay, 0.35m thick, containing frequent small chalk inclusions and interpreted as a buried subsoil. The top of the natural chalk was only exposed in the north-west corner of the excavation.

Plate 03 - Indicative section, looking NW
