M/A-COM BUILDING Cambridge Road, Harlow, Essex.

HN641

Archaeological Monitoring Report

Report no. 418

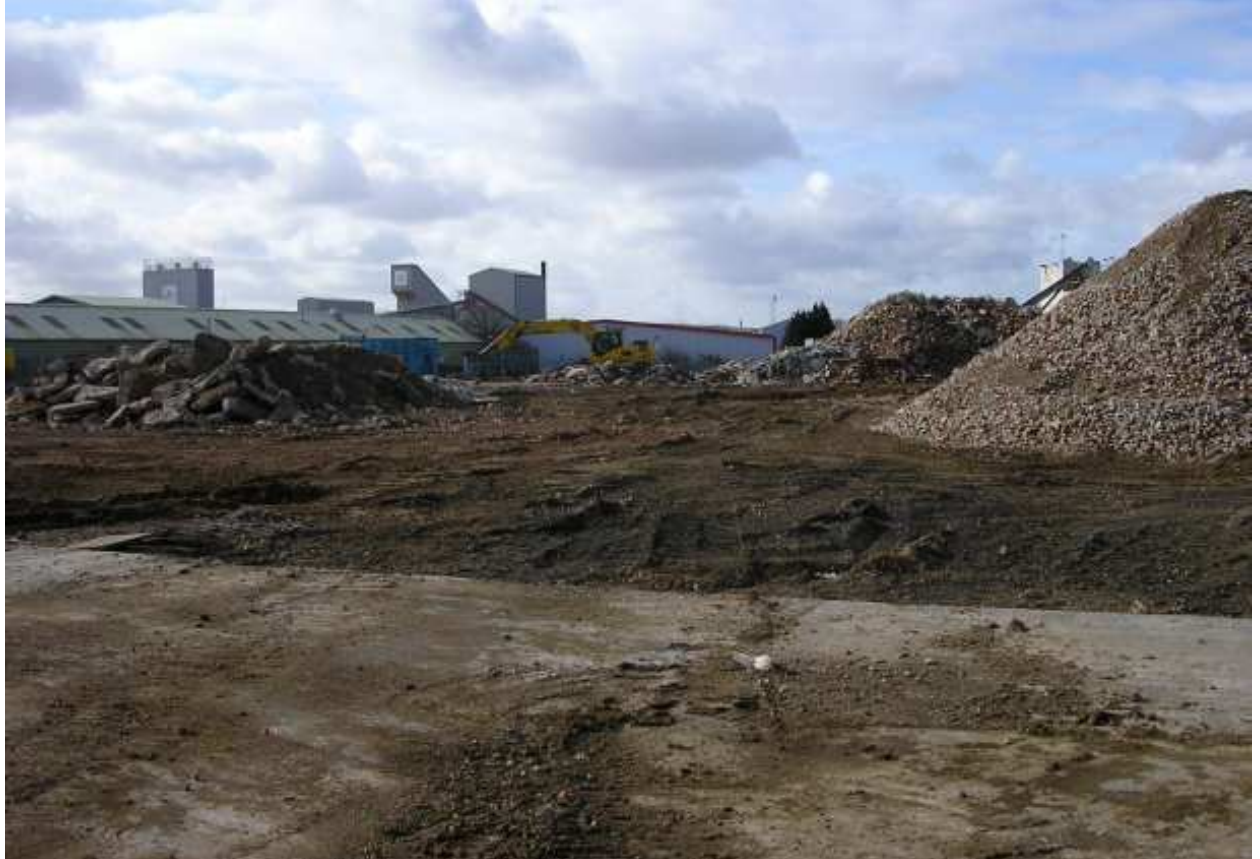
2.9 Removal of the tarmac reduced the ground level by approximately 0.20m, revealing a modern make up layer, containing hardcore, which varied between 0.20m and 0.35m in depth (Plate 1).

Plate 1: Area of tarmac removal

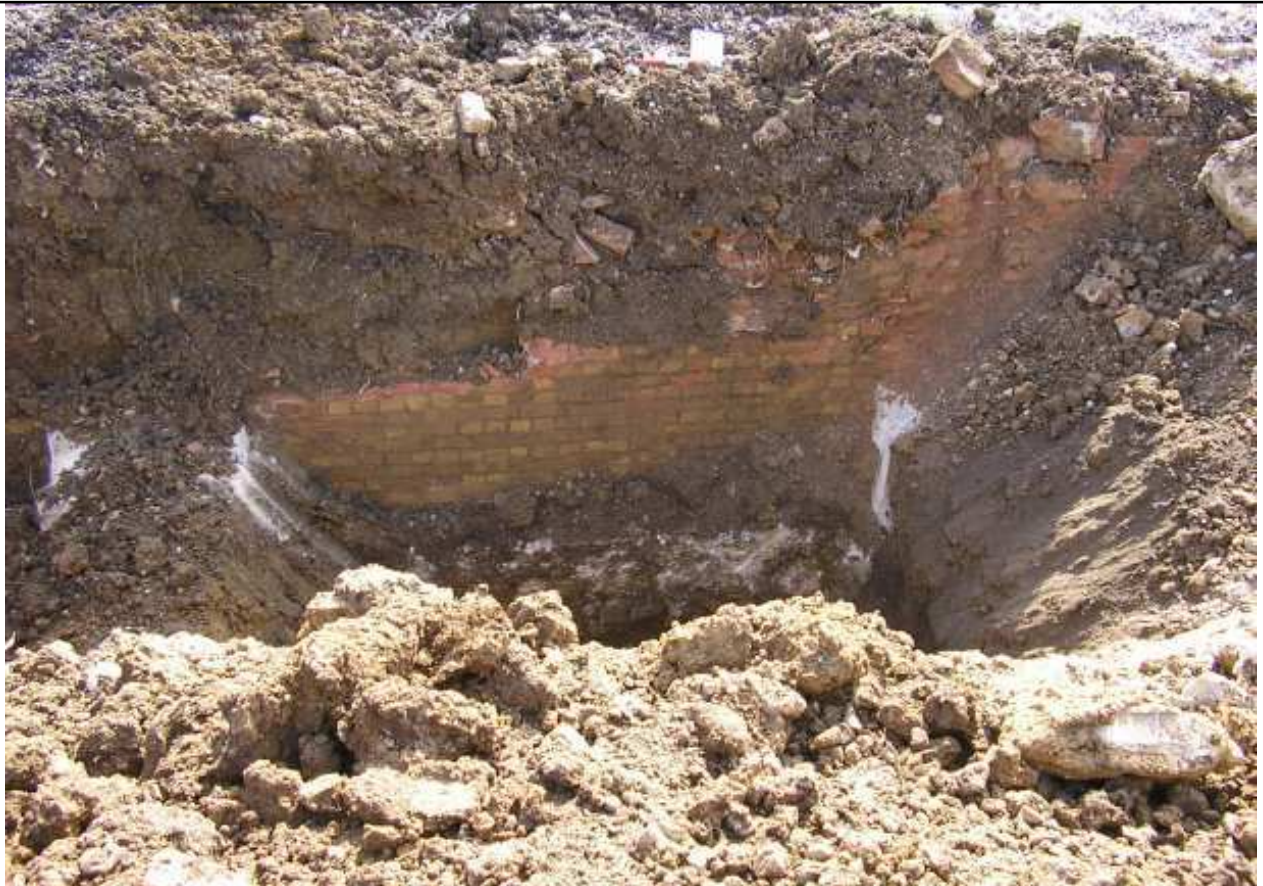
2.10 The demolition of the wall was abandoned due to the depth of its footings, which exceeded 2.50m below the present ground level (Plate 2). They were, however, successfully removed to a depth of 0.82m below the ground surface, revealing a series of deposits on the southern, exterior, side of the wall.

Plate 2: South wall, former M/A-Com building, under demolition

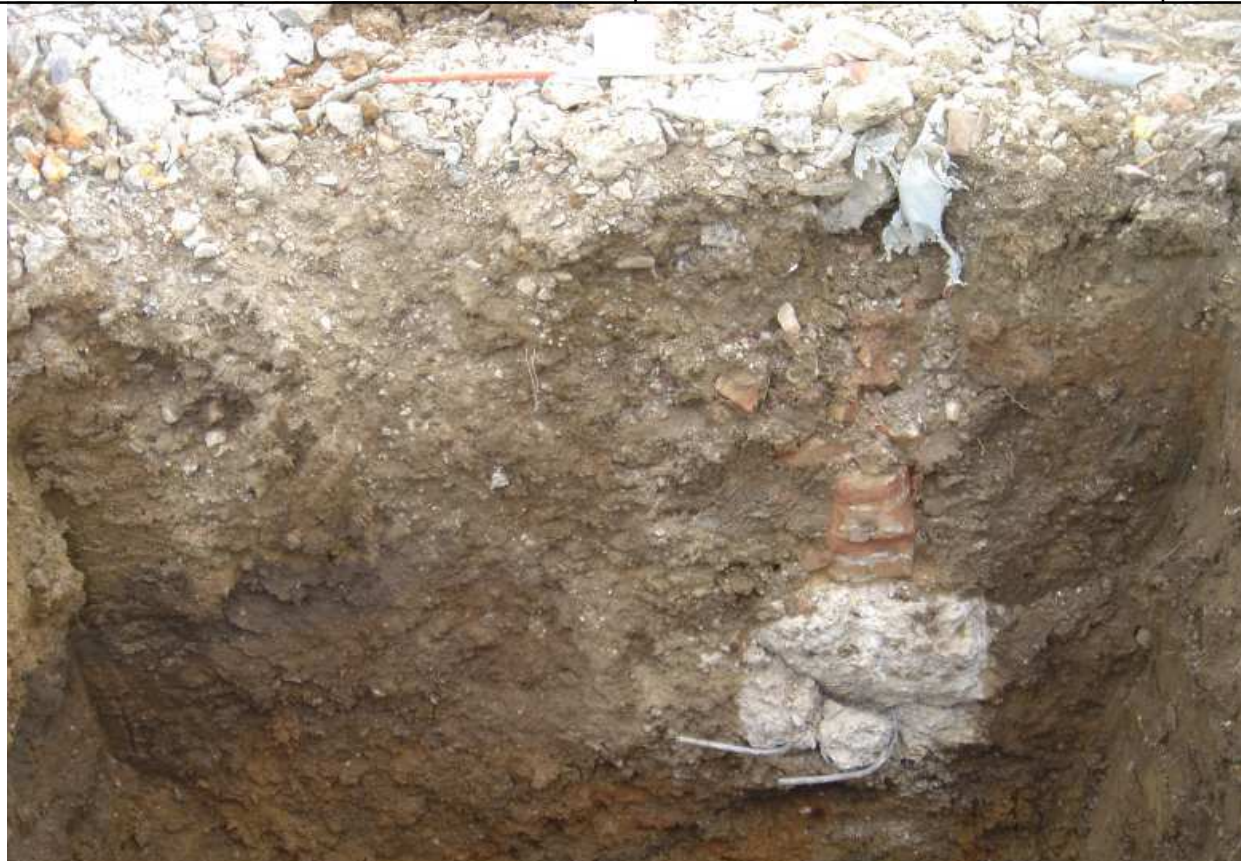
2.19 The cut for the wall foundation trench was observed in the east and west sections of Pads 1 and 8 (Plate 3). The cut measured approximately 1m wide and 1.20m deep, with straight sides and a flat base. It contained a very dark grey (10YR 3/1) silty clay with frequent small stones. The wall was two bricks wide, approximately 0.21m, and was bedded into a concrete foundation measuring 0.50m wide and approximately 0.50m deep.

Plate 3: East facing section, Pad 8, showing wall foundation trench

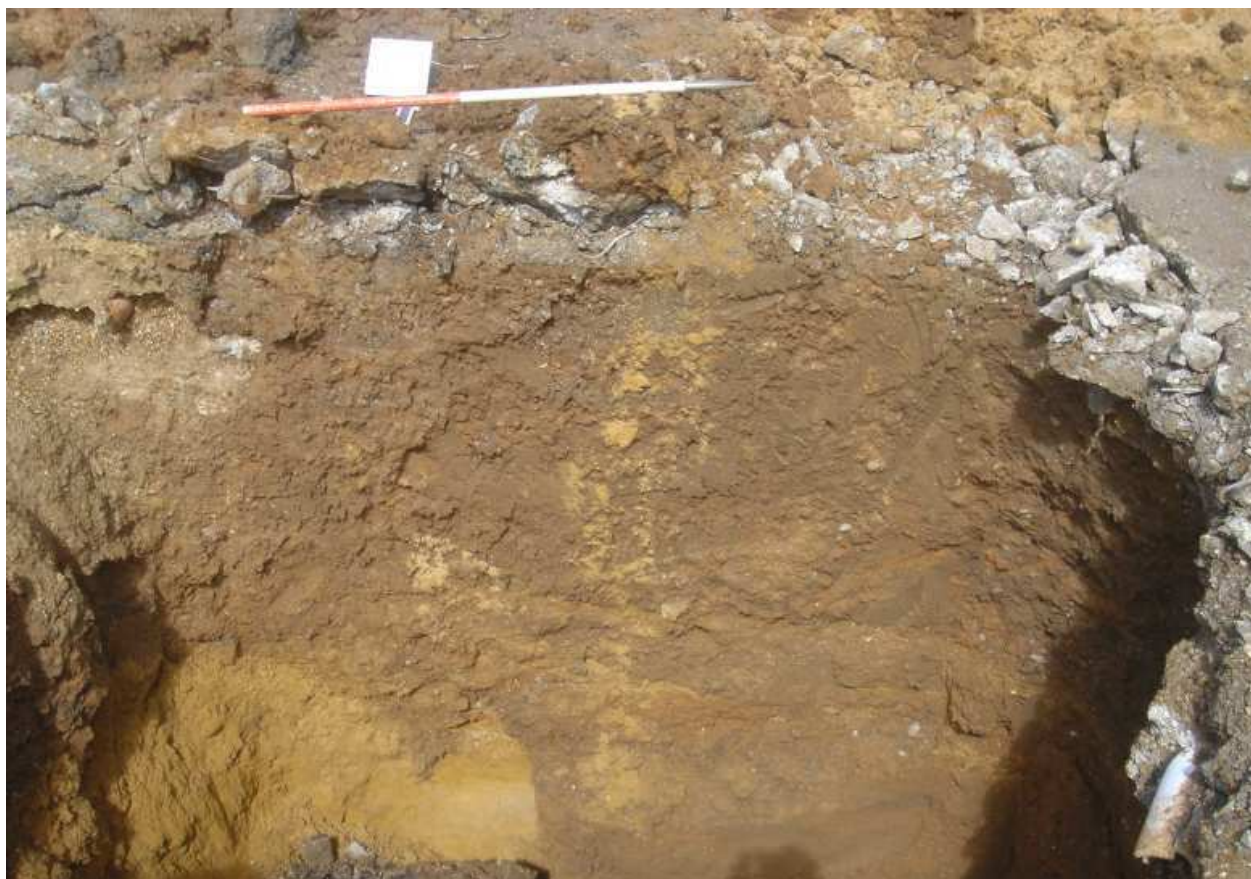
2.20 The general stratigraphy recorded in the foundation pad sections along the eastern side of the new building consisted of a dark yellowish brown (10YR 4/4) silty clay, over 2.50m in depth. The edge of a brownish yellow (10YR 6/8) sand layer, possibly re-deposited natural sand 1.20m in depth, was observed in the bottom corner of the eastern section of Pad 12 (Plate 4).

Plate 4: North facing section, Pad 12

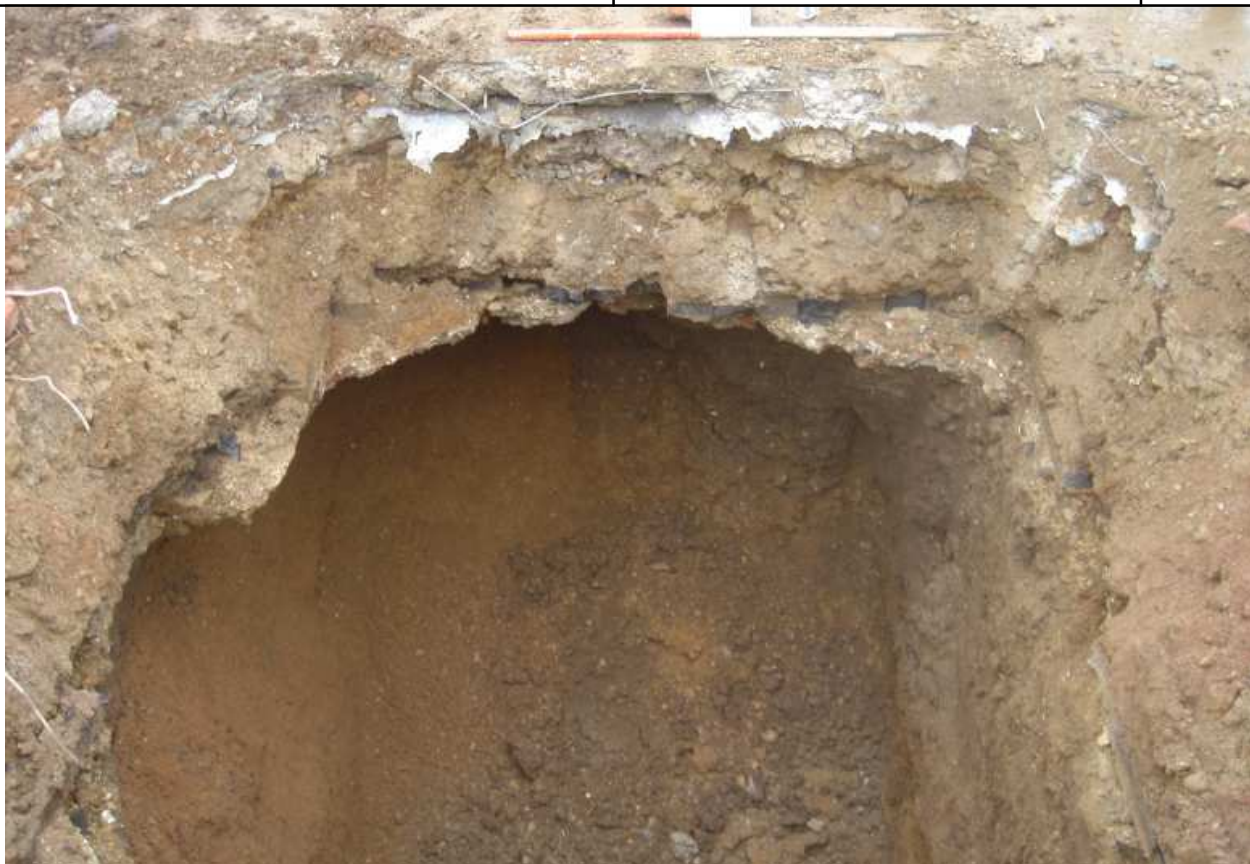
2.23 A brick floor was observed in the sections in Pad 22, halfway along the northern side (Plate 5). The floor lay at a depth of 0.60m, beneath the concrete surface and sand and gravel make-up layer previously recorded. It measured at least 8m wide and 0.20m deep and sat on a concrete base, 0.30m deep. Its depth below ground and its location suggest that it may have been associated with one of the structures built between 1921 and 1938.

Plate 5: North facing section, Pad 22, showing brick floor

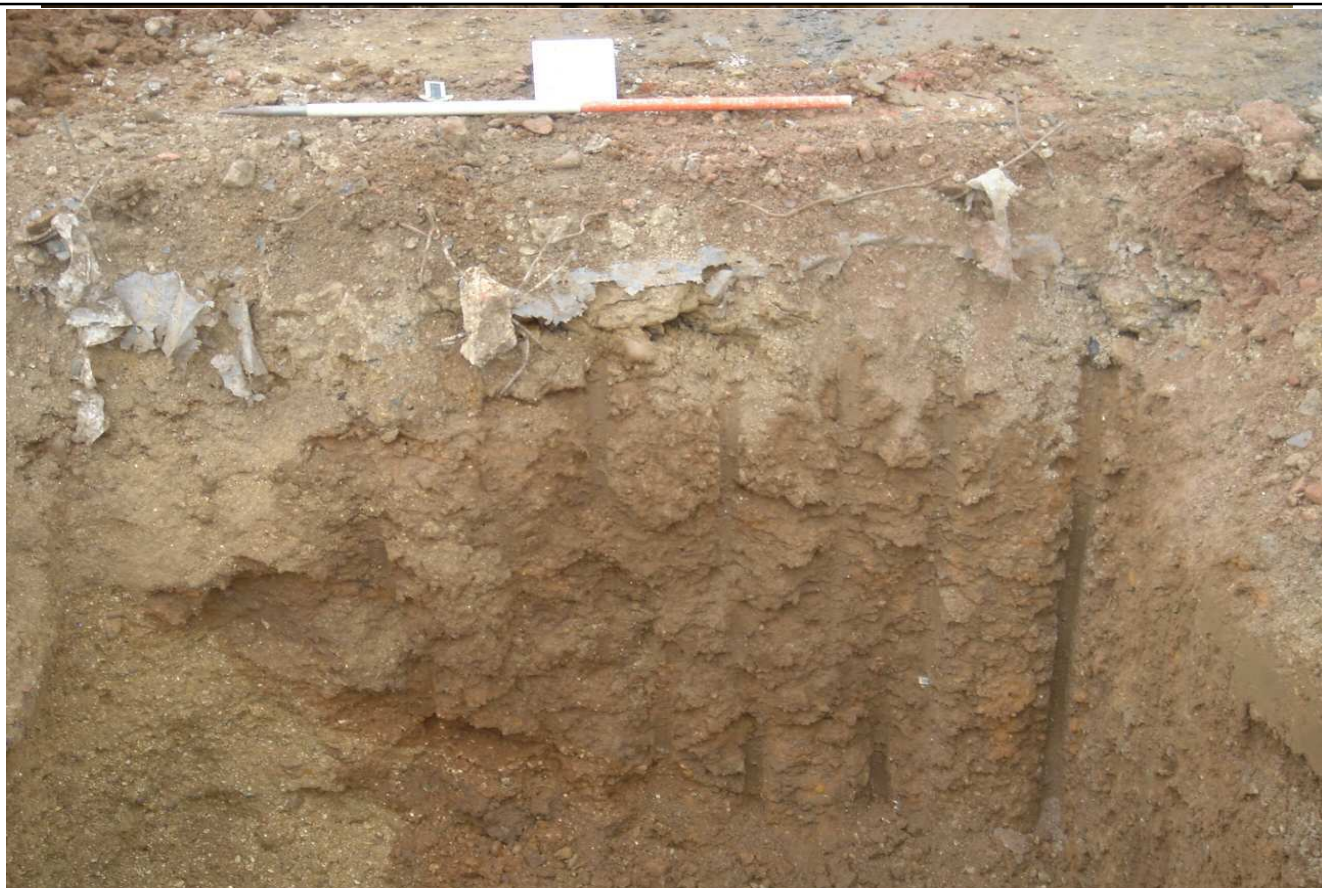
2.25 The possible cut for the eastern edge of a quarry pit was recorded in the southern section of Pad 27 (Plate 6). This showed as a diagonal line, sloping steeply downwards, east to west. The natural sand lay on the eastern side of the line and a greyish brown (10YR 4/4) silty clay, representing possible backfill, lay on the western side.

Plate 6: East facing section, Pad 27, showing cut for gravel pit

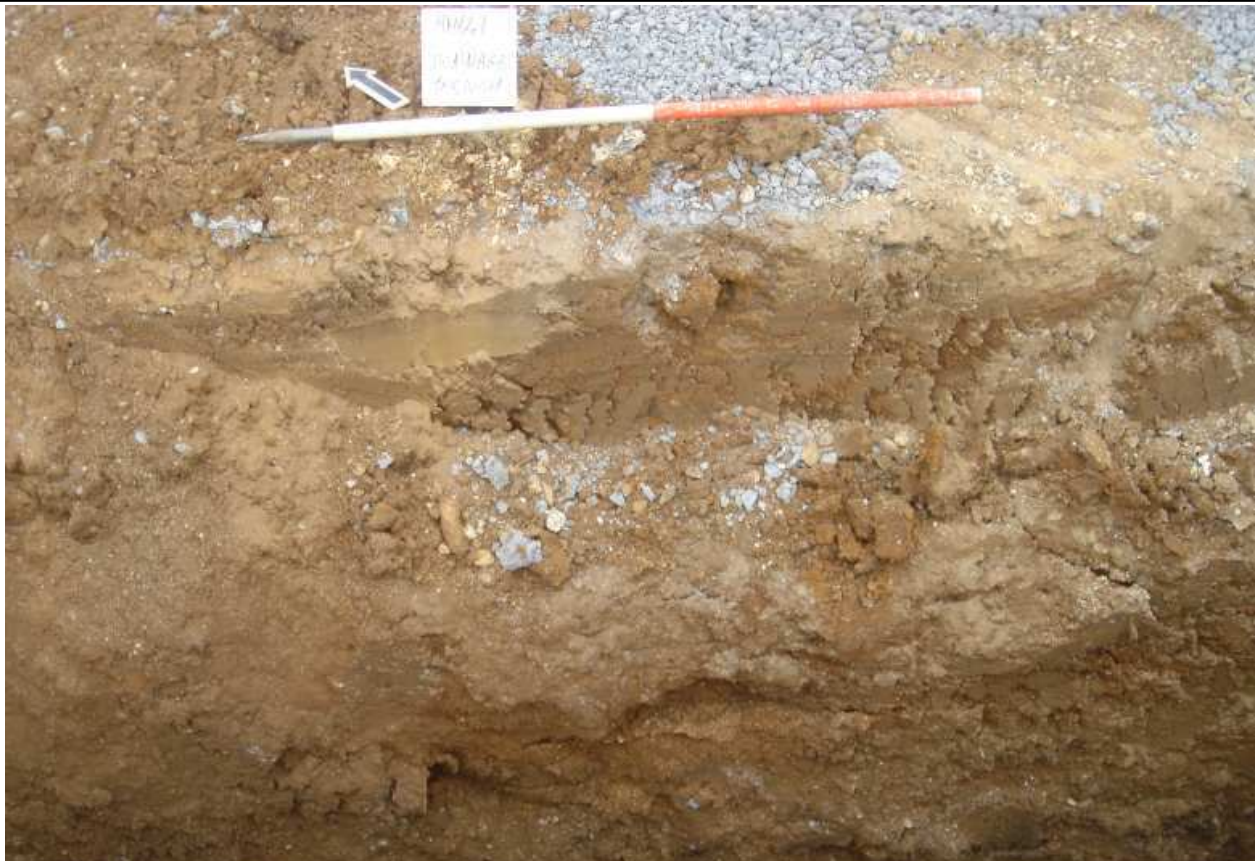
2.27 The drainage trenches on the eastern side of the site were excavated to a depth of c.2.10m and on the western side to a depth of c.1.70m. The general stratigraphy observed in the eastern side consisted of a layer of concrete, c.0.15m deep, over grey (10YR 3/4) silty clay, approximately 1.50m deep (Plate 7). The sections in the drainage trenches in the north-western corner of the site revealed a layer of yellowish brown (10YR 5/8) silty clay, 0.40m deep, above a grey (10YR 3/4) silty clay soil, 0.50m deep. Below this was a layer of very dark greyish brown (10YR 3/2) silty clay soil. The natural sand and gravel was not reached in any of these trenches and no finds were recovered to date the deposits.

Plate 7: Stratigraphy in drainage trench at west end of site

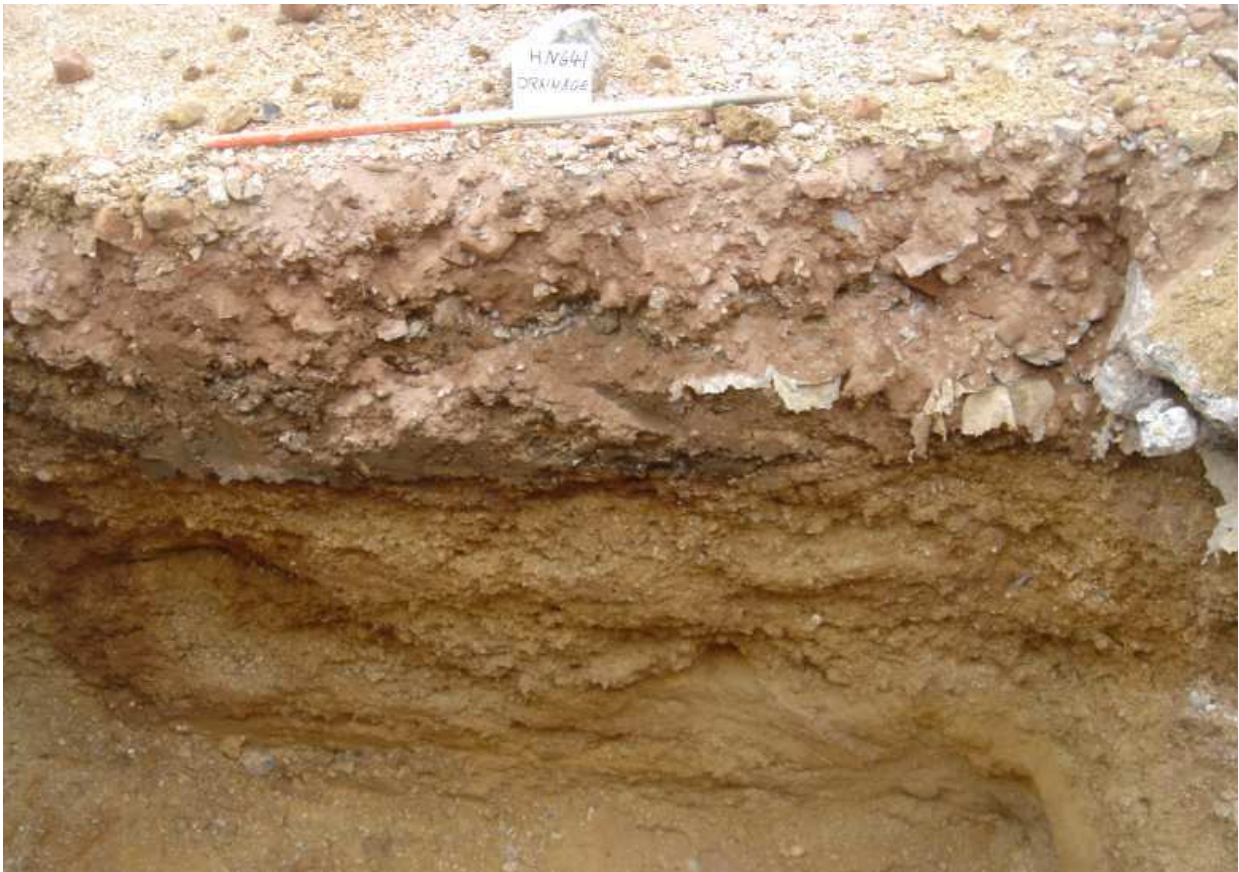
2.28 In the south-east corner of the site, the drainage trench sections revealed a layer of hardcore, 0.60m deep, above the natural sand and gravel (Plate 8).

Plate 8: Stratigraphy in drainage trench in south-east corner
