**CAPEL HOUSE,
Temple Drive, Watford,
Hertfordshire**

HN1427

***ARCHAEOLOGICAL
MONITORING REPORT***

Report no. 1154

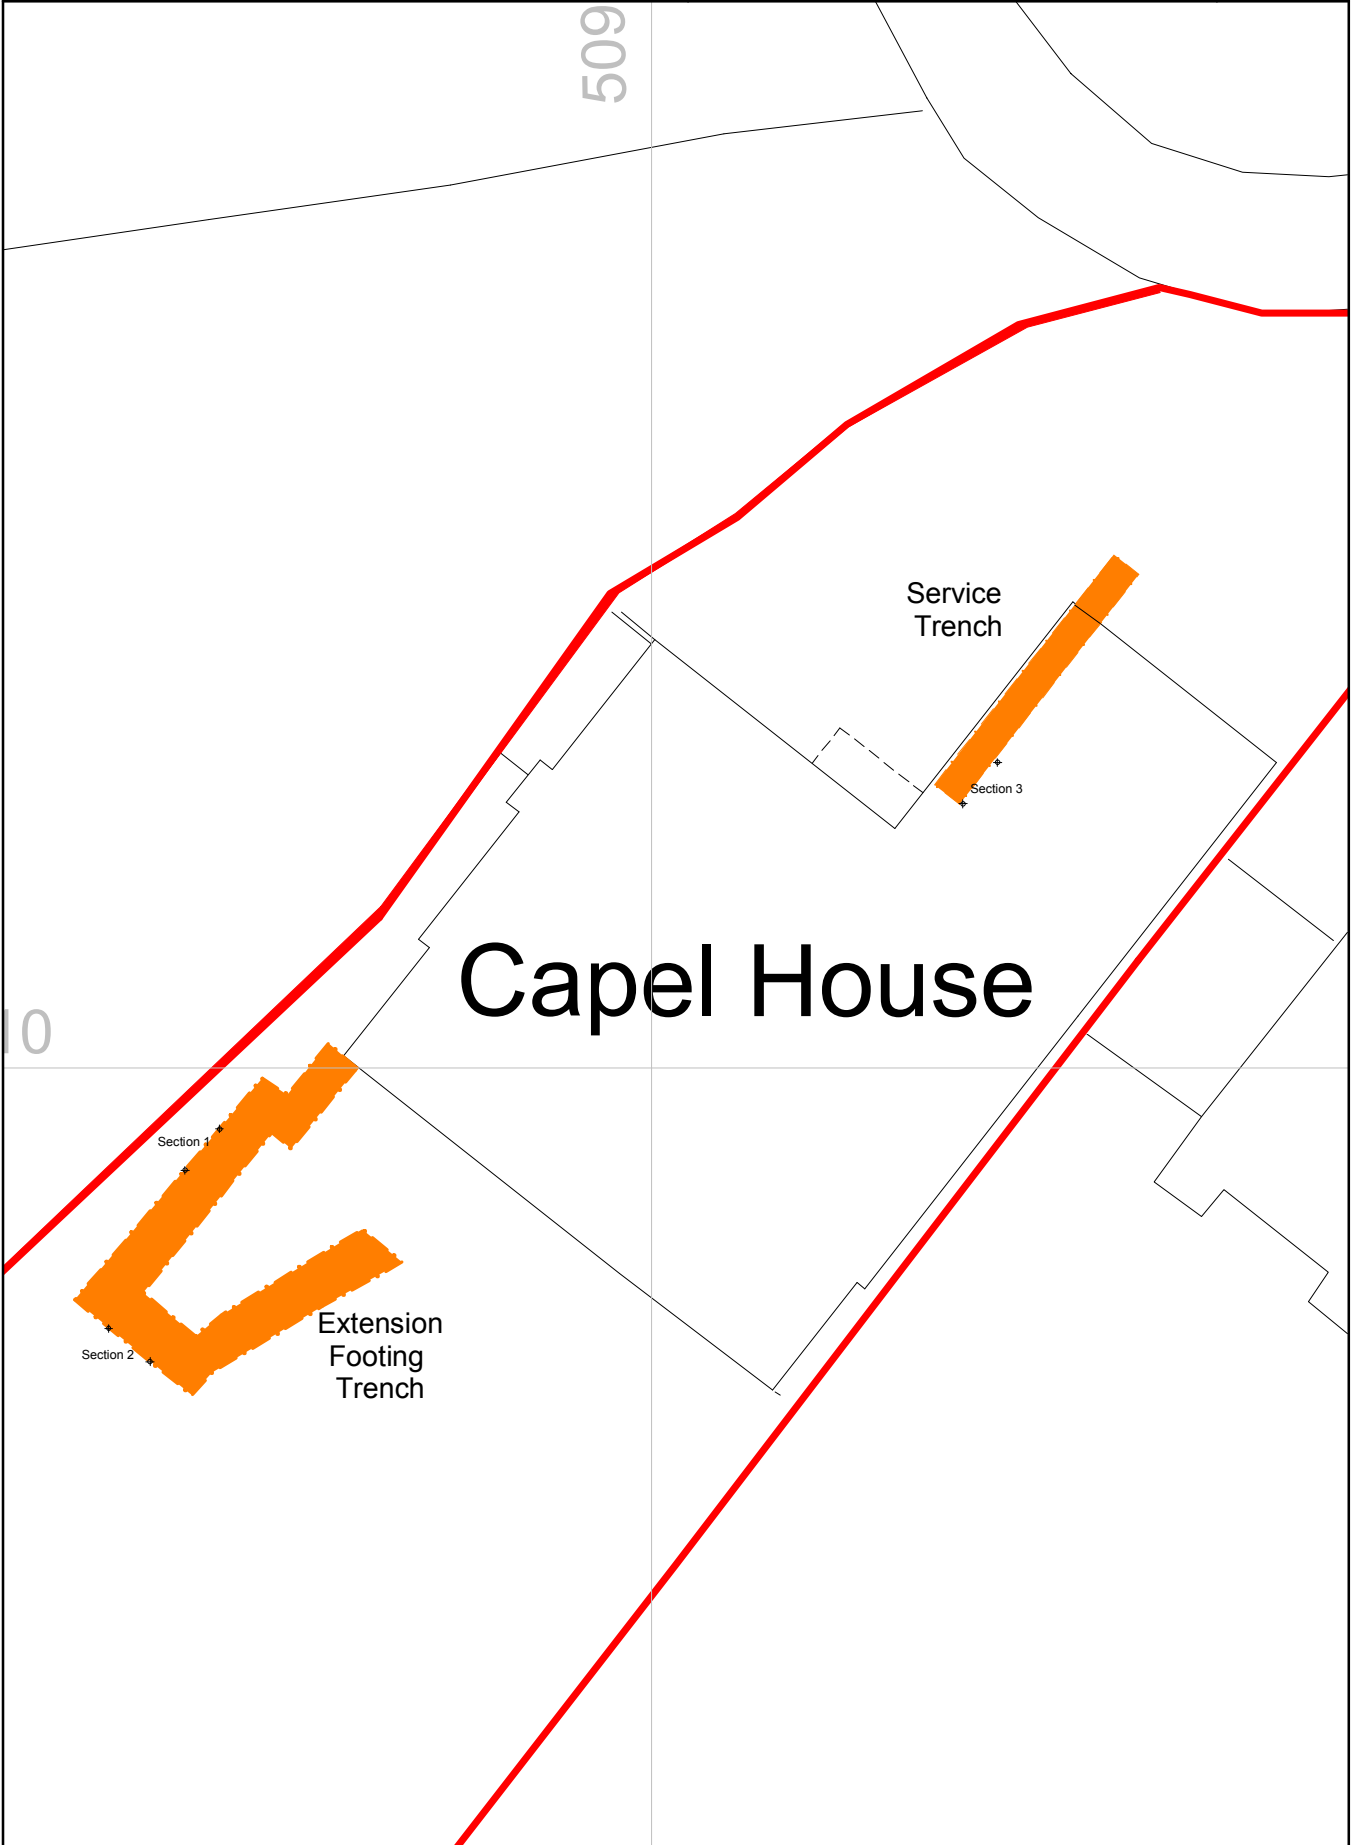
Figure 2

2.9 The groundworks for the present project consisted of the excavation of footings trenches for the new extension at the rear of the property and a service trench within the present ground floor bedroom (Figure 2).

Site Layout

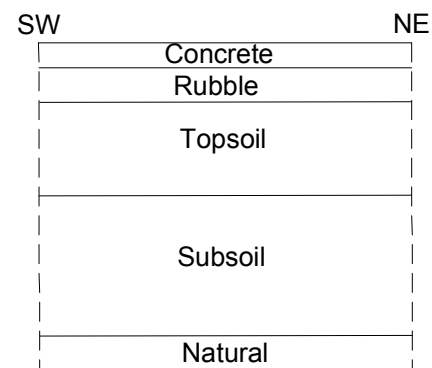
2.13 The stratigraphy exposed in the sections consisted of a friable very dark greyish brown, silty clay topsoil, 0.1m in depth, with frequent rooting and occasional small sub-rounded stone inclusions (Figure 3, Plate 3). This overlay a mixed demolition spread, between 0.2 and 0.4m thick, which comprised a mid brown friable silty clay, lumps of re-deposited natural and contained plastic, slate, coal, brick, plaster and mortar inclusions. Below this was the natural compact mid reddish brown silty sandy clay.

Sections 1 and 2 are from the extension
Section 3 is from the service trench

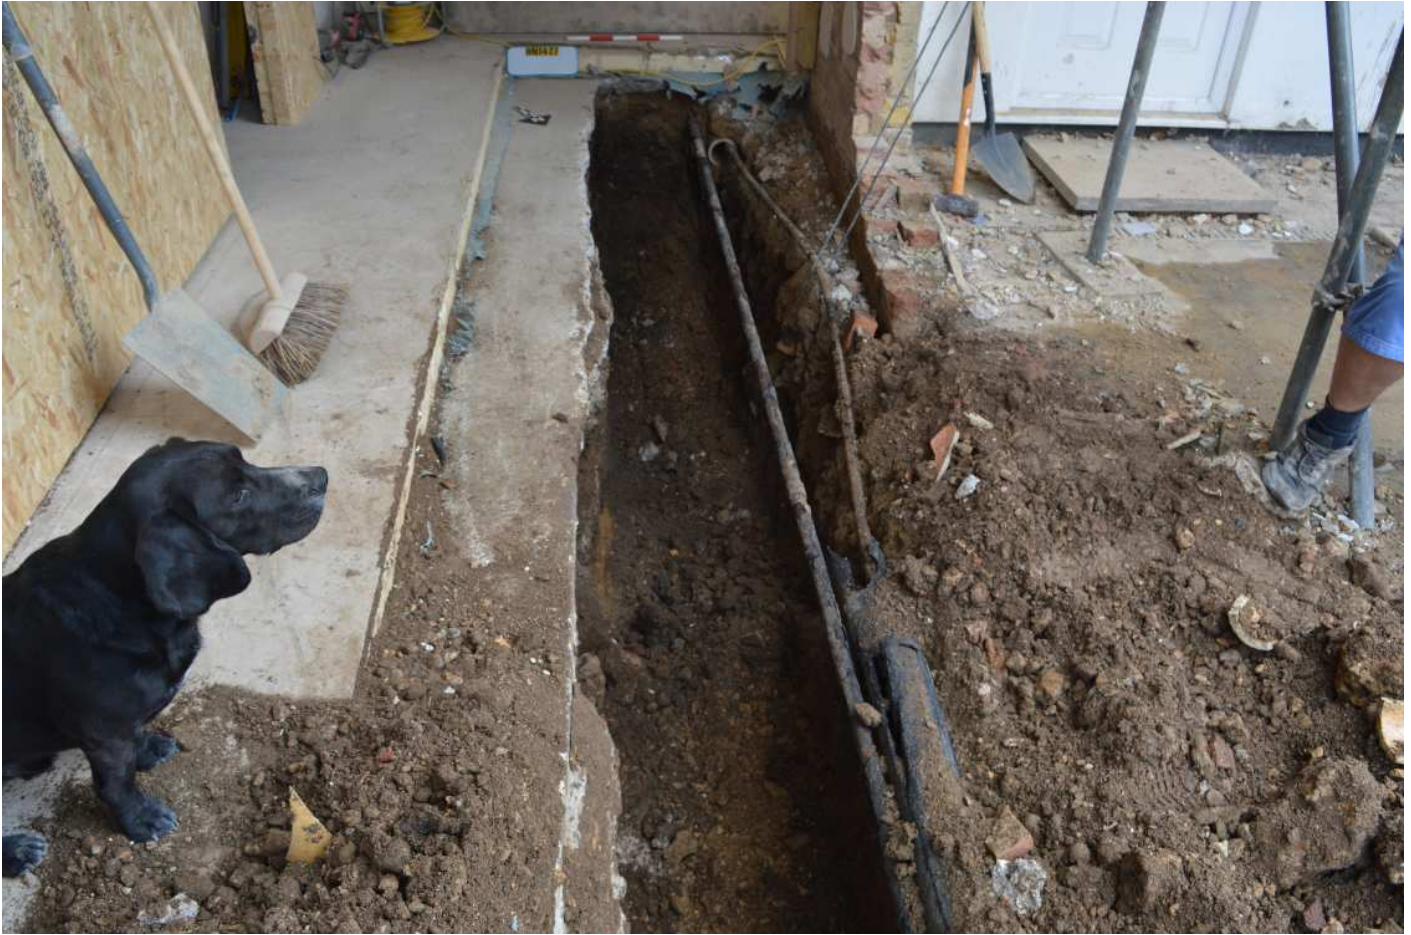
2.10 The service trench measured approximately 5.75m in length, 0.6m in width and was excavated to a depth of approximately 0.9m (Plate 1). The stratigraphy exposed in its sections consisted of a layer of rubble, 0.06m in depth, above a layer of concrete, 0.1m in depth (Figure 3, Plate 2). This sat directly above a dark greyish brown silty sandy clay topsoil, 0.25m in depth, which contained brick rubble. A mid brown silty sandy clay subsoil, approximately 0.35m in depth, was encountered below the topsoil. This overlay the natural silty sandy clay, which were encountered at approximately 0.76m below the present ground level.

Plate 01 - Service trench, looking S

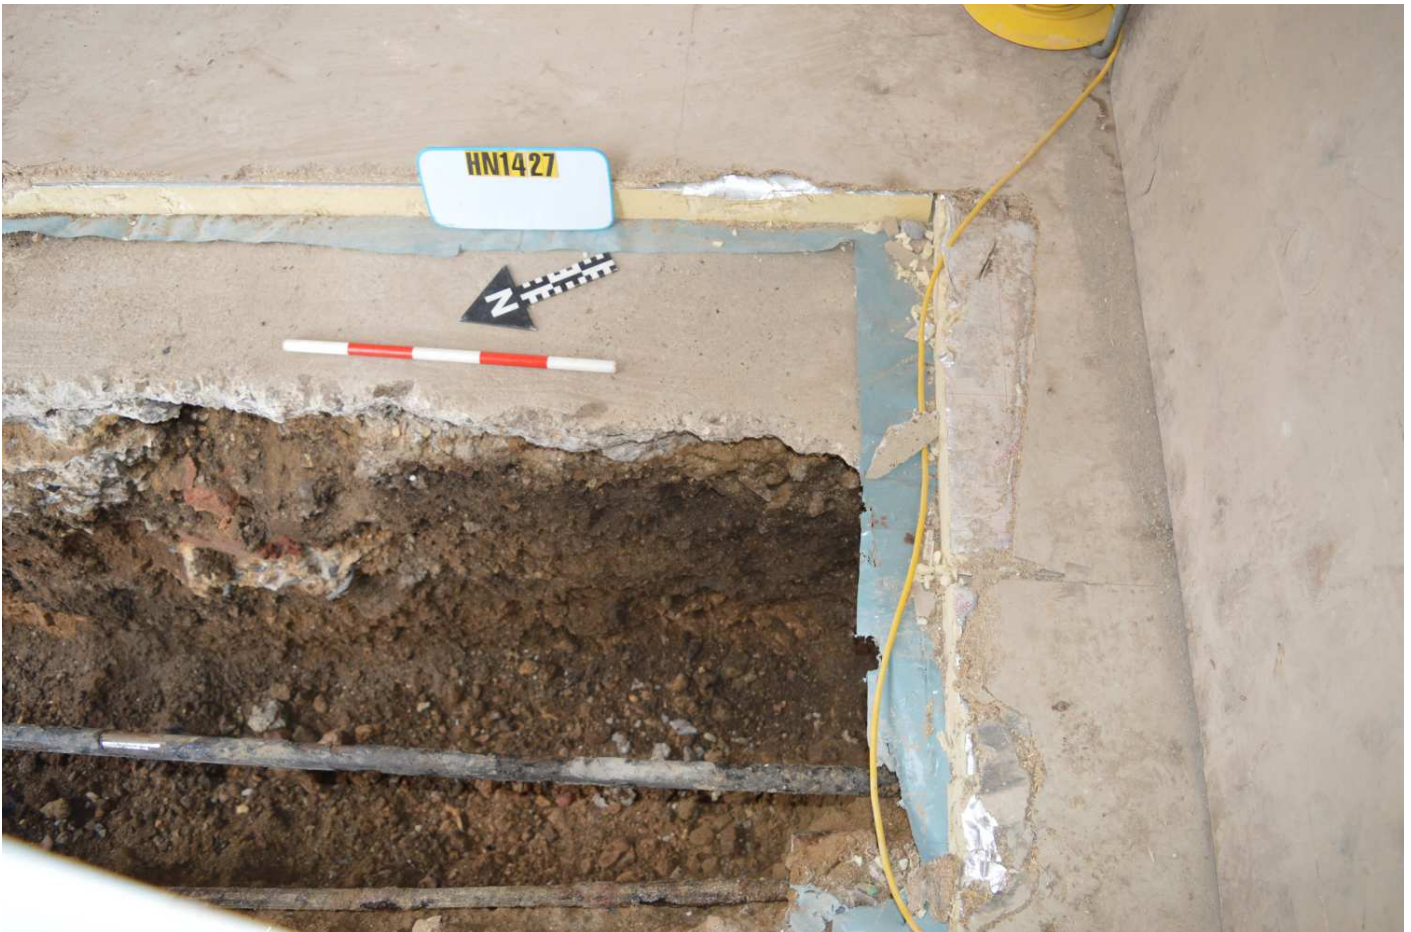
Plate 02 - Service trench, indicative section, looking SE

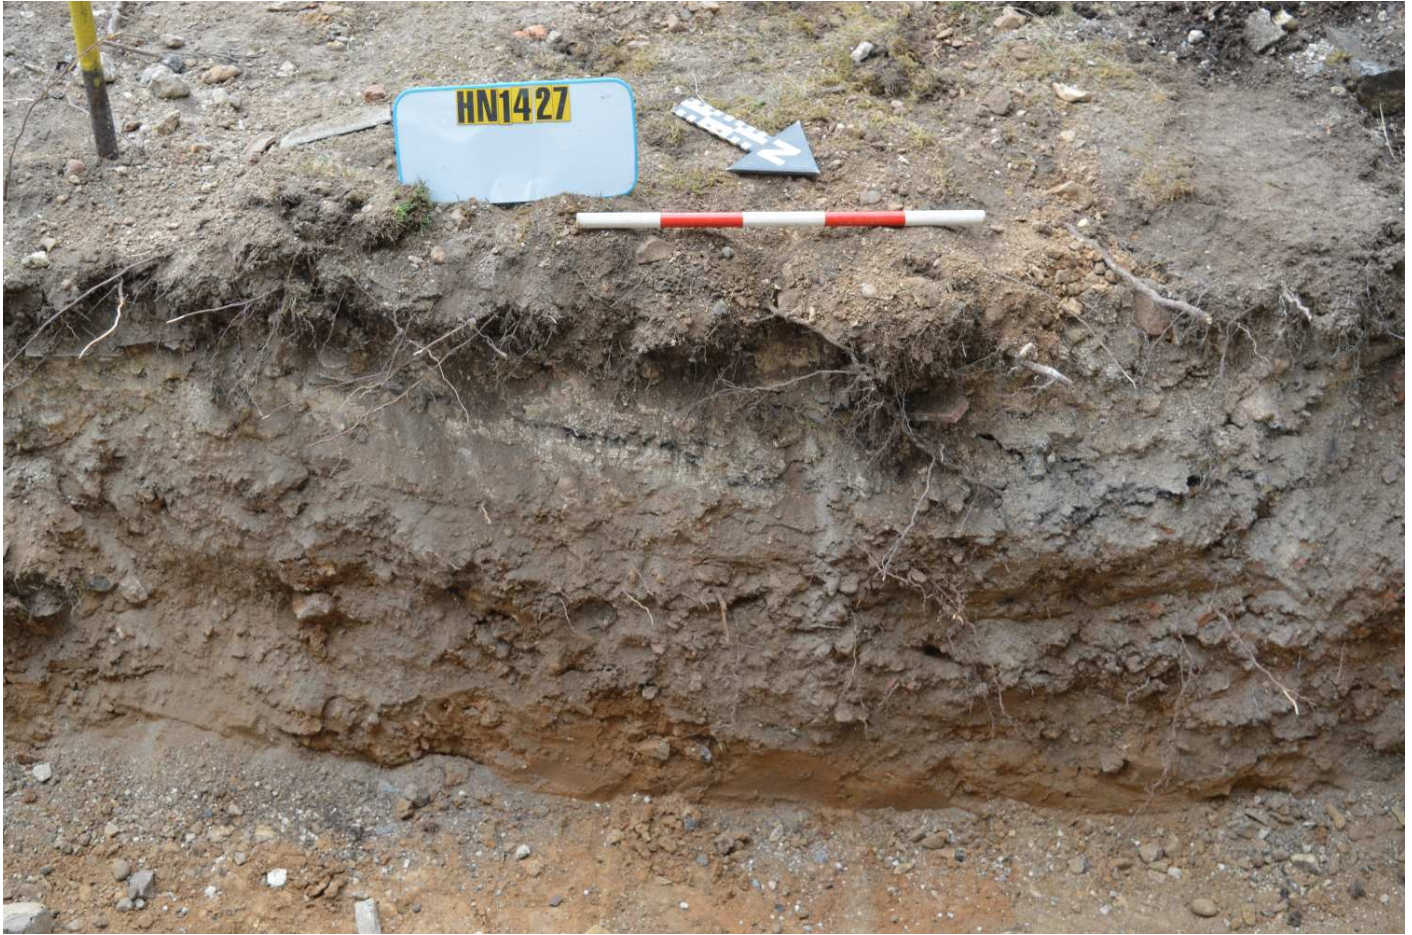
Plate 03 - Footings trench, indicative section, looking SW

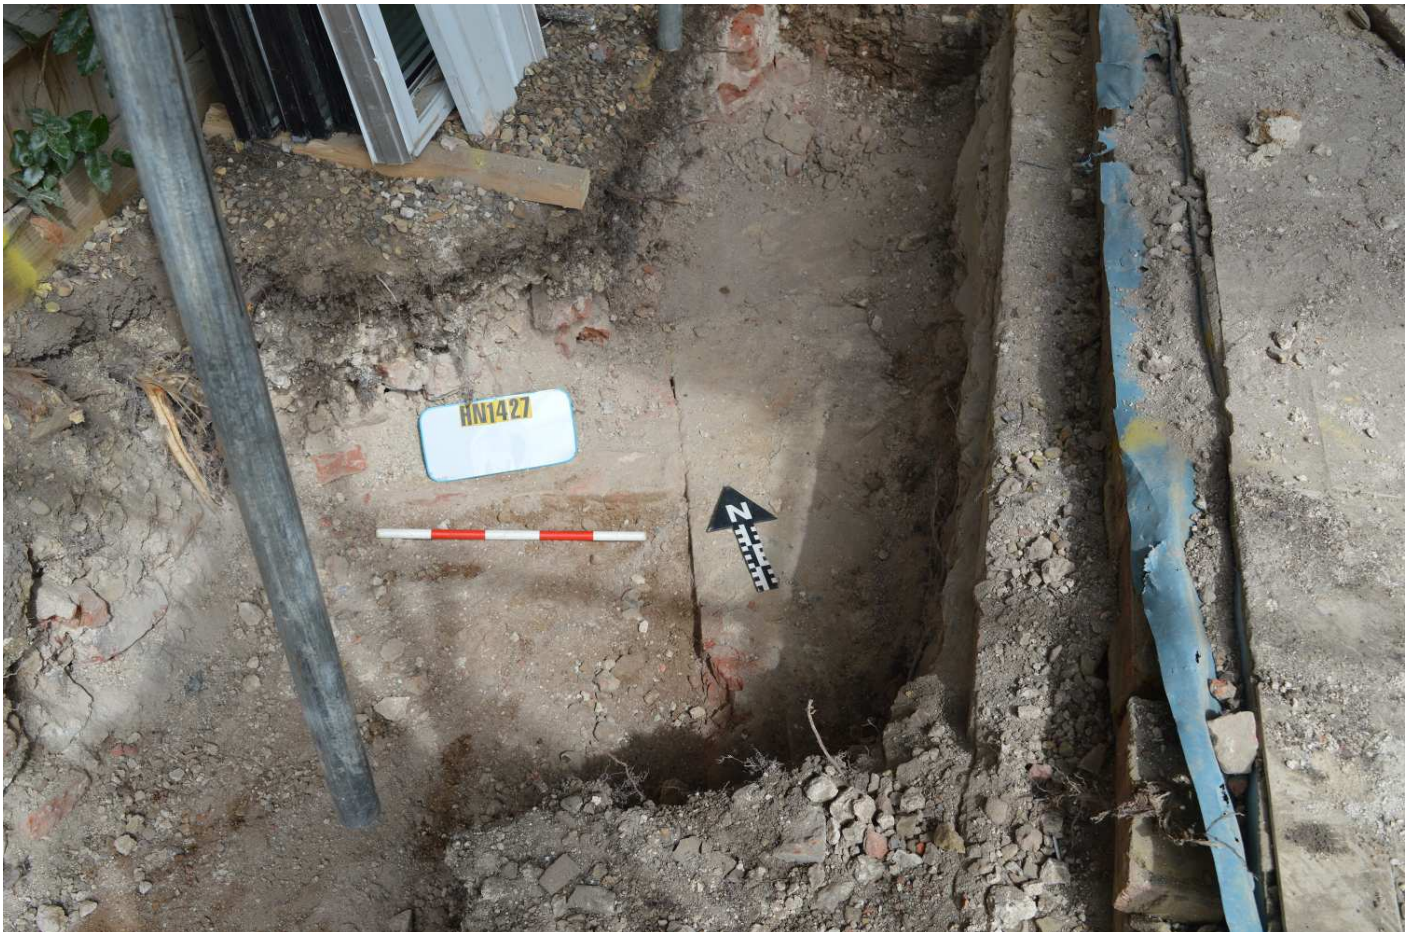
2.16 Wall [102] was set at right angles to and butted the western side of [101]. It appears to run north-west to south-east diagonally across the trench and into the baulk (Plates 4 & 6). Its exposed area measured over 1m in length, 0.3m in width and over 0.3m in depth. The construction of this wall, which may form part of a wall running north-west from the bathroom, was similar to that of [101].

Plate 04 - Walls [101] & [102], looking S

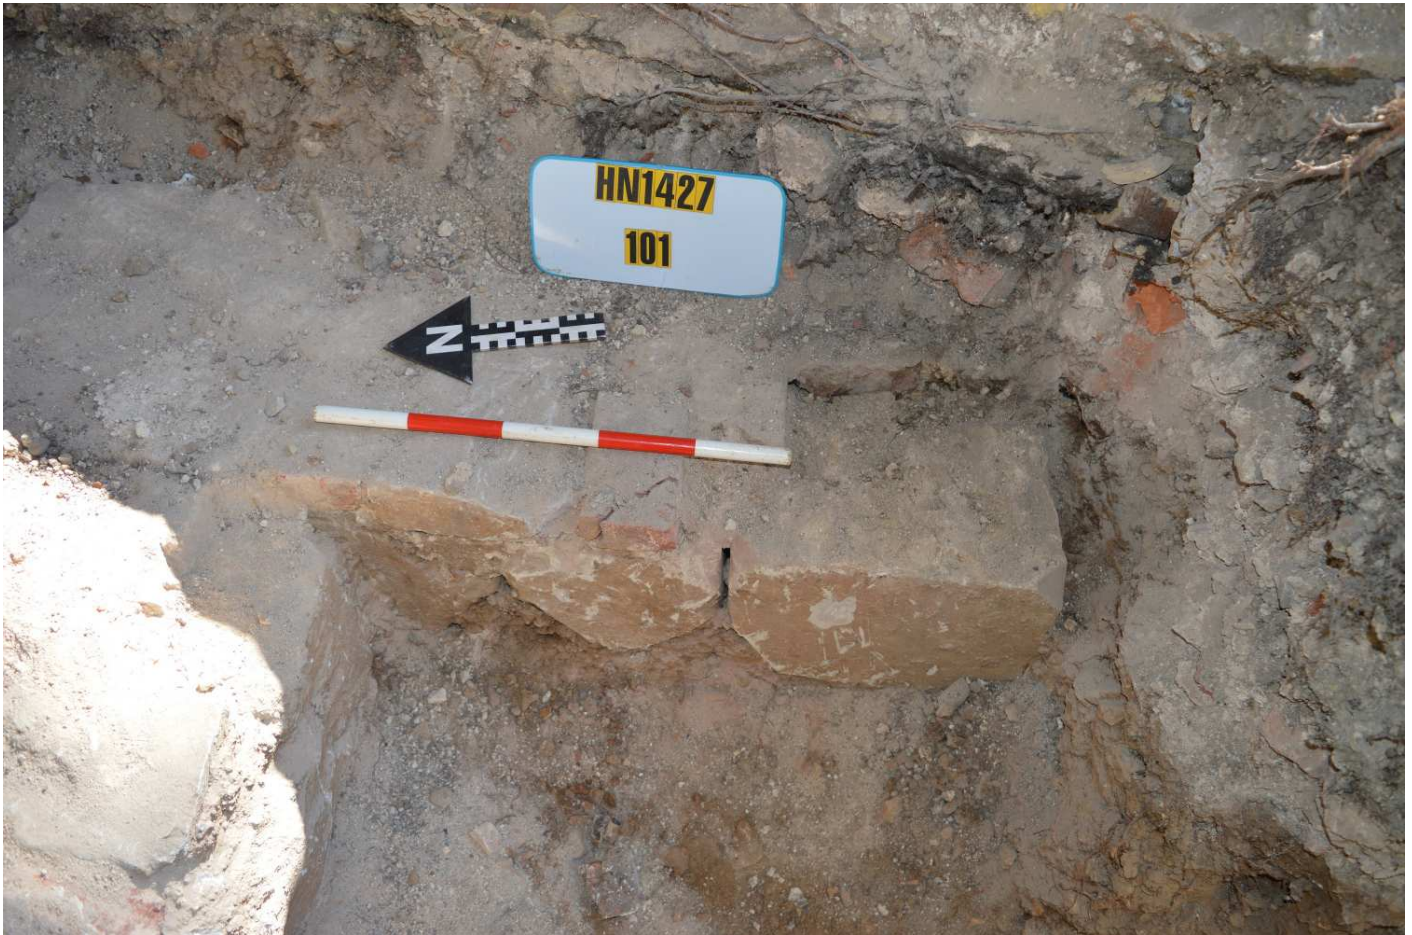
2.15 Wall [101], was located at the north-eastern end of the trench, closest to the house and was orientated north-east to south-west. Its exposed area measured over 2m in length, 0.45m in width and over 0.3m in depth. The wall, which crossed the trench on a 45-degree angle, consisted of a series of cut Totternhoe stone blocks, with a single course of red bricks set on top (Plates 4-6). The bricks were hand-made and have been dated to the early 19th century. It may represent part of the north-western wall to a bathroom, marked on Britton's plan of Cassiobury House in 1837 (Figure 5).

Plate 05 - Wall [101] showing Tottenhoe Stone foundation, looking E

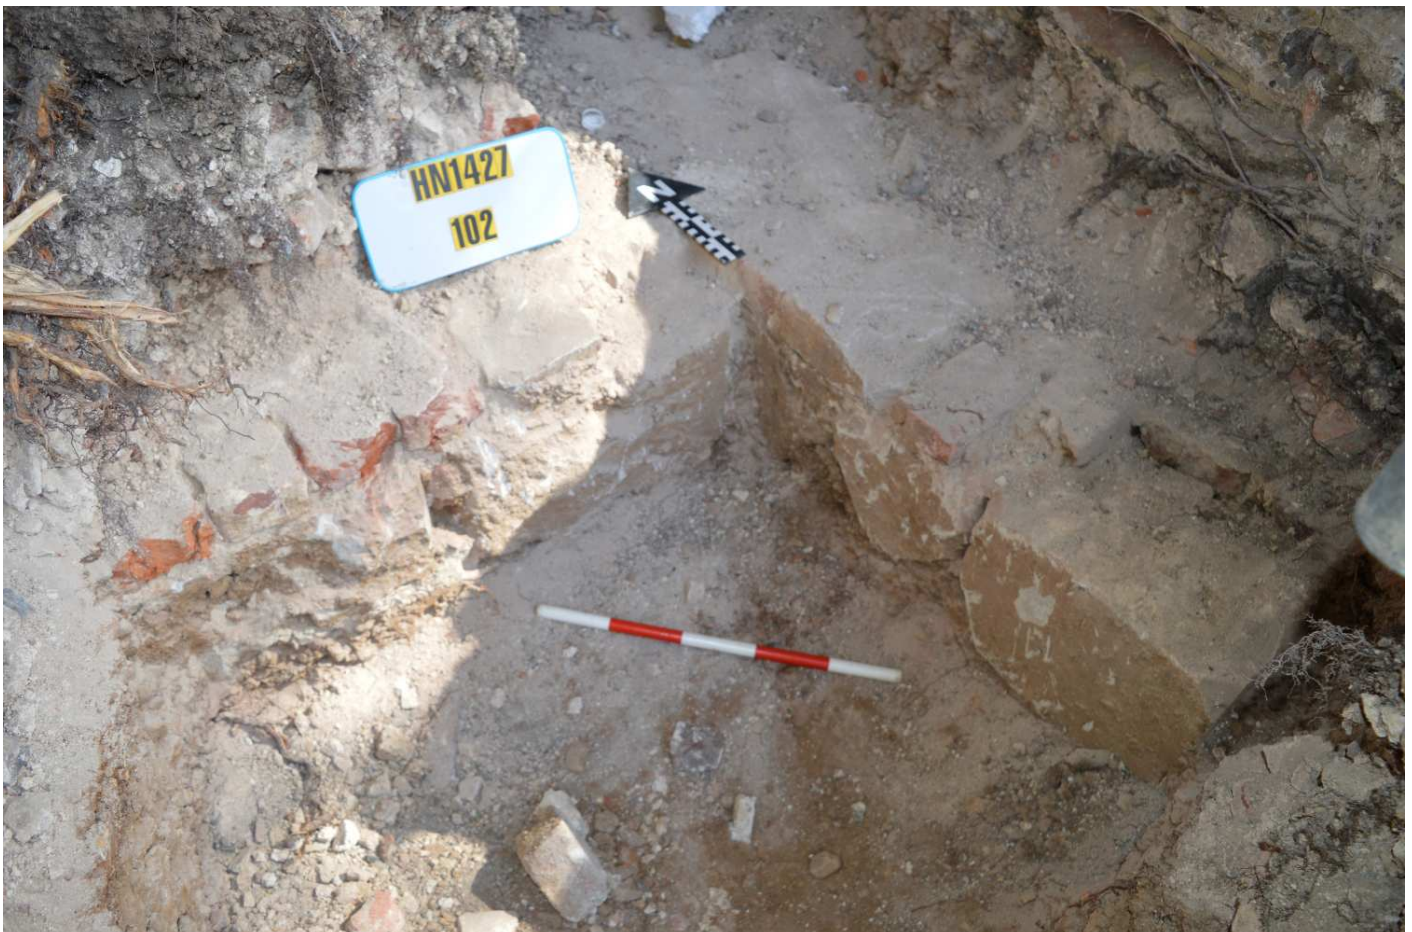
Plate 06 - Wall [102], showing Tottenhoe Stone foundation, butting Wall [101], looking NE

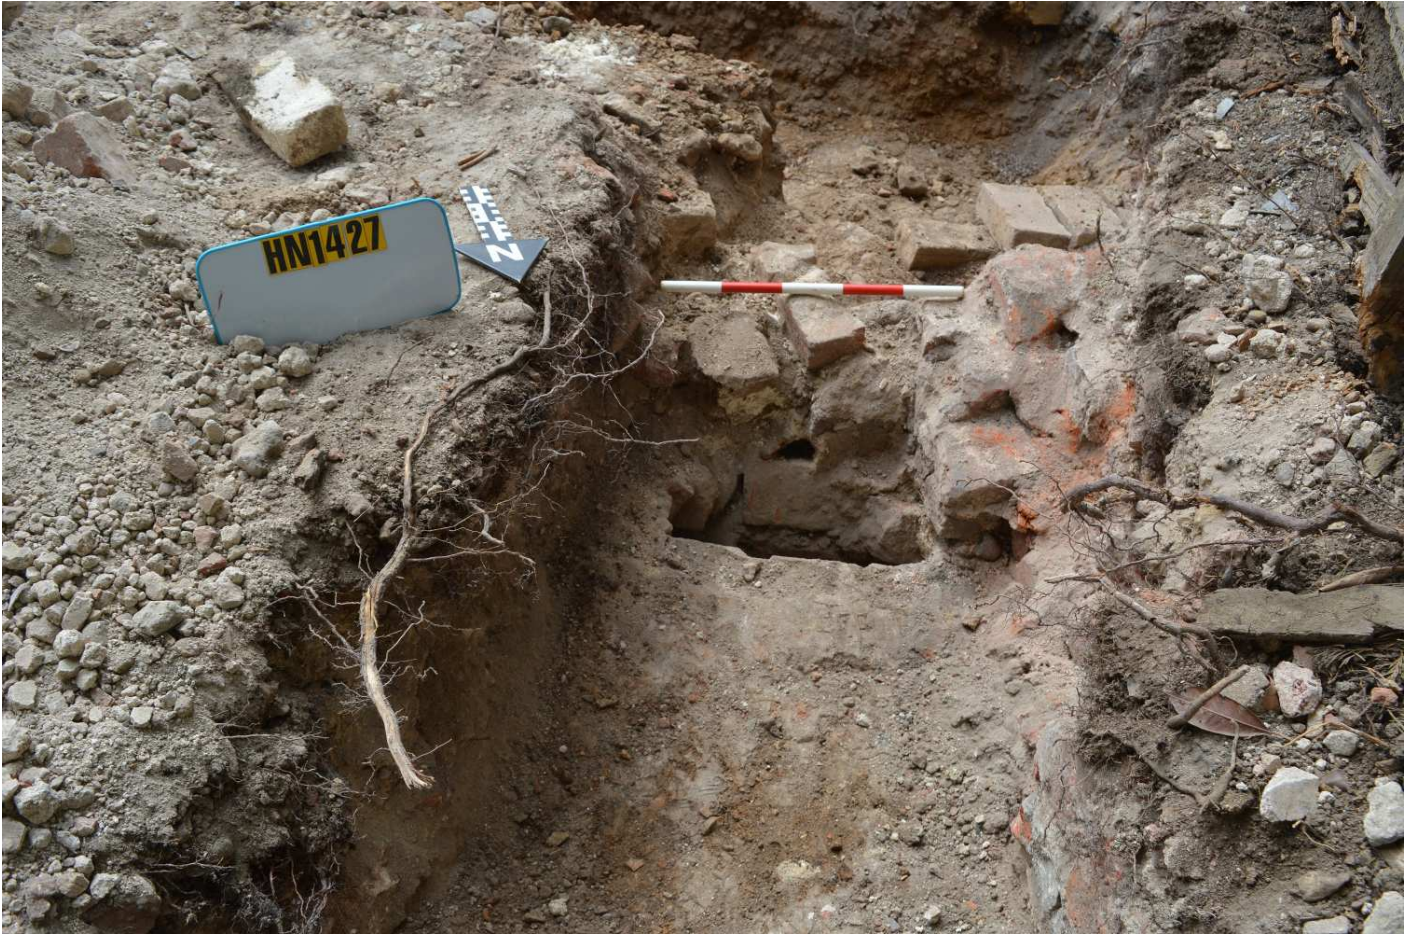
2.17 Wall [103], which was encountered at the south-western end of Trench 1, was aligned north-east to south-west (Plates 7 & 8). Its exposed area measured over 1.5m in length, over 0.5m in width and over 0.3m in depth. This structure was built of red brick, laid in English bond and bonded with lime mortar. It may represent part of the south-eastern wall to the Still Room marked on Britton's plan of Cassiobury House in 1837 (Figure 5). No bricks were recovered to date this wall.

Plate 07 - Wall [103], overlying drain [104], looking S

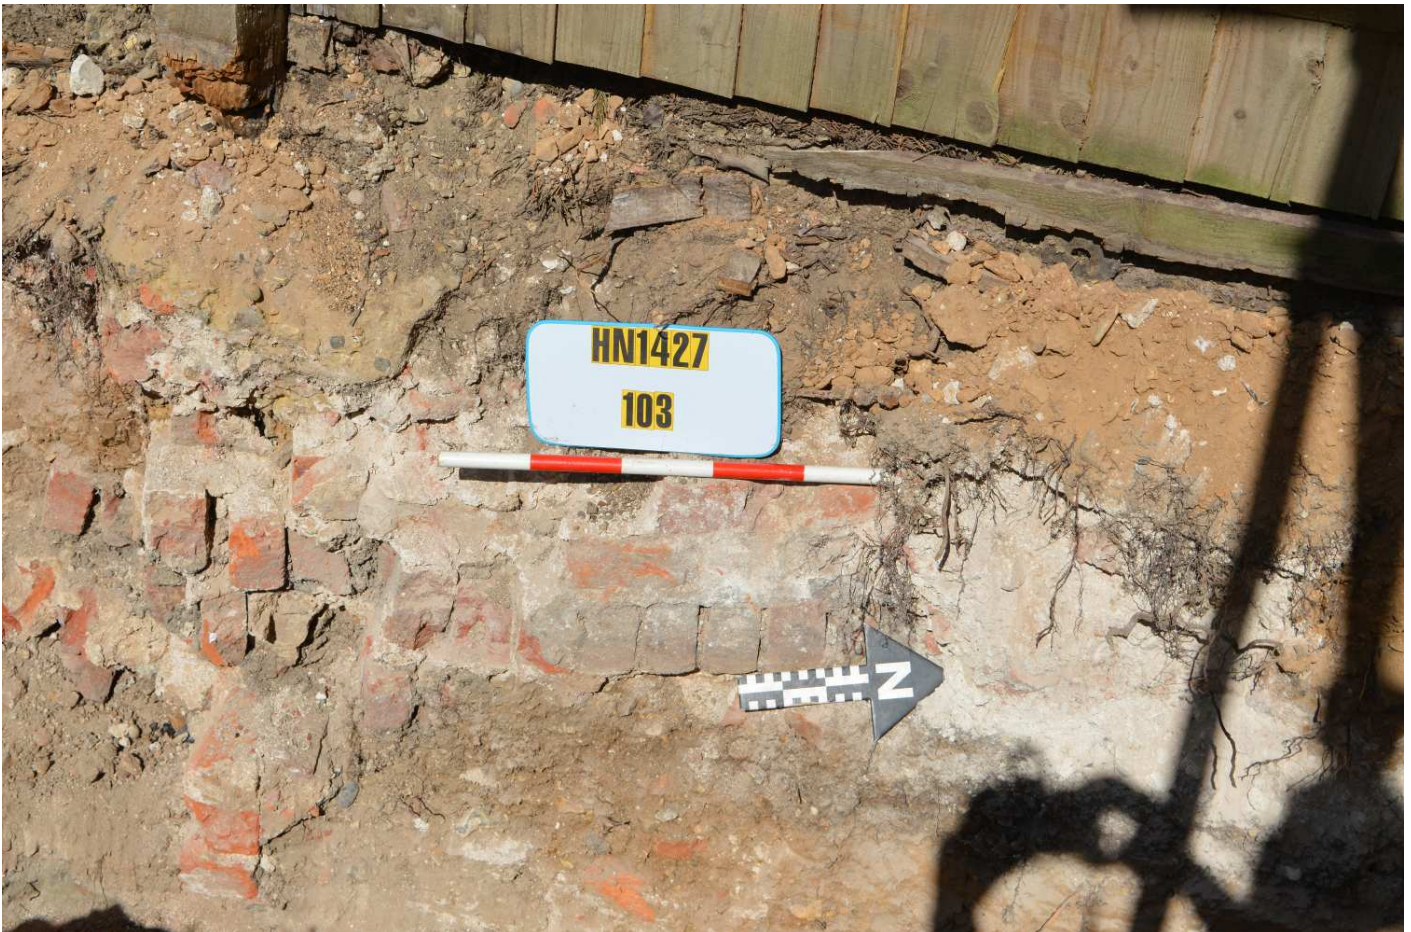
Plate 08 - Wall [103] in section, looking W

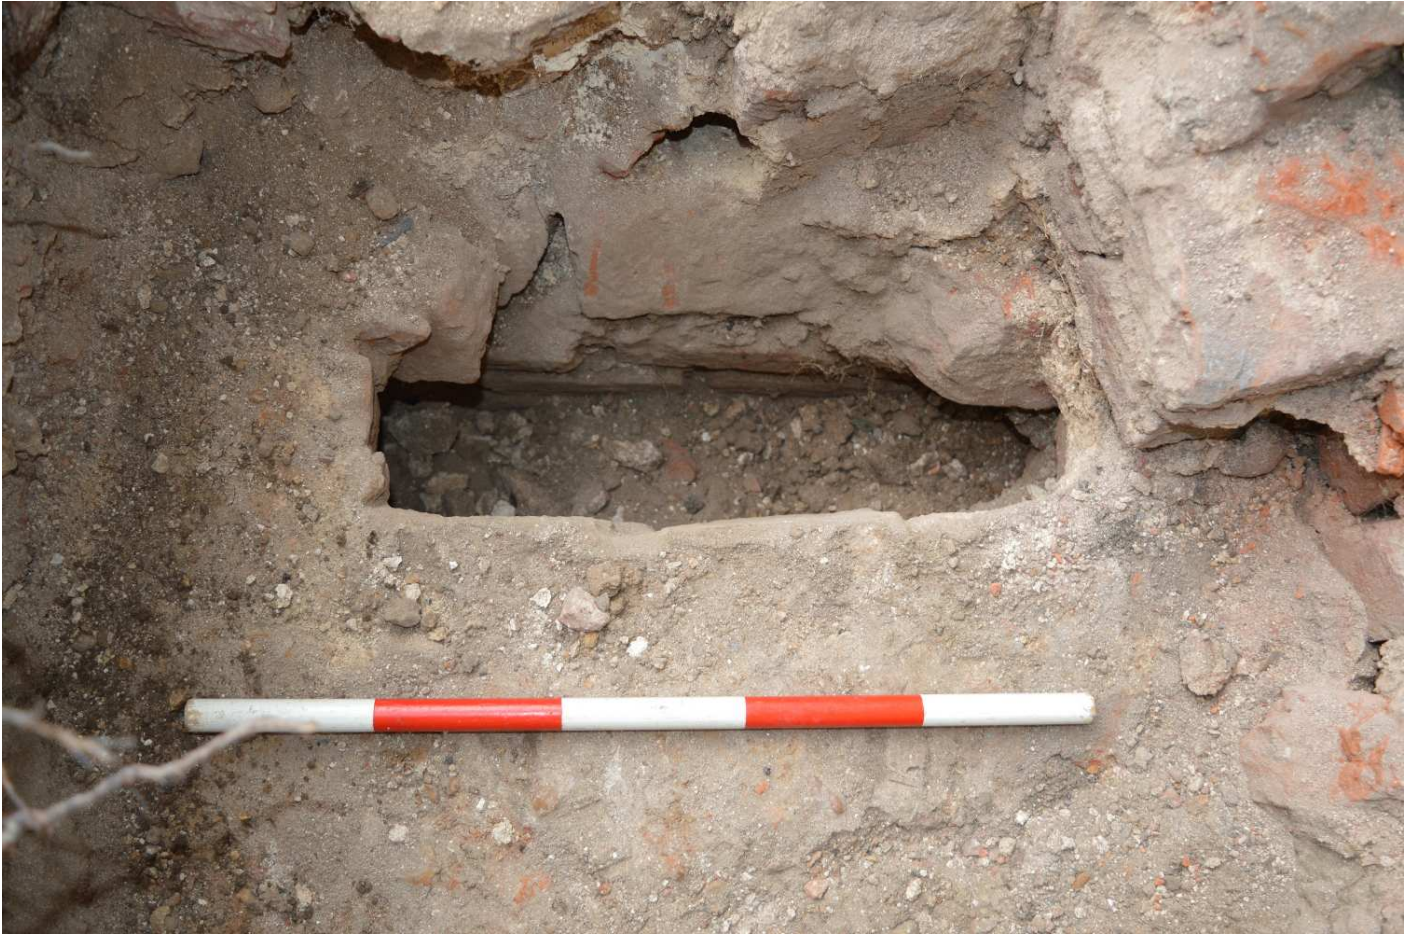
2.18 Drain [104] ran north-west to south-east across the south-western end of Trench 1 and appeared to run beneath [103]. Its exposed area measured approximately 0.69m in length, 0.7m in width and 0.3m in depth. The drain was constructed of handmade red bricks, laid in lime mortar to form an arch. The bricks have been dated to the first half of the 19th century, though they are later than those from wall [101].

Plate 09 - Brick drain [104], looking S

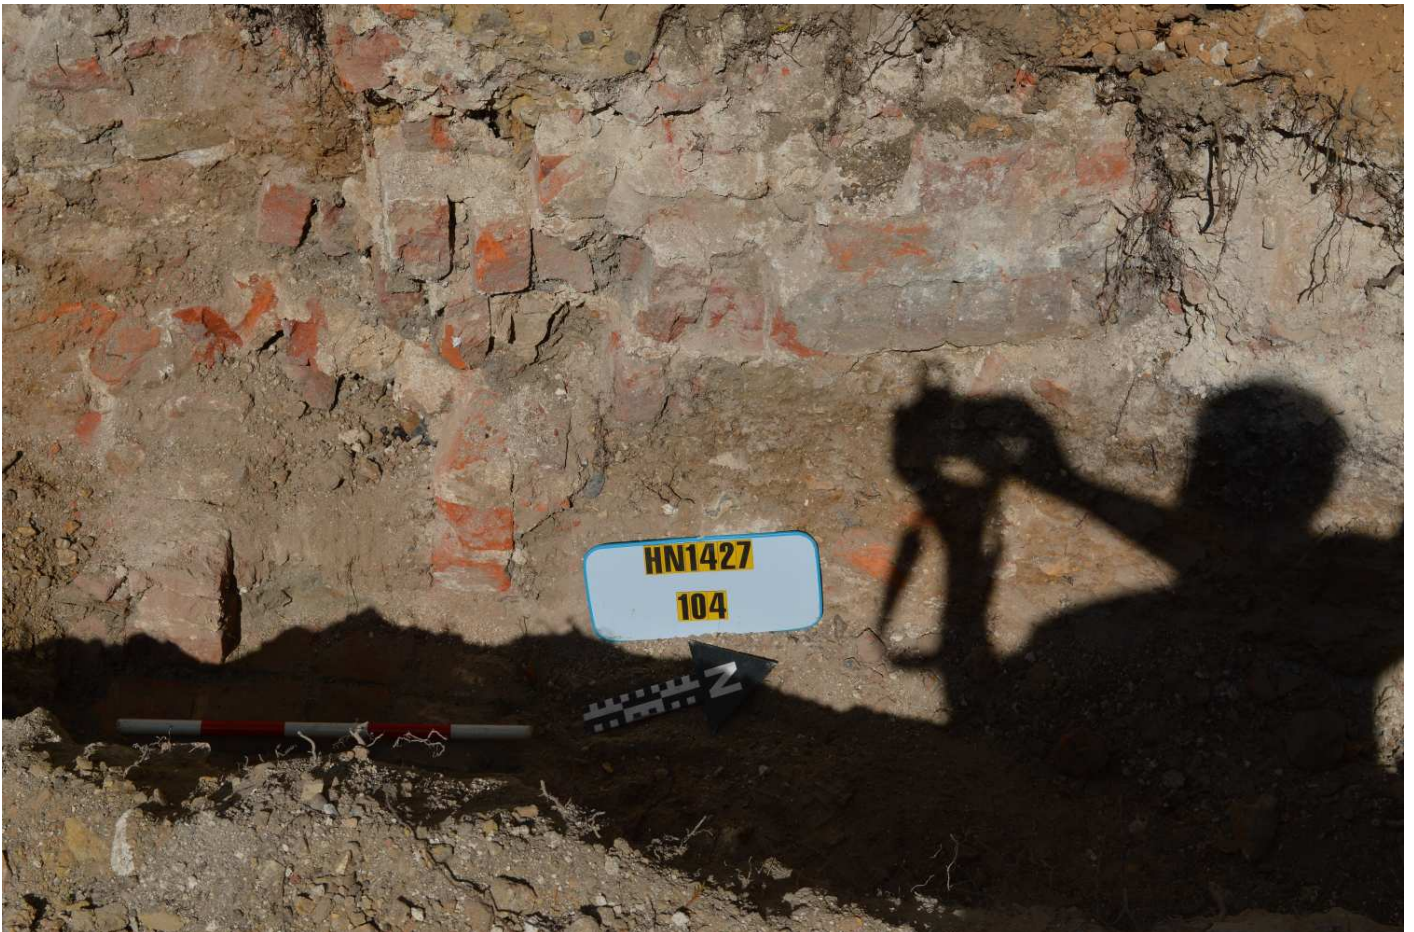
Plate 10 - Brick drain [104] in section, looking W

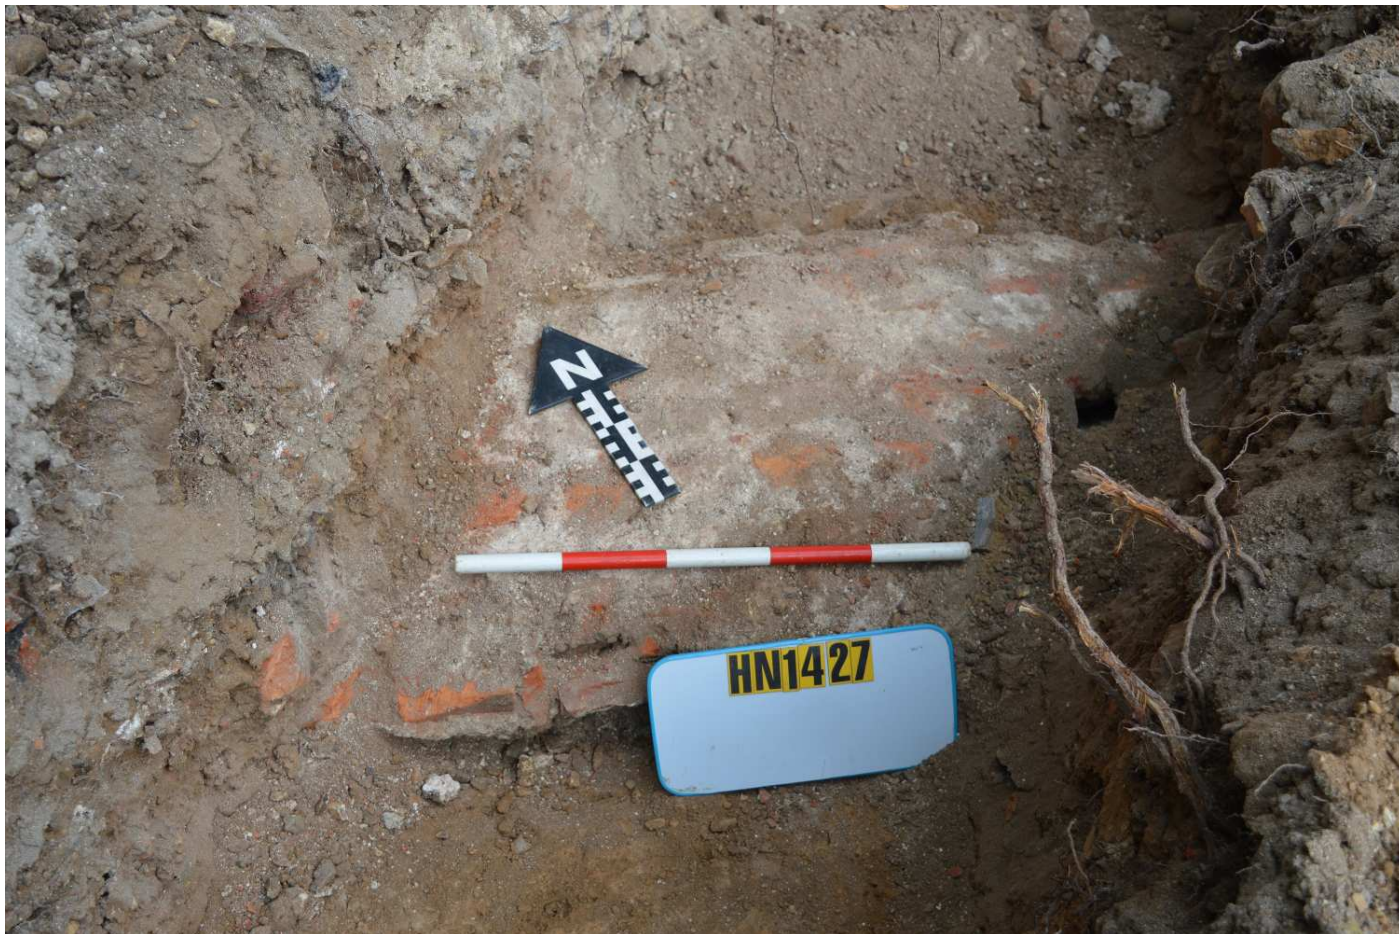
2.19 A brick-built drain, [105], possibly representing a south-western continuation of [104], was recorded at the south-western end of Trench 3. Only the top of the feature was revealed, but its exposed area measured 1.05m in length and 0.7m in width (Plate 11). No bricks were recovered to date the structure.

Plate 11 - Brick drain [105], looking N
