**PARK VIEW, 6A FORD LANE
Roxton, Bedfordshire**

HN1433

***HISTORIC BUILDING
RECORD***

Historic Building Record

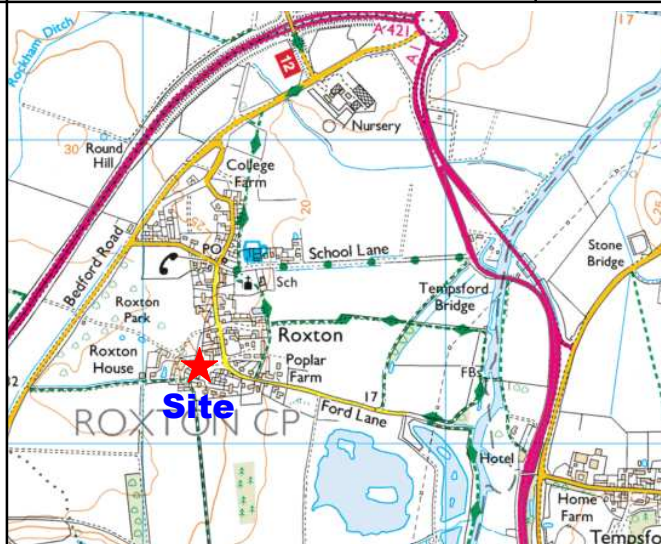
Site location and layout

Scale 1:625

1.3 The site is located on the north side of Ford Lane, c.125m west of its junction with High Street, centred on NGR 515158 254270. Although the house is modern, the property includes the barn proposed for conversion, which is attached to a group of Grade II listed buildings (NHLE1114922). These formerly made up Park Farmhouse, which has now been subdivided into two separate dwellings. Whilst the former Park Farmhouse is considered to be c.1600AD in origin, the attached barn is thought to be 19th century in origin. The development proposes the refurbishment and conversion of the barn to create two carports, a workshop and a lobby on the ground floor, with a guest area to the first floor, including a bedroom and ensuite bathroom. (Figure 1).

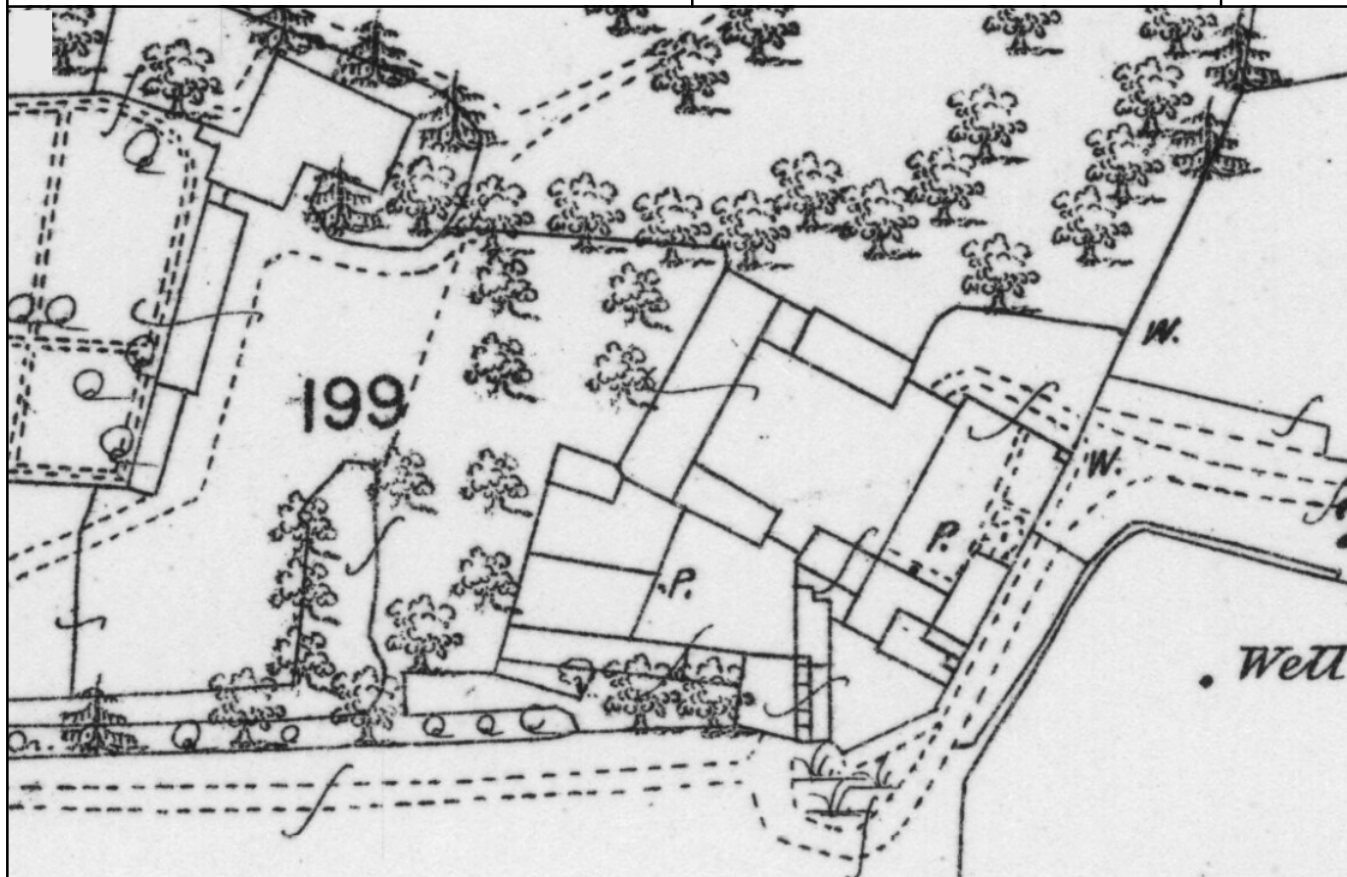
Figure 2

Ordnance Survey 25-inch County Series, 1st Edition, 1884

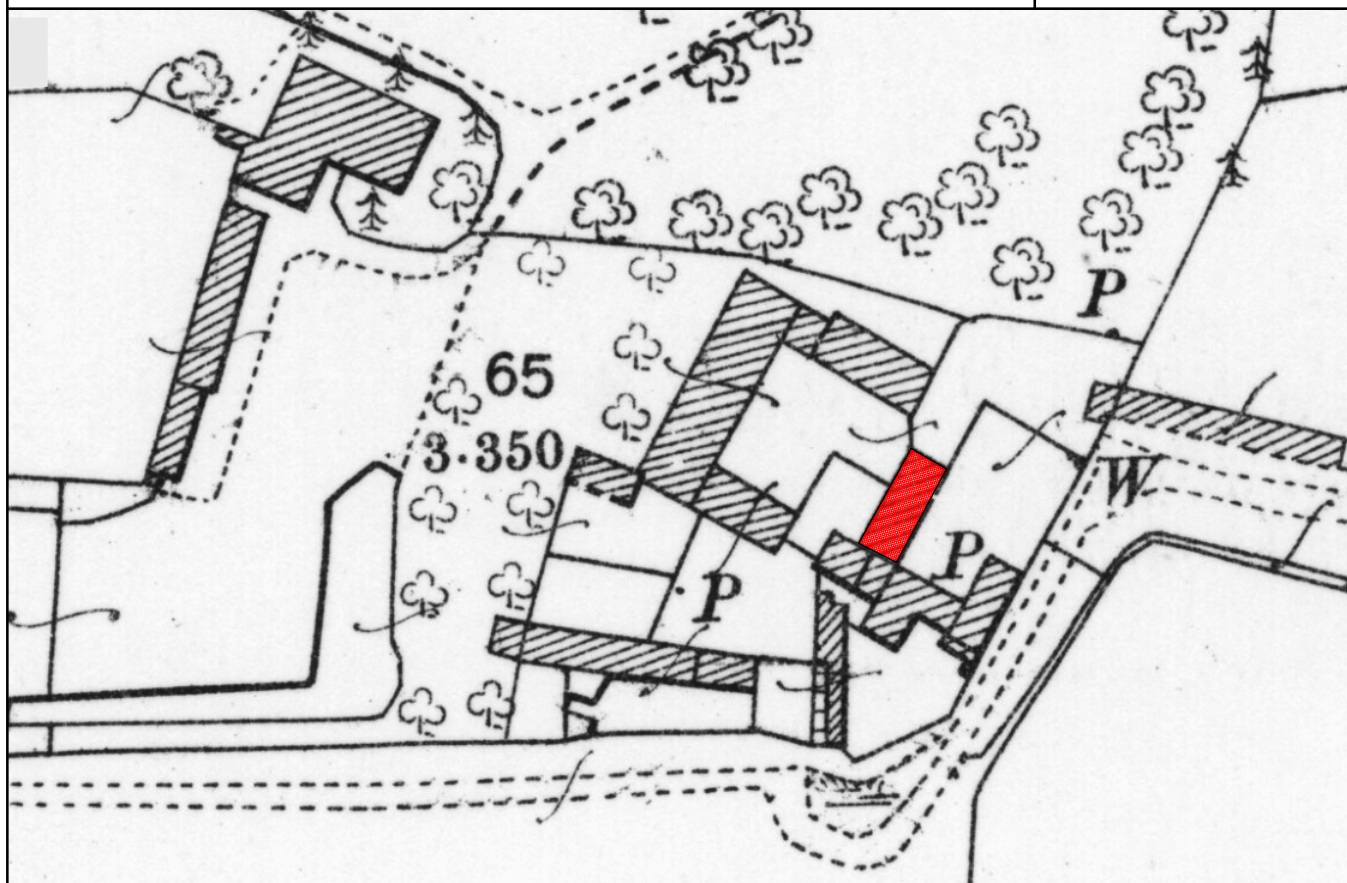
Figure 3

2.6 The barn forming the subject of the present study, is located at the western end of the northern elevation of the former farmhouse and is included in the listing, which dates to 1980. The barn is not shown on the 1st edition of the 25-inch Ordnance Survey County series of 1884 (Figure 2), first appearing on the 2nd edition of 1901 (Figure 3).

Ordnance Survey 25-inch County Series, 2nd Edition, 1901

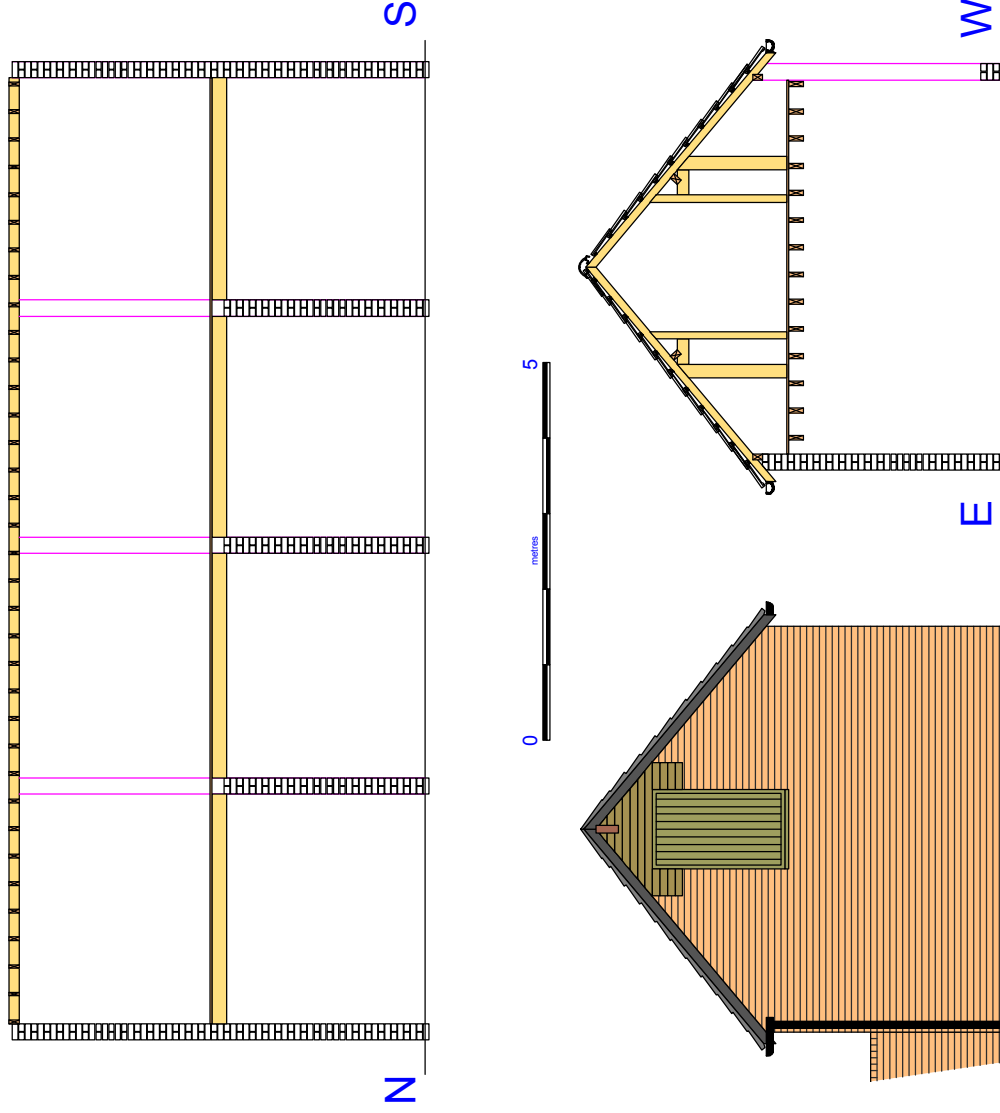
Northern elevation and sections

North elevation (Figure 6; Plates 2 & 3)

3.4 The north elevation is formed of white bricks measuring $8\frac{3}{4} \times 2\frac{3}{4} \times 4\frac{1}{4}$ inches, laid in Monk bond with a lime mortar. There is a chamfered string course two courses above ground level. There is a former window opening at ground floor level, closed with Fletton bricks laid in English bond with a cement mortar. The location of former braces can be seen, intended to support a platform outside the loft door, blocked at the same time. Cantilevered supports for the platform extend from the elevation at the base of the loft door, possibly truncated. Above this is a boarded door, flanked by former window openings, now closed with weatherboard. There is a braced hoist support above the door, with a shackle but no pulley.

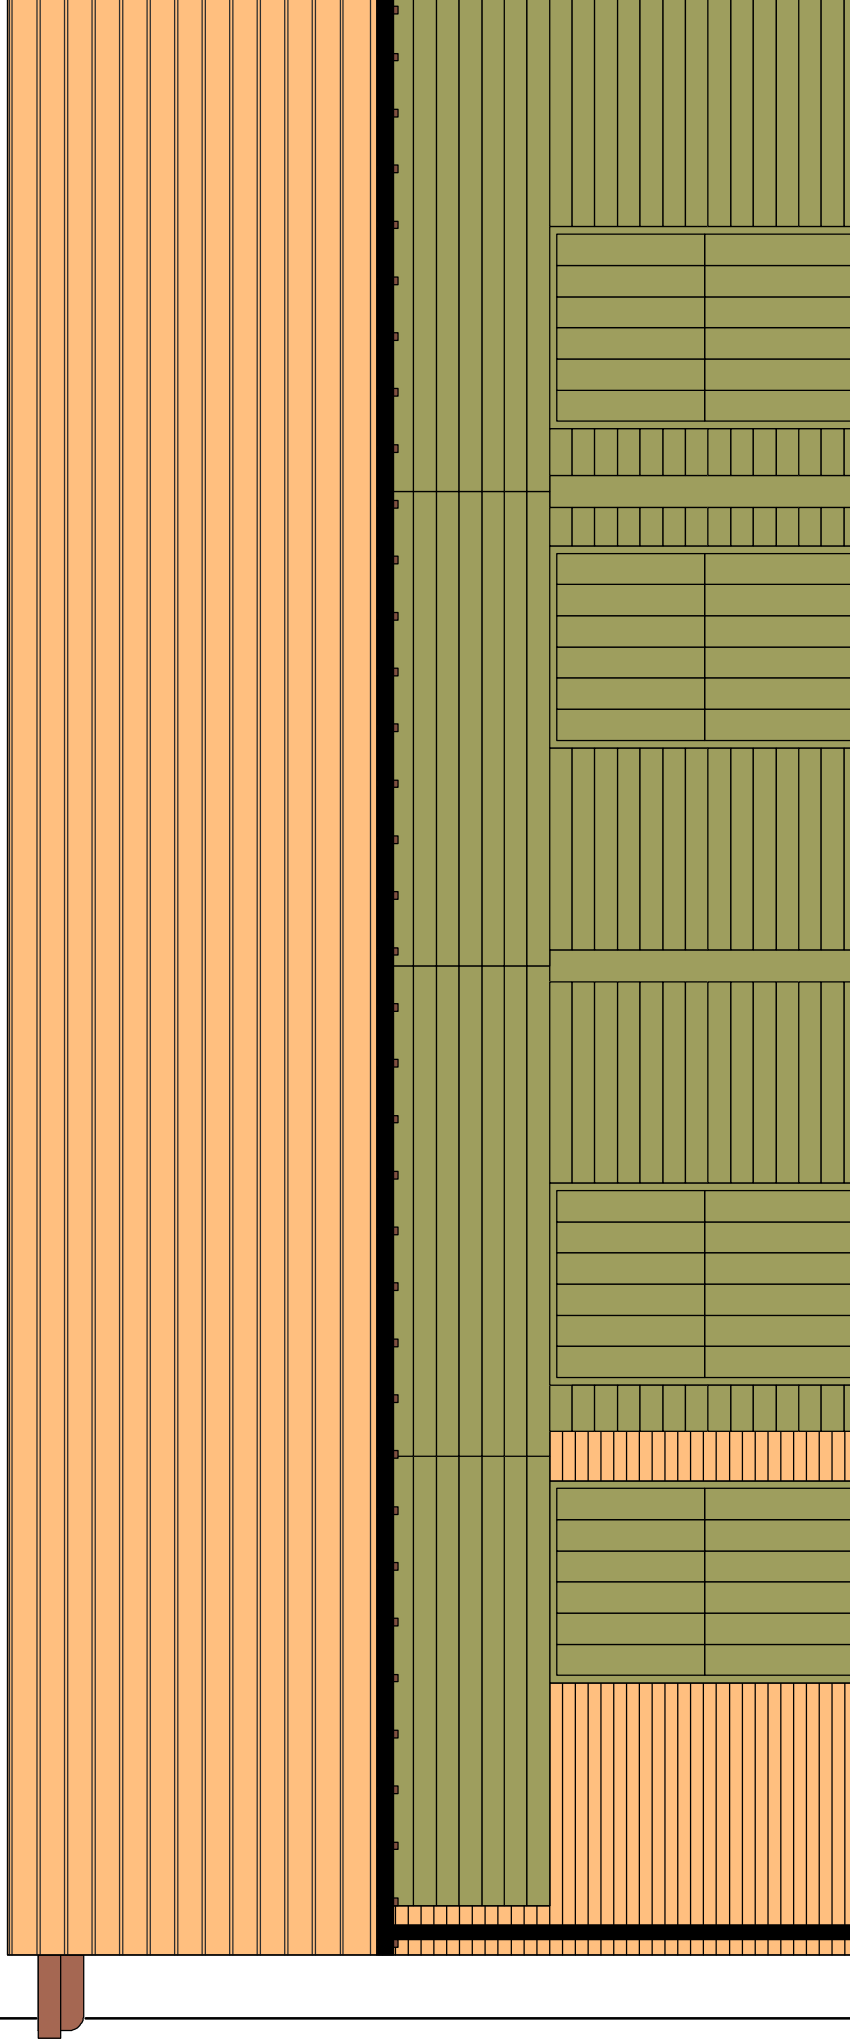
Scale 1:50
Figure 7

West Elevation (Figure 7; Plate 4)

3.5 Bay 1, to the north, is brick faced at ground level, in white bricks laid in Monk bond with lime mortar. Bays 2 – 4 are faced with creosoted softwood weatherboard, each bay accessed by boarded, ledged and braced stable doors. The upper 0.30m of this storey is slatted to provide ventilation. Bumpers against the principal post between Bays 2 and 3, and at the south end of Bay 4 indicate that Bays 2 – 4 were formerly open fronted and used as a cart shed. Mortice holes in the Bay 2/3 post suggest a former yard fence extending from this location. At loft level, this elevation is weatherboarded.

Western elevation
Courtesy JPG Architects

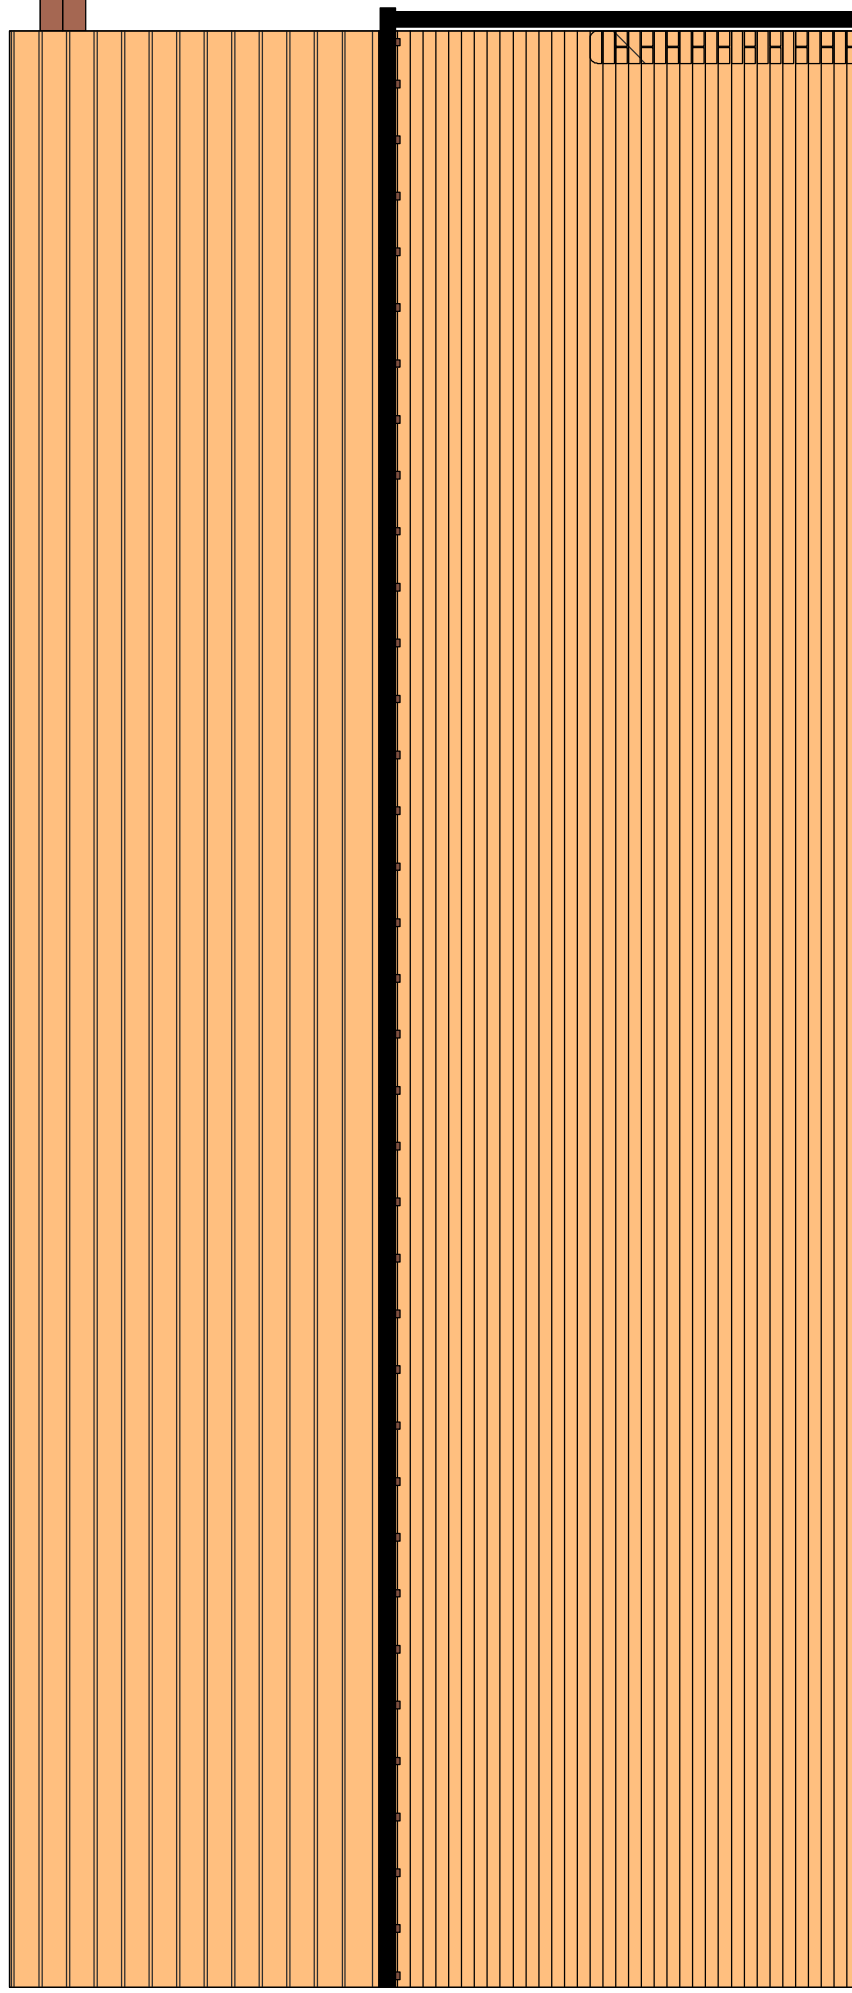
Scale 1:50
Figure 8

3.6 The south elevation abuts the neighbouring property. The east elevation is only accessible from the neighbouring garden and is largely obscured by vegetation and a garden shed (Figure 8; Plate 5).

Eastern elevation
Courtesy JPG Architects

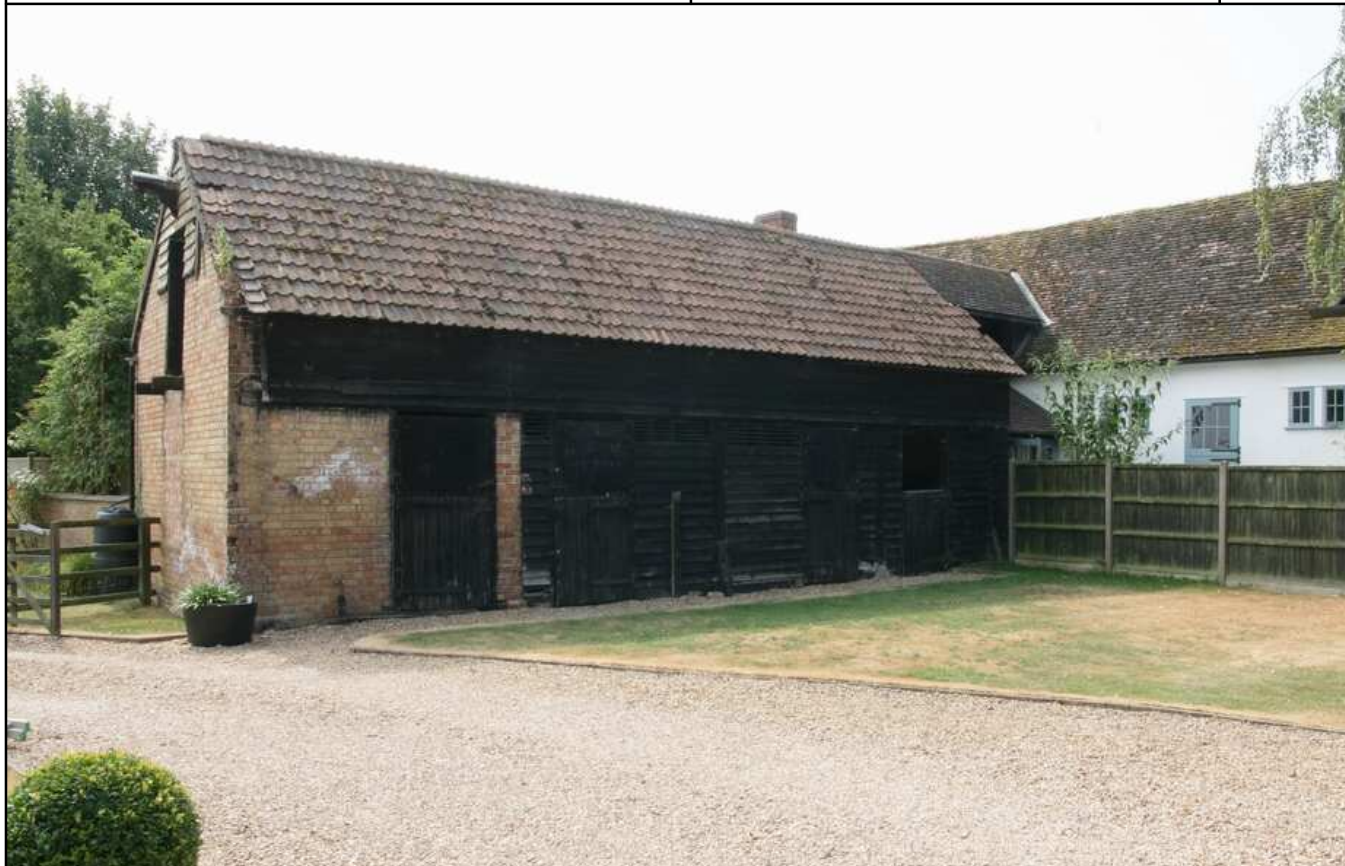
3.3 The barn forms a single storey brick block of four bays with loft, running approximately north-south, with timber framing to the west elevation, last used as stables (Figures 4 and 5, Plate 1). The pitched roof is covered in red pan-tiles.

Plate 01 - Park View barn, facing ESE

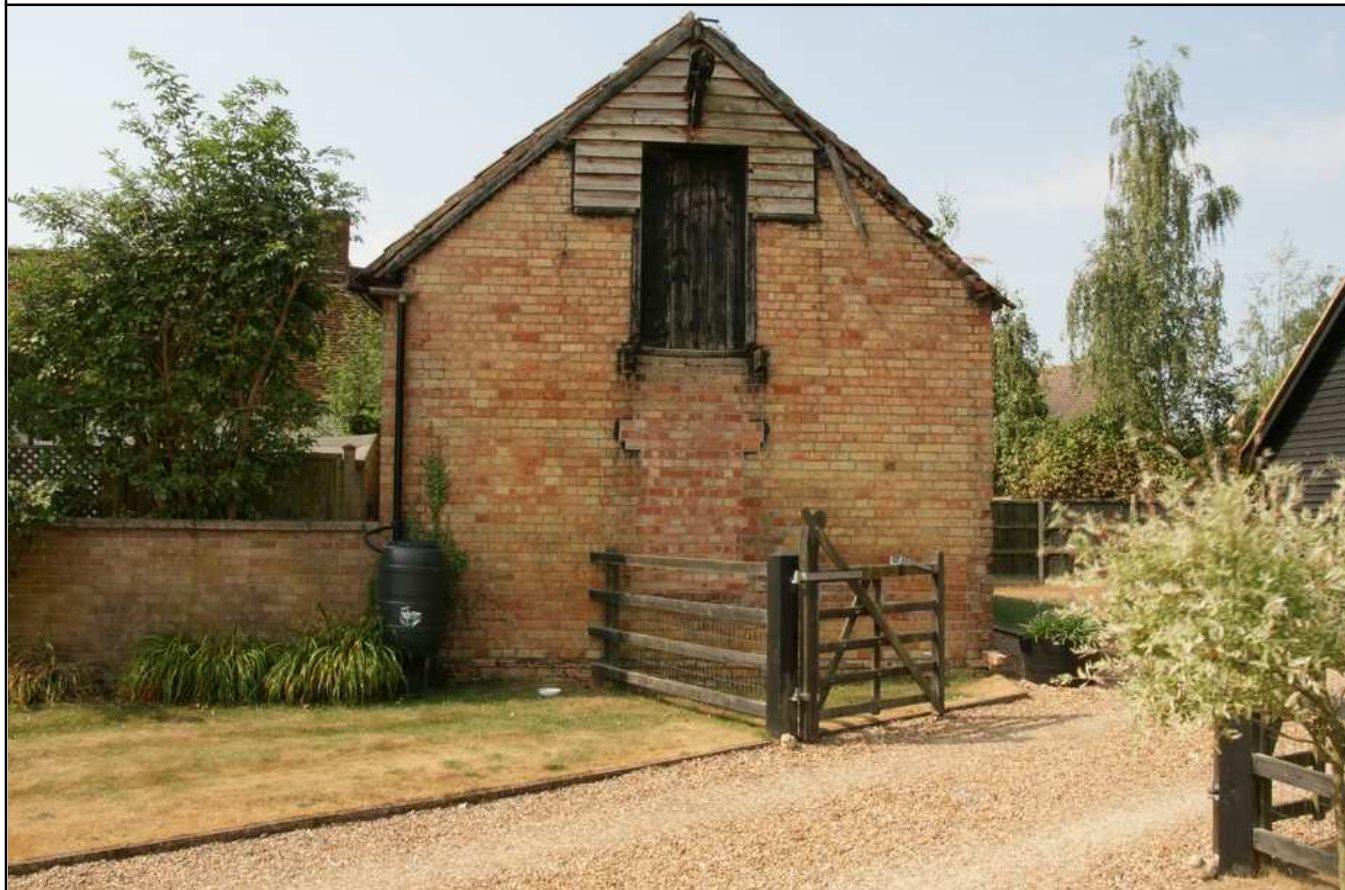
Plate 02 - Northern exterior elevation, facing S

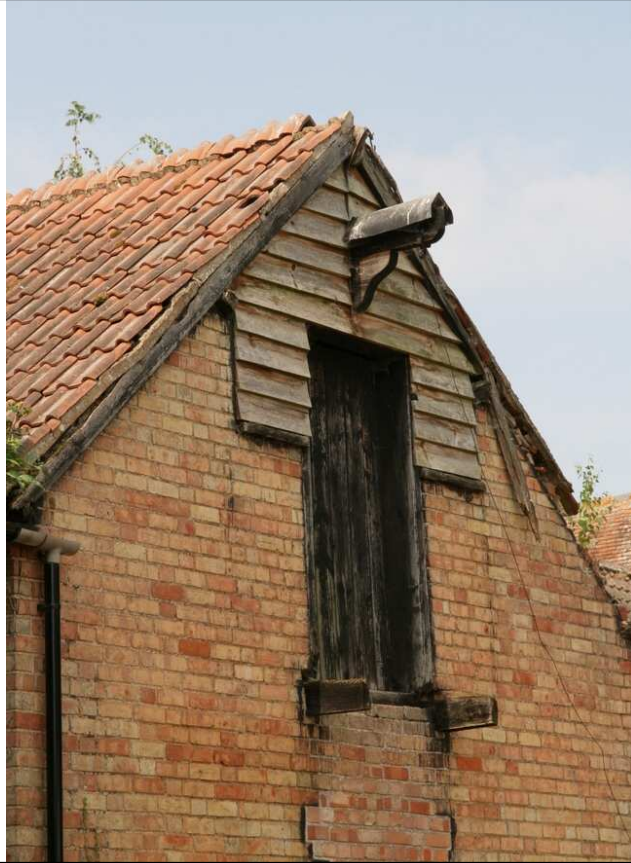
Plate 03 - Loft access and hoist, facing SW

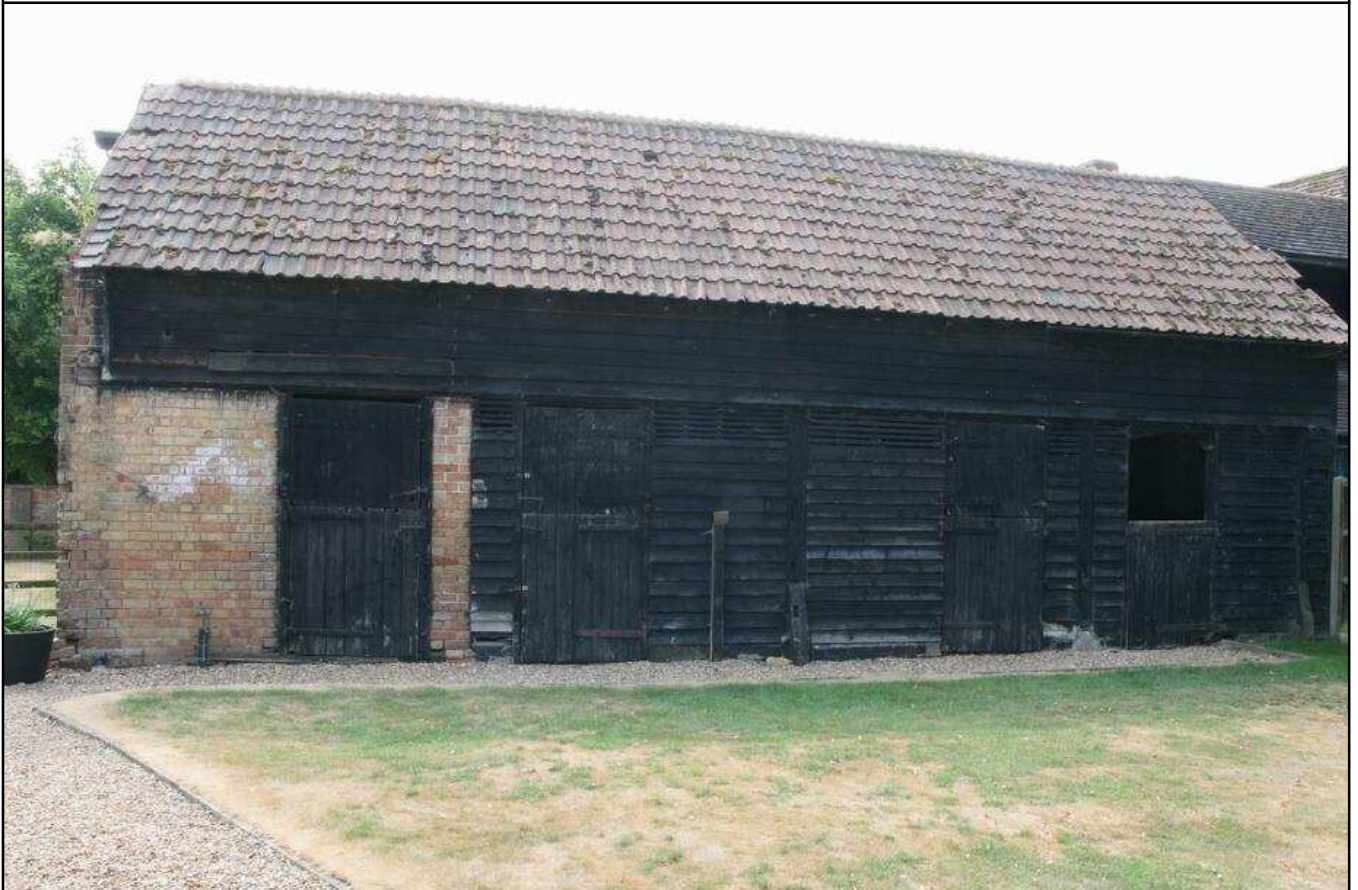
Plate 04 - Western exterior elevation, facing E

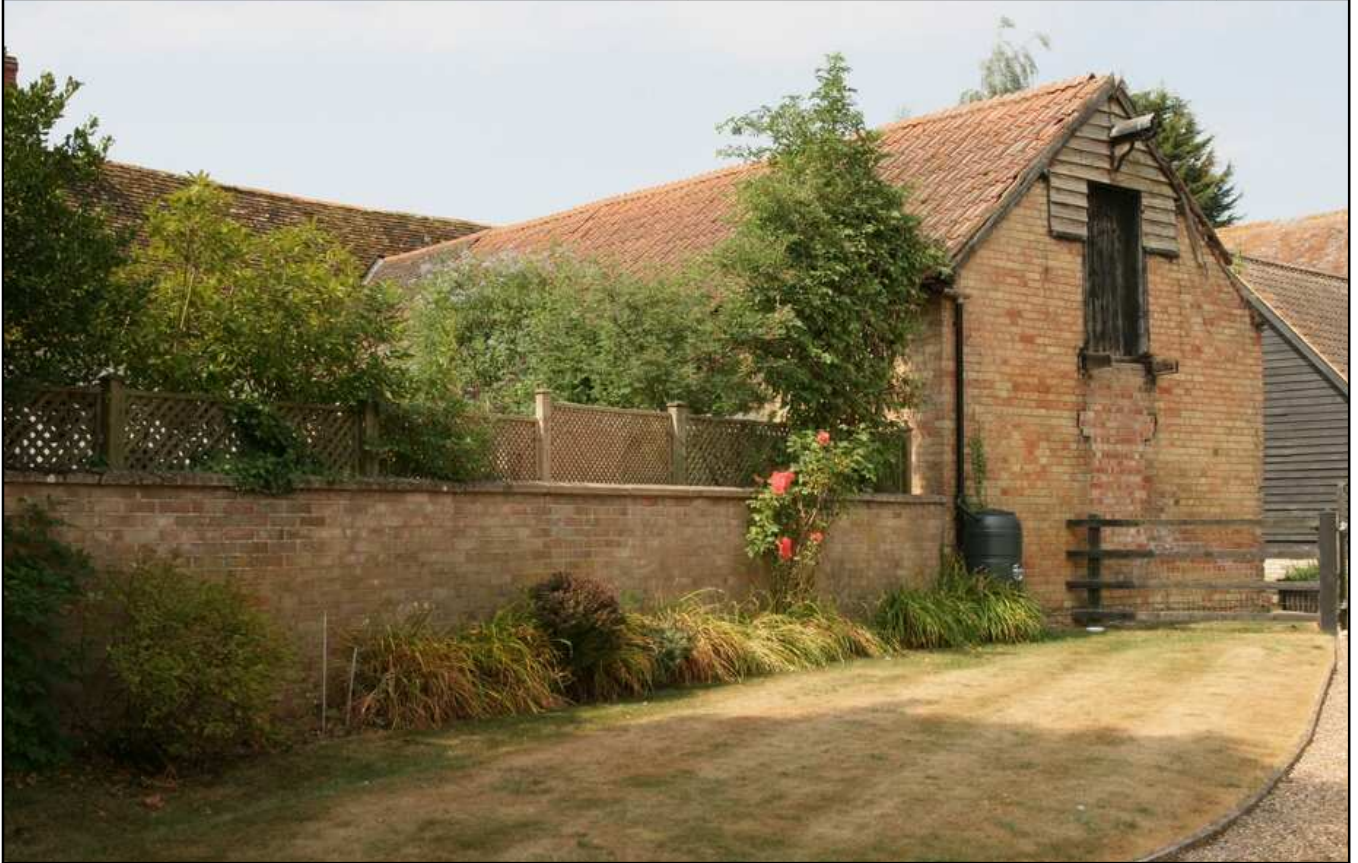
Plate 05 - Eastern exterior elevation, facing SW

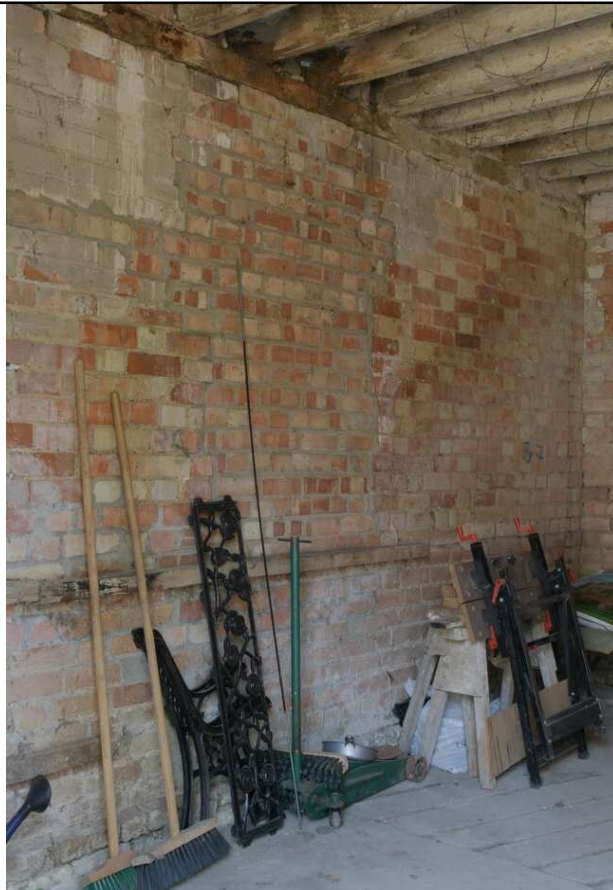
3.7 The north elevation is of unfinished white brick laid in Monk bond with lime mortar (Plate 6). There is a blocked central window opening, and a sleeper beam supports joists running north-south at the top of the wall.

Plate 06 - Bay 1, northern interior elevation, facing NE

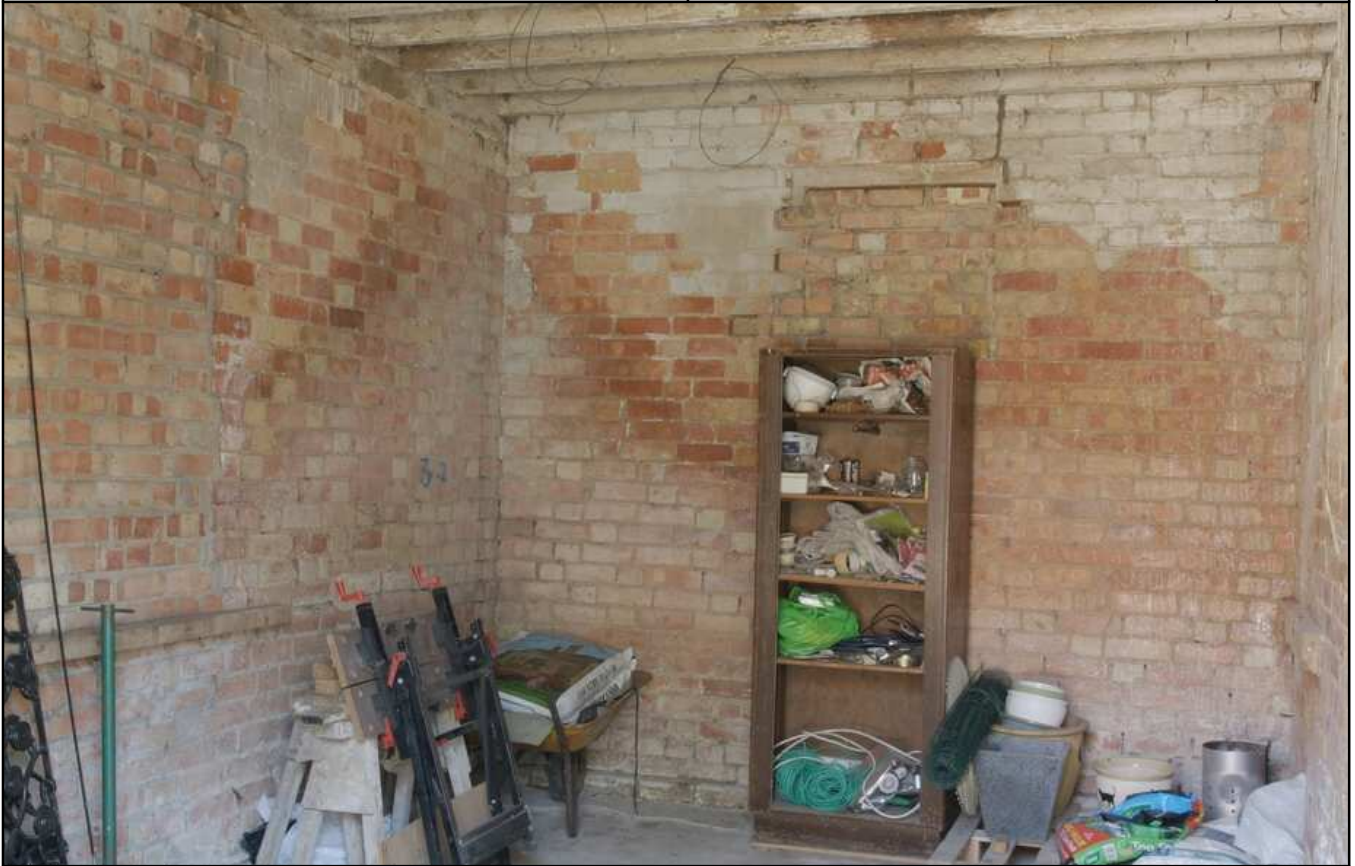
3.8 The east elevation is also of unfinished white brick, as in the north elevation (Plate 7). There is a high level central window opening, now blocked with Fletton bricks in a cement mortar, with a wooden lintel measuring 0.7 x 0.7m, located 1.72m above floor level.

Plate 07 - Bay 1, eastern interior elevation, facing E

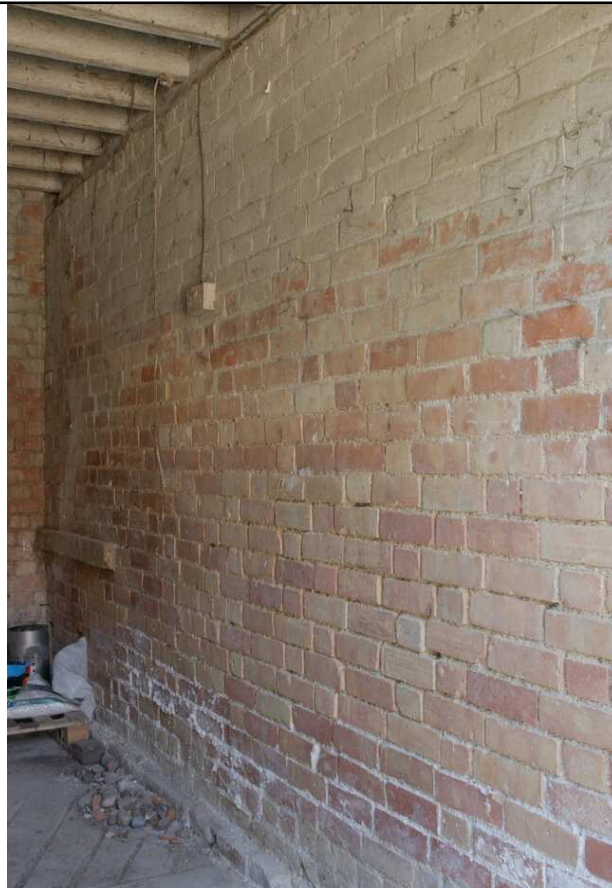
3.9 The south elevation is also of unfinished white brick, as in the north elevation (Plate 8). A sleeper beam supports joists running north-south at the top of the wall.

Plate 08 - Bay 1, southern interior elevation, facing SE

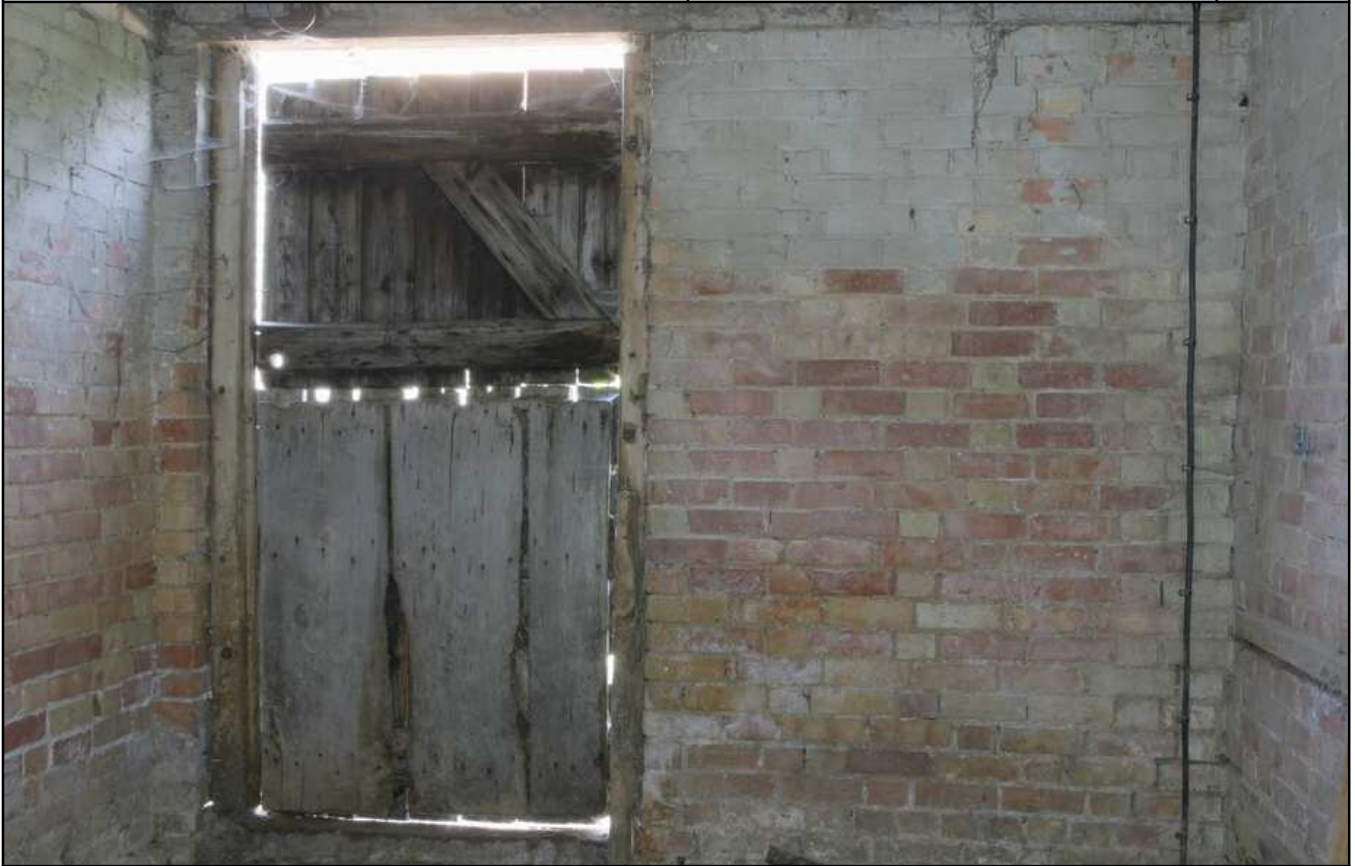
3.10 The west elevation is of unfinished brick, built in alternating layers of stretchers, and headers and stretchers (Plate 9). A boarded, ledged and braced stable door is located at the south end of the elevation, the lower door being faced with wide planks that may be reused floorboards.

Plate 09 - Bay 1, western interior elevation, facing W

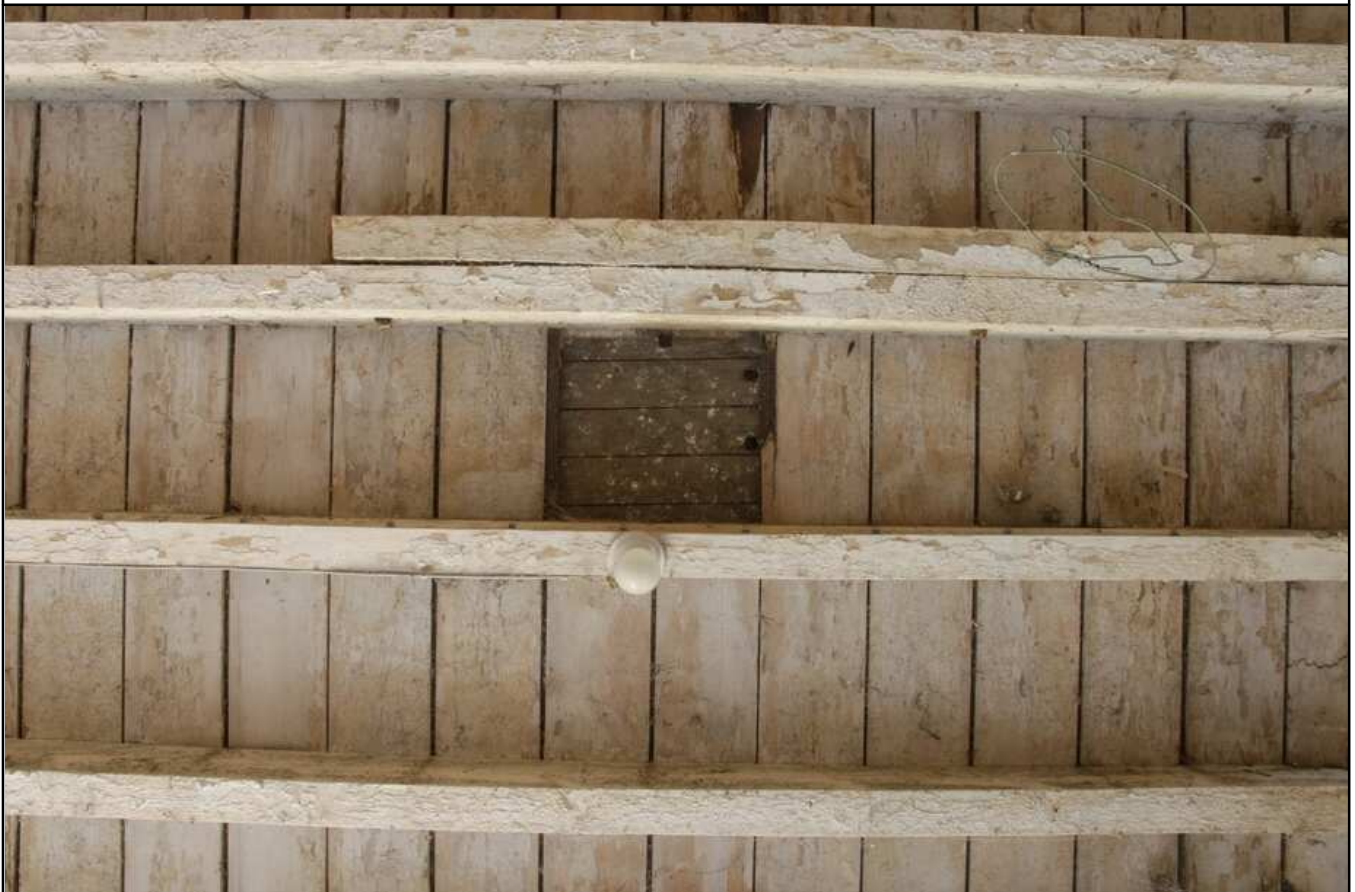
3.11 The softwood joists that support the loft space run north-south on 15-inch centres (Plate 10). The joists flanking the loft access have the supporting timbers for the former loft stair platform bolted to them. A small trapdoor has been let into the floorboards in the centre of the space.

Plate 10 - Bay 1, ceiling structure and trapdoor

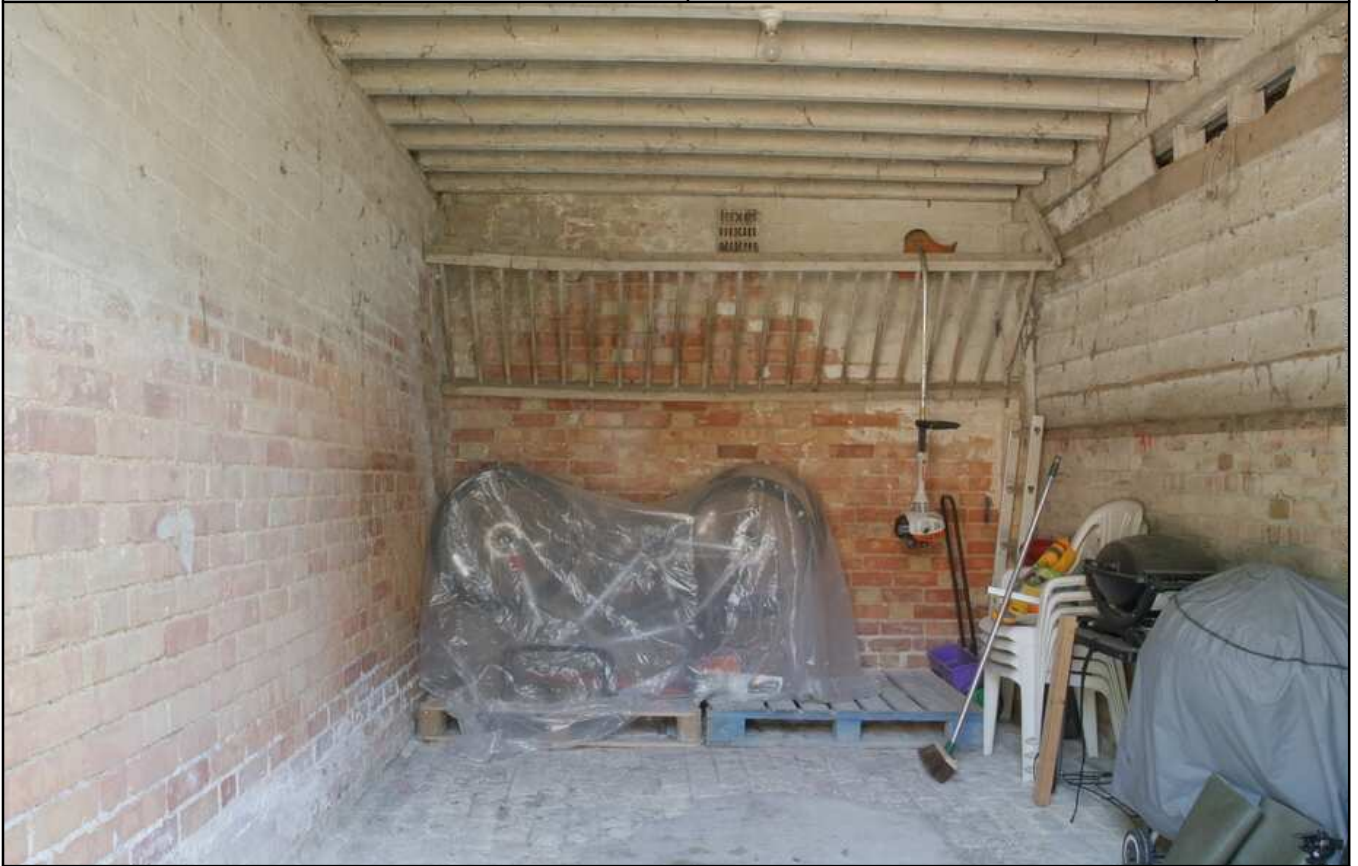
3.14 The east elevation is of unfinished white brick laid in Monk bond with lime mortar. Three small ventilation grates have been inserted in the centre of the elevation at high level. A hayrack is mounted 1.60m above ground level.

Plate 11 - Bay 2, eastern interior elevation, facing E

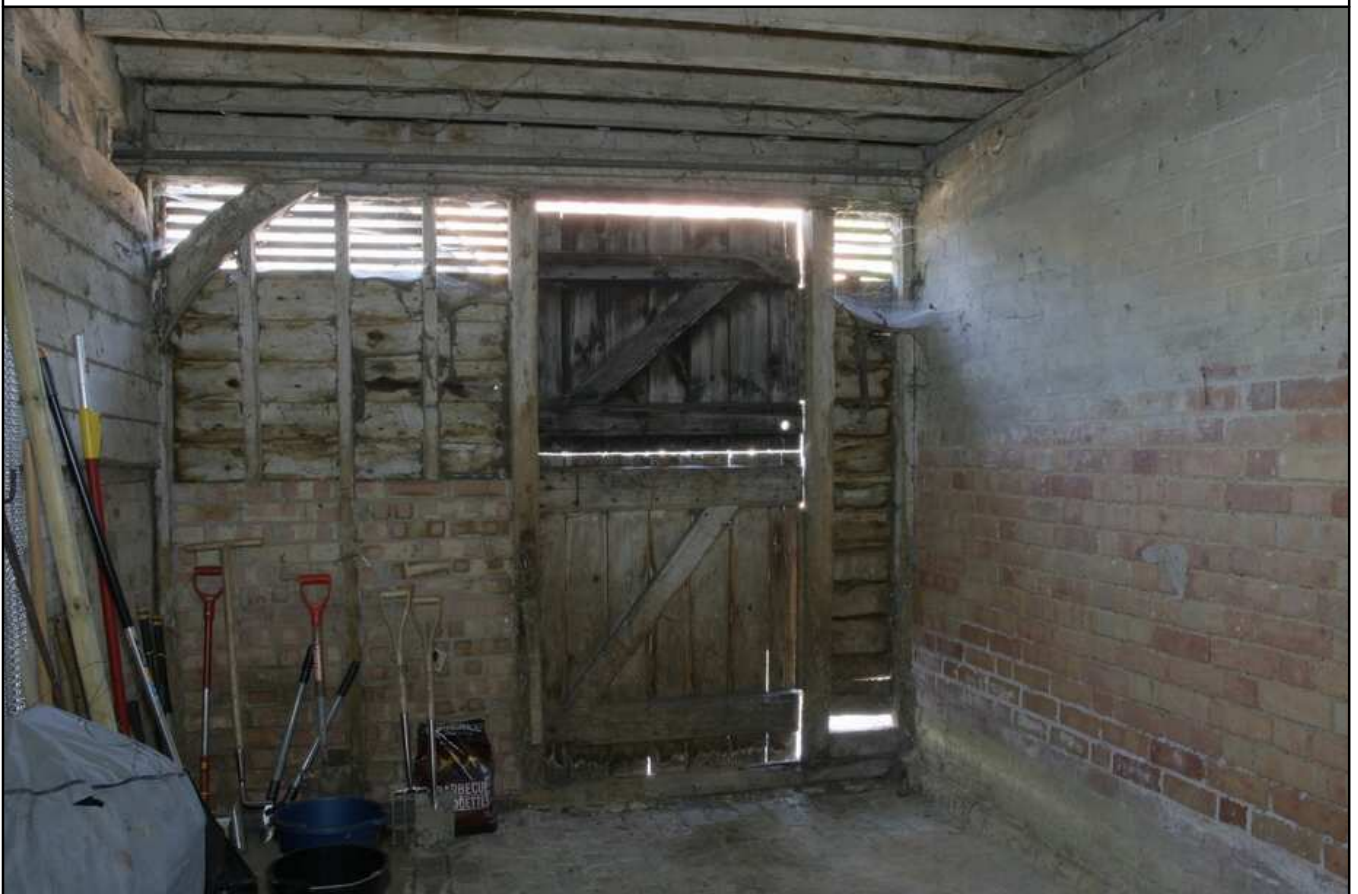
3.16 The west elevation has a similar 1.33m high Fletton brick wall surmounted by studwork. At the north end of the elevation is a boarded, ledged and braced stable door.

Plate 12 - Bay 2, western interior elevation, facing W

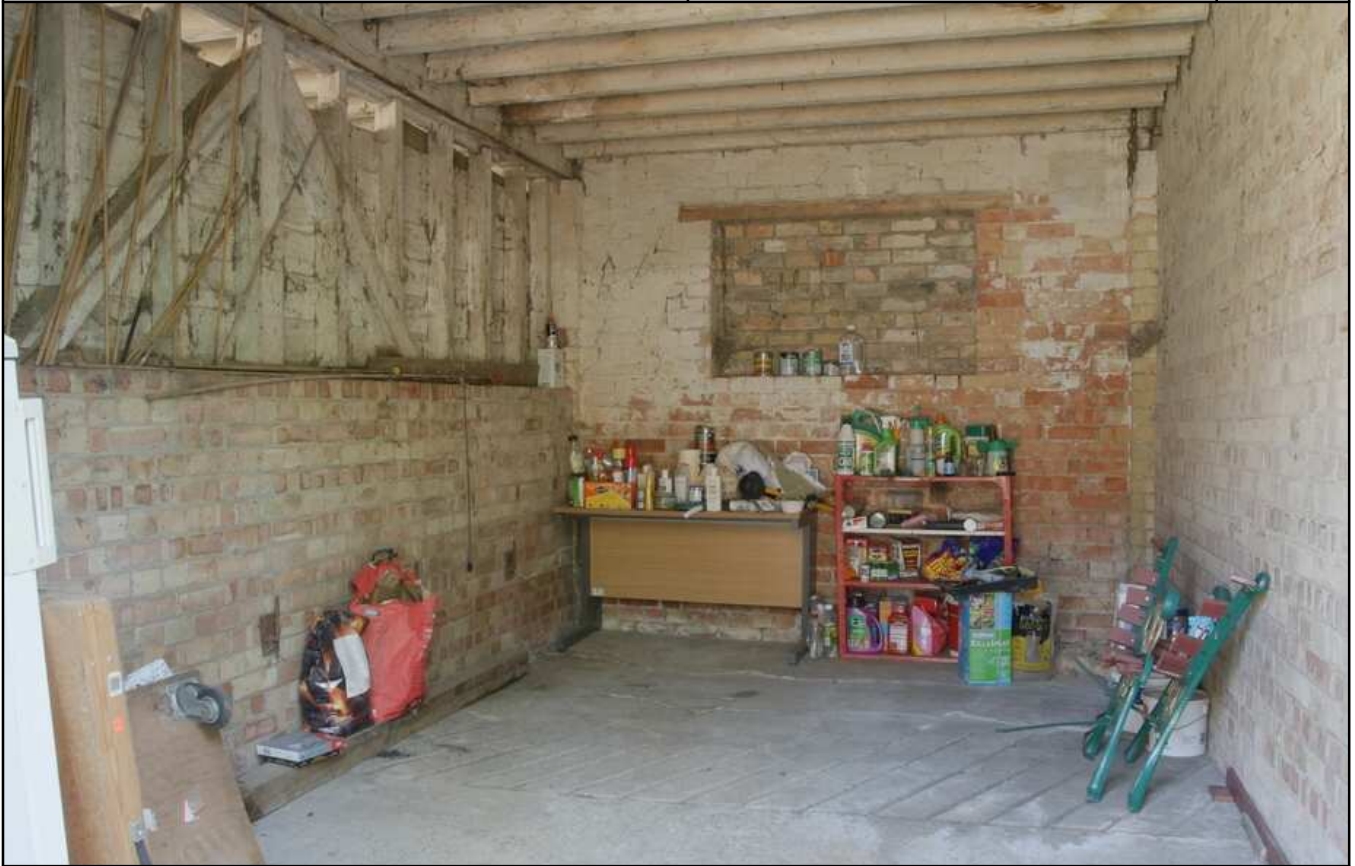
3.18 The north elevation is formed by a 1.33m high Fletton brick wall running between a white brick pier to the east and a principal post to the west, with framing above. This is formed of a central principal post with primary bracing and softwood studs on 15-inch centres. A curved brace extends between the cross-beam and the principal post in the west elevation.

3.19 The east elevation is of unfinished brick, as noted elsewhere. There is a blocked window opening in the centre of the elevation 1.33m above floor level, measuring 1.36 x 0.90m, with a wooden lintel. The blocking makes use of mixed bricks and has been undertaken from the exterior.

Plate 13 - Bay 3, eastern and northern interior elevations, facing NE
