**PARK VIEW, 6A FORD LANE
Roxton, Bedfordshire**

HN1433

***HISTORIC BUILDING
RECORD***

Historic Building Record

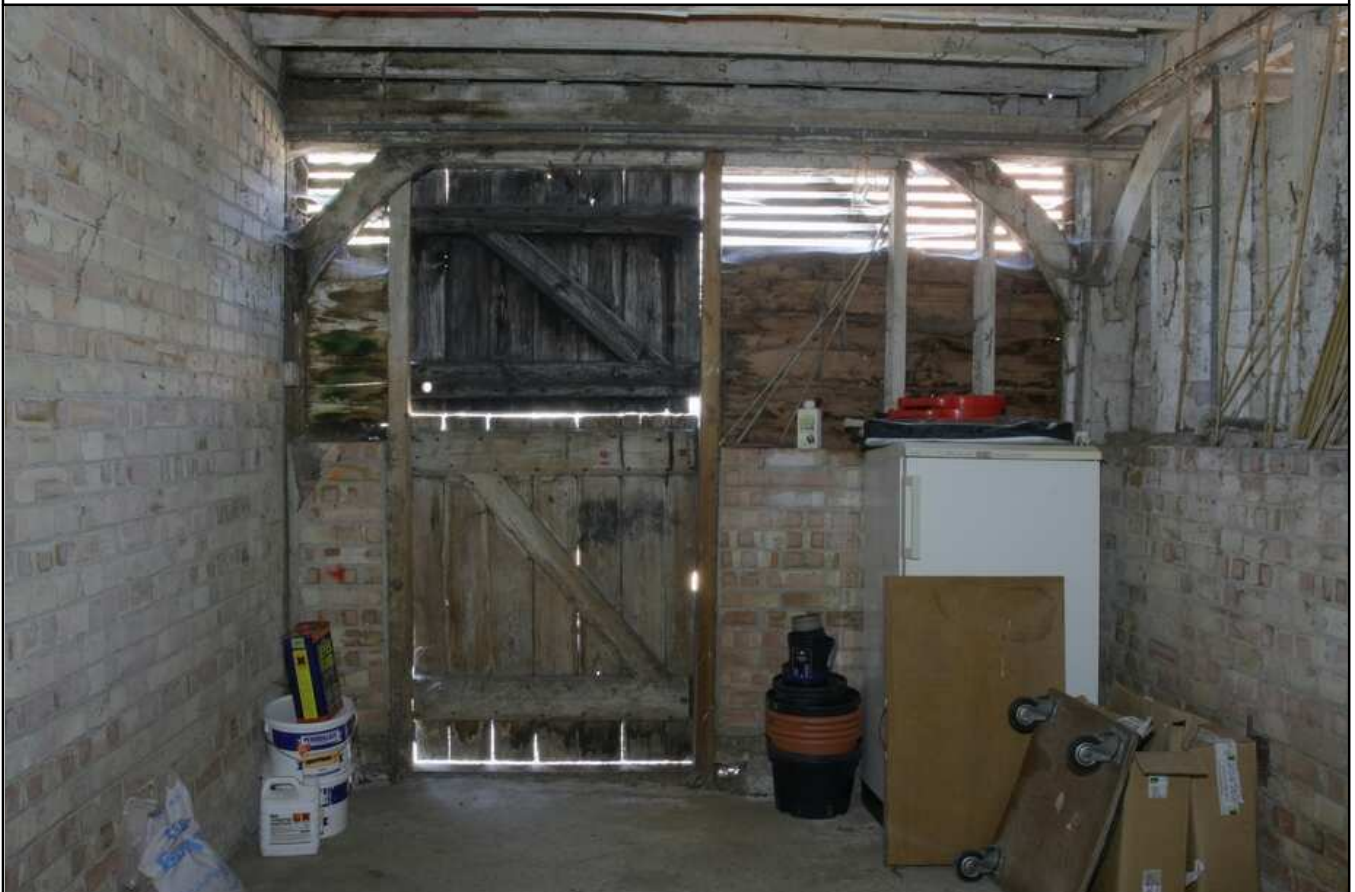
3.21 The west elevation has a 1.33m high Fletton brick wall surmounted by studwork. At the south end of the elevation is a boarded, ledged and braced stable door. Curved braces run between the wall plate and the principal posts to north and south.

Plate 14 - Bay 3, western interior elevation, facing W

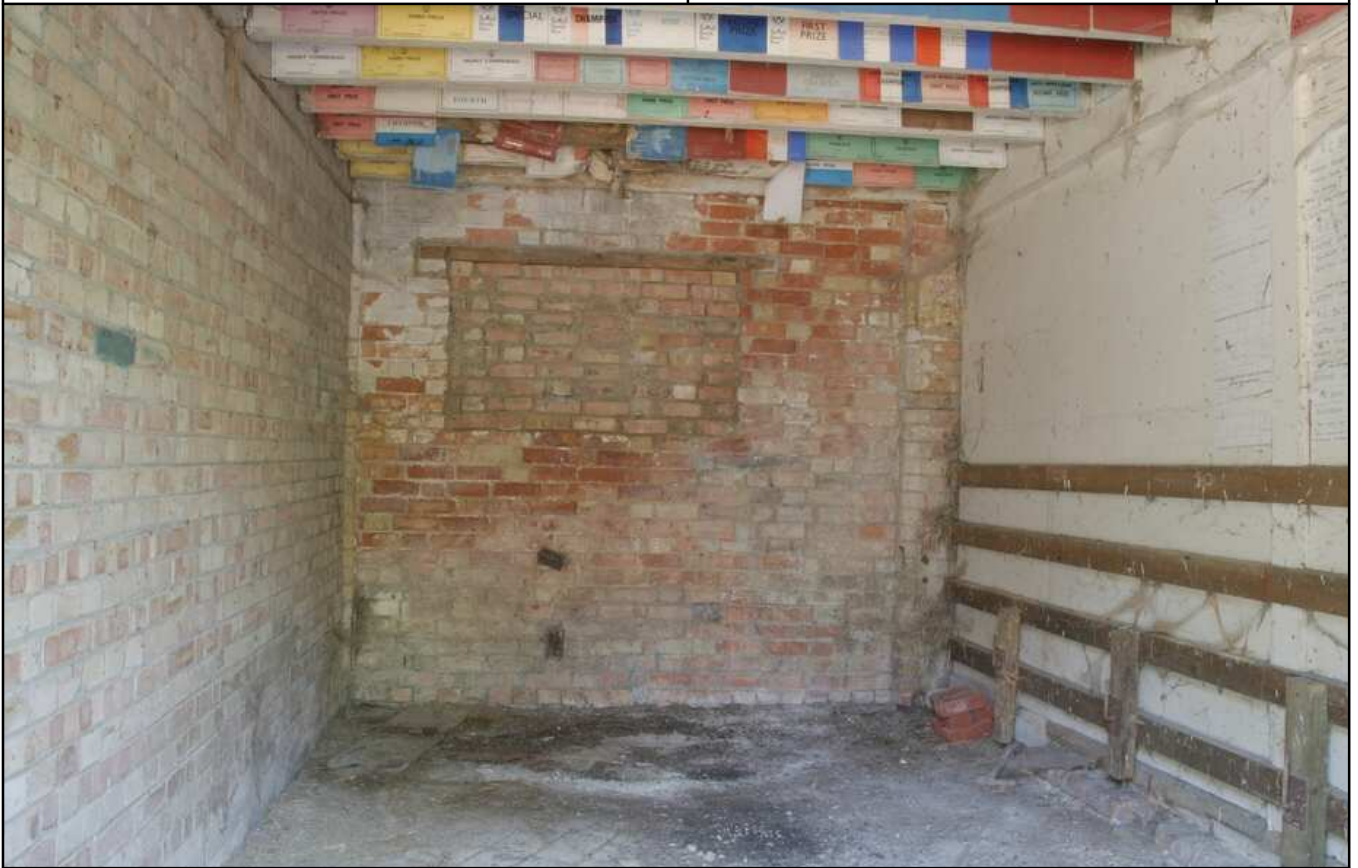
3.24 The east elevation is of unfinished brick, as noted elsewhere. There is a blocked window opening offset to the north of the elevation. 1.33m above floor level, measuring 1.36 x 0.90m, with a wooden lintel. The blocking makes use of mixed bricks and has been undertaken from the exterior.

Plate 15 - Bay 4, eastern interior elevation, facing E

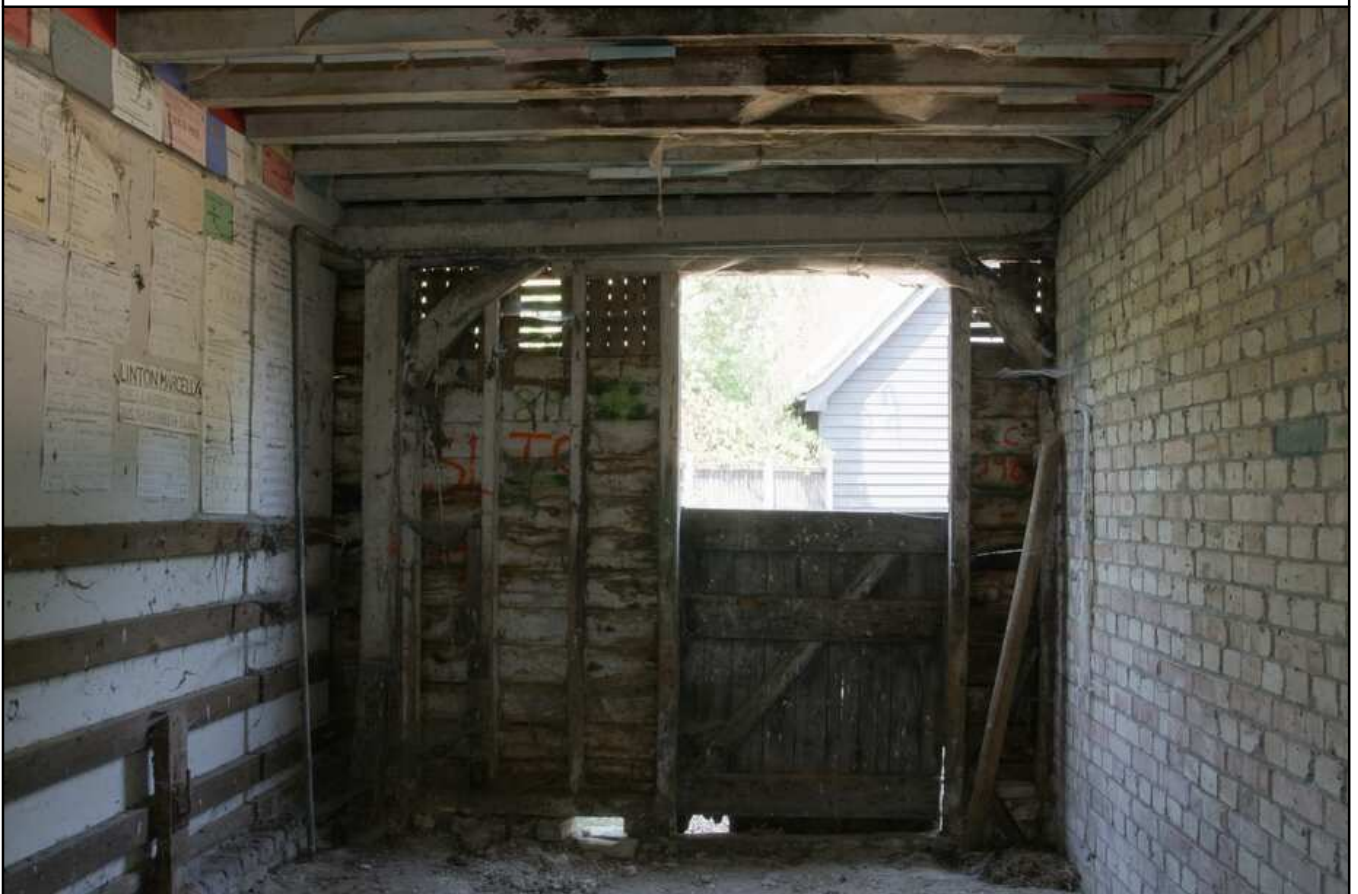
3.26 The west elevation is formed of secondary timber studwork to the south, with a boarded, ledged and braced stable door to the north.

Plate 16 - Bay 4, western interior elevation, facing W

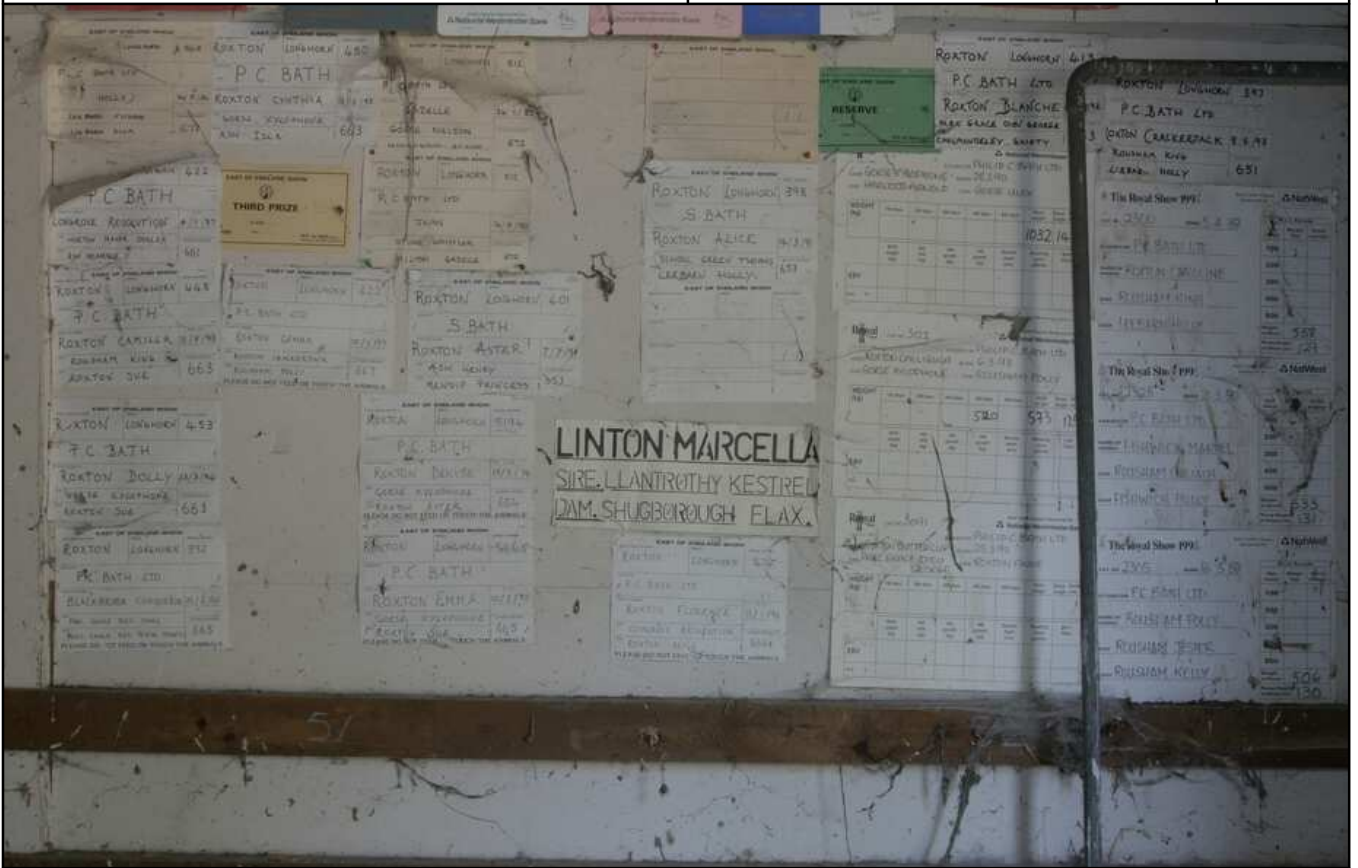
3.25 The south elevation has been faced with modern plasterboard and timber rails. Records of show cattle have been mounted on the board (Plate 17).

Plate 17 - Bay 4, southern elevation, cattle show forms, facing S

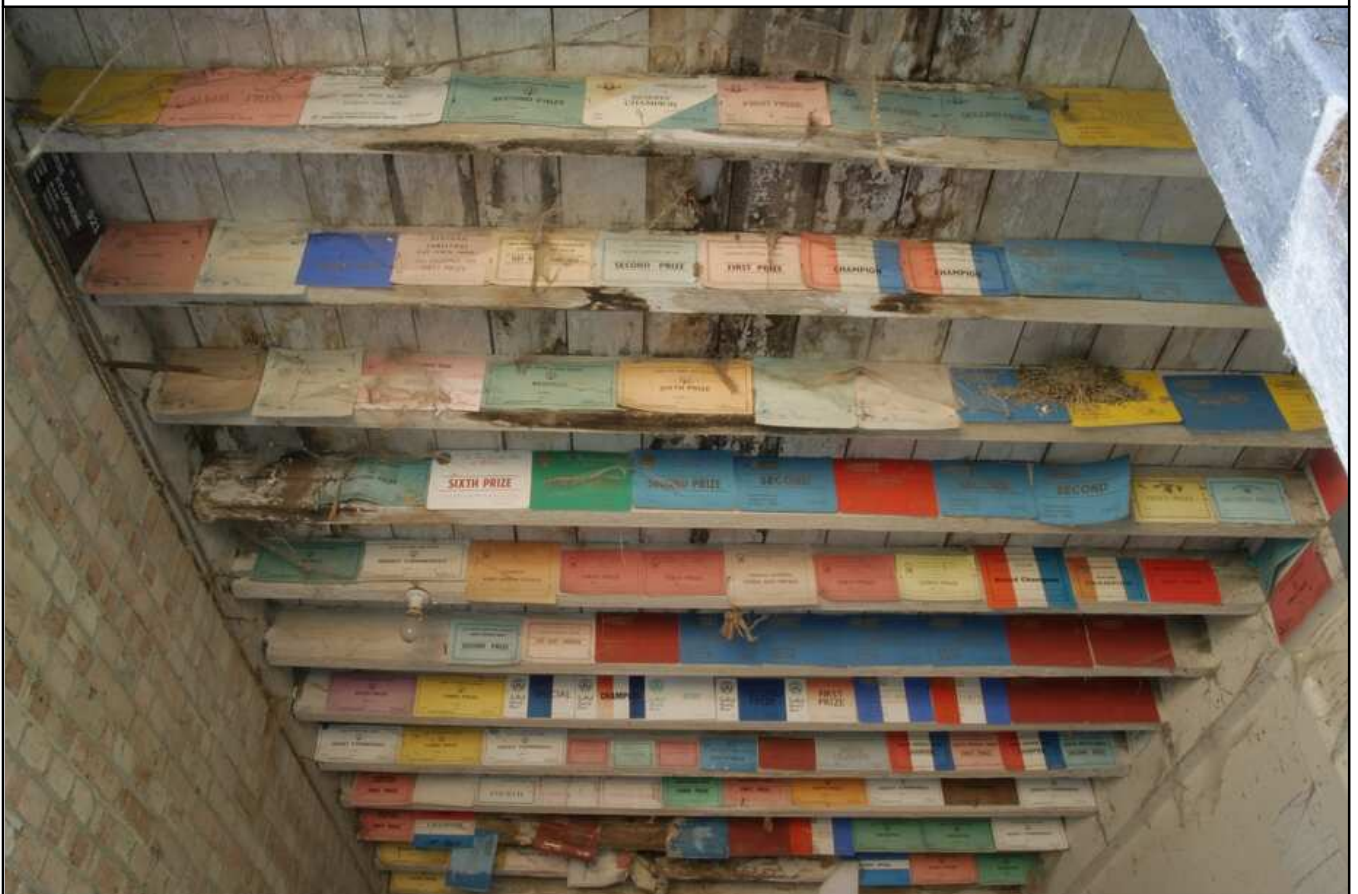
3.27 The ceiling has exposed joists supporting the loft space, on 15-inch centres. Further records of show cattle have been mounted on the joists (Plate 18). The floor is covered in modern concrete to the east and is of earth to the west.

Plate 18 - Bay 4, prize certificates on joists, facing E

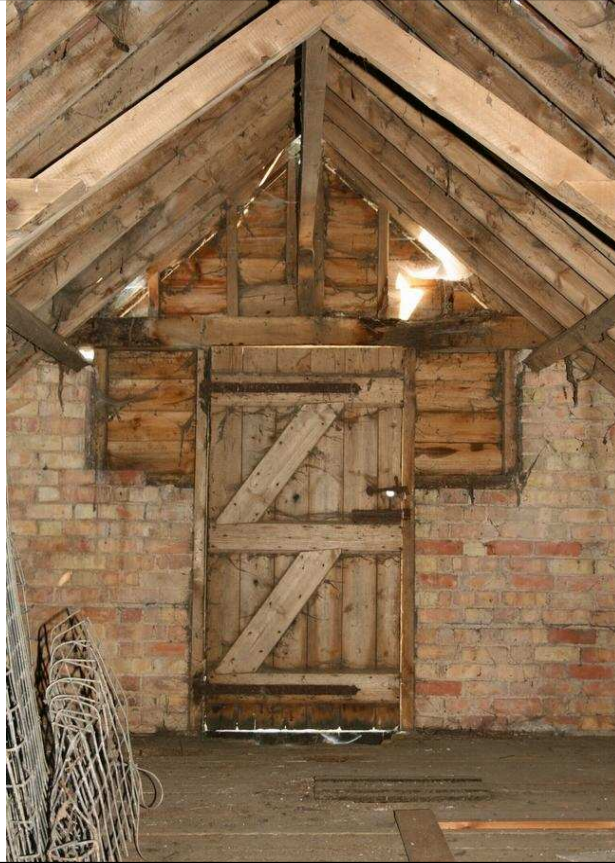
3.28 The north elevation is of unfinished brick, with a central boarded, ledged and braced door, flanked by window openings that are blocked with weatherboard (Plate 19).

Plate 19 - Loft, northern interior elevation, facing N

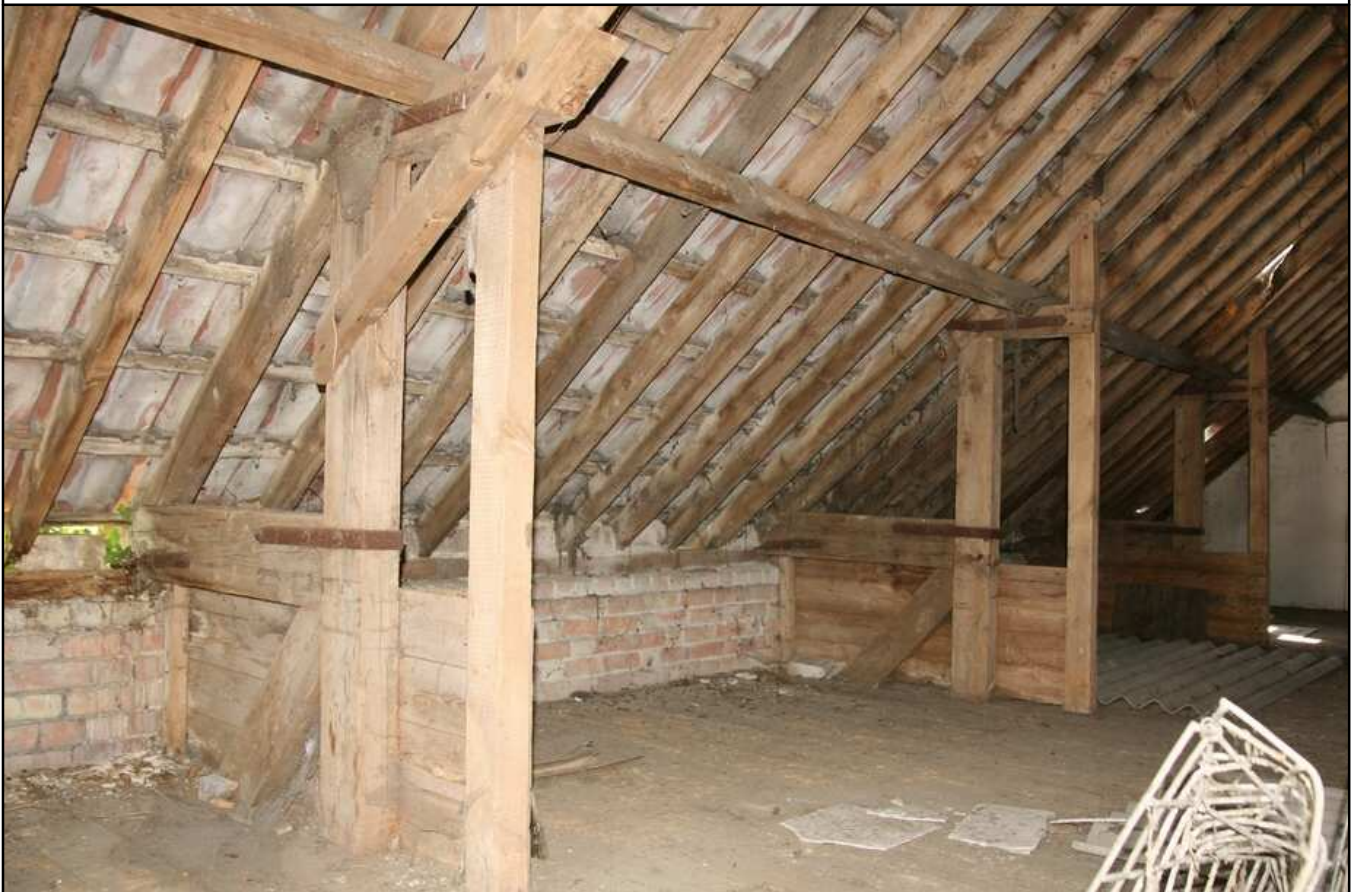
3.29 The east elevation has six courses of unfinished brick extending above the level of the floor and supporting the wall-plate, with the roof structure above (Plate 20).

Plate 20 - Loft, eastern interior elevation, facing SE

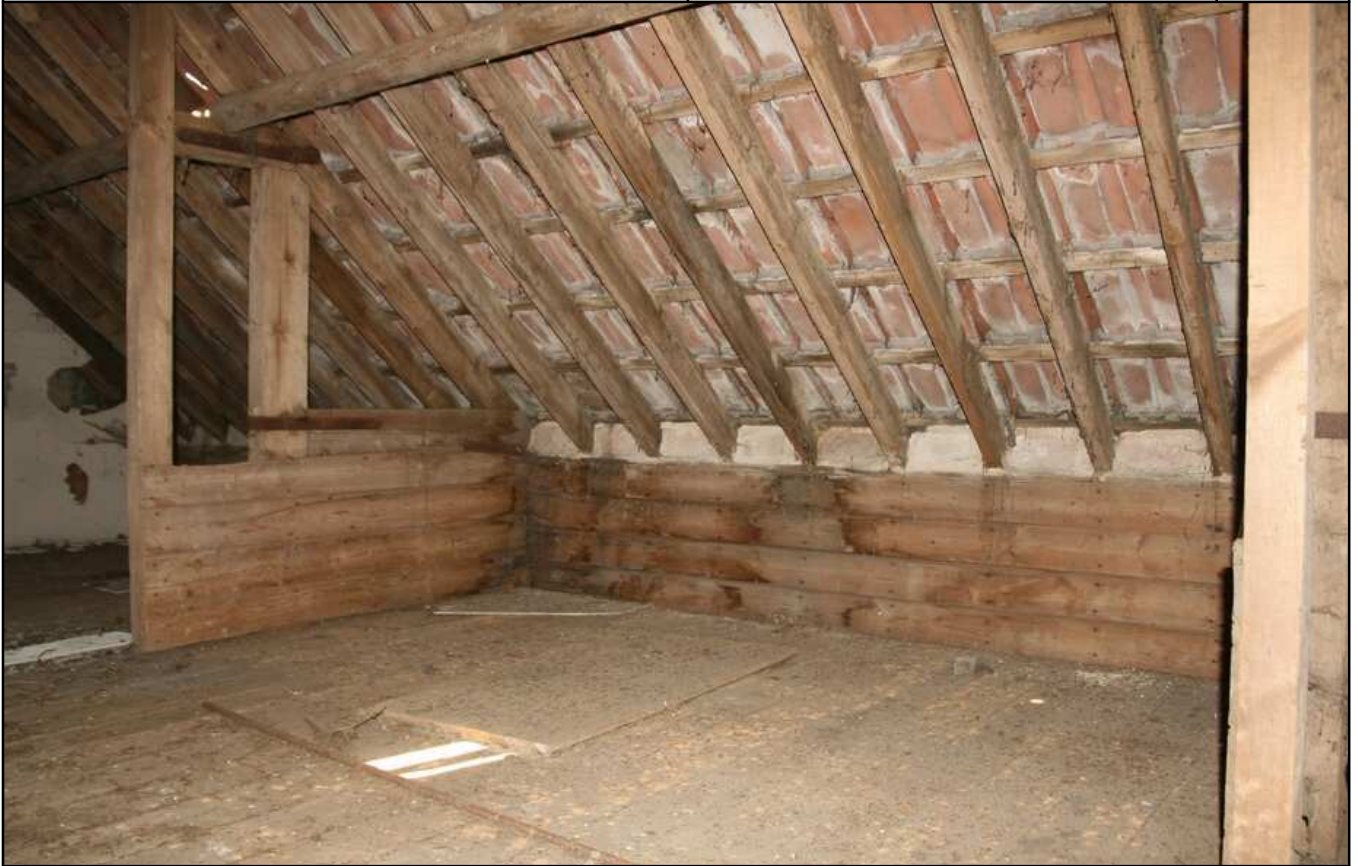
3.31 The west elevation is weatherboarded between the floor and the wall-plate (Plate 21).

Plate 21 - Loft, western interior elevation, facing SW

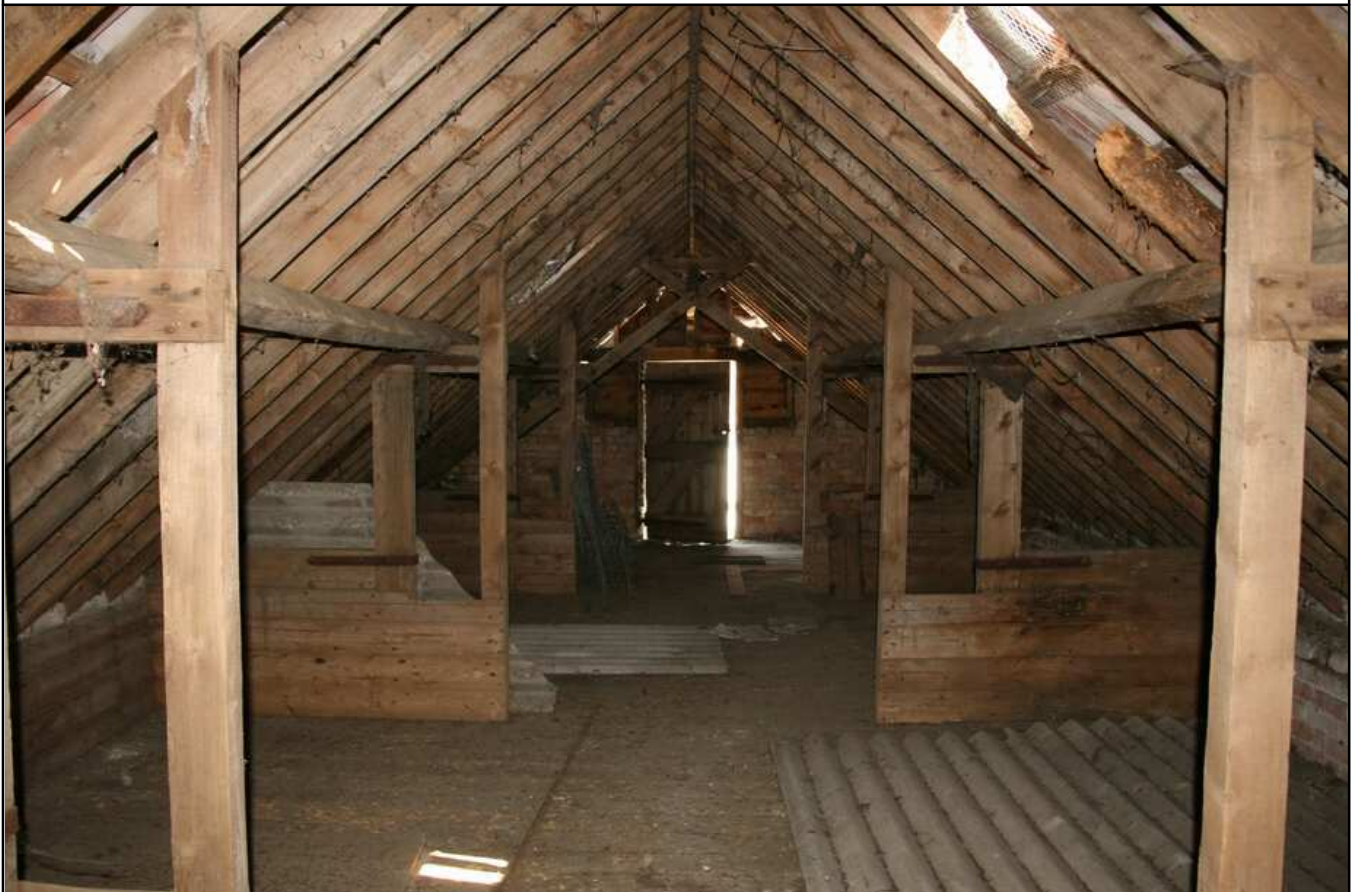
3.32 The roof structure is formed of interrupted tie-beams and collars, with principal and secondary posts supporting the principal rafters and a single clasped purlin in each slope (Plate 22). In between the trusses, rafter pairs meet at a ridge plate.

Plate 22 - Loft, interior view north

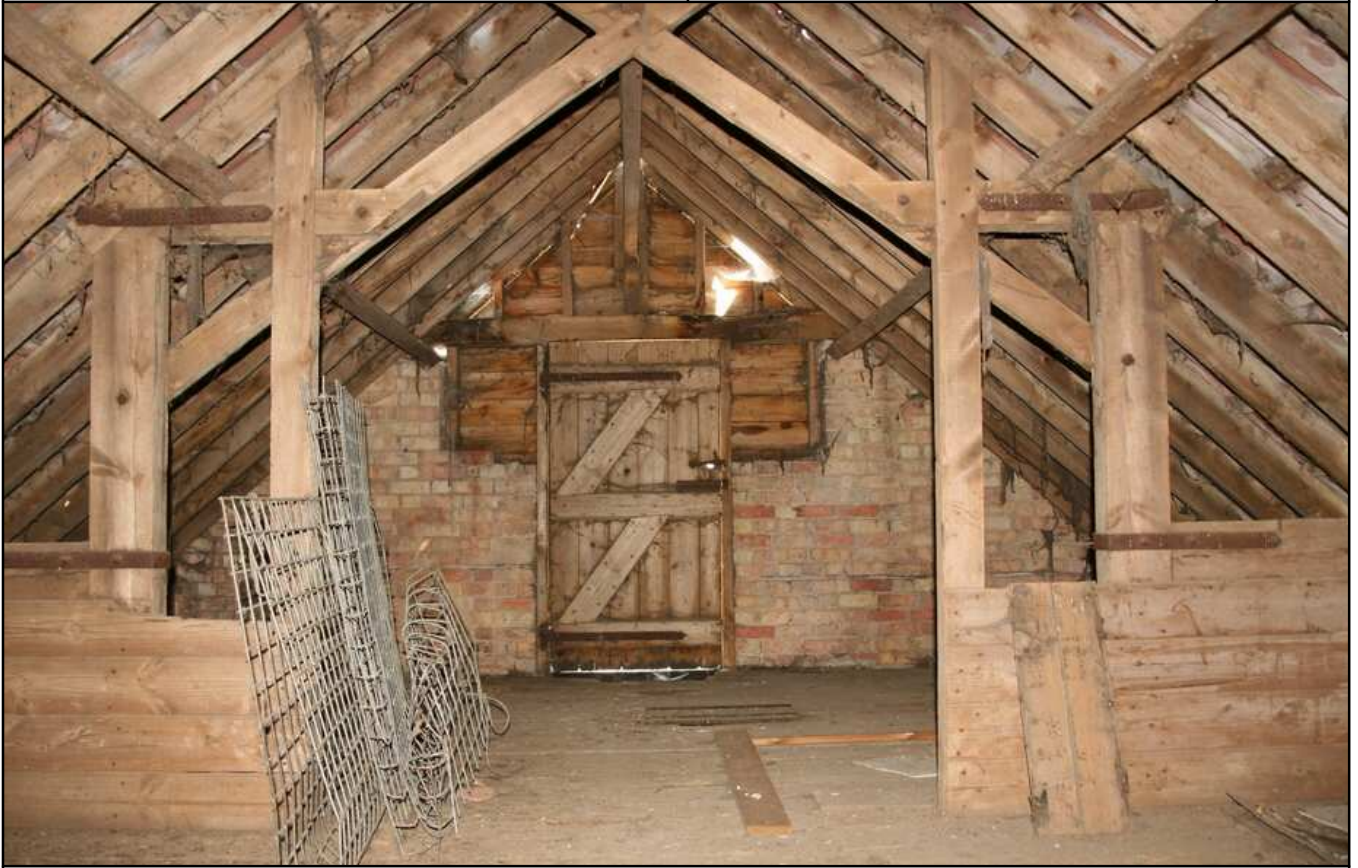
3.34 The hoist beam, that projects through the north elevation, is supported by a cross-brace between Bays 1 and 2 (Plate 23). Each bay is semi-partitioned for storage of loose feed or hay. The trusses have all been strengthened with contemporary iron straps.

Plate 23 - Loft, roof and hoist structure, facing N
