BARN AT THE COACH HOUSE **Witney Green, Fyfield, Essex**

HN1440

***HISTORIC BUILDING
RECORD***

Report no.1180

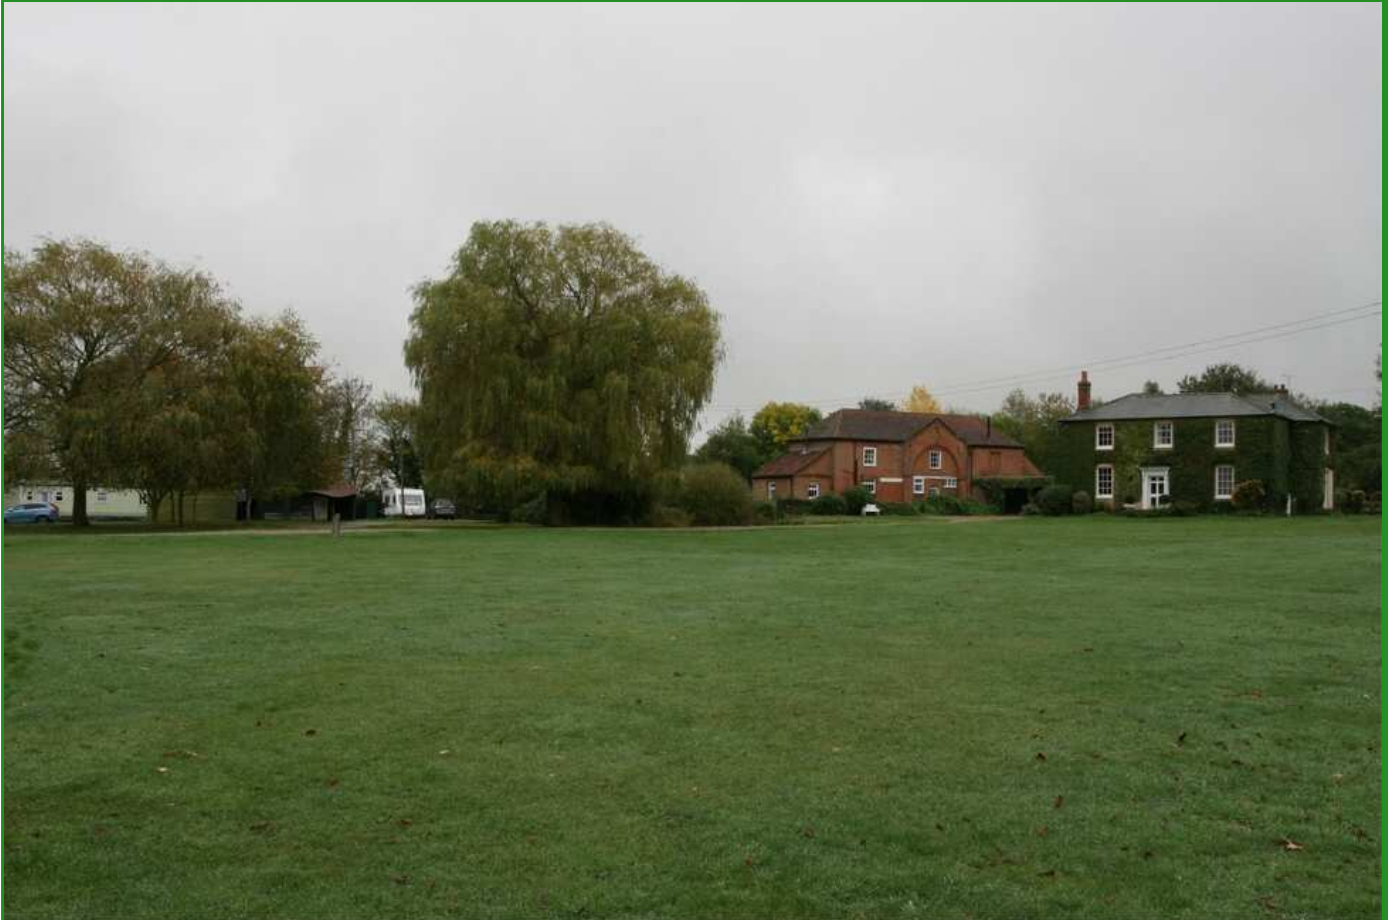
The cover photograph shows Witney Green Farm looking south-east, showing the barn on the far left, with Witney Green Farmhouse and The Coach House on the right.

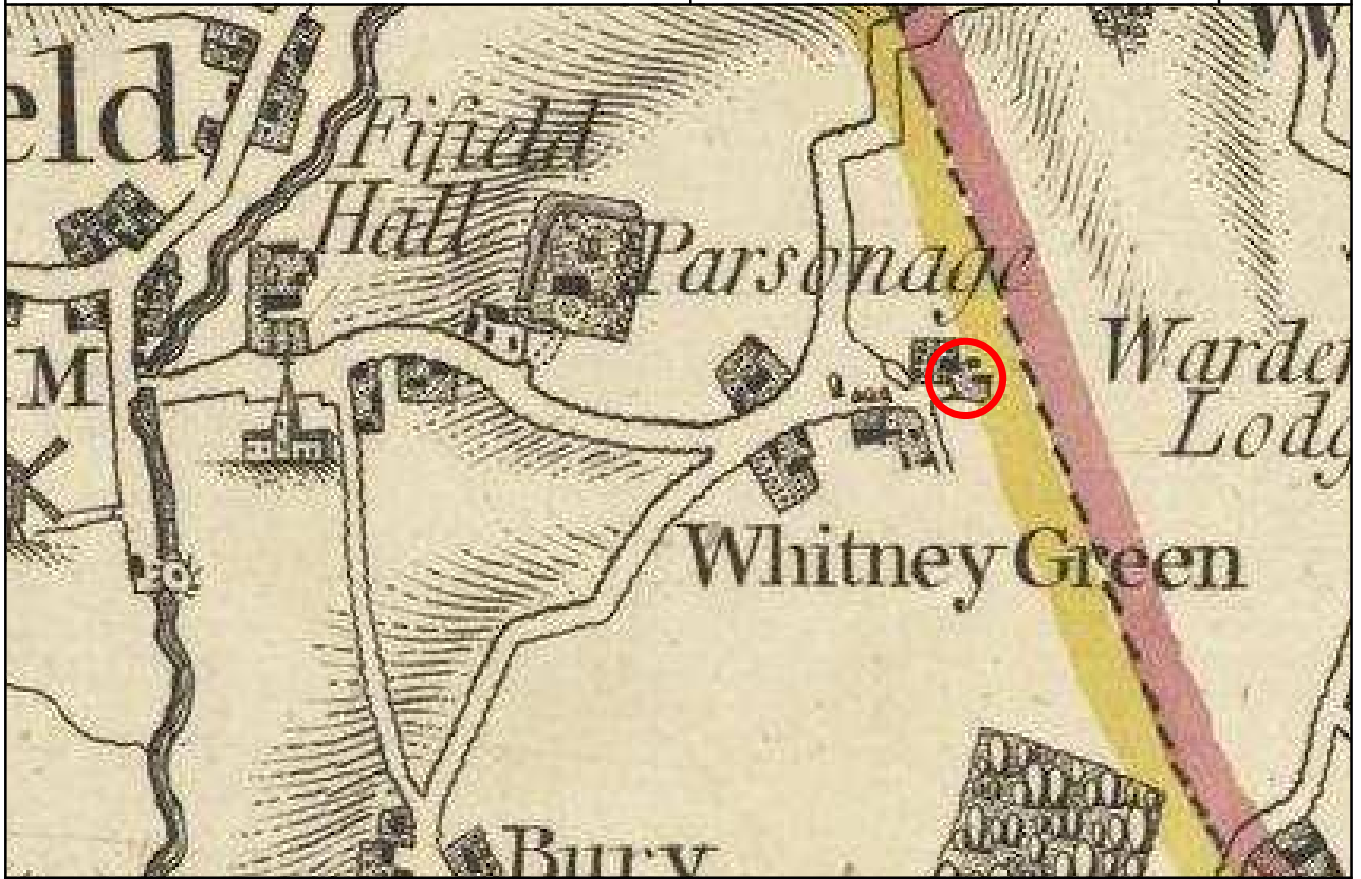
Figure 2

2.5 Chapman and Andre's rather schematic county map of 1777, shows Witney Green with four distinct properties around a triangular open space, which presumably forms the 'green' in the place name (Figure 2).

2.5.1 On the western side of the green is a property that equates to Little Witney Green, which is still extant.

2.5.2 On the opposite side of the highway to Little Witney Green, a further property is marked, apparently formed of three buildings around a courtyard that is open on the road side, set within an orchard or garden. The form appears to be agricultural.

2.5.3 At the eastern end of the green, a square enclosure may denote an orchard or garden, with a building in the south-west quadrant and a further enclosure with two buildings to the south-west. These buildings may form the original Witney Green farmhouse, and its outbuildings, including the present barn.

2.5.4 On the west side of a lane running south-east off the green, is a large building and several smaller ones, which may be the forerunners of the present Witney Green farmhouse, and associated Coach House.

Extract from Chapman & Andre's Map of Essex, 1777

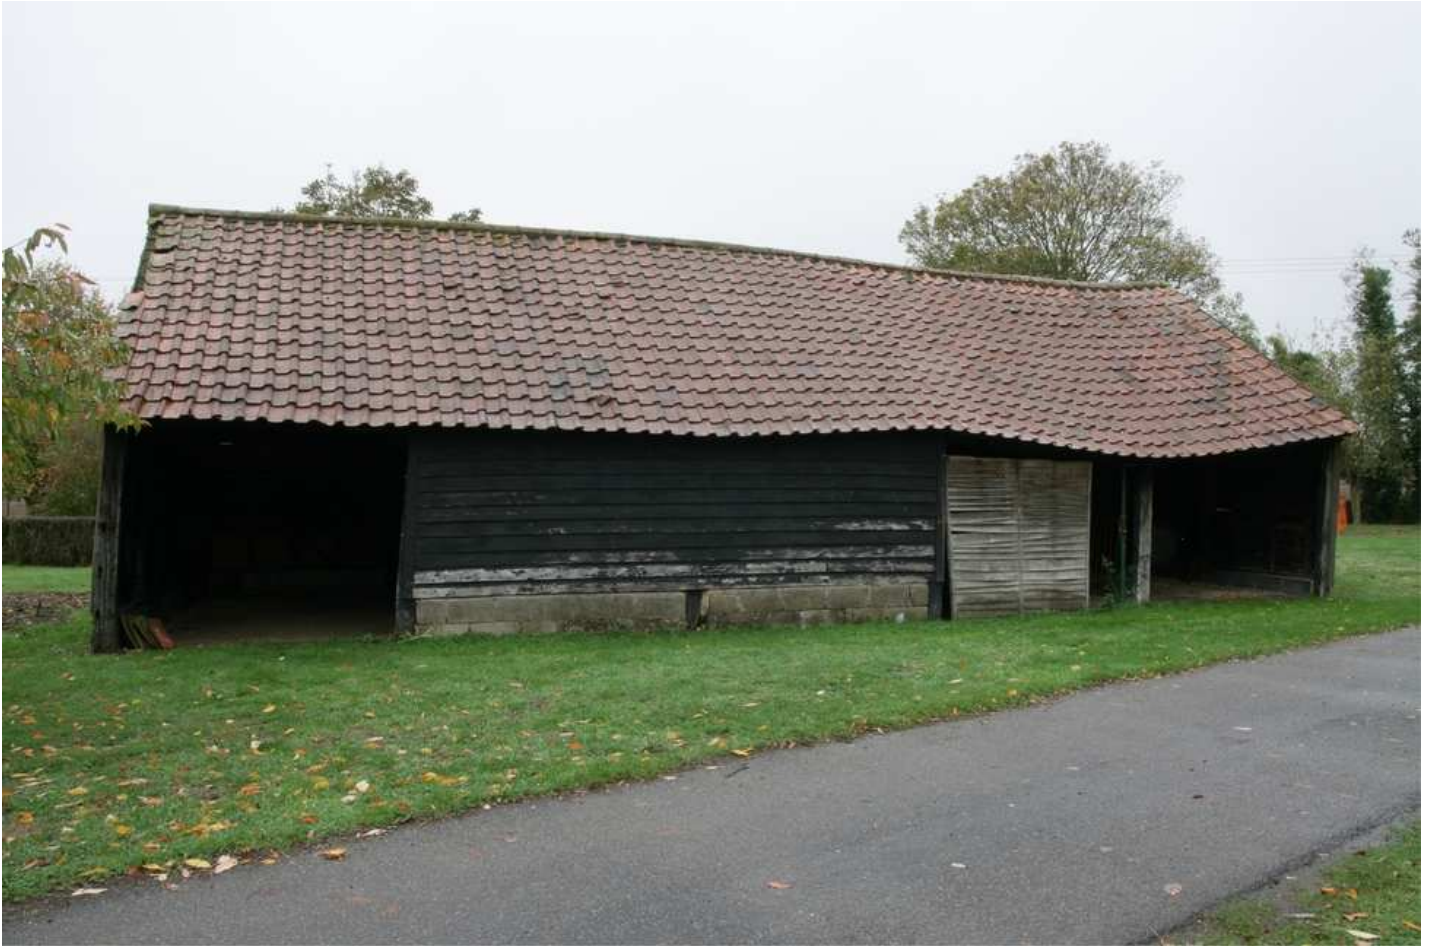
3.6 The northern bay of the west elevation is open. The following two bays have modern softwood weatherboarding above a plinth of modern cement blocks. The southern two bays are open.

Plate 01 - Western exterior elevation, looking E

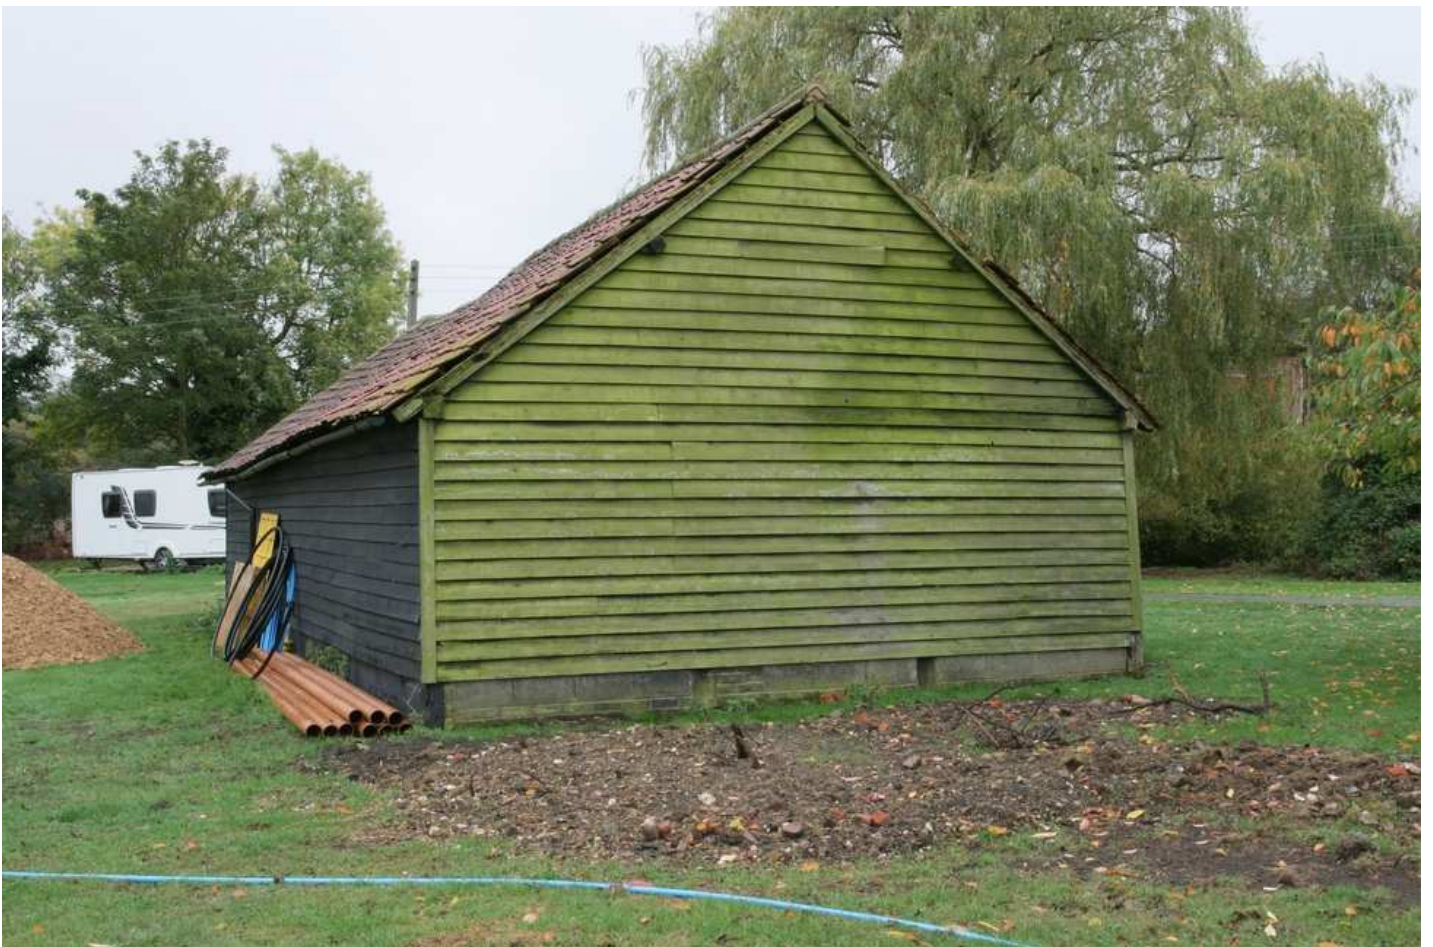
3.7 The north elevation is faced in modern softwood weatherboarding to 300mm above ground level. Below this, the bases of the principal posts are exposed, with infill of modern cement blocks between them. The horns of wall-plates, modern purlins and modern ridge board are exposed.

Plate 02 - Northern exterior elevation, looking S

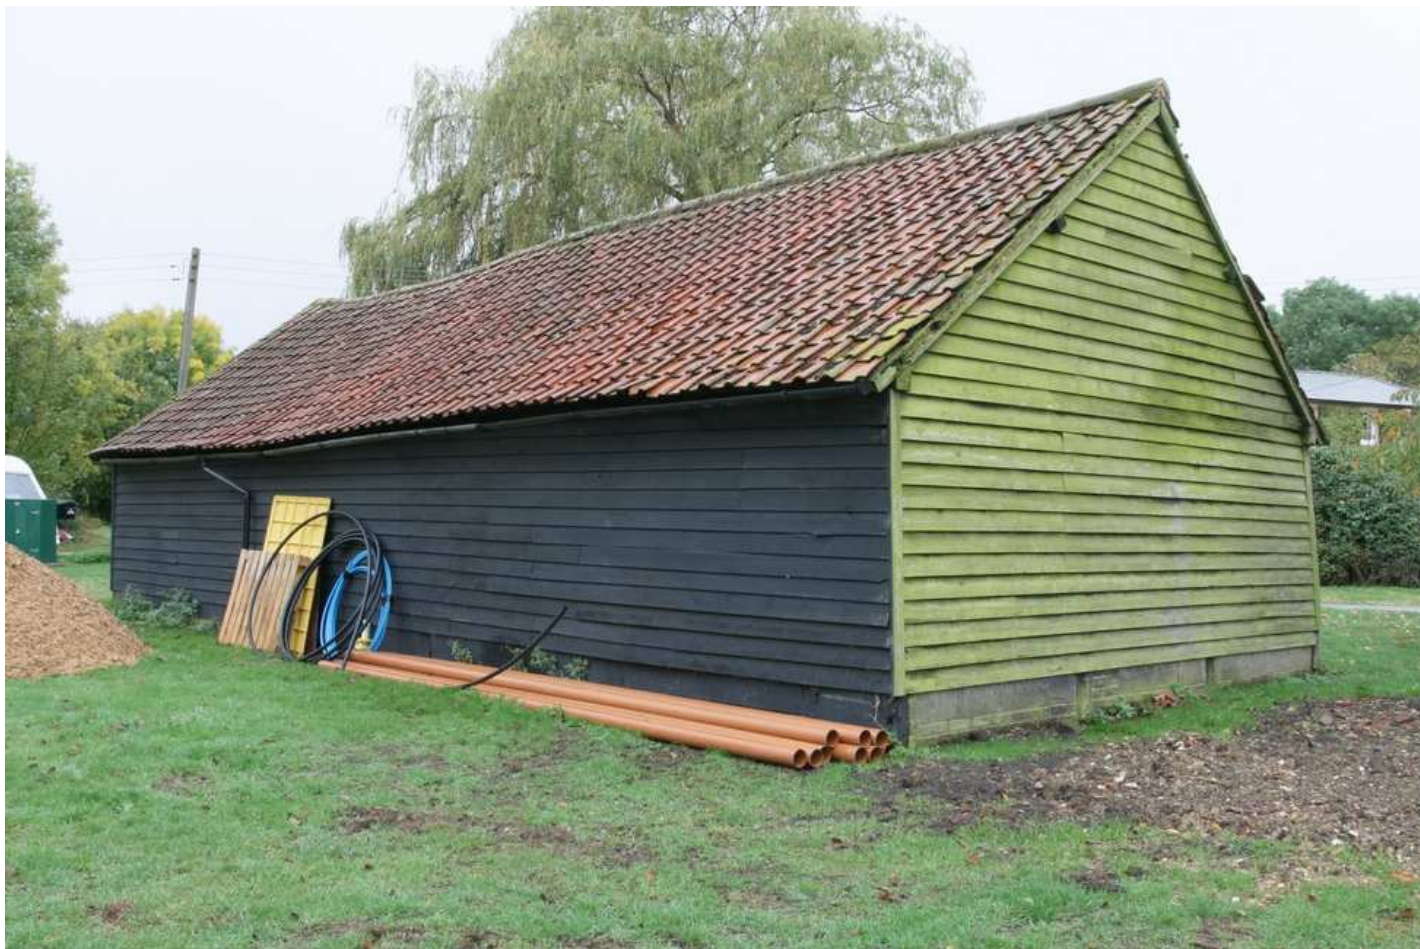
3.8 The east elevation is faced in modern softwood weatherboarding to 300mm above ground level. Below this, the bases of the principal posts are exposed, with infill of modern cement blocks between them. The two southern bays have a concrete plinth replacing the brick, with cement blocks above.

Plate 03 - Eastern exterior elevation, looking SW

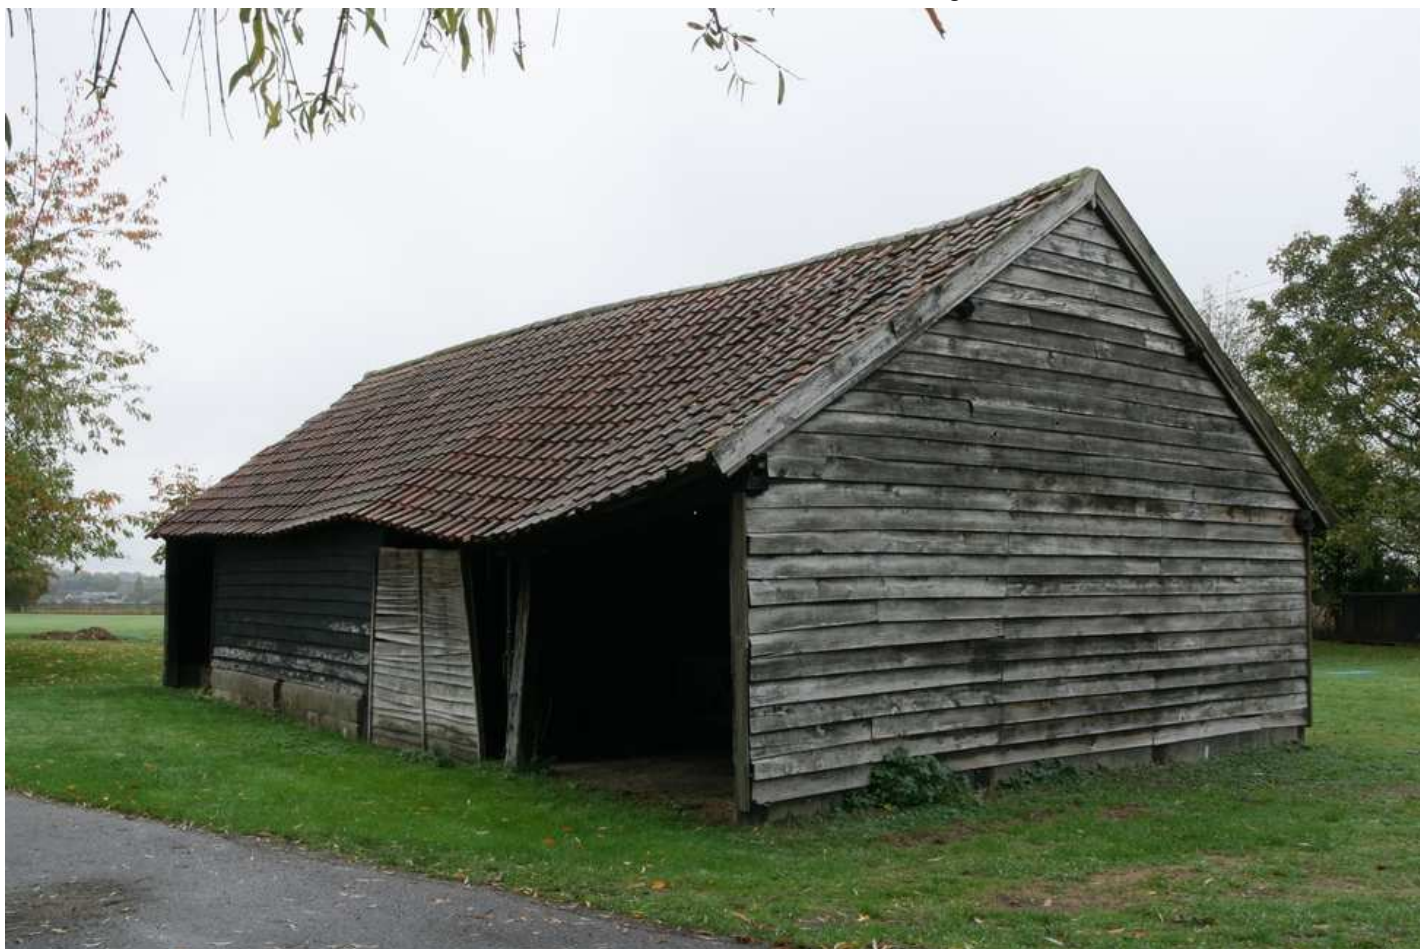
3.9 The south elevation is faced in modern softwood weatherboarding to 300mm above ground level. Below this, the bases of the principal posts are exposed, with infill of modern cement blocks between them. The horns of wall-plates, modern purlins and modern ridge board are exposed.

Plate 04 - Southern exterior elevation, looking NE

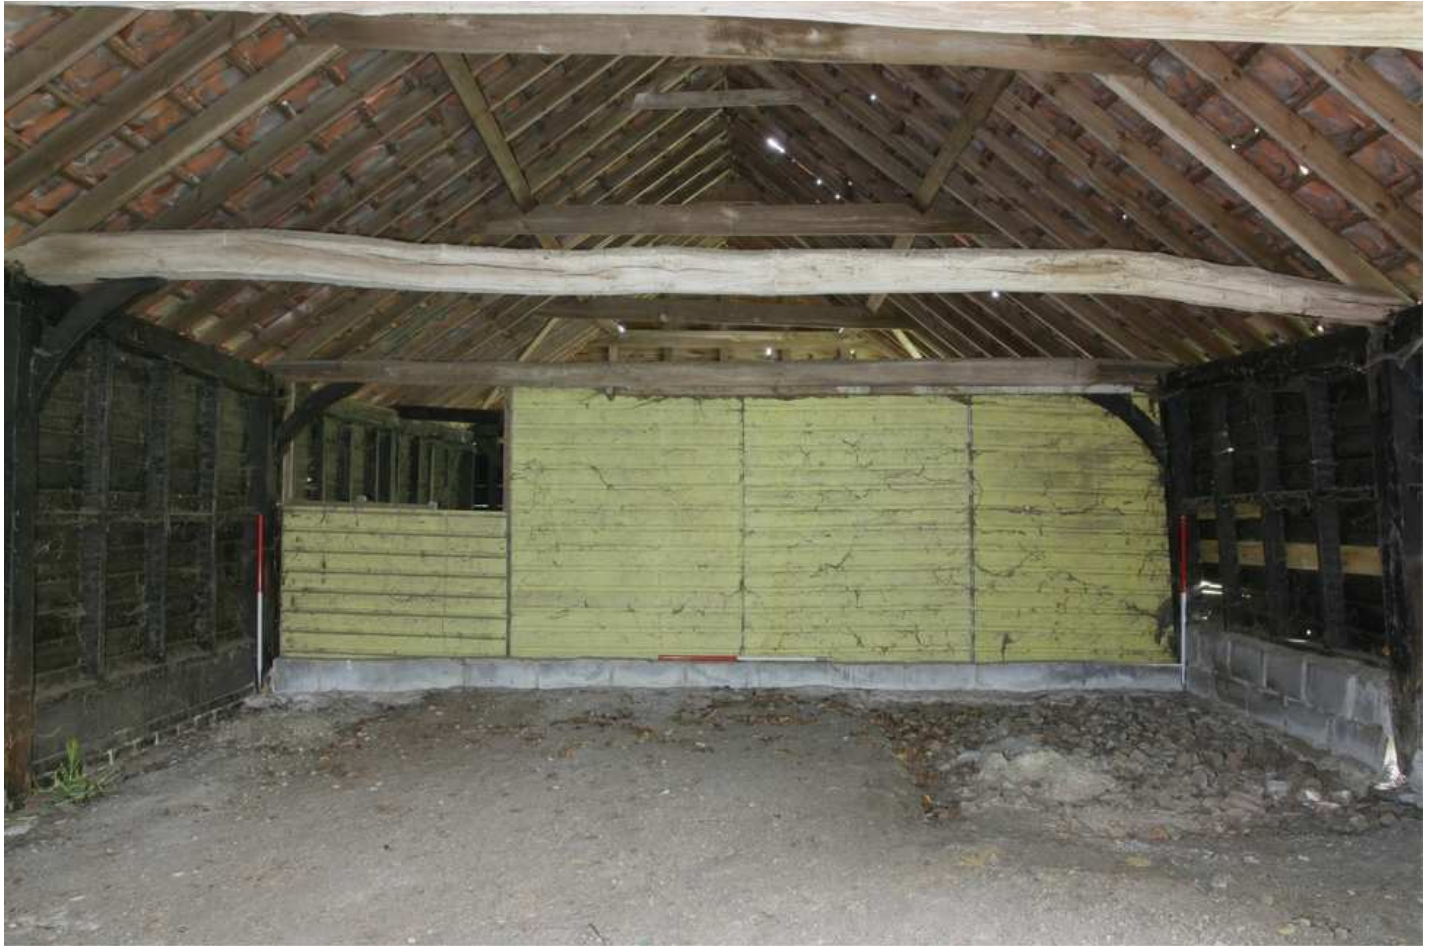
3.10 The interior of the barn is essentially open, apart from a recent partition that runs between Bays 3 and 4 (numbered from the north) and that stands just to the south of a dwarf wall formed of cement blocks marking an earlier sub-division (Plate 5).

Plate 05 - Partition between Bays 3 & 4, looking S

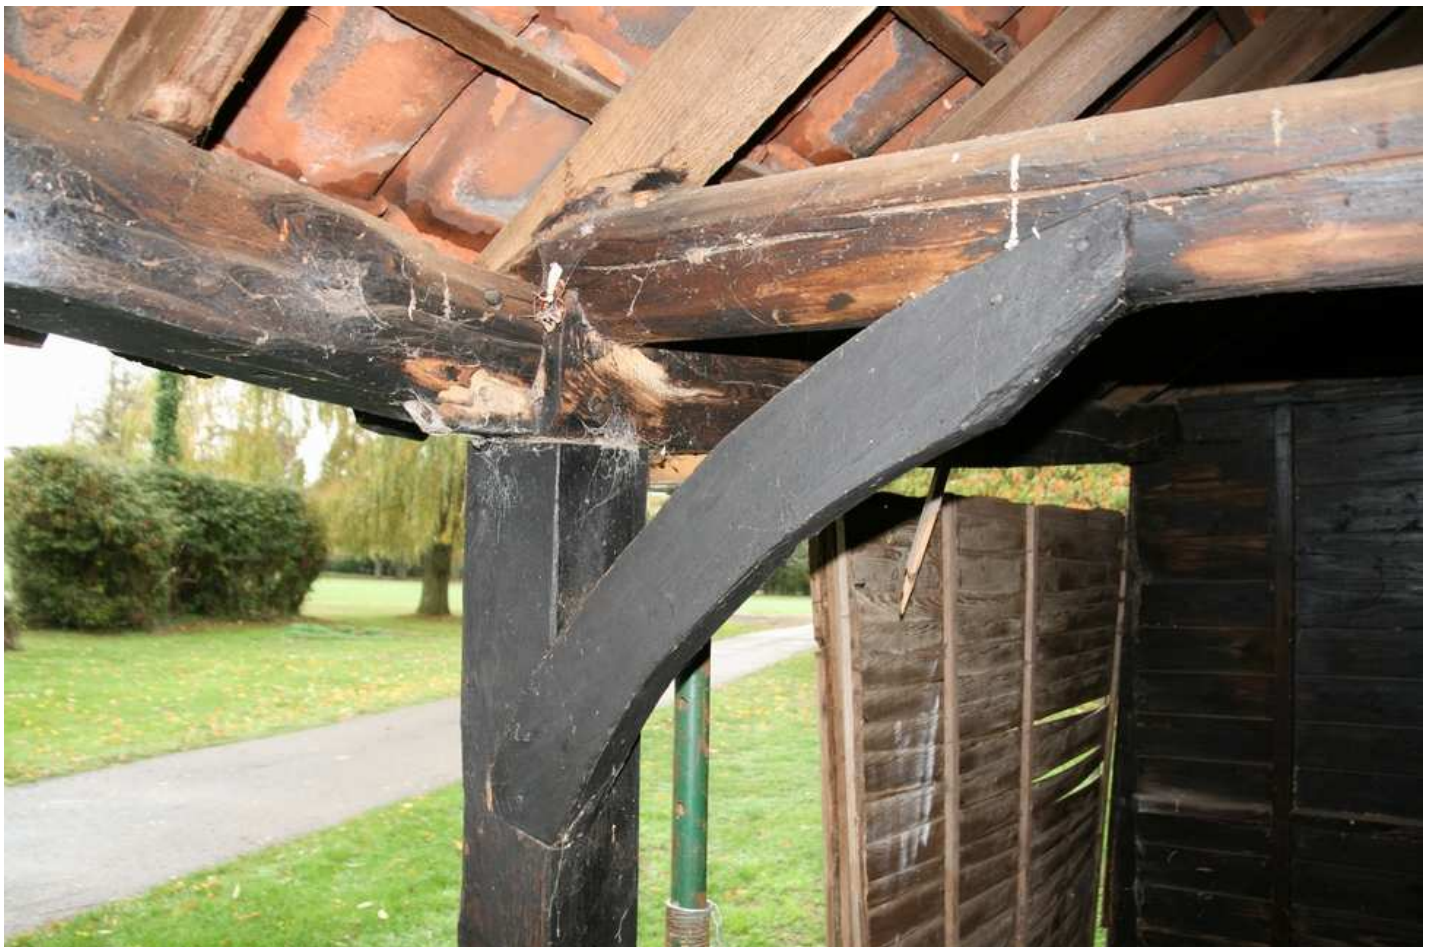
3.11 The principal posts are machine cut throughout, and formed of softwood. The eastern principal posts are linked to their western counterparts by tie-beams resting on the wall-plate (see Plate 5), with a curving brace to the post, nailed in place (Plate 6). There is no lateral bracing.

Plate 06 - Bracing to principal post between Bays 4 & 5, looking NW

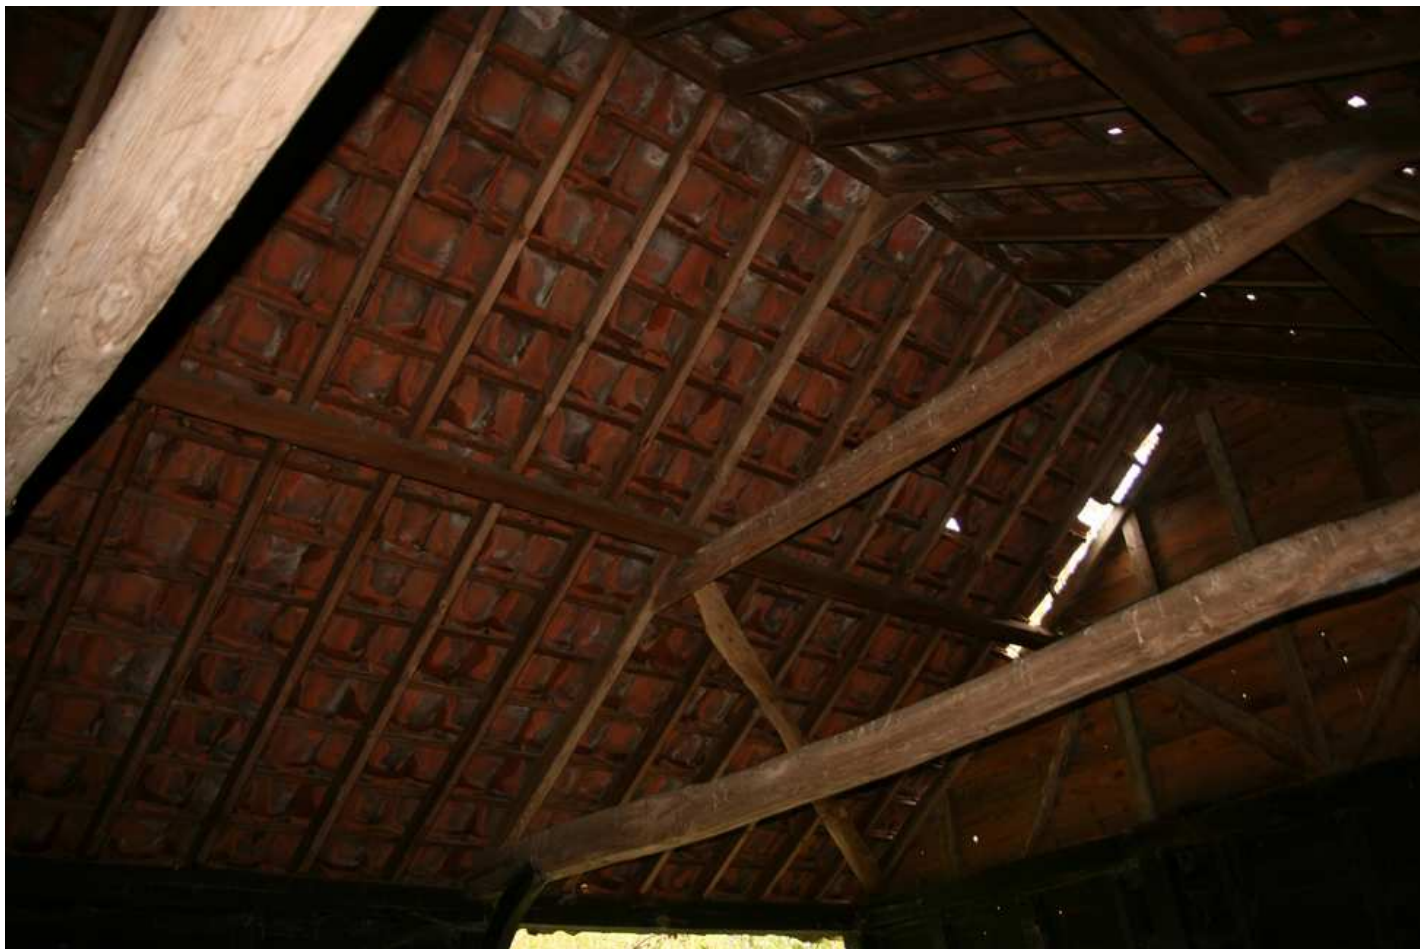
3.12 The entire roof structure is modern, consisting of a single purlin in each slope, a ridge board and rafter pairs on 17-inch centres (Plate 7). The outer bays have collars and wind bracing. The end gables above the tie beam are also modern (Plates 8 & 9).

Plate 07 - Roof structure at northern end, looking NW

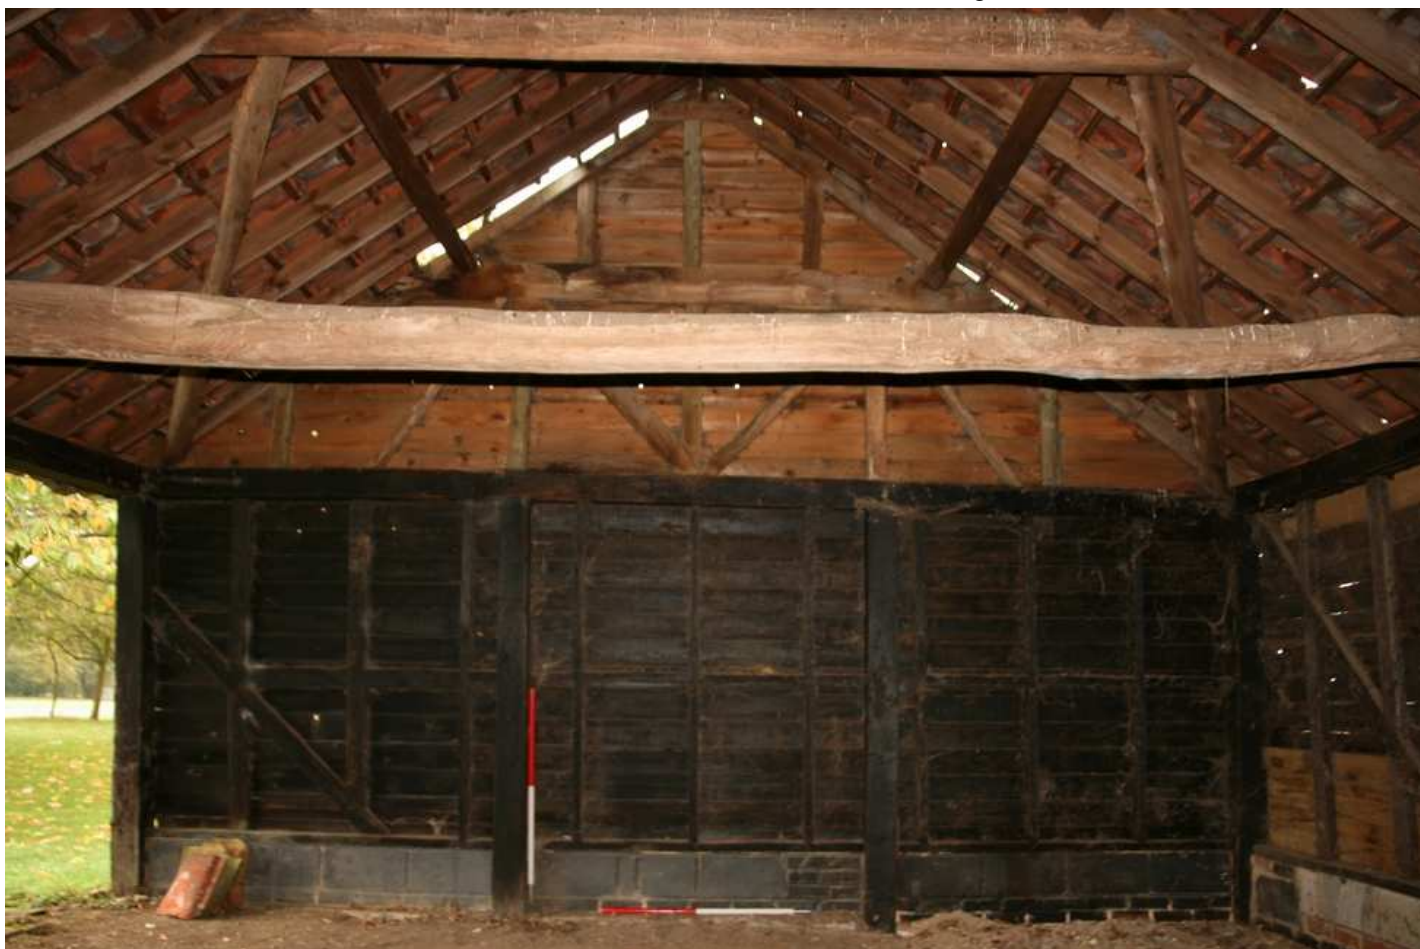
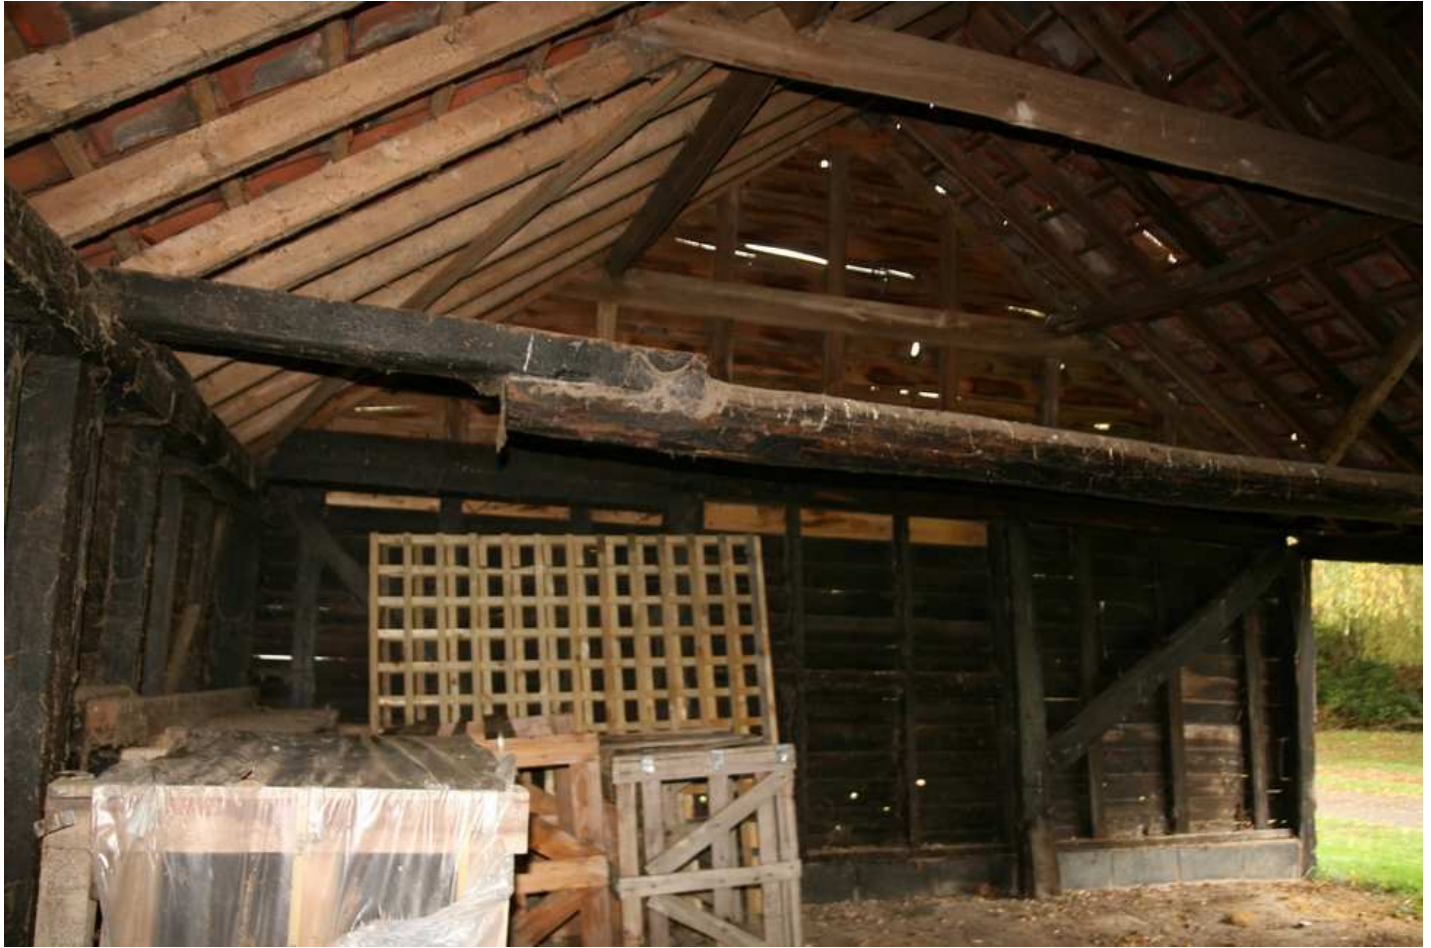
Plate 08 - Northern gable end, looking N

Plate 09 - Southern gable end, looking SW

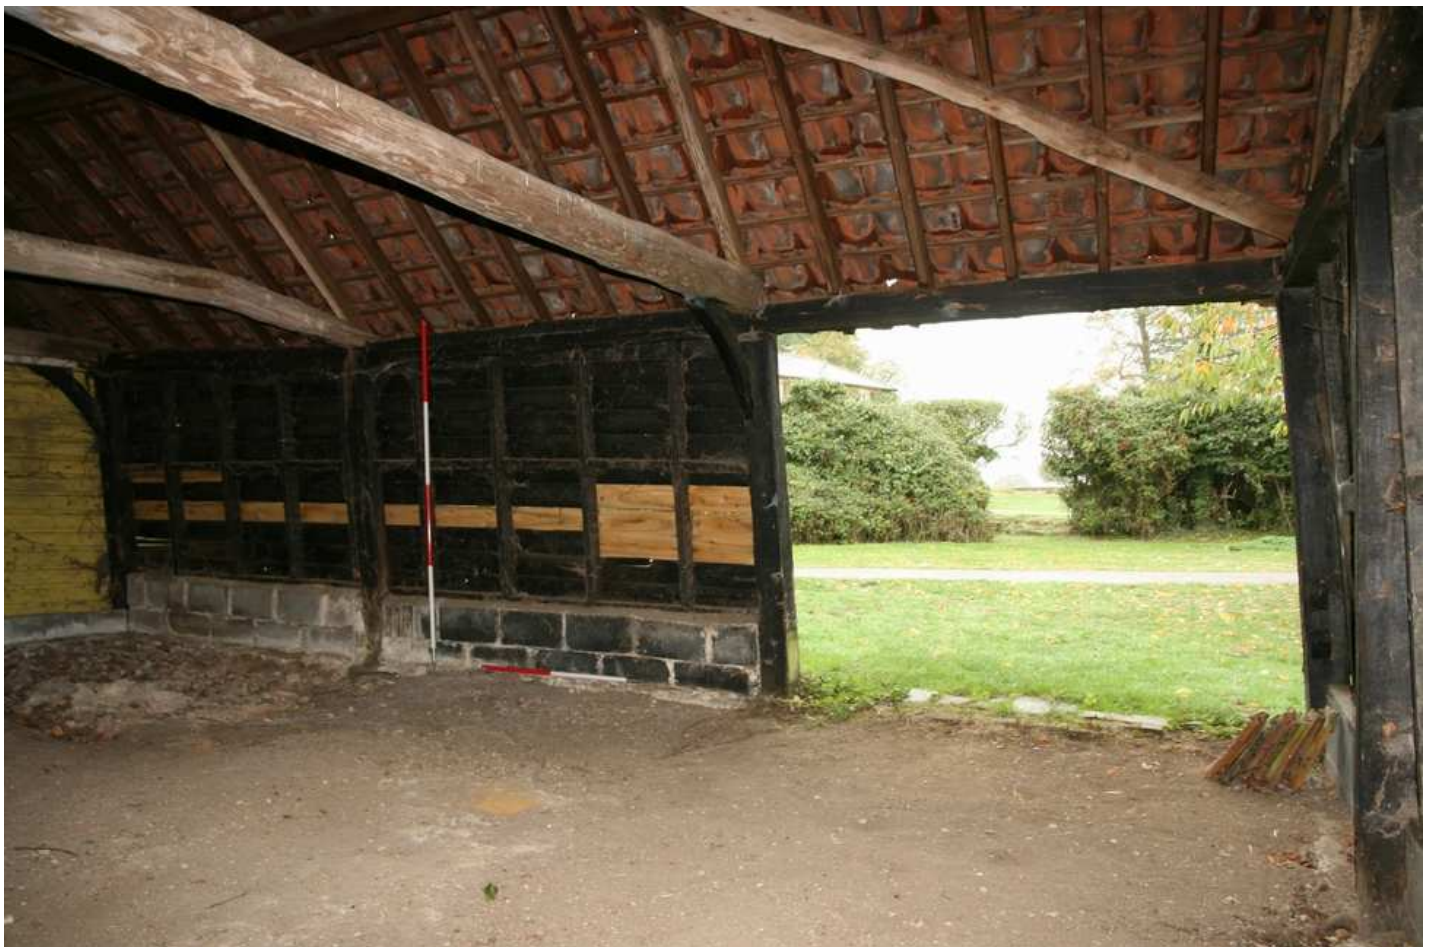
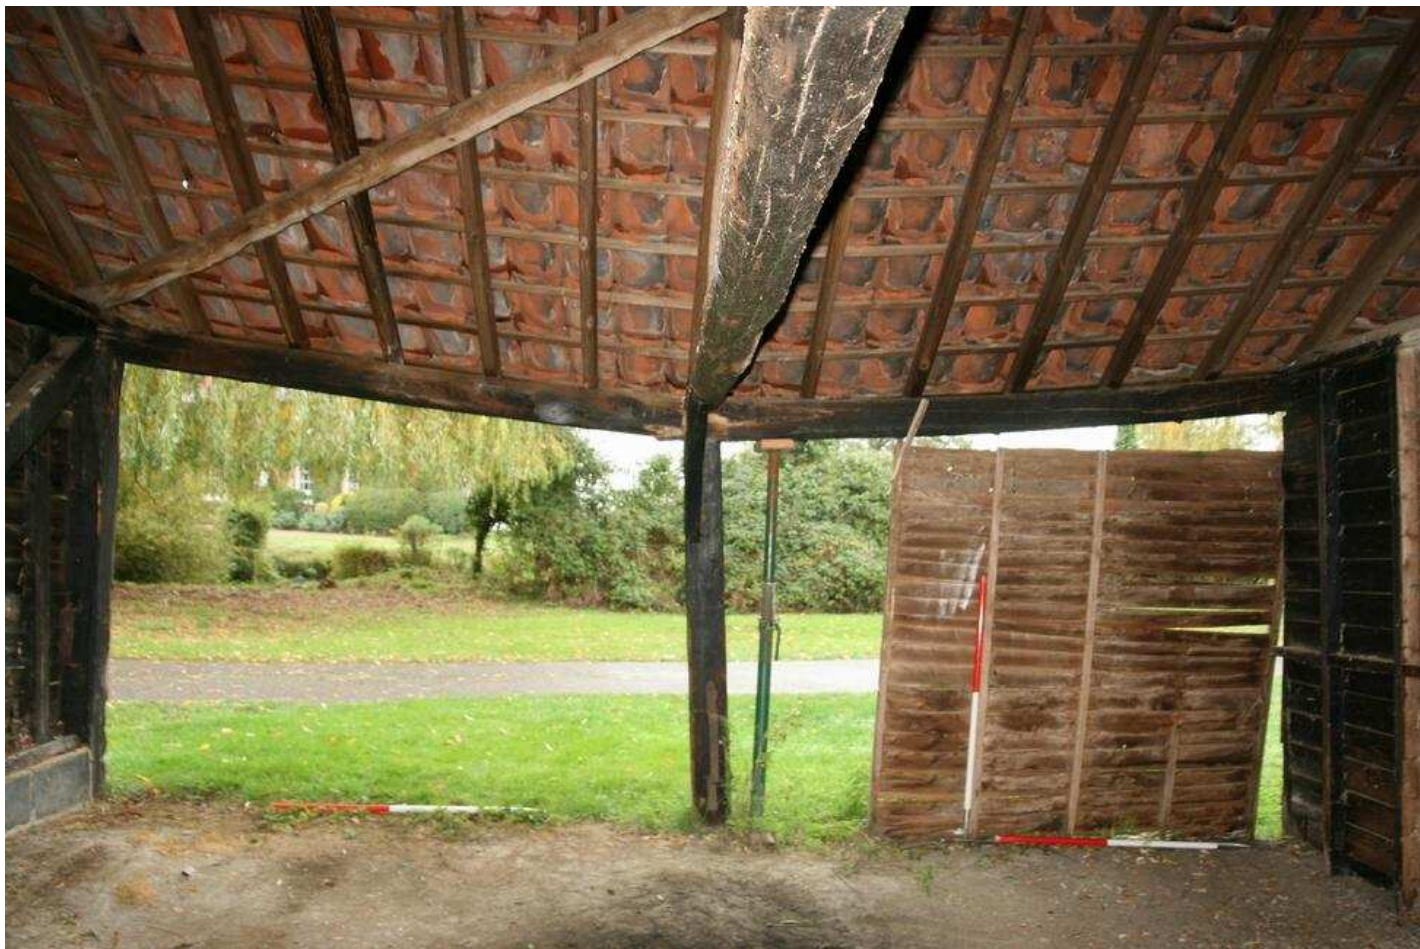
3.14 The west elevation has some original framing, consisting of the principal posts and wall-plate. Bays 2 and 3 are closed with modern softwood studwork above infill of modern cement blocks. Bays 1, 4 and 5 are open.

Plate 10 - Western interior elevation, Bays 1-3, looking W

Plate 11 - Western interior elevation, Bays 4-5, looking W

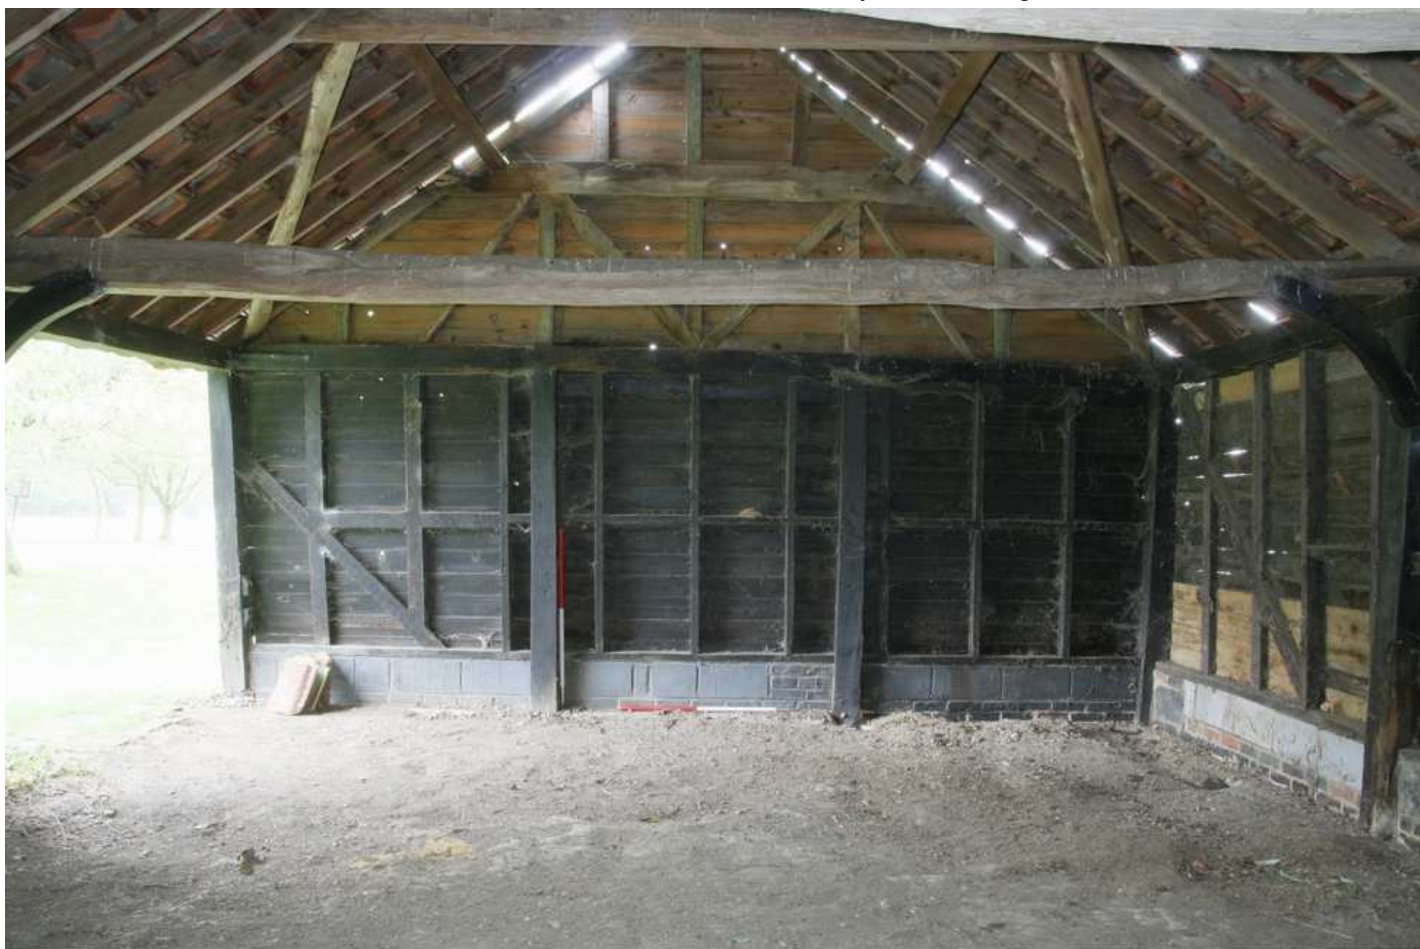
3.15 The north elevation has some original framing, consisting of the principal posts and tie-beam, with metal ties to the wall plates at either end. The studwork between the posts is formed of modern softwood. Beneath the framing is infill of modern brick and cement blocks.

Plate 12 - Northern interior elevation, looking N

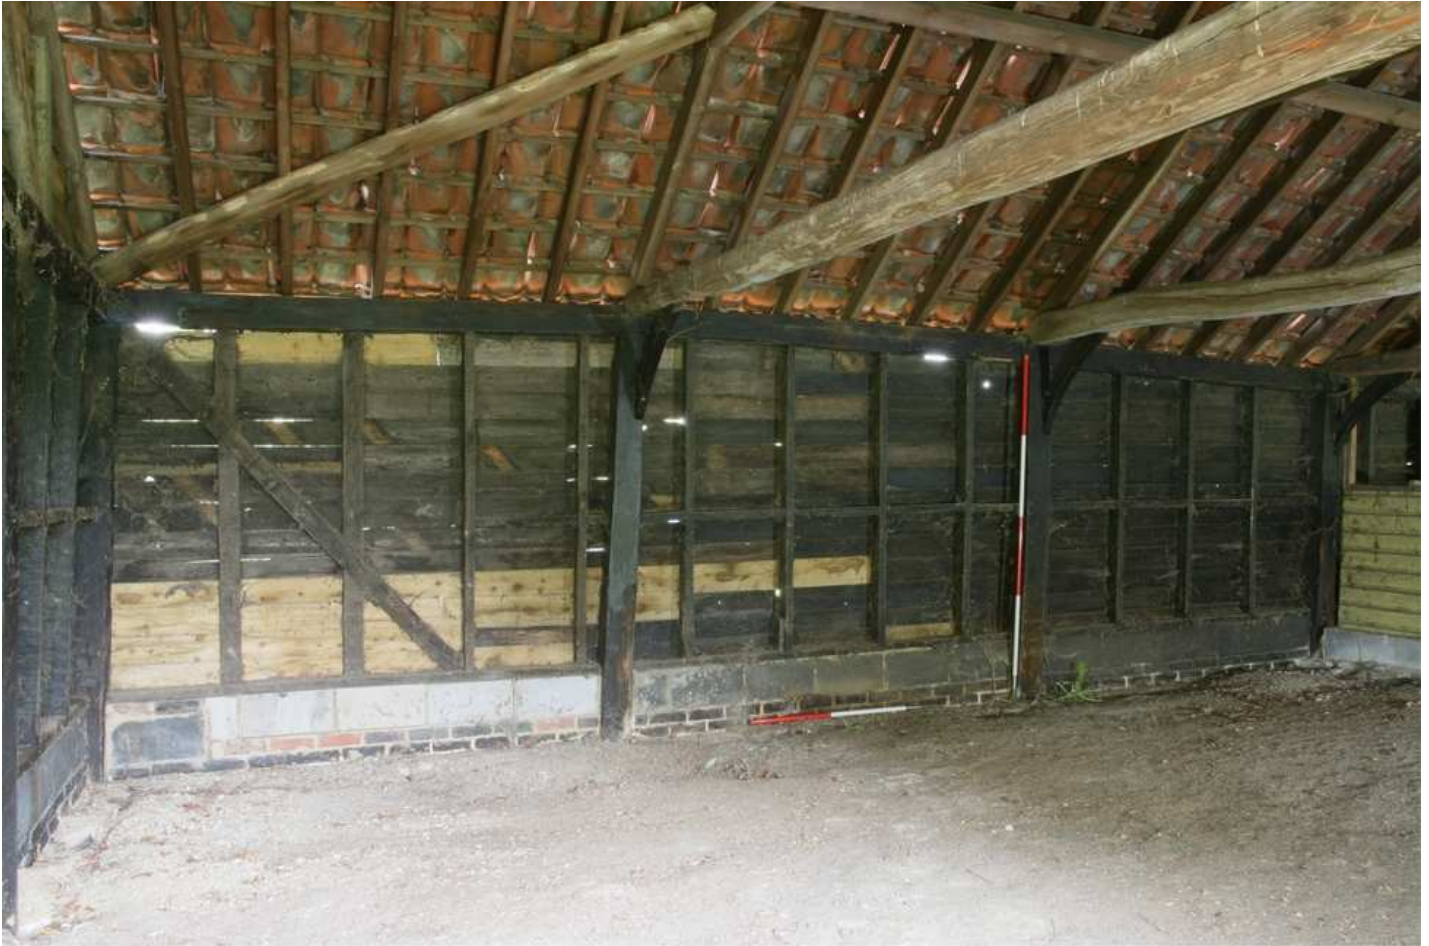
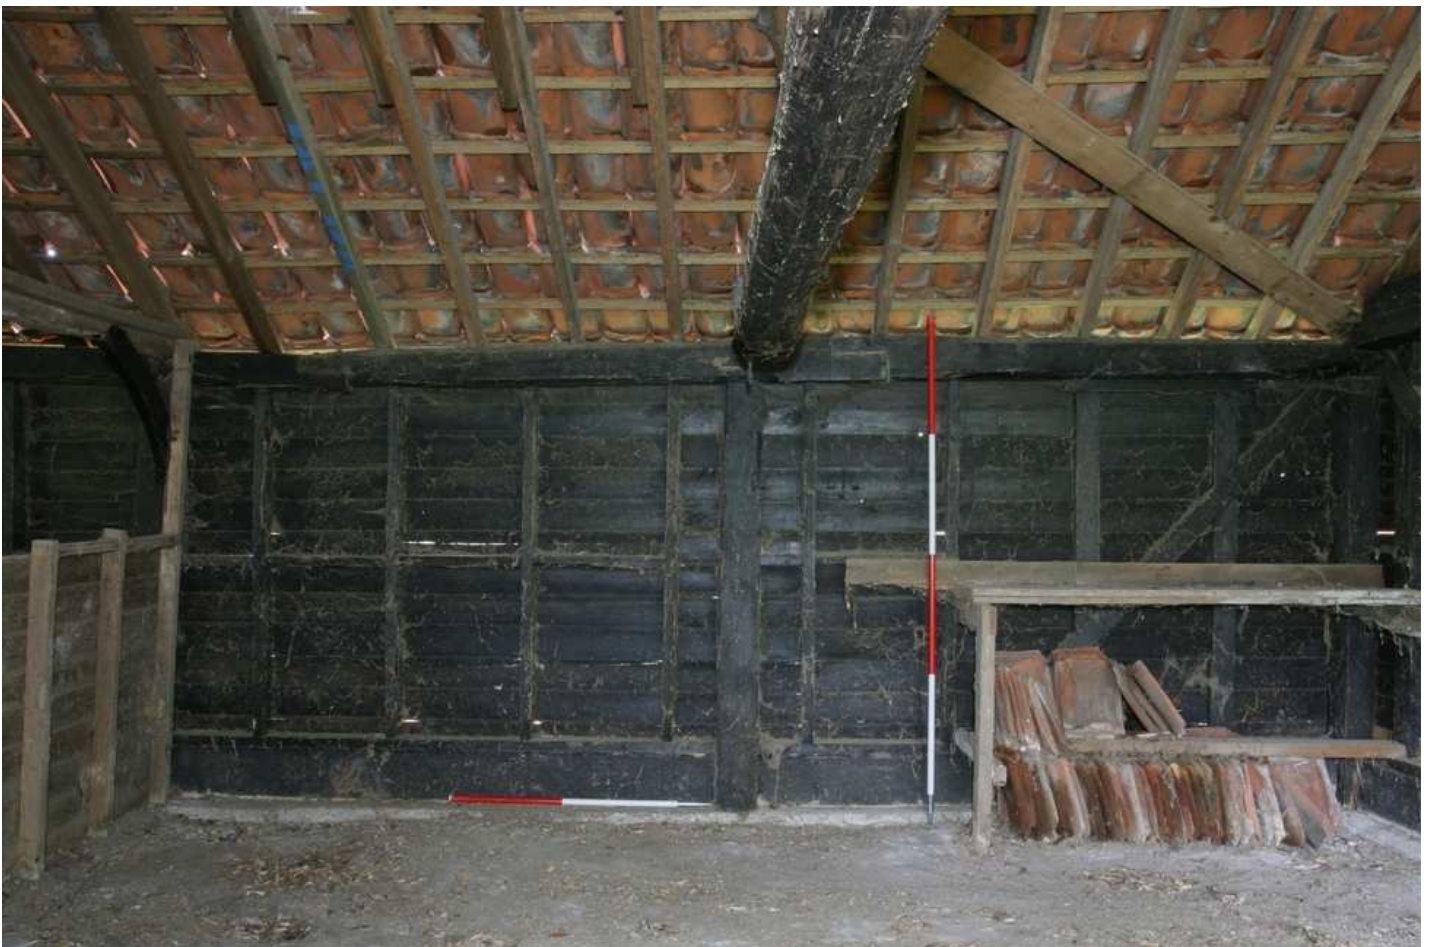
3.16 The east elevation has some original framing, consisting of the principal posts and wall-plate. The studwork between the posts is formed of modern softwood. Beneath the framing is infill of modern brick and cement blocks.

Plate 13 - Eastern interior elevation, Bays 1-3, looking E

Plate 14 - Eastern interior elevation, Bays 4-5, looking E
