BARN AT THE COACH HOUSE **Witney Green, Fyfield, Essex**

HN1440

***HISTORIC BUILDING
RECORD***

Report no.1180

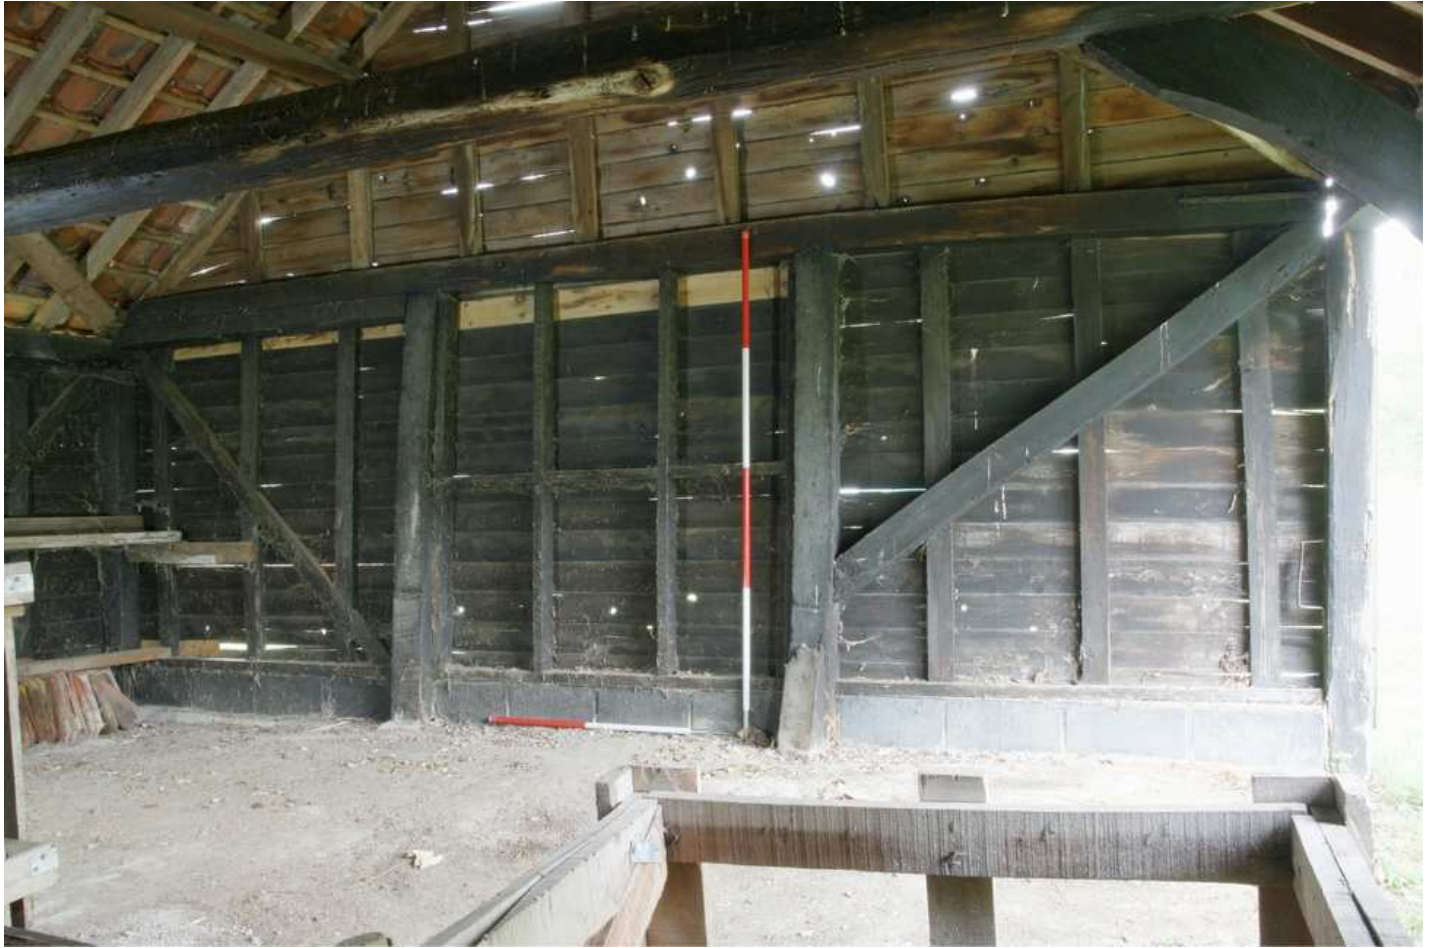
3.17 The south elevation has some original framing, consisting of the principal posts and tie-beam, with metal ties to the wall plates at either end. The studwork between the posts is formed of modern softwood. Beneath the framing is infill of modern brick and cement blocks. A substantial secondary diagonal brace has been added to the west side of the elevation, and a bumper protects the second post from the west (Plate 16).

Plate 15 - Southern interior elevation, looking S

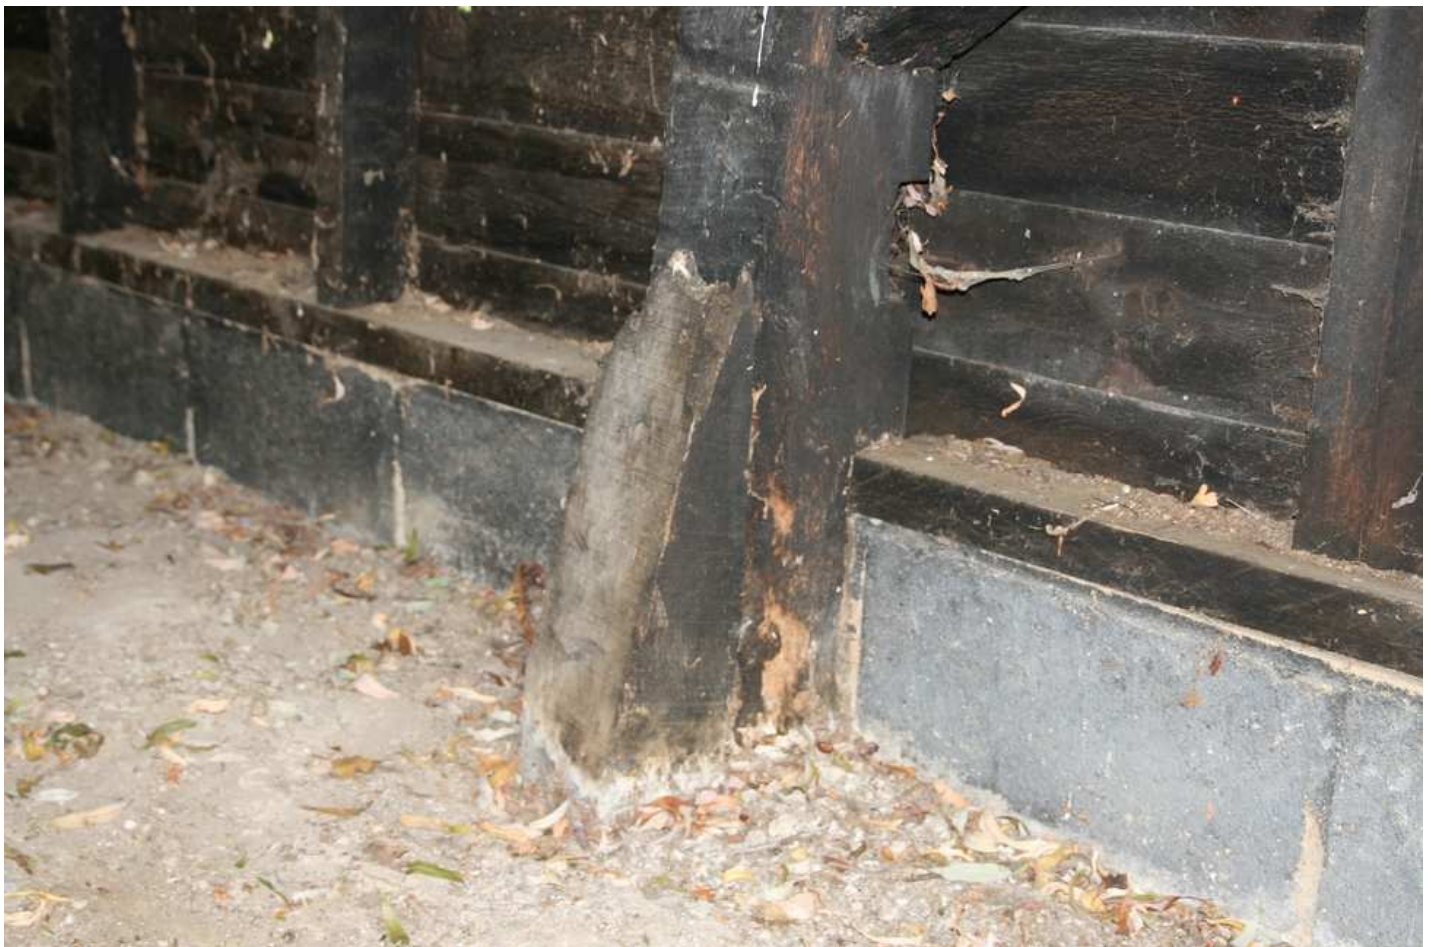
Plate 16 - Protective bumper on post in southern elevation, looking SE
