THE OLD VICARAGE Brent Pelham, Herts.

HN678

Archaeological Monitoring Report

Report no. 437

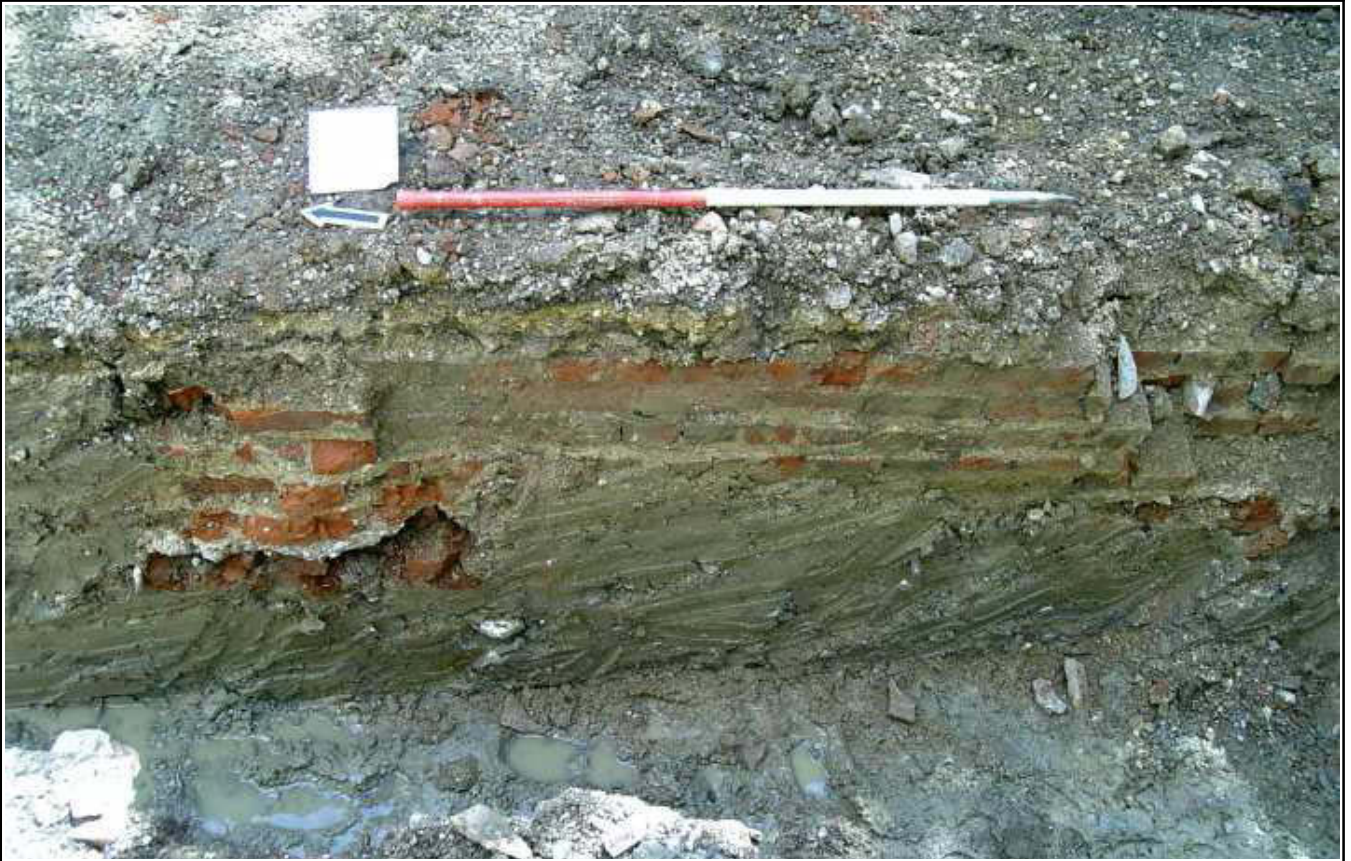
2.7 Excavation of the eastern footings trench revealed the remains of an L-shaped wall which had been bonded to the eastern elevation of the house (Figure 5; Plate 1). It was of similar construction to the house being laid in English bond using bricks of the same dimensions. A possible return was identified at the northern end of the north-south arm of the wall.

Plate 1: Foundation to demolished eastern extension

3.5 The existing building appears to date to the latter half of the 19th century. It is shown on a smaller footprint on the first edition of the Ordnance Survey dated 1878, with a small extension against the eastern elevation in the general location of the wall foundation identified in the course of the present project (Figure 2). The building has been extended, and subject to other alterations, on a number of occasions since.

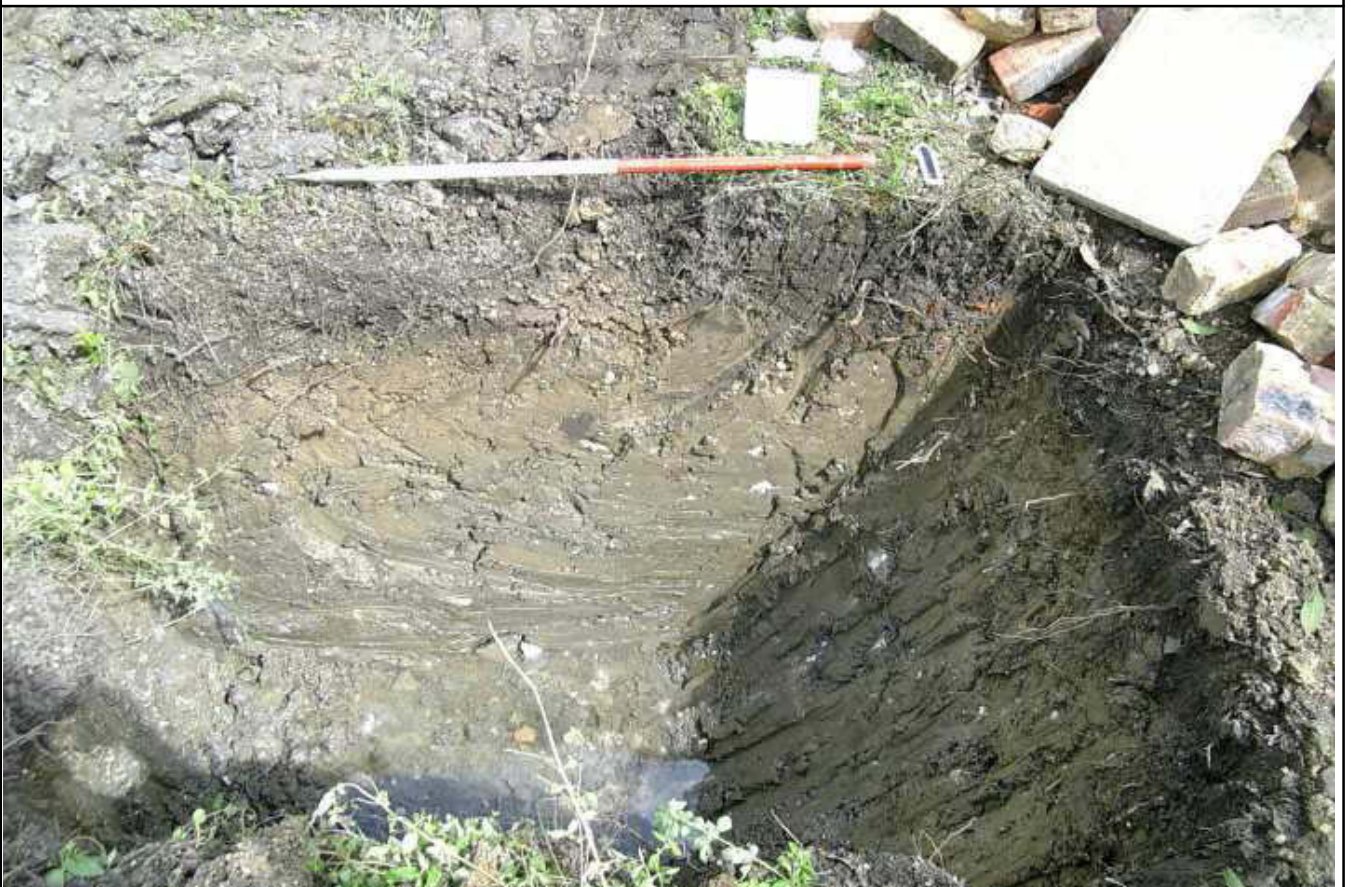
2.6 The stratigraphy across the site consisted of a greyish brown, silty clay topsoil layer, measuring between 0.20m and 0.50m deep (Plate 2). Below this was the olive brown clay natural which contained chalk fragments. The only variation occurred in the area of the new basement where a 0.5m thick layer of redeposited natural containing CBM fragments was observed beneath the topsoil.

Plate 2: Typical stratigraphy
