## LAND NW OF LUG FEN DROVEWAY Lode, Cambridgeshire

HN706

*Archaeological Monitoring Report*

Report no. 449

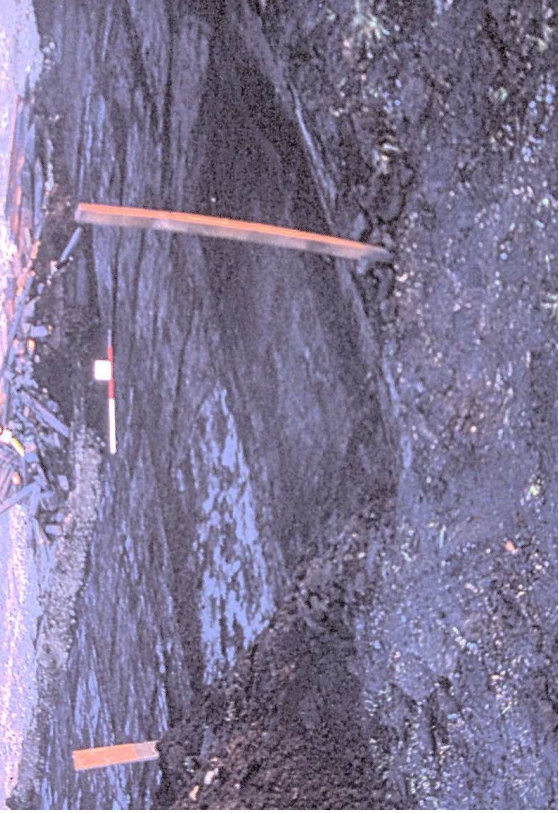
**2.7** Three areas were reduced by 0.20m to 0.40m to provide a surface for construction. These measured 121.8m<sup>2</sup>, 37m<sup>2</sup> and 95.48m<sup>2</sup> and did not breach the topsoil.

<p data-bbox="794 1413 826 1839">Plate 1: Area 1, looking southeast</p>	<p data-bbox="794 439 826 797">Plate 2: Area 2, looking east</p>

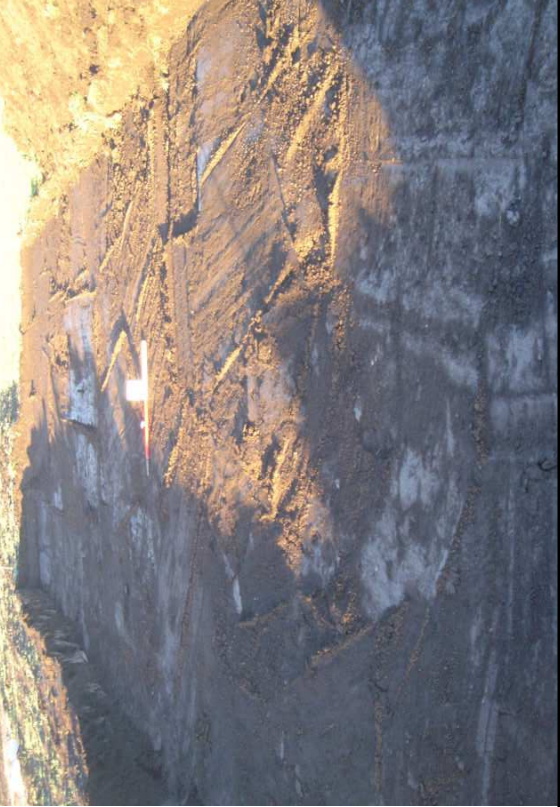
<p data-bbox="1441 1442 1473 1816">Plate 3: Area 3, looking north</p> <p data-bbox="1441 371 1473 864">Plate 4: Tank area, looking south west</p>

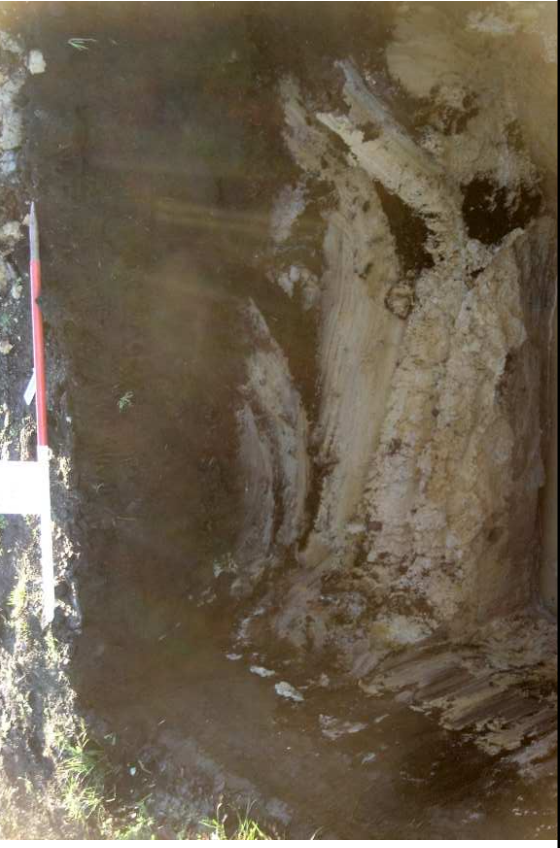
**2.8** A single pit measuring approximately 1.70m wide by 2.30m deep was reduced by 1.60m for a septic tank.

**2.9** No archaeological cut features, deposits or artefacts were encountered during any of the groundworks. No unstratified finds were recovered from any of the spoil.
