**Meadow Cottage
13 ROSE VALE
Hoddesdon, Herts.**

HN719

*Historic Building Record &
Archaeological Monitoring Report*

Report no.475

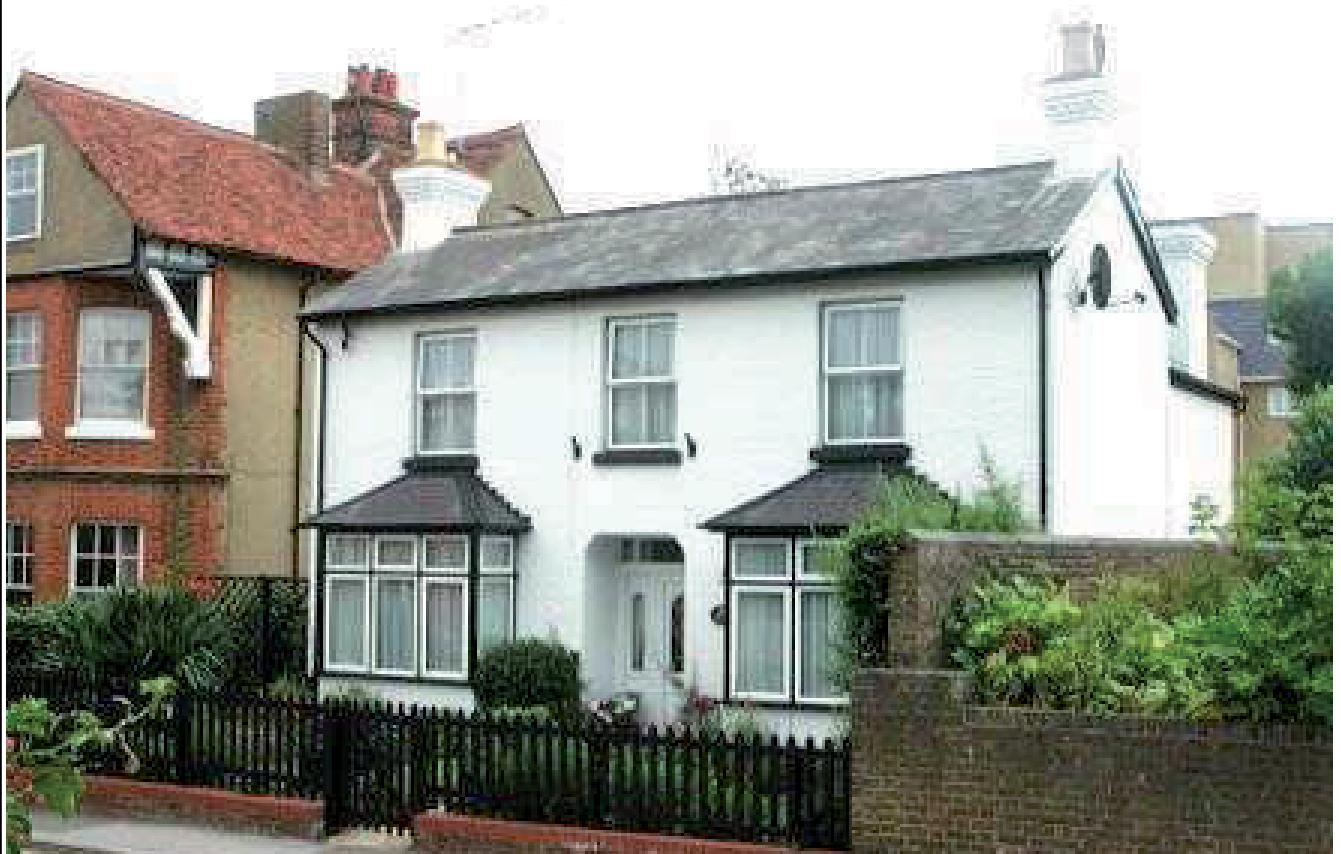
Plate 1: West elevation
(Photo courtesy of Bayhill Homes)

3.2 The house was built in brick, later painted, with a gabled slate roof and end decorated chimney stacks (Plate 1). It stood on the east side of Rose Vale facing west with a small garden to the front and low red brick wall with a picket fence to the west boundary. To the south the property boundary consists of a brick wall approximately 2m in height. To the east was the garden, with access onto Norris Road. The northern boundary is somewhat obscured in the available photographs but appears to have been formed of wooden latticed panels of approximately 1.5m in height.

3.3 The west elevation (front) of 13 Rose Vale comprised two ground floor, box bay windows with sloping slate roofs above. Positioned between these windows was an internal, shouldered, porch with a recessed panelled door and side light. On the first floor were three equally spaced, recessed, 2-over-2 sash windows with projecting sills.

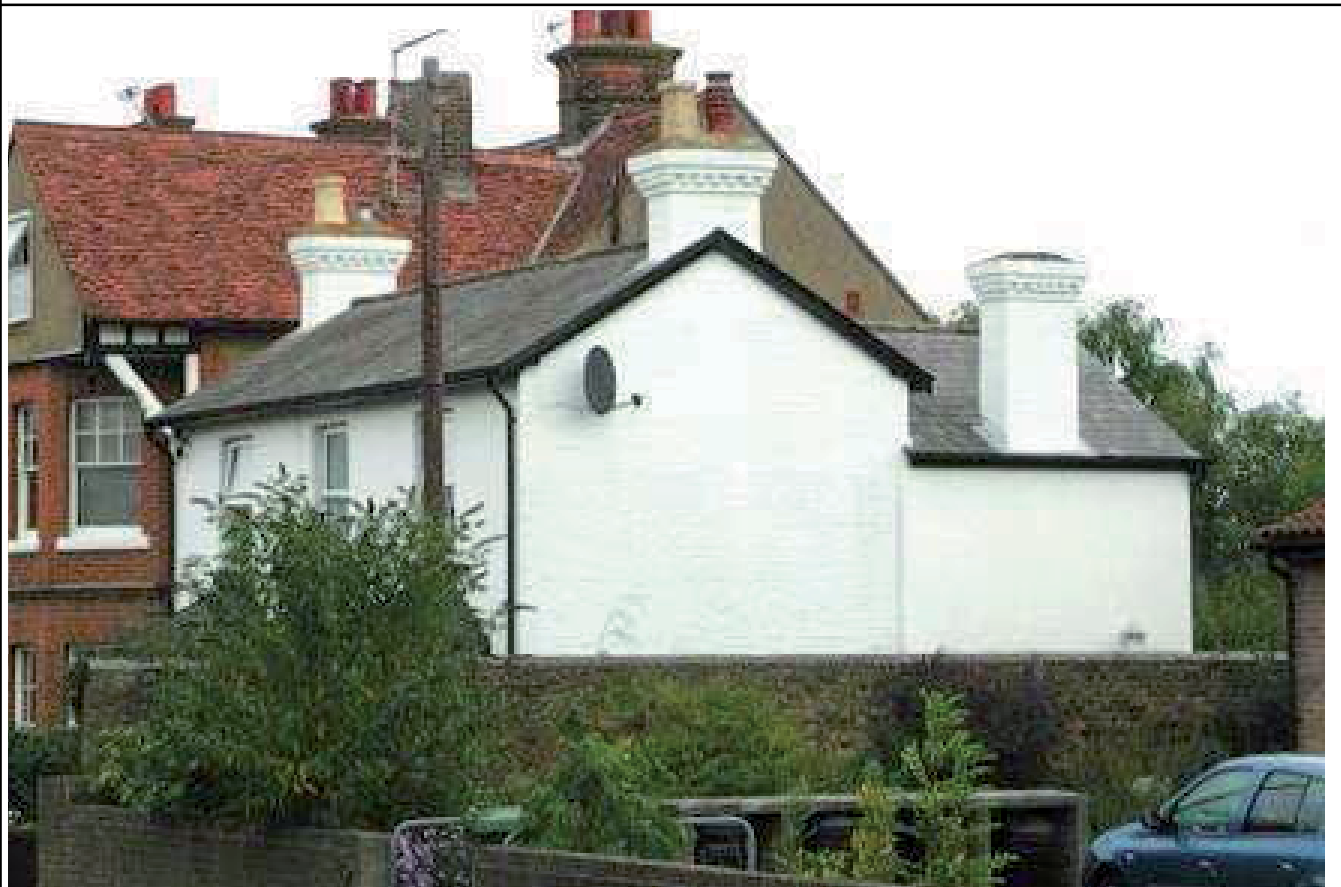
Plate 2: West and south elevation
(Photo courtesy of Bayhill Homes)

3.5 The southern elevation can be split into two parts, the first incorporating the front range of the house, while the second includes the eastern extension (Plate 2). The front range of the house was characterised by its painted brick construction and the plain bargeboard to the gable end, while the extension appears to have been covered in a plaster render or pebble dash. There are no windows or doorways within this elevation, the only other feature of note being a possible extraction fan in the ground floor eastern part of the elevation.

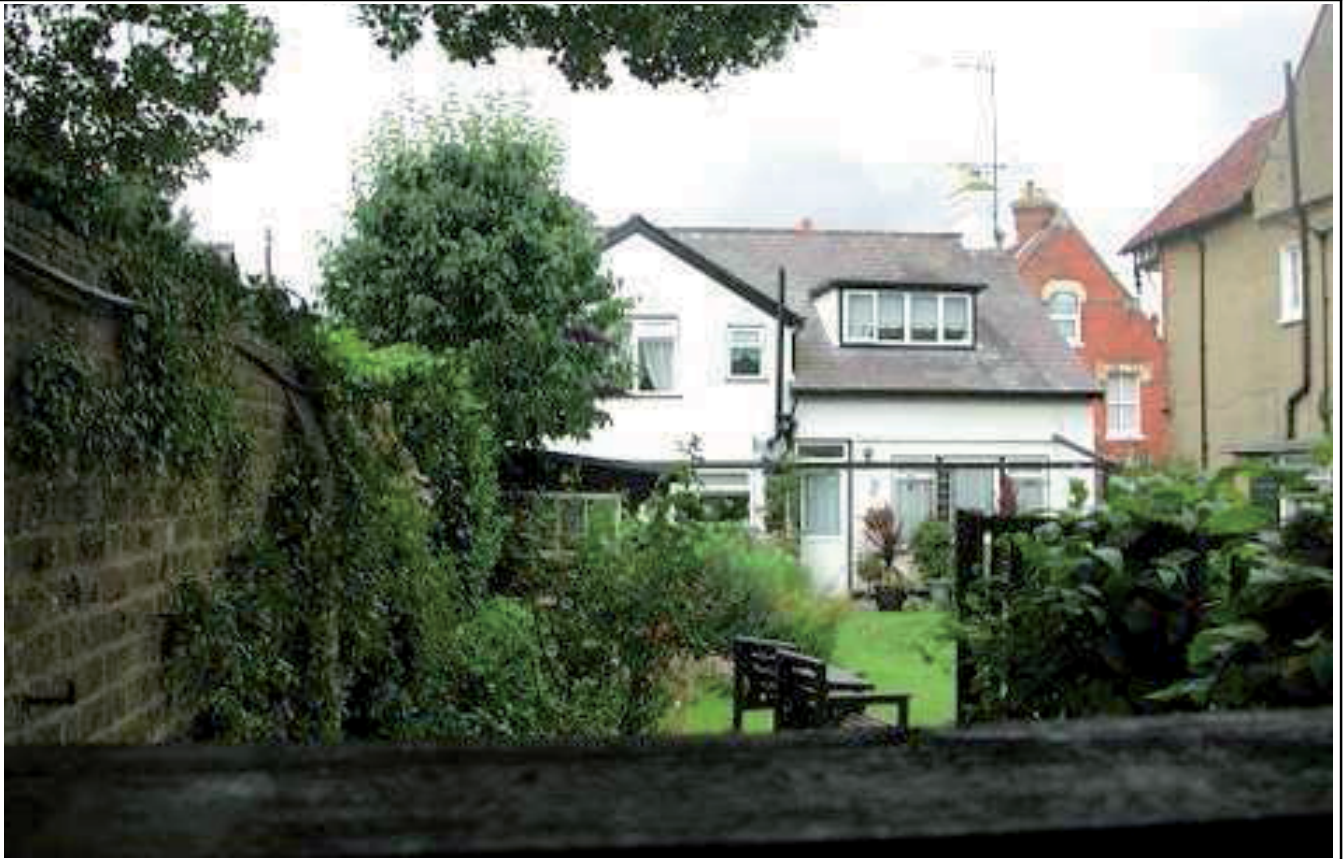
Plate 3: East elevation
(Photo courtesy of Bayhill Homes)

3.4 At the south end of the east (rear) elevation was a two storey extension with an east facing gable end (Plate 3). Adjacent to this along the remainder of the east elevation was an out-shut with a cat slide slate roof. Within the two storey extension were three casement windows, a large window on the ground floor and two windows on the first floor. These windows were all of different sizes and appear to have been inserted later. On the ground floor, the out-shut had a large casement window intersected with two mullions, with the rear doorway located to the south. The door appears to have been of modern design. Within the roof slope of the out-shut was an inserted dormer window, segmented into four parts by mullions.

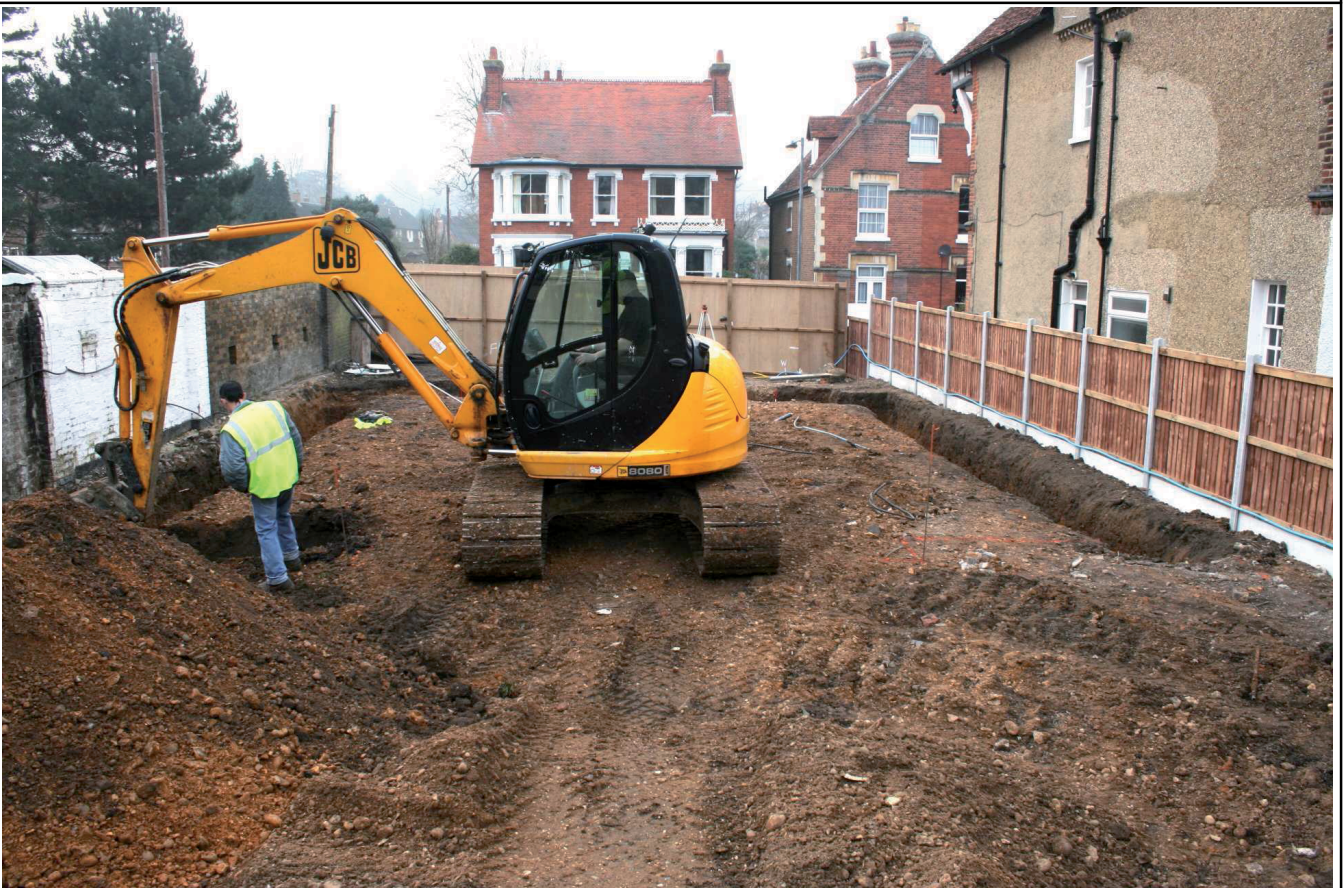
Plate 4: View east to west after demolition of Meadow Cottage

4.6 Meadow Cottage was demolished and the site was levelled in advance of the construction groundworks (Plate 4). A mixed overburden was left across the site including garden soil and some building debris.

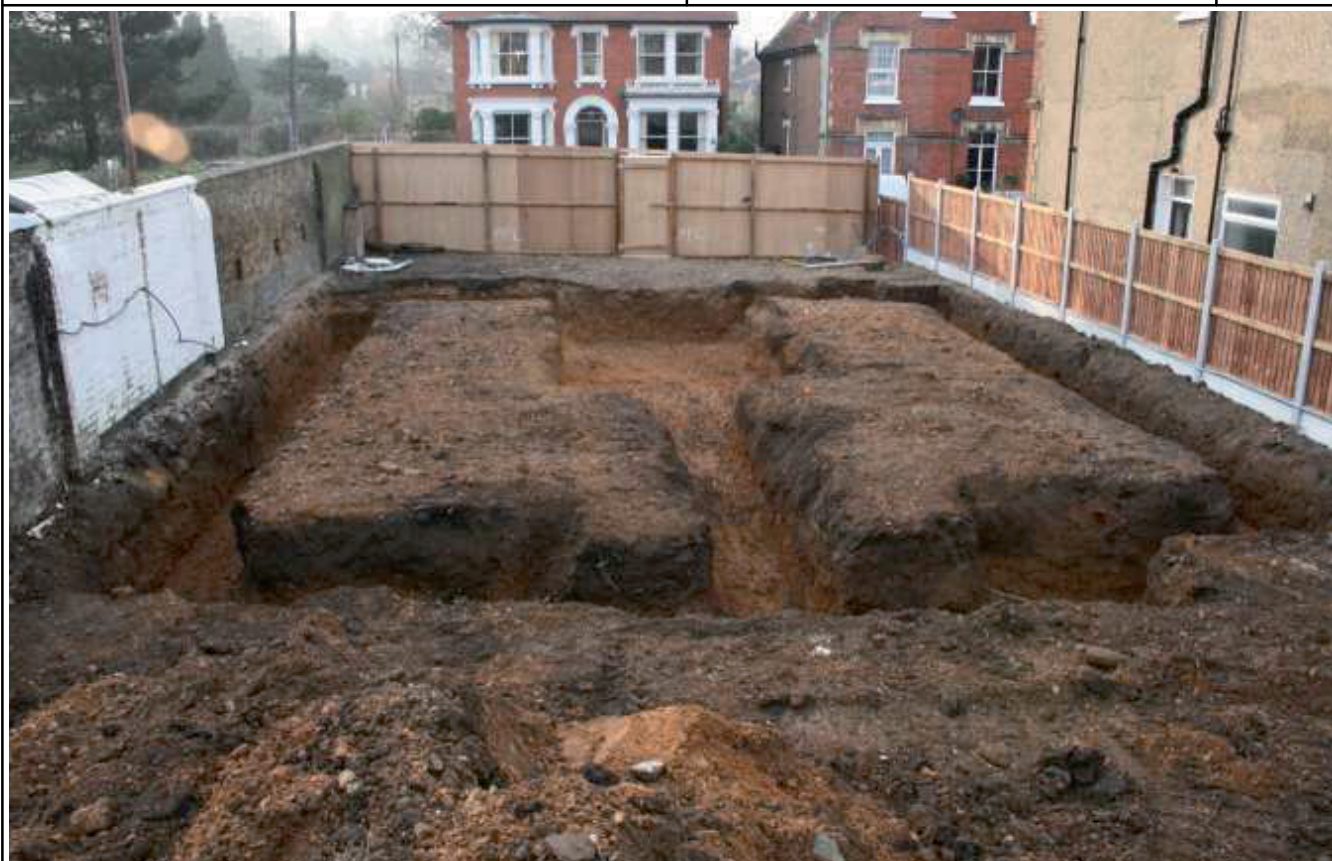
Plate 5: Construction footings

4.7 The footings for the new building included two trenches running east-west and an additional two running north-south to form the outline of the proposed development (Figure 3, Plate 5). An intermediate trench, running east-west, was also cut. The trenches measured 0.9m wide and were approximately 1m deep (Plate 6). Natural hoggin was noted at approximately 0.25m below the existing ground, as was evidence of dead services including foul drainage and water serving Meadow Cottage.

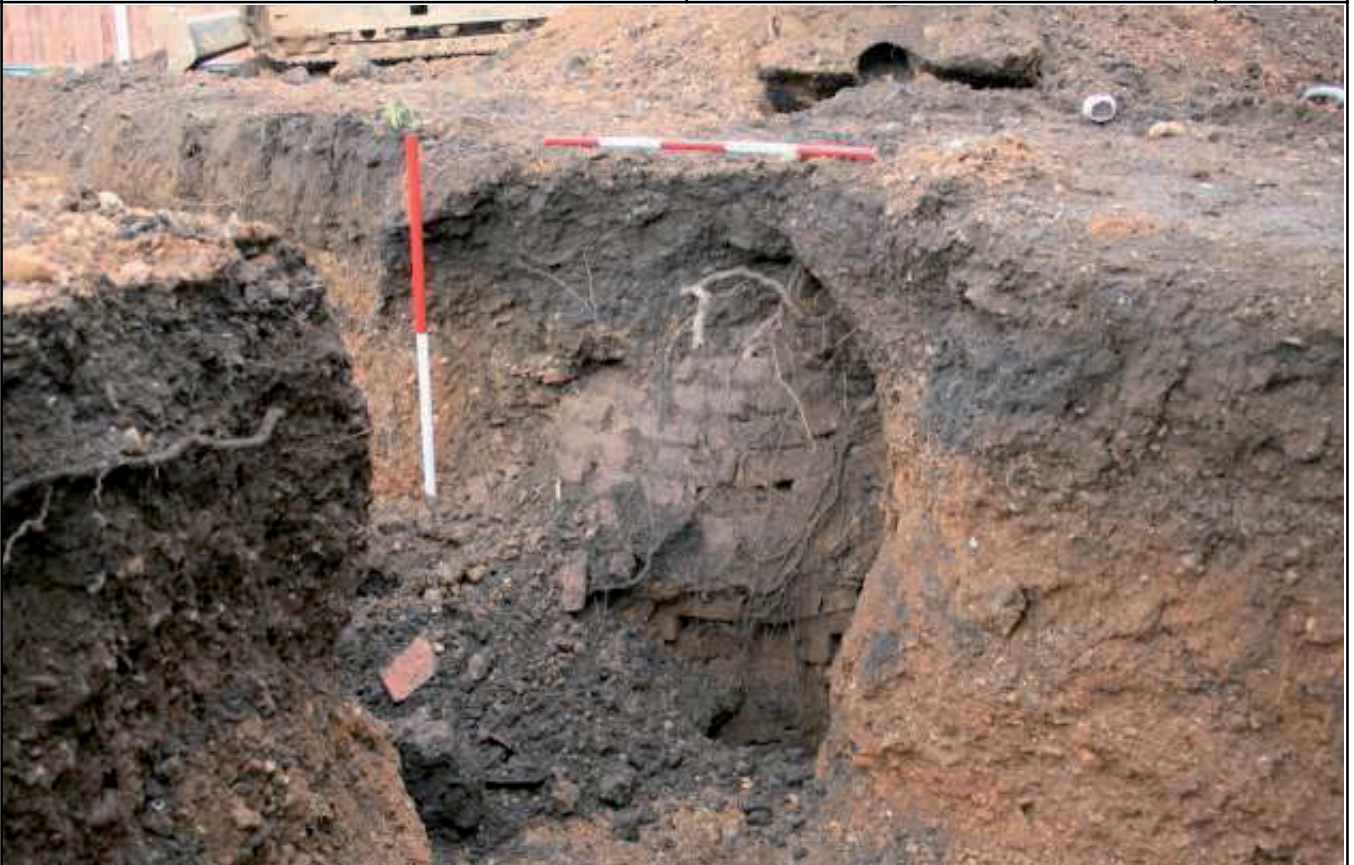
Plate 7: View of Well facing North-east

4.8 A dome-capped well was exposed in eastern section of the eastern footing, centred 2.40m from the southern boundary wall (Plate 7). The exterior diameter measured c.1.50m and water was present c.4m from existing surface and was visible where packing had dropped away from the brick lining. Other than the well no archaeology was apparent in any of the trench sections and there were no unstratified finds that could have been indicative of archaeological potential.

5.4 No archaeological features or deposits were noted in course of the groundworks for the new buildings, with the exception of a dome-capped well located within the eastern section of the eastern footing. This well may have been contemporary with the house, as it was common practice to have wells located adjacent or close to dwellings. It should be noted, however, that its presence is not recorded on the 1842 Tithe Map or on any of the later Ordnance Survey maps, nor is its presence referred to in the documentary records consulted.
