**Land at
THOMAS ROAD,
Fulbourn, Cambridge**

HN745

Archaeological Evaluation

Report no.492

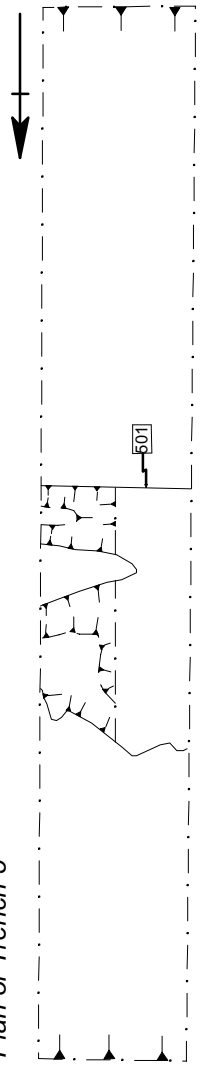
Plan of Trench 8a

3.39.1 Feature [801] was cut through the second subsoil layer and survived in the trench to a depth of only 0.09m. The single fill (802) was a firm, brown, slightly silty clay which yielded no artefacts and contained no inclusions other than occasional small unworked sub-angular flints. The form and function of the feature is unclear, but it was cut through a layer which contained modern concrete and CBM.

3.39.2 A potential linear feature [803] was also sealed by the concrete, and was investigated in section. Investigation demonstrated it to be limited to staining of the natural geology and it had no definitive cut edge. No artefacts were recovered from the stained area.

3.40 This trench was located very close to the present site boundary, and the overburden observed in the trench was substantially deeper than that encountered elsewhere on the site. This, and the two recorded features, are likely to date to the construction of the accommodation blocks that currently occupy the site.

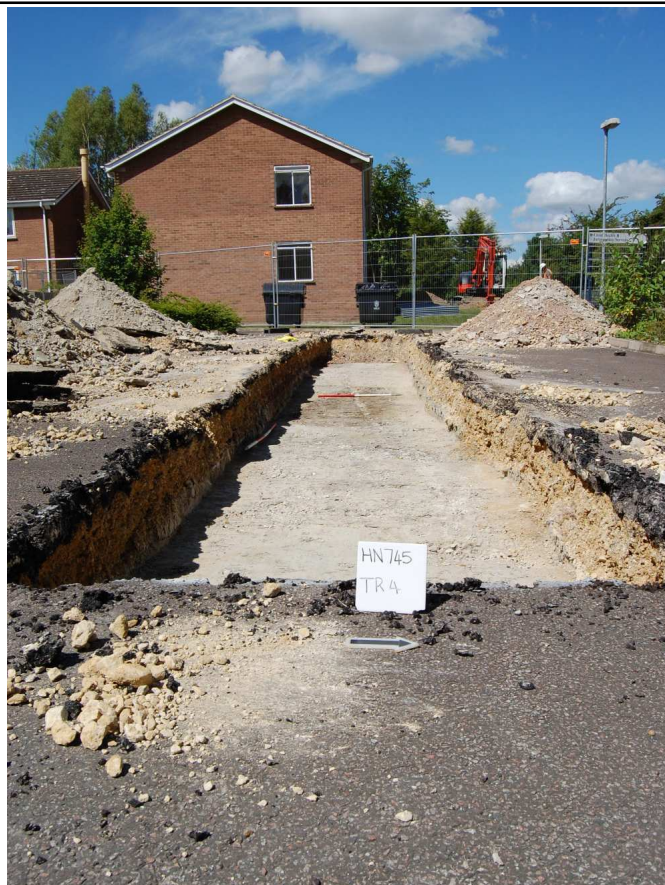
Plate 4: Trench 4 looking West

3.18 The stratigraphy in the trench consisted of a layer of tarmac which formed the surface of the car park. Beneath this was a make-up layer of aggregate directly above the natural geology recorded as white (10YR 8/1) very clayey chalk.

3.19 The interface between the natural geology and the levelling aggregate was separated by a breathable fabric indicating that when the car park was constructed significant ground reduction had been undertaken.

3.20 Two land drains were observed in the trench, one running along the length of the trench, the other forming a ‘T’ junction and running south beyond the trench.

3.21 The trench contained a single feature [401], a large but shallow irregular shaped cut with an irregular base and sides. The solitary fill (402) was a firm, brown, slightly silty clay that yielded no artefacts and contained no inclusions other than occasional small unworked sub-angular flints. The irregular shape and cut of the feature and the lack of archaeological artefacts or inclusions in its fill indicate that it is likely to be natural in origin.

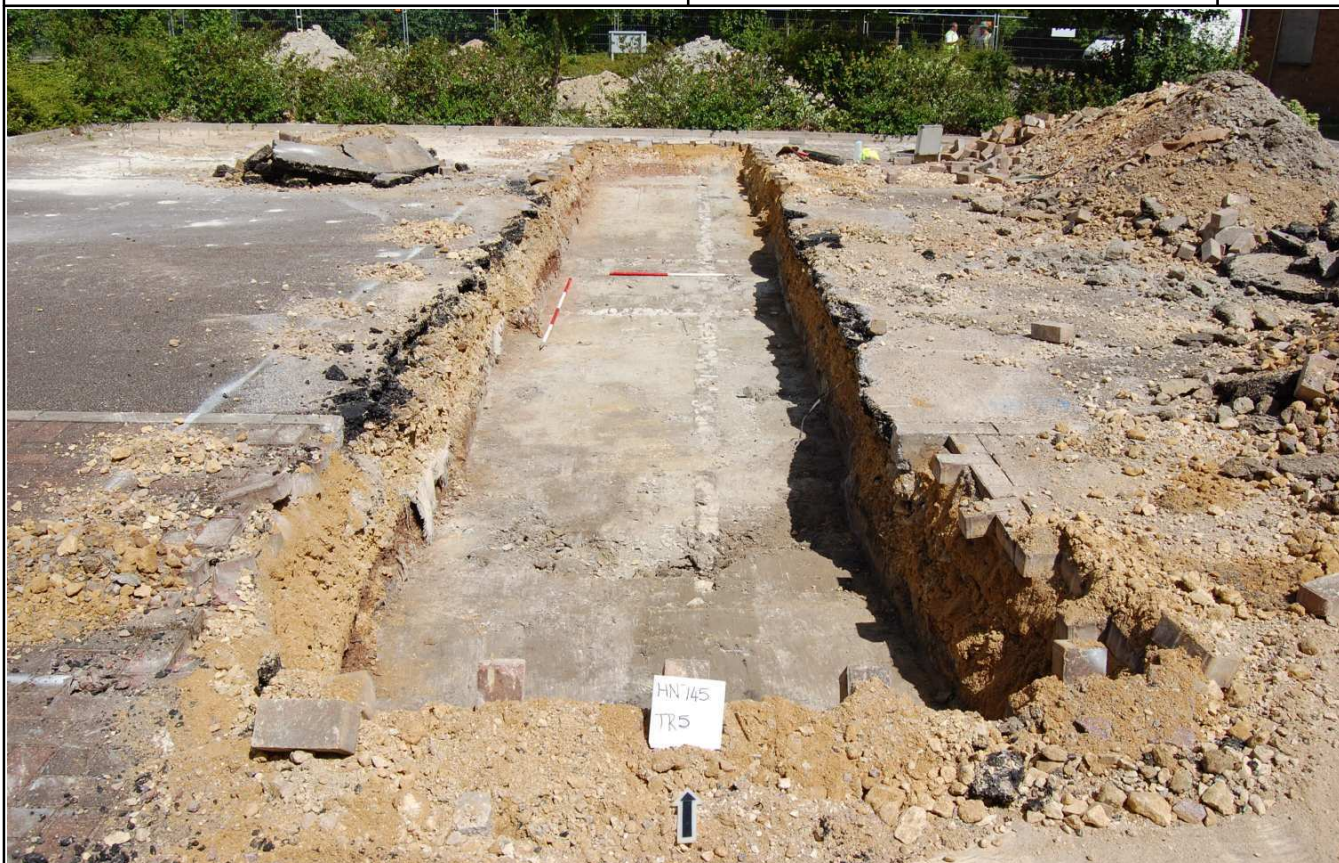
Plate 5: Trench 5 looking North

3.24 The stratigraphy in the trench consisted of a tarmac layer, comprising of part of the car park surface. Beneath this was a layer of aggregate. No original topsoil or subsoil remained.

3.25 The interface between the natural geology and the levelling aggregate was separated by a breathable fabric indicating that when the car park was constructed significant ground reduction had been undertaken.

3.26 A single land drain was observed running along the trench on a North – South alignment.

3.27 The trench contained one irregular shaped feature [501], which was situated in the northern half of the trench and was aligned east-west. The solitary fill (502) was a firm, brown, slightly silty clay which yielded no artefacts and contained no inclusions other than occasional small unworked sub-angular flints. The irregular shape and cut of the feature and the lack of archaeological artefacts or inclusions in its fill indicate that it is likely to be natural in origin.

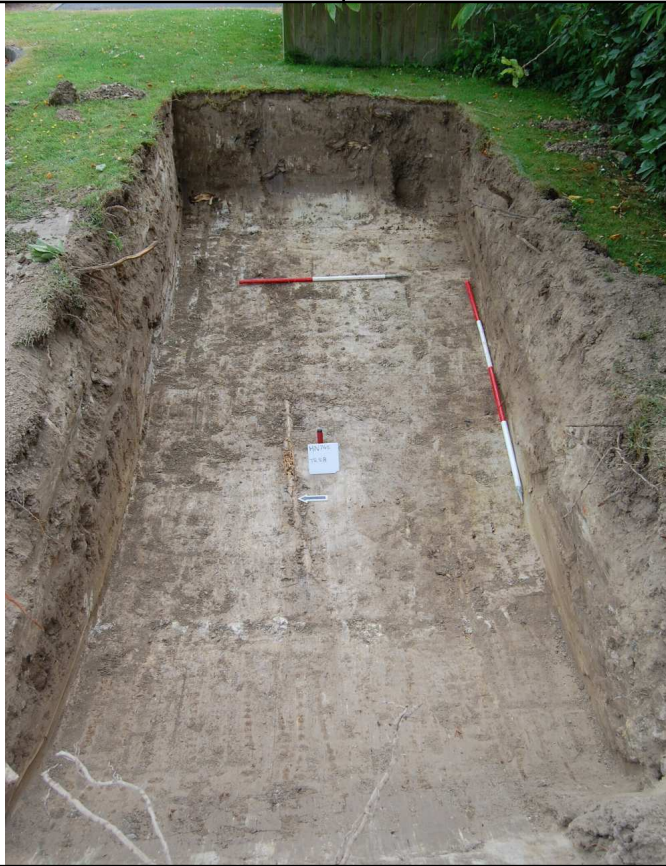
Plate 9 : Trench 8b looking East

3.43 The stratigraphy in the trench consisted of a firm, very dark greyish brown, slightly clayey silt topsoil over a layer of firm, white, redeposited chalk. Below this lay a firm, brown, silty clay subsoil which sealed the natural geology.

3.44 A single land drain was observed running along the trench on an east – west alignment.
