ST LAWRENCE VA LOWER SCHOOL Wymington, Beds.

HN406

Archaeological Evaluation Report

Report No.183

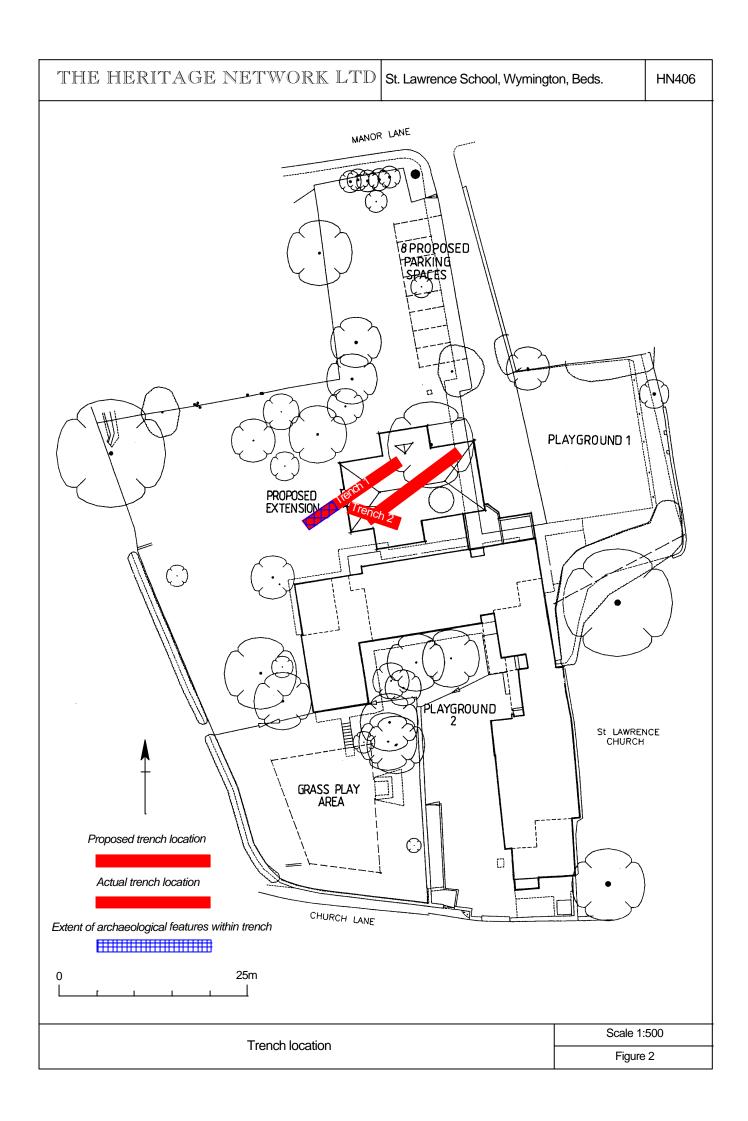
2.3 The plot covers an area of approximately 400m^2 and it was proposed that an area of approximately 24m^2 should be excavated within the building footprint. Circumstances on site led Trench 1 to be moved so that the southwestern end extended beyond the footprint of the proposed building. Consequently, an additional trench, Trench 2, was excavated to the south of Trench 1, which brought the total area excavated within the footprint to 27.2m^2 (see Figure 2).

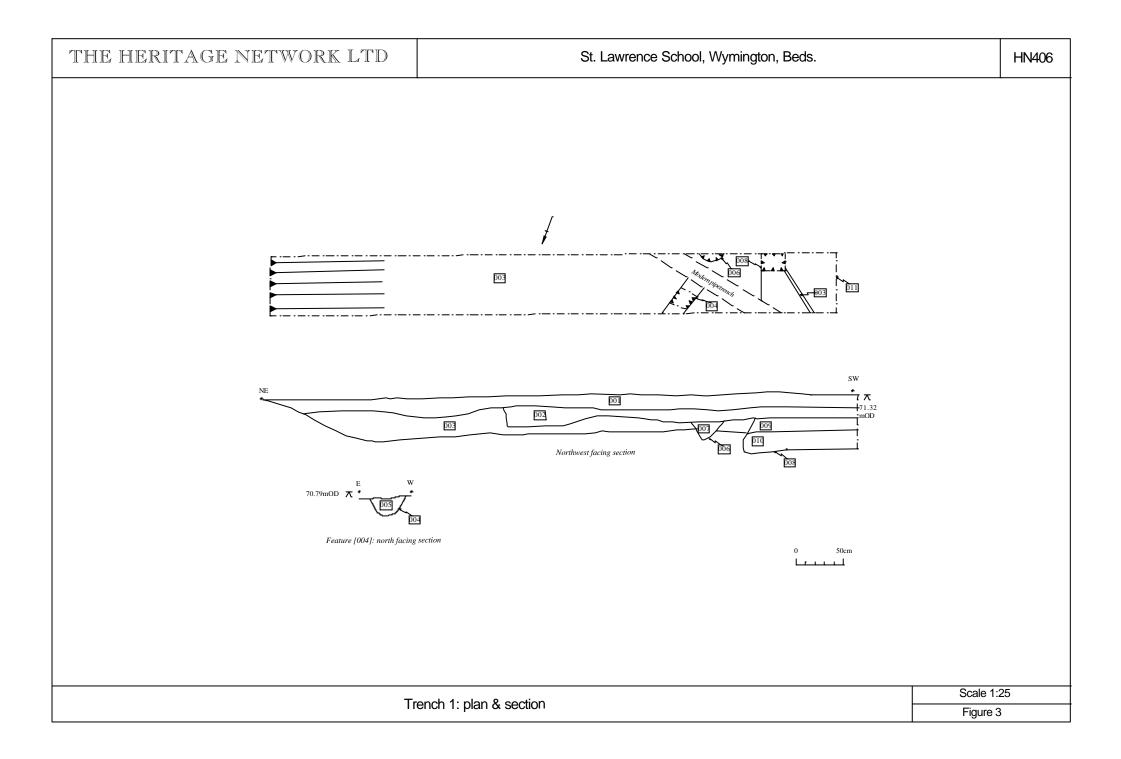
2.7 Trench 1 measured 15m by 1.6m, and was aligned northeast-southwest (see Figure 3). The underlying natural geology was reached at a depth of approximately 0.4m and a layer of the natural limestone brash was revealed towards the northeast end of the trench.

2.8 The trench contained four archaeological features, only one of which produced any datable material which dated to the Saxo-Norman period. The contexts assigned in Trench 1 are summarised in the table below:

2.9 Two of the features identified in Trench 1 produced archaeological finds, these were pit [006] and feature [008]. The table below provides a quantification of these finds.

3.2 The material recovered from the southwestern end of Trench 1 indicates that there was activity on the site during the Saxon period, although it was not possible to characterise the exact nature of the remains within the confines of the evaluation exercise. It is possible that feature [008] represents a boundary of some sort, with perhaps further remains to the southwest of the study area.

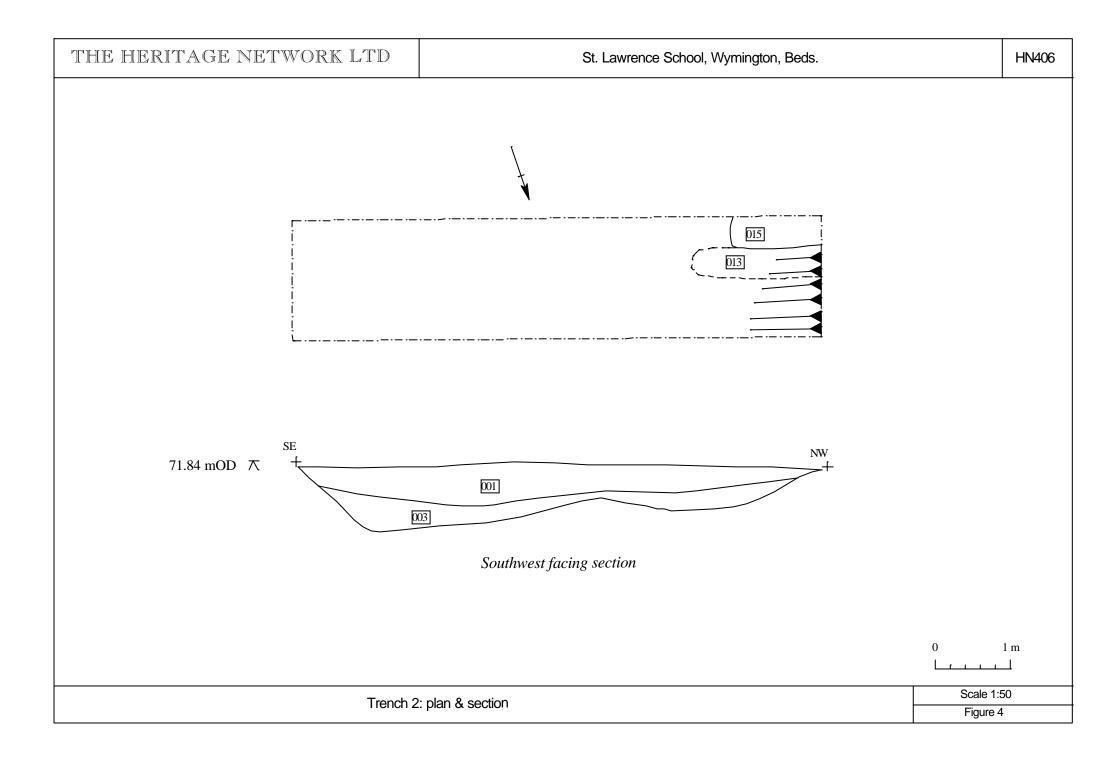
2.13 Trench 2 was placed to the immediate south of Trench 1, within the building footprint and closer to the existing school buildings (see Figure 4). It measured 7m by 1.6m and it was aligned northeast-southwest. The natural geology was reached at a depth of 0.46m and a summary of the contexts assigned are presented in the table below.

2.14 The recovery of later post-medieval pottery and ceramic building materials from feature [013] and its relationship with the modern drain [015] seems to indicate that it is also likely to be a modern feature. No other archaeologically significant remains were recovered from Trench 2 and the finds from feature [013] were not retained.
