WARREN FARM Braughing, Herts.

HN398

Archaeological Monitoring Report

Report No.177

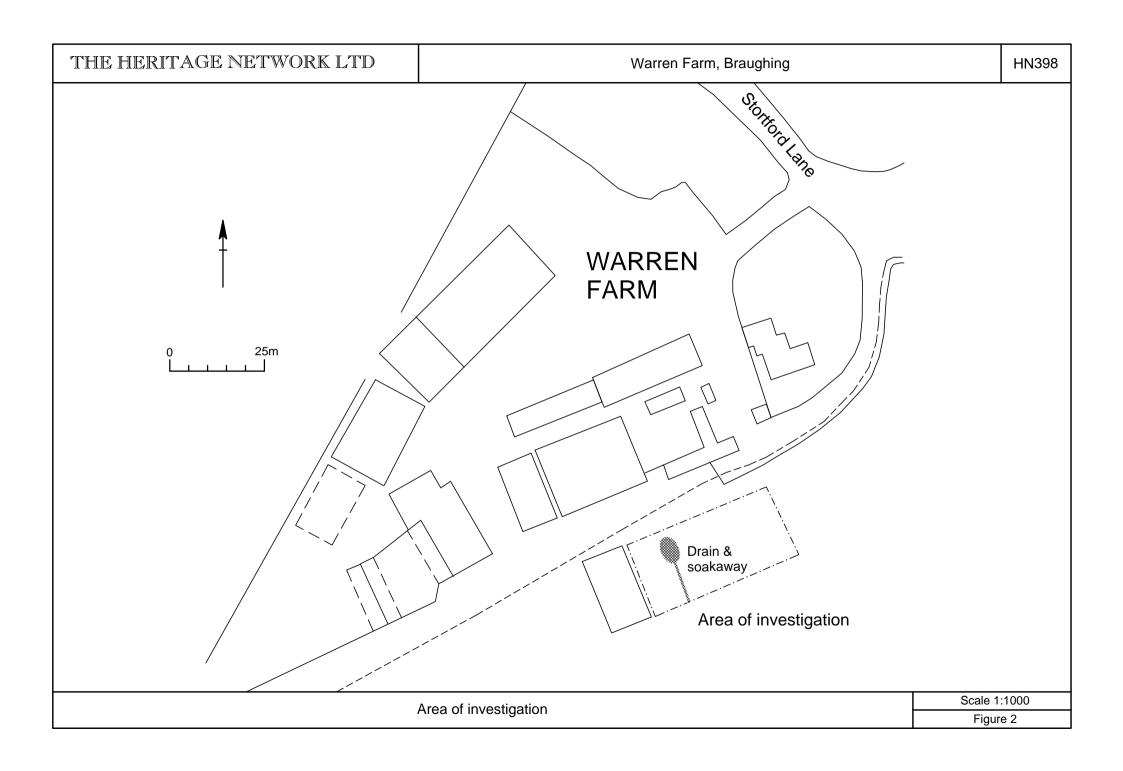
Figure 1	Site location plan
Figure 2	Area of investigation

- 2.10 A linear feature measuring approximately 0.90m in width, 11.0m in length and 0.18m in depth was revealed 10.50m east of the new barn. This was orientated north-west to southeast and ran from the southern edge of the area, petering out into a very gravelly area with indistinct edges. This gravelly area did not appear to extend as far as the northern edge of the menage area (Fig.2). The fill of the linear feature was topsoil as described above. A small area was investigated and found to contain a fragment of Victorian/modern brick.

3.1 The linear feature had every appearance of a recent land drain emptying into a soakaway. The gravelly area, which represents the possible soakaway in question, was aligned with a barn to its north, which had previously been used for cattle. The smell as the topsoil was being removed suggested that the soakaway also served the cattle shed, but there was no direct evidence to support this.
