THE MASTER TANNER'S HOUSE **12 High Street, Buntingford, Herts.**

Historic Building Record

THE MASTER TANNER'S HOUSE 12 High Street, Buntingford, Hertfordshire

HISTORIC BUILDING RECORD

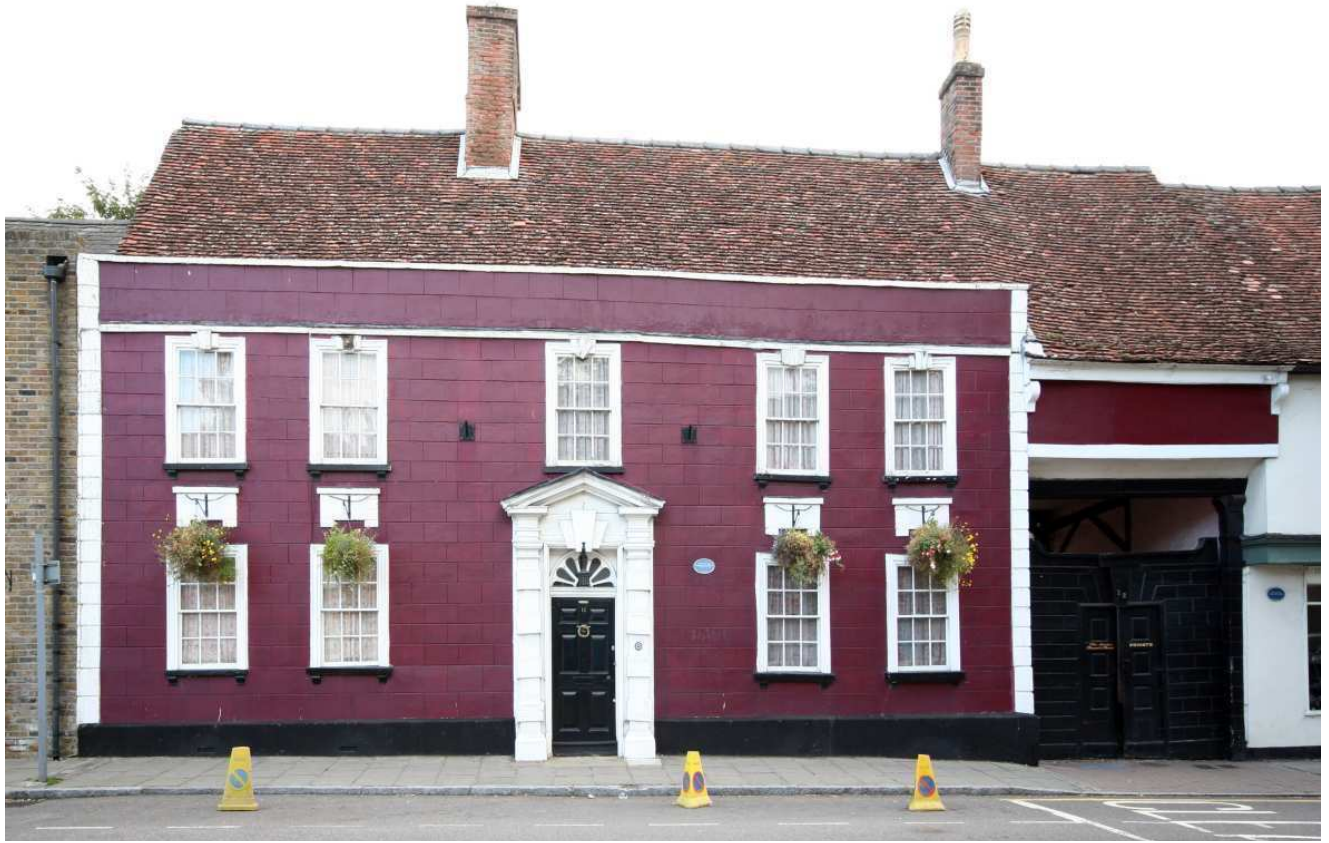
Plate 1: House - west exterior elevation

3.4 The west (front) elevation of the Master Tanner's House faces onto the High Street (Plate 1, Figure 12). The frontage is Georgian in date and is thought to have replaced a 16th century jettied timber frontage in 1720. The façade is rendered to look like ashlar stonework and is painted a deep burgundy. The windows and doorway are painted white, whilst the door is black. There is a plaque located to the right of the entrance which reads *A 16th Century house Re-fronted in 1720, formerly the Tanner's house.*

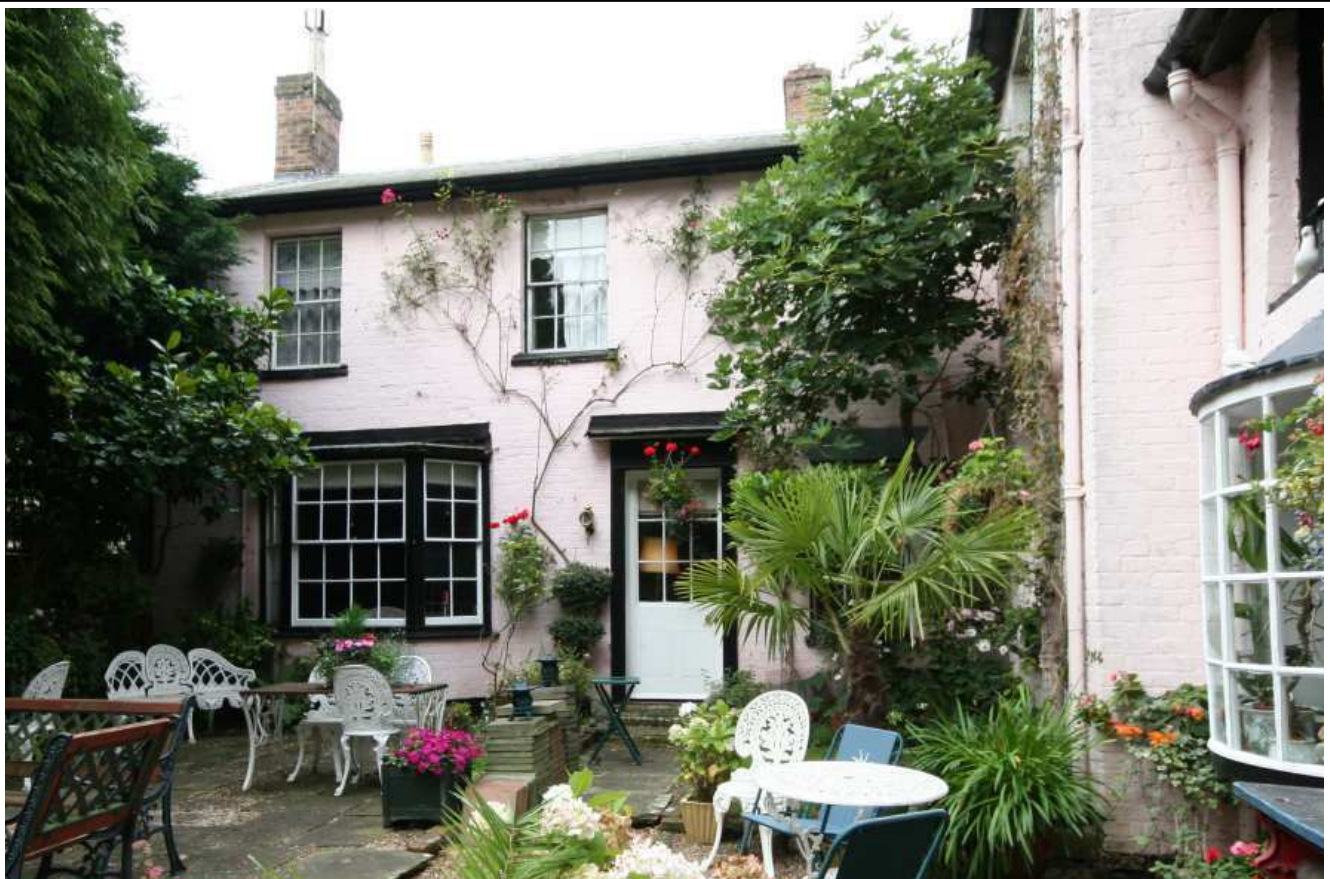
Plate 2: House - east exterior elevation

3.11 The east (rear) elevation of the Master Tanner's House faces into the rear courtyard (Figure 13). It is constructed of brick, painted white. This elevation may date to the late 18th century, when a significant remodelling of the rear of the house was undertaken.

3.12 The rear entrance is located towards the northern side and has a modern door set in a wooden frame below a timber lintel (Plate 2). A 6-over-6 sash window, with a splayed brick header painted light blue, is located to the north of the doorway and a bay window, with a timber lintel, to the south. The sash window is similar in style to those in the south elevation of the kitchen wing and is doubtless contemporary. Three 6-over-6 sash windows, with projecting sills but no header, are located below the eaves.

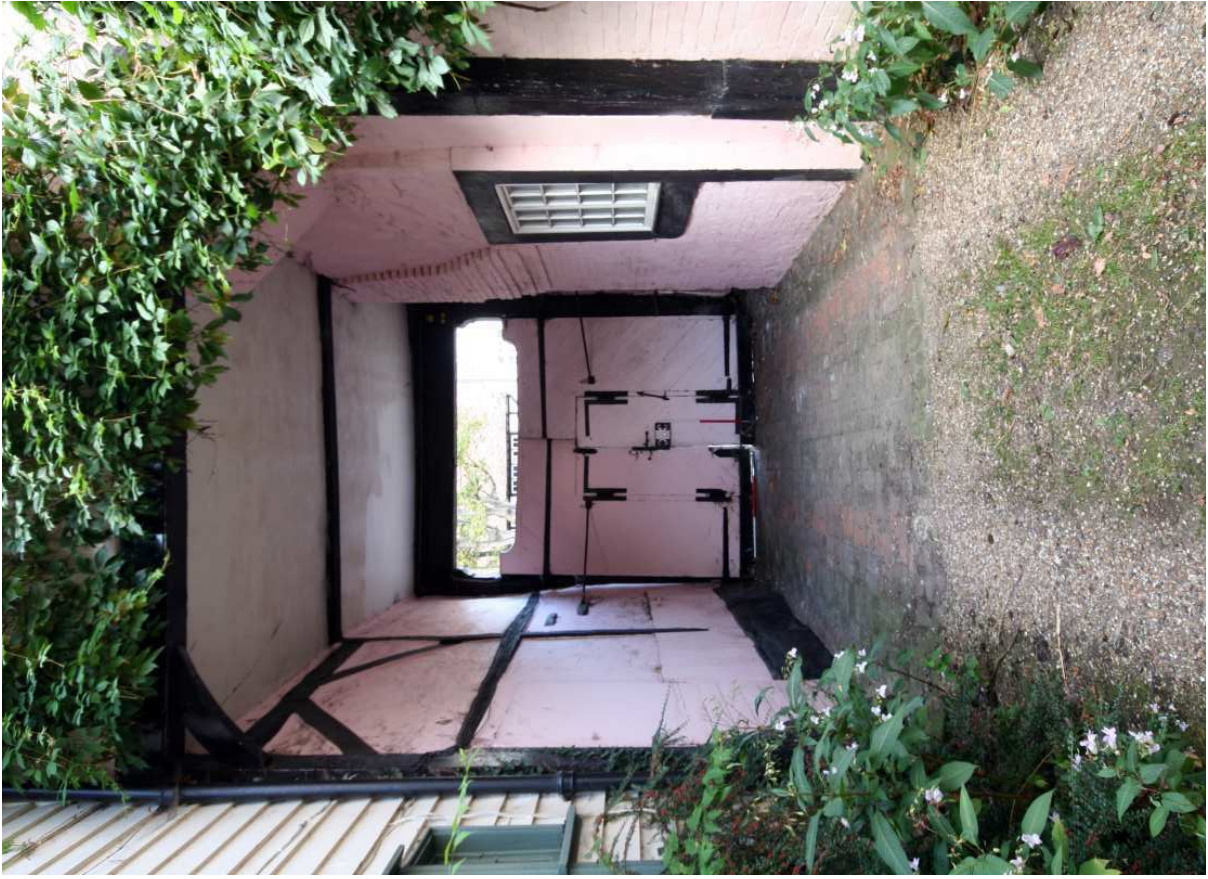
Plate 3: Carriageway, looking west

3.9 The south elevation of the main house faces on to the carriageway (Plate 3, Figure 12). A two-light casement window in a black painted frame occupies a blocked doorway towards the eastern end at ground floor level. Corbelled brickwork to the west of the window indicates the presence of the chimney for the fireplace in Room 2. A blocked opening, with a boarded chute, is located at ground level at the western end of the elevation. This leads down to Cellar 2 and was probably intended for coal deliveries.

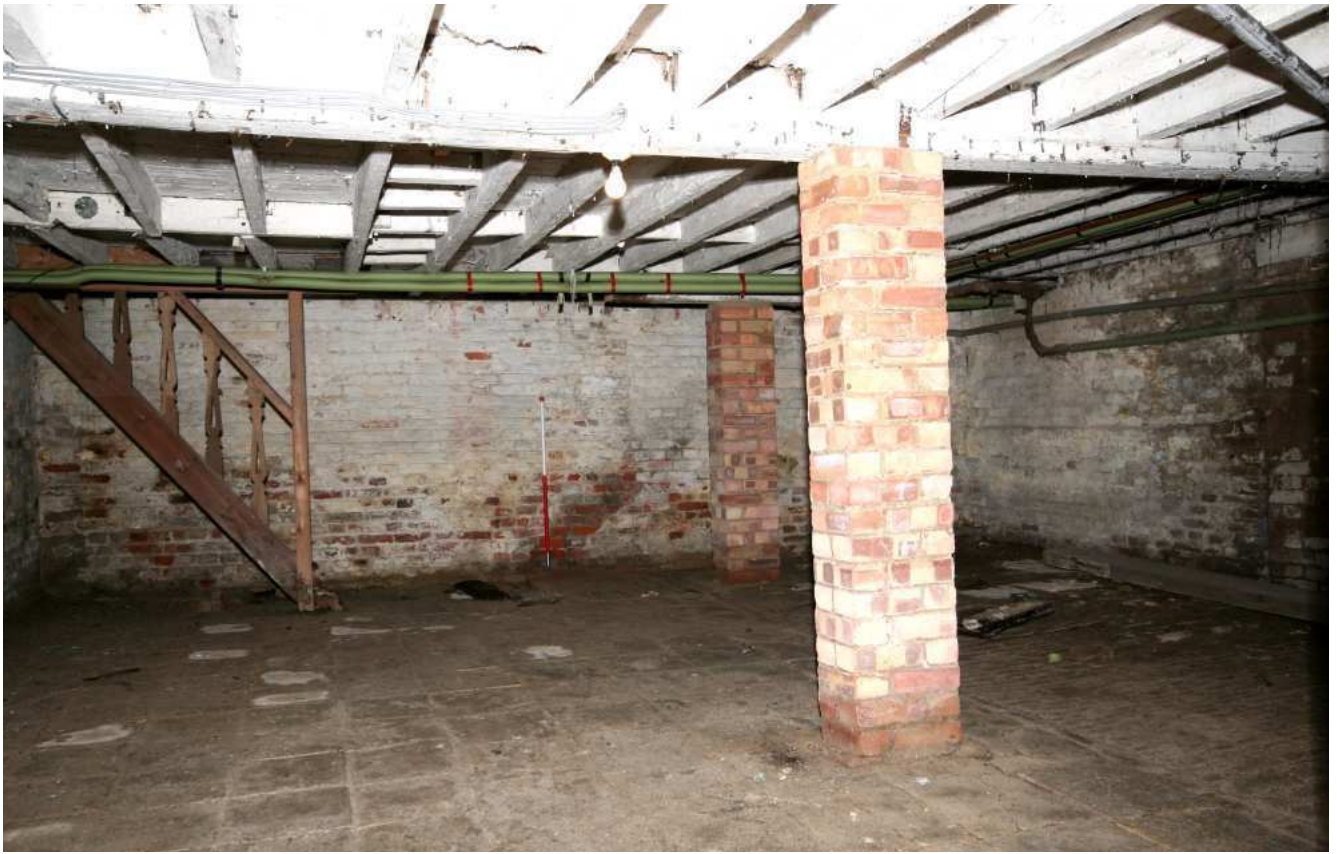
Plate 5: Cellar 1 - north interior elevation

3.16 Timber joists, with lath and plaster infill to provide insulation to the rooms above, are exposed in the ceilings. These are similar to joists noted in the ceilings of the rear range, which dates to the mid 17th century, suggesting that they are contemporary. The ceiling itself is supported throughout by modern brick piers. The line of a former passageway, on the ground floor above, is marked by the presence of additional bracing between the adjacent joists and the absence of lath and plaster infill (Plate 5).

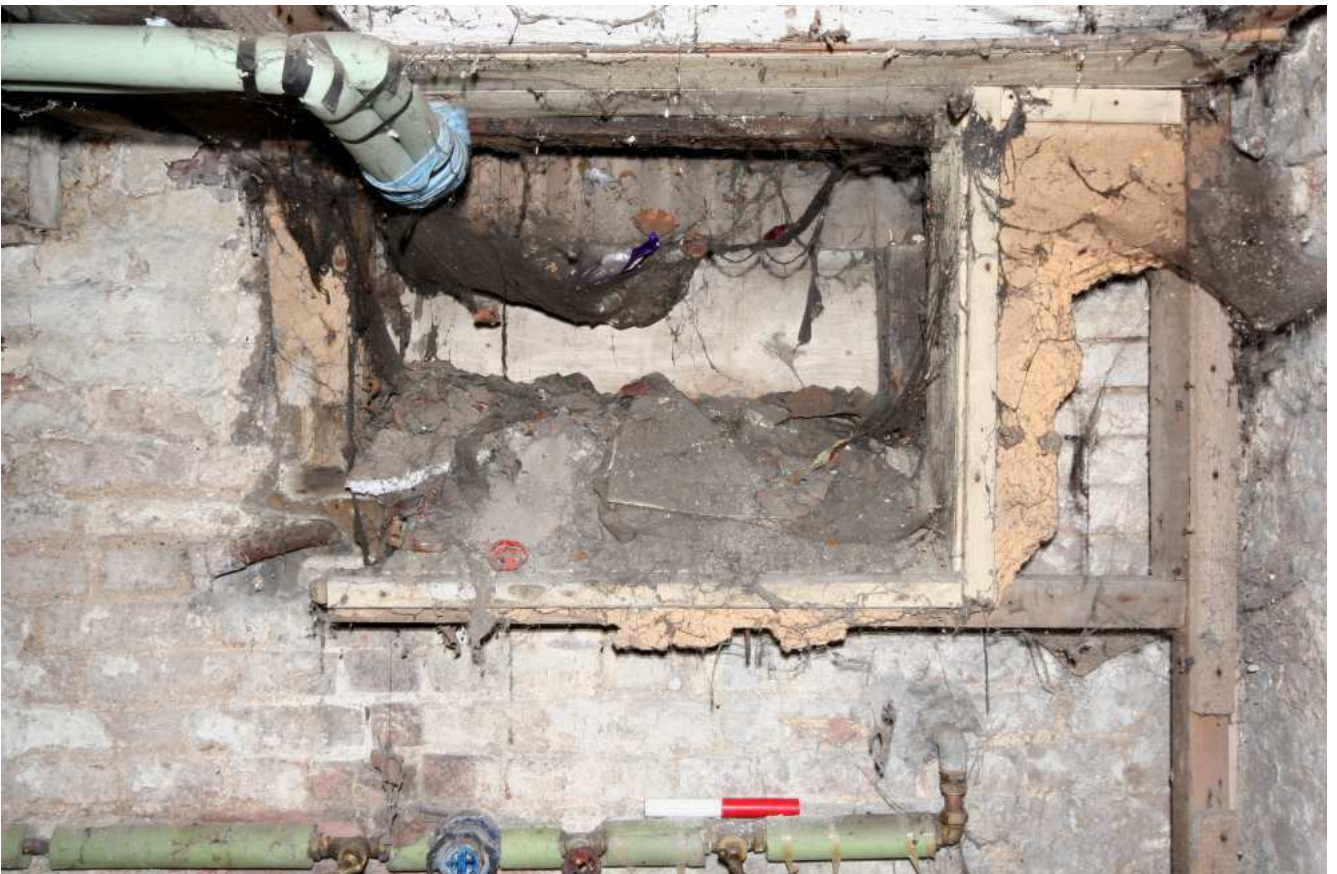
Plate 6: Cellar 2 - coal chute in south elevation

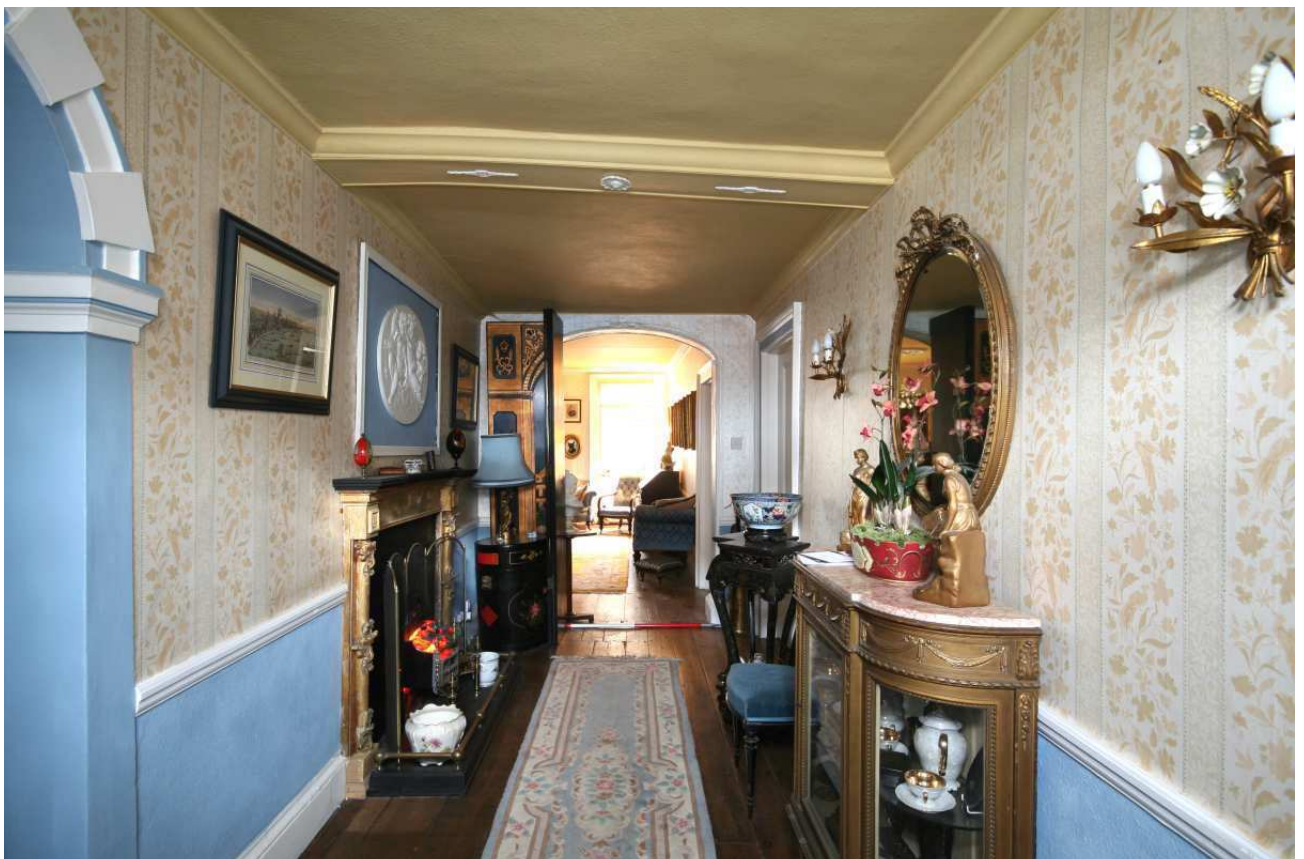
Plate 10: Entrance hall, looking east

3.19 The front door leads in to an east - west aligned entrance hall (Figure 14), with torus moulded skirting and modern dado rails (Plate 10). It has been suggested that the hallway follows the line of a medieval alley running back from High Street. The cottages on either side were subsequently joined, possibly in the mid 16th century.

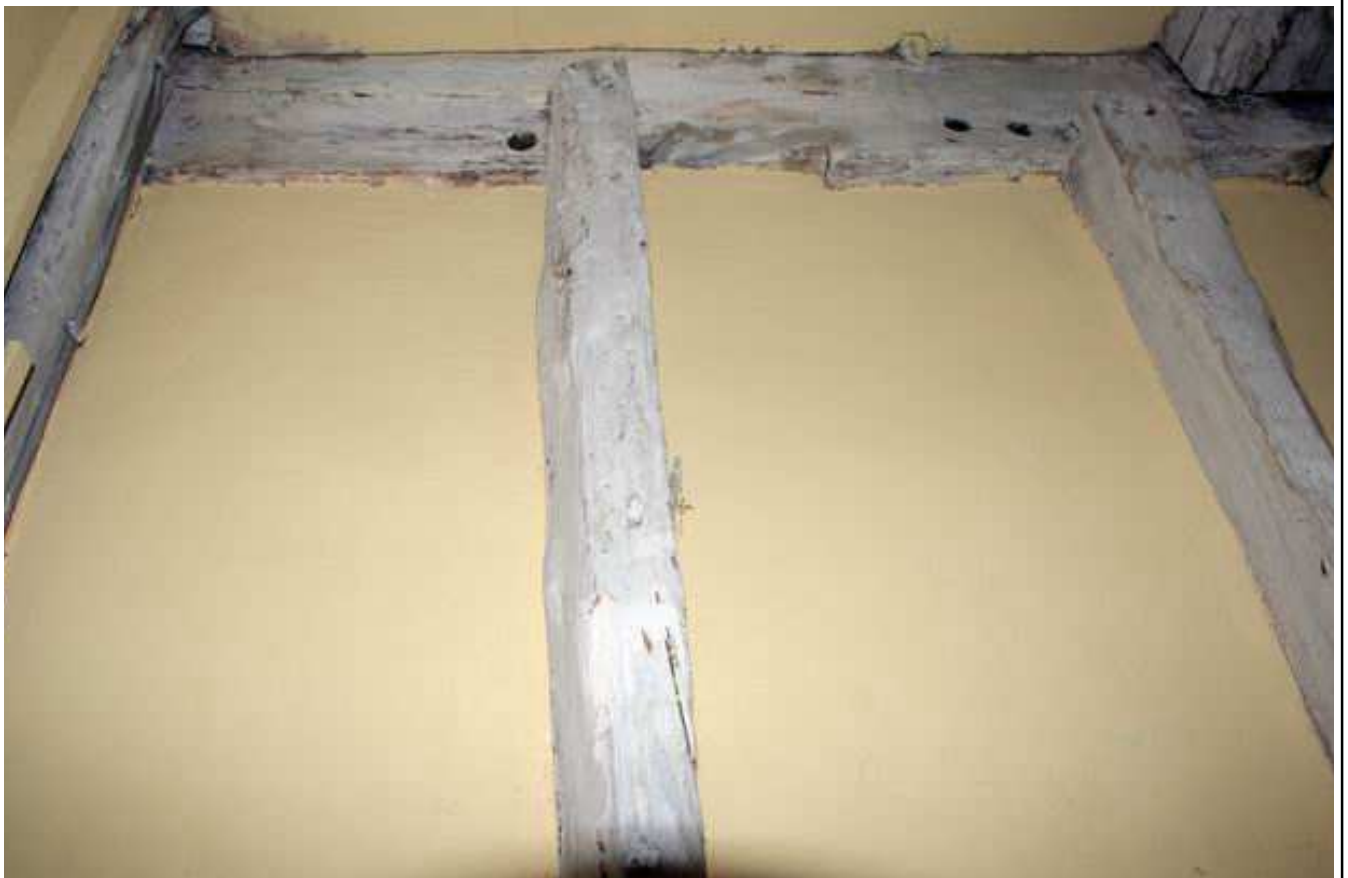
Plate 12: Hall cupboard, timber framing in south elevation

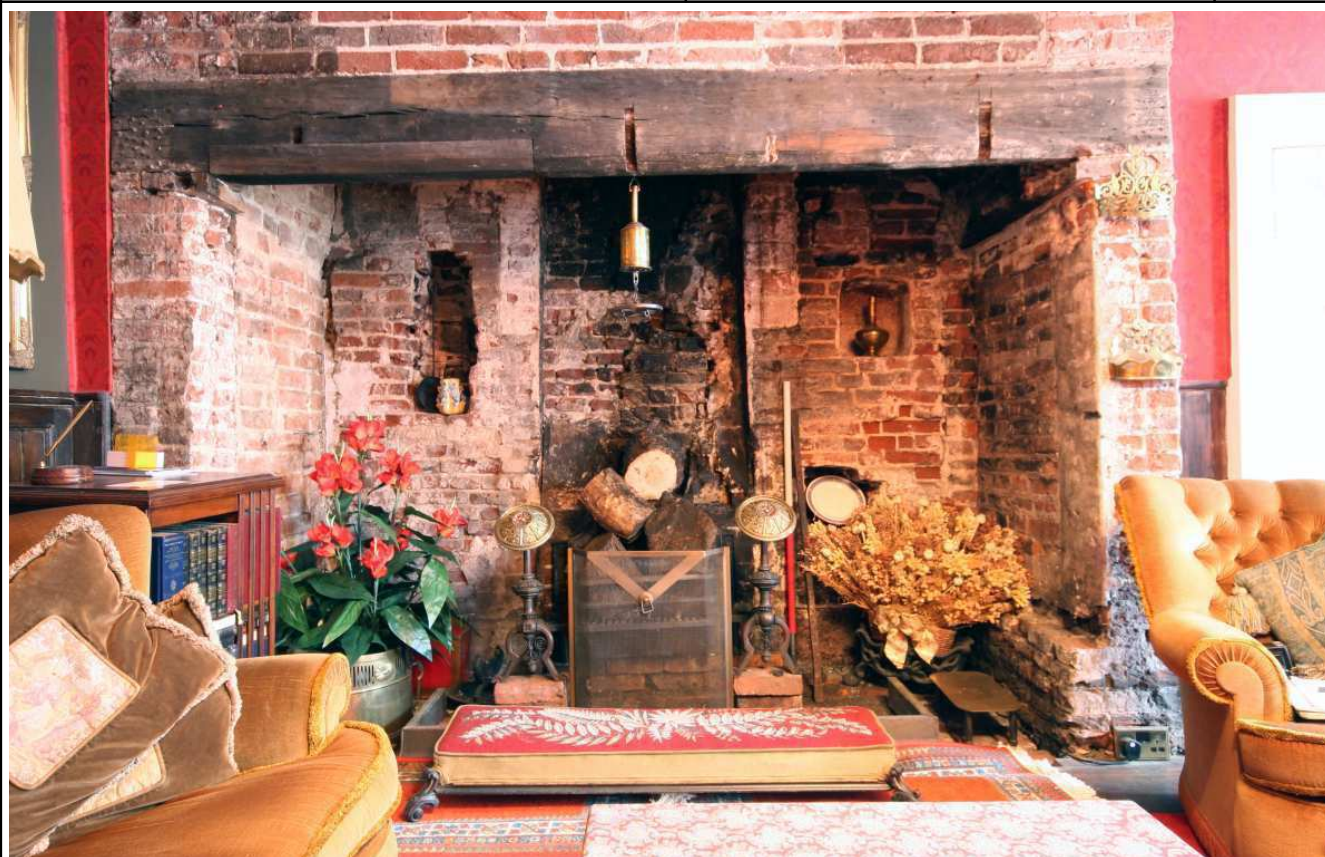
Plate 13: Room 1, inglenook fireplace in the south elevation

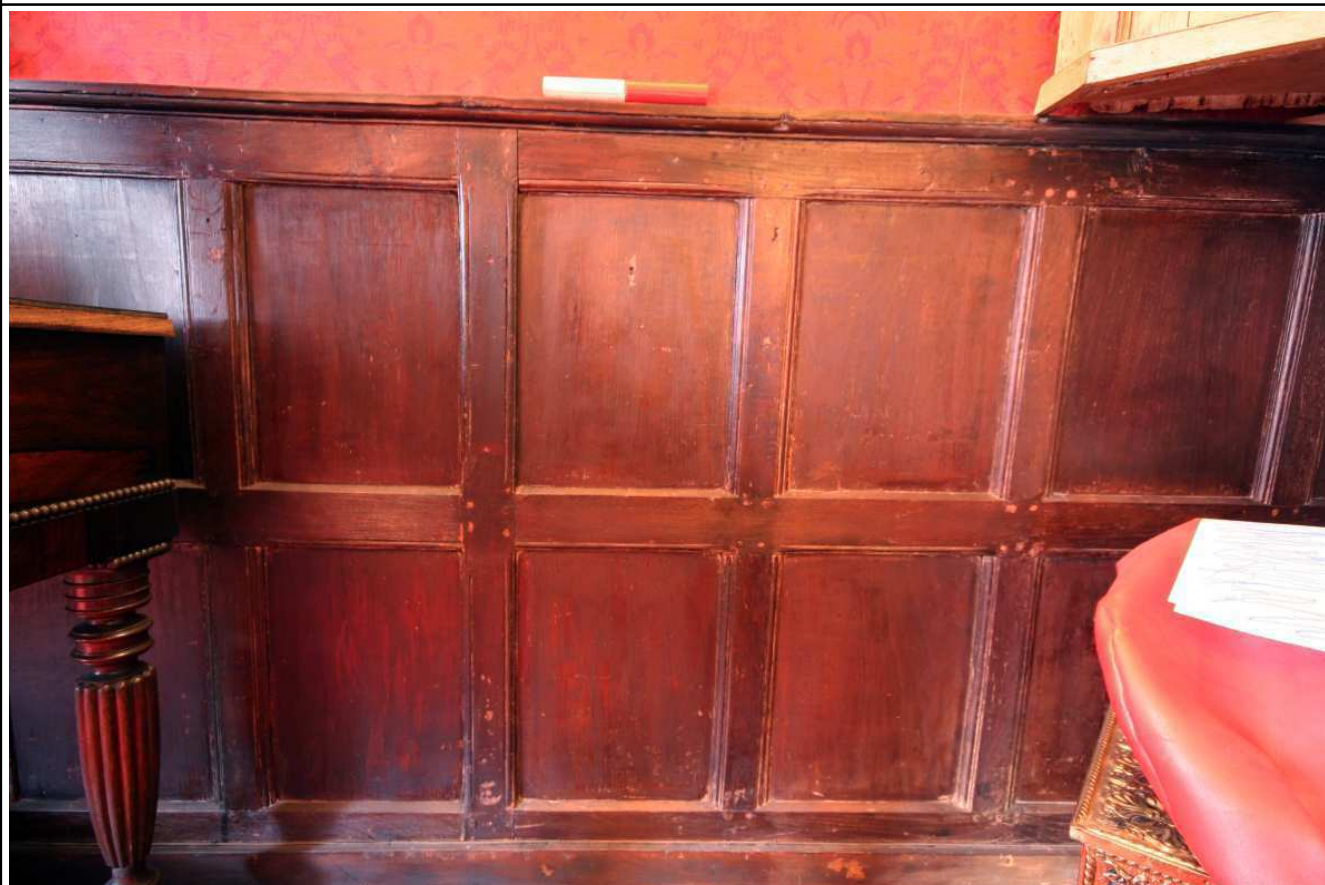
Plate 14: Room 1, detail of Jacobean panelling on the north elevation

3.25 Half-height wooden panelling, with moulded styles and rails, survives on the eastern, northern and western walls (Plate 14). This is possibly Jacobean in date and this is the only room in the house in which this feature survives intact. A break was noted in the coving on the north elevation in line with a change in the panelling and a shadow in the wall above. The panelled infill measured c.1.18m wide and it is possible that this could mark a blocked doorway into London House to the north.

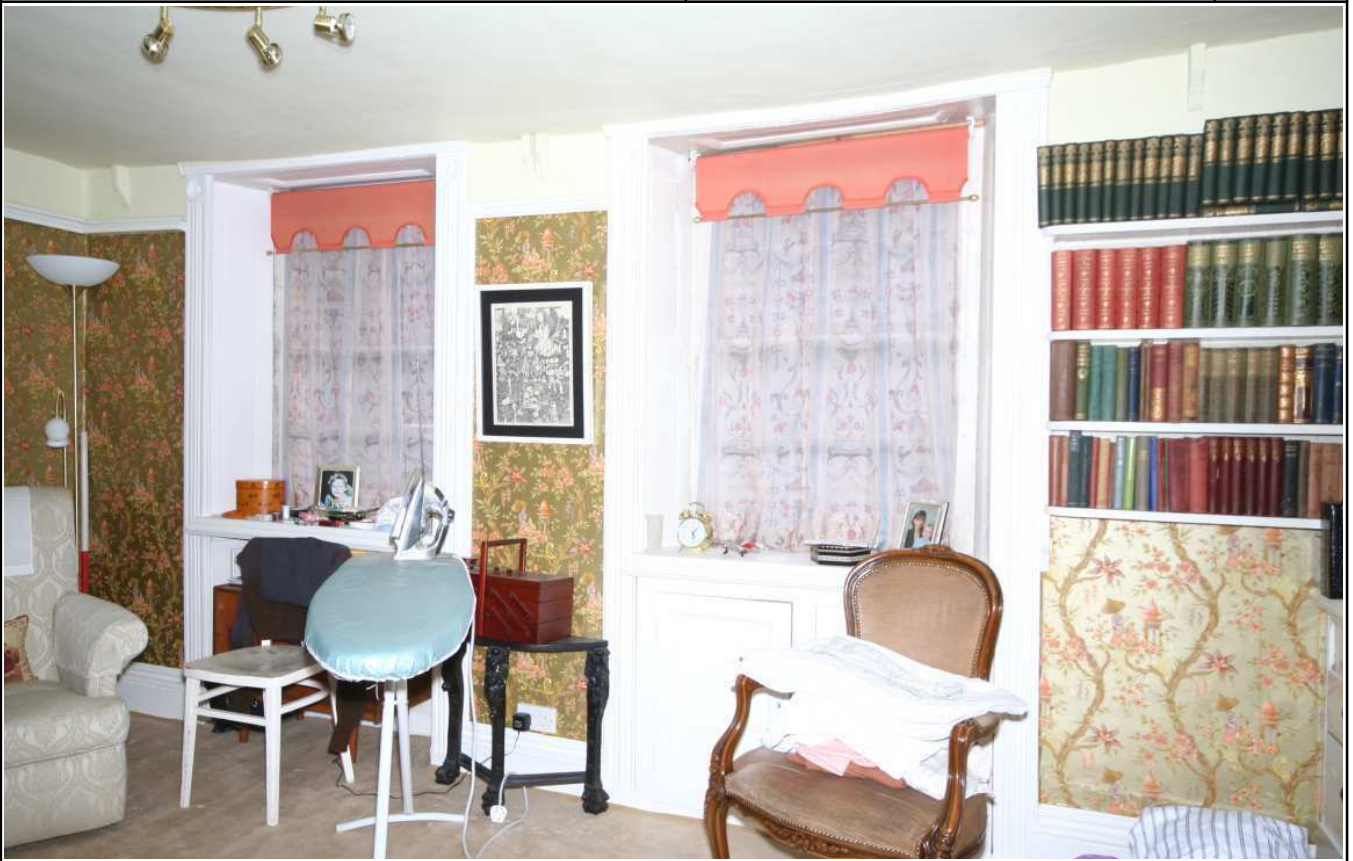
Plate 17: Room 2, west elevation

3.28 There are two 6-over-6 double-hung sash windows in the west elevation, set in deep embrasures with a moulded frame and roundels (Plate 17). Brackets were noted between, and on either of the windows, suggesting that the ceiling has been lowered at some time.

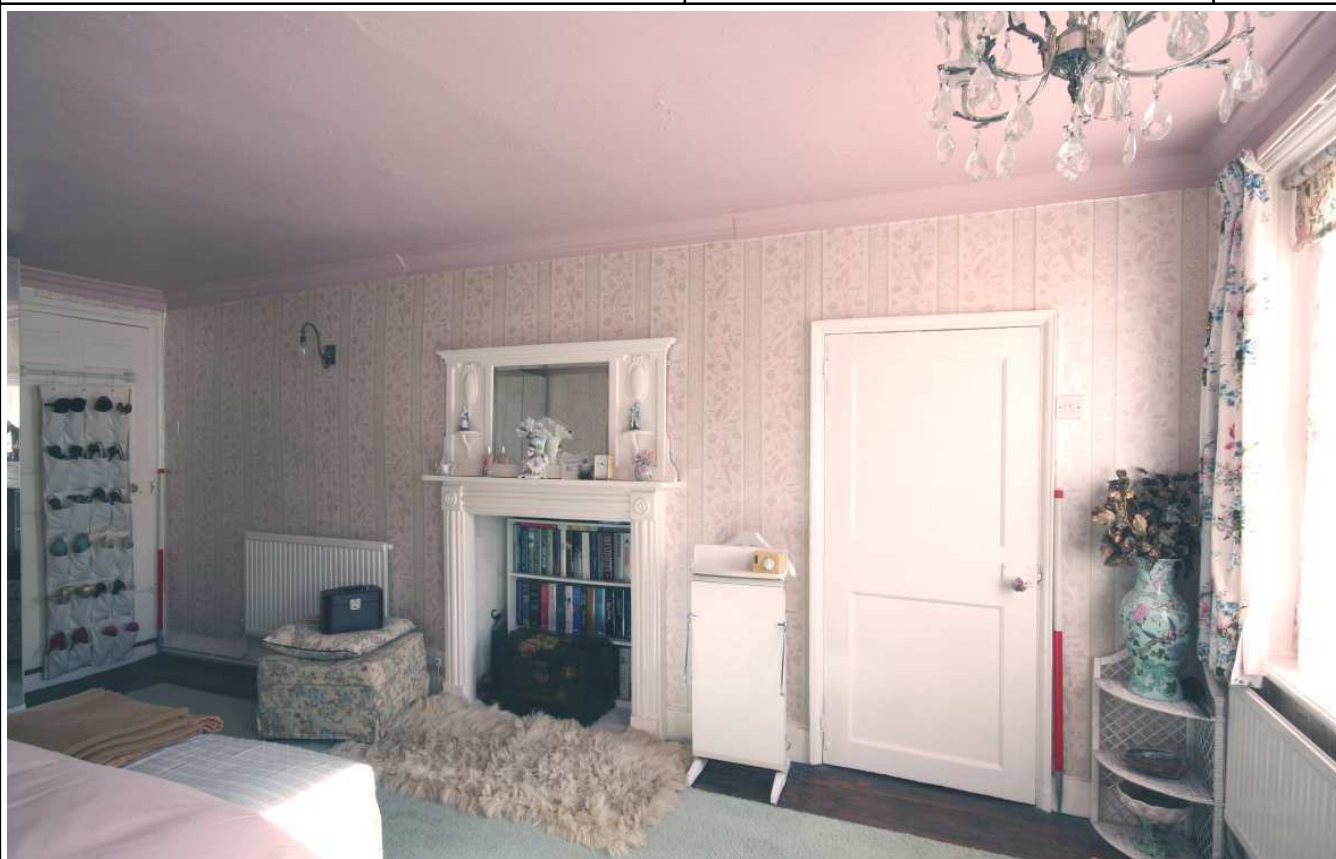
Plate 25: Room 5, south elevation

3.37 There is a central fireplace on the south elevation, with wooden mantelpiece decorated with twin roundels on raised square blocks, dating to the mid 19th century (see Plate 25). The grate has been replaced by a bookshelf. The two windows in the west elevation are original Georgian 6-over-6 double hung sash windows (Plate 26). They may once have had shutter boxes below. Part of the wall plate has been exposed in the east elevation (Plate 27).

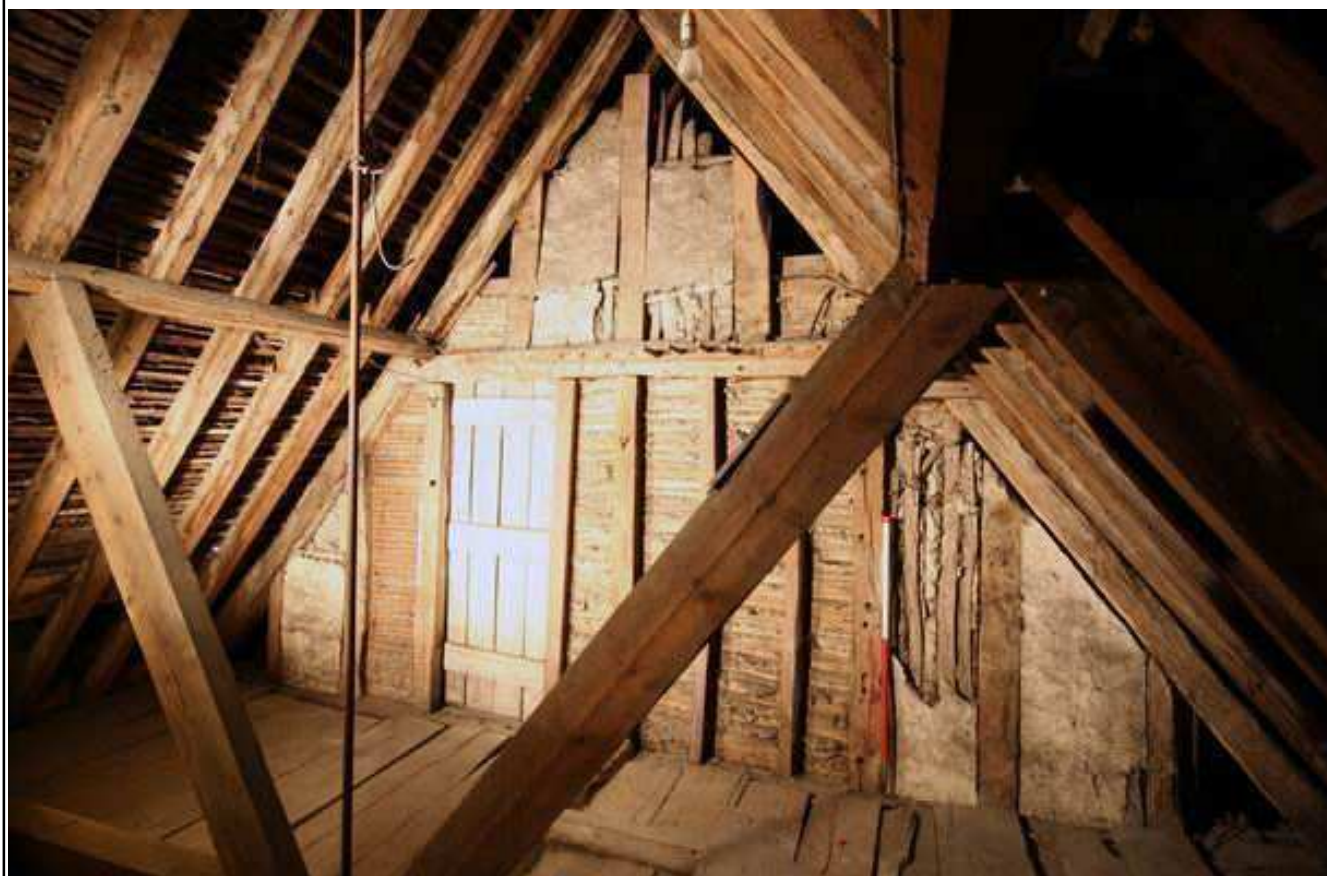
Plate 38: Attic, partition between Bays 4 and 5, looking south

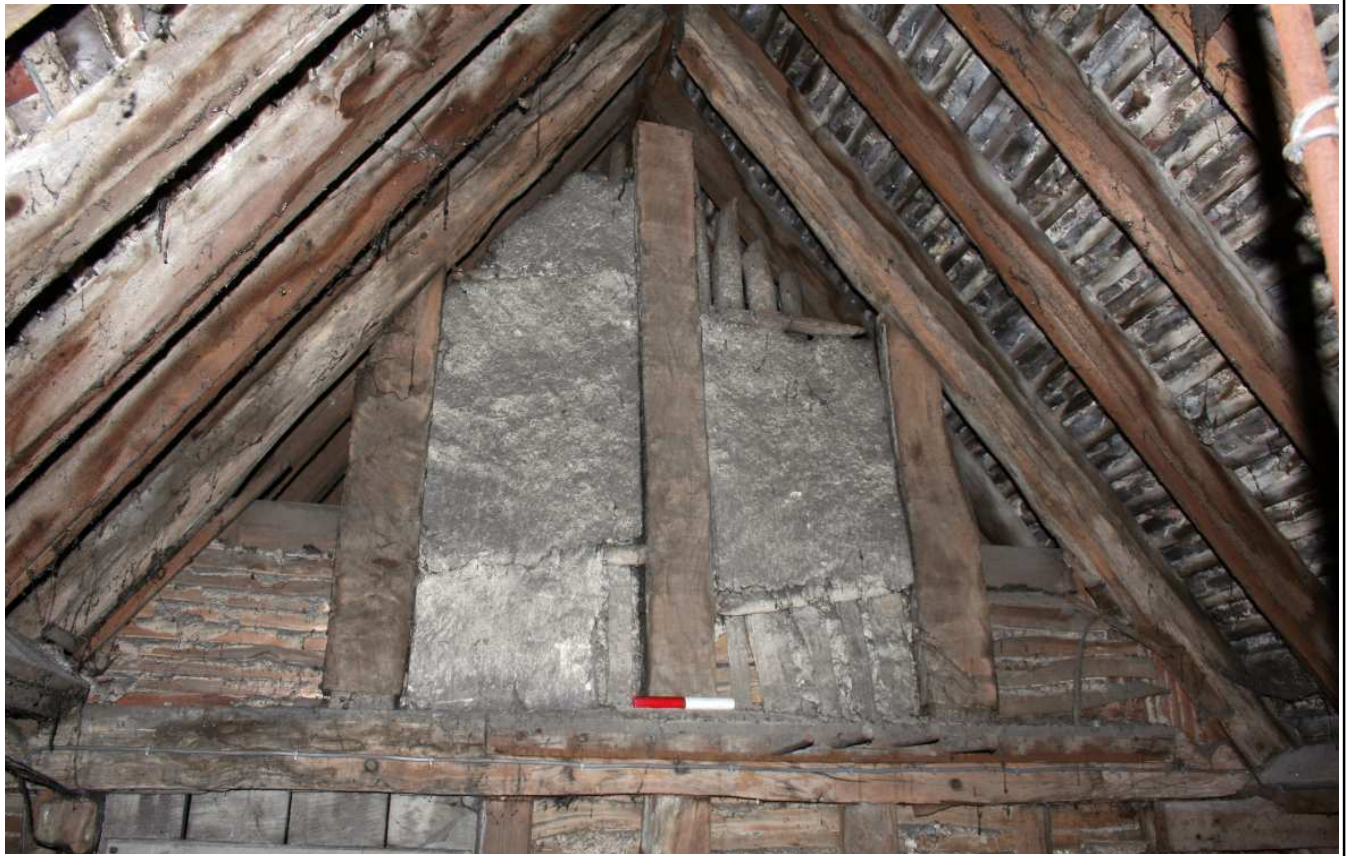
Plate 39: Attic, detail of wattle and daub in partition between Bays 4 & 5

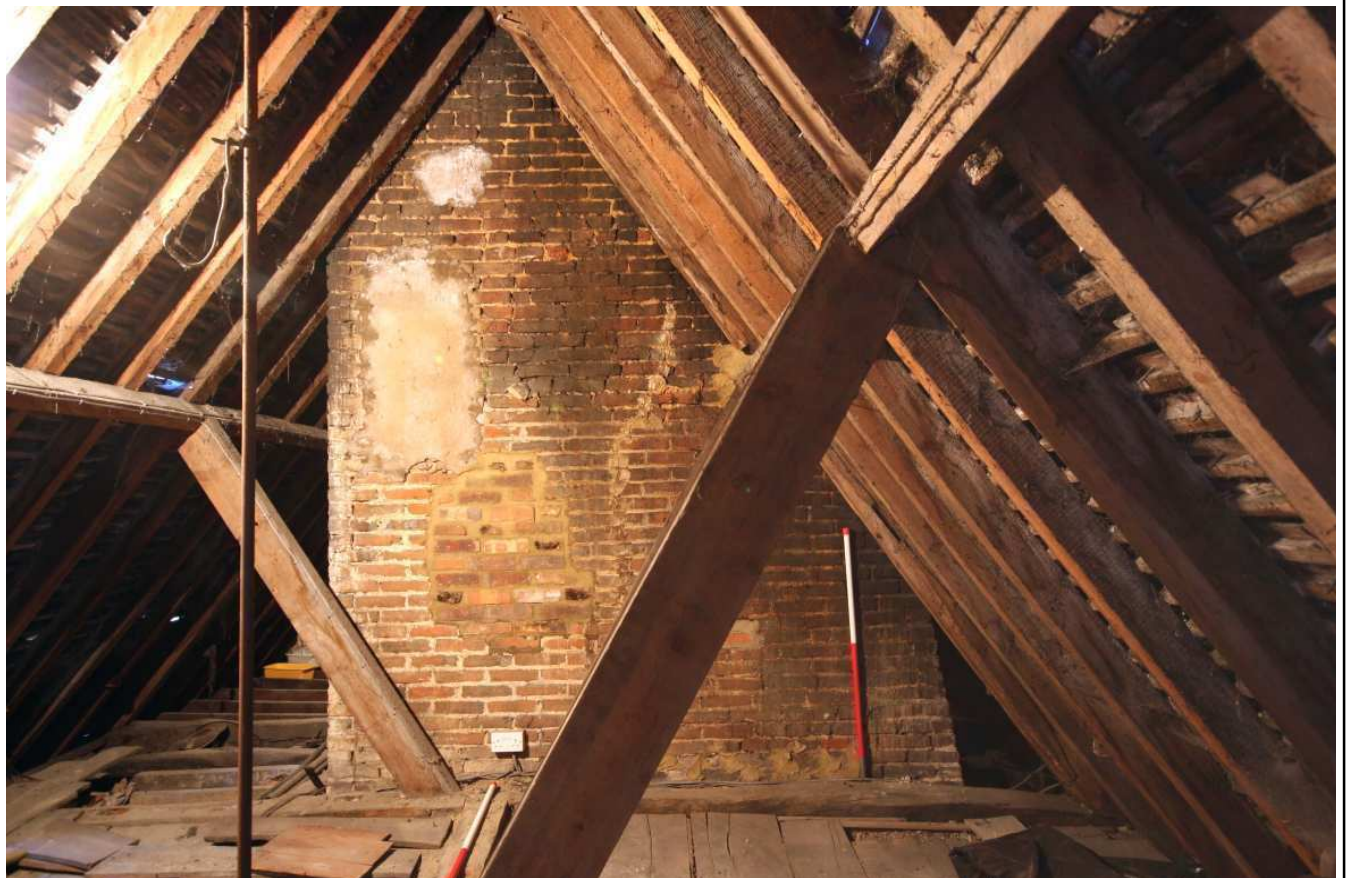
Plate 40: Attic, chimney in Bay 2, looking north

3.48 Bay 2 is occupied by a brick chimney, offset to the east, which slopes steeply on the eastern side but is vertical on the west (Plate 40). The bricks, which measure 9" x 2¼" x 4¼" are laid in stretcher bond. The tie beams on either side of the chimney appear to be original, although the raking queen struts date to the replacement of the roof in about 1900.

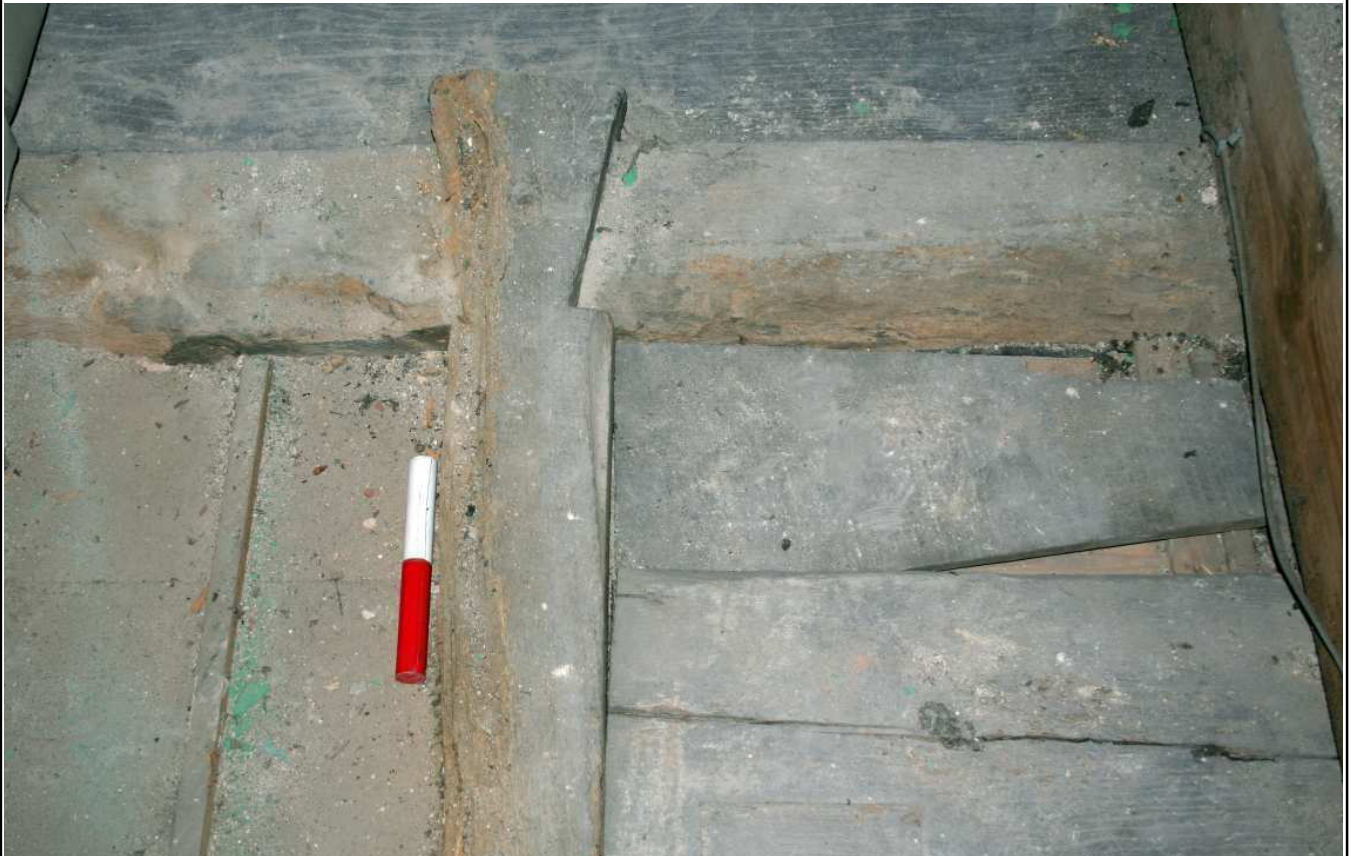
Plate 41: Attic, detail of dovetail joint between central joist and brace to wall plate

3.49 The floor consists of a central joist, which runs south to north, with dovetail joints for braces running west to the wall plate (Plate 41). The two braces in Bay 2 survive in situ, one brace is missing in Bay 1, although mortices for the braces running east are visible in the east face of the joist (Plate 42). The floor in Bays 3 and 4 is boarded with wide boards measuring 0.36m. The timber framed parapet to the Georgian front is visible at the base of the rafters on western side (Plate 43).

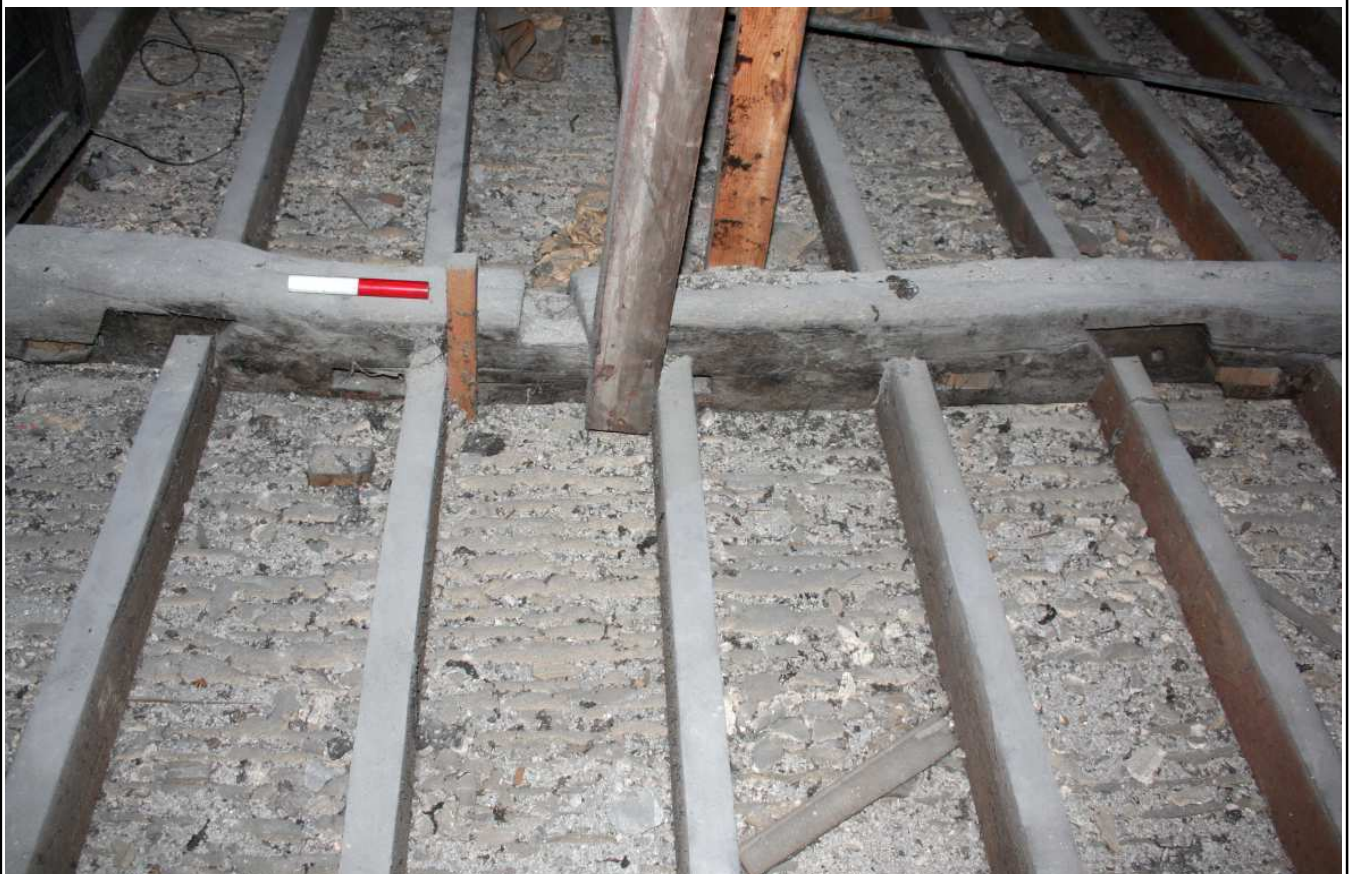
Plate 42: Attic, detail of mortice for missing brace to eastern wall plate

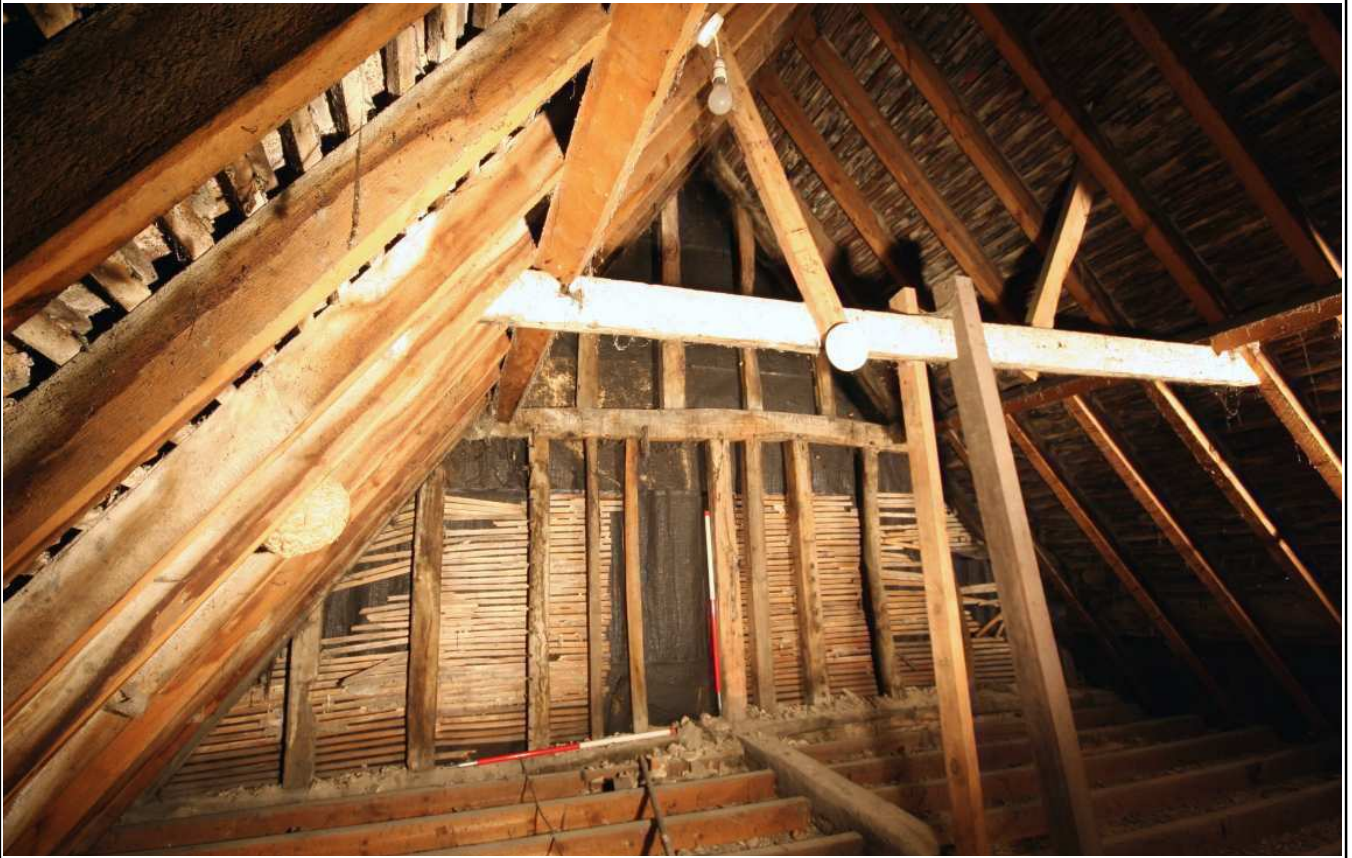
Plate 45: Attic, north gable, looking north

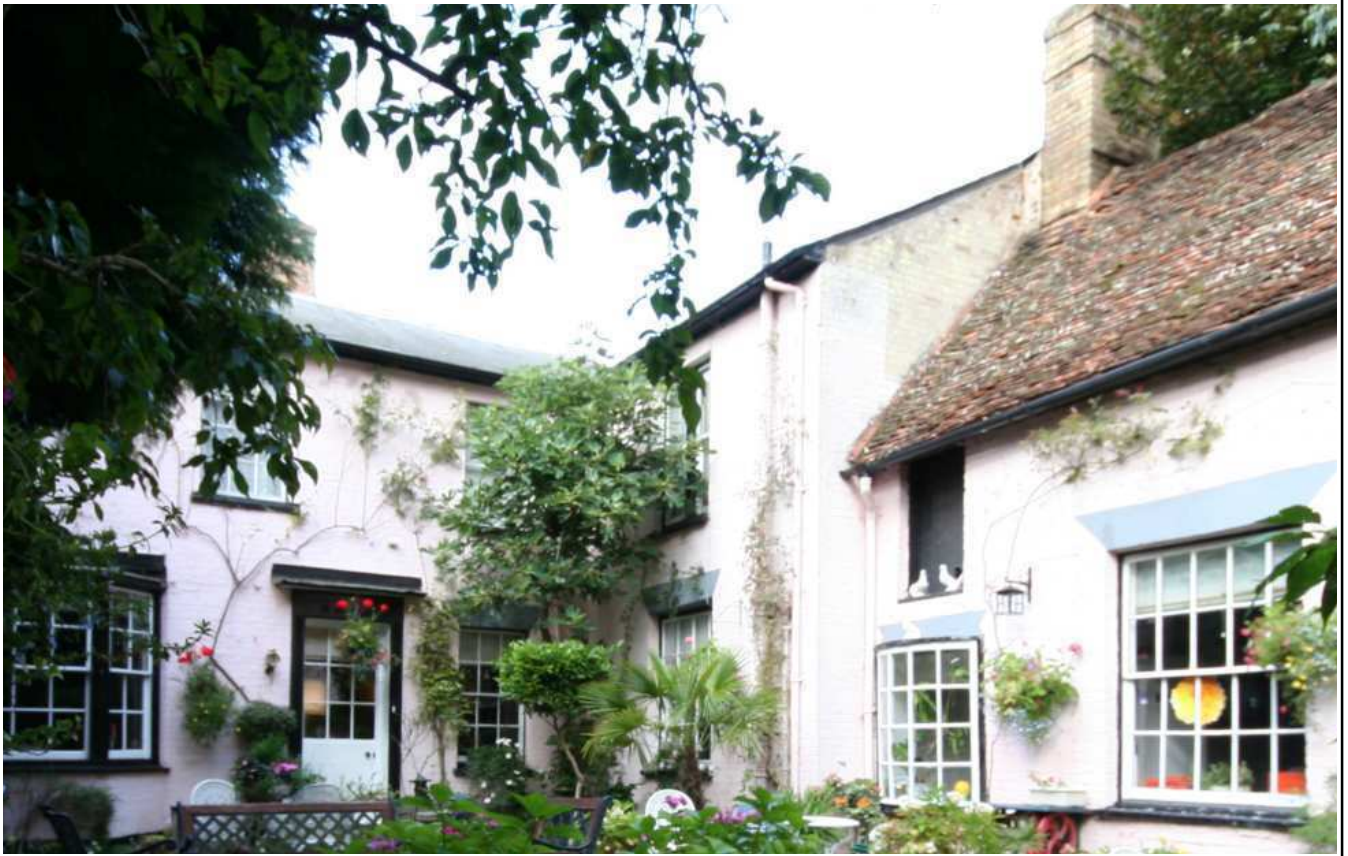
Plate 47: Former kitchen wing, south and east exterior elevations
