THE MASTER TANNER'S HOUSE **12 High Street, Buntingford, Herts.**

Historic Building Record

THE MASTER TANNER'S HOUSE 12 High Street, Buntingford, Hertfordshire

HISTORIC BUILDING RECORD

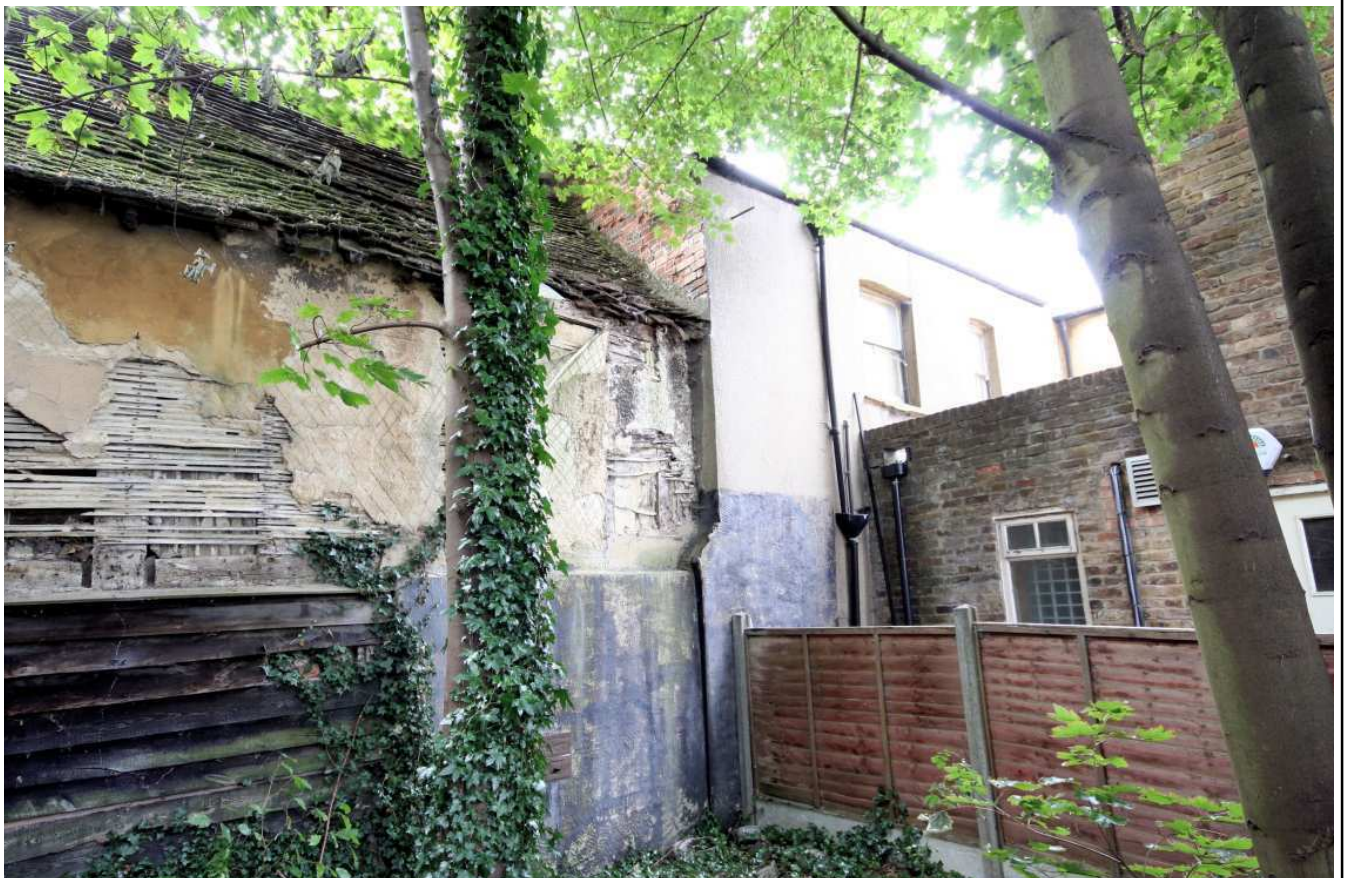
Plate 48: Former kitchen wing, north exterior elevation

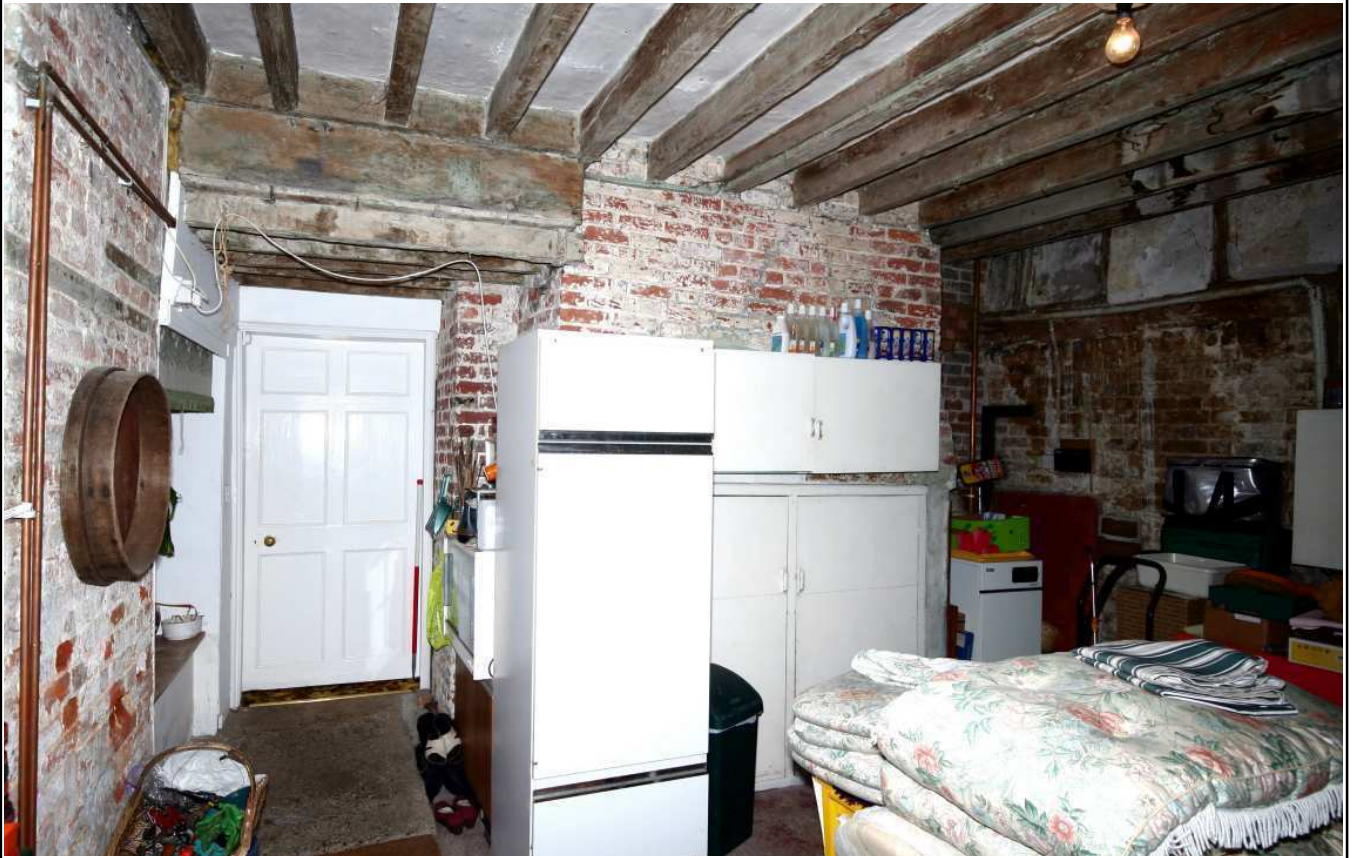
Plate 57: Rear range, Pantry, west elevation

3.67 This is accessed from the kitchen wing via a ramp alongside the chimney (noted above), in the south-western corner. The west elevation is occupied by the base of the chimney, with an alcove to the north (Plate 57). The north elevation is in brick at the western end, and timber framed at the eastern end (Plate 58). The timber joists, and a tiebeam, for the upper floor are exposed in the ceiling. The joists are similar to those exposed in the cellar ceilings, indicating that the rear range and the cellars may be contemporary.

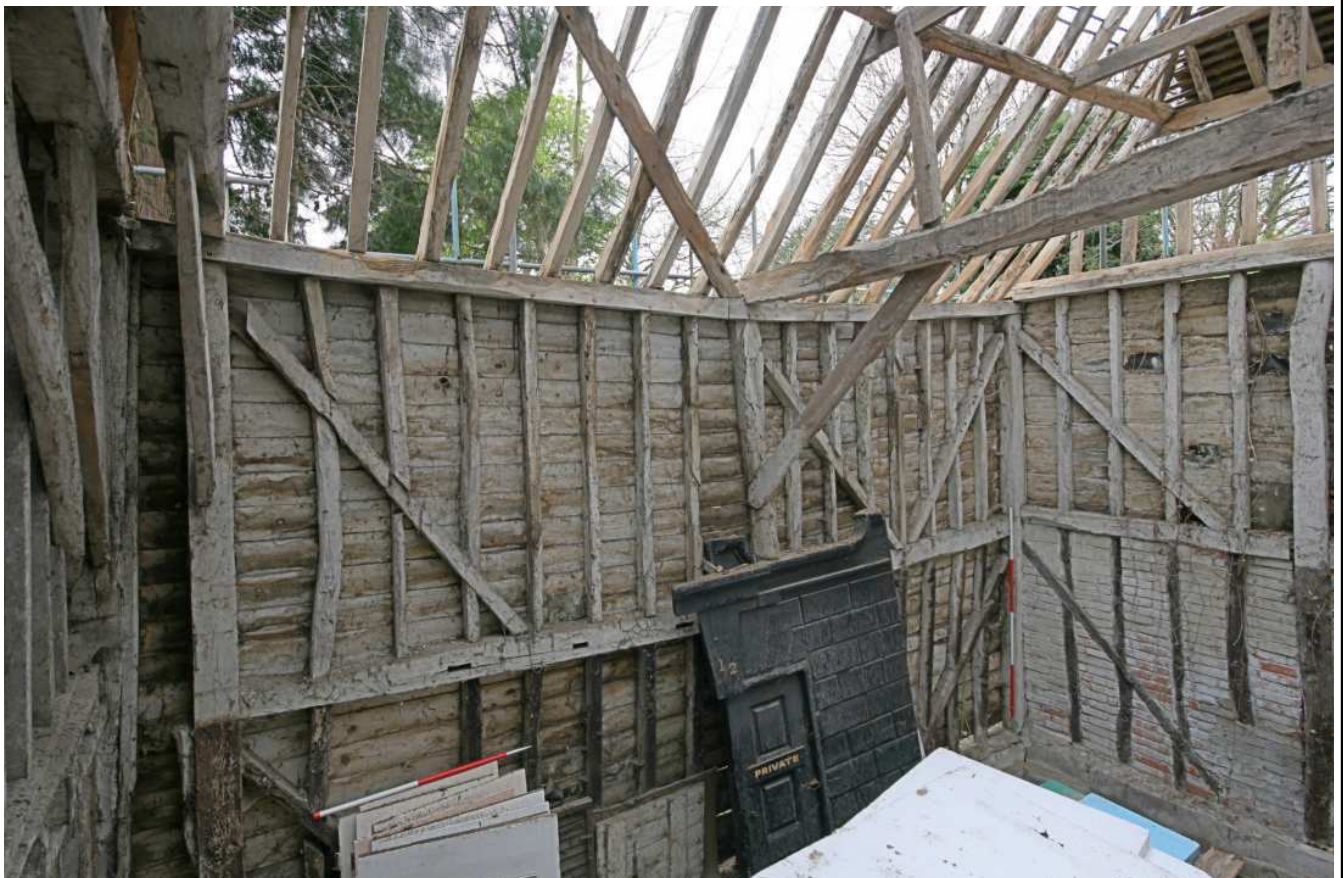
Plate 62: Rear range, the Store, interior north elevation

3.77 The roof structure is formed of paired rafters clasping a ridge piece, with collars supported on vertical queen struts and a single clasped purlin in each slope (Plate 62).

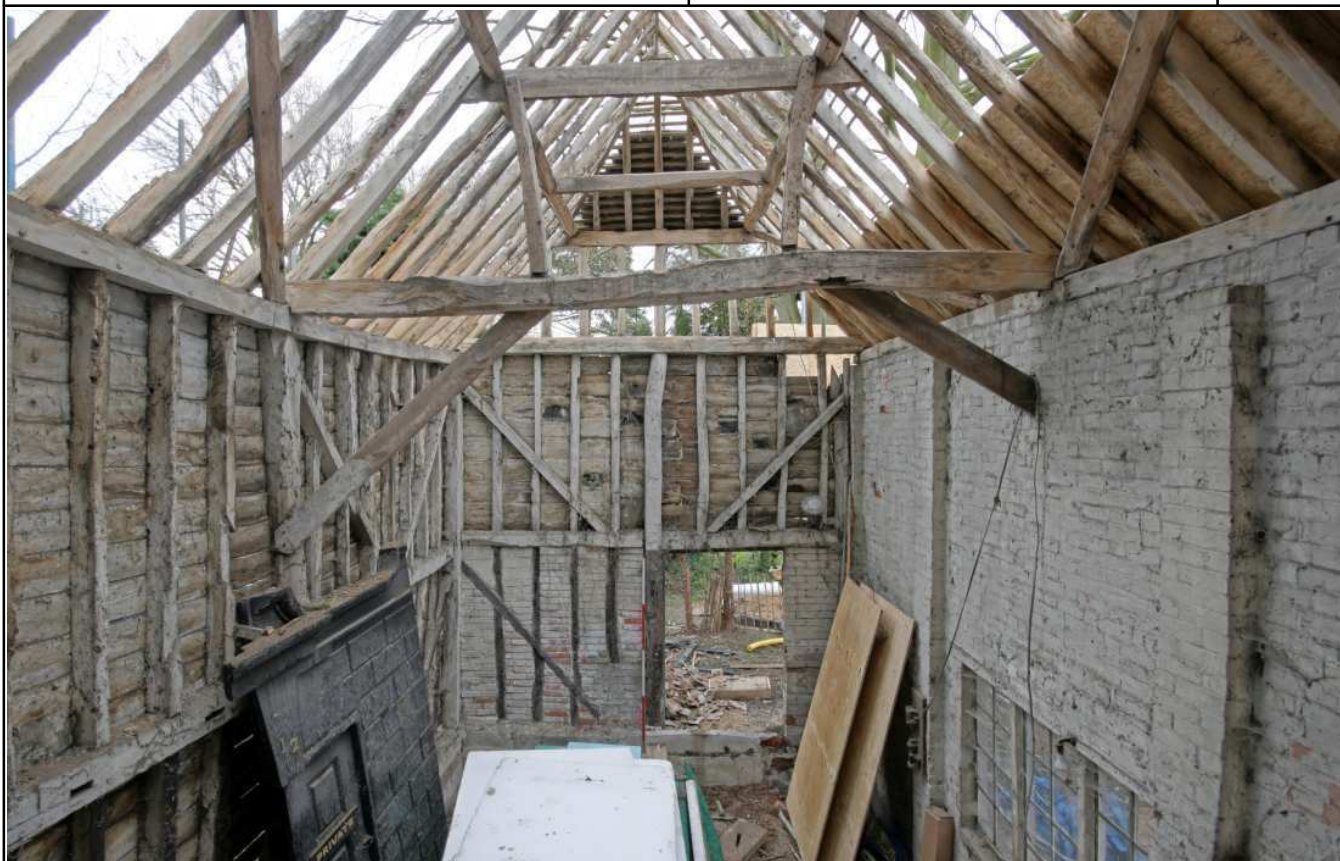
Plate 63: Rear range, the Store, interior east elevation

3.74 The east elevation is of similar construction, with single bracing to each storey (Plate 63). As with the north elevation, the studs above the bracing on the upper storey have been reused. The eastern elevation has weatherboarding above the mid rail and brick noggin below. A doorway appears to have been inserted through the southern end of the elevation, below the mid rail. The replacement post is in soft wood and the studding in the southern corner has been removed and replaced with brick. This may be contemporary with the refronting of the south elevation of the rear range.

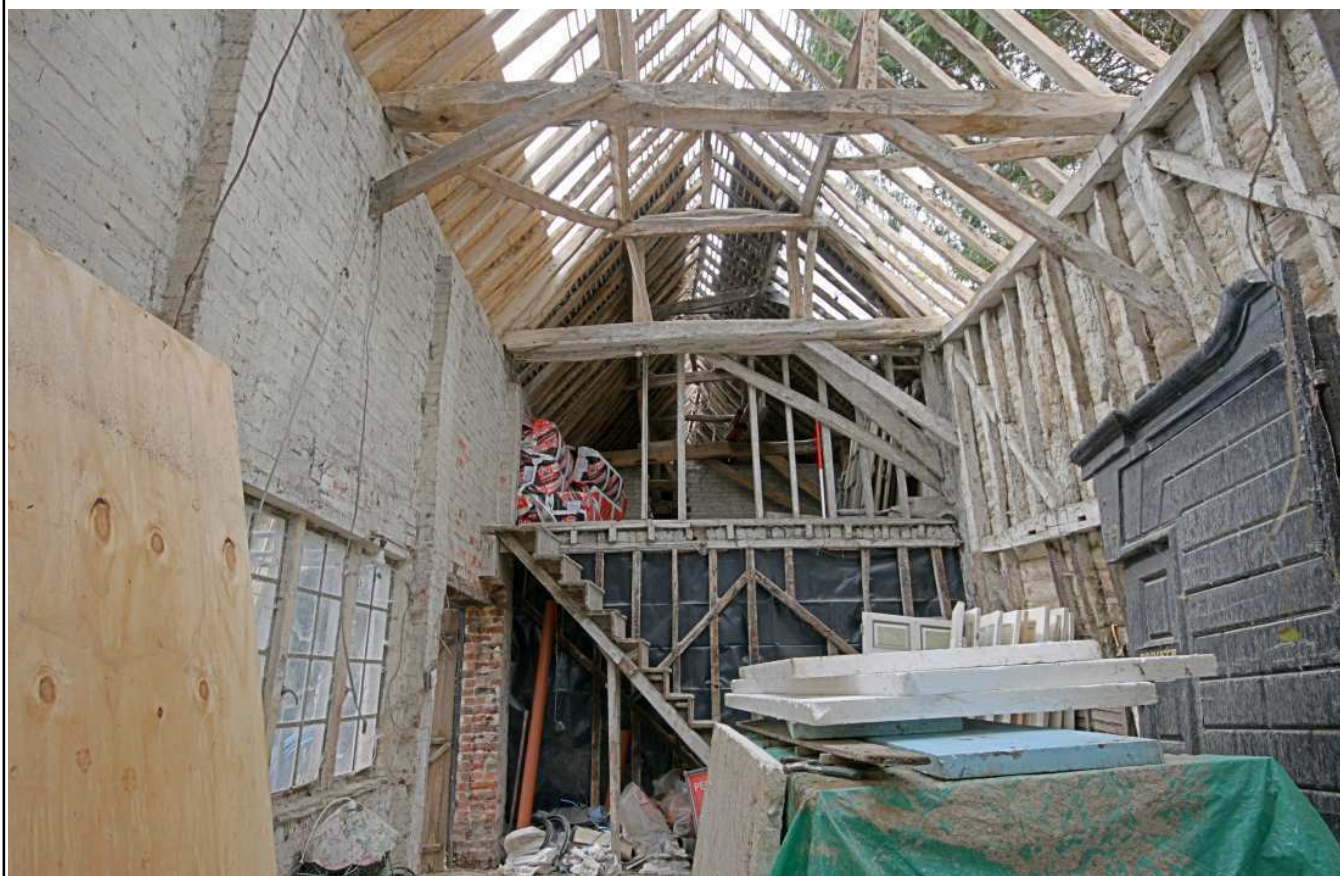
Plate 64: Rear range, the Store, interior west elevation

3.76 The west elevation is open, the paired trusses showing that the store has been butted against the western end of the rear range. Framing for the partition wall of the garage can be seen beyond (Plate 64). A wooden staircase giving access to the upper storey is set against the west elevation.

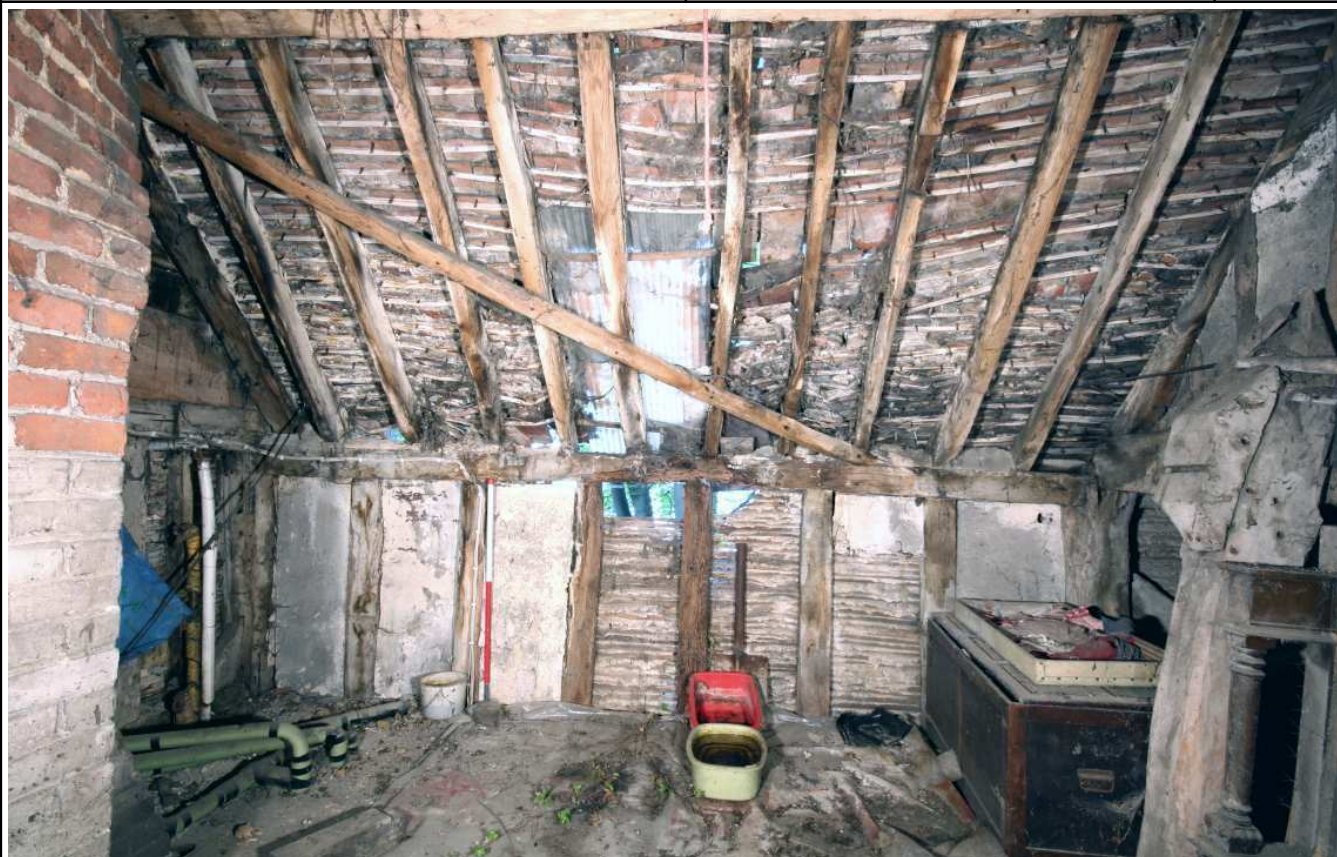
Plate 65: Rear range 1st floor, Bay 1, N elevation

3.79 Jowled posts survive in the northern elevation, with studs of elm on 22-inch centres between the mid rail and the wall plate. An area of original wattle and daub infill survives in the north elevation in Bay 1 (Plate 65). Oddly, the north-east corner post, in Bay 3, which has a gently splayed jowl, faces east rather than south.

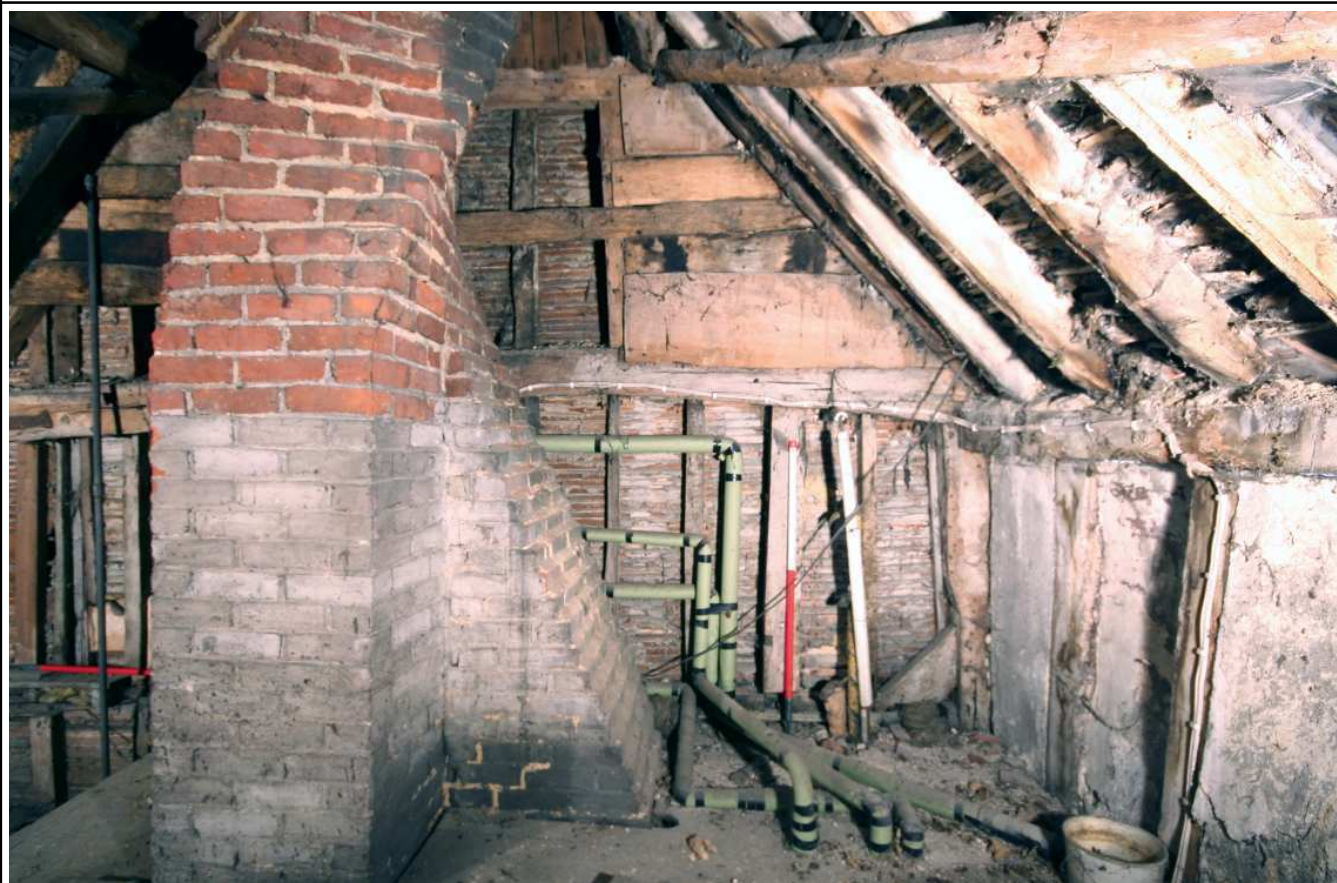
Plate 66: Rear range, 1st floor, Bay 1, west elevation

3.81 The north-west corner post, in Bay 1, has a gunstock jowl and a diagonal brace crossing the western elevation to a supposed mid rail (Plate 66). A small boarded and ledged door is located in the south-western corner. The floor level is lower by the door, suggesting that the original floor level has been raised, possibly when the kitchen wing was added and the southern elevation of the east range rebuilt in brick.

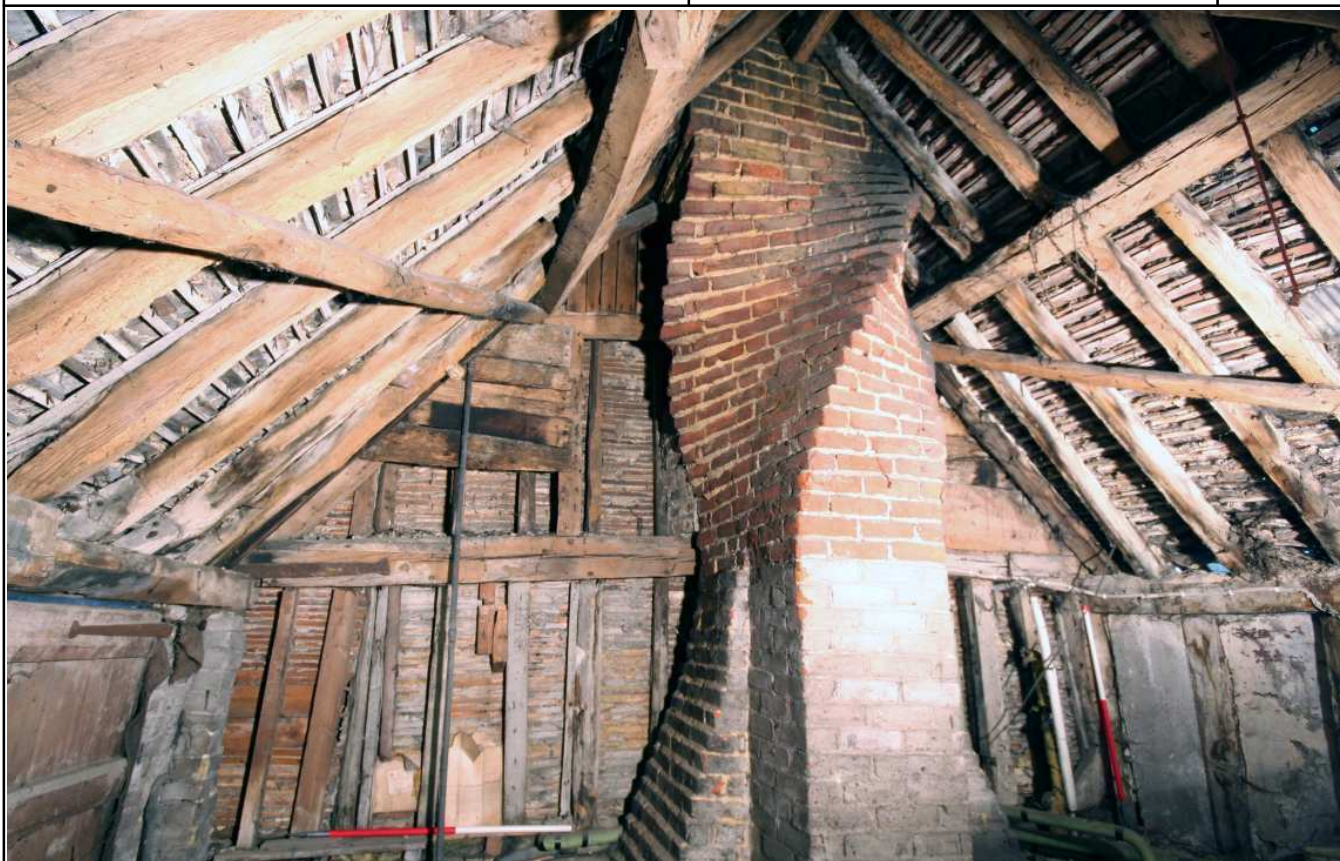
Plate 67: Rear range, 1st floor, Bay 1, twisted chimney looking west

3.80 Much of Bay 1 is occupied by a twisted chimney to the fireplace serving the kitchen wing and the Pantry (Plate 67). The chimney is built of red bricks, measuring 8¼" x 4" x 2½", laid in stretcher bond and pointed in very soft yellow mortar which crumbled when touched.

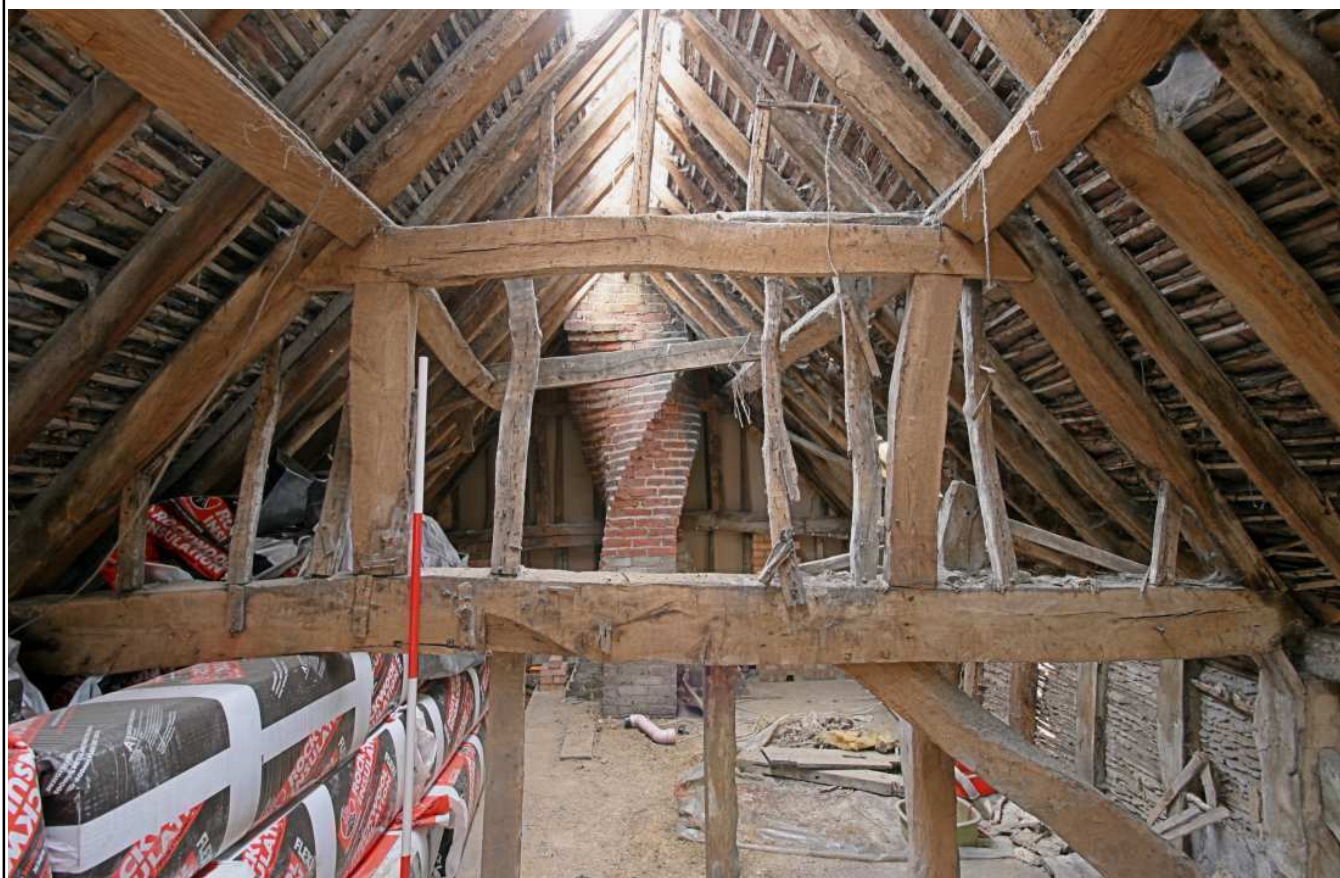
Plate 68: Rear range, roof structure, looking west

3.83 The roof structure is formed of common rafters which clasp a ridge piece. They are supported by collars and queen posts with a single clasped purlin in each slope. Wind braces link the tie beams and principal posts (Plate 68). An additional tie beam has been inserted in Bay 2.
