**ST JAMES' CHURCH,  
Pulloxhill, Beds.**

HN806

*Archaeological Monitoring Report*

Report no. 535

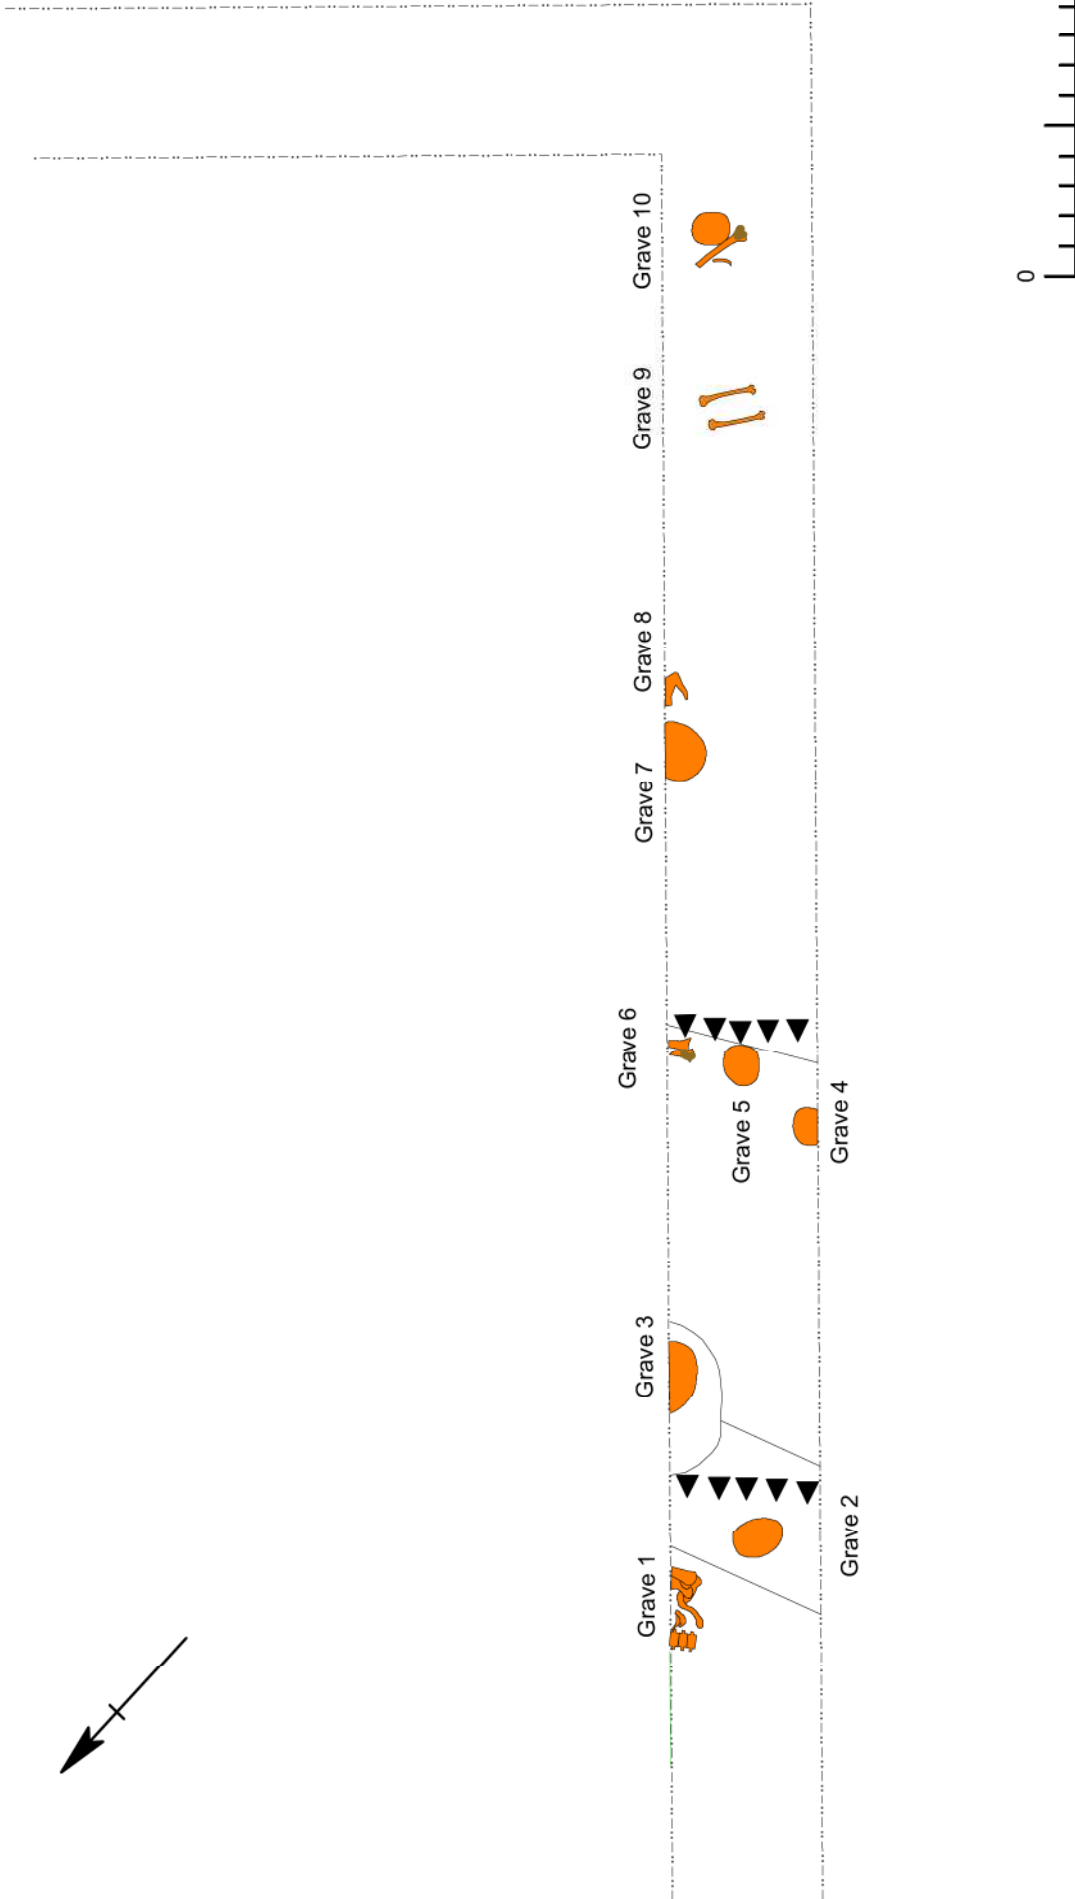
Grave Layout

**2.10** Excavations on site revealed a total of at least 10 graves (Figure 3), none of which appeared to have either grave goods or evidence for coffins:

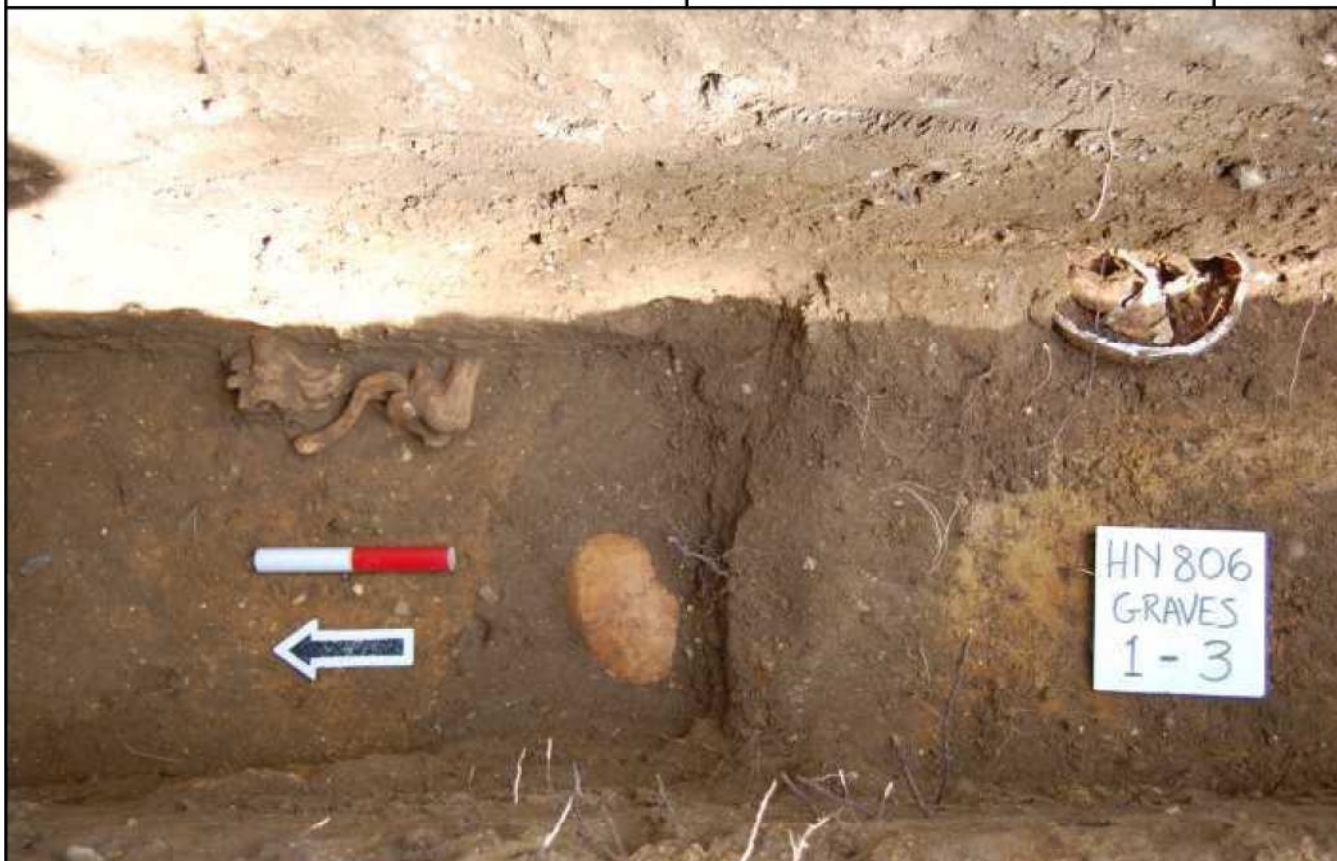
Plate 1: Graves 1-3, looking east

**2.11** Grave 1 had been heavily disturbed prior to the Heritage Network's arrival on site. Despite this the cervical vertebra and right side clavicle, scapula and humerus were all evident, protruding from the trench section at a depth of 0.90m below the existing ground level. A large amount of material was recovered from this area and taken to the Heritage Network offices for

assessment. This revealed the presence of elements from the skull, torso, arm, upper leg and foot. Given the orientation of the remains still present in the trench it therefore seems that two individuals were encountered in this area. The first consisting of a skull and upper elements of the torso and the second consisting of the lower body. All elements associated with these individuals appear fully fused and adult in nature but the poor level of preservation and high degree of fragmentation makes ascertaining sex of the individuals impossible.

**2.12** Grave 2 contained a skull at a depth of 0.90m below the surface. This appears to be of adult size and completely fused and was contained within a clearly defined grave cut. Given the position of the body in the trench it is possible that some elements recovered near Grave 1 belong to this individual.

**2.13** Grave 3 contained a skull at a depth of 0.70m below the ground surface. These remains appear to be fully fused and of adult size and, given its location, it is unlikely that any other material recovered from the site is associated with this individual.

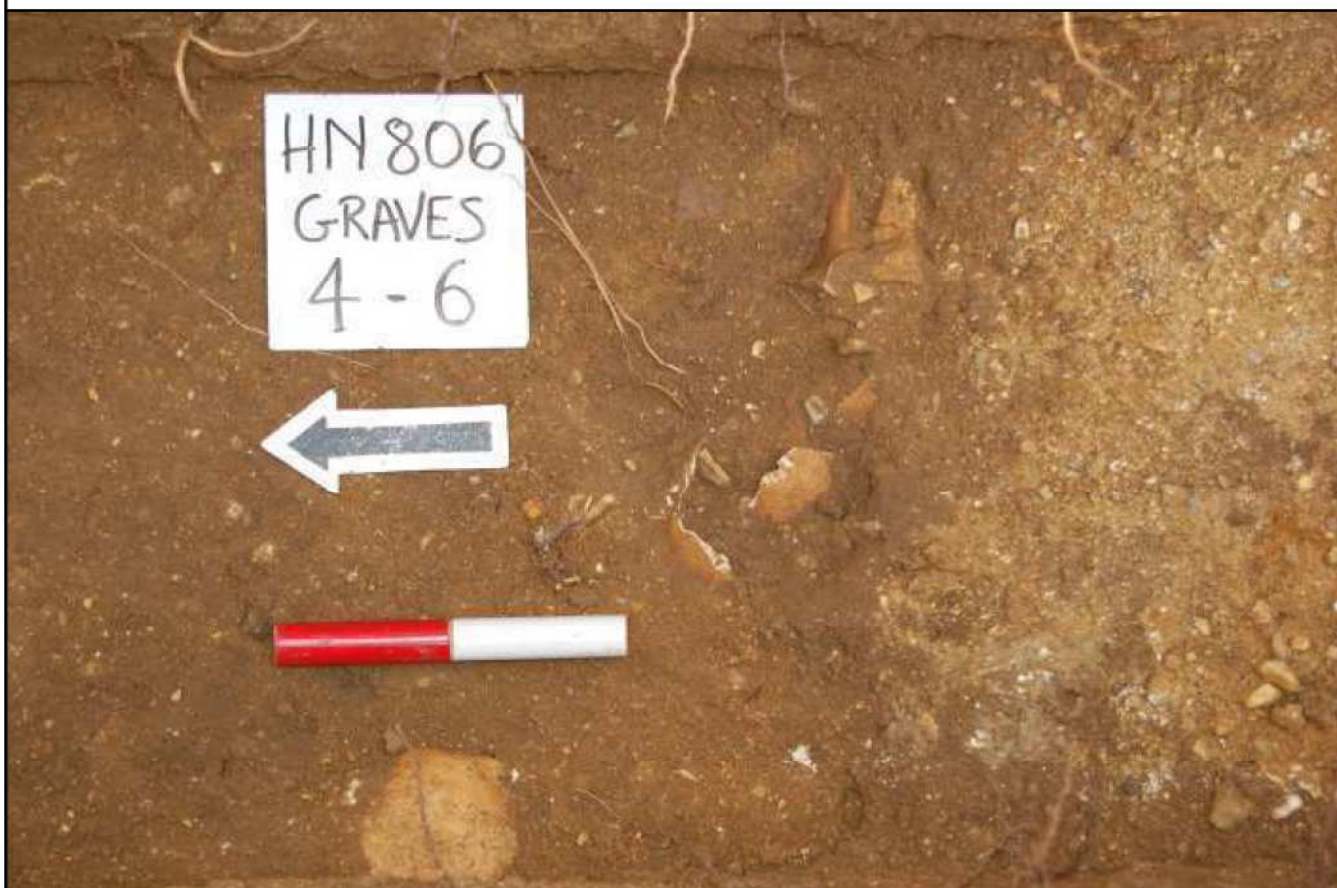
Plate 2: Graves 4-6, looking east

**2.14** These graves were all located very closely together. Grave 4 contained a skull at a depth of 0.90m below the surface and was observed within a grave cut. Grave 5 contained a badly damaged skull, possibly of a child, at a depth of 0.90m below the ground surface. Grave 6 appears to be a left and right tibia and may represent the lower limbs of Grave 4. This was observed at a depth of 0.90m below the surface.

**2.15** A quantity of bone from near these graves was recovered and brought to the Heritage Network offices for further analysis. These remains belonged to the skull, torso and upper limb. The remains were also largely unfused suggesting that this individual was a juvenile, and these remains are most likely from Grave 5. Two left humeri were observed here indicating that two individuals are represented within these remains, both of which can be considered as juveniles.

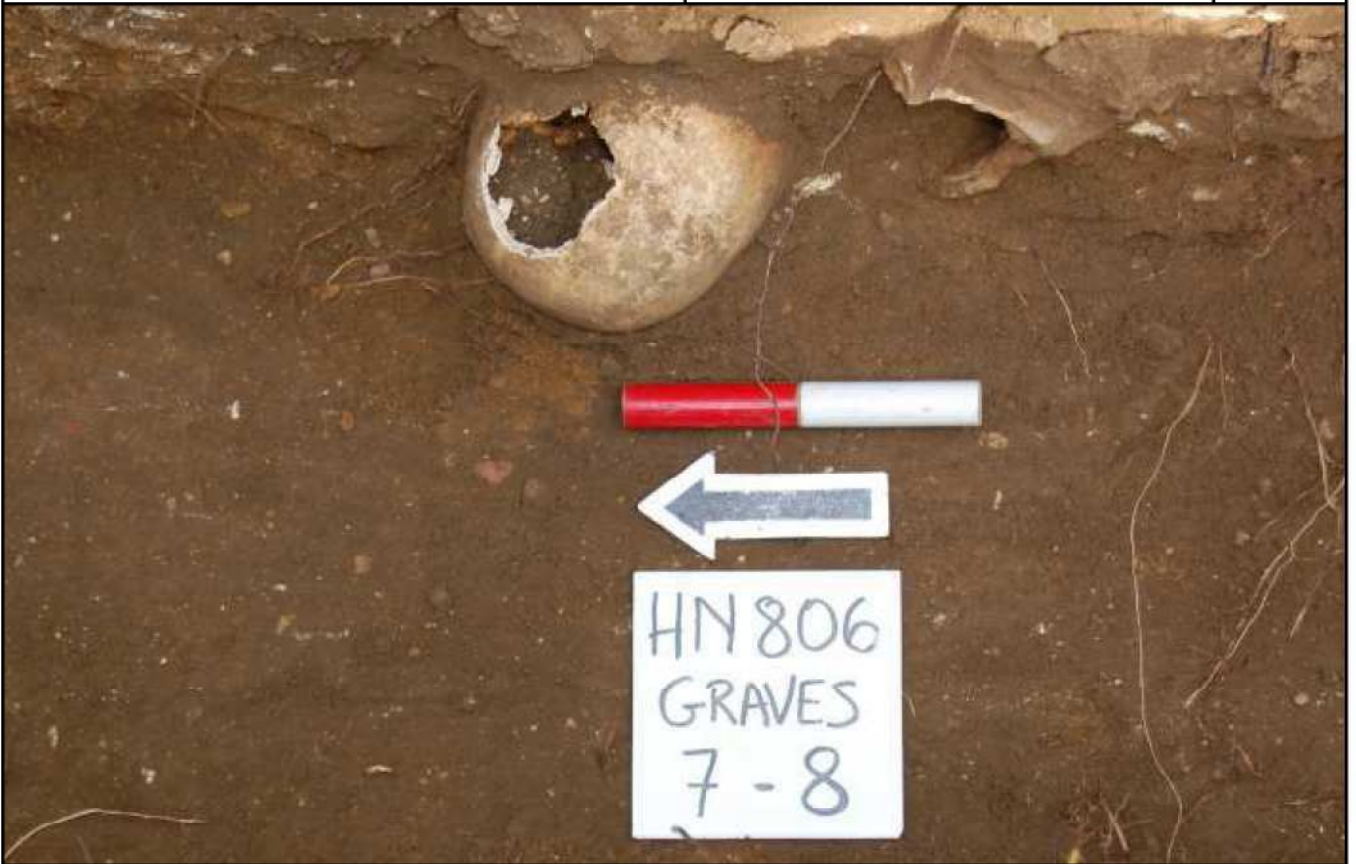
Plate 3: Graves 7-8, looking east

**2.16** Grave 7 contained a skull at a depth of 0.60m below the existing ground surface. These remains appear to be fully fused and of adult size.

**2.17** Grave 8 may represent a pelvis and was observed at a depth of 0.55m below the ground surface. Further remains were disturbed in this area and brought to the Heritage Network office for further analysis. These appear to represent the pelvis, lower limbs and feet of at least two individuals. Examination revealed that these elements were largely unfused, suggesting that these individuals were juveniles.

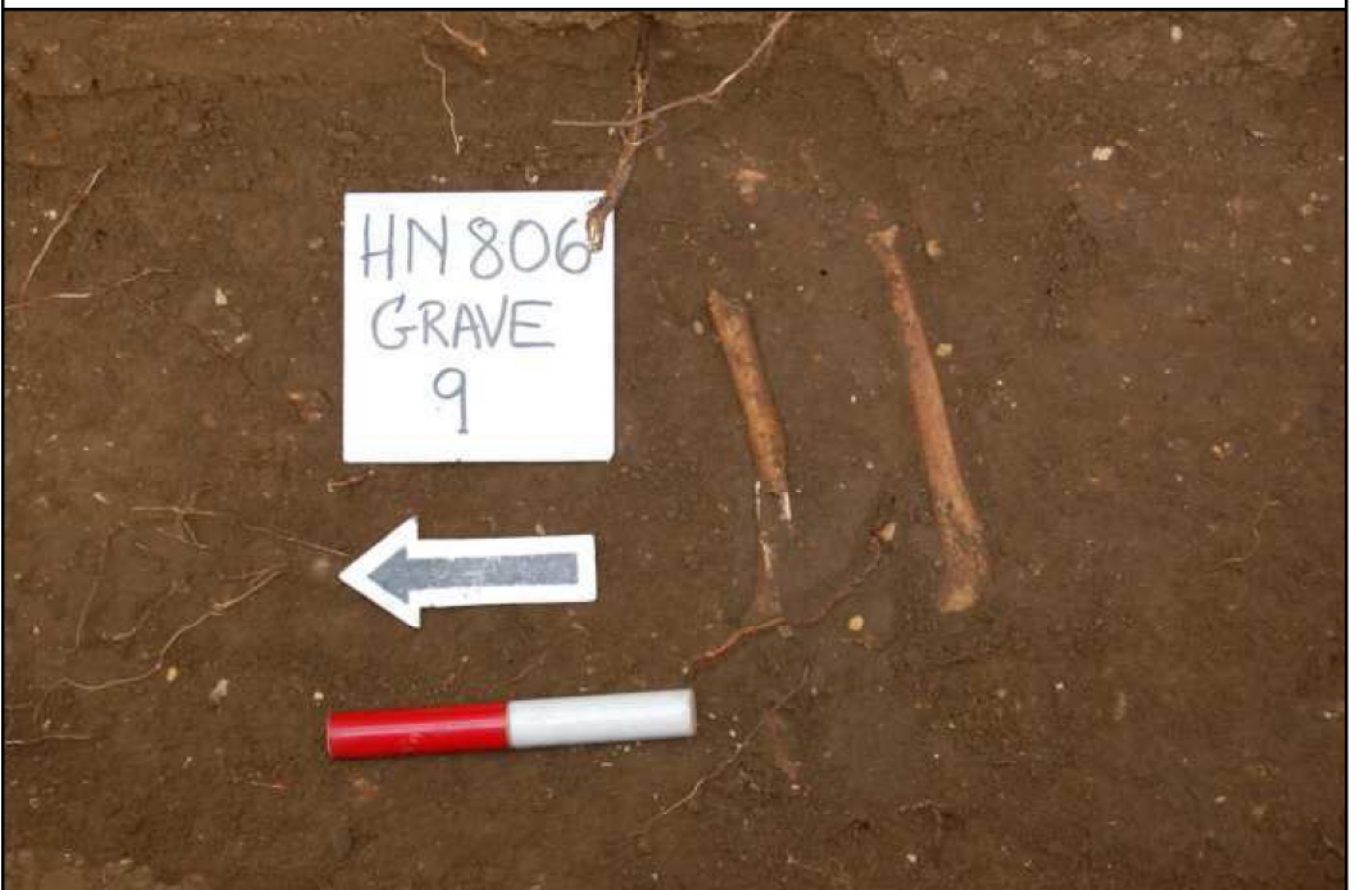
Plate 4: Grave 9, looking east

**2.18** Grave 9 appears to contain a left and right tibia at a depth of 0.80m below the existing surface. Further remains recovered from near this grave include elements of the torso and the left side of the mandible. This individual appears to be of adult size and has adult dentition.

Examination of the mandible revealed heavy wear on the premolars and third molar and the absence of the first and second molars with complete remodelling of the sockets.

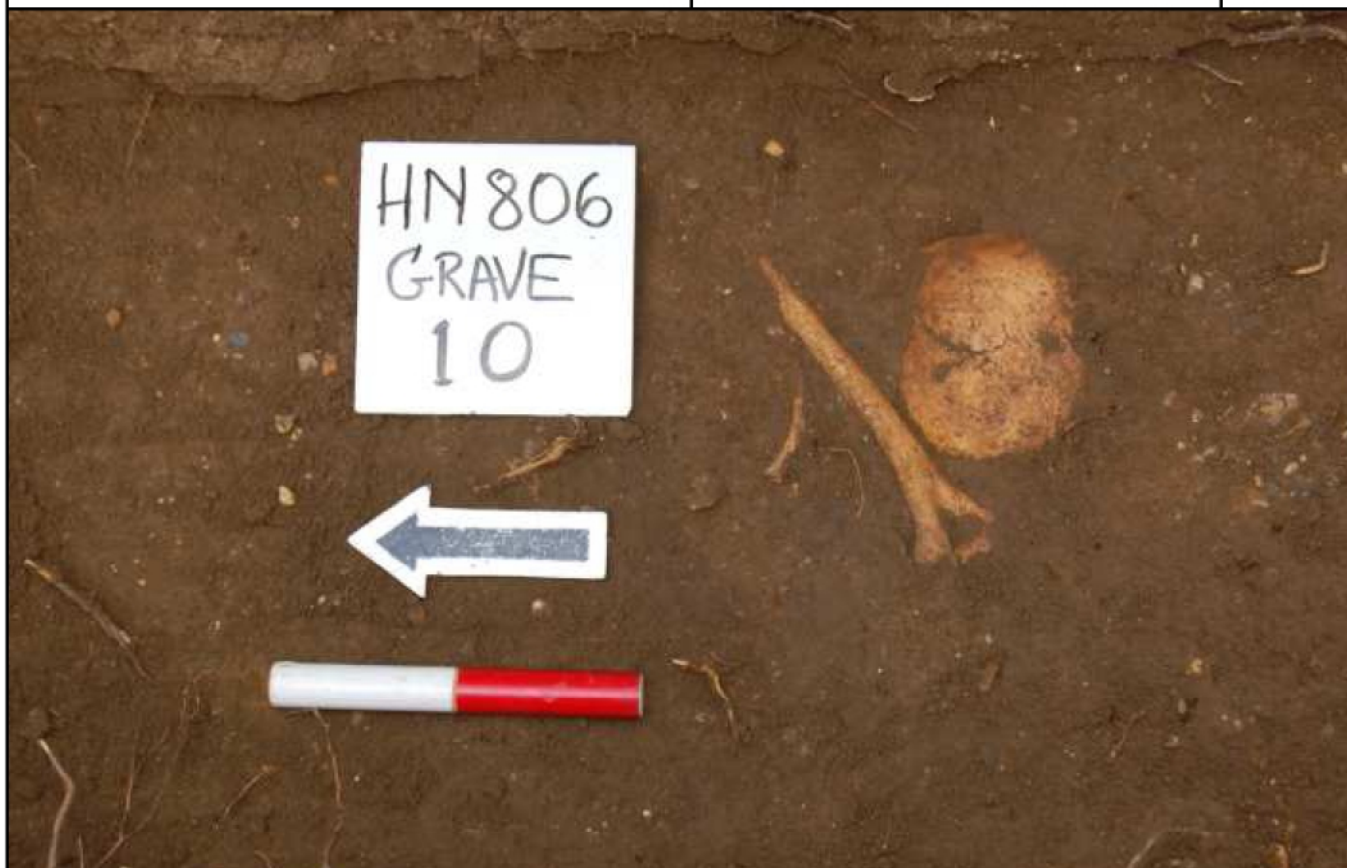
Plate 5: Grave 10, looking east

**2.19** Grave 10 contained a skull and redeposited humerus at a depth of 0.80m below the ground surface. These elements appear to be of adult size and fully fused.
