**Church Hall Extension
ST ANDREW'S CHURCH
Biggleswade, Beds.**

Archaeological Evaluation Report

Church Hall Extension ST ANDREW'S CHURCH Biggleswade, Bedfordshire

Project no.: HN805
LPA ref.: MB/07/02175/FUL
Accession no.: BEDFM 2009.41

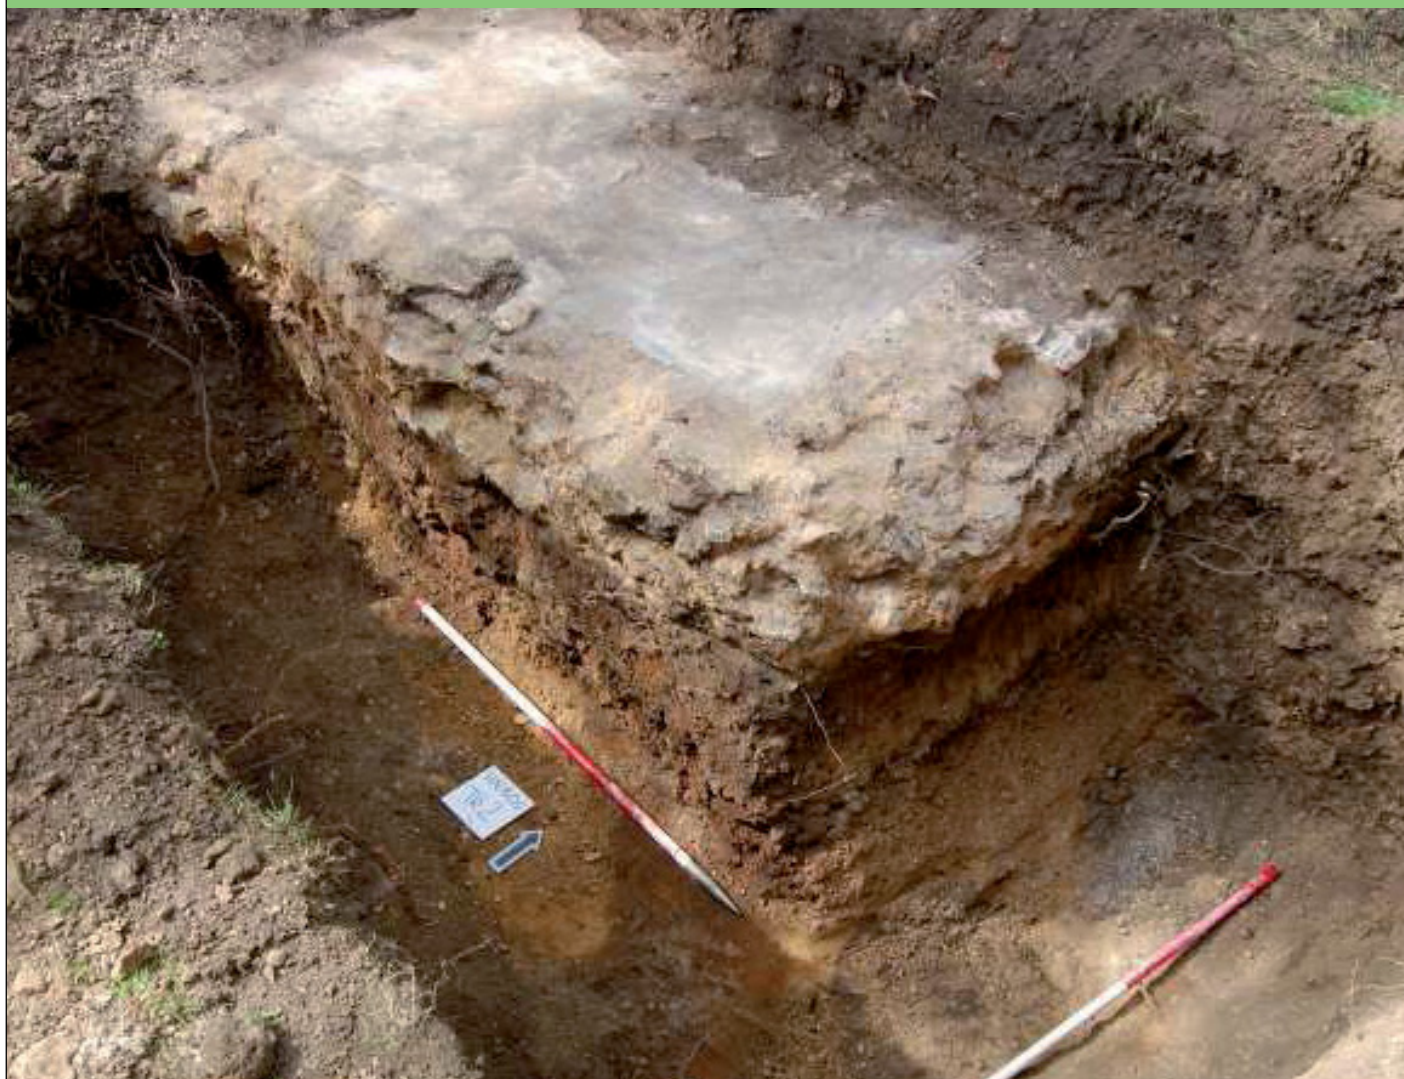
The cover illustration shows Structure [201] in Trench 2

2.11 Trench 2 was located at the north end of the site (Figure 2). A total of six graves was encountered. Graves [203] and [205] were orientated in a northwest-southeast direction while all others were aligned east-west. In addition to the graves, the remains of a structure were encountered. This consisted of a concrete layer resting on a foundation formed of sandstone, ironstone and tile in a sandy mortar (Figure 3, Plate 3). This may form the base of a grave monument or vault of unknown date, although the concrete layer which caps the structure is unlikely to be earlier in date than late 19th century.

3.8 Examination of historic OS maps did not show any evidence for a structure in the study area, though grave markers and monuments are not usually shown. It is possible that the observed structural remains represent the base of a grave monument or part of a vault. It was noted that the rubble foundation of the structure was similar in appearance to the exterior elevation of the north-aisle of the church, though less compact.

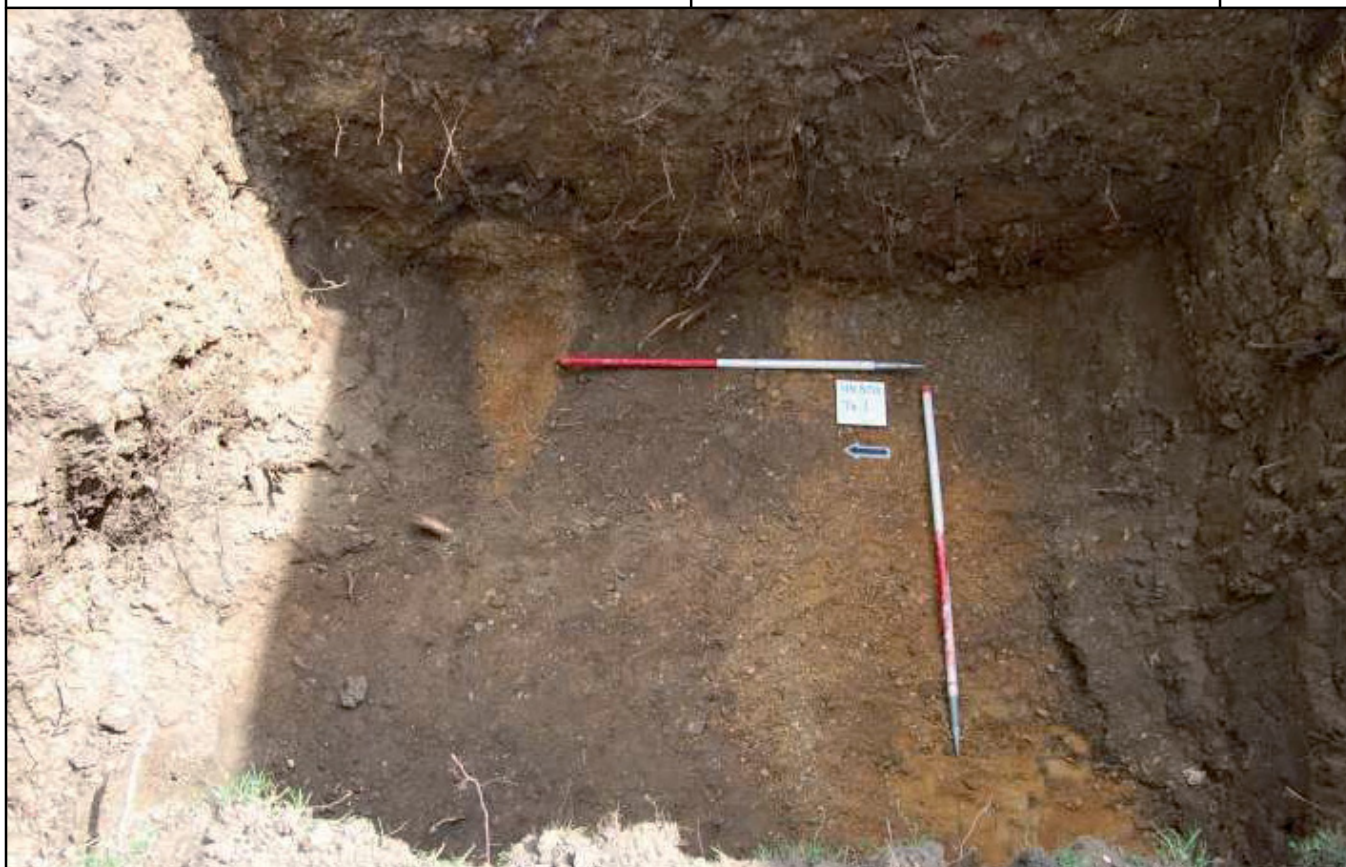
Plate 1: Northern end of Trench 1, looking east

2.9 Trench 1 was located at the south end of the site and was extended to meet the existing building in order to provide the clients with geotechnical information for the development (Figure 2); it contained seven graves (Figure 3, Plates 1 and 2). No evidence for grave goods or coffins was observed and the human remains were left undisturbed. The graves were aligned east-northeast – west-southwest with the exception of grave [102], which was aligned east-southeast – west-northwest.

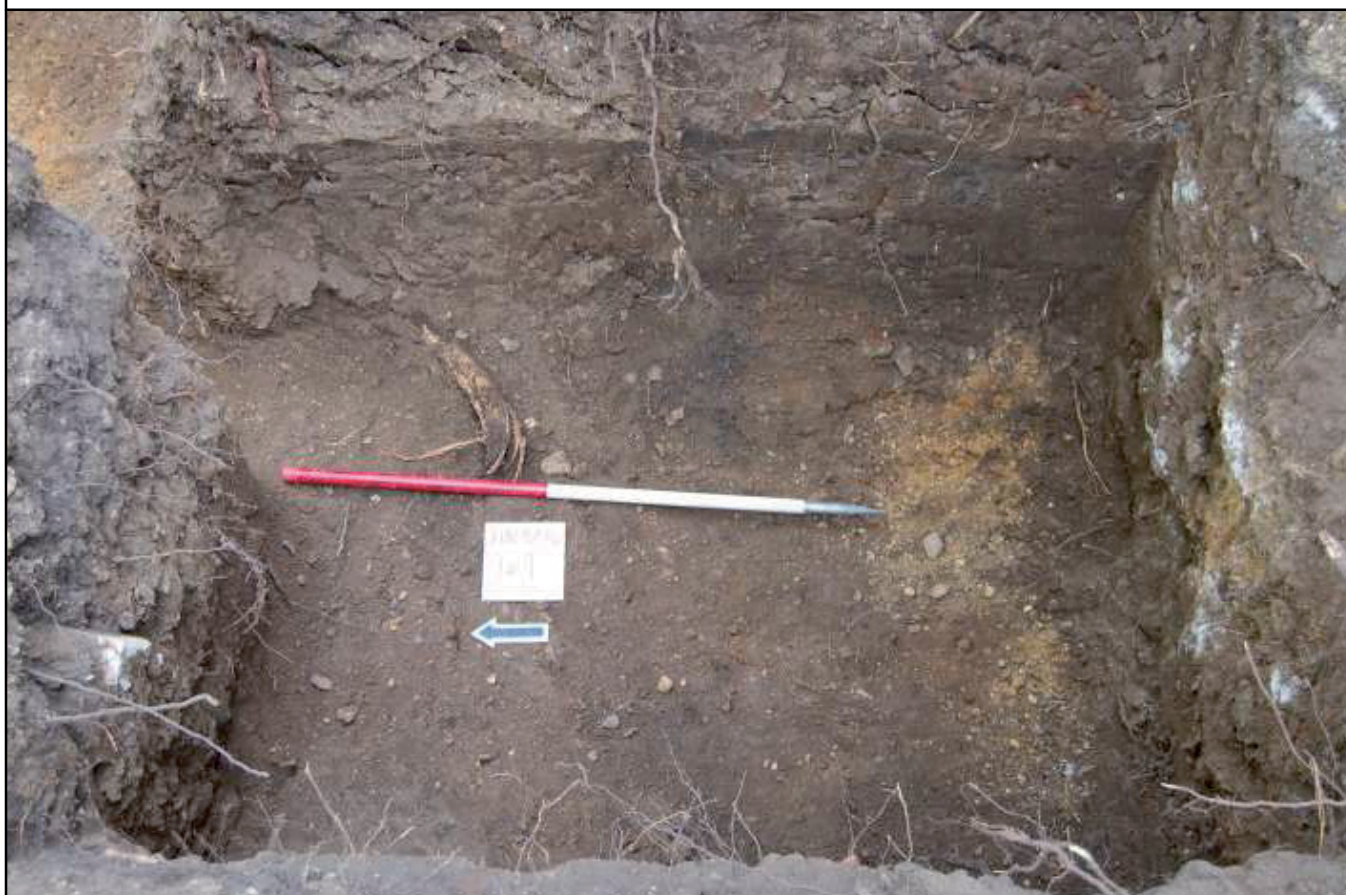
Plate 2: Southern end of Trench 1, looking east

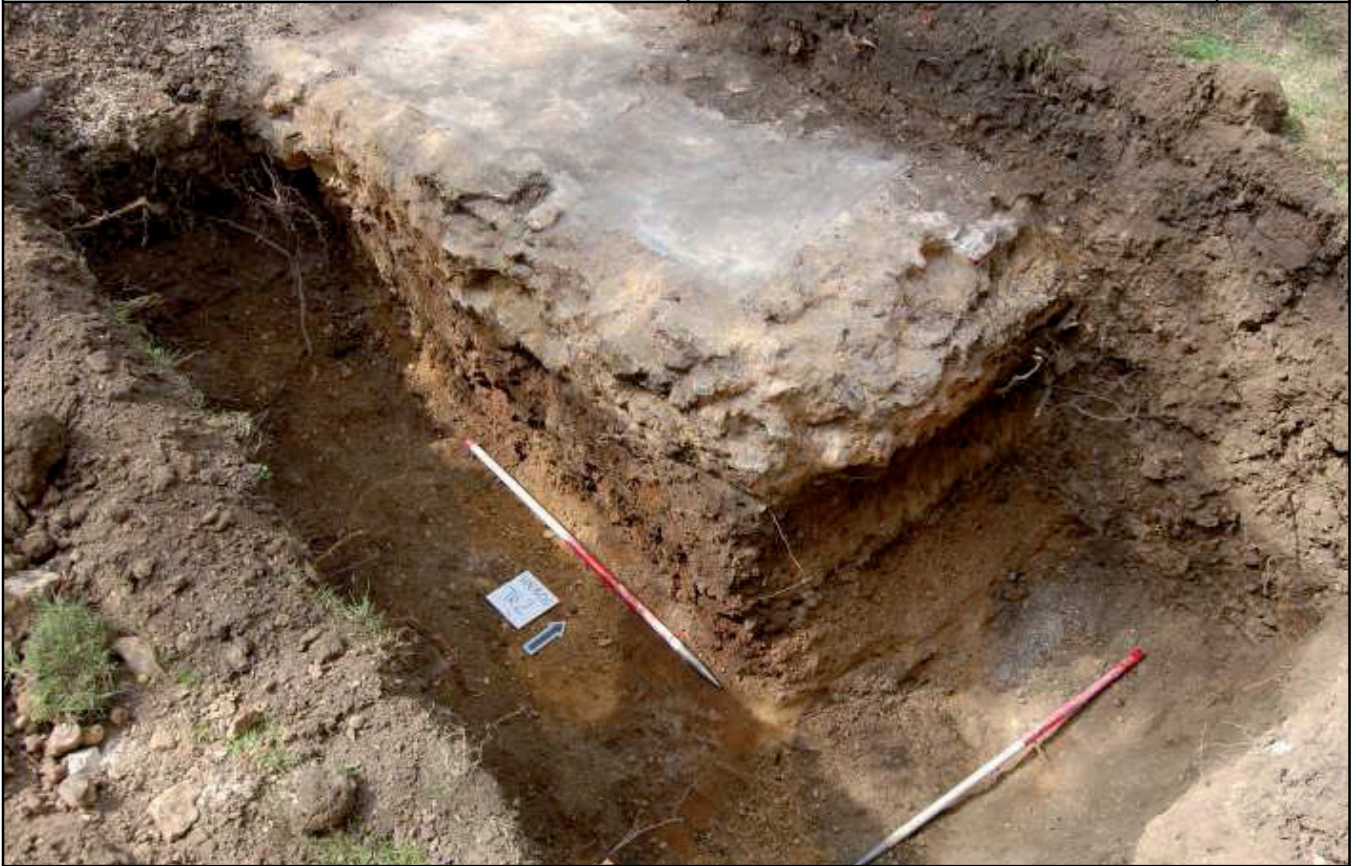
Plate 3: Trench 2, looking northwest
