**Granary
FELSTED PLACE
Felsted, Essex**

*Historic Building Record
&
Archaeological Monitoring*

Report No.622

September 2010

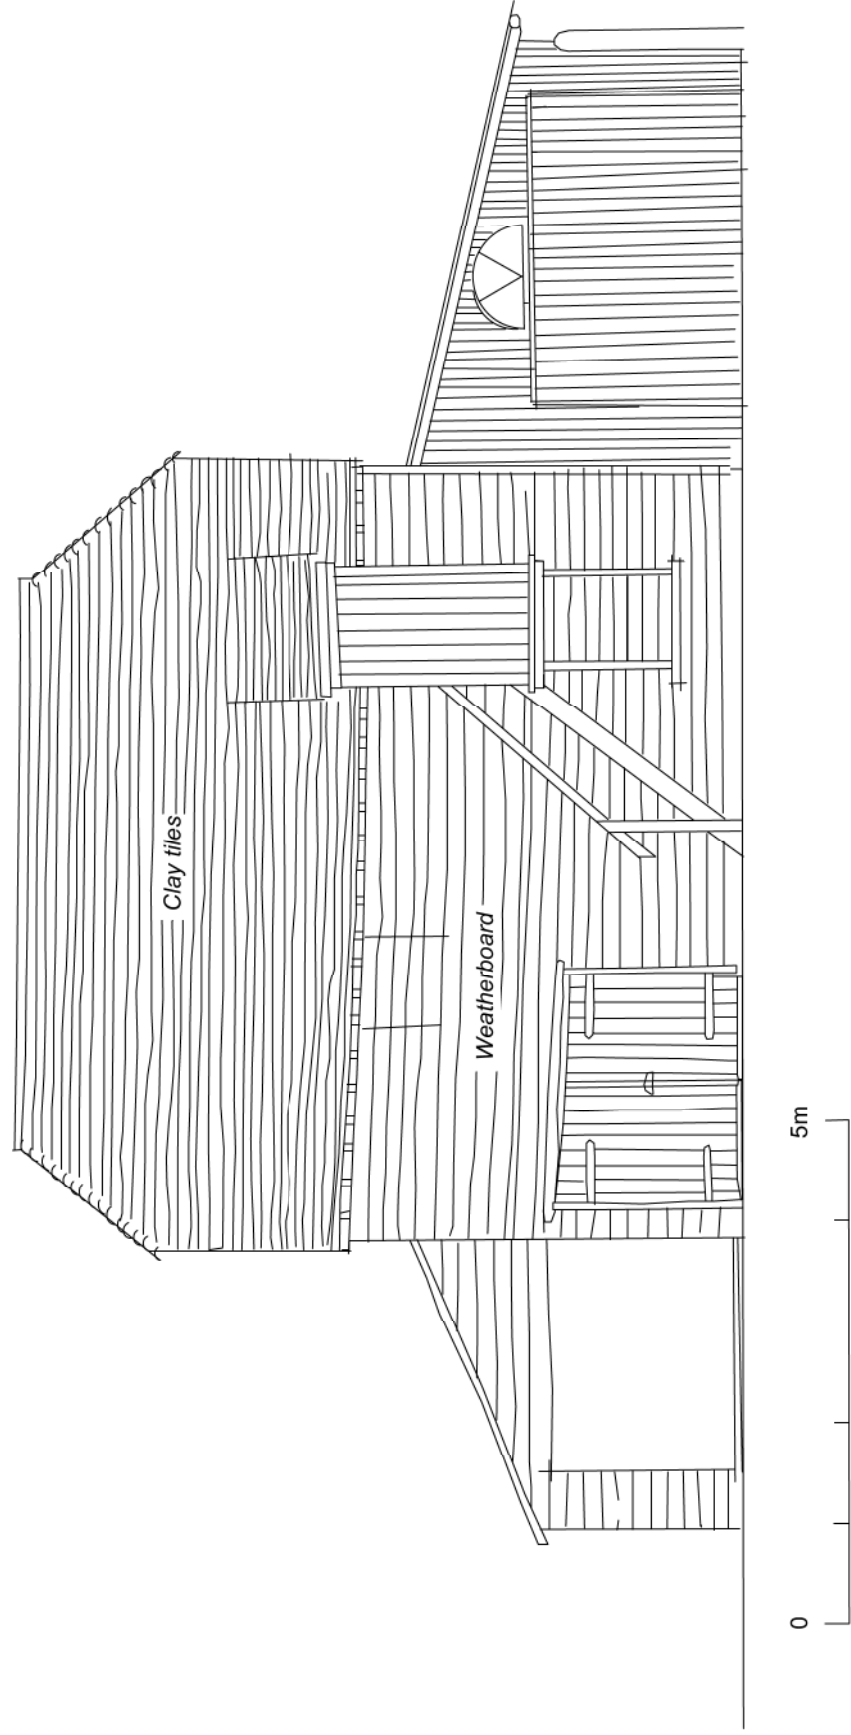
West exterior elevation
Courtesy Donald Purkiss Associates

3.2 The entire western elevation is weatherboarded (Plate 1). At the northern end of the lower storey is a pair of modern ledged and braced doors, opening outwards (Figure 7). A doorway at the southern end of the upper storey is reached by a steep flight of wooden stairs attached to a platform supported on struts, which extends from the face of the elevation. The roof above the door has been raised with a shallow flat dormer to provide additional head room. In the middle of the northern end of the upper storey an opening has been blocked with weatherboard. The sprocket ends of the roof structure are exposed in the eaves.

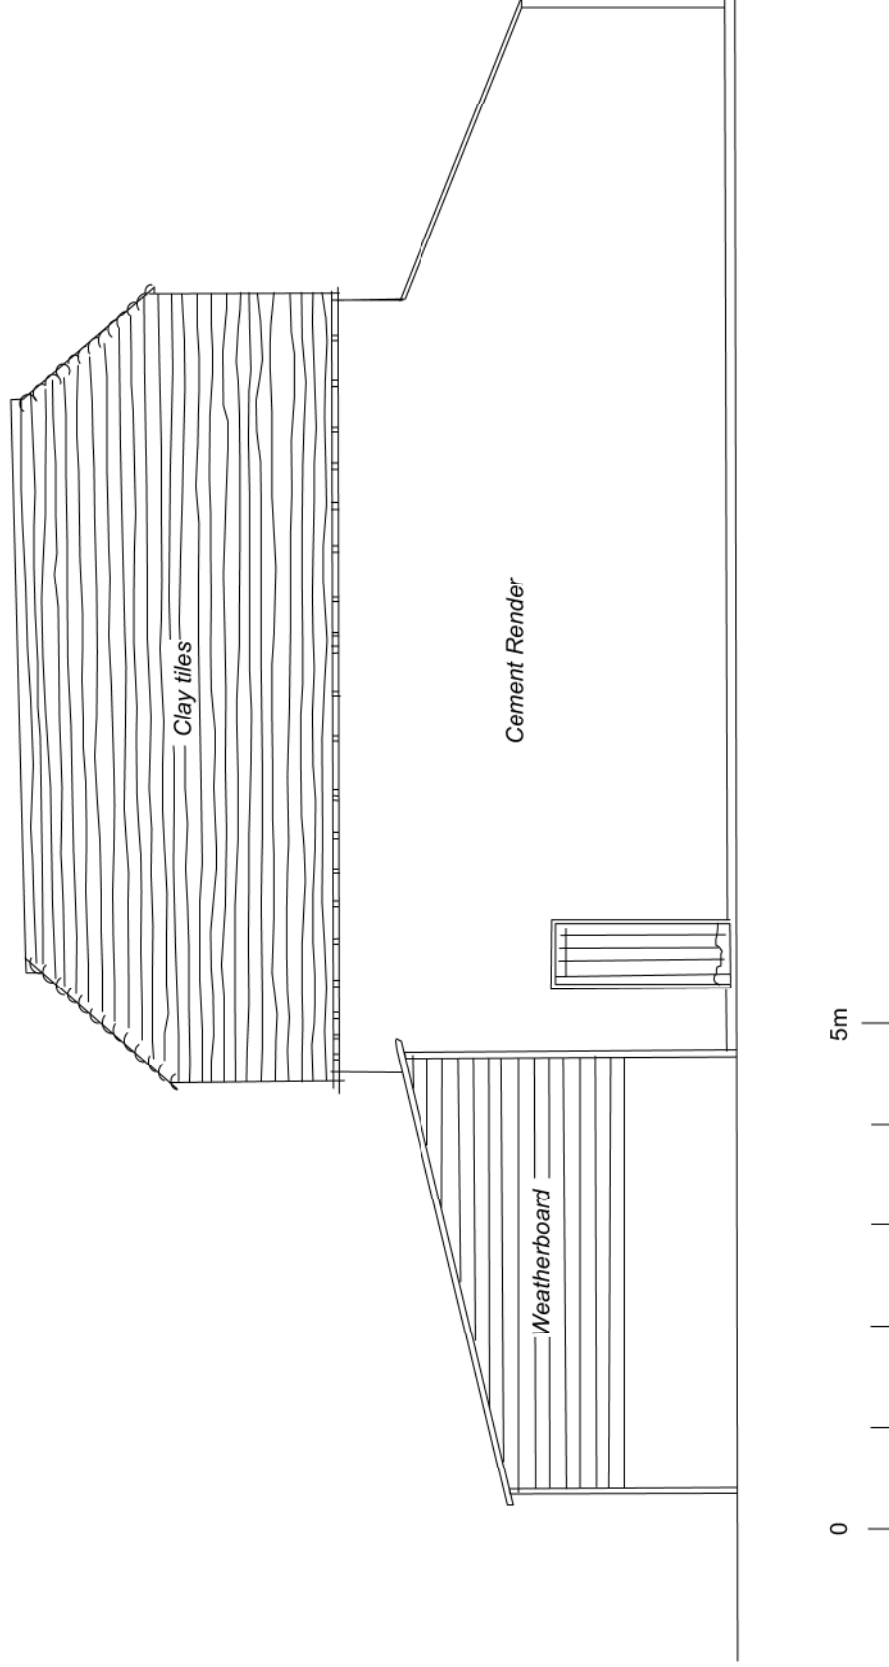
Scale 1:75
Figure 8

East exterior elevation
Courtesy Donald Purkiss Associates

3.3 The eastern elevation is entirely rendered to the eaves, including the northern lean-to (Plate 2). At the far southern end of the lower storey is a doorway with a boarded and ledged door..

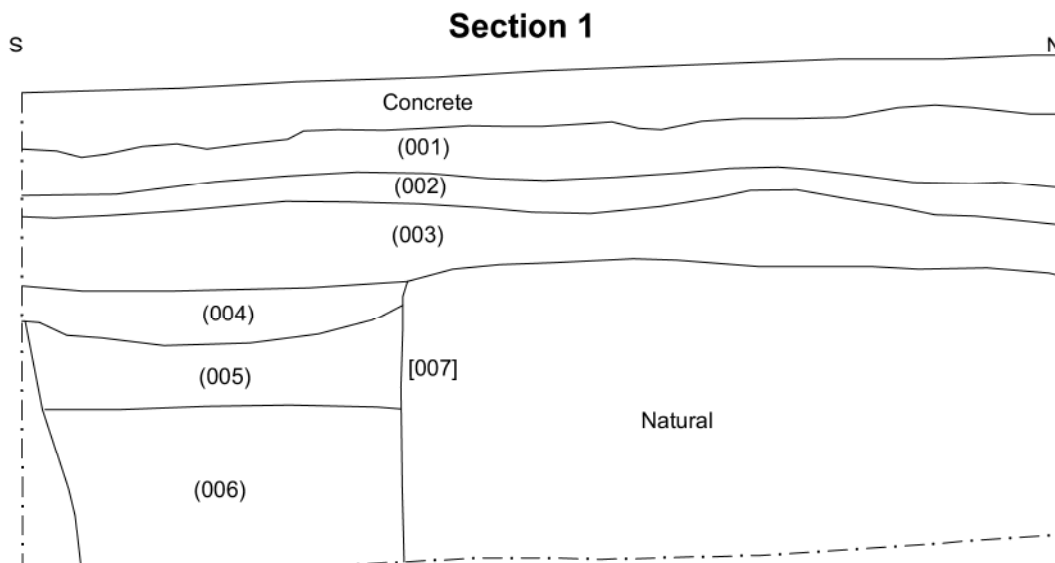
Figure 15

Indicative sections after ground reduction in the Granary

4.2 A visit was made to record the exposed surface and sections. On the southern and western sides (Section 1) the sections revealed a brick sill, 0.14m in depth, which sat directly on a layer of concrete, 0.20m in depth (Figure 15). Below this was a series of surfaces and make-up layers. Context (001) was a layer of rounded flint cobbles within a greyish brown silty clay matrix, between 0.06 and 0.10m thick. This overlay a 0.06m layer of yellowish brown silty clay and gravel (002), above a 0.10m thick layer of dark greyish brown silty clay, (003), with frequent gravel and medium sized rounded pebbles.

4.3 In the south-west corner, the natural had been cut by a vertical sided pit [007], 0.50m wide and more than 0.40m deep (Figure 15). Filling the pit was a dark greyish brown silty clay deposit (006) overlain by 0.1m of re-deposited natural (005) and 0.07m of dark greyish brown silty clay with occasional rounded pebbles (004).

4.4 On the east side of the Granary, the reduction of the floor revealed a different sequence of deposits (Section 2). Above the natural was a 0.15m thick layer dark greyish brown silty clay (010), with occasional rounded pebbles. Above this was a sill wall or foundation (008), five courses of hand made brick in an irregular pattern, although probably mostly headers. This wall was bonded with lime mortar, and only patches were revealed. For the most part the make-up of the granary floor (009) was visible, as a pale yellowish brown silty clay with small chalk fragments.

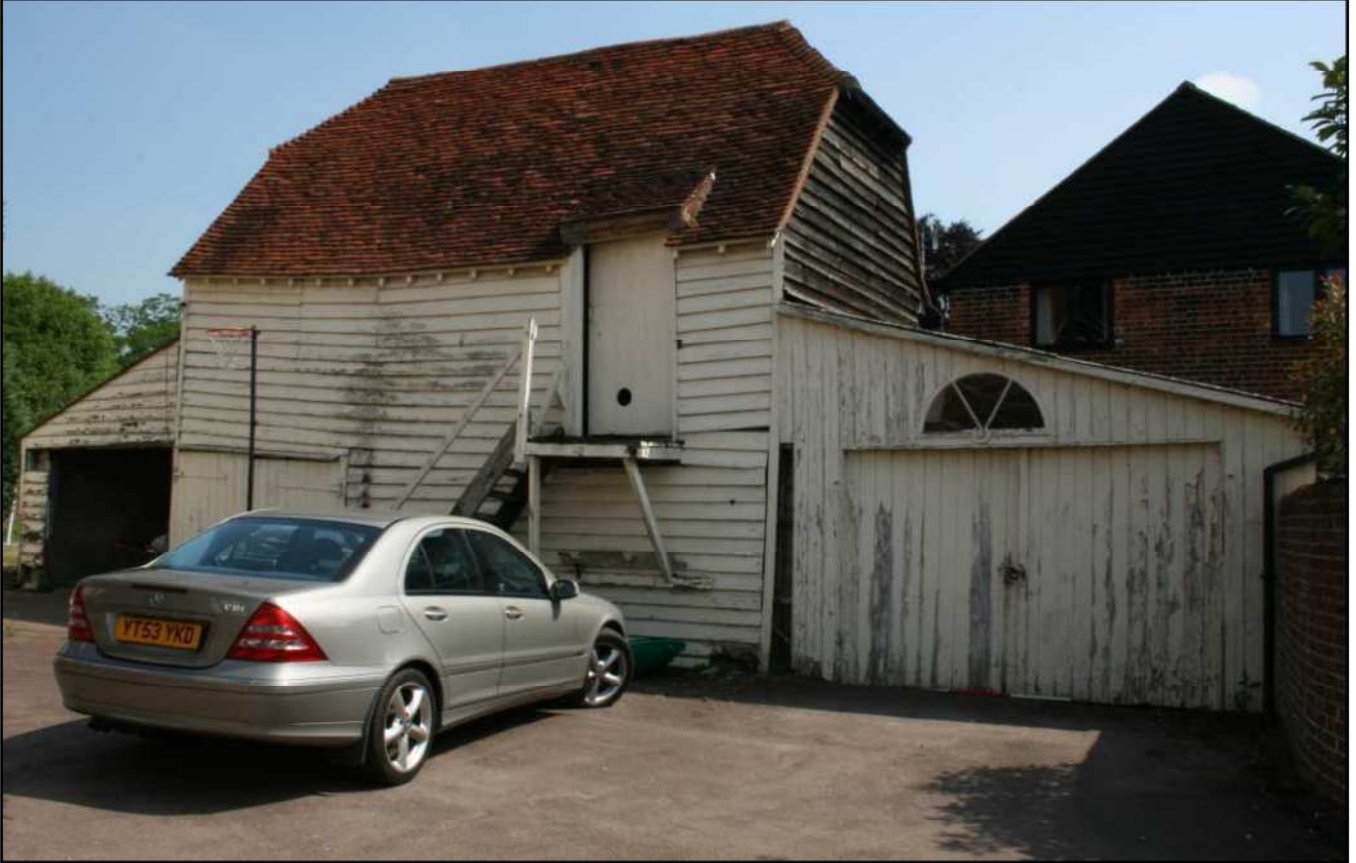
Plate 1: Granary, west exterior elevation, looking north-east

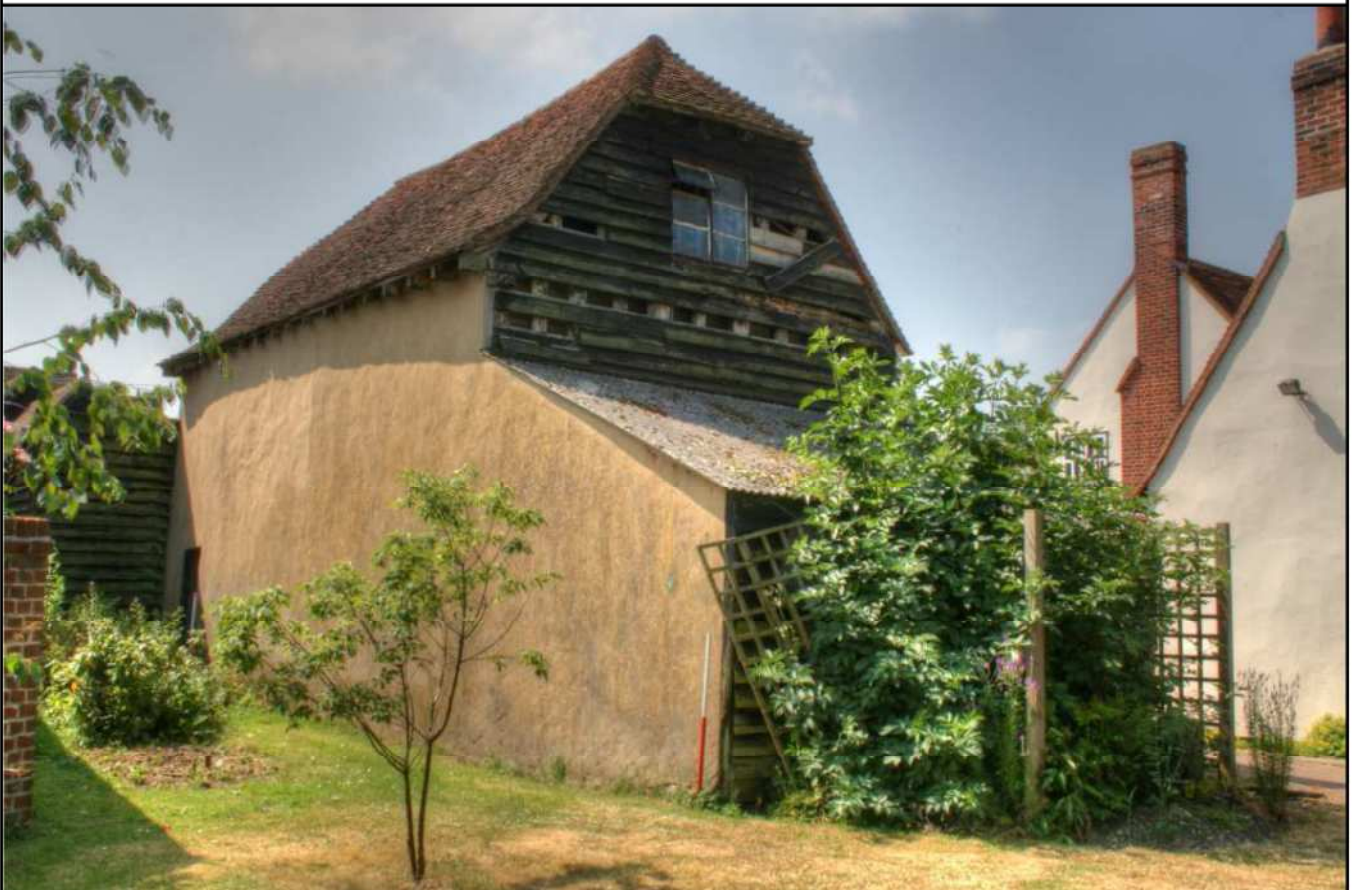
Plate 2: Granary, east and north exterior elevations, looking south-west

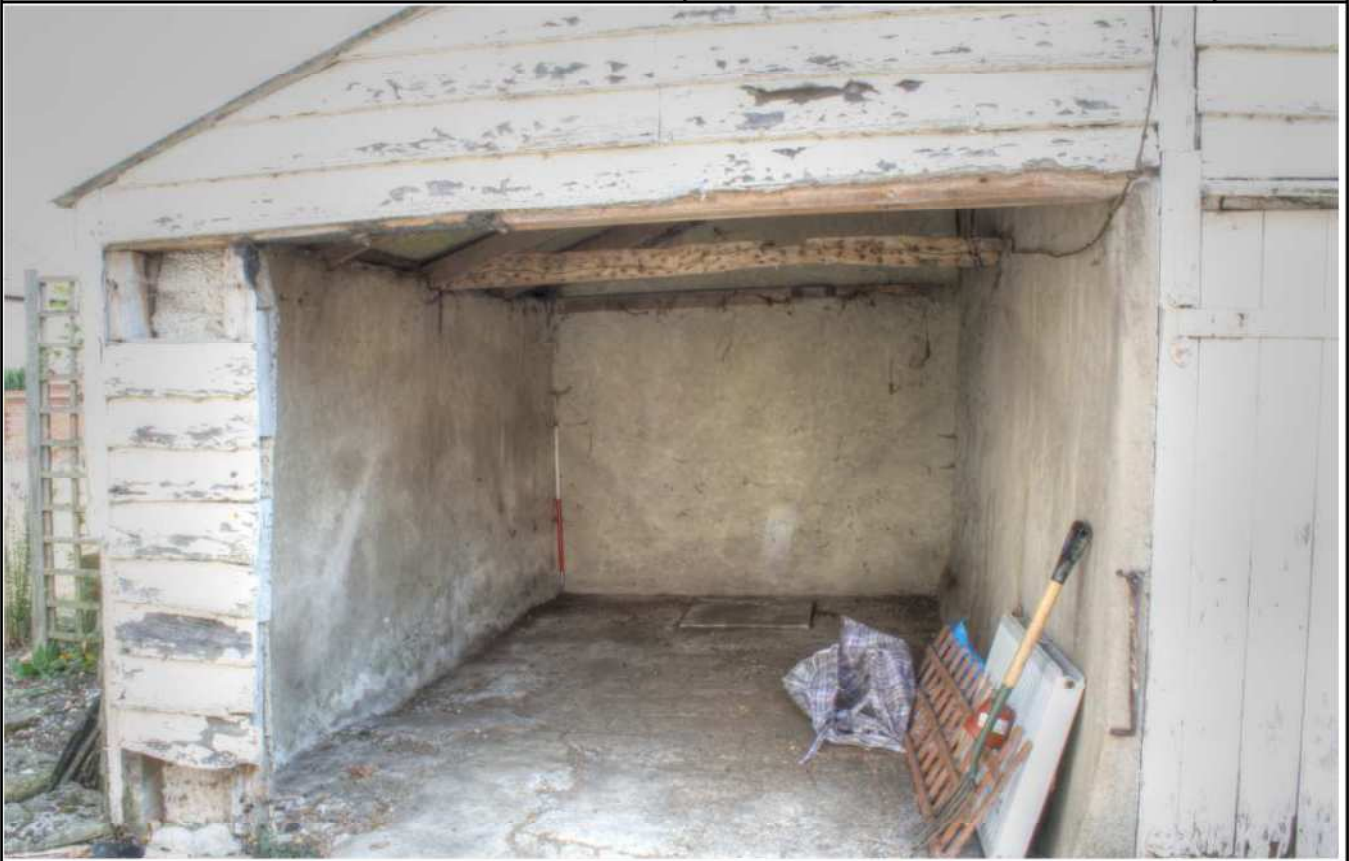
Plate 3: Northern lean-to, looking east

3.4 The lower half of this elevation is obscured by modern render within the northern lean-to (Plate 3). Above the roof of the lean-to, the elevation is weatherboarded but the ends of the wall plate are exposed (Plate 4). A modern metal framed window of two lights has been inserted towards the top of the gable end.

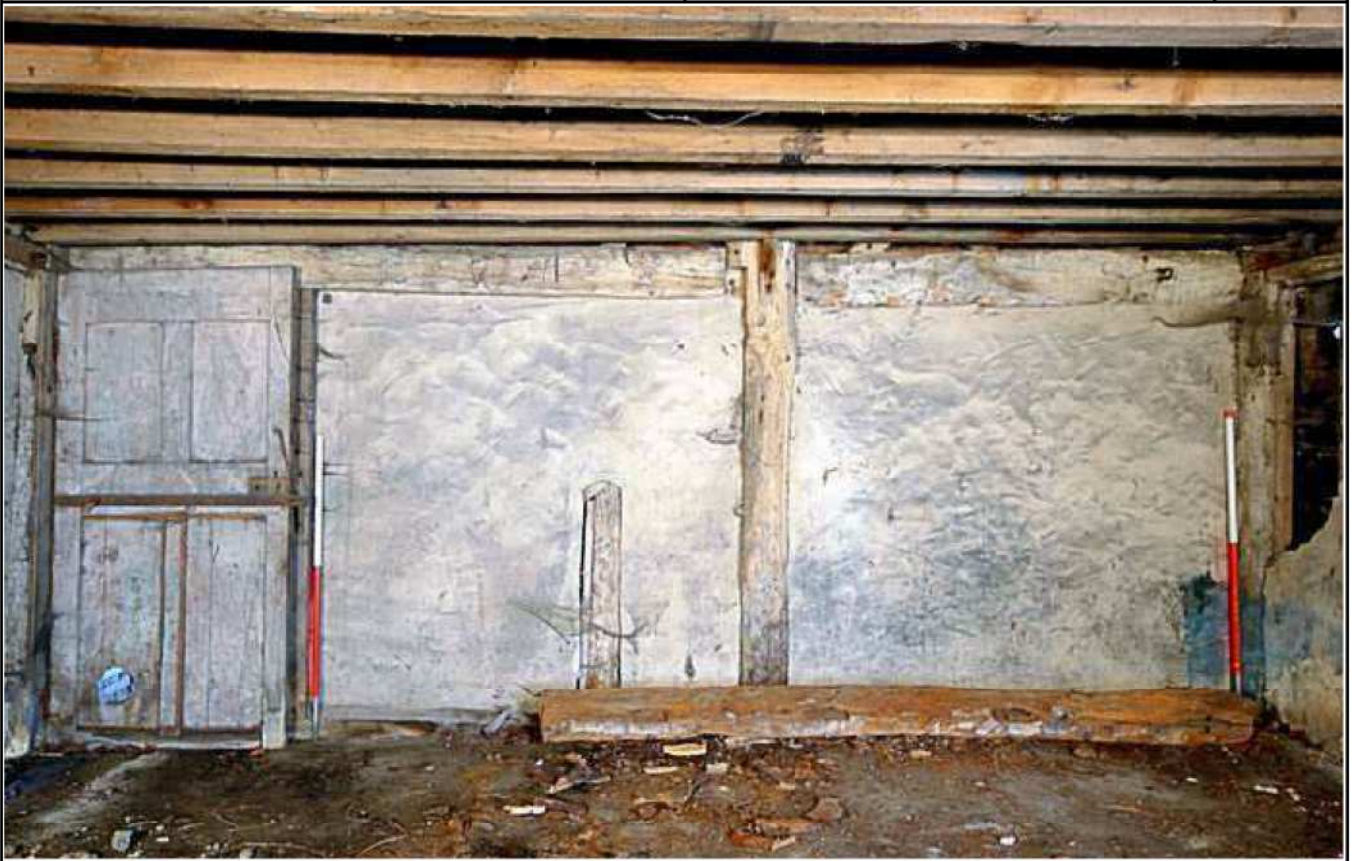
Plate 7: Ground floor, south interior elevation

3.6 The interior is rendered throughout but the principal posts and the mid-rails are exposed (Plates 7 - 10). The middle posts, between the northern and southern bays are jowled below the mid rail to support a cross-beam (Plates 11 & 12). This indicates that a second storey was an original part of the structure although the existing floor is a modern replacement. The ground floor is of concrete.

3.7 Two grain chutes protrude from the ceiling in Bay 1 (numbered from the north) (Plates 13 & 14). At the eastern end of the southern elevation a panelled door opens into the southern lean-to (Plate 7). At the southern end of the eastern elevation a ledged door opens onto the garden, and may have given access to the eastern lean-to shown on the historic mapping (Plate 8).

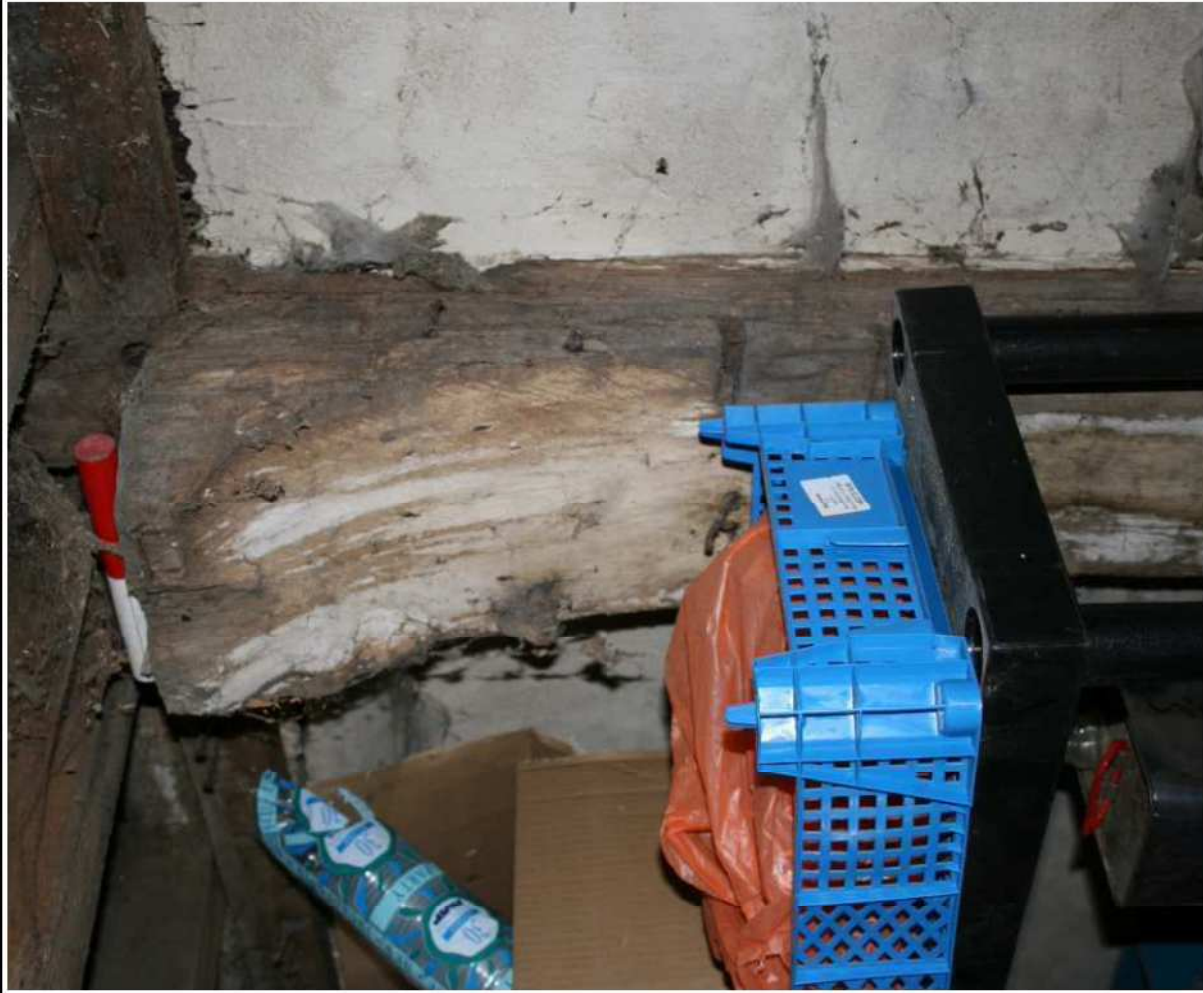
Plate 11: Detail of east middle post

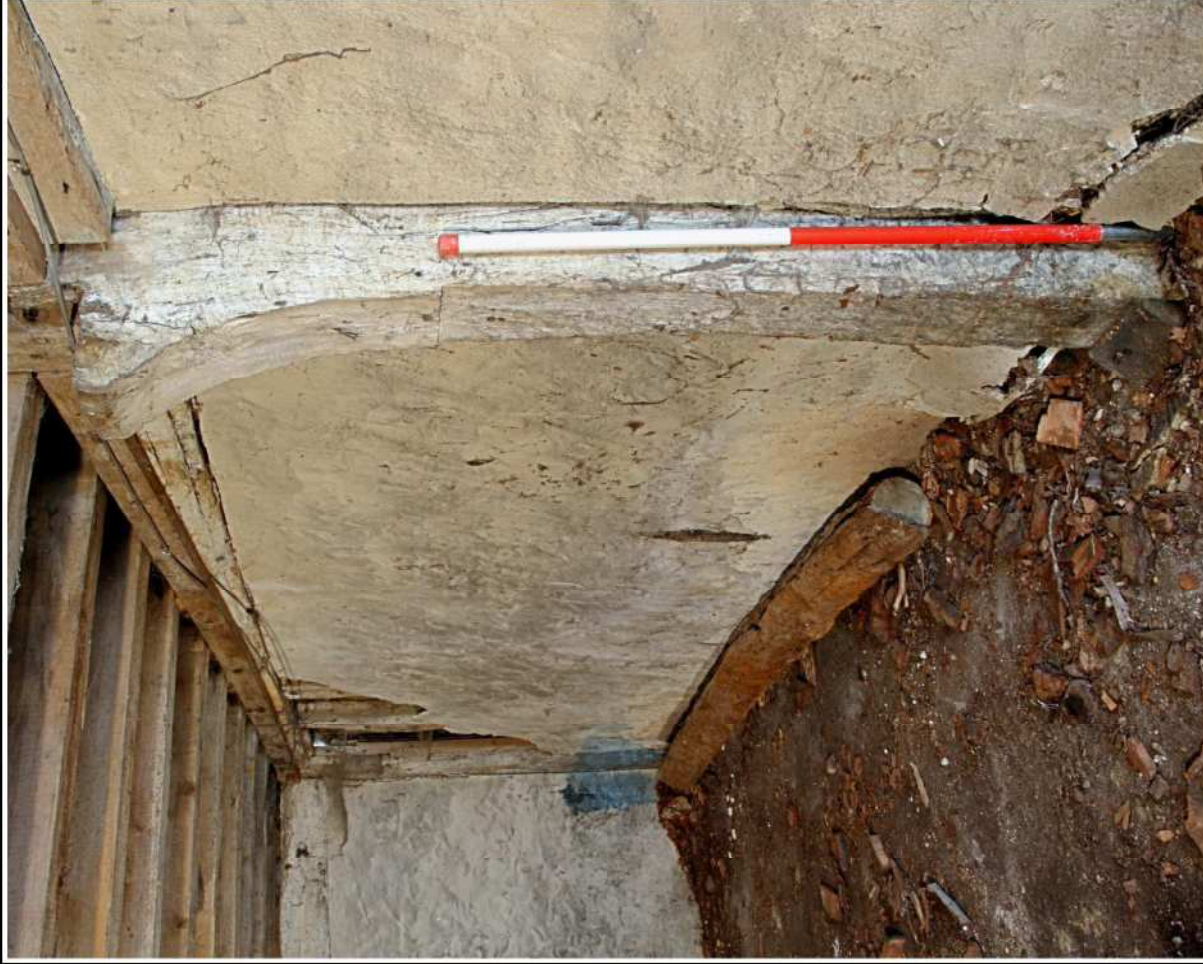
Plate 12: Detail of west middle post

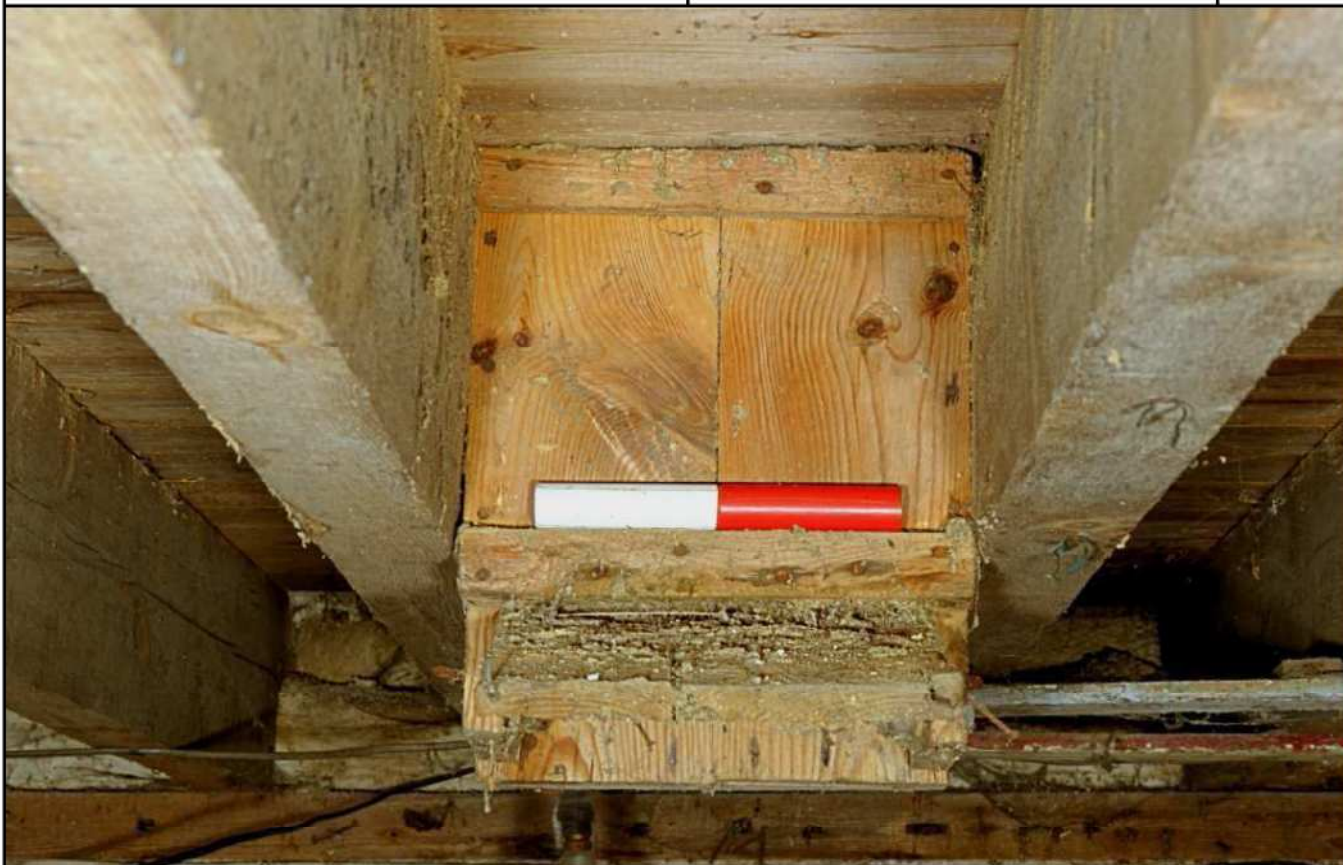
Plate 13: Ground floor, north grain chute

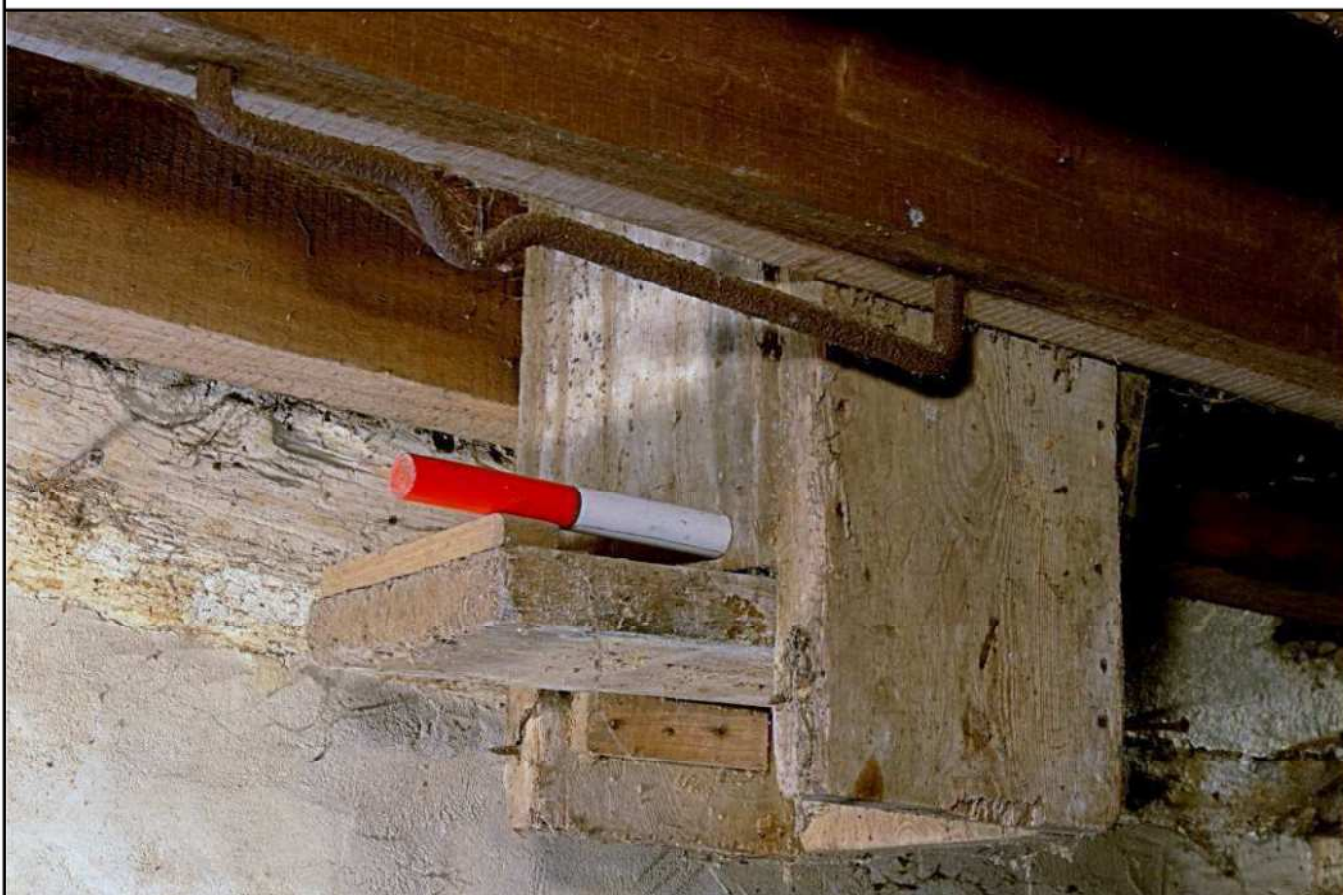
Plate 14: Ground floor, south grain chute

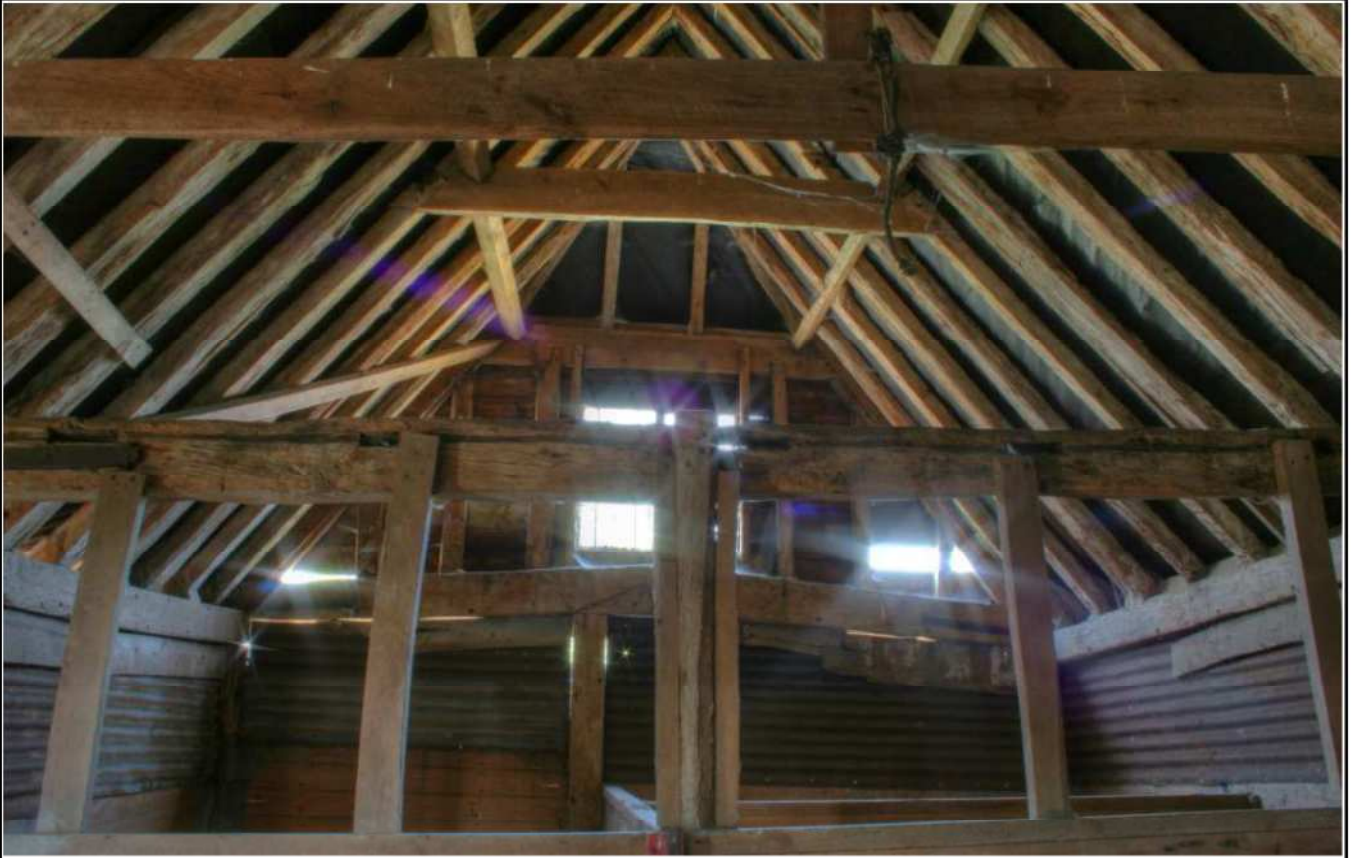
Plate 15: Upper floor, roof structure, looking north

3.9 The roof structure is formed of common rafter pairs with clasped side purlins and collars (Plate 15). Above the existing collar, the rafters pairs have each been notched to accept a collar at a higher level which is no longer extant (Plate 16). Carpenter's marks in the form of crude Roman

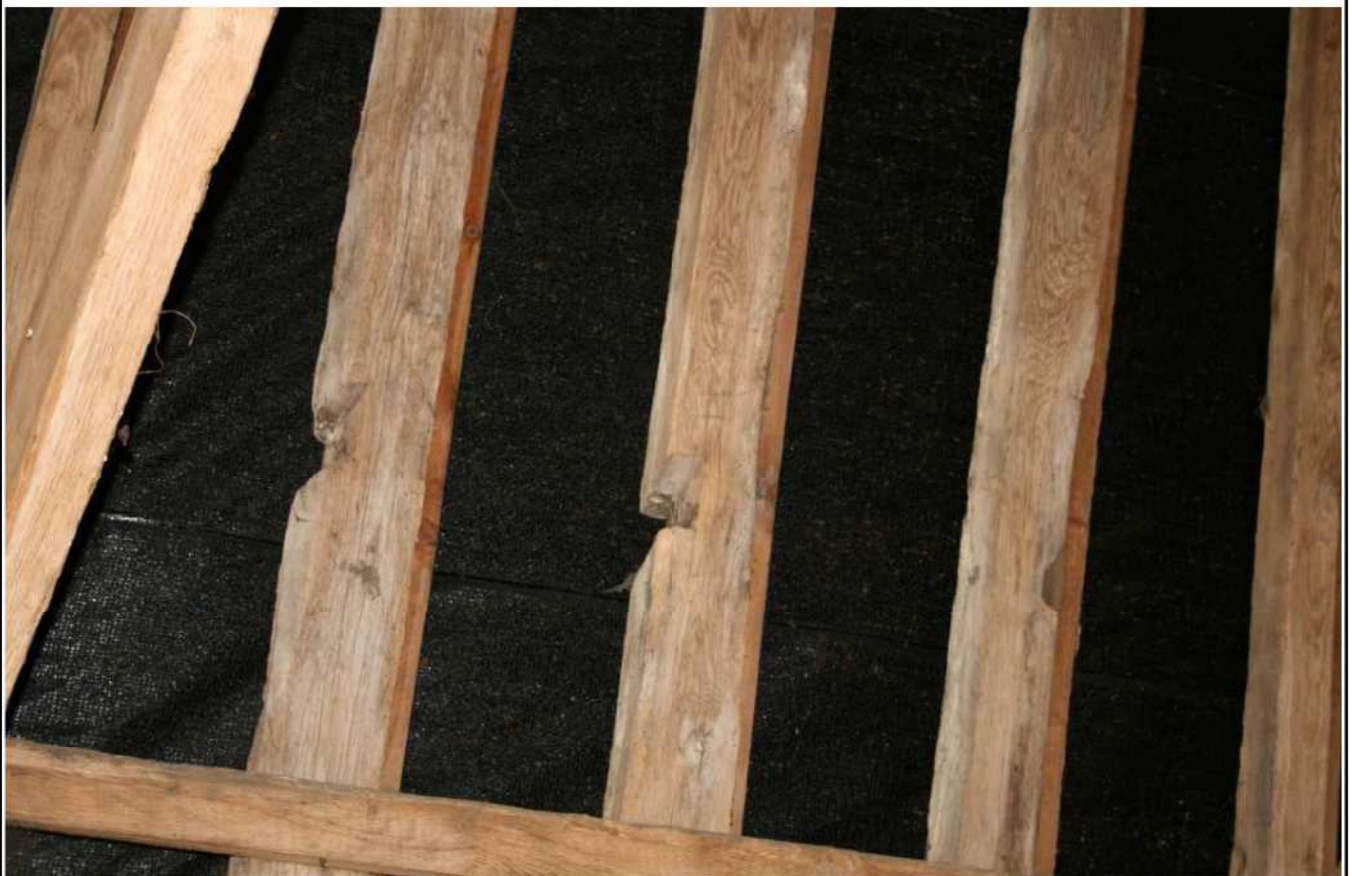
Plate 16: Upper floor, detail of notched rafters

numerals can be identified on the inward face of some of the rafters above the notches. The notches do not all face the same way, although they do appear to be consistent in each rafter pair. It is likely, therefore, that the entire roof has been reinstalled. This would be consistent with the suggestion that the building was moved to its present location in the mid-19th century, or may indicate that the roof has been reused from another building.

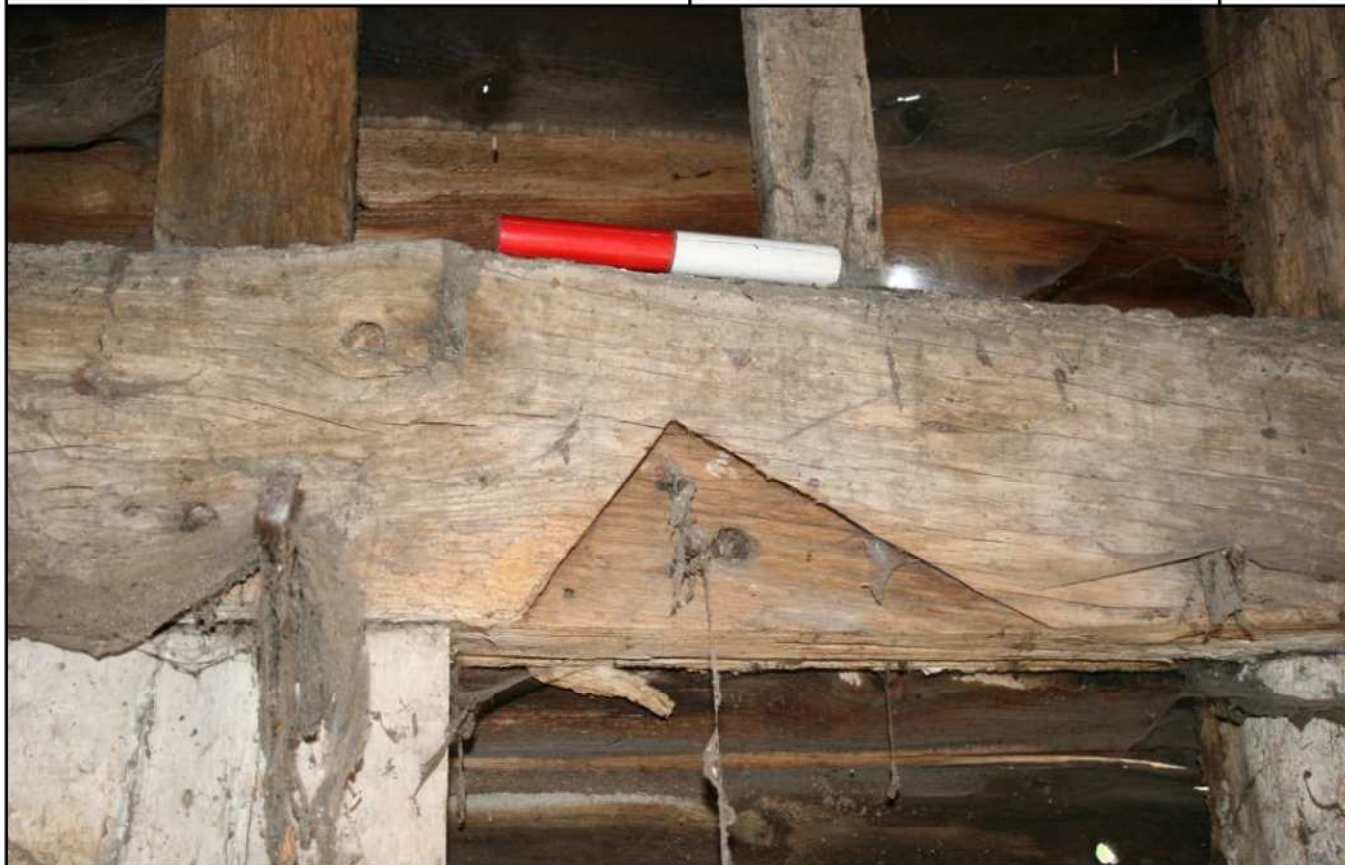
Plate 17: Upper floor, detail of cut-out for lapped timber in southern tie beam

3.11 The tie beam in the northern gable end is cambered but the southern tie beam is level. Both gable ends have intermediate posts that are off-set to the west. Both northern and southern tie beams have cut-outs to accept a lapped timber running at a shallow, diagonal angle down towards the west (Plate 17). The studs above the tie beam in the northern and southern elevations are later replacements. The middle tie beam, separating the northern from the southern bay, is secured to the wall plates at either end by iron braces and is badly weathered suggesting that it may have been exposed to the elements for some time.

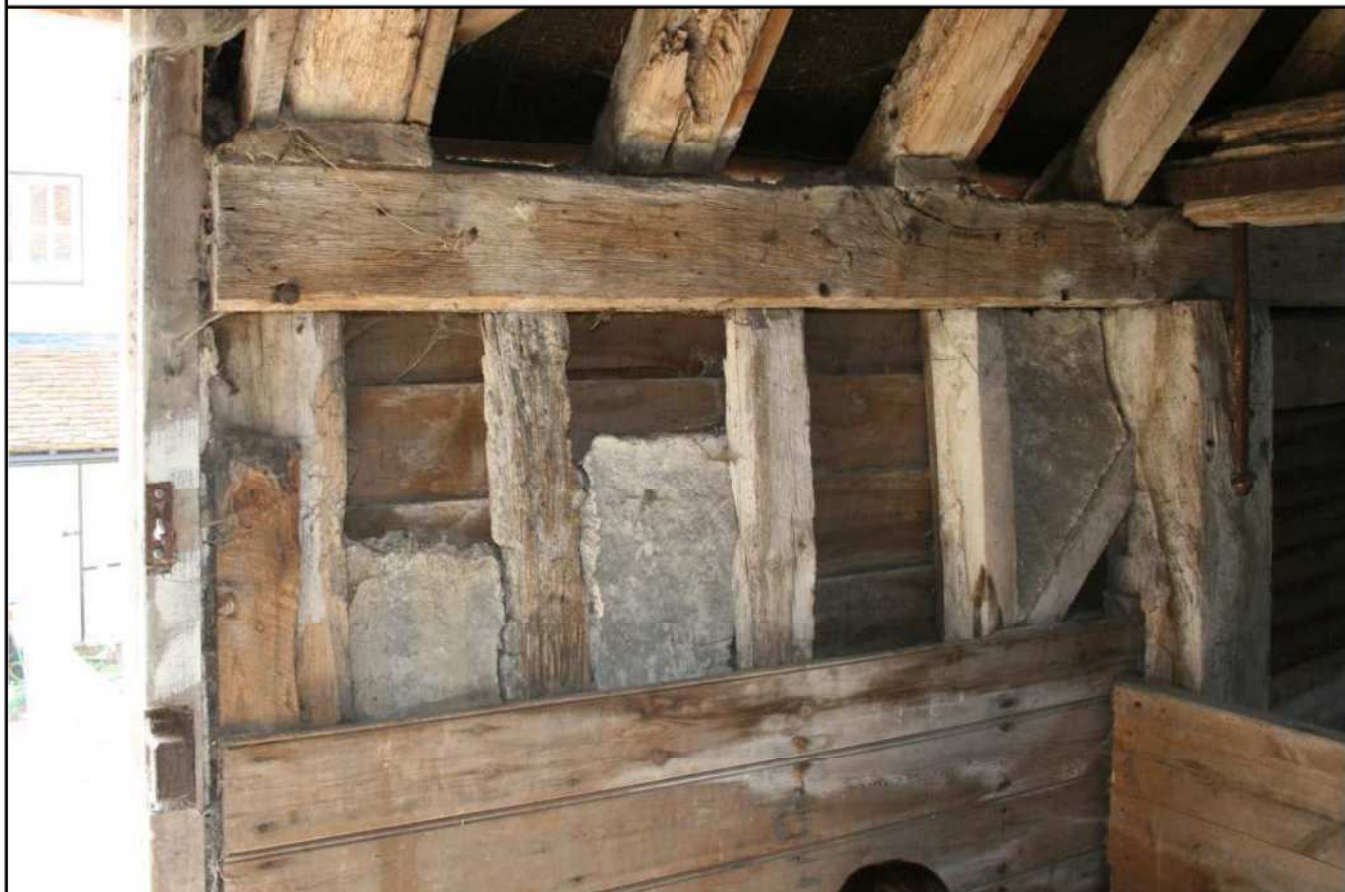
Plate 18: Upper floor, plaster panels in west elevation, Bay 2

3.12 In the western elevation of Bay 2, panels of coarse horse-hair plaster survive in places (Plate 18). In the eastern elevation of Bay 2 it is clear that the exterior render is modern, being mounted on galvanised iron mesh.

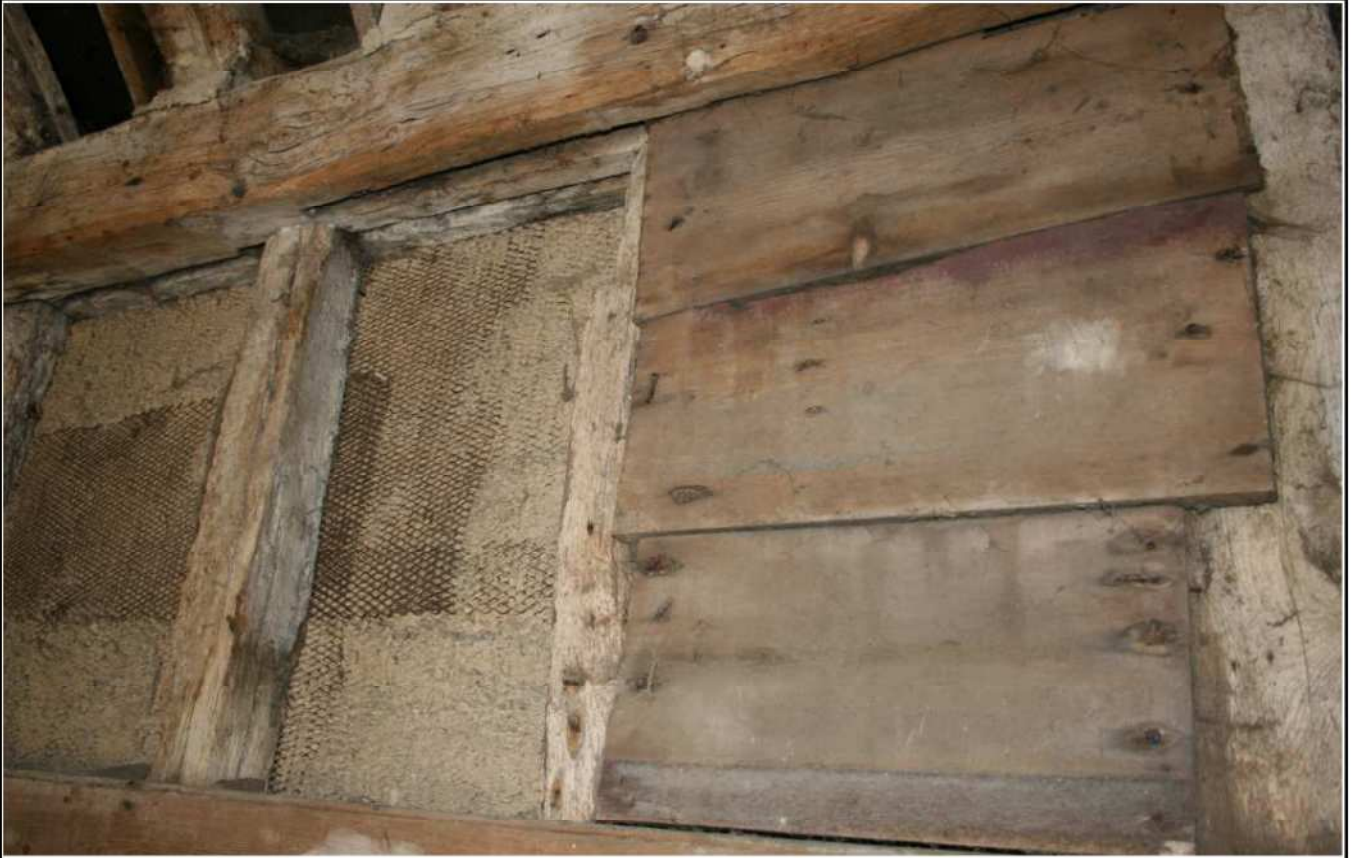
Plate 19: Upper floor, blocked window and groove for shutter, west elevation, Bay 2

3.13 In the western elevation of the southern bay, to the north of the doorway, a blocked window is visible (Plate 19). A groove in the bottom of the wall plate above indicates the presence of a former shutter. A similar arrangement can be seen in the eastern elevation of Bay 2 and in the eastern elevation of Bay 1 (Plate 20). A similar groove is also just apparent at the northern end of the western elevation of Bay 1.

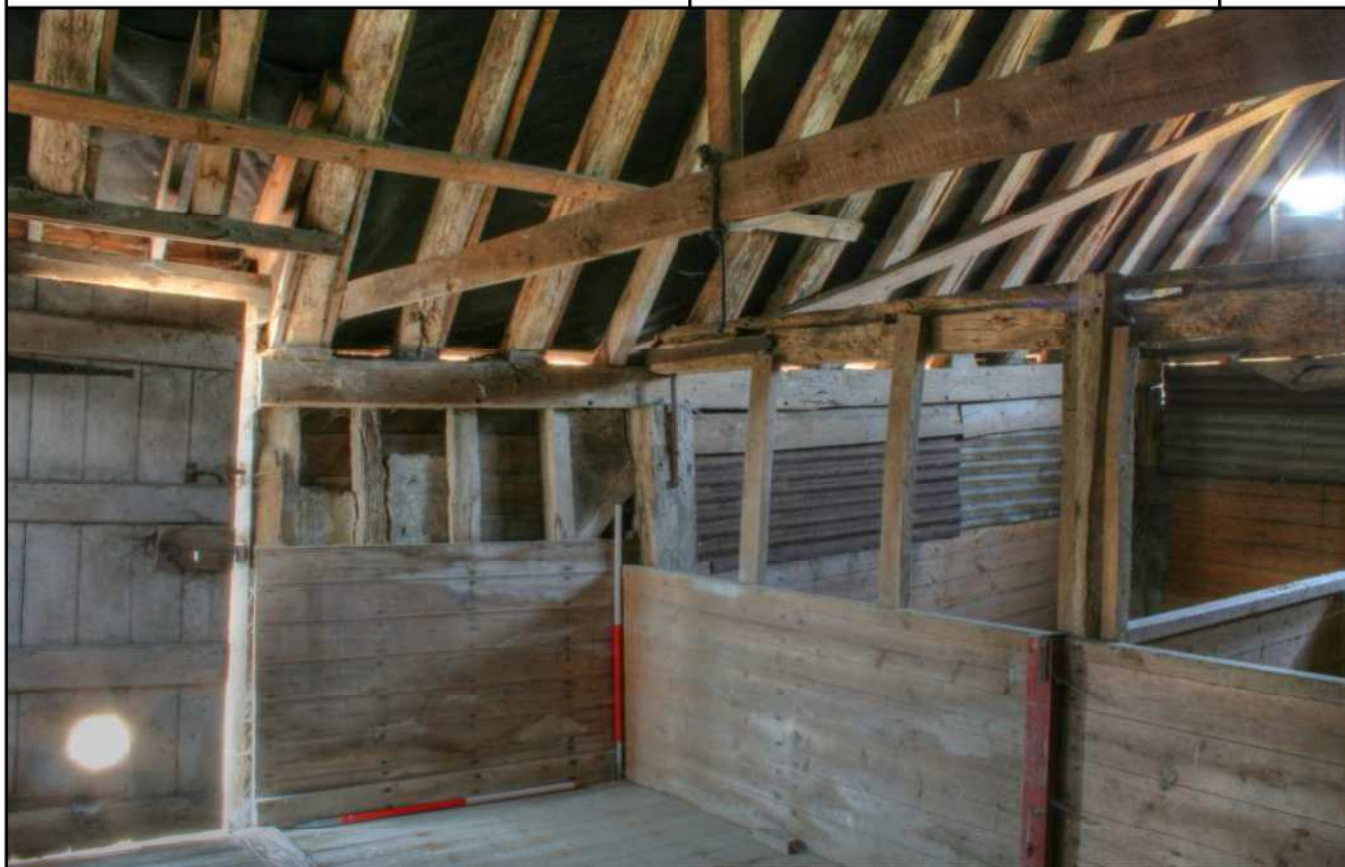
Plate 21: Upper floor, partition between Bays 1 & 2, looking NW

3.14 The floor area of the upper storey is divided by a waist high partition in line with the middle tie-beam (Plate 21). Bay 1 has been further divided into three bins by similar partitions formed of modern soft wood, presumably for the storage of grain (Plate 22). The first bin occupies the western half of the bay, the eastern half being divided into two smaller bins by a partition running east to west. The western bin has a chute in the middle of the floor towards the north (Plate 23), and the south-eastern bin has a similar chute, both noted in the ceiling of the lower storey. In the north-eastern bin, diagonal wooden guide rails indicate the location of a former baffle or shutter (Plate 24). The remains of galvanised sheet metal sealing the angles of the bins can still be seen. A sawn off return, in the middle of the panelling to the eastern elevation of Bay 2, suggests that the bins extended into the southern bay (Plate 25). A pencilled tally on the panelling to the north of the door in the western elevation indicates the use of the bins to store oats (Plate 26).
