**Granary
FELSTED PLACE
Felsted, Essex**

*Historic Building Record
&
Archaeological Monitoring*

Report No.622

September 2010

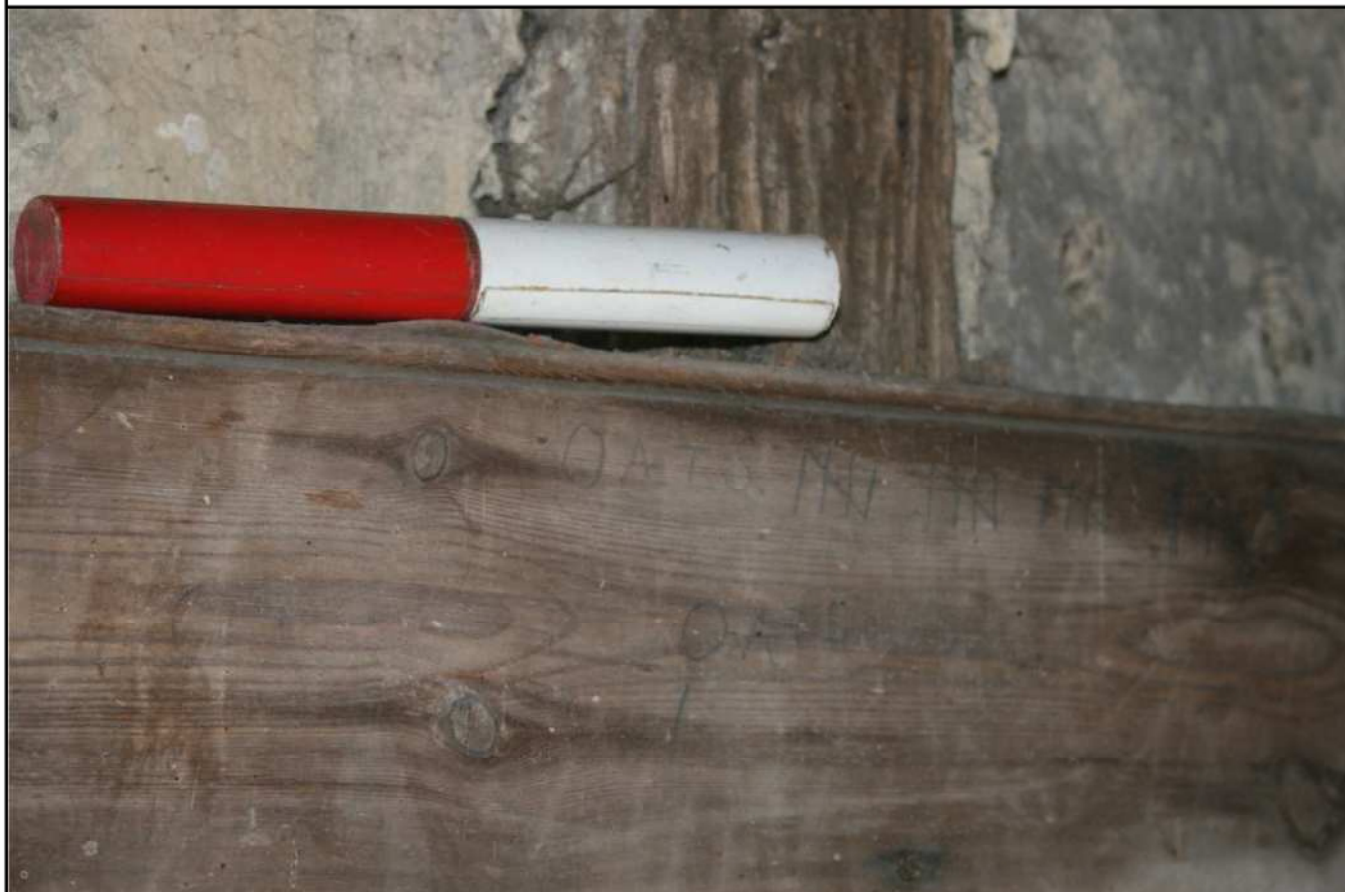
Plate 26: Upper floor, pencilled tally, W elevation, Bay 2

3.14 The floor area of the upper storey is divided by a waist high partition in line with the middle tie-beam (Plate 21). Bay 1 has been further divided into three bins by similar partitions formed of modern soft wood, presumably for the storage of grain (Plate 22). The first bin occupies the western half of the bay, the eastern half being divided into two smaller bins by a partition running east to west. The western bin has a chute in the middle of the floor towards the north (Plate 23), and the south-eastern bin has a similar chute, both noted in the ceiling of the lower storey. In the north-eastern bin, diagonal wooden guide rails indicate the location of a former baffle or shutter (Plate 24). The remains of galvanised sheet metal sealing the angles of the bins can still be seen. A sawn off return, in the middle of the panelling to the eastern elevation of Bay 2, suggests that the bins extended into the southern bay (Plate 25). A pencilled tally on the panelling to the north of the door in the western elevation indicates the use of the bins to store oats (Plate 26).

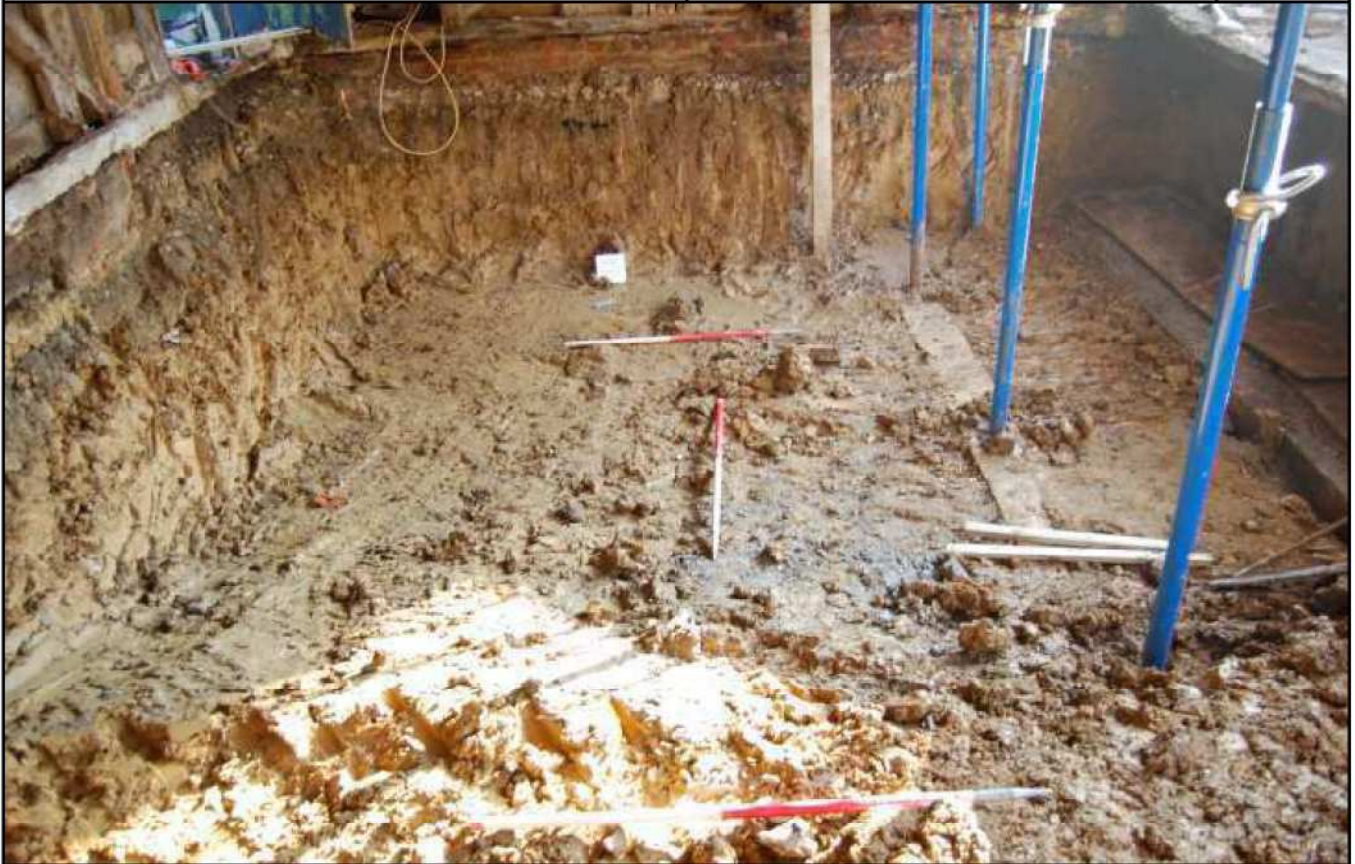
Plate 27: Granary after ground reduction, looking south

4.1 The groundworks within the Granary were undertaken without archaeological supervision. These involved removing the Granary floor and reducing the ground levels by between 0.90m and 1.20m (Figure 14; Plate 27).

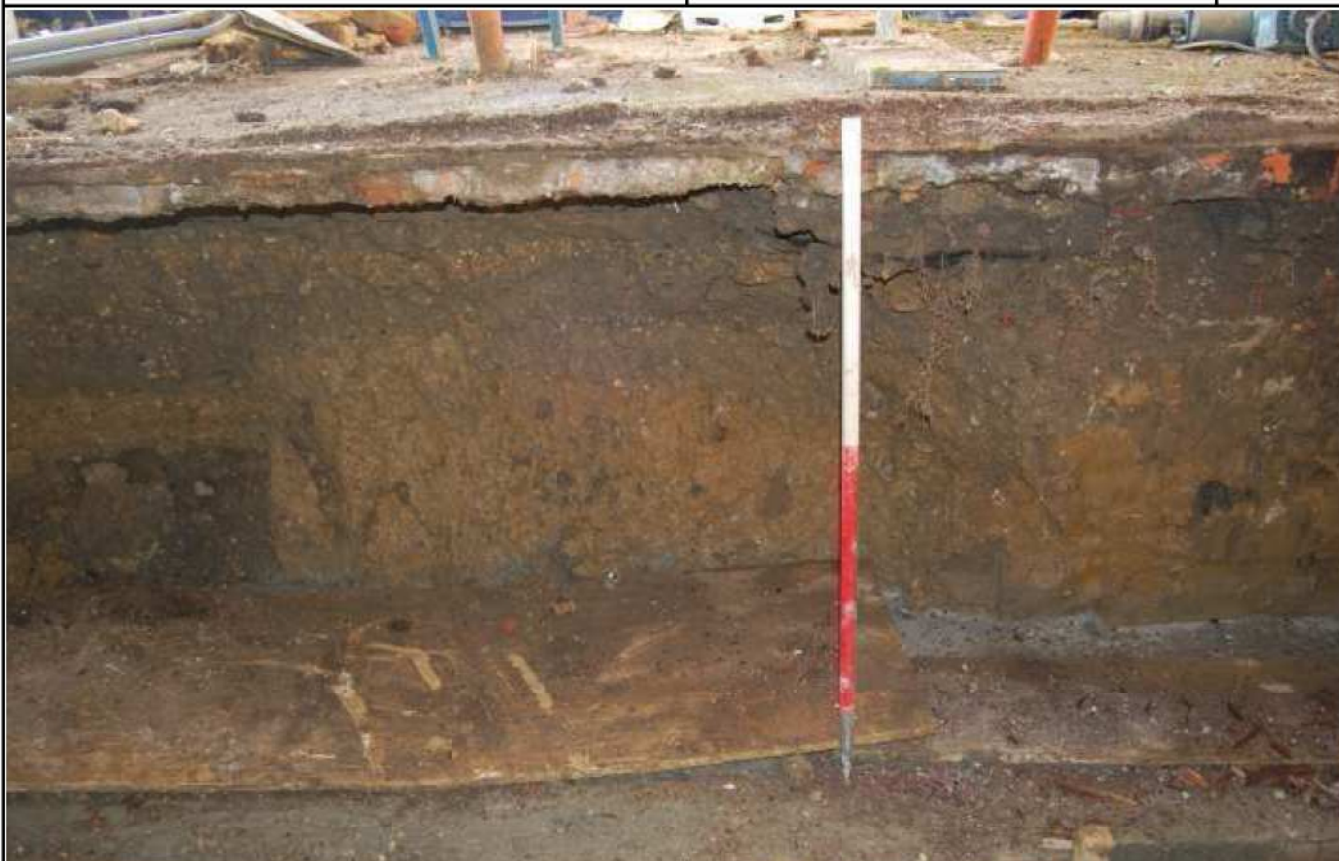
Plate 29: South-west corner after ground reduction, showing pit [007] (Section 1)

4.3 In the south-west corner, the natural had been cut by a vertical sided pit [007], 0.50m wide and more than 0.40m deep (Figure 15). Filling the pit was a dark greyish brown silty clay deposit (006) overlain by 0.1m of re-deposited natural (005) and 0.07m of dark greyish brown silty clay with occasional rounded pebbles (004).

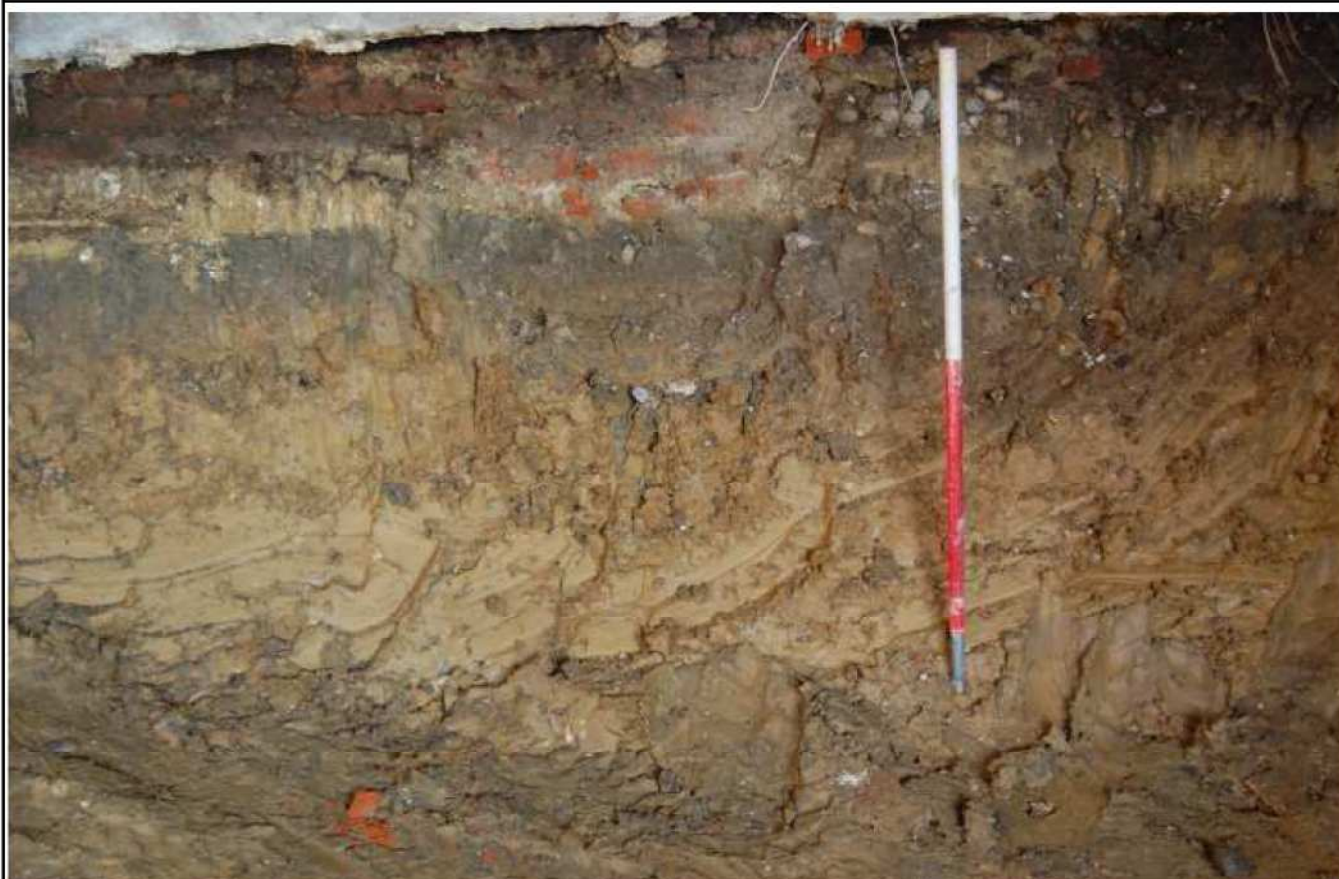
Plate 30: East side after ground reduction (Section 2)

4.4 On the east side of the Granary, the reduction of the floor revealed a different sequence of deposits (Section 2). Above the natural was a 0.15m thick layer dark greyish brown silty clay (010), with occasional rounded pebbles. Above this was a sill wall or foundation (008), five courses of hand made brick in an irregular pattern, although probably mostly headers. This wall was bonded with lime mortar, and only patches were revealed. For the most part the make-up of the granary floor (009) was visible, as a pale yellowish brown silty clay with small chalk fragments.

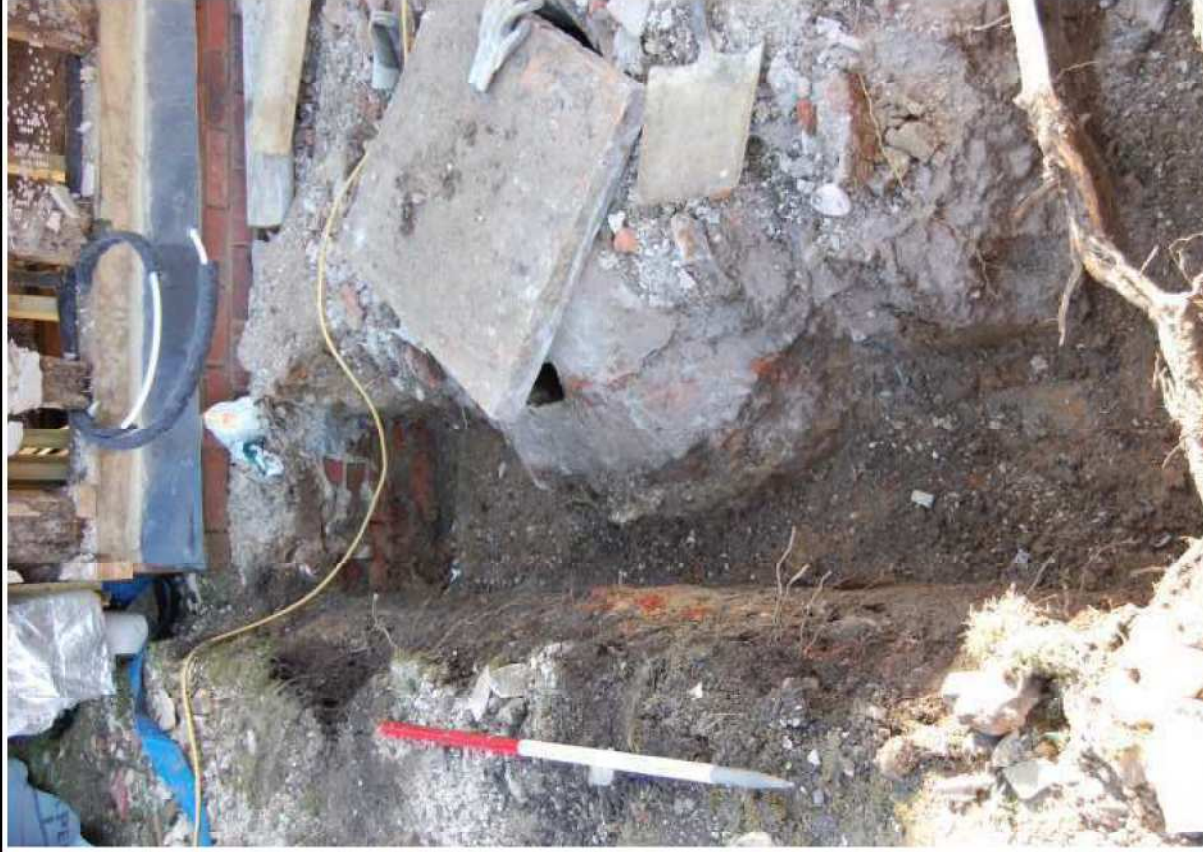
Plate 31: Footings trench to N of Granary, showing well

4.5 Monitoring of the excavation of the footings trench for the new northern extension, on the site of the former lean-to, revealed that the natural was overlain by a dark greyish brown overburden which contained few stones, but a moderate quantity of handmade brick, dated to the 1860s. A brick well was encountered in the footprint of the lean-to, adjacent to the western side of the eastern footings trench (Figure 14; Plate 31). This was left in situ.

5.4 Monitoring of the footings trenches for the new extension on the north side of the existing building revealed a post-medieval brick well, approximately 1m in diameter. This has been left in situ. Inspection of the drainage trench which ran north to an existing soakaway revealed a layer of overburden above the natural clay, this became cleaner and more like garden soil towards its northern end.

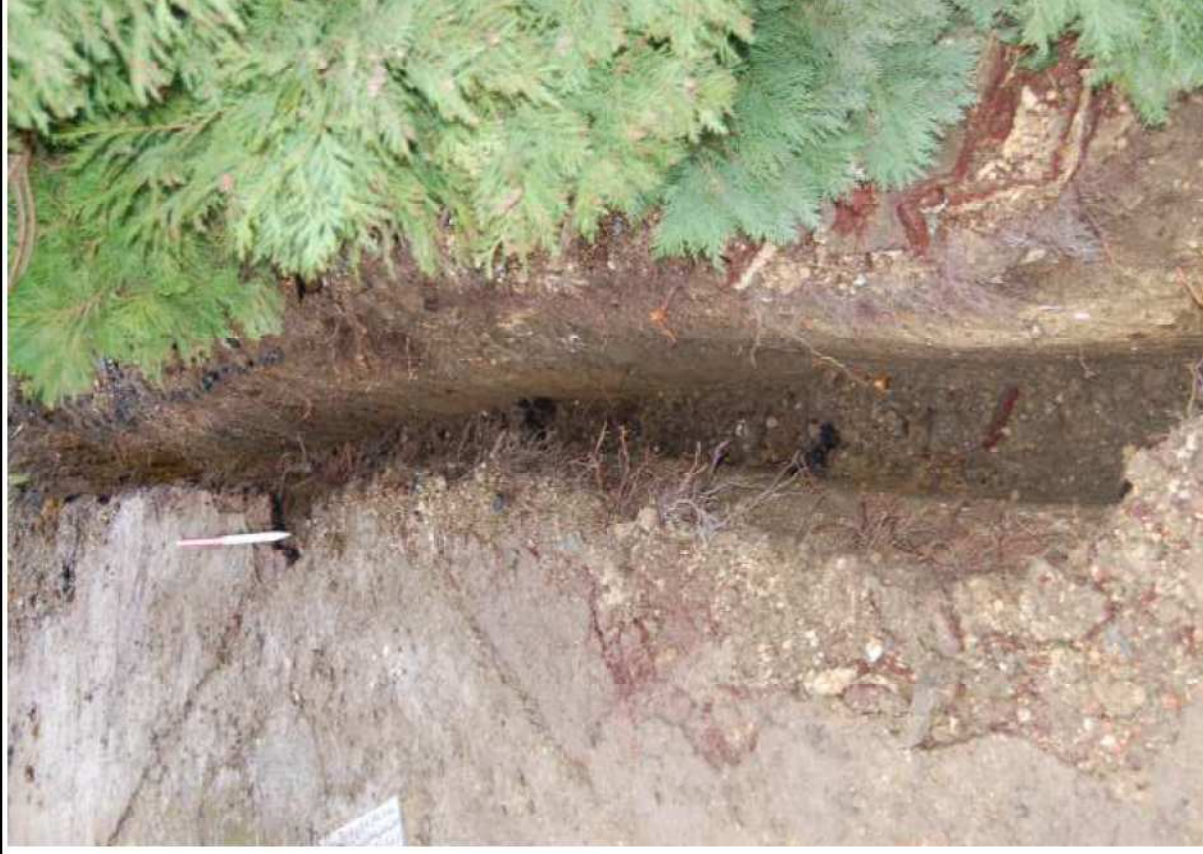
Plate 32: Drainage trench to N of Granary, looking N

4.6 A drainage trench was excavated northwards from the building to an existing soakaway. This revealed a similar stratigraphy to that observed in the footings trenches, comprising a layer of overburden, approximately 0.30m in depth, above the natural clay (Plate 32). However, as the trench extended north, the overburden became cleaner and more like a garden soil.
