'AUBYNS', 11 The Green, Writtle, Essex

Archaeological Monitoring Report

Project ref.: HN816
Site Code: WRAU09
Planning ref.: 04/02340/FUL

Archaeological Monitoring

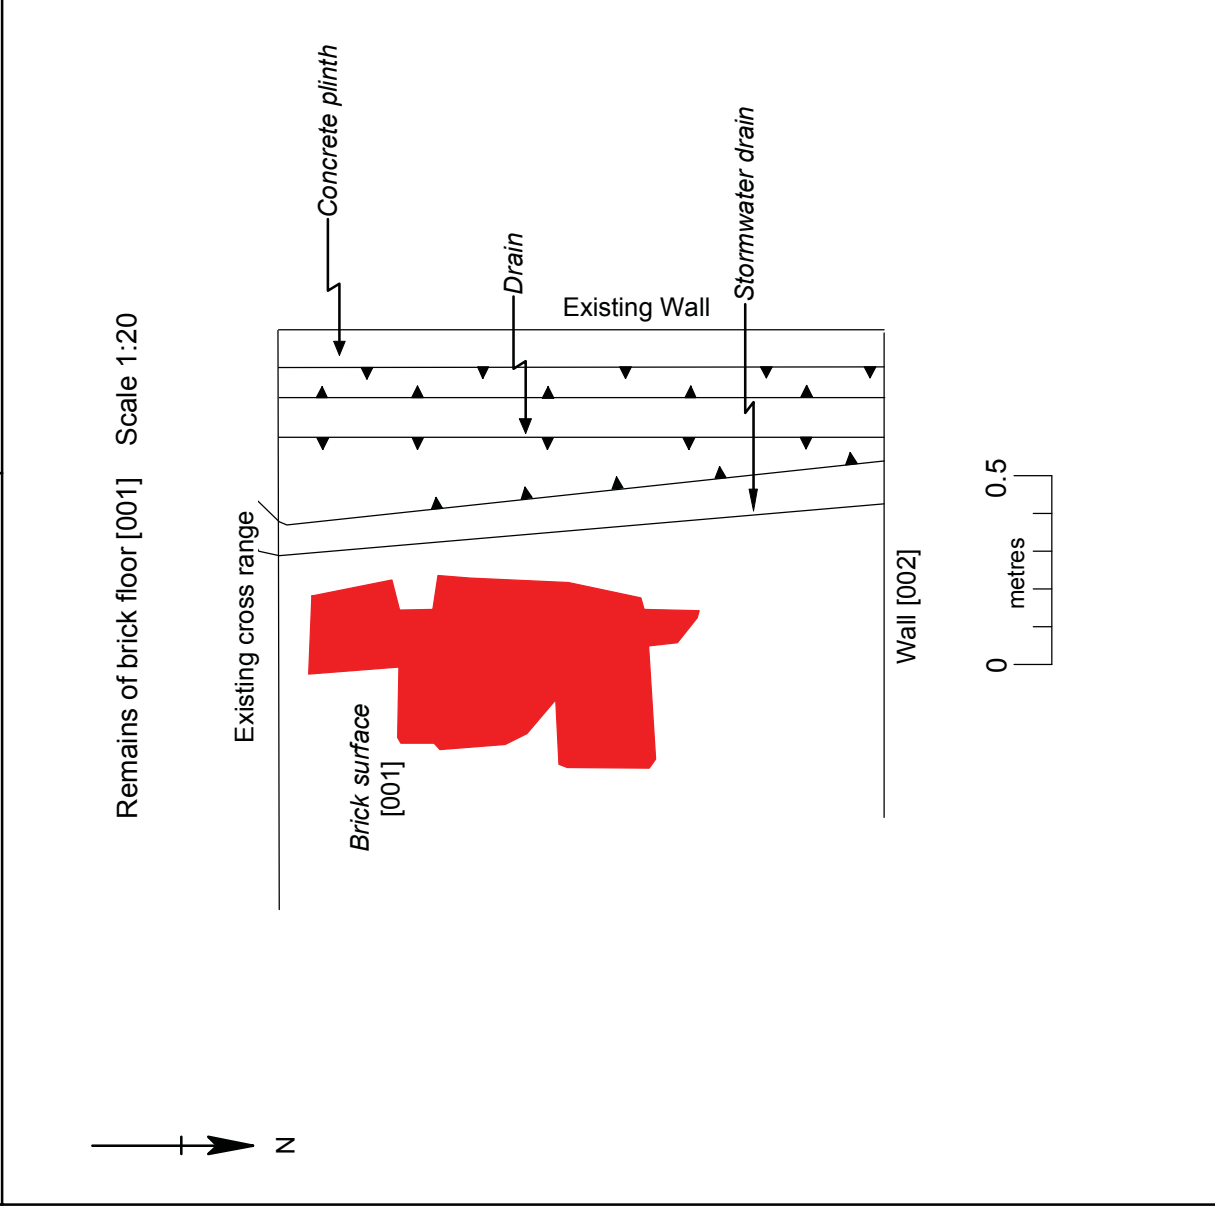
Plan of [001] & Section through [002]

2.7.2 The irregularly shaped remains of a brick surface [001], composed of red and white paviers, was recorded immediately to the east of the stormwater drain. This measured approximately 1m in length and had a maximum width of 0.48m (Figure 4; Plate 1). The white bricks measured 9½" x 4½" x 1⅞" (235mm x 110mm x 42mm). None of the red bricks was complete, but the recovered fragments indicate that they were approximately the same size. A layer of

- 2.7.4** Wall [002] was largely dismantled in the course of the works, exposing its foundation, which consisted of two layers of tile, contexts (005) and (007) sandwiching flint pebbles bonded in firm yellowish brown clay, context (006) (Figure 4). Beneath the wall, exposed in a trench excavated to accommodate the toe to the proposed concrete raft, was a layer of clean mid-grey silty clay and gravel, context (004) (Plate 3). This may be natural, but is different to the anticipated natural of mid-yellowish brown clay.

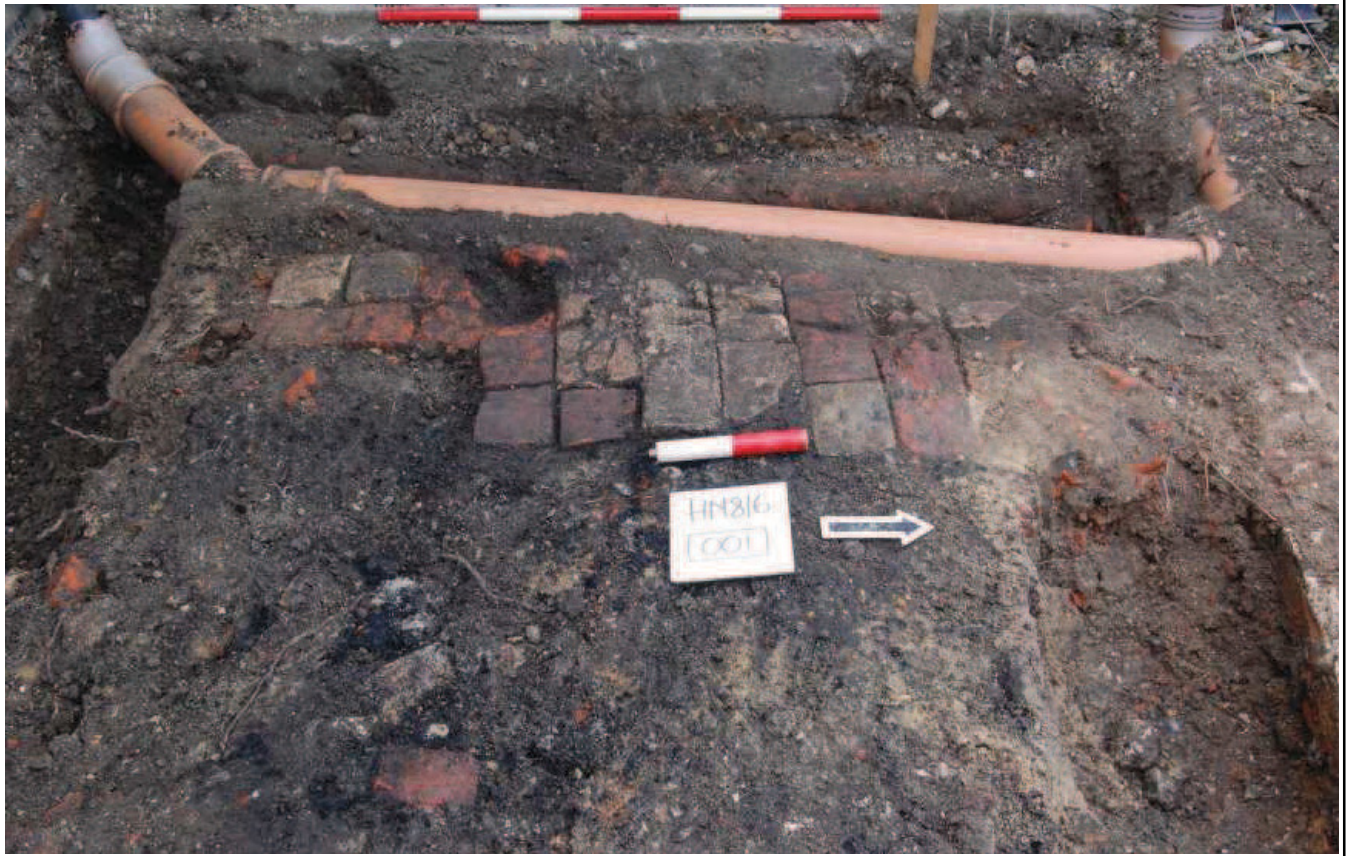
2.7.1 The northern exterior wall of the west range has been underpinned by a concrete plinth extending 0.10m beyond the face of the elevation. Two modern drains, including a plastic rainwater drain, were noted immediately to the east of the plinth (Plate 1).

charcoal covered the brick surface and extended eastwards for approximately 2m. This may have been derived from the fire in the 1930s that destroyed the original cross range.

Plate 1: Concrete plinth below existing wall & brick surface [001], looking west

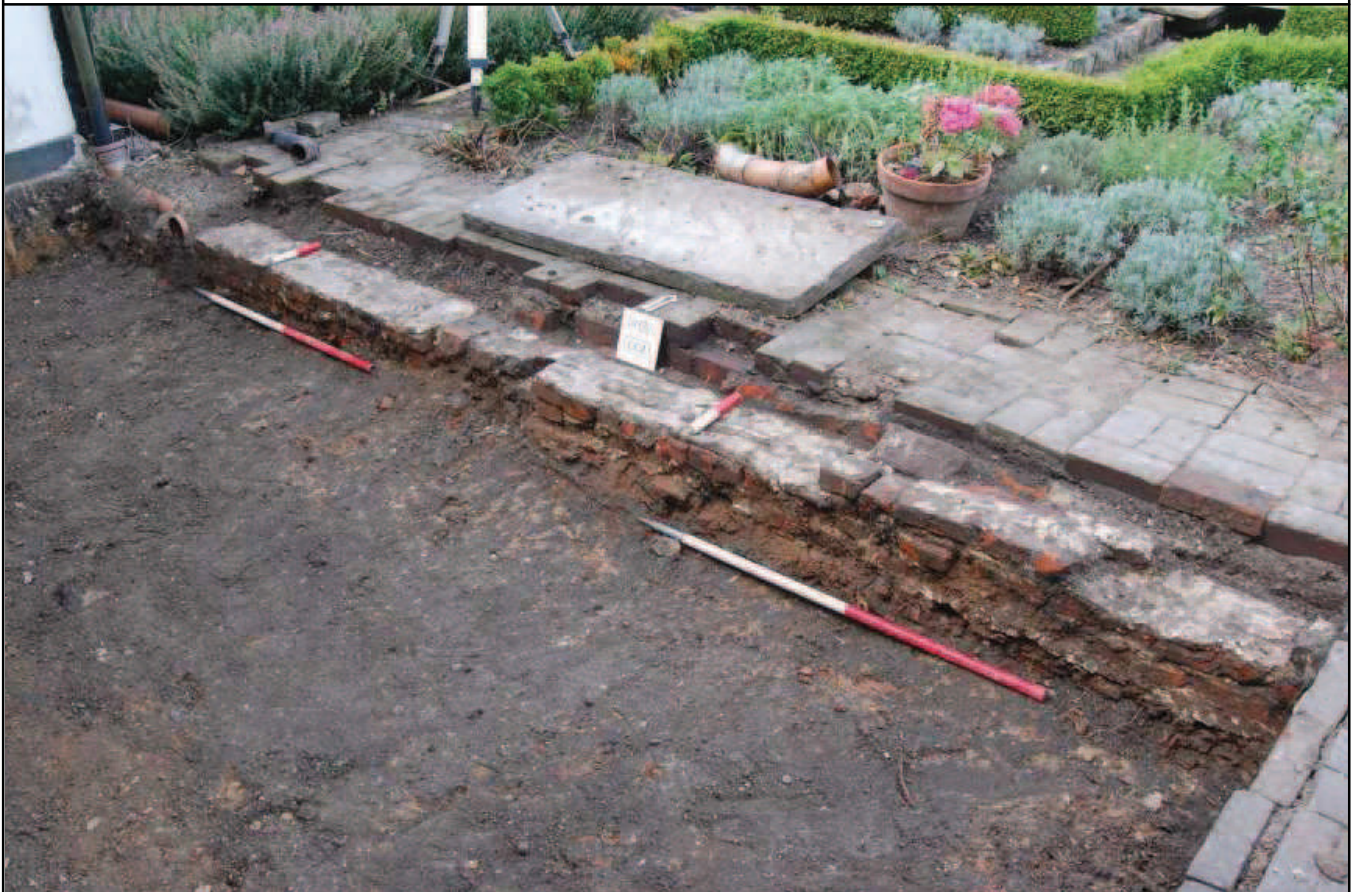
- 2.7.3** The line of a brick plinth [002] was recorded on the northern edge of the reduced area. This ran on an alignment linking the north-east corner of the west range with the north-west corner of the east range (Figure 5; Plate 2). The plinth, which survived to a maximum depth of 3 courses (0.20m), was formed of thin red bricks, laid randomly and bonded with a hard coarse lime mortar. A possible break in the wall, measuring 0.46m in length and located centrally between the two ranges, was noted. Two sample bricks were recovered, these measure 9½" x 4½" x 1½" (236mm x 115mm x 44mm). This feature has been interpreted as a foundation for the northern elevation to the earlier cross wing.

Plate 2: Wall [002], looking north-west

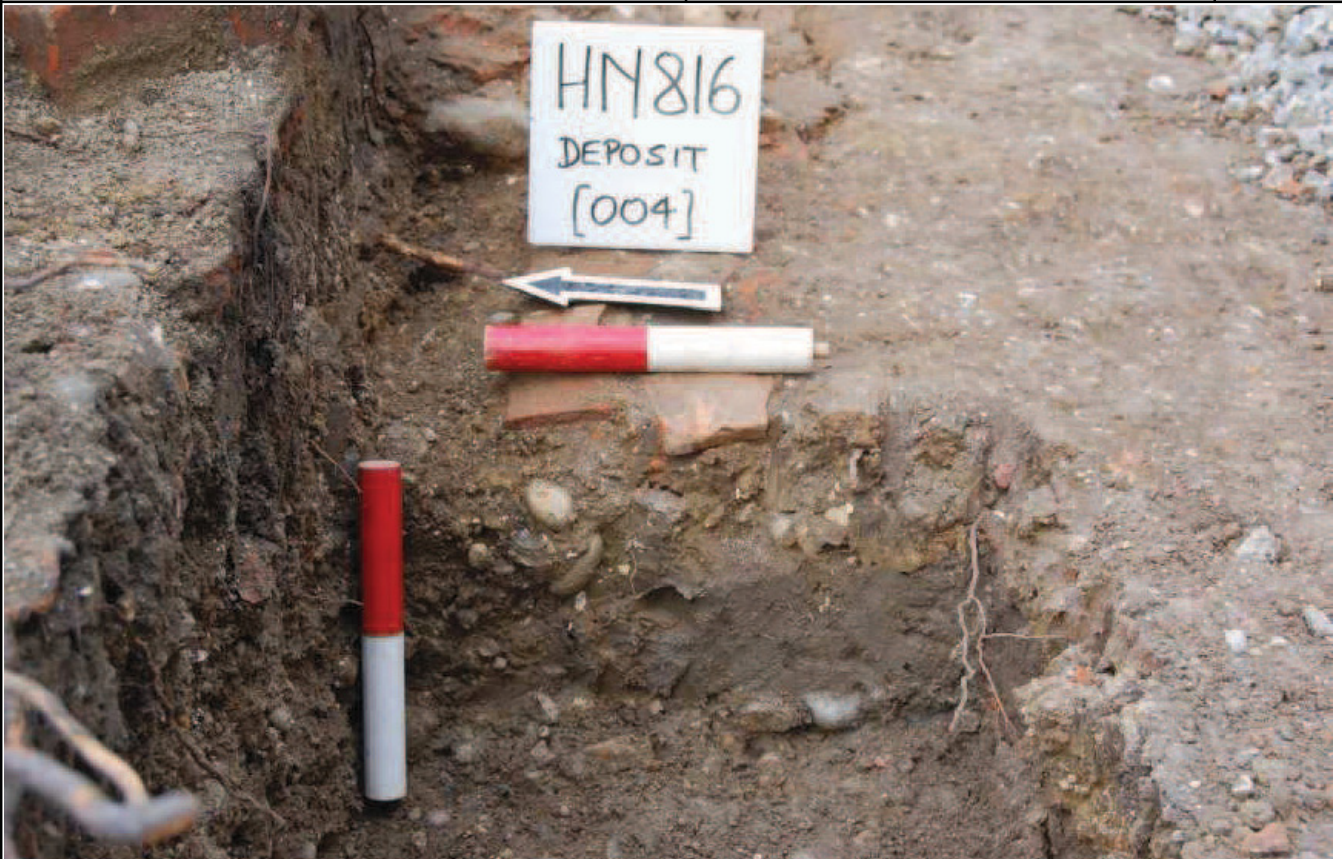
Plate 3: Deposit [004], looking east

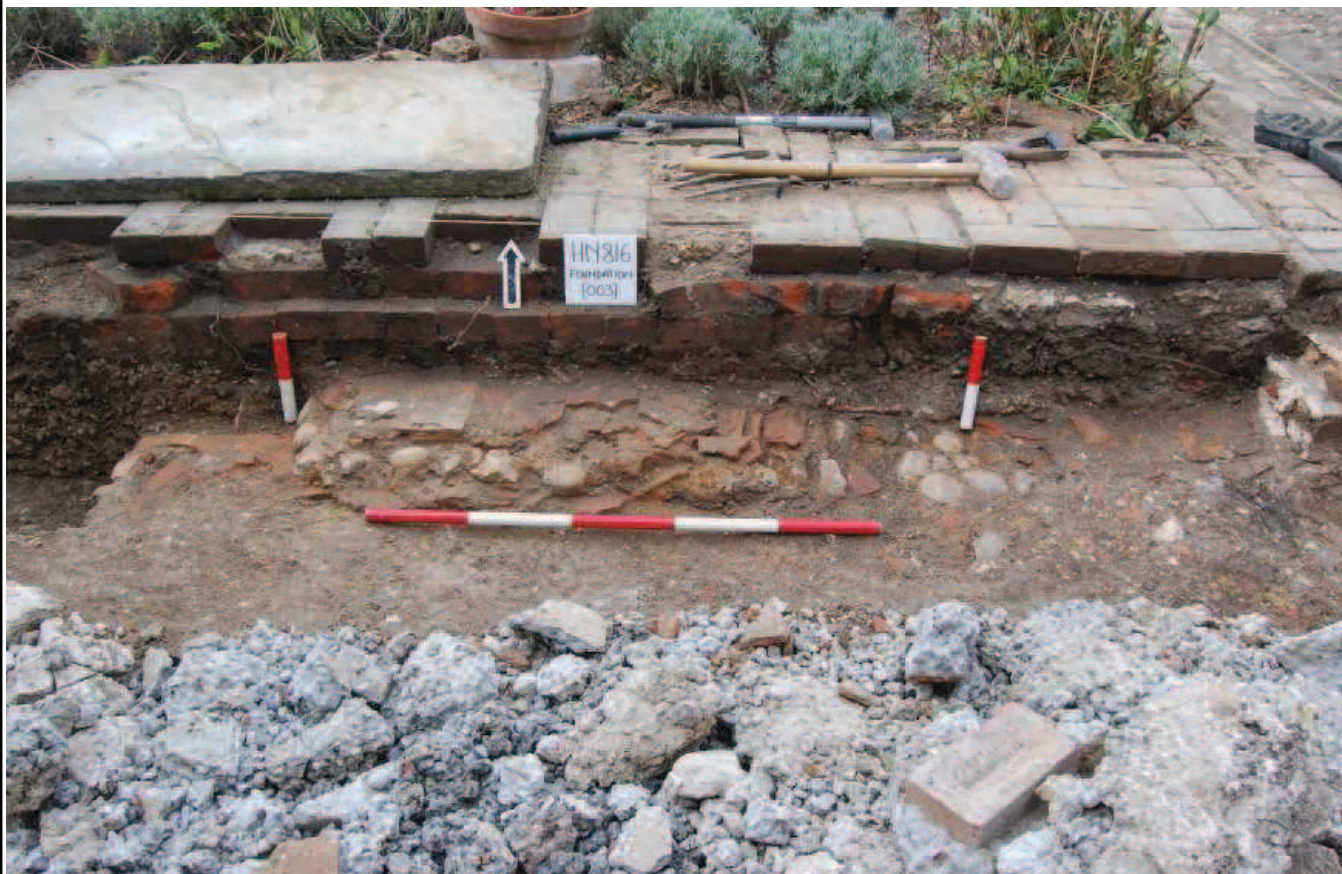
- 2.7.5** A line of 12 brick headers, [003], 3.95m in length, was observed below the present brick paving to the north of wall [002] (Figure 3; Plate 4). A shaped brick was recorded at either end, resting on the surface of the end bricks. This feature has been interpreted as the possible foundation to a former porch.

Plate 4: Brick foundation [003], looking north

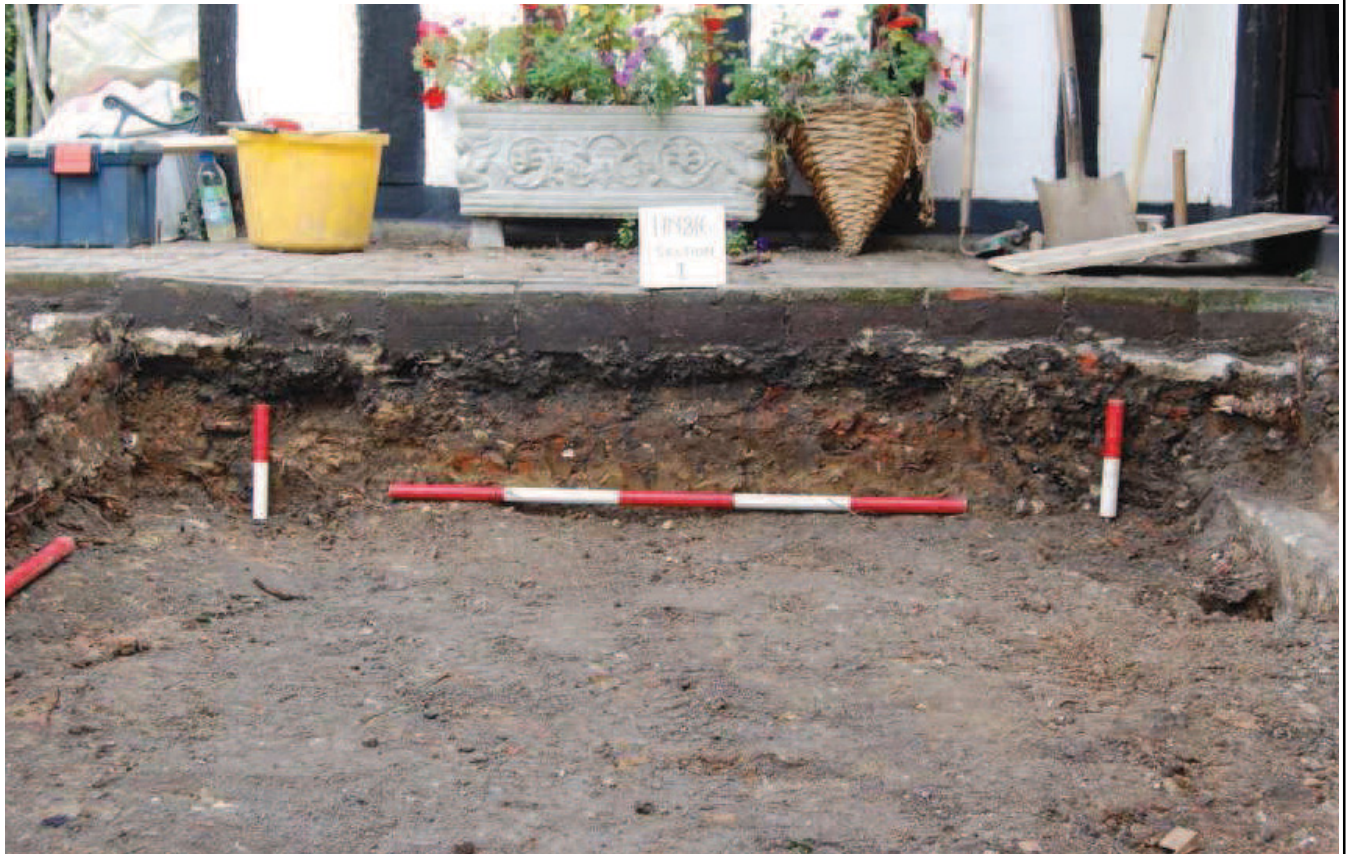
2.8 Section 1, on the western side of the baulk, retained to support the brick path giving access to the existing front door, revealed a layer of mixed material, 0.20m deep, which consisted of frequent tile fragments, frequent charcoal flecks and fragments, occasional lenses of mortar and occasional animal bone fragments, within a matrix of dirty redeposited natural clay (Figure 5; Plate 5). At the southern end of the section, 0.87m from the north wall of the present cross range, a cut was observed sloping down at 45° towards the wall. It contained broken tile and mortar fragments and a very high concentration of charcoal in a redeposited clay matrix. This feature has been interpreted as the foundation trench for the existing cross wall.

Plate 5: Section 1, looking east

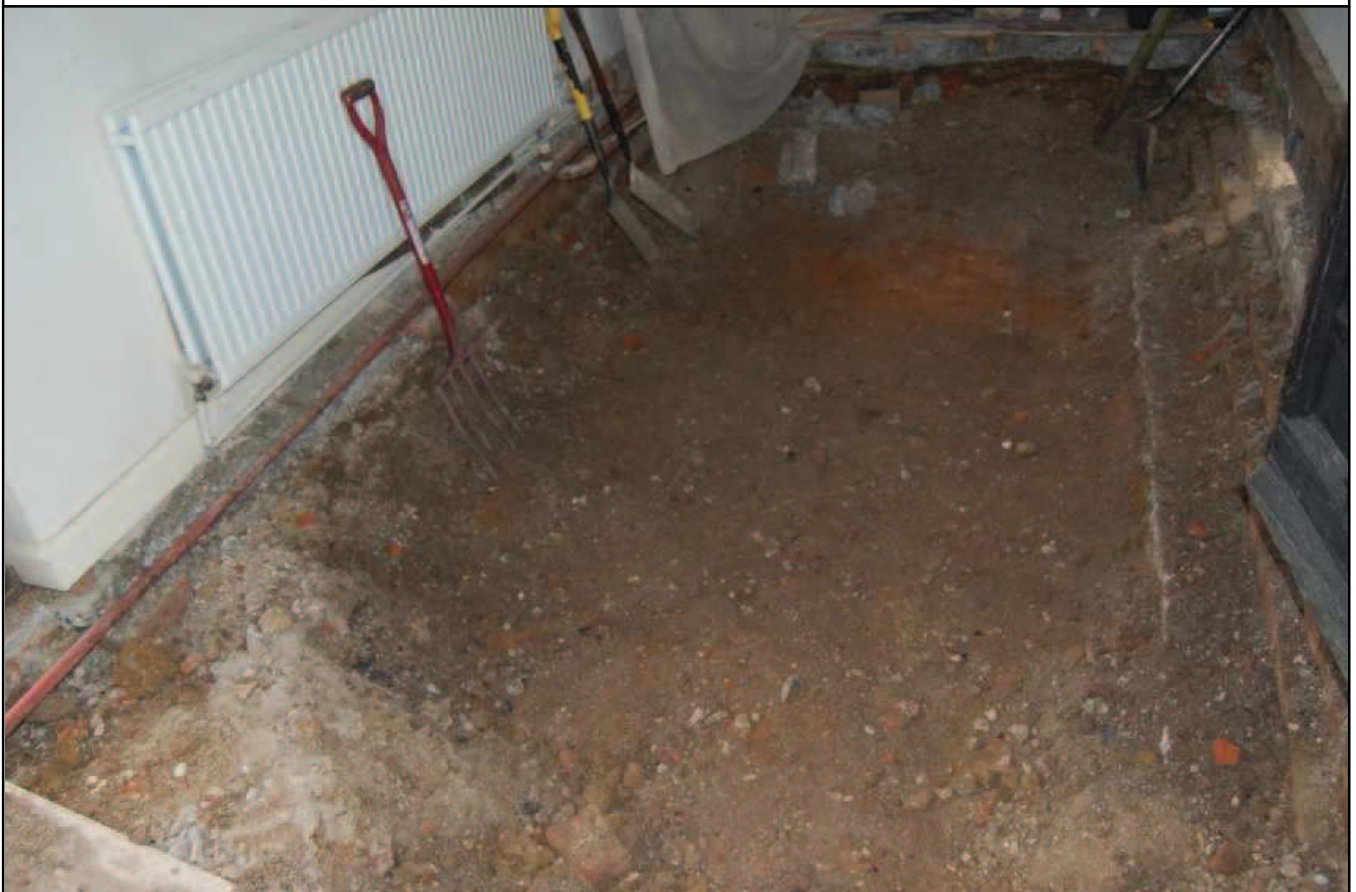
2.9 The floor on the interior of the existing cross range was lifted, exposing concrete and brick foundations to the northern and southern walls. The fill between the walls was similar to that noted on the exterior, comprising a mixed deposit containing burnt wood, charcoal, brick rubble, sand and mortar (Plate 6). This is almost certainly contemporary with the 1930s rebuild.

Plate 6: General shot of interior showing wall foundations and floor makeup

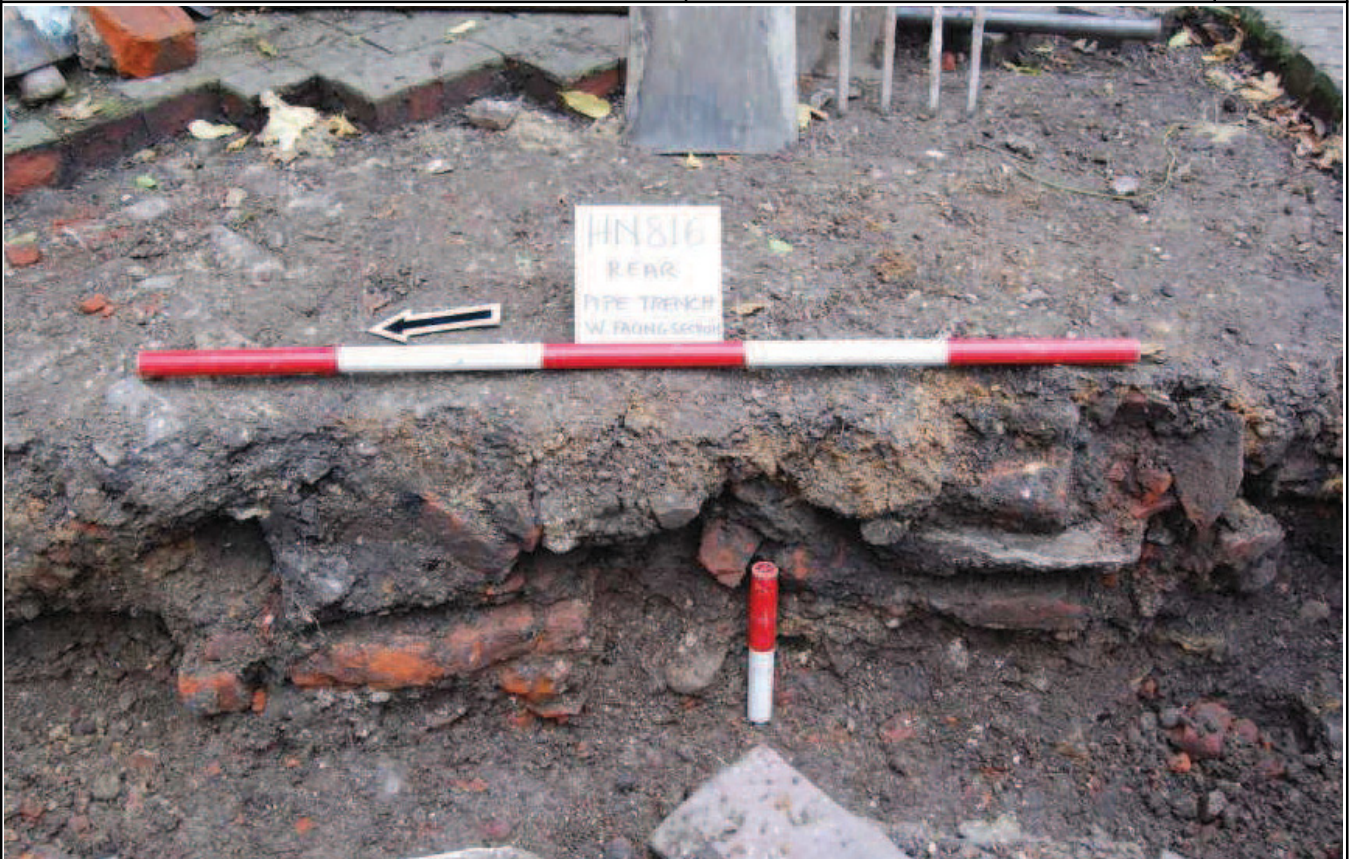
2.10 A pipe trench and a soakaway were excavated to the rear (south-east) of the existing cross range (Figure 6). The pipe trench, [011], which measured 3.97m in length, 0.35m in width and 0.45m in depth, ran on a north-west to south-east alignment across the rear patio. The patio is laid in a herringbone pattern and is formed of handmade frogged bricks of various sizes, some of which are stamped BEACH. The make up for the patio, which consisted of mixed rubble, including broken bricks, tile fragments and lumps of concrete, in a dark brown

sandy clay matrix, was observed in the trench (Plate 7). A ceramic drain was observed crossing the trench on an east – west alignment.

Plate 7: Section through pipe trench [011] across the rear patio, looking east

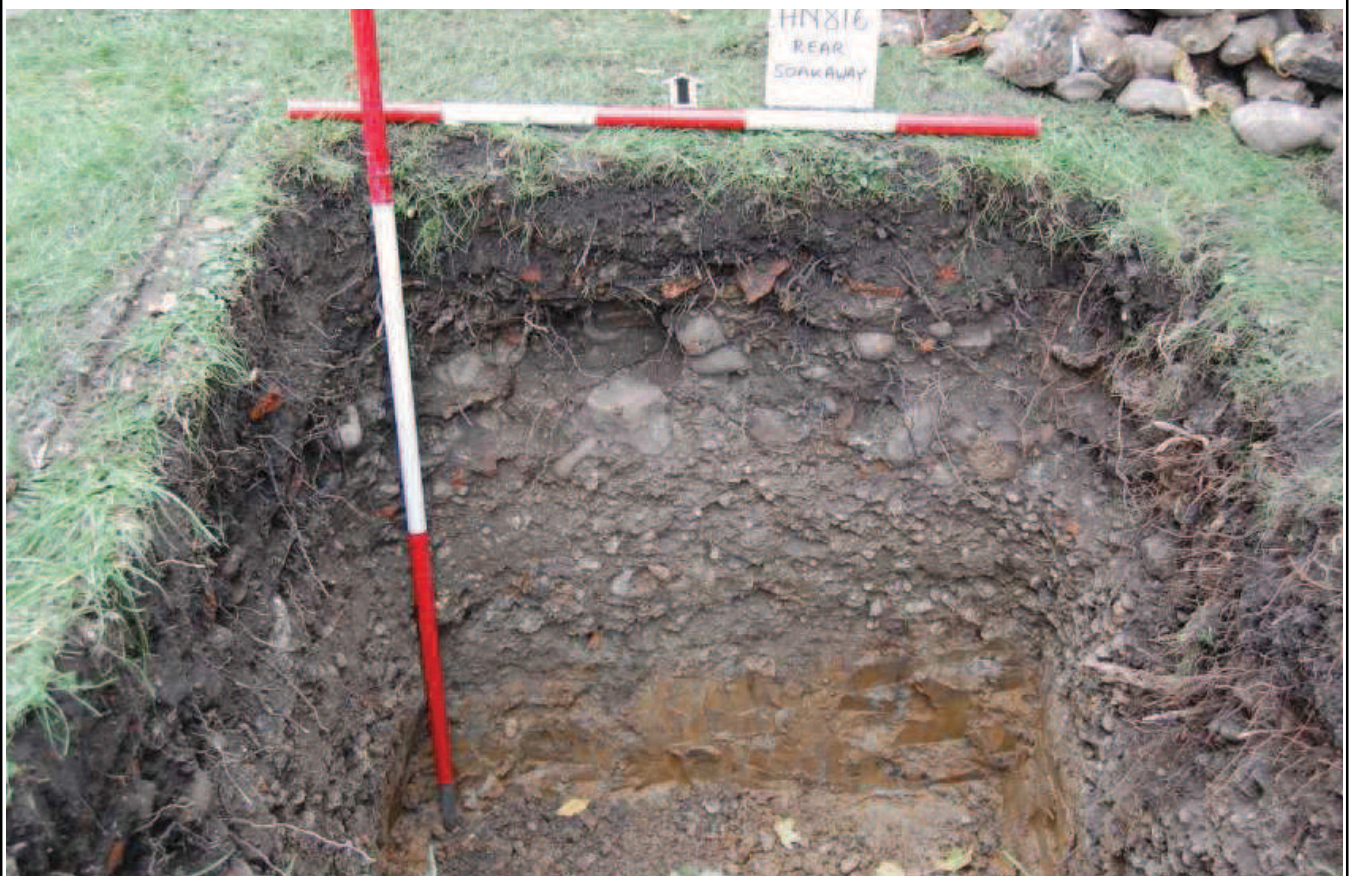
2.11 The soakaway, which measured 1.30m square and 1.20m in depth, was dug through the rear lawn (Figure 3). The sections were similar and revealed a layer of topsoil and turf, 0.15m in depth, above context (010) a dark brown silty sand humic layer, 0.30m in depth, which contained frequent small and medium stones, occasional tile fragments and much root activity (Figure 6; Plate 8). Below this was context (009), a layer of compact flint and gravel in a dark yellowish brown silty sand matrix, 0.18m in depth, which contained occasional tile fragments. This lay above context (008), a layer of compact gravel in a dark yellowish brown silty sand matrix, 0.30m in depth. Below this was the natural mid yellowish brown clay, with lenses of mid yellowish brown sand.

Plate 8: Soakaway pit, looking north
