**MANOR FARM**  
**62 High Street, Meppershall, Bedfordshire**

HN821

*Archaeological Monitoring Report*

Project ref.: HN821

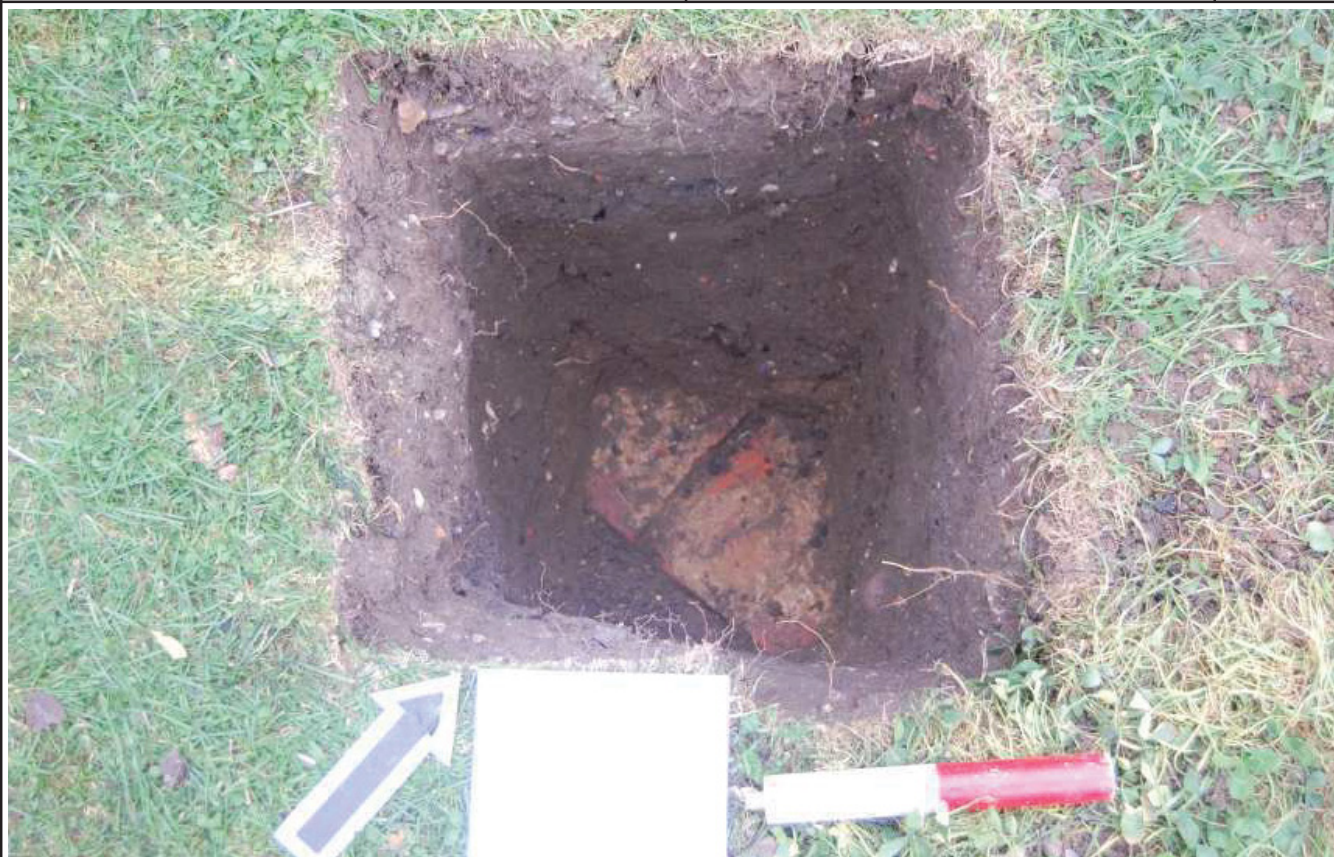
**2.12** A brick wall, running approximately east – west, was encountered at a depth of 0.65m below the present ground level (Plate 1). The exposed area had a maximum length of 0.21m and a maximum width of 0.25m. Only the surface of the structure was revealed. It was constructed from red unfrosted bricks of 19<sup>th</sup> century date, bonded with lime mortar. Following discussion with the owner it was interpreted as part of an outbuilding to the rear of the house, marked on mid-19<sup>th</sup> century maps and demolished in the 1880s. Its eastern continuation was investigated as context [104] during the course of the ground reduction (see below & Figure 4).

Plate 1: Brick structure in test pit

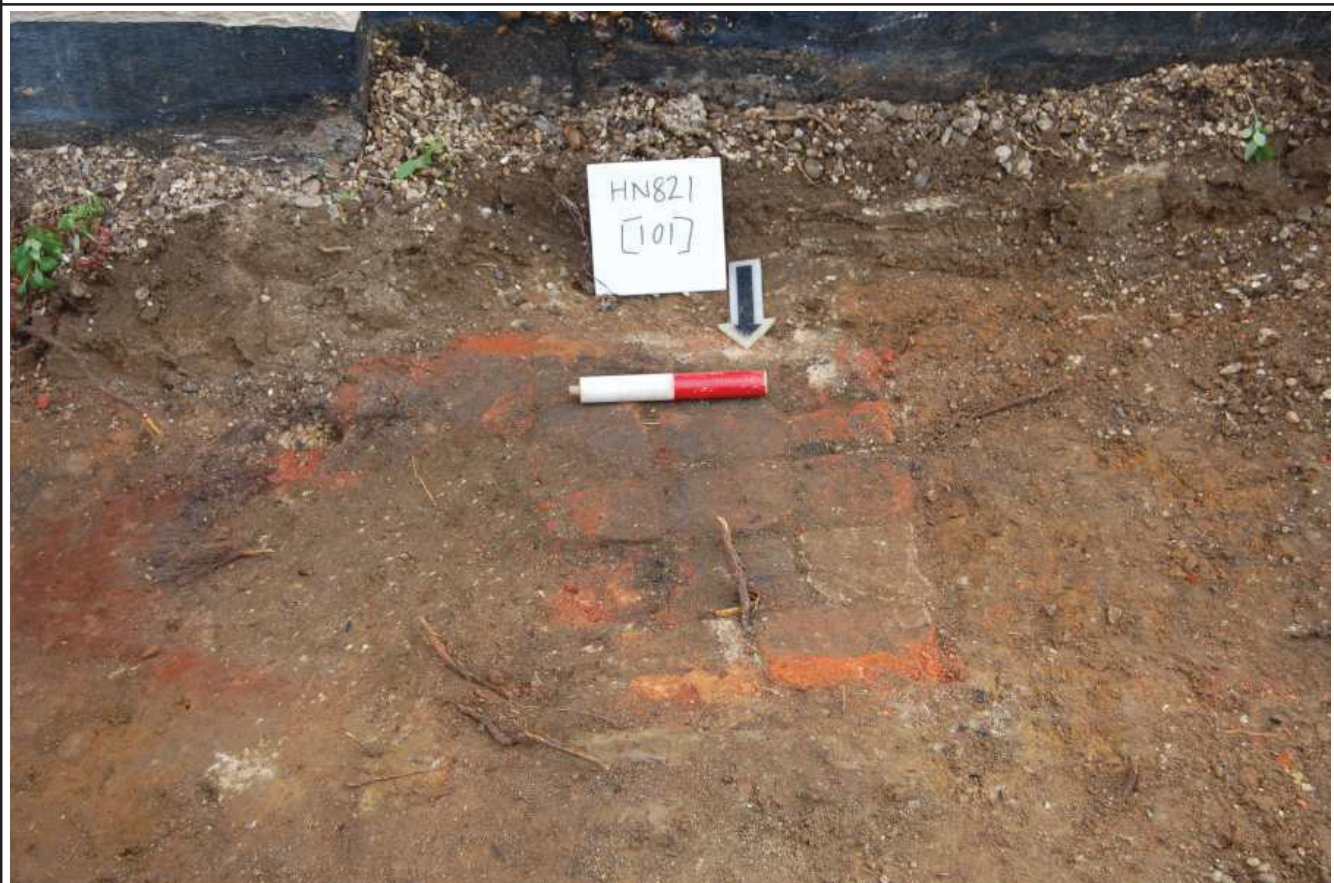
Plate 2: Brick surface [101], looking south

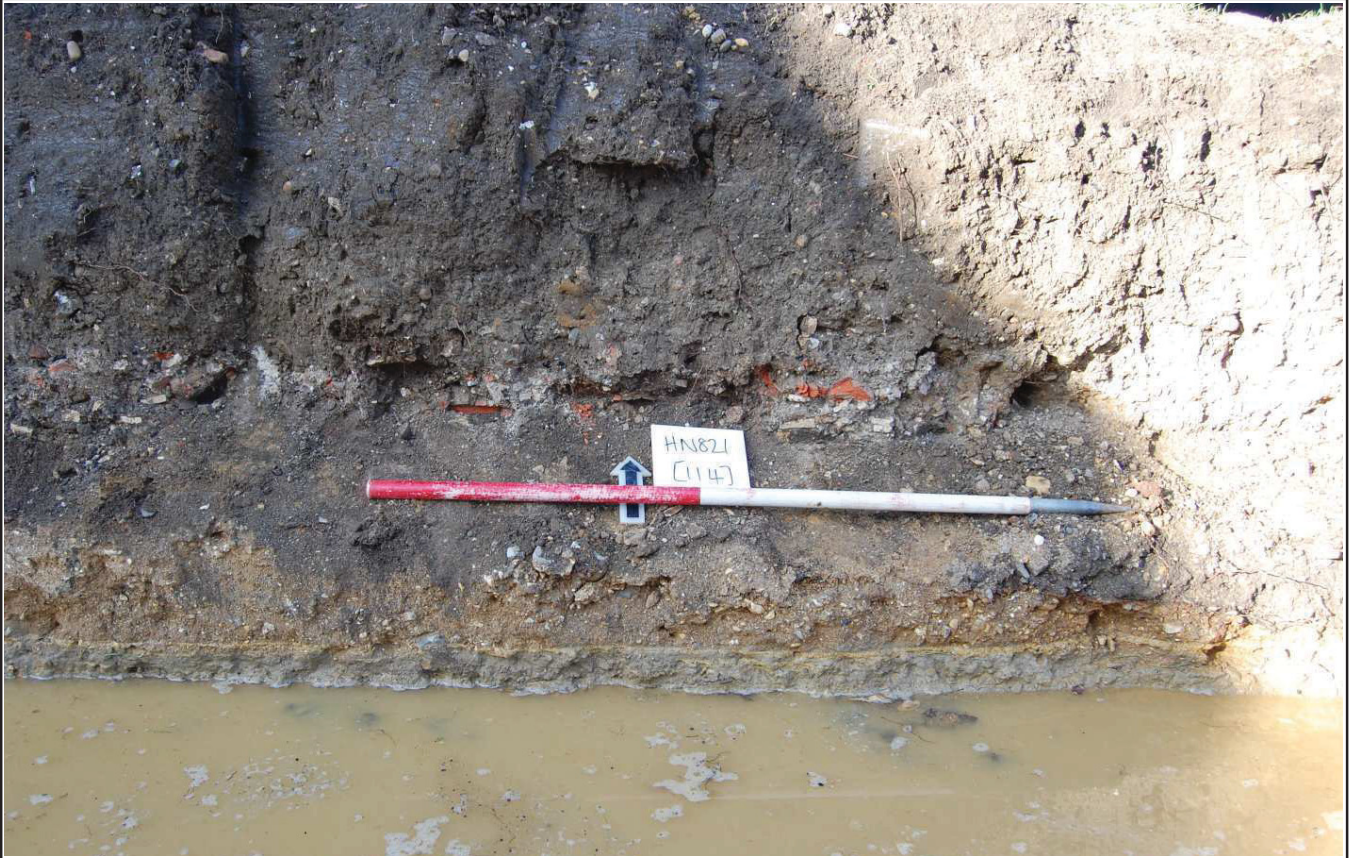
**2.20** Feature [114] was observed in the northern baulk at a depth of 0.60m. The exposed area consisted of a narrow band of brick and tile rubble, 2.6m in length and 0.08m in depth (Figure 5; Plate 3). The brick and tile fragments, which had mortar attached, have been dated to between c.1450/1500 and 1650/1700. Not enough of the feature was exposed to determine whether it represented a structure or a demolition layer / surface.

Plate 3: Layer (114), looking north

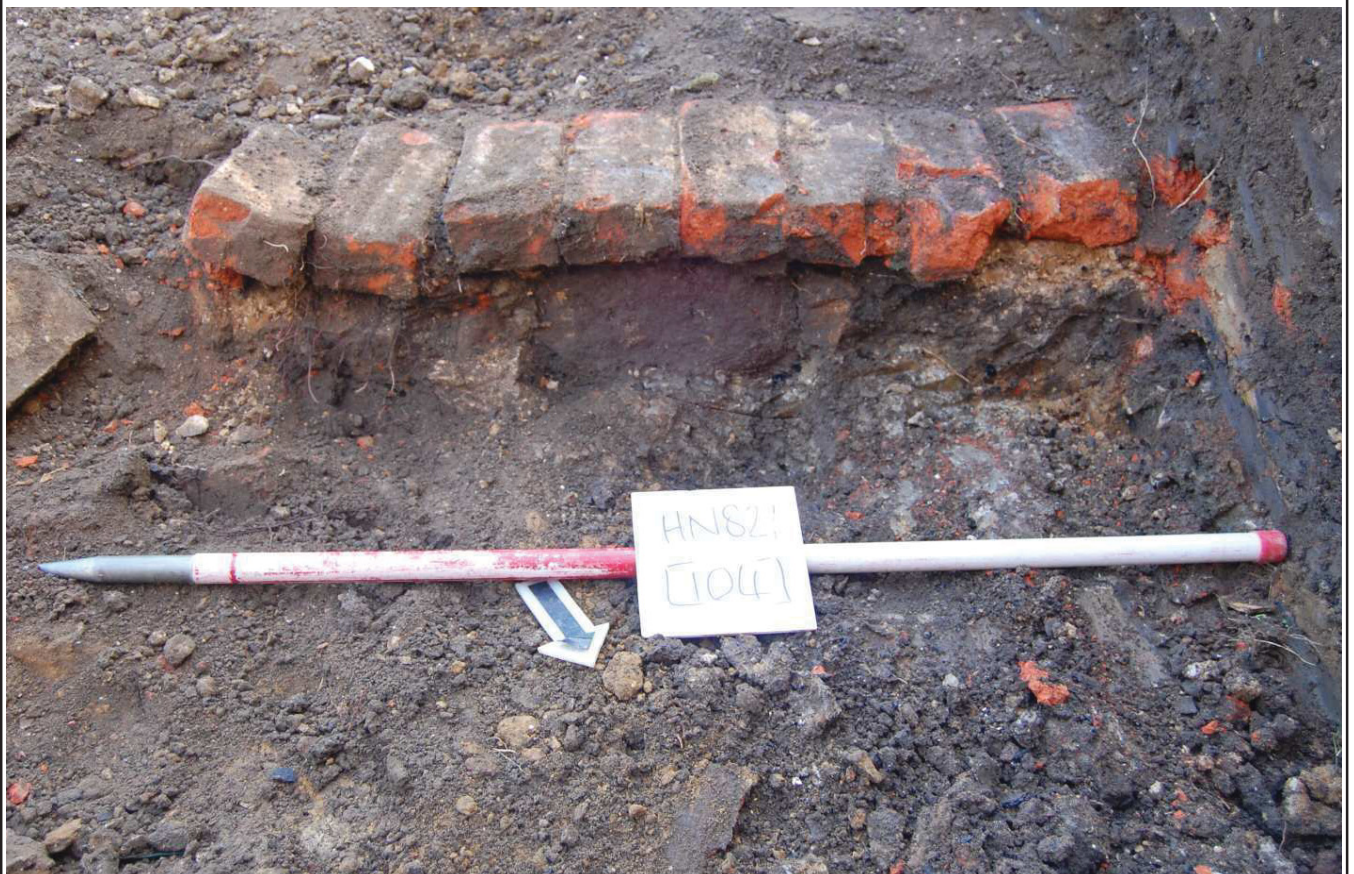
**2.21** Feature [104] represents the lower course of a north-west to south-east aligned wall which had slumped forward (Plate 4). It measured 0.98m in length and 0.24m in height and was located on the western edge of the excavation area (Figure 4). It represents the eastern continuation of the wall identified in the test pit. Bricks from this feature date to the 1870s.

Plate 4: Wall [104], north-east facing elevation

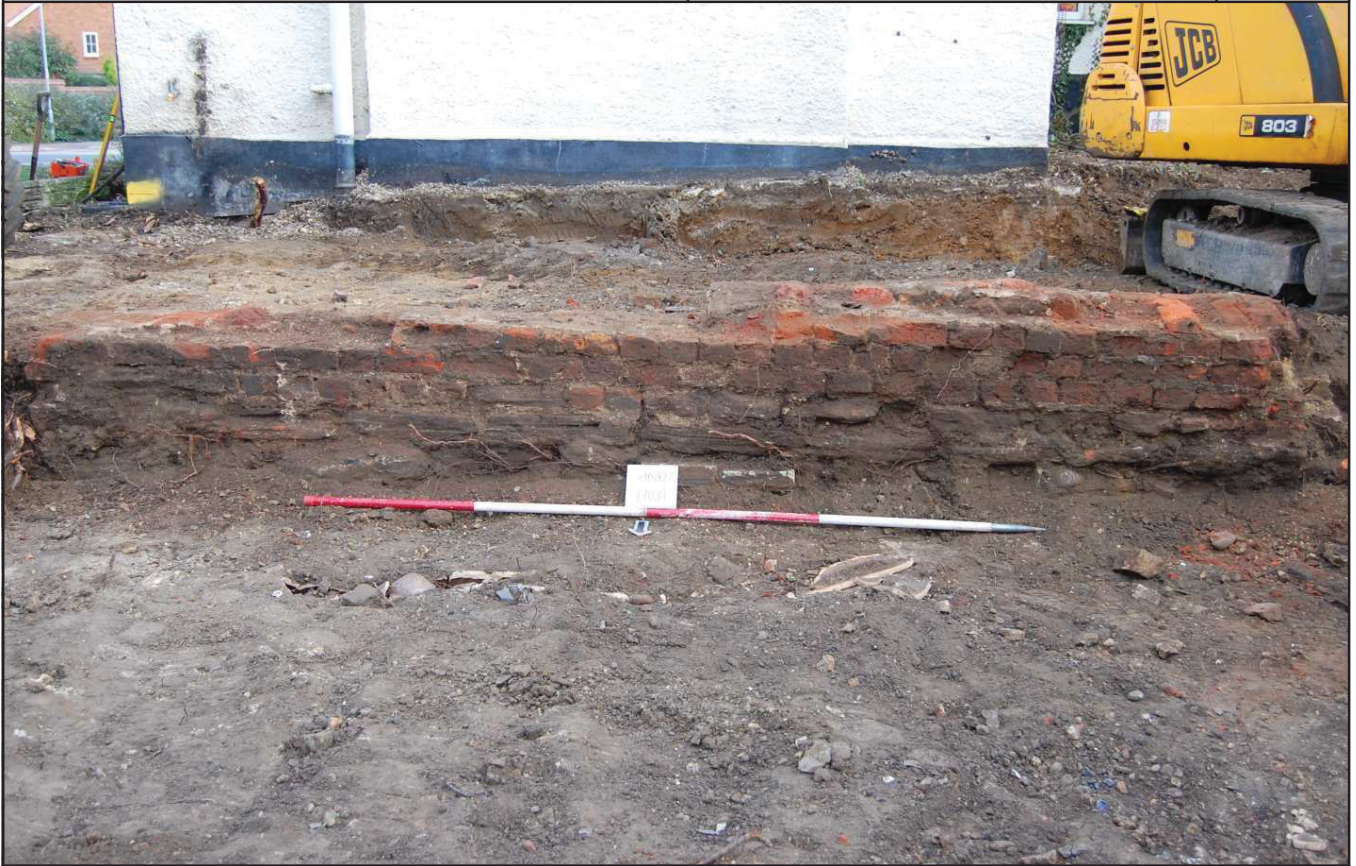
**2.22** Wall [103] ran on an approximate east – west alignment 3.92m to the north of the existing building (Figure 4). The wall was built of red bricks, bonded with lime mortar, and survived to a height of 0.72m (6 courses) (Plate 5). The bricks have been dated to the 1840s/50s. The wall may represent the lower courses and foundations of the rear wall to an earlier range of the present house which, according to records held by the client, had been used as a farm shed since at least the 1920s and was demolished in 1949 (Sandra Read, *pers. comm.*).

Plate 5: Wall [103], north facing elevation

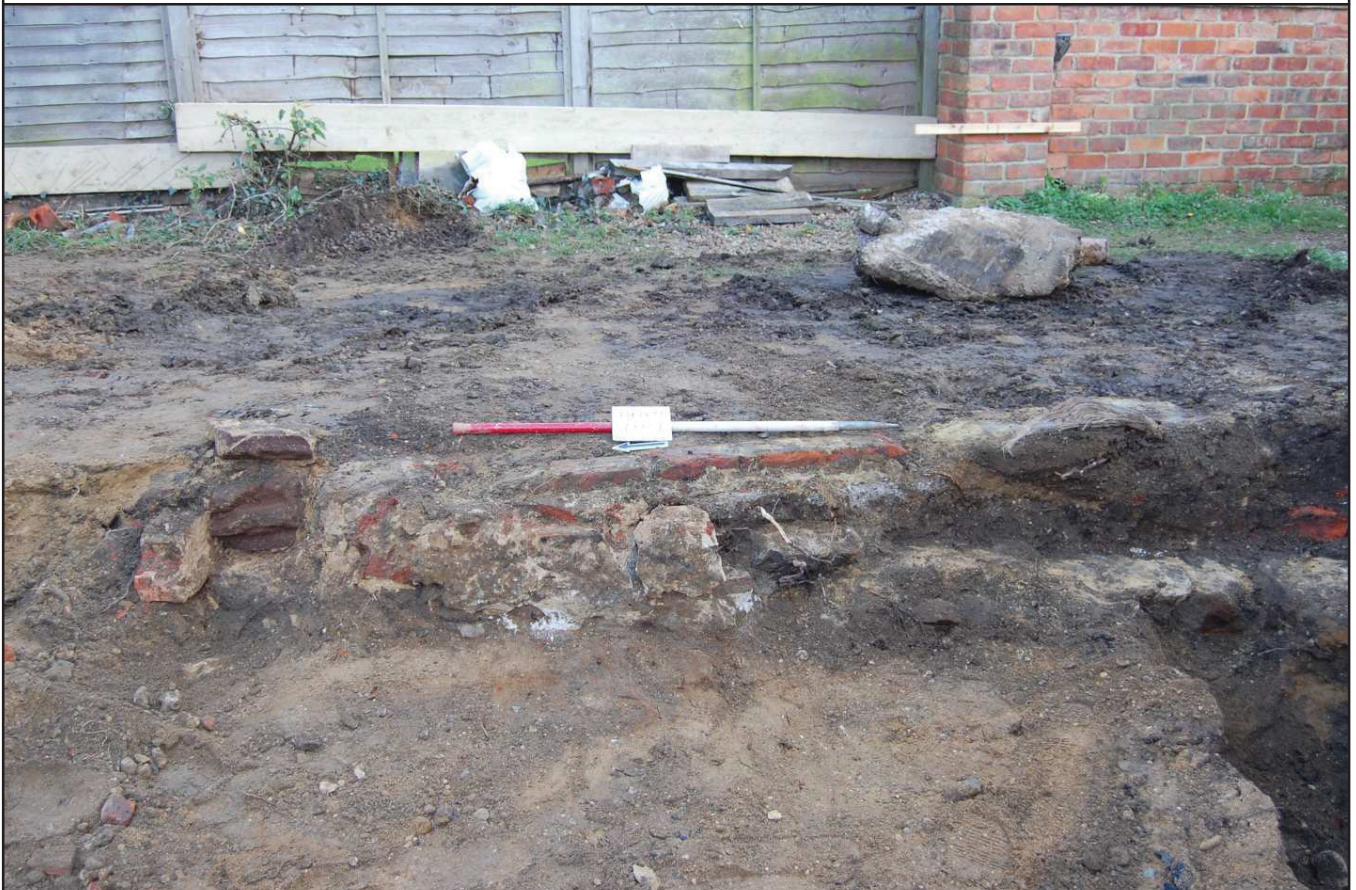
**2.23** Wall [113] ran north to south along the eastern side of the rear extension (Figure 4). It measured 3.35m in length and survived to a maximum height of 0.44m and was constructed from red bricks bonded with lime mortar (Plate 6). The bricks represent footings bricks and have been dated to the 1850s. The wall had a sandstone block foundation and could also be part of the demolished range. Walls [103] and [113] appear to be contemporary, although no clear stratigraphic or physical relationship could be demonstrated.

Plate 6: Wall [113] looking east

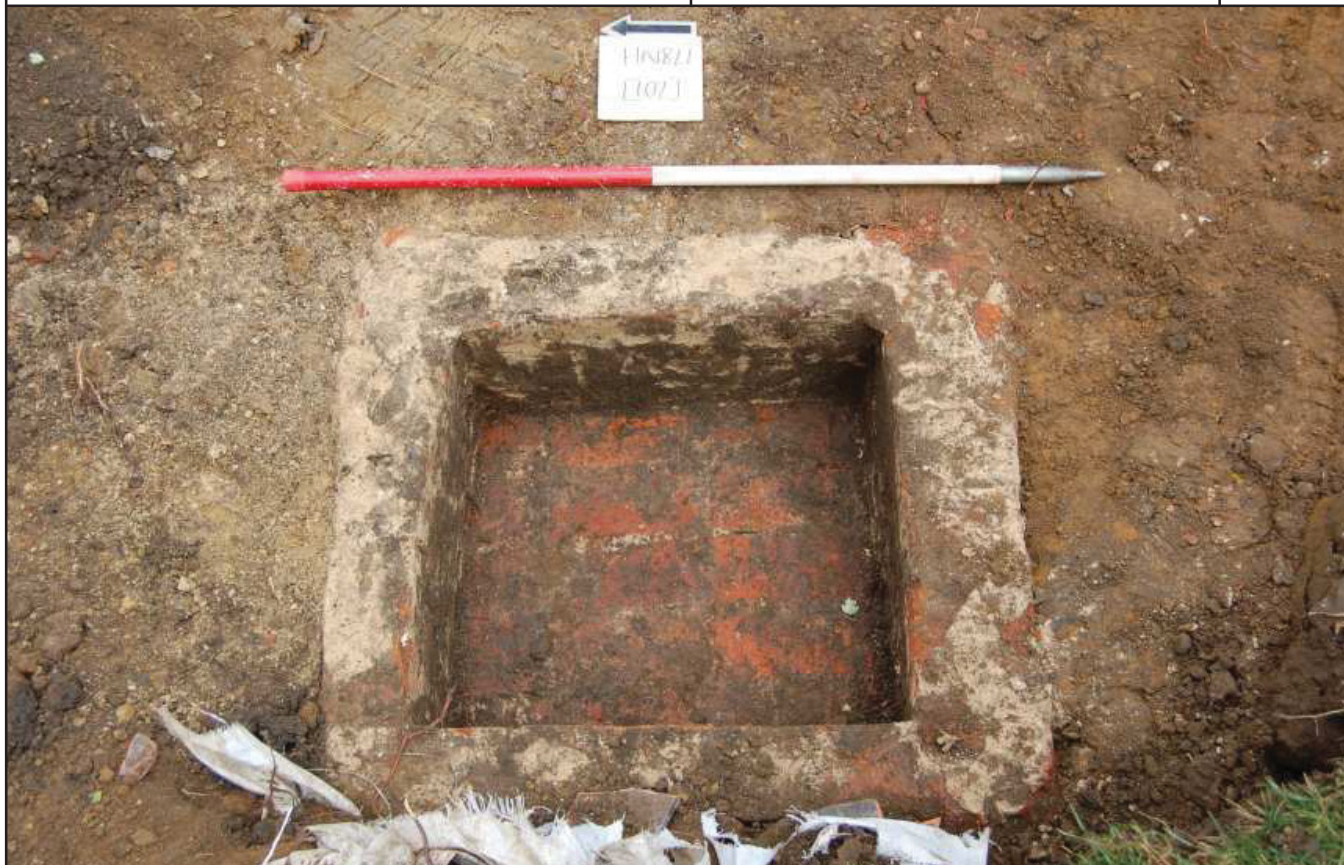
**2.24** Structure [102] was a rectangular brick lined pit, aligned north-east to south-west and located on the western edge of the excavation area, approximately 6m north of the existing house (Figure 4). The feature was observed at a depth of 0.30m below the present ground level. Its external dimensions measured 0.80m x 0.90m, with internal dimensions of 0.65m x 0.55m and a depth of 0.30m. It was constructed from red brick, bonded with lime mortar and rendered on its internal surface (Plate 7). The bricks have been dated to the 1840s. There was no evidence to suggest a possible use, though it has previously been interpreted as an ice store (HER 16164).

Plate 7: Structure [102], looking east

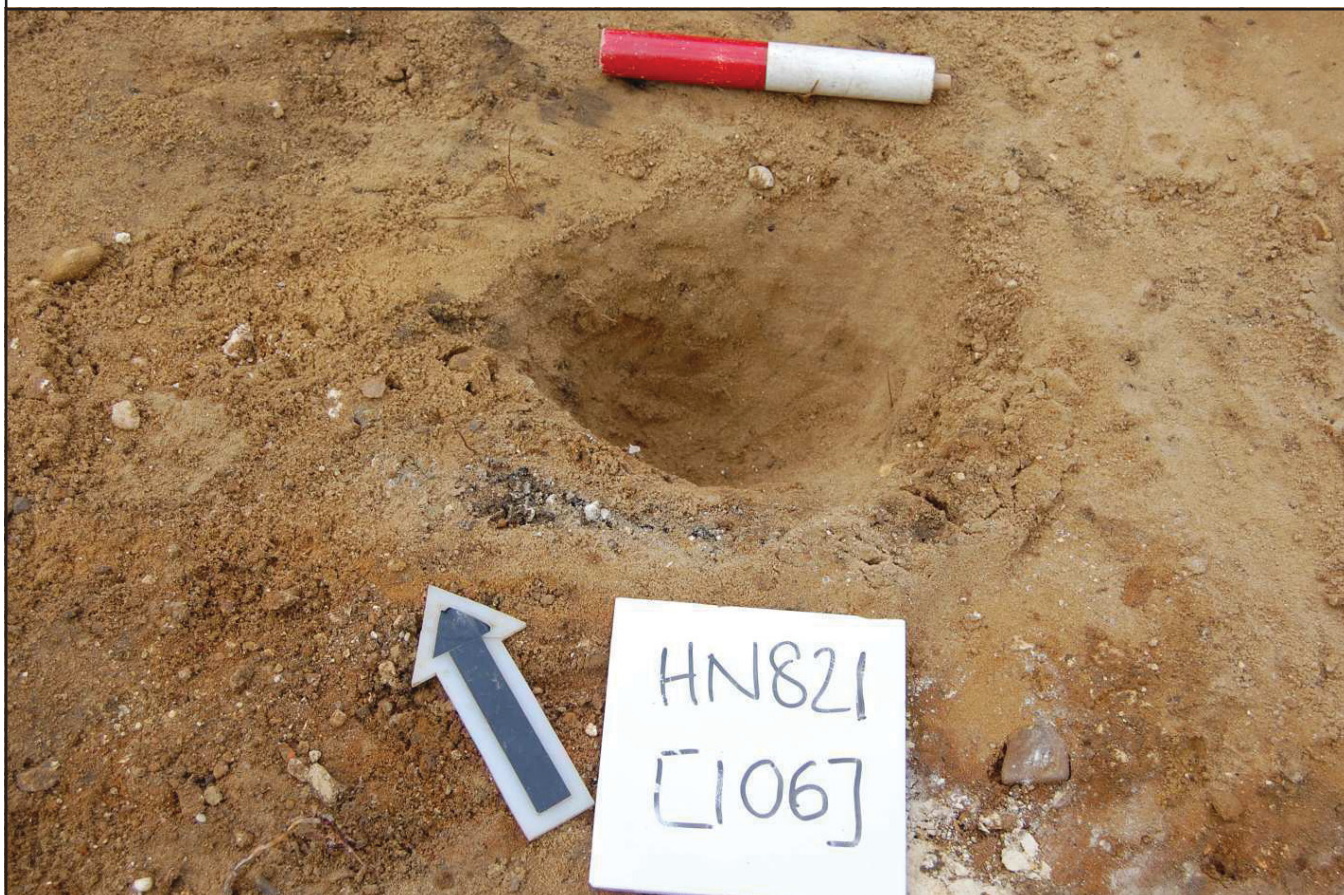
**2.25** Feature [106] was a small sub-circular pit, measuring 0.55m in length, 0.40m in width and 0.34m in depth. It was located in the centre of the excavation area and was observed cutting the natural sand at a depth of 0.80m below the existing surface (Figure 5). The feature contained fill (105), a loose yellowish brown (10YR 5/8) sand (Plate 8). A small pit or posthole, cut [108], was located 0.40m to the north-west. This measured 0.28m in length, 0.20m in width and 0.20m in depth and contained fill (107), which was similar to fill (105) and suggests that these features may be contemporary. No finds were present to date either feature.

Plate 8: Pit [106] looking north east

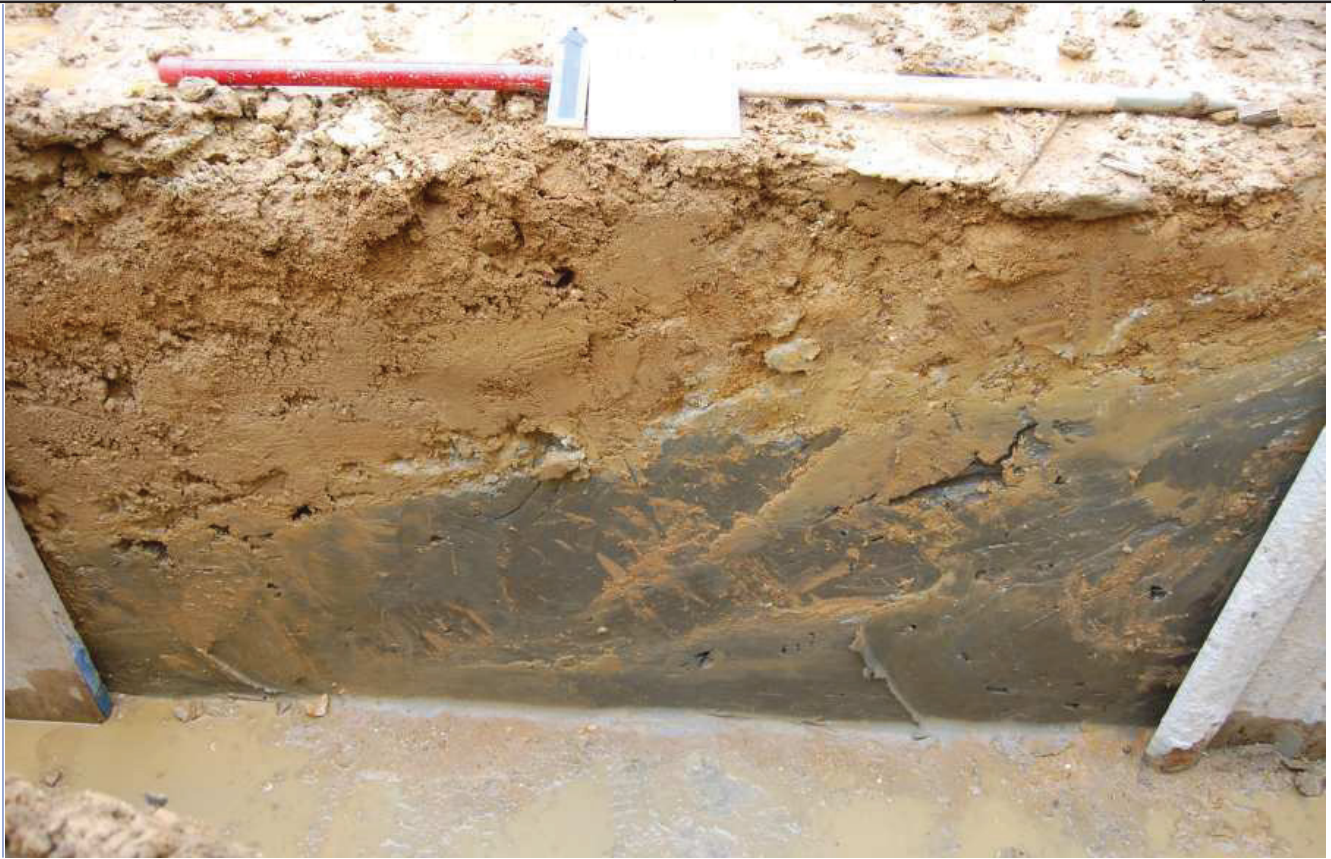
**2.26** A seam of natural dark grey (5Y 4/1) clay was observed running through the natural sand, across the south-western corner of the excavation area, on a north-west to south-east alignment (Figure 5; Plate 9). On the surface this seam was 0.80m in width, but it became wider as the depth increased.

Plate 9: Section showing natural sand and clay seam in N footings trench

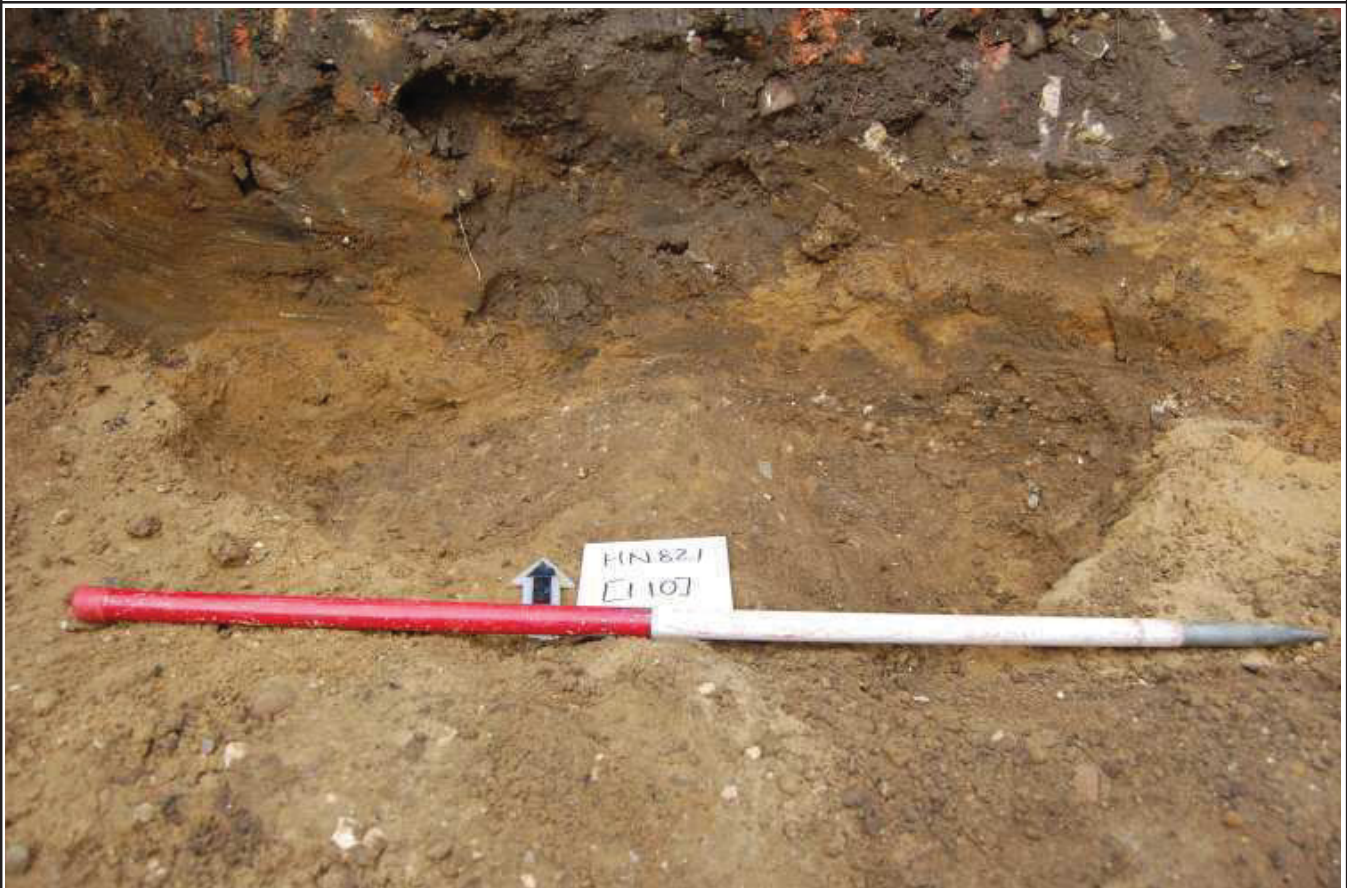
**2.28** Two associated pits, cuts [110] and [118], were encountered in the north-western corner of the northern footings trench (Figure 5). Cut [110] lay on the western side and had a V-shaped profile with irregular sides and base measuring 0.60m in width and 0.20m in depth. It contained fill (109), a loose yellowish brown (10YR 5/6) sand with occasional tile fragments dated to the late medieval / early post-medieval period. Cut [118] was located immediately to the east of [110] and was similar in nature, comprising a V-shaped profile with irregular sides and base measuring 0.55m in width and 0.20m in depth. It contained fill (117), which was very similar to (109).

Plate 10: Pit [110] looking north
