Land at THE ROSE AND CROWN 14 London Road, Sandy

Archaeological Evaluation Report

Project ref.:HN826
Accession no.: BEDFM 2009.62
LPA ref.: MB/TP/08/191

Report no. 565

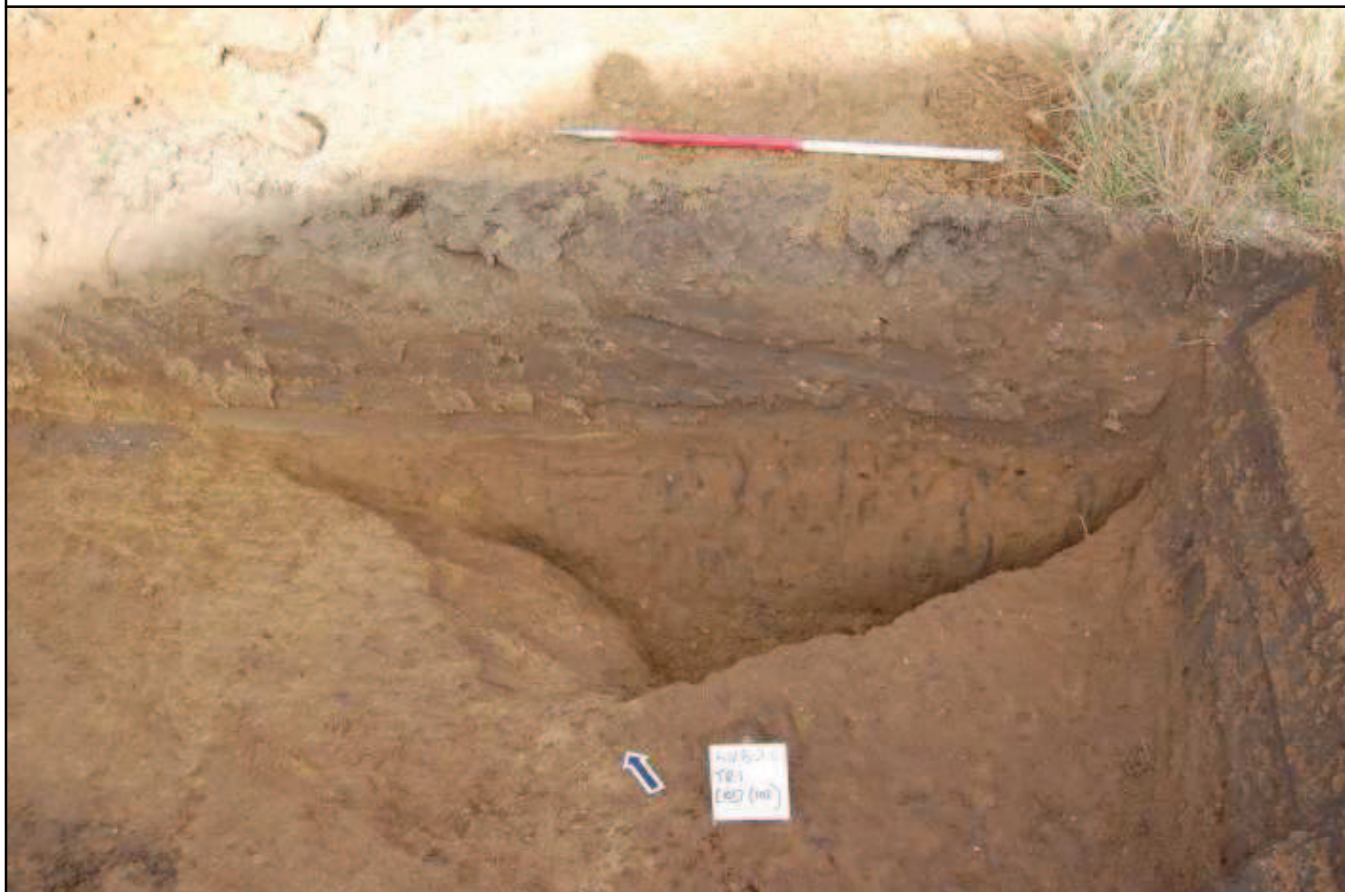
Plate 2: Ditch [101], looking northeast

3.13 An undated ditch, cut [101], was encountered at the eastern end of Trench 1. This was aligned with the existing site limit and appeared to curve slightly to follow the course of Church Street to the east. A possible prehistoric flint flake was the only dateable artefact recovered from the fill of this feature, though it is likely that this is residual in a later feature. Nevertheless, its presence indicates prehistoric activity in the vicinity. A second possible prehistoric flint flake was recovered from fill (108) in pond [103].

- No clear dating evidence was recovered from Ditch [101] at the eastern end of Trench 1. However it follows the alignment of Church Street and the later features appear to respect the feature, suggesting that it is medieval or post-medieval in date and represents the eastern boundary to the plot. A possible prehistoric flint flake was recovered from its fill, but this is likely to be residual.

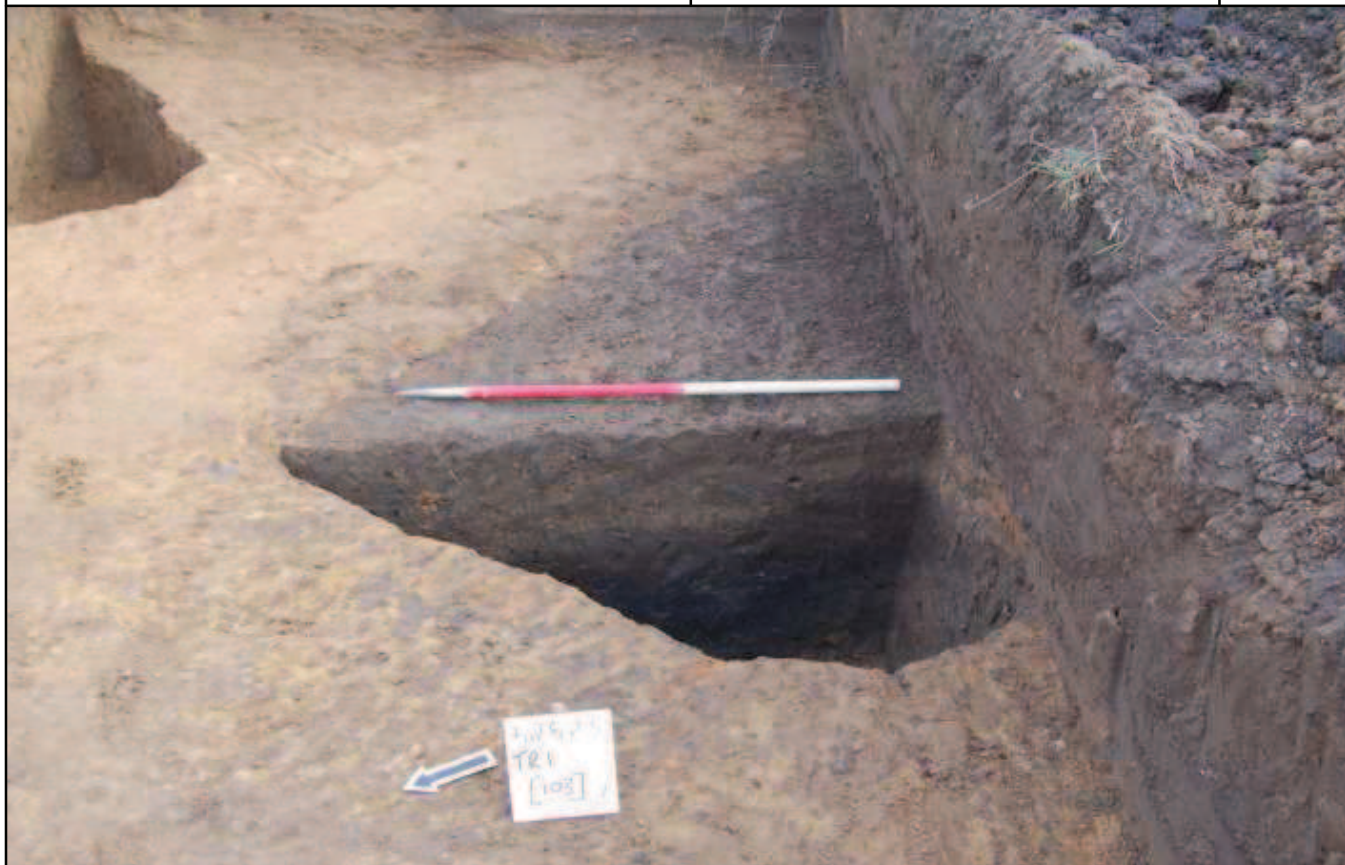
Plate 3: Pit [103], looking southwest

3.11 The garden also contained a pond, cut [103], which was recorded at the eastern end of Trench 1. This contained a number of fills, several of which included organic material. Pottery of 19th and 20th century date was recovered from its fills.

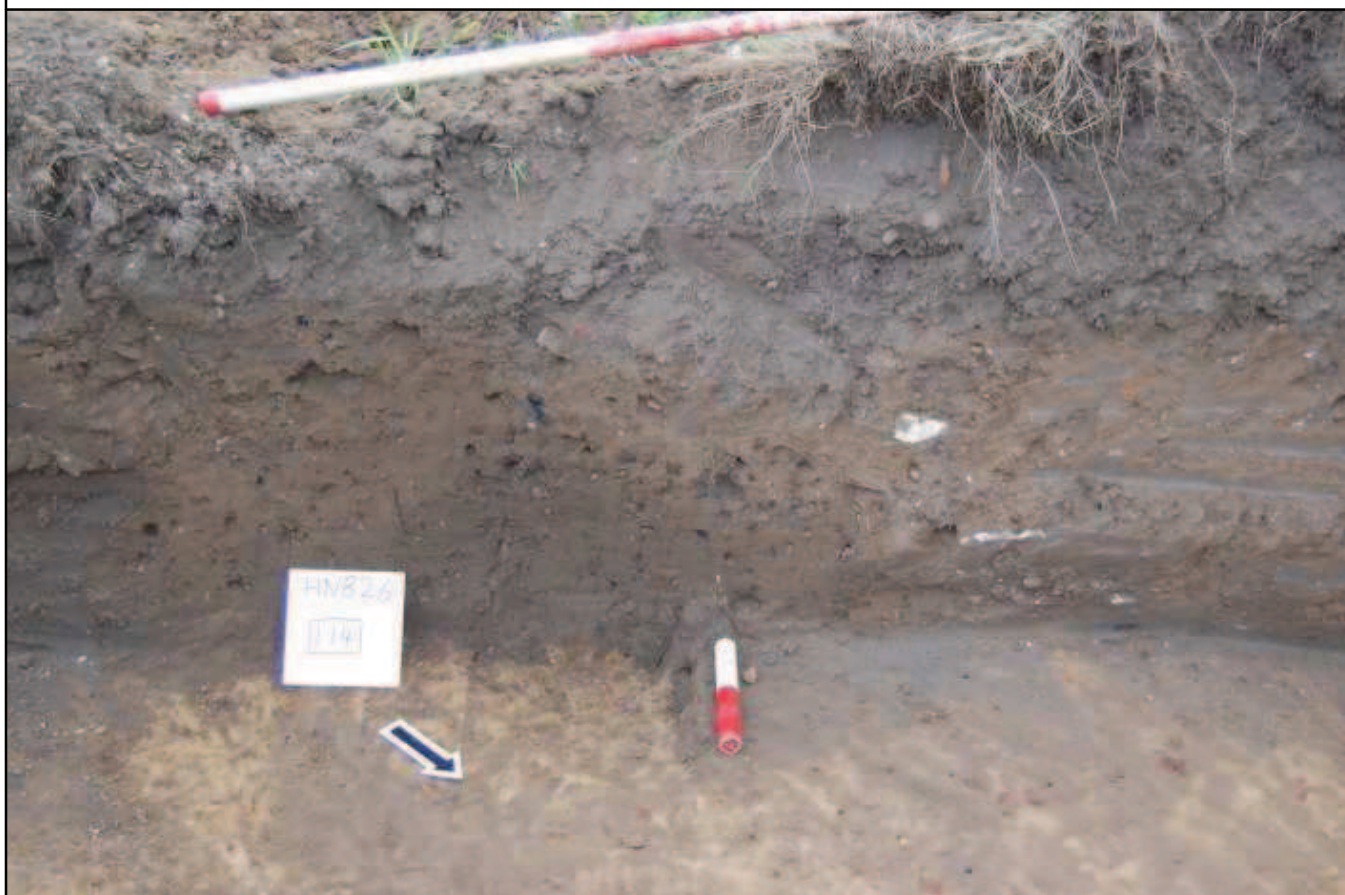
Plate 4: Pit [114], looking southwest

orientation as the existing rear boundary and appear to be the remains of a series of possible horticultural features (Figure 3, Plates 4 and 5). Two postholes were observed at the northwest end of the trench (Figure 3, Plates 6 and 7). These were very close together and may represent different phases of a former fence line.

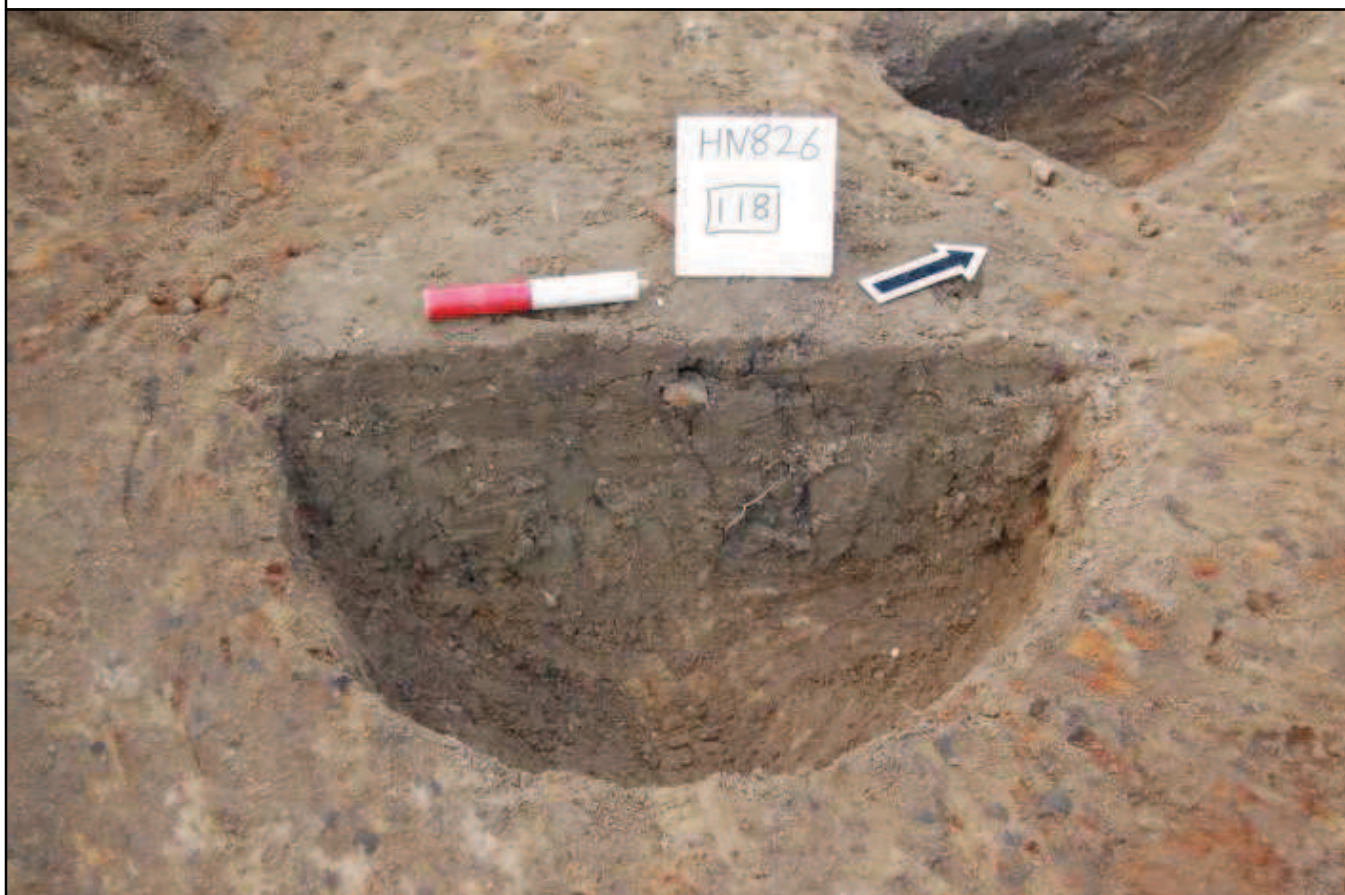
Plate 6: Posthole [118], looking northwest

3.10 Two postholes were also observed in Trench 1, cuts [118] and [120]. These are contemporary with the other post-medieval features and possibly represent different phases of an internal fence.

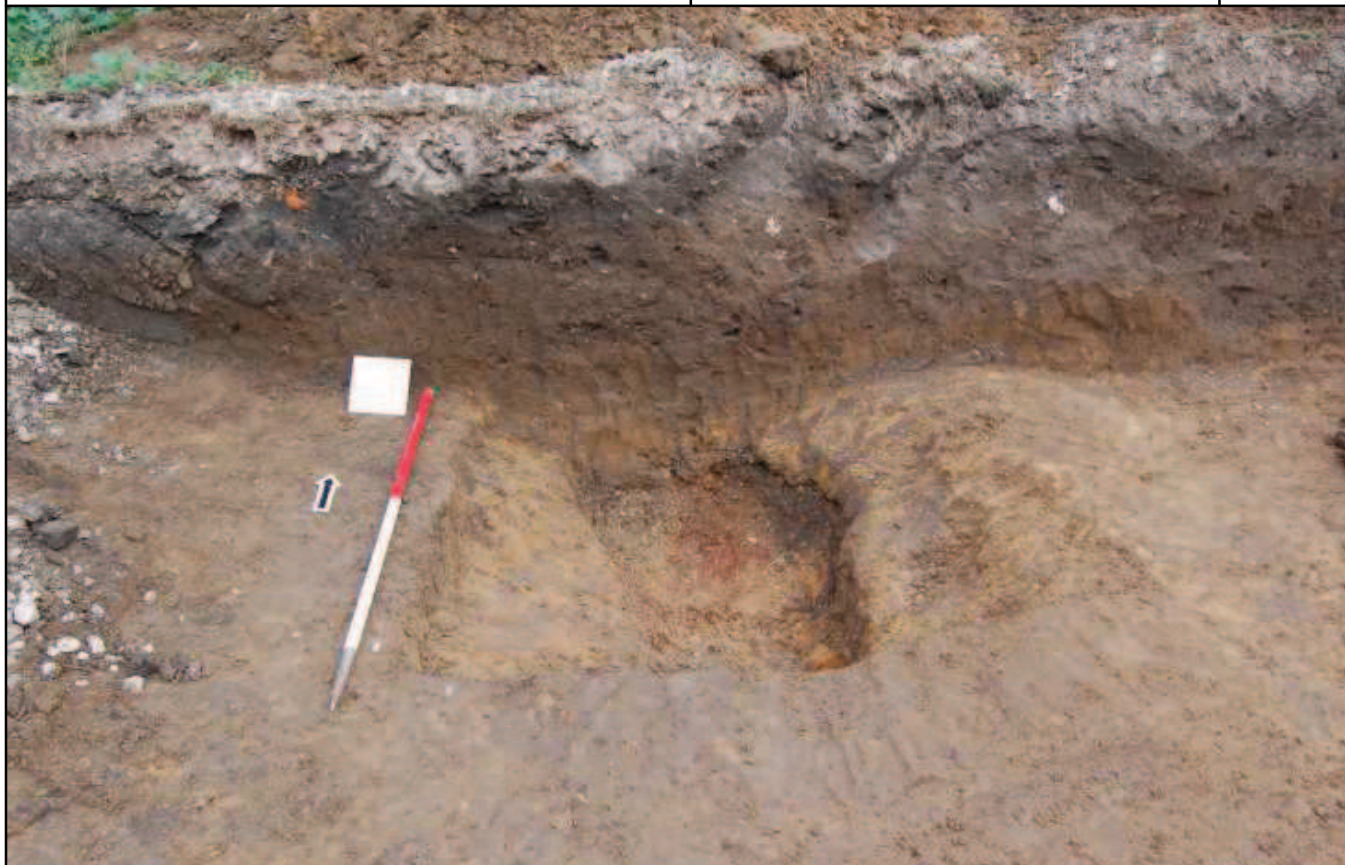
Plate 9: Layer (201), looking northeast

2.12 Trench 2 was located to the southeast of the Rose and Crown (Figure 2, Plate 8). The trench contained a layer of dumped material (201), from which one sherd of late Saxon pottery was recovered, and a possible horticultural feature [202], similar to those observed in Trench 1 (Figure 3, Plates 9 and 10).

2.15 The single body sherd from dump layer (201), which weighs 14g, displays very little abrasion and is hand made. It is tempered with quartz sand and frequent, but ill-sorted, shell and equates to Bedfordshire fabric A05. The sherd is likely to date from the 8th to 9th/10th century AD and may have been imported onto the site in the modern period.

- The origins and development of the settlement at Girtford.
 - A single sherd of late Saxon pottery was recovered from layer (201) in Trench 2. Although this is likely to have been imported on to the site, the nature of the layer suggests that it was not brought in from a great distance and indicates activity of this date in the vicinity.

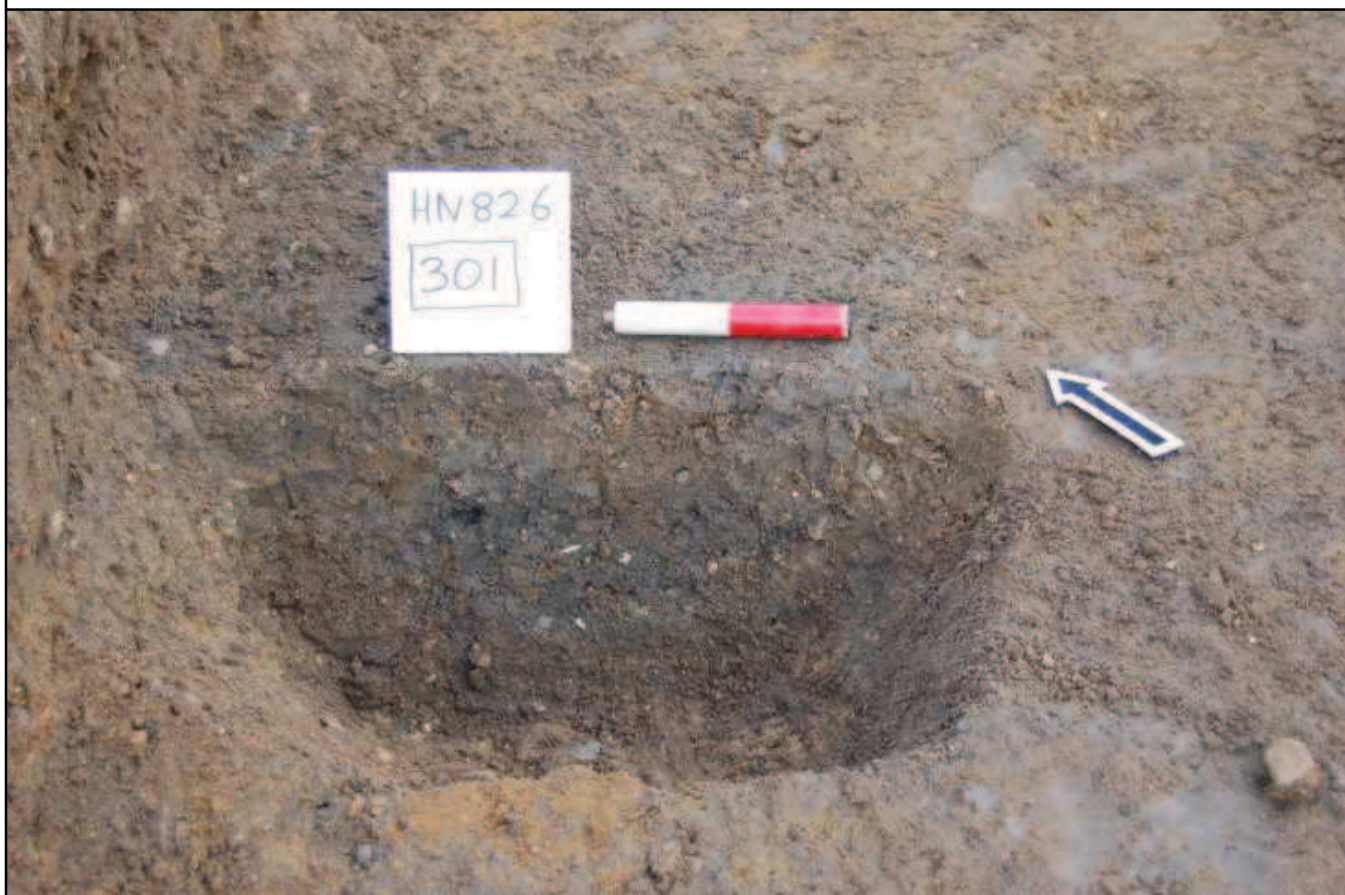
Plate 12: Posthole [301], looking northeast

2.13 Trench 3 was located at the east end of the site in the area of the new garage block (Figure 2, Plate 11). Posthole [301] (Figure 3, Plate 12) was observed at the northeast end in an area of slightly higher ground. Pottery sherds from 1 vessel, dating to the early post-medieval period, were collected from its fill. A series of walls were observed at the southwest end of the trench (Figure 3, Plates 13 and 14). These align with the existing barn and possibly represent the remains of an extension to this structure. A number of make-up layers were observed beneath this and the natural geology appears to have been reduced in this area.

2.16 The 7 body sherds from context (302) (Bedfordshire fabric P02), all belong to the same vessel and are dated from the very late medieval to early post-medieval period (c. AD1550/1600 to 1700).

- Pit [301] at the northeastern end of Trench 3, contained pottery sherds, brick and tile fragments of 16th/17th century date and may represent a domestic rubbish pit relating to a late medieval or early post-medieval property fronting the Great North Road.

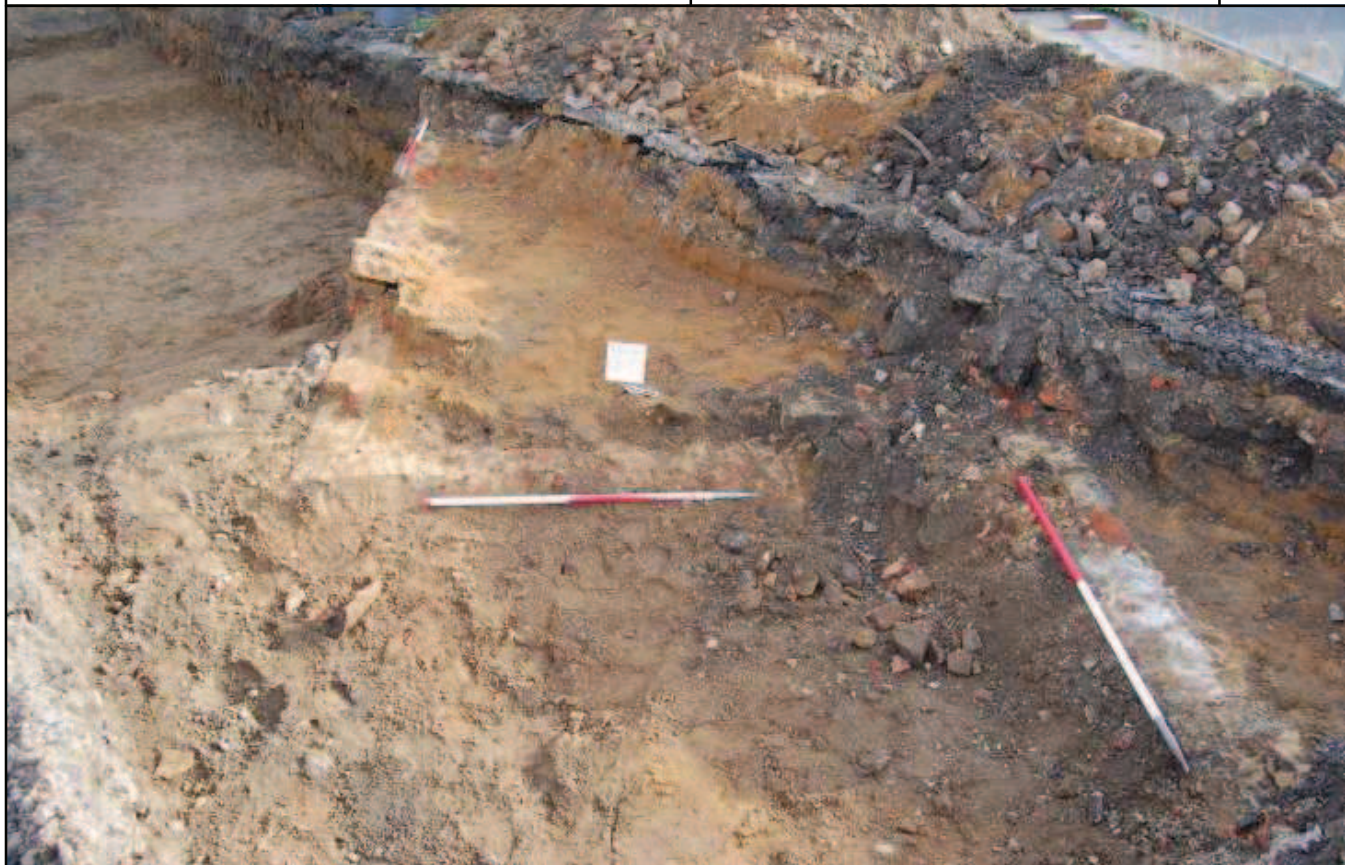
Plate 13: Wall [303], looking east

3.12 A series of brick walls were encountered at the southwestern end of Trench 3, structure [303]. These probably represent the original southwestern end of the 19th barn that currently stands in the southwestern corner of the site. Late 19th century OS maps show that it originally extended further to the southwest. It seems likely that construction of these features will have removed any earlier archaeological remains from this area, as a pit containing very late medieval/early post-medieval pottery was encountered at a higher level to the northeast.
