Church Hall Extension ST. ANDREW'S CHURCH Biggleswade, Beds.

HN843

Stage III: Archaeological Monitoring Report

Report no. 585

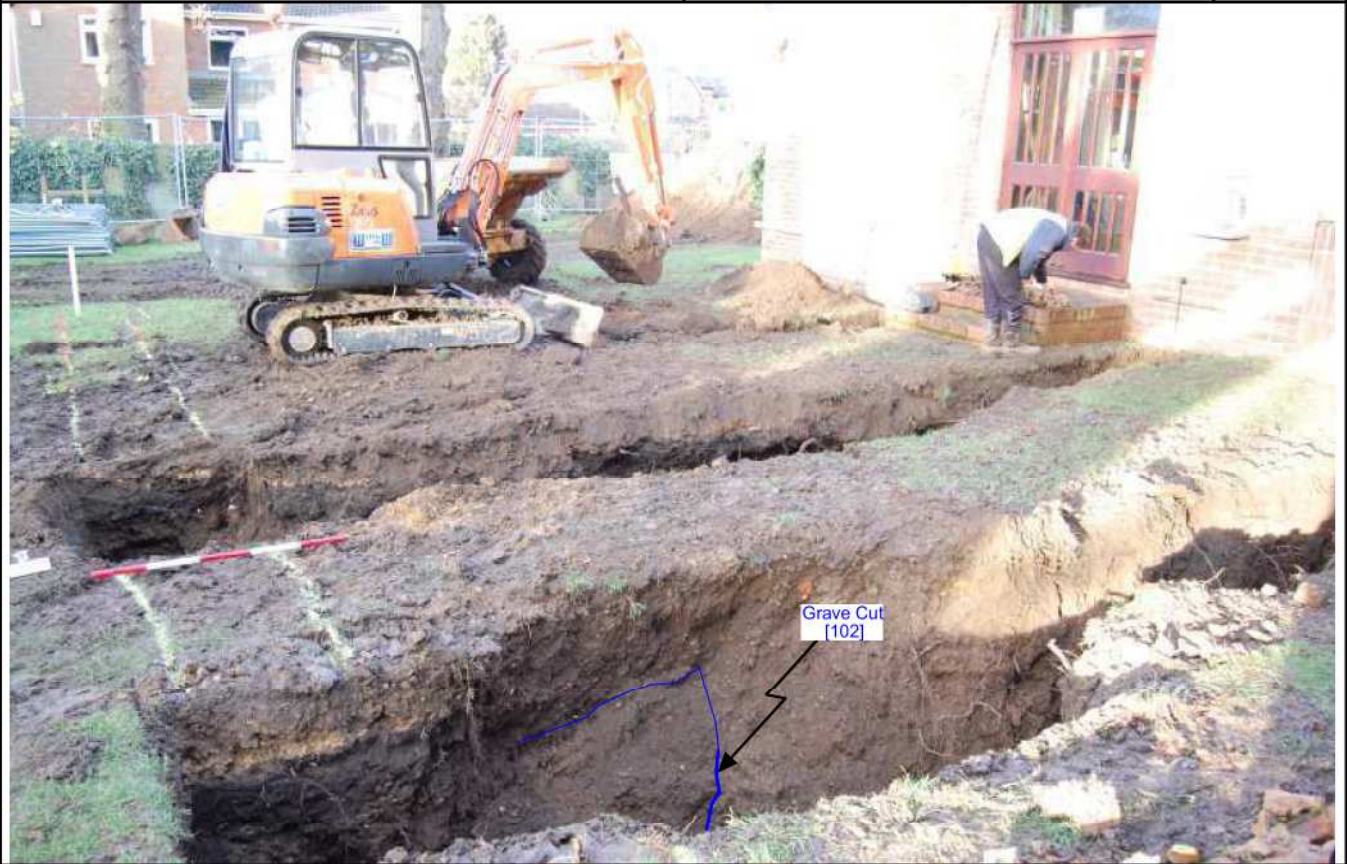
Plate 1: Trenches 1 and 2, looking north; showing grave cut [102]

2.10 Trench 1 was located approximately 2.5m north of the north wall of the existing meeting room (Figure 3). Excavation revealed Grave [102], c.1.50m from the west end of the trench at a depth of c.1.20m below the existing surface, within layer (101) (Plate 1). No evidence for grave goods or a coffin was observed. The grave was aligned east-west, on the axis of the church.

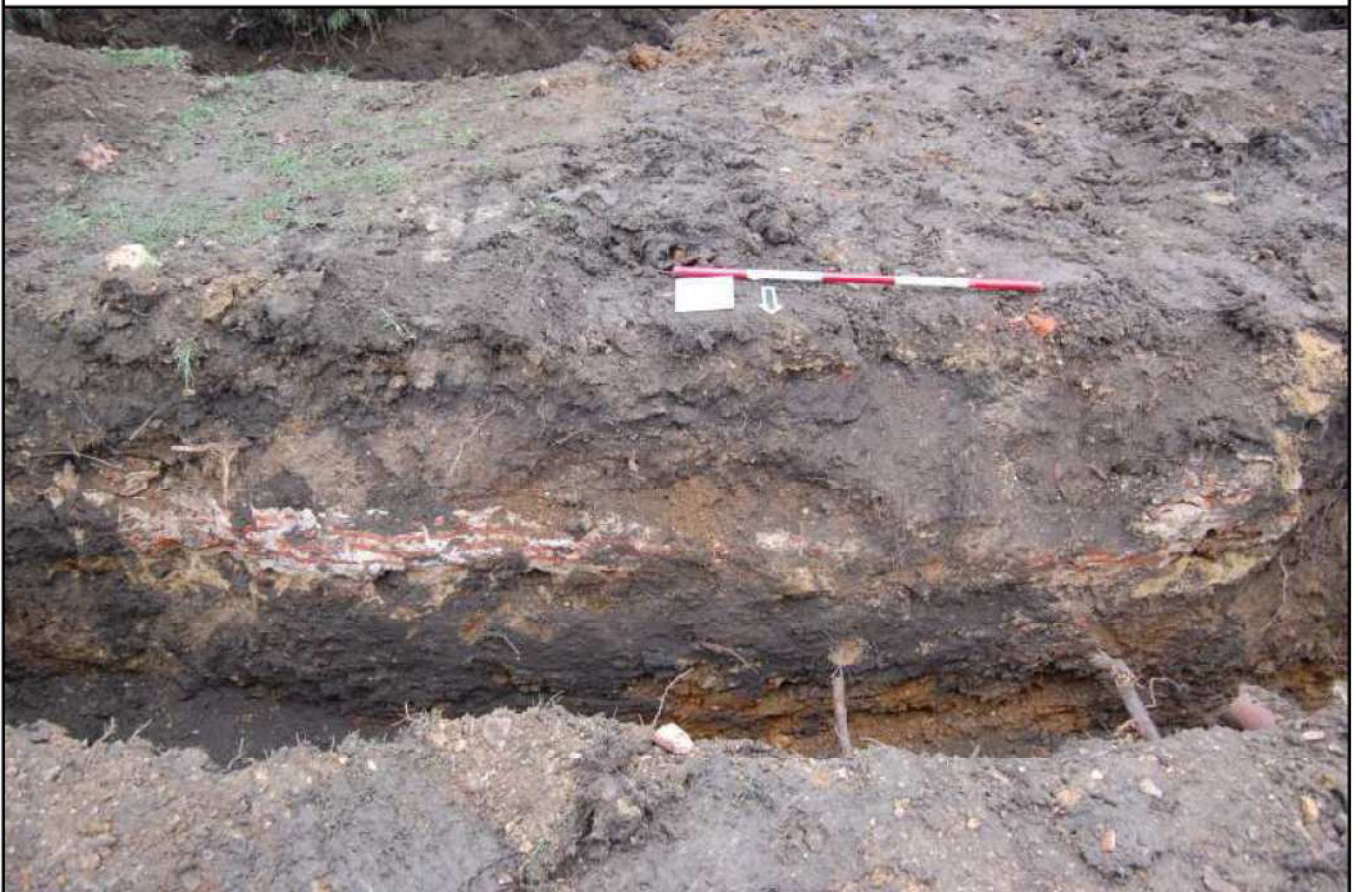
Plate 2: Structure [402], looking south

2.13 Trench 4 was located c.2.75m to the north of Trench 3 (Figure 3). The graveyard soil (401) contained a quantity of disarticulated human remains from a disturbed human burial. At c.2.2m from the east end of the trench, at a depth of c.0.3m, the remains of a structure [402] were encountered. These consisted of a concrete layer resting on a foundation formed of sandstone, ironstone and tile in a sandy mortar (Figure 3, Plate 3). This may form the base of a grave monument of unknown date, although the concrete layer which caps the structure is unlikely to be earlier than late 19th century in date. This appears to be the same structure that was encountered during the earlier evaluation phase.

3.5 The monitoring also revealed structure [402] in Trench 4. It is clear that this structure is the same as the one uncovered during the evaluation. At that time it was suggested that it may have formed part of a burial vault, but in the course of the present project it became clear that it formed some sort of plinth or foundation of unknown purpose, apparently capped with concrete. The sandstone rubble base of the feature was noted to be similar in appearance to the exterior elevation of the north-aisle of the church, though less compact. It was aligned north northwest – south southeast relative to the axis of the church.

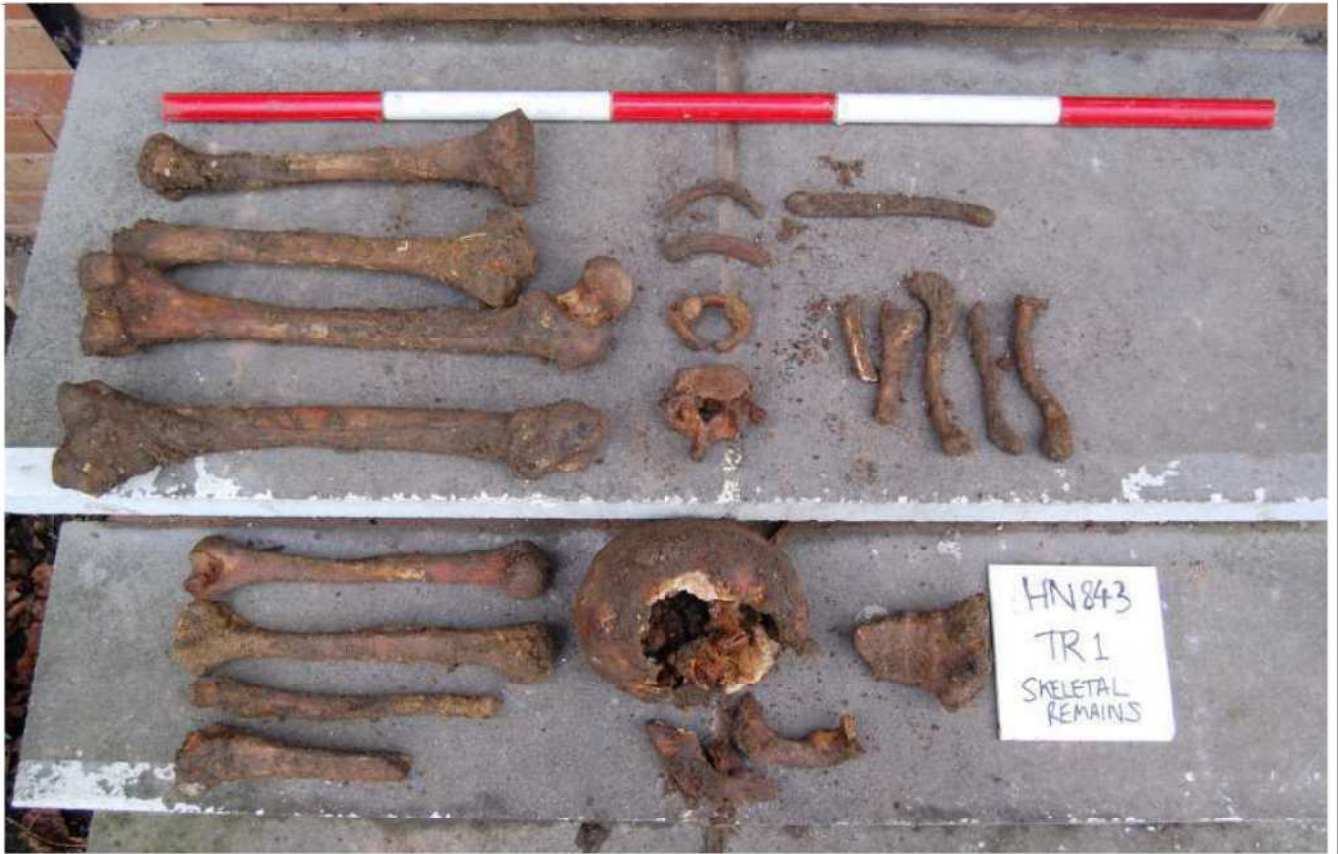
Plate 3: Skeletal Remains - Trench 1

2.16 Grave [102], containing Skeleton 1, was exposed within Trench 1 at a depth of c.1.20m below the present ground surface (Plate 3). It was orientated east-west on the axis of the church, and extended for 1.70m along the middle of the trench. On-site examination of the bones showed they consisted of the cranium, mandible, both arms and legs, an ilium fragment, some rib fragments, clavicle, pectoral girdle and fragments of vertebrae. The evidence from the brow ridge and forehead, and lack of a nuchal crest, suggests that the individual was probably female. This is further supported by evidence from the mandible which was rounded to a point, which is also indicative of a female. The age of the individual was probably adult due to the evidence from the femur showing ossification of the epiphysis. No evidence to date the burial was recovered.

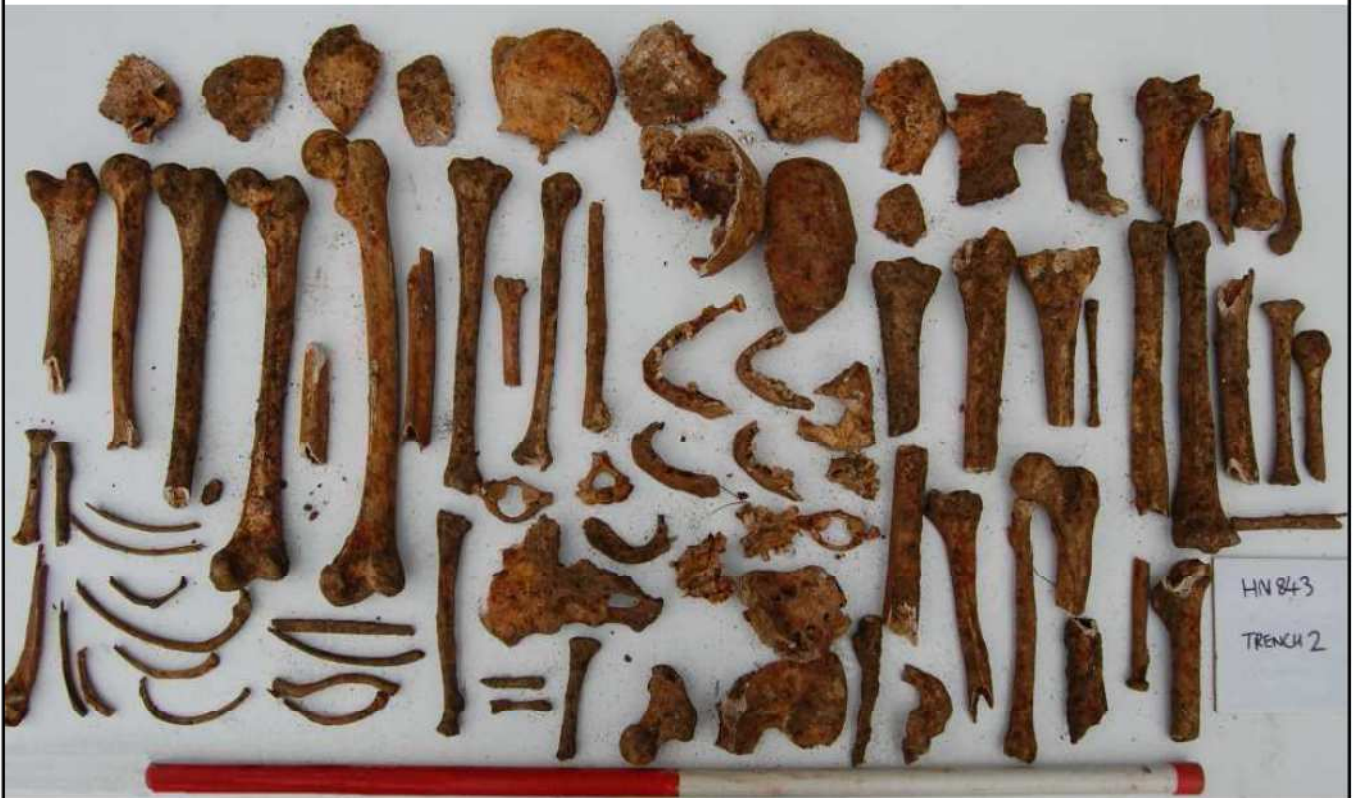
Plate 4: Skeletal Remains - Trench 2

2.17 In the course of the excavation of Trench 2, a number of disarticulated human bones were unearthed throughout the trench (Skeleton 2) (Plate 4). Examination of these bones suggests that they included the remains of at least two individuals due to there being more than two humeral epiphyses. The bones were in a very poor condition, making an assessment of the age at death and sex impossible.

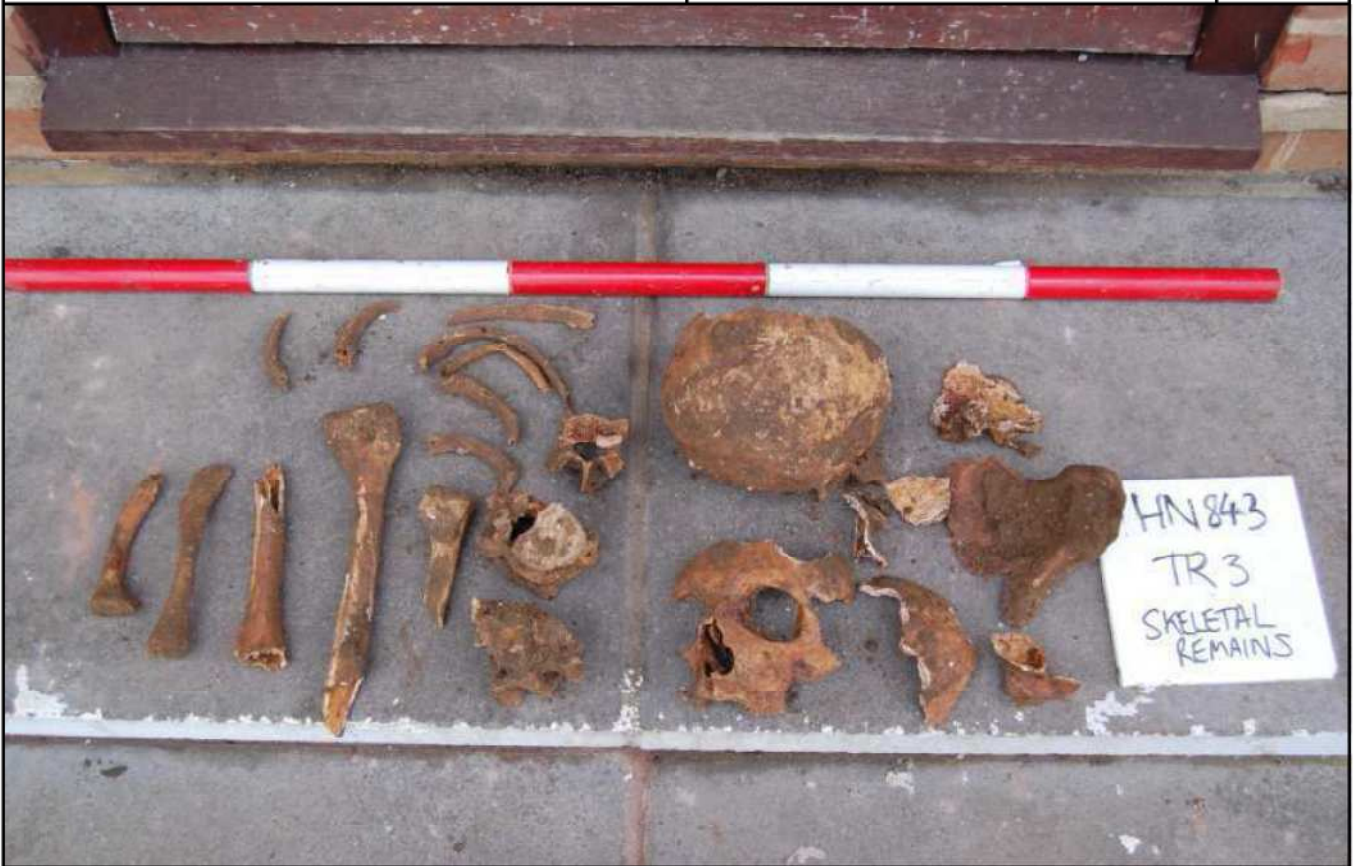
Plate 5: Skeletal Remains - Trench 3

2.18 The remains of a disarticulated skeleton (Skeleton 3) were revealed during the excavation of Trench 3 (Plate 5). They were located at the eastern end of the trench and appeared to be aligned east-west. On-site examination of the bones showed they consisted of the cranium, a scapula, a humerus, a tibia fragment, a fragment of the ilium, three lumbar vertebrae and seven rib fragments. The evidence from the brow ridge and forehead, and lack of a nuchal crest, suggests that the individual was probably female. It is also probable that the individual was adult based on the ossification of the epiphysis in the femur. Evidence for a coffin was noted in the form of an iron coffin handle, but no other clear evidence was recovered to indicate the date of the burials encountered.

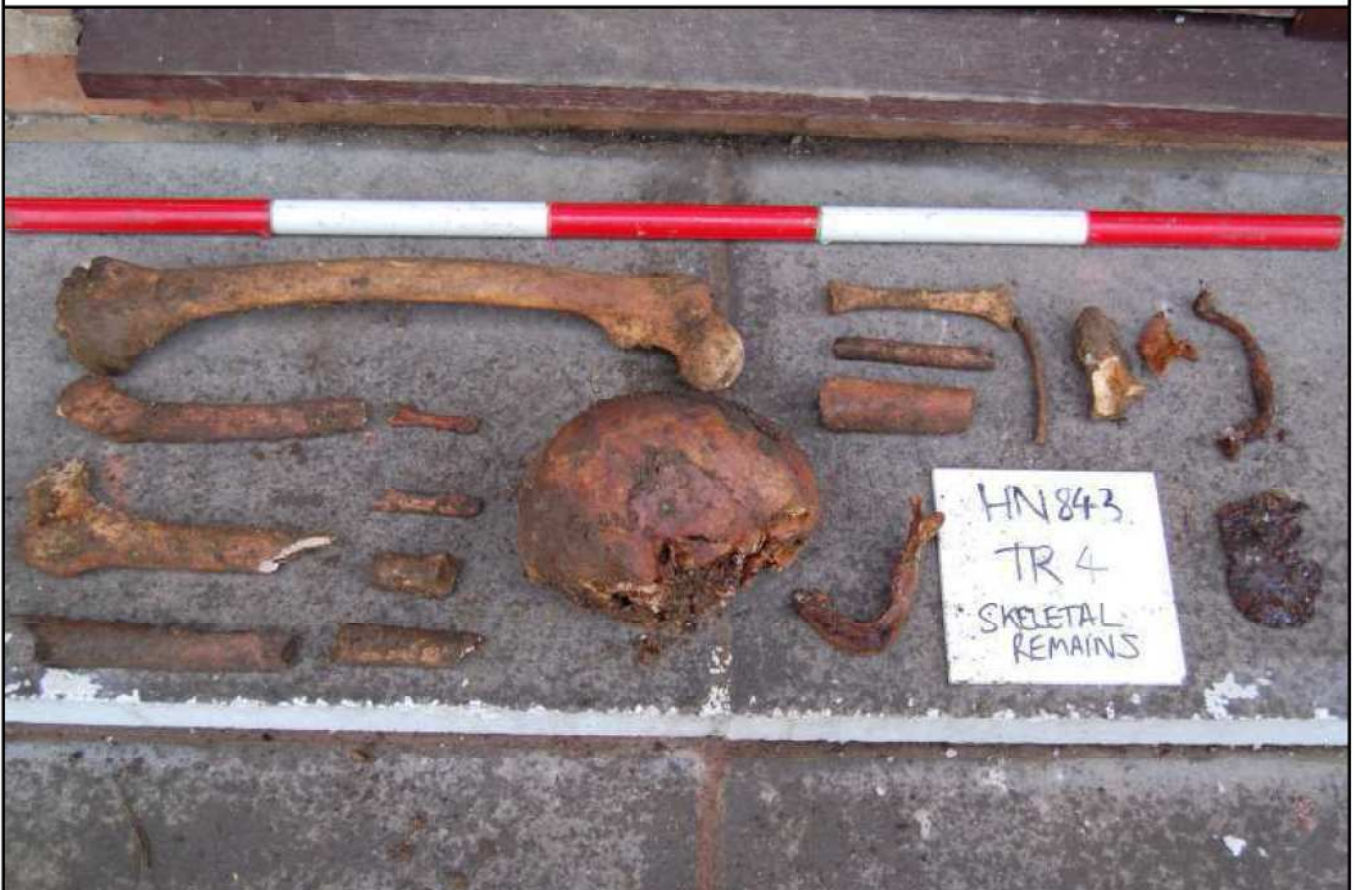
Plate 6: Skeletal Remains - Trench 4

2.19 During the excavation of Trench 4, the remains of a disarticulated skeleton (Skeleton 4) (Plate 6) were uncovered at the western end of the trench, which appeared to be aligned east-west. On-site examination of the bones showed they consisted of the cranium, the mandible, the right femur and fragments including arm and leg bones and rib bones. The evidence from the cranium, mandible and femur all suggest that the individual was an adult, whilst the evidence from the cranium alone suggests that the individual was probably female. A single iron coffin handle was also recovered from this trench, in a different style from those recovered in Trench 2.

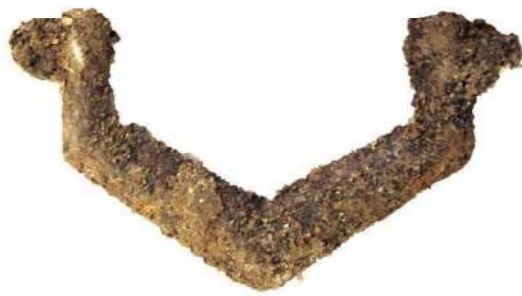
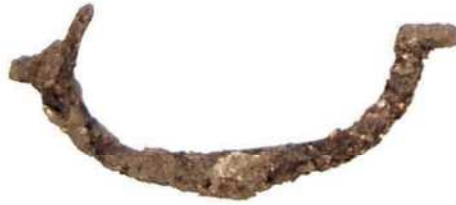
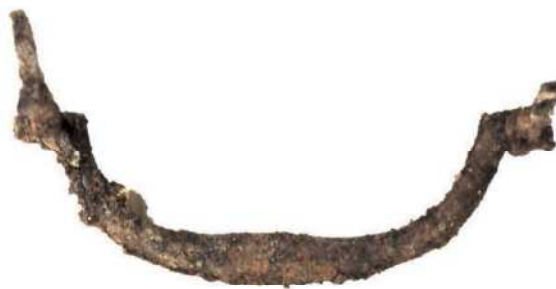
Trench 2

Trench 4

2.21 A total of five iron coffin handles were recovered from Trenches 2 and 4. They appear to be in five different styles indicating five separate coffins, all of probable post-medieval date. The handles were photographed (Plate 7) but, in the context of a limited intrusion in an established graveyard, the significance of these objects was not considered sufficient to warrant an application
