**St. Mary's Church  
Watford, Herts.**

Report No. 575

The present interim report is intended to summarise the results of a field evaluation focused on features identified using ground penetrating radar, in advance of a full report on the project as a whole.

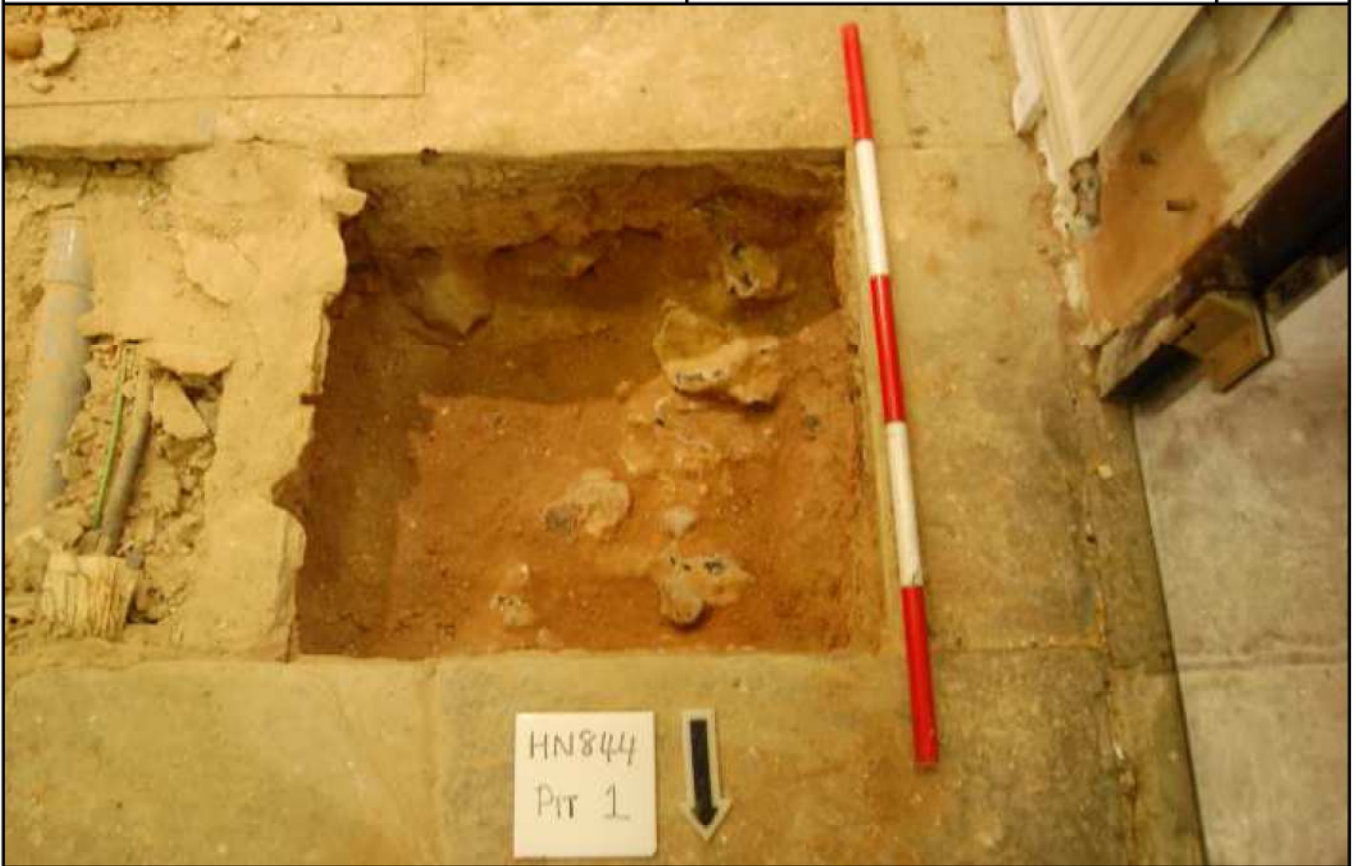
Plate 1: Test Pit 1, looking south

<b>Length (m):</b>	0.70	<b>Width (m):</b>	0.69	<b>Maximum Depth (m):</b>	0.45	<b>Orientation</b>	E-W
Context	Type	Description	Dimensions (m)				
			Length	Width	Depth		
-	Layer	Pinkish Grey (5YR 7/2) Overburden.	0.70+	0.69+	0.45		
101	Structure	Wall Foundation	0.70+	0.40+	0.30

Test Pit 1, which was located inside the west tower, revealed a flint wall foundation aligned north-south [101], confirming the results of the GPR survey which indicated the possible presence of structural remains or debris in this area. It is possible that this wall represents the foundations of an earlier western tower.

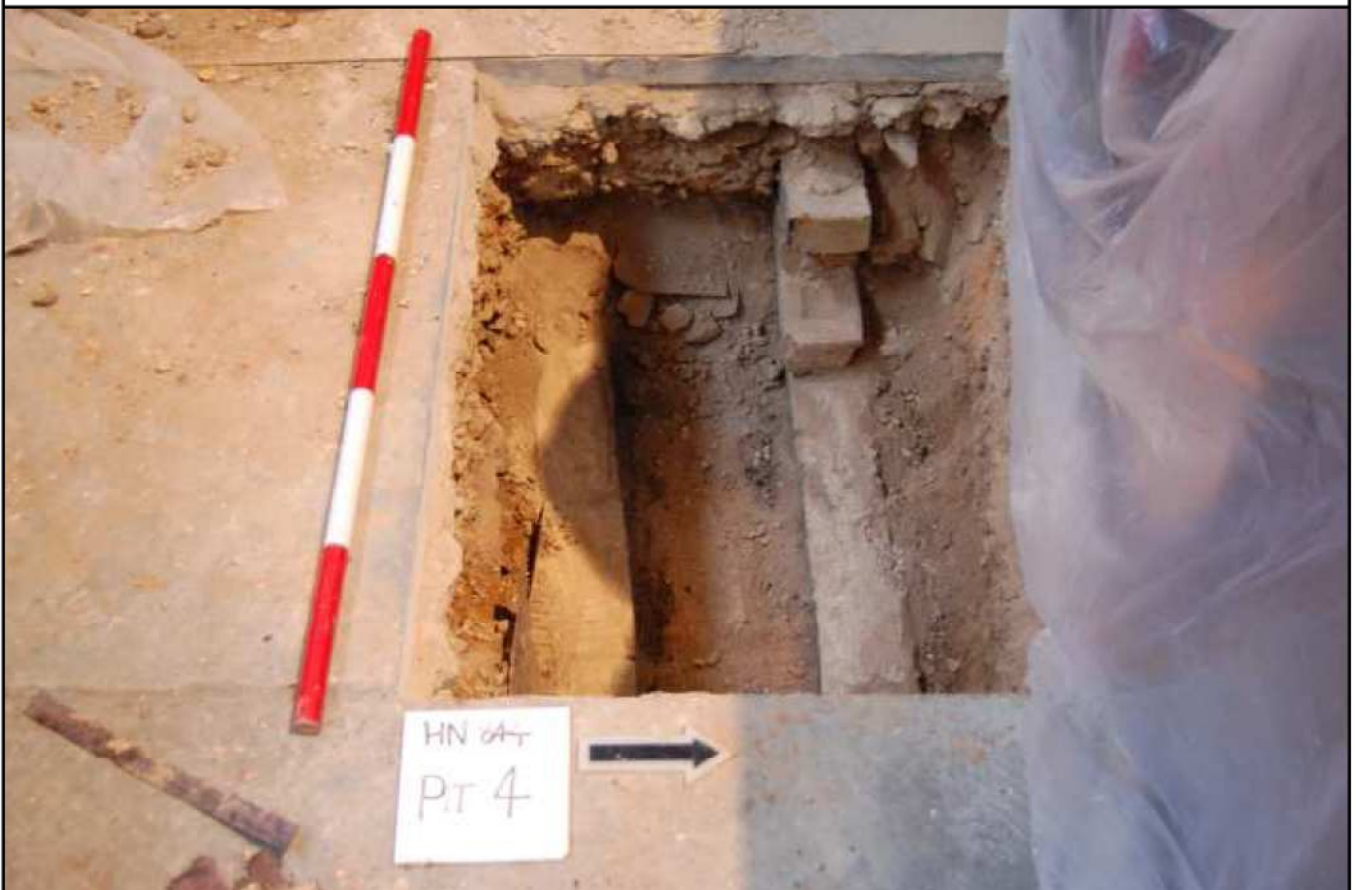
Plate 2: Test Pit 4, looking west

<b>Length (m):</b>	0.70	<b>Width (m):</b>	0.69	<b>Maximum Depth (m):</b>	0.45	<b>Orientation</b>	E-W
Context	Type	Description	Dimensions (m)				
			Length	Width	Depth		
-	Layer	Light Grey (5YR 7/1) Overburden	0.70+	0.69+	0.45		
401	Structure	Modern brick duct	0.93+	0.40	0.45+		
402	Fill	Very Dark Grey (10YR 3/1) soot from within [401]	0.93+	0.25	0.10

Test Pits 4, 9 and 10 were targeted on GPR anomalies which had been interpreted as possible burials. Test pit 4 contained a Victorian brick duct [401] which appears to be associated with an earlier heating system. Test Pit 9 revealed a chalk make up layer [901] which may form part of a medieval or post-medieval floor. Test pit 10 was sited between a substantial grave and the wall of the south aisle, exhibiting its foundations[1001]. These were formed of flint rubble, of a similar nature to the footings seen in Test Pit 1. Investigation beneath the grave slab revealed a makeup layer which included modern brick, suggesting that the slab had been relaid in recent times, but no evidence of burials was uncovered.

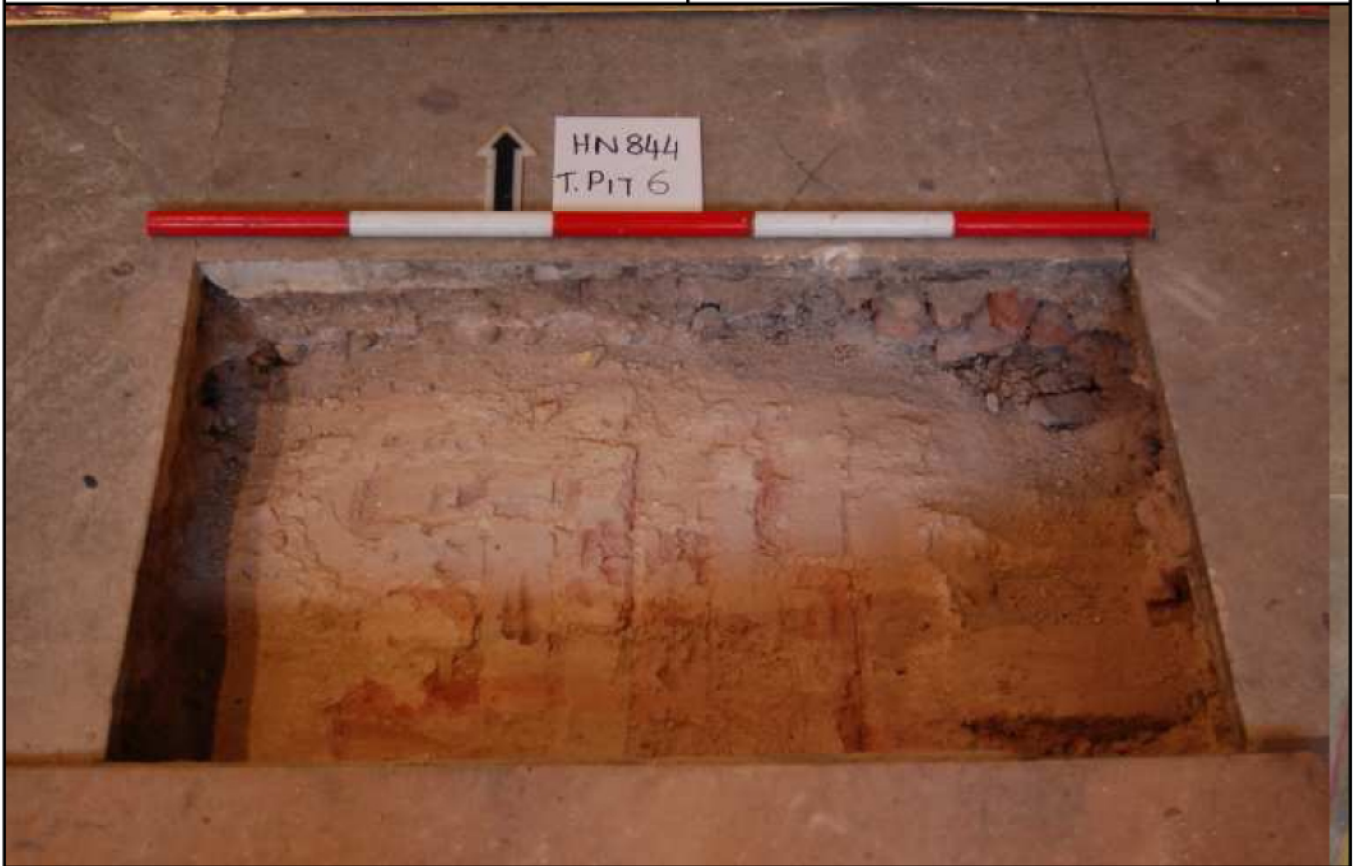
Plate 3: Test Pit 6, looking north

<b>Length (m):</b>	0.92	<b>Width (m):</b>	0.55	<b>Maximum Depth (m):</b>	0.32	<b>Orientation</b>	E-W
Context	Type	Description	Dimensions (m)				
			Length	Width	Depth		
-	Layer	Pinkish White (7.5 YR 8/2) Overburden	0.92+	0.55+	0.32+		
601	Structure	Brick Vault	0.92+	0.55+	0.25+

The evaluation conducted by the Heritage Network successfully located and identified the brick vaulted structures anticipated from the GPR survey in Test Pits 6 and 7. The vaults were sealed but it is considered to be highly likely that burials will be present within them. Disarticulated human bone and iron nails uncovered in Test Pit 7 may indicate the presence of other nearby burials.

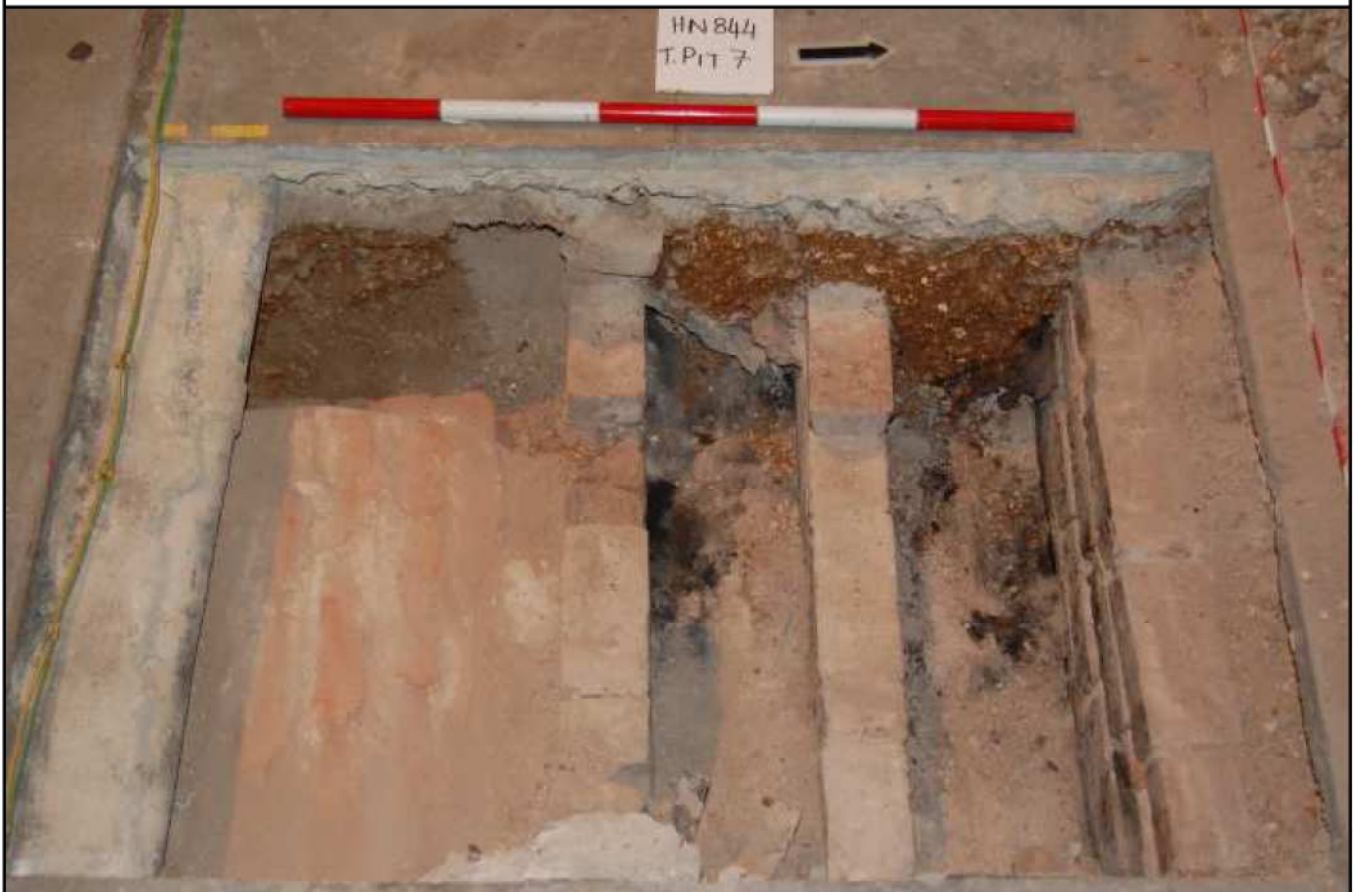
Plate 4: Test Pit 7 looking west

<b>Length (m):</b>	1.20	<b>Width (m):</b>	0.93	<b>Maximum Depth (m):</b>	0.45	<b>Orientation</b>	N-S
Context	Type	Description	Dimensions (m)				
			Length	Width	Depth		
-	Layer	Pinkish White (5 YR 8/2)	1.20+	0.93+	0.45+		
701	Layer	Light Yellowish Brown (2.5 YR 6/4)	1.20+	0.93+	0.45+		
702	Structure	Brick Vault	0.75+	0.35+	0.30+		
703	Structure	Modern brick duct	0.93+	0.50+	0.30+

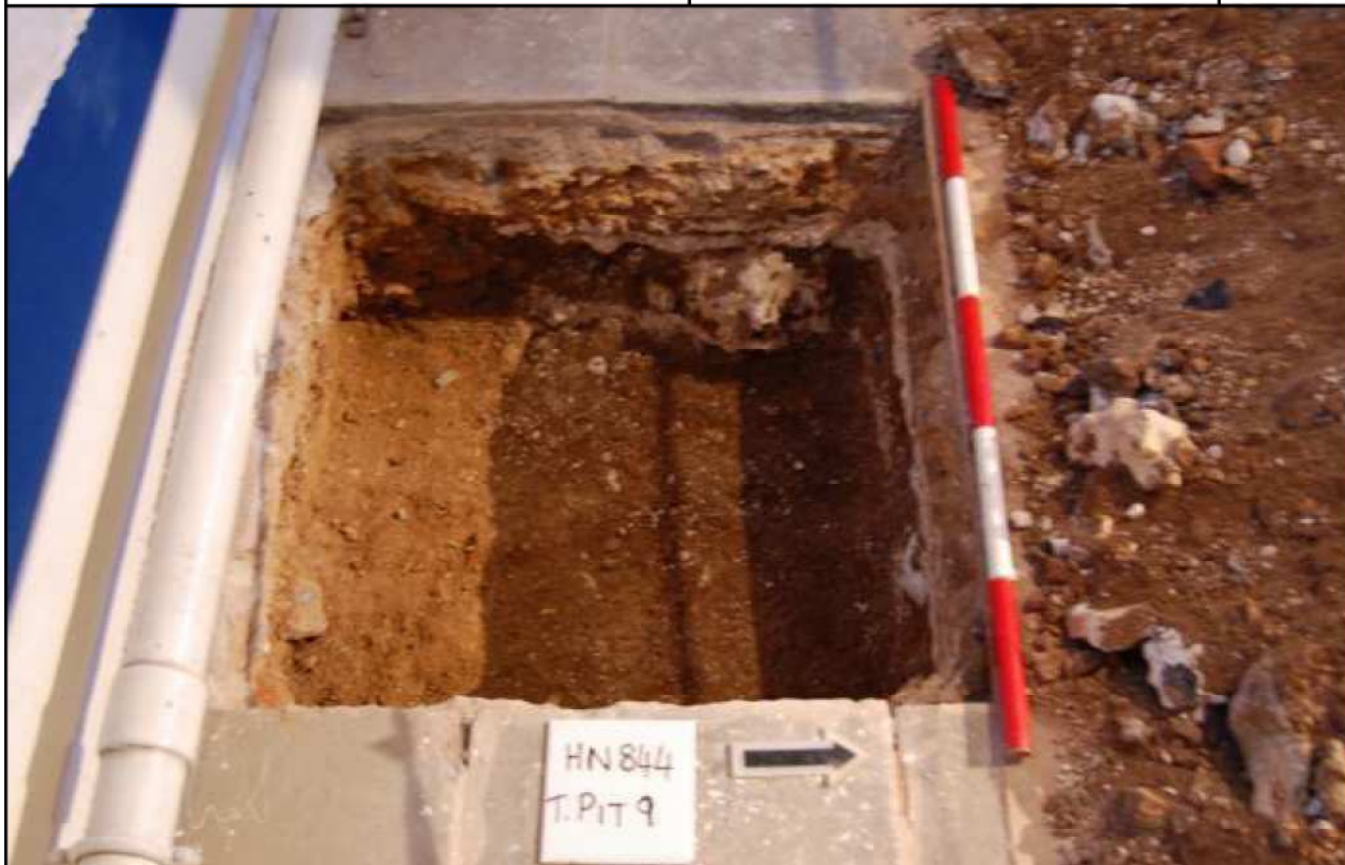
Plate 5: Test Pit 9, looking East

<b>Length (m):</b>	0.90	<b>Width (m):</b>	0.90	<b>Maximum Depth (m):</b>	0.45	<b>Orientation</b>	-
Context	Type	Description	Dimensions (m)				
			Length	Width	Depth		
-	Layer	Reddish Brown (5 YR 4/4)	0.70+	0.40+	0.20		
901	Layer	White compacted chalk floor make up layer	0.70+	0.40+	0.07		
902	Layer	Reddish Brown (5 YR 4/4)	0.70+	0.40+	0.18

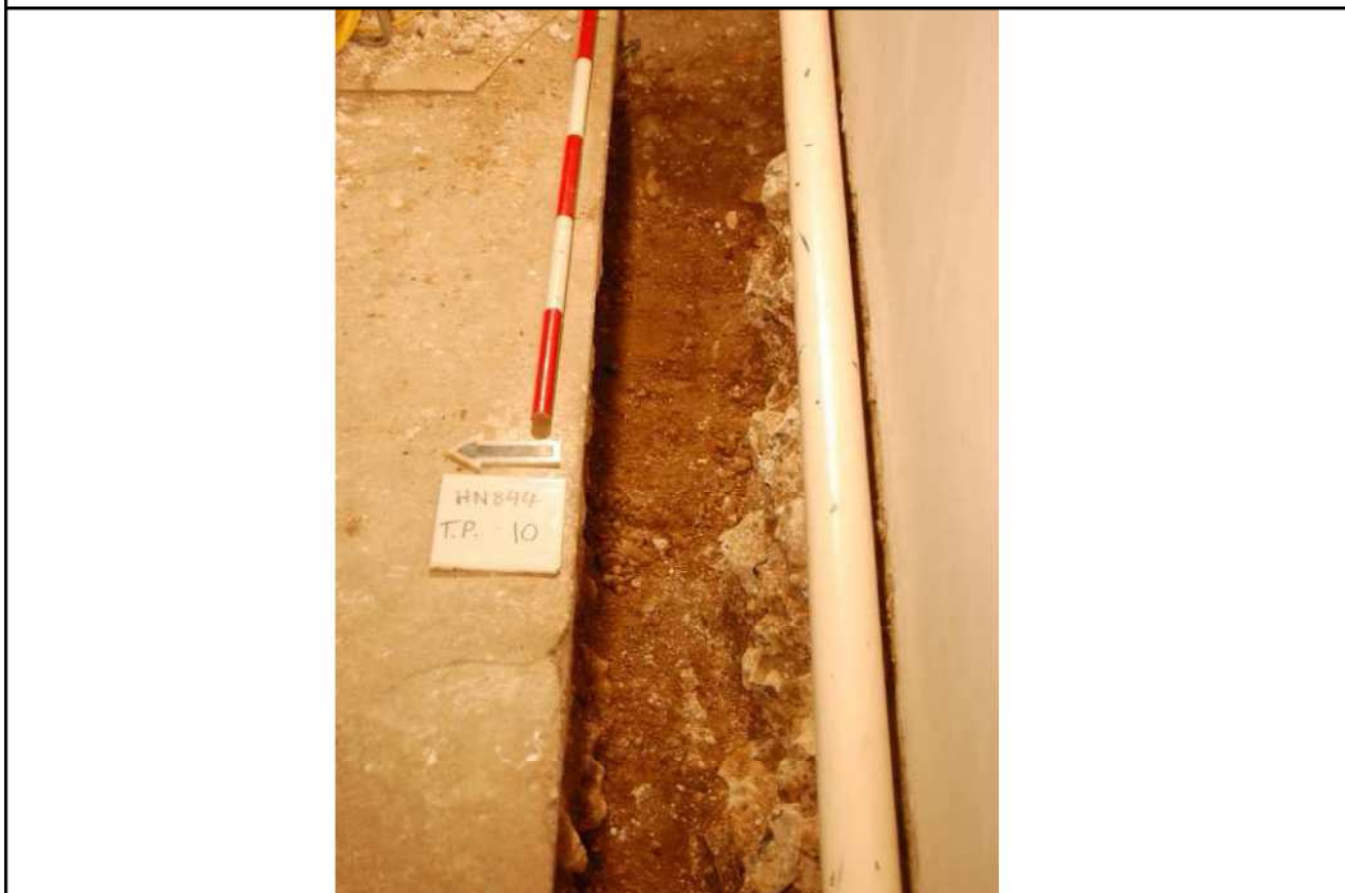
Plate 6: Test Pit 10, looking West

<b>Length (m):</b>	1.80	<b>Width (m):</b>	0.36	<b>Maximum Depth (m):</b>	0.45	<b>Orientation</b>	E-W
Context	Type	Description			Dimensions (m)		
					Length	Width	Depth
-	Layer	Reddish Brown (5 YR 4/4)			1.80+	0.36+	0.45+
1001	Structure	Flint foundations of wall of south aisle			1.80+	0.10+	0.45+
