# Land adjacent to 28 WYCHDELL Broadwater, Stevenage, Herts.

*(HN449)*

Archaeological Monitoring Report

Report no.220 February 2004 © The Heritage Network Ltd

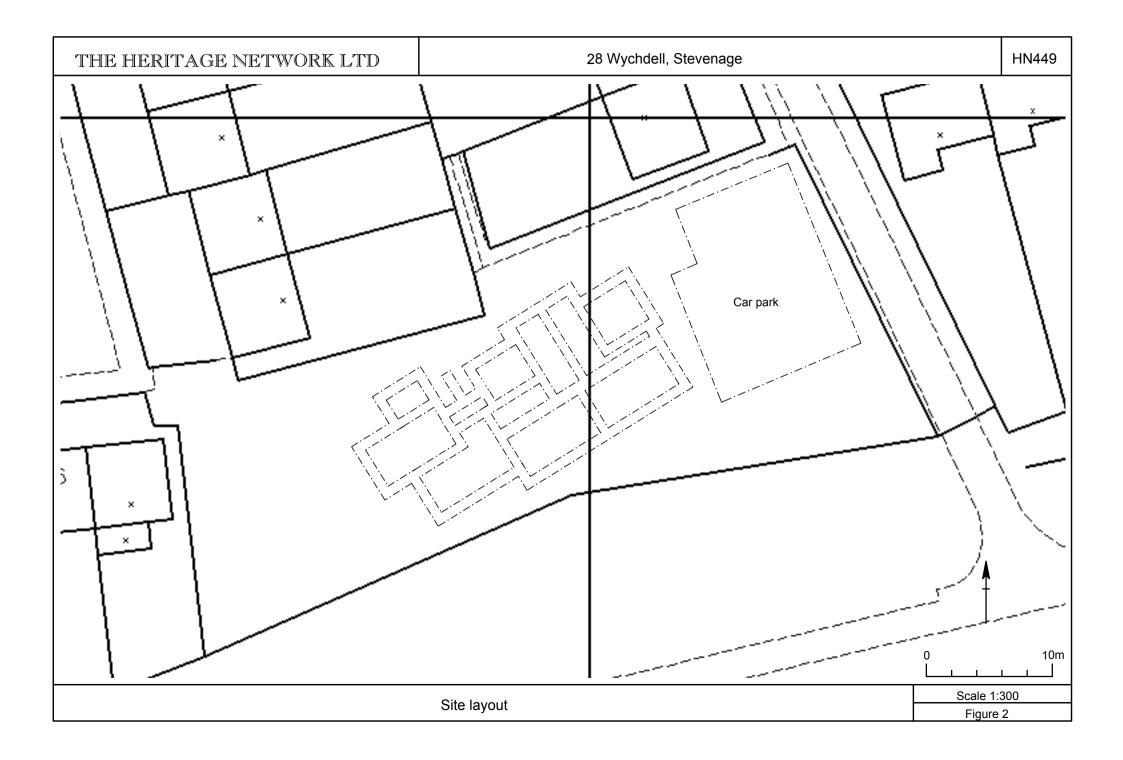
*1.2* The site is located in the south-west corner of Wychdell, centred on NGR TL 26211 21582. It is bounded by no.28 Wychdell and no.94 Holly Leys to the north, by no.92 Holly Leys to the west, by protected green space to the south, and by an access track leading from Wychdell to the east. The development involved the construction of a two storey block of flats with associated services, landscaping and car-parking (see Figure 2).

2.2 Ground reduction across the footprint of the new building and the associated car park was undertaken using a  $360^{0}$  tracked machine fitted with a toothless ditching bucket. The footprints of the building and car park covered an area of approximately  $235m^{2}$  and  $175m^{2}$  respectively. In the footprint of the building the ground was reduced by approximately 0.10m, and across the area of the car park the ground was reduced by approximately 0.40m. The ground reduction did not extend below the modern overburden, and as such, no archaeology was observed.

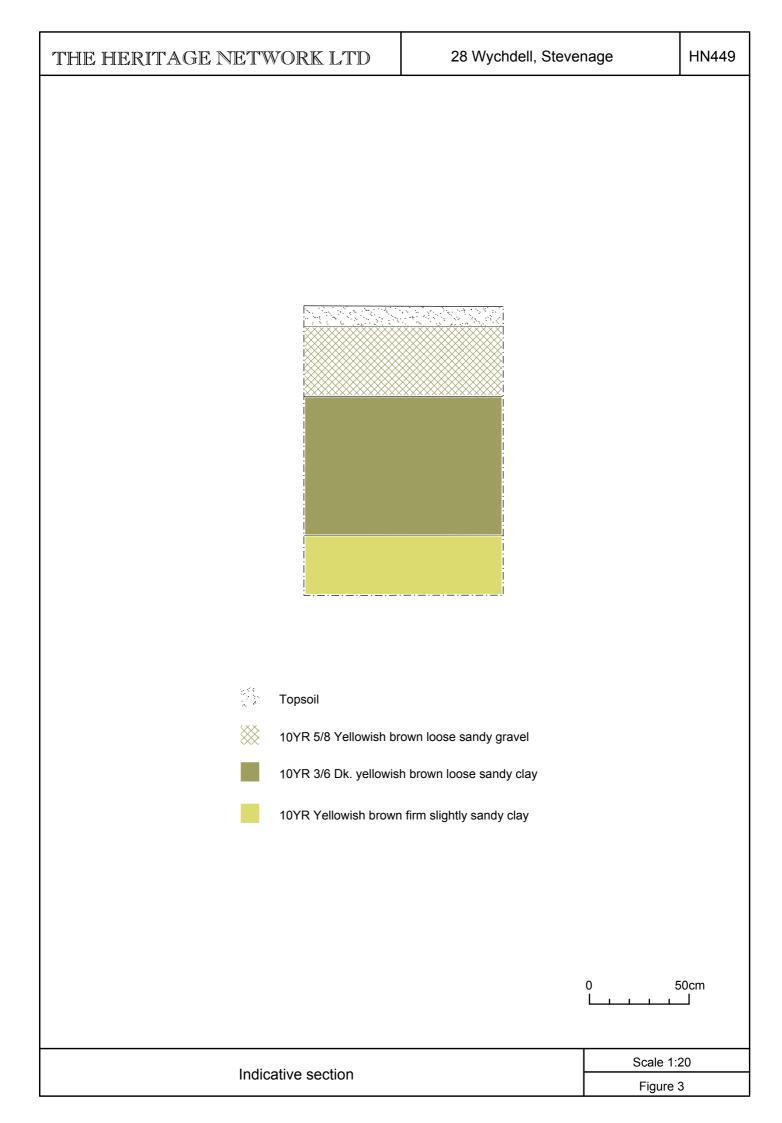
2.1 The site lies to the southwest of the centre of Stevenage on level ground. The geology is reasonably consistent across the site and consists of a thin layer of friable, greyish brown (10YR 5/2), sandy clay topsoil over an imported layer of loose, yellowish brown (10YR 5/8), sandy gravel. Beneath this is a second layer of imported material of loose, dark yellowish brown (10YR 5/6), sandy clay with frequent gravel and root disturbance. This overlies the natural geology which is firm, yellowish brown (10YR 5/6), slightly sandy clay with moderate inclusions of large angular flints.

*3.3* Despite the site's location within an Area of Archaeological Significance (AAS15), the fieldwork failed to identify any archaeological artefacts or features. The stratigraphy observed on the site consisted of a thin layer of modern topsoil overlying modern imported levelling layers immediately beneath which was the natural geology.
