**The Mill
VICTOR WHARF
Roden Street, Ilford, LB Redbridge**

Archaeological Evaluation Report

Site Code: VWF10
Project ref.: HN850
LPA ref.: 0201/06
OASIS ref.: heritage1-71756

Report no.596

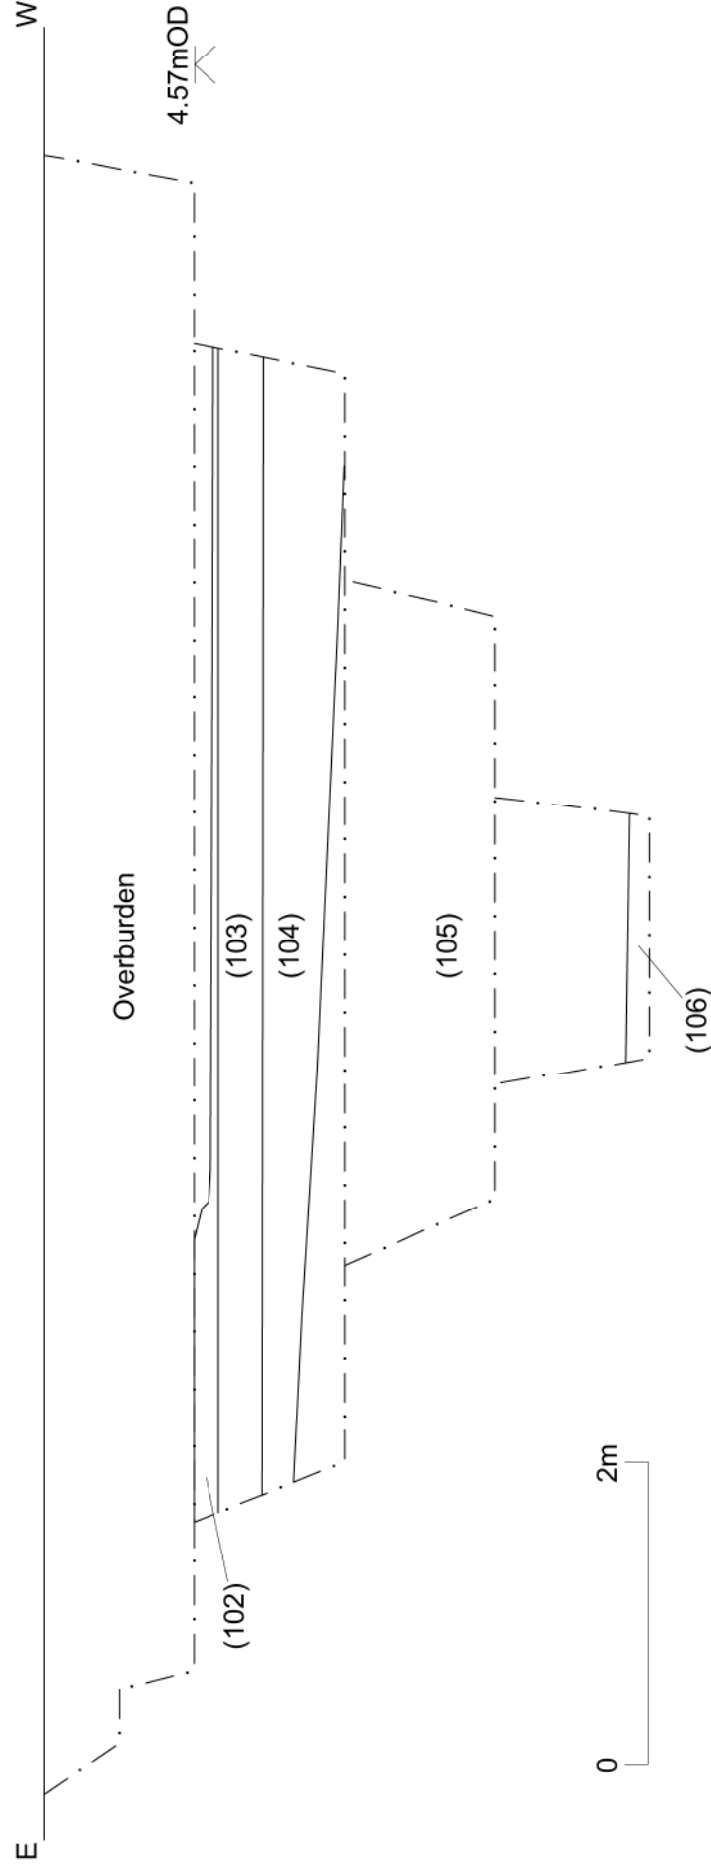
Representative section of deposits (Trench 1)

2.9 Below the overburden and concrete was a 0.30m deep layer of large rounded flint cobbles bonded by a black ashy matrix (103, 202 & 302). Supporting the cobble layer was a levelling deposit composed entirely of friable low fired brick wasters (104, 203 & 303), between 0.20m and 0.50m thick. Below the levelling deposit was a c. 2m thick layer of laminated blue-grey silty clay (105 & 204) that became slightly lighter with depth. In the

northern most trench this deposit was significantly drier and had oxidised to a brownish grey colour (304). The earliest deposit encountered was a layer of grey sandy gravel (106, 205 & 305) in excess of 0.10m thick (Figure 3, Plates 2 to 4).

3.8 The earliest deposits were natural floodplain gravels, consistent with the local underlying geology, which were overlain by alluvial riverbank silts. The earliest anthropogenic deposit was a layer of under fired brick wasters that probably derived from the adjacent brick fields and was used as a levelling deposit when the Roding was canalised and the wharf constructed. Over this was a substantial cobble layer that would have formed the 19th century wharf surface. Above this was evidence of modern building and levelling.

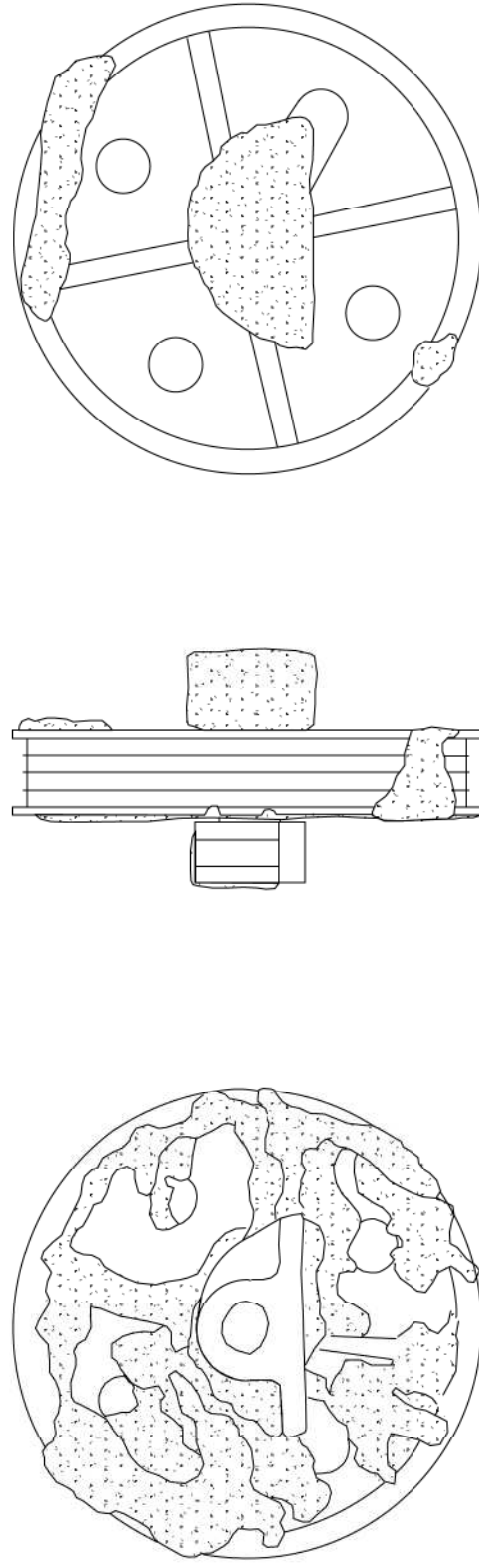
Sketch Drawing of Cast Iron Pulley Wheel (101)

2.14 Recovered from Trench 1 was a 0.66m diameter cast iron pulley wheel. This was a disk wheel with 4 raised spokes dividing it into quarters. In three of the quarters was a circular perforation 0.09m in diameter. In the fourth quarter, the perforation was allantoidal and extended to the wheel hub, where it housed a fixing bolt or grease nipple. Extending through the hub of the wheel was a solid 7.5cm diameter axle that was held on either side by a pair of semi circular axle blocks. The best preserved of these had a fixing bolt or grease nipple at the apex of the curved side. The outer rim of the wheel was 11.2cm wide and flanged on both edges. Four cable grooves were visible in the outer face of the rim. On one side, much of the face of the wheel was encrusted with corrosion products; on the other, more detail was visible but the axle block has heavily encrusted.

Corrosion Products

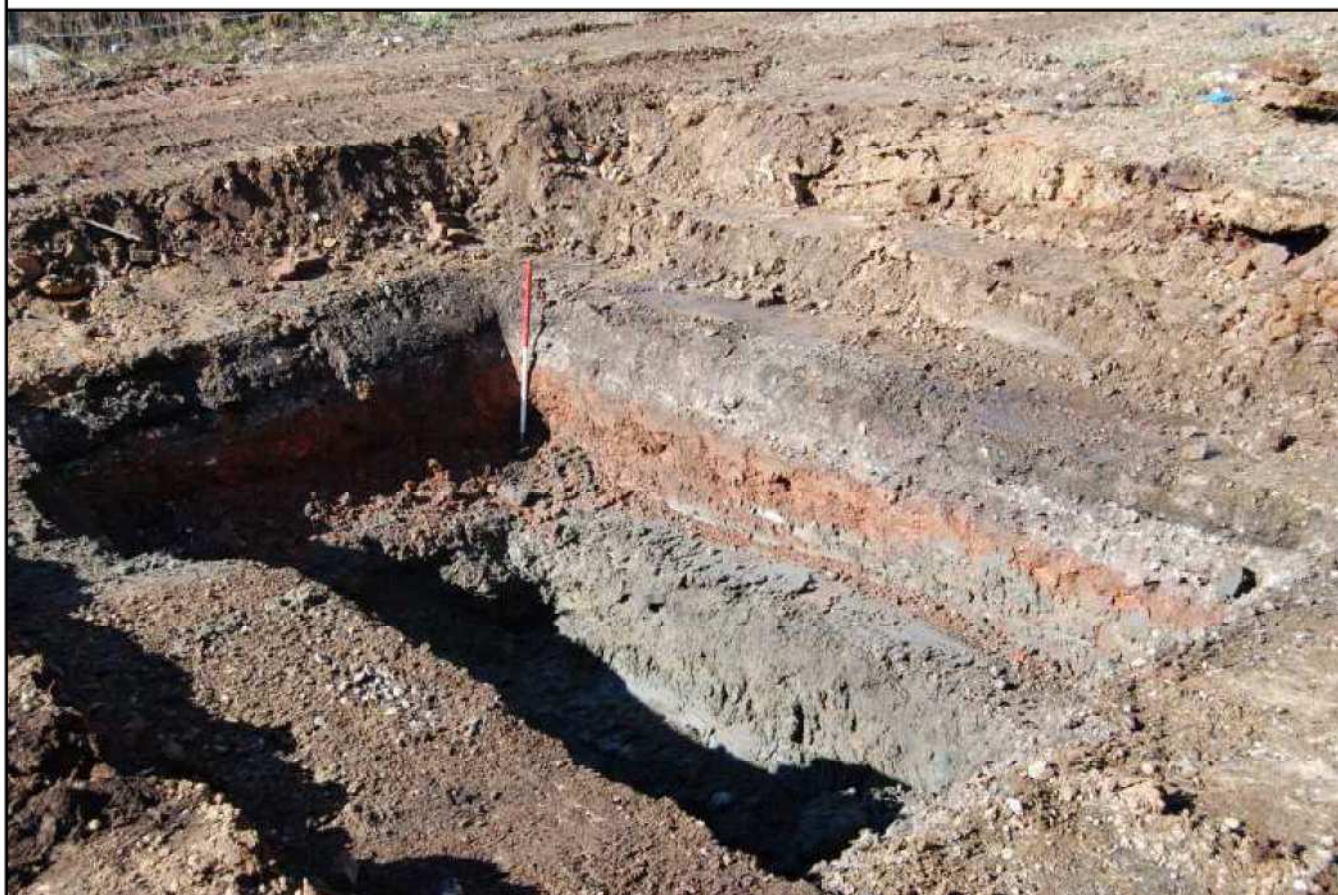
Plate 2: General view of trench 1, looking northwest.

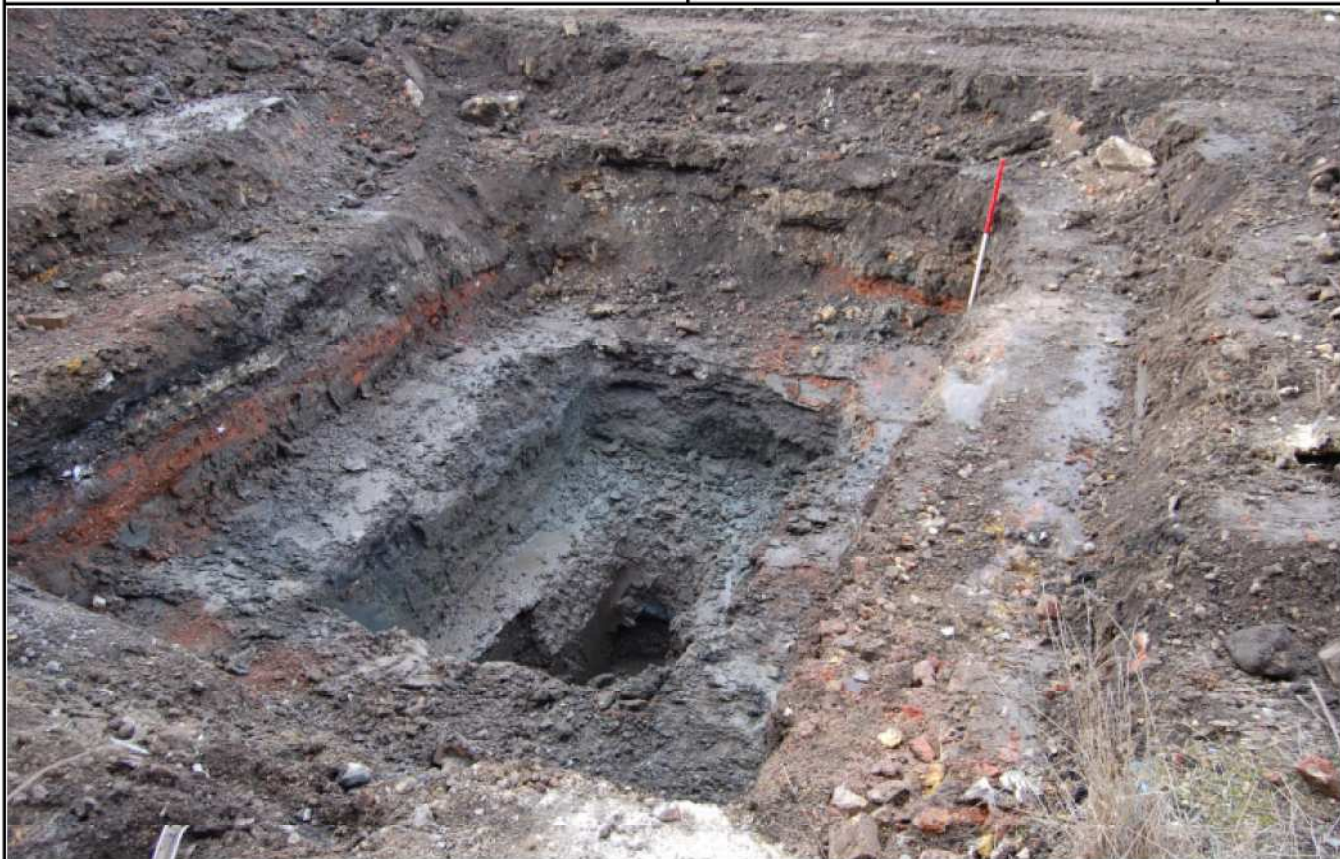
Plate 3: General view of trench 2, looking southwest.

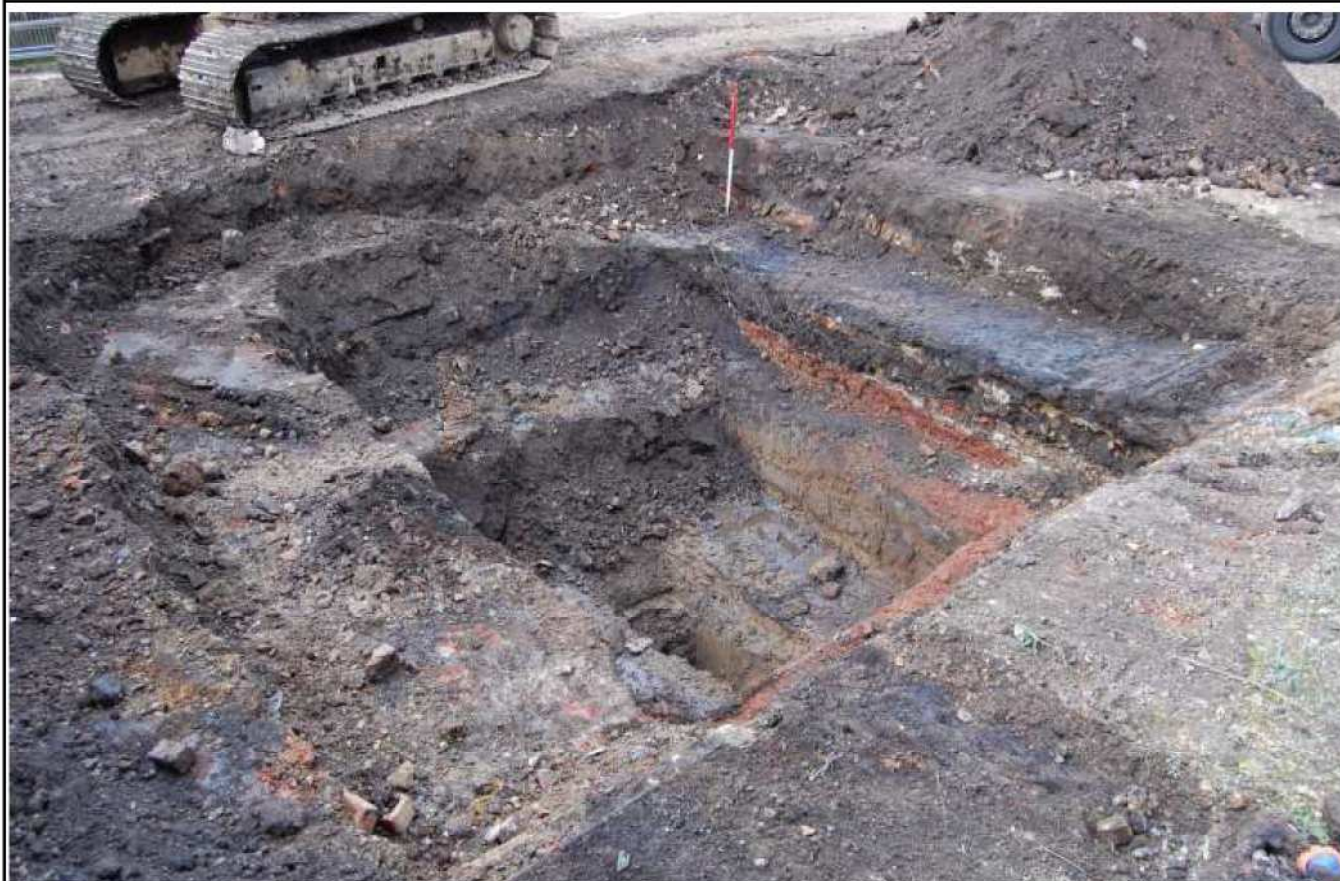
Plate 4: General view of trench 3, looking northwest.

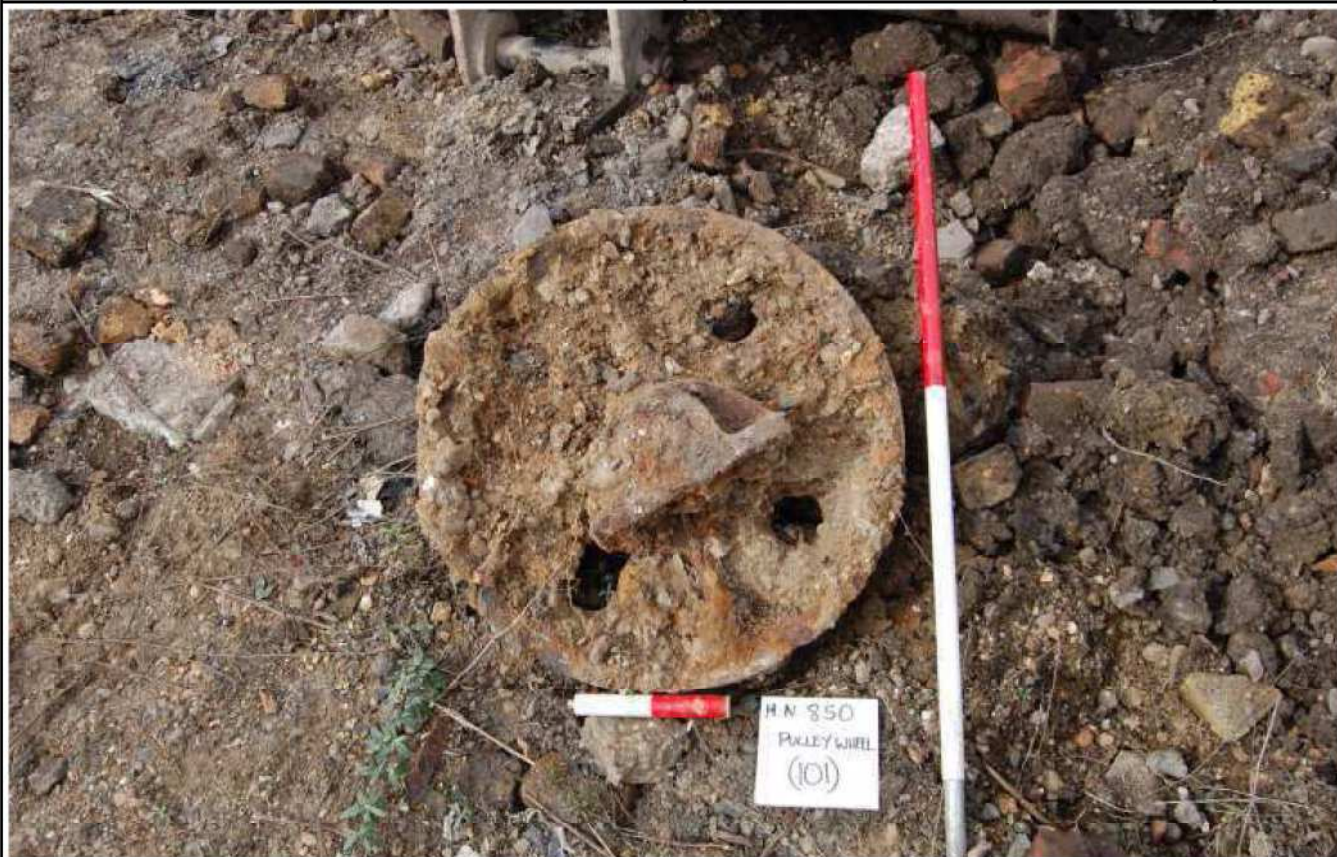
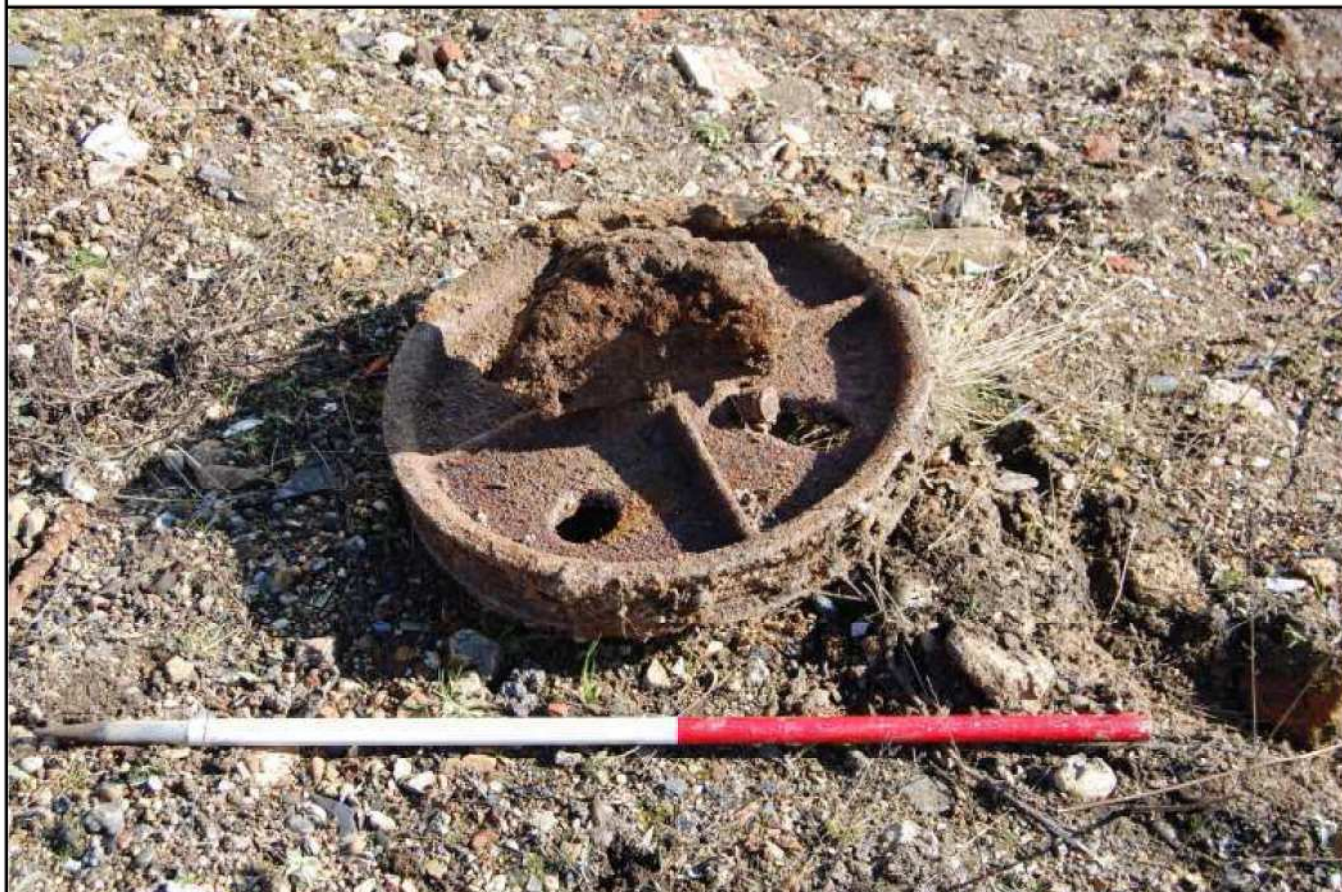
2.10 During the removal of overburden in Trench 1, at the southern end of the site, a 0.66m diameter cast iron pulley wheel (101) was recovered from just above the cobble surface (Figure 4, Plates 5 and 6).

Plate 5: Cast Iron Pulley Wheel (101).

Plate 6: Cast Iron Pulley Wheel (101).

3.9 Nineteenth century maps of the area note the presence of a crane at Victor Wharf. This may be the origin of the substantial cast iron pulley wheel recovered during the excavation of Trench 1.
