## **HARE STREET COTTAGE** **Hare Street, Hertfordshire**

HN852

### ***HISTORIC BUILDING RECORD & ARCHAEOLOGICAL MONITORING REPORT***

Project ref: HN852  
Planning ref: 3/1501/09/FP

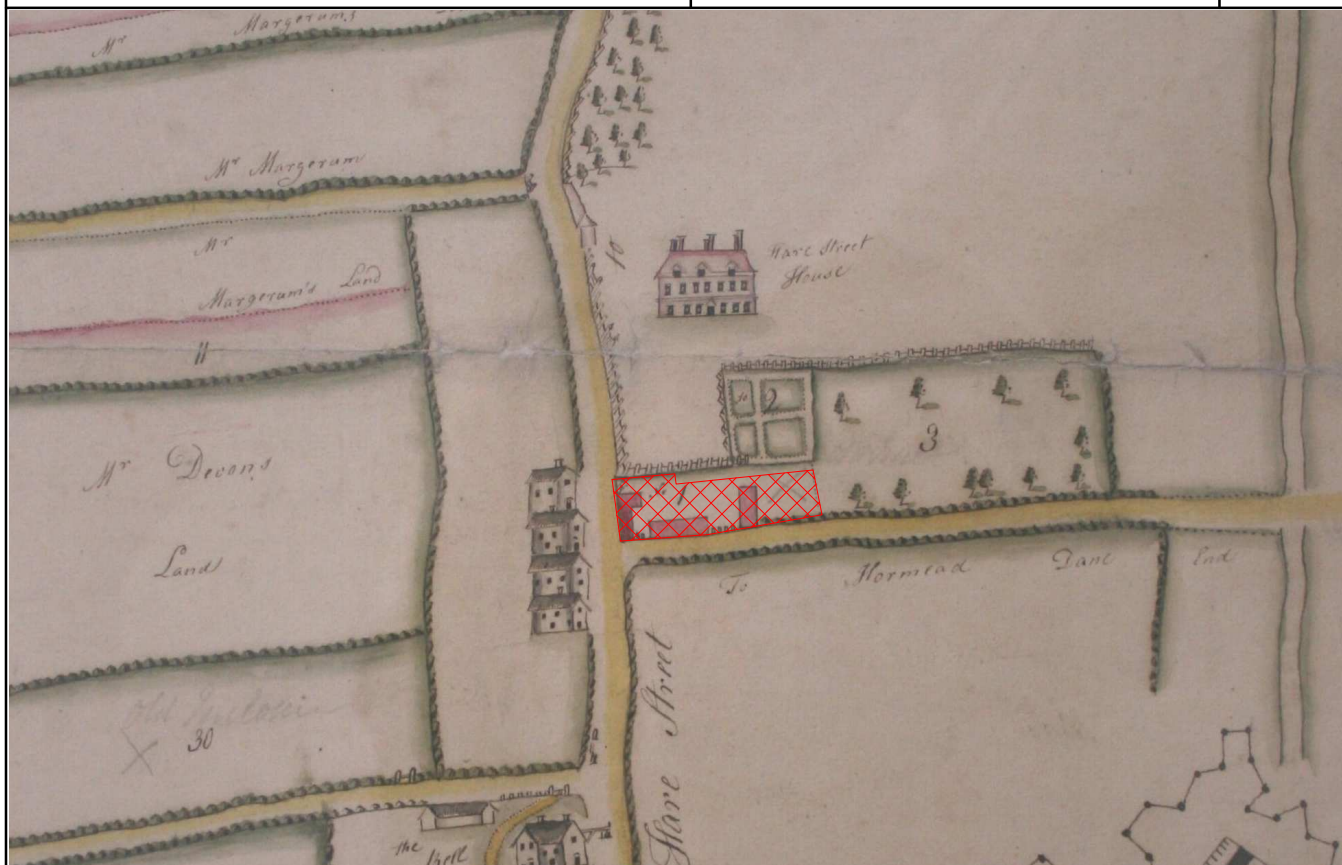
Figure 2

Extract from map of Samuel Lee's estate, 1806 (HALS 79990)

**2.10** A map of Samuel Lee's estates (HALS 79909), dated 1806, shows the village in some detail (Figure 2). Those properties not owned by Samuel Lee are shown as stylised buildings along the road, whereas the study area, which forms part of the estate, is drawn in plan, showing outbuildings to the rear. The study area forms part of a larger L-shaped plot aligned east – west and bounded by a fence to the north and by a hedge to the south and east, on the north side of the lane to Great Hormead and the east side of the former London – Cambridge road.

**2.10.1** The property is divided into three sections. Section 1 is located on the main road frontage at the west end of the property and is occupied by a rectangular building, aligned north - south, with a north range aligned east – west. A long rectangular building lies to the rear, along the north side of the lane, with a third rectangular building behind, at right angles to the lane.

**2.10.2** Section 2 lies at the point where the property widens, to the north of the third building. It is shown as a formal garden, divided into four unequal plots by intersecting paths.

**2.10.3** Section 3 lies at the rear of the property and consists of an open space with a number of trees around the edge.

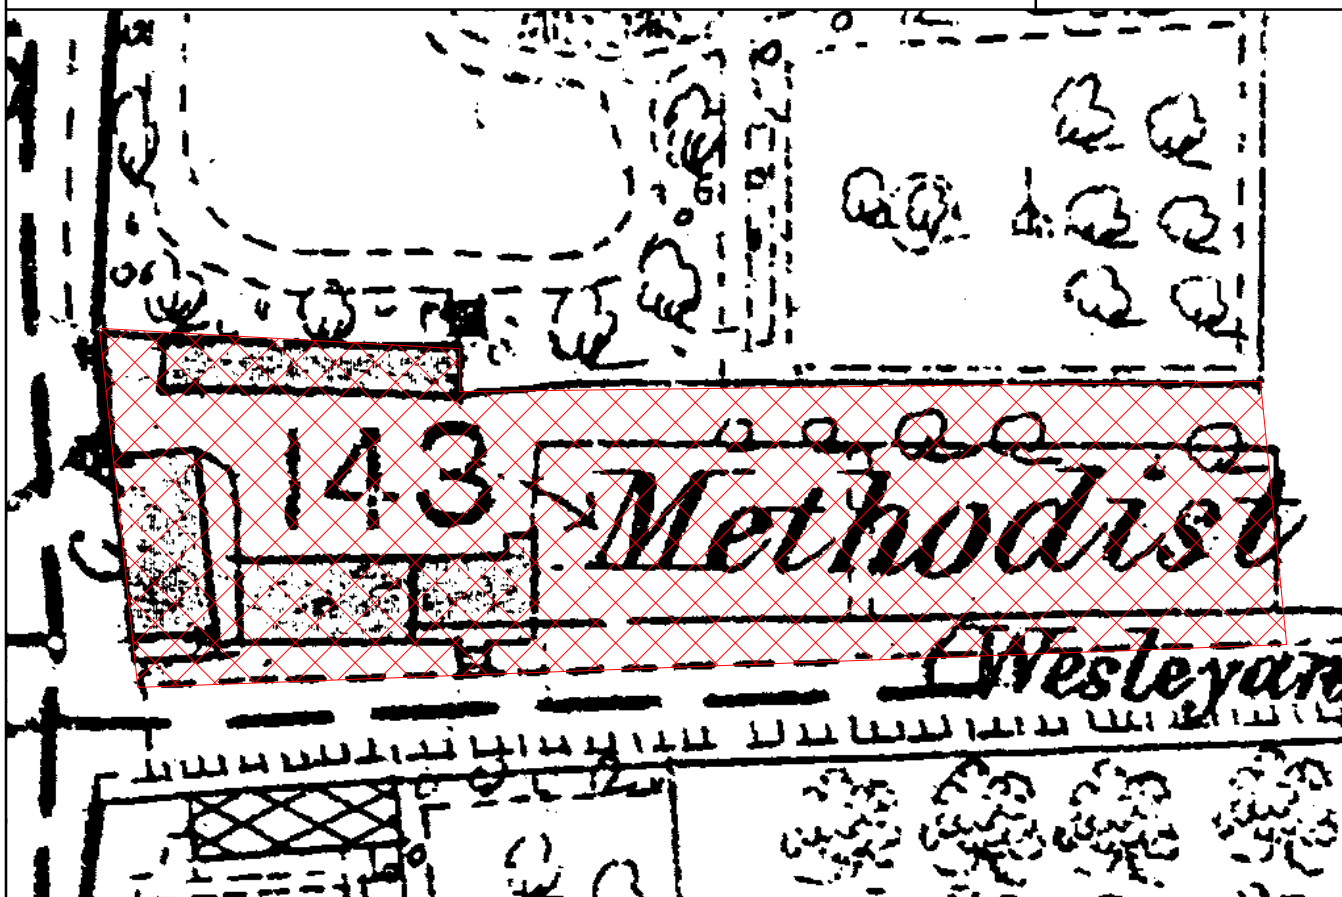
Figure 3

OS 1st edition, 1877

**2.11** The 1<sup>st</sup> edition 25" OS map of 1877 shows some changes to the property (Figure 3). The house along the main road frontage is marked as rectangular in plan, indicating that the building had undergone a number of alterations during the 19<sup>th</sup> century. The northern wing, shown on the map of 1806, had apparently been demolished.

- 2.11.1** A two-cell structure on an east – west alignment is marked to the rear of the house. This is likely to be the present barn. The eastern cell appears to have a southern porch and a small extension on its north side. The map names this as a Methodist Chapel (Wesleyan).

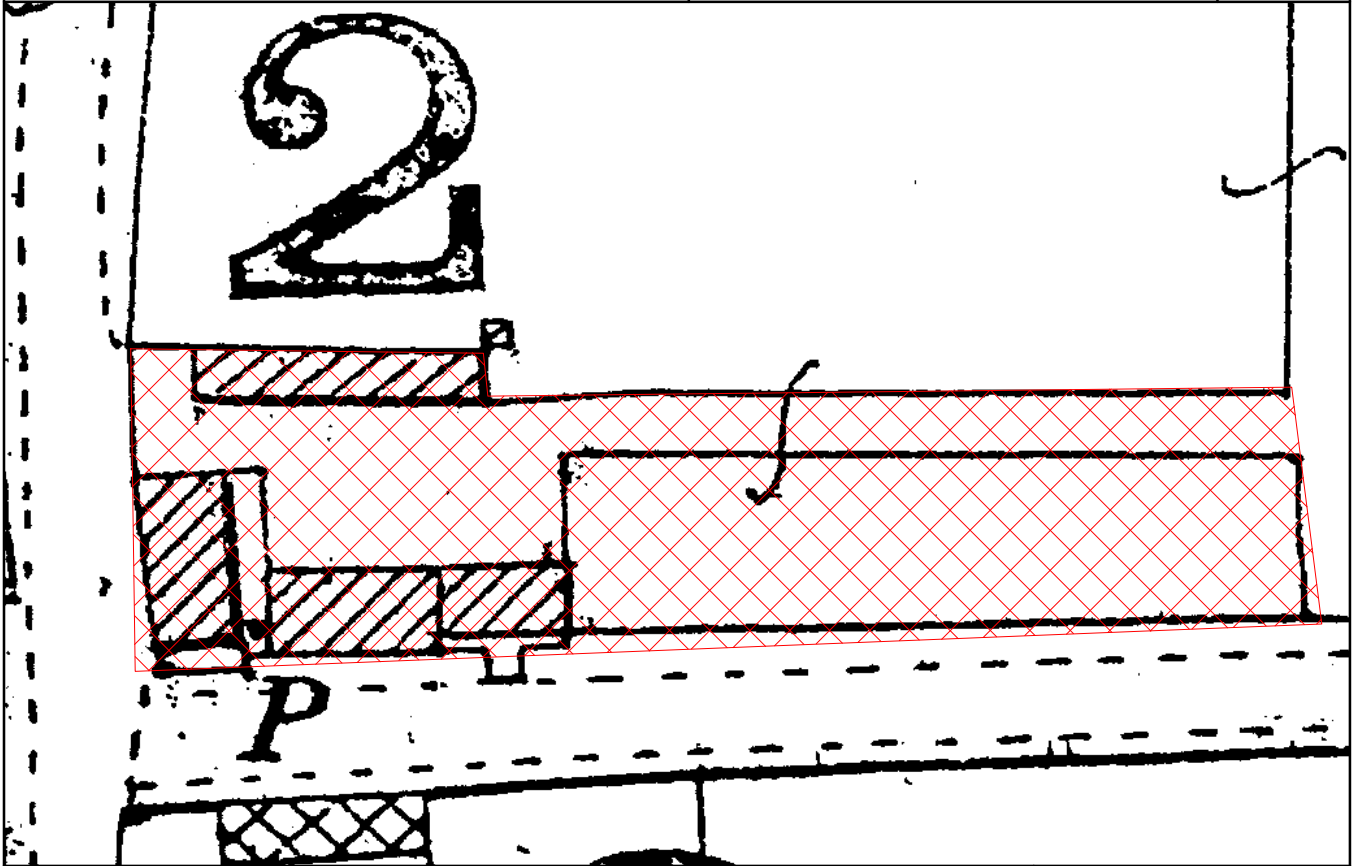
Figure 4

OS 2nd edition map, 1897

- 2.12** Little change is visible on the 2<sup>nd</sup> edition OS map of 1897 (Figure 4). The extension on the north-eastern corner of the Methodist chapel is not shown, suggesting it may have been demolished. The site is no longer identified as a Methodist chapel.

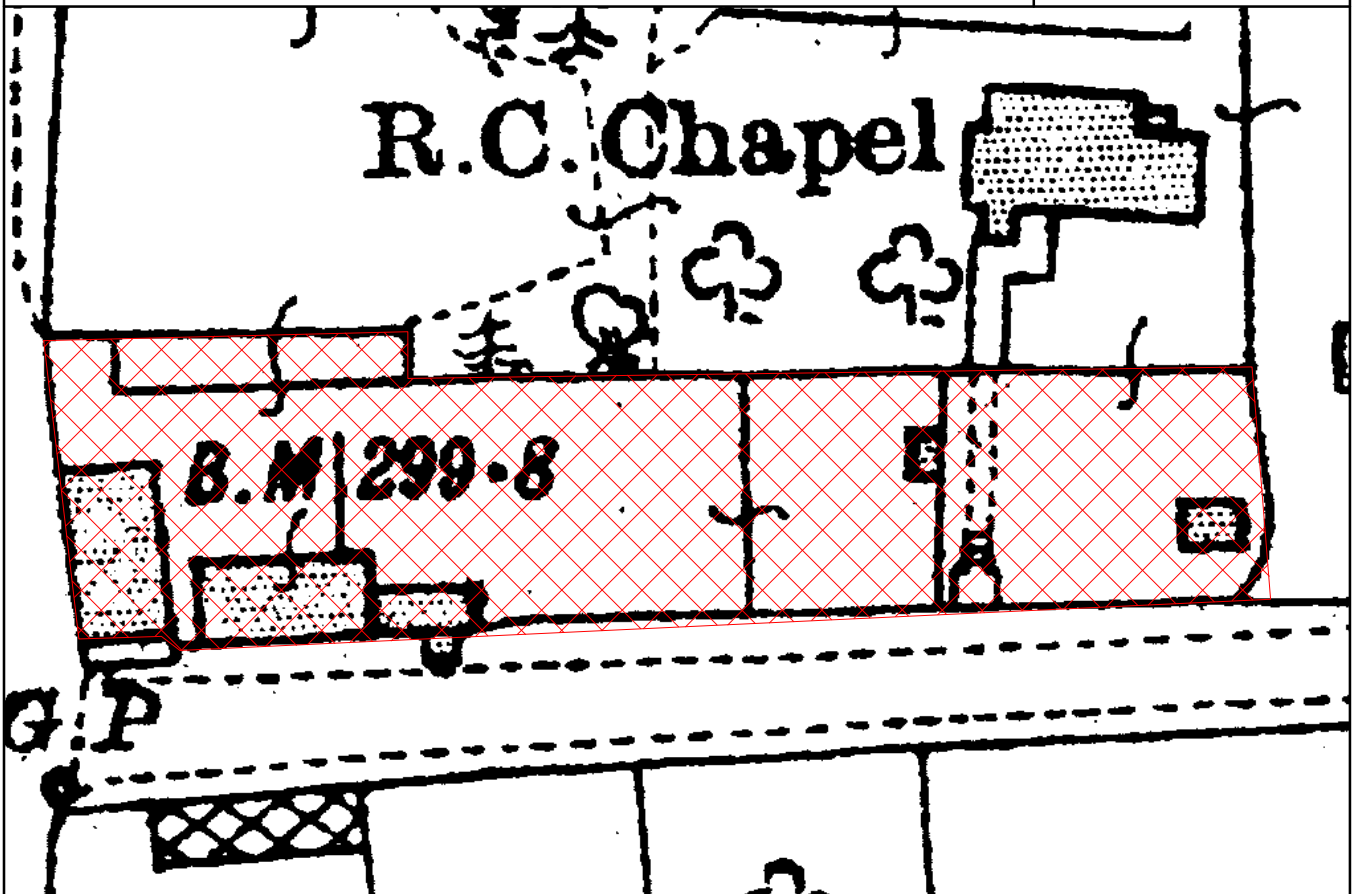
Figure 5

OS 3rd edition, 1921

- 2.12.1** The eastern boundary has been moved further west, reducing the size of the former Home Close.
- 2.13** The 1921 Ordnance Survey shows a number of changes to the property (Figure 5). The eastern cell to the barn has been altered by the removal of its northern side, or has been rebuilt, leaving a narrow structure with a south porch. The boundaries to the enclosed area to the east of the barn have also been removed by this time and new boundaries created.

- 2.13.1** A house has been built on the former Home Close to the east and a Catholic chapel, accessed by a footpath from the lane to Hormead, on the site of the former garden.

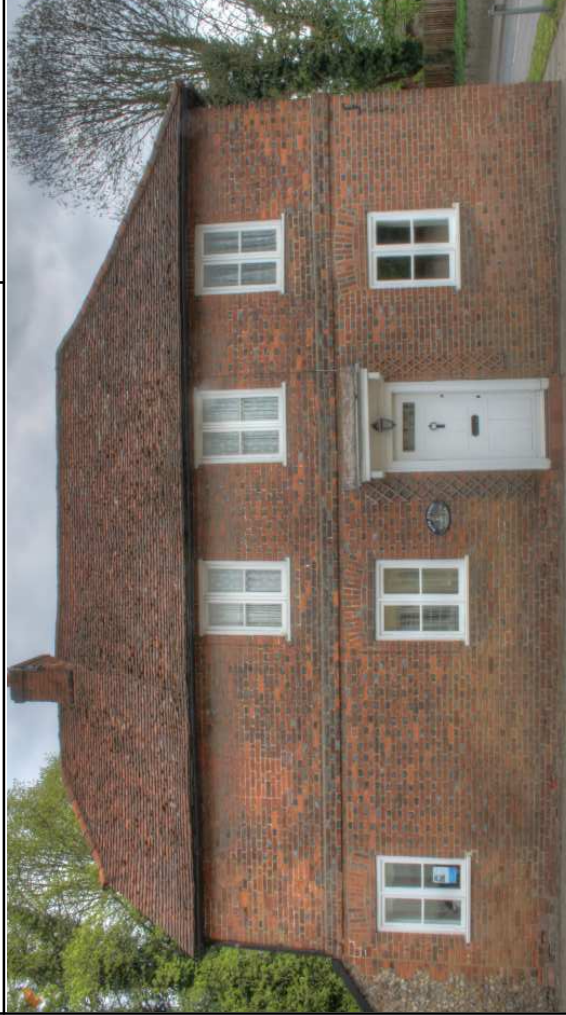
Plate 1: Cottage, west elevation, looking E

**3.4** This is the front elevation, which faces directly on to the B1368 (Figure 7). It is constructed of handmade red brick, laid in Flemish bond with lime mortar (Plate 1). The headers are burnt and the stretchers show diagonal stack marks. The ground and first floor are separated by a plat band of three courses. A line in the brickwork, 0.90m (36") from the northern corner, indicates that the north end of the wall may have been rebuilt. An S-shaped iron tie-plate is visible below the plat band at the southern end of the elevation.

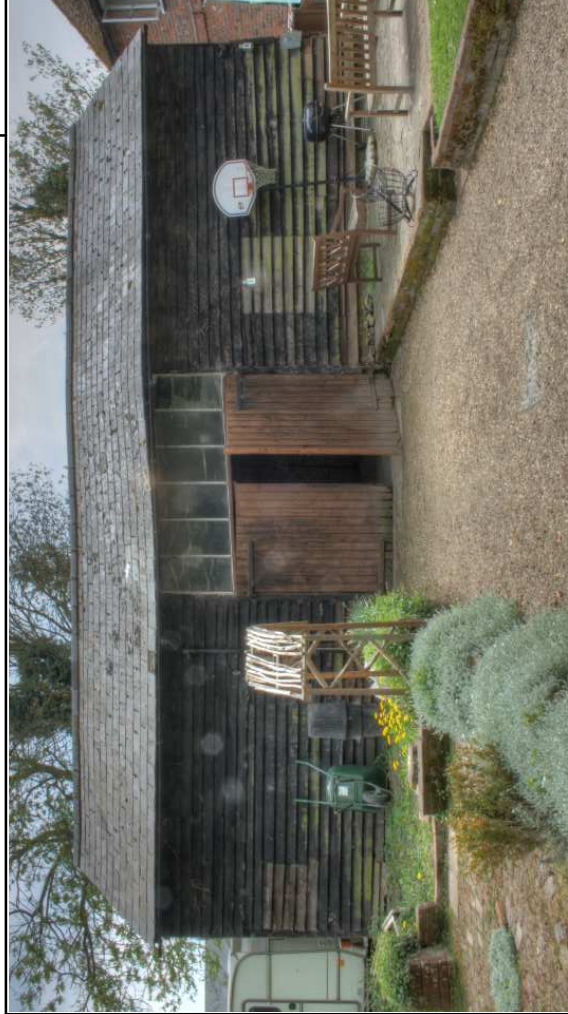
Plate 14: Barn, north elevation, looking S

**3.30** The north elevation is clad in dark stained weatherboarding above a low brick sill wall (Plate 14). The roofline is slightly irregular, possibly indicative of progressive partial repairs to the structure. Double doors, of plank and batten construction, have been inserted in the centre of the elevation. A long rectangular window, with six panes, is located between the top of the door and the eaves.

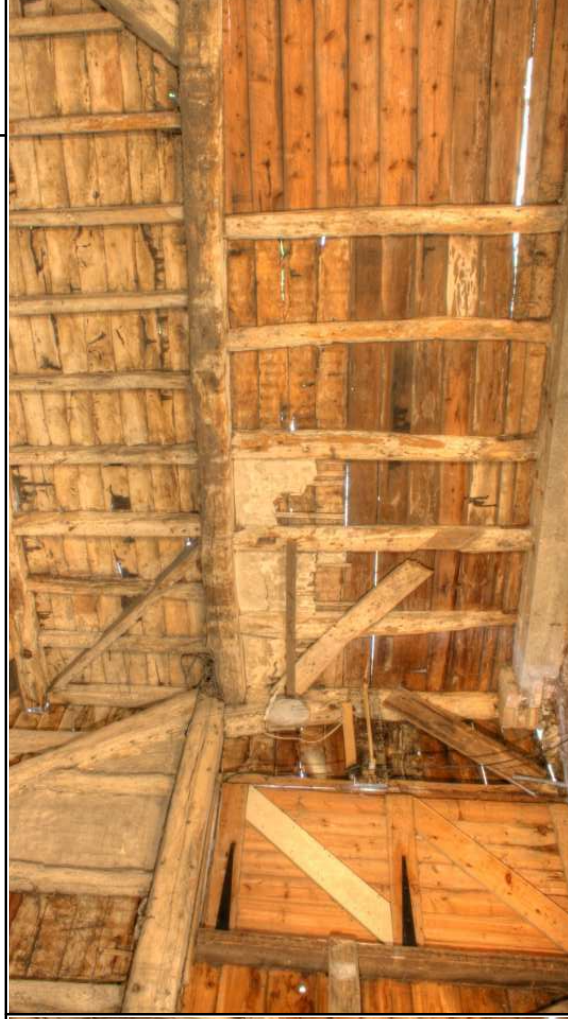
Plate 18: Barn, N & W elevations, looking NW

**3.43** As noted above, the north-western corner post is jowled, and this is matched by the north-eastern corner post. A further jowled post survives in the middle of Bay 2, 1.4m east of the door opening. These support what was originally a wall plate, which now plays the role of a mid-rail, broken by the door opening (Plates 19 & 20). Primary bracing survives in Bays 2 and 5 (Plates 18 & 19). The studs below the mid rail match the associated peg holes and appear to be original, and traces of plaster infill survive between the studs at the western end of the elevation (Plate 18).

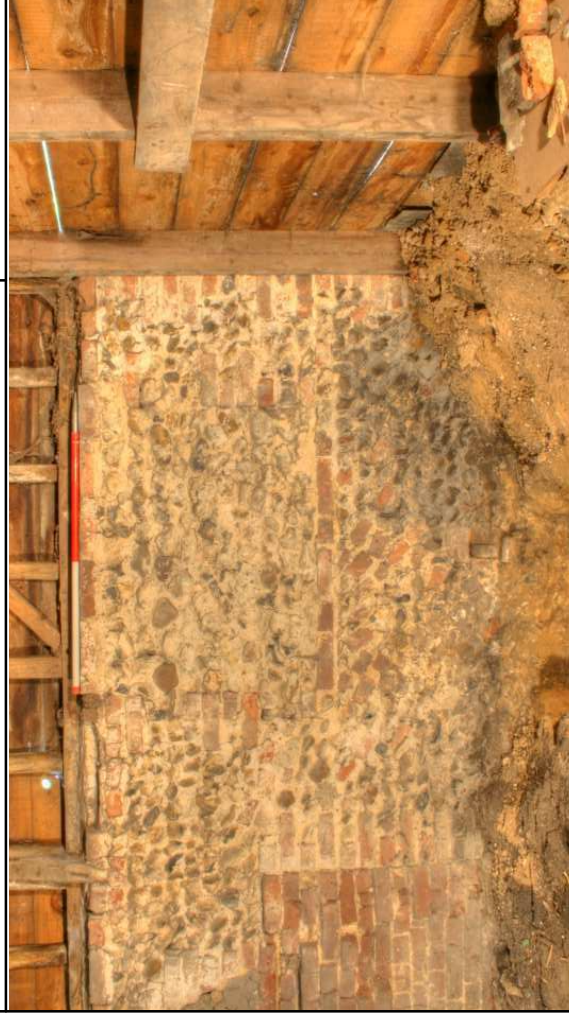
Plate 25: Barn, S elevation, detail of blocked opening in Bay 5

**3.50** A second blocked opening, possibly a window, is visible in Bay 5 to the west. This is located at 0.60m above the present floor surface and measures approximately 1.10m in width by 0.85m in height (Plate 25). It has a surround of handmade brick and is filled with flint cobbles bonded with lime mortar. The wall below is stained with coal dust or soot.

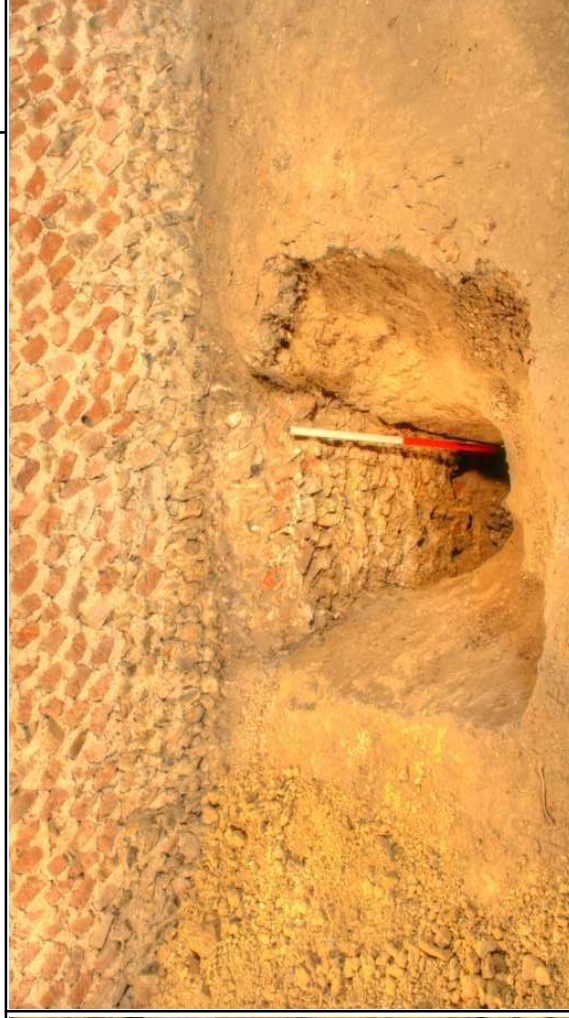
Plate 26: Barn, trial pit excavated against S elevation in Bay 5

**3.51** A trial pit was excavated in the south-western corner, below the westernmost blocked opening, to investigate the wall foundation. It revealed that the footings were composed of flint cobbles, with a band of brick, 0.2m thick, at 0.2m below ground level (Plate 26).

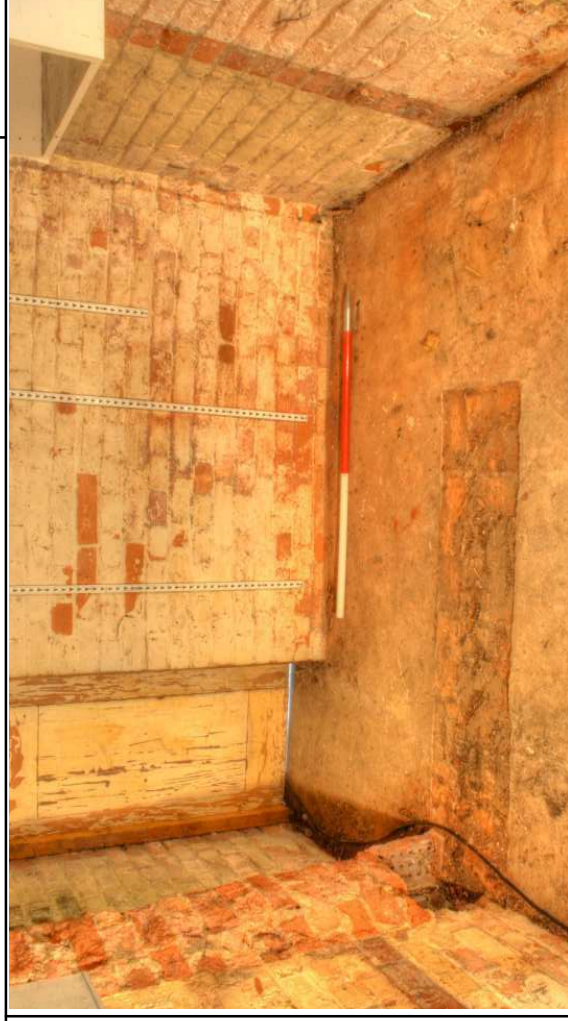
Plate 42: Air-raid shelter: detail of the floor & E wall, showing evidence for demolished blast wall

**3.67** Evidence for the former presence of a blast wall was noted in the form of a visible scar on the floor and ceiling and broken brickwork on the east elevation (Plate 42). A fragment of an air brick remains at the foot of the east wall suggesting that there was some ventilation between the entrance and the refuge.

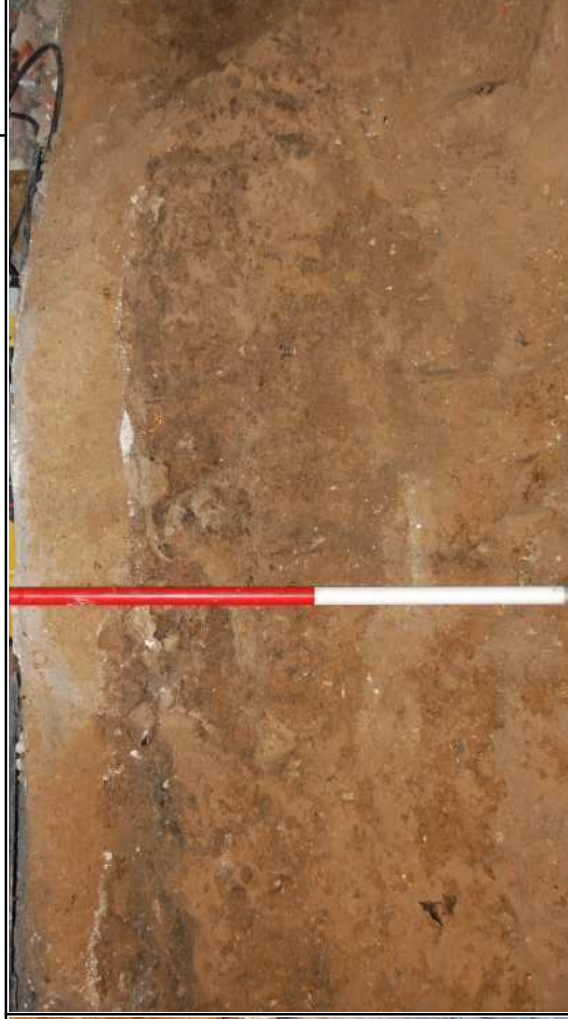
Plate 46: Barn, section through floor layers to W of [104]

**4.5** To the west of [104], the floor comprised beaten chalk, layer (116), which contained frequent brickearth flecks (Plate 46). It had a maximum length of 5m and a maximum width of 4m and was 0.02m in depth. It extended from the north wall to [112] and [107] in the south and to [104] in the east. Below (116) was a layer of light yellowish brown loose sandy clay silt, context (117), between 0.06m and 0.16m in depth. This may represent a make-up layer for (116). A layer of loose chalk, context (118), which measured between 0.03 and 0.13m in depth, lay beneath (117). Below this was a layer of very dark brown loose sandy clay silt with frequent flints, context (119), which measured approximately 0.08m in depth. This overlay a loose dark brown sandy silt clay with moderate amounts of flint, context (120), which measured between 0.06m and 0.12m. This may represent a buried soil layer.

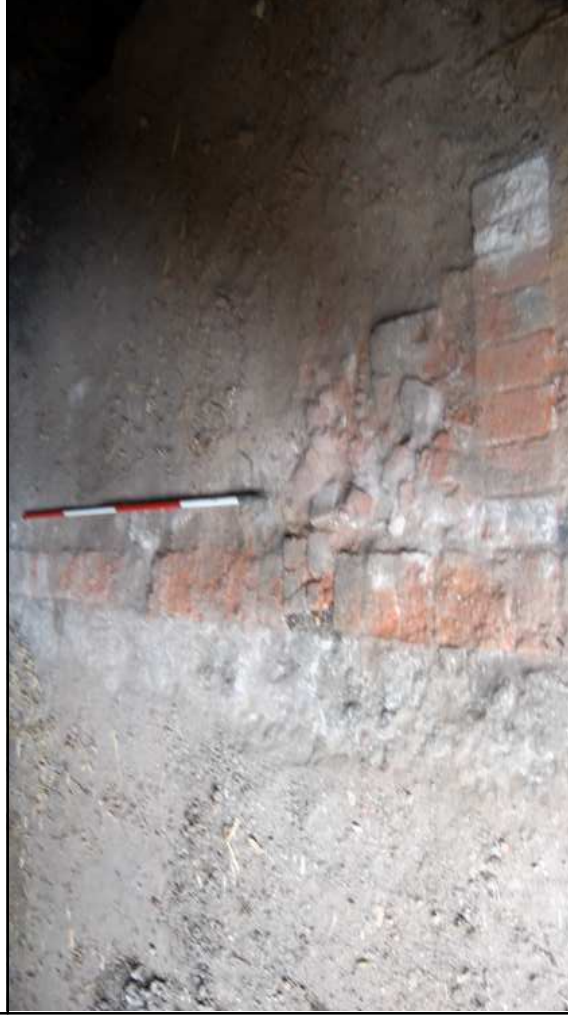
Plate 47: Barn, walls [104] & [105] looking S

opening in the south wall (Plate 47). This may represent the base of a former partition within the barn. It measured 5m in length, 0.30m in width and approximately 0.14m in depth. The wall was constructed of red bricks bonded with a lime mortar and stood two courses high. The bricks on the eastern side were laid in header bond, with an additional line of stretcher bricks on the west side (Figure 20). The cut lines to the east, [113], and west, [114], of the wall may mark the edge of its foundation trench.

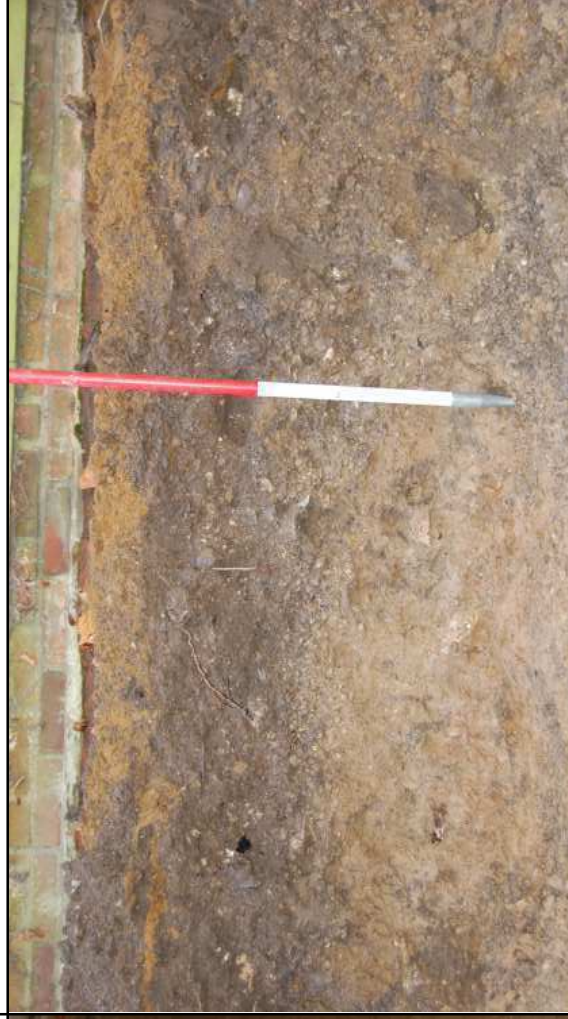
Plate 52: Section through ground to N of the barn

**4.7** Ground reduction to the north of the barn revealed a number of make-up and soil layers below the existing flagstones. Layer 121 comprised the make-up for the flagstones and consisted of loose yellowish brown sand, 0.08m in depth. Below this was (122), a layer of firm dark brownish grey sandy silty clay with frequent flints, 0.10m in depth. Deposit (123) lay below (122) and consisted of firm mid grey coarse sandy clay silt with frequent flints, 0.18m in depth. Below this was layer (124), comprising yellowish brown sand and clay with moderate amounts of flint and gravel, 0.18m in depth. Layer (125), below (124), comprised loose dark grey sandy clay silt with moderate amounts of flint, 0.15m in depth. Deposit (126) overlay the natural clay and comprised mixed grey sandy clay silt with frequent brick and slate fragments, 0.15m in depth.
