**72-74 SOUTH ROAD
Baldock, Hertfordshire**

Project ref.: HN853
LPA ref.: 1/09/00479

Archaeological Monitoring

Report no.618

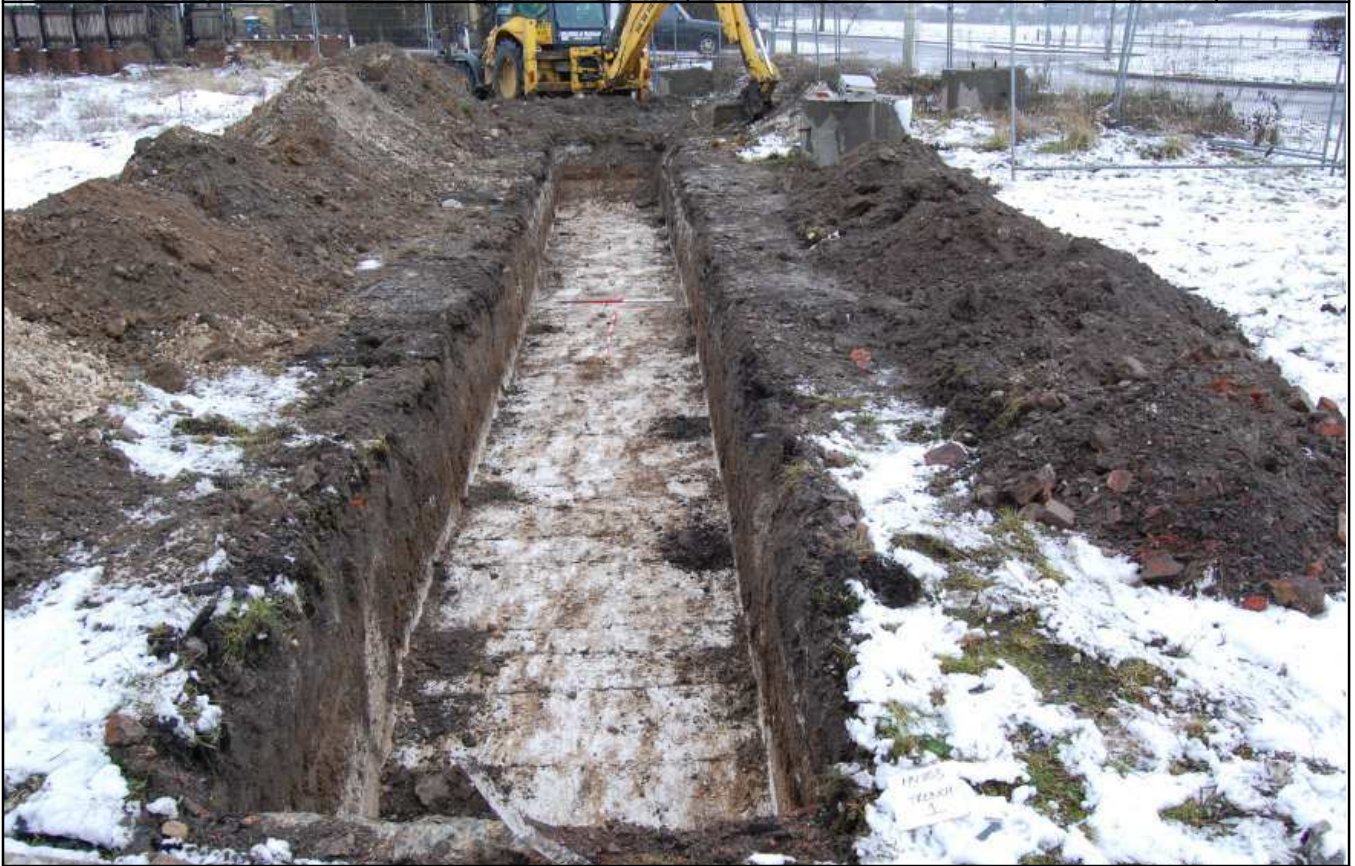
Plate 1: Trench 6, looking north-west

2.12 The stratigraphy in the trench consisted of a very mixed demolition overburden, 0.50m in depth, below which was a brown (10YR 4/3) silty clay subsoil, 0.50m in depth. Beneath this was the natural chalk, which contained patches of reddish brown (2.5 YR 4/4) silty clay, representing root activity (Plate 1).

2.13 No evidence for the presence of cremation burials was encountered and no other archaeological features, deposits or finds were present in Trench 6.

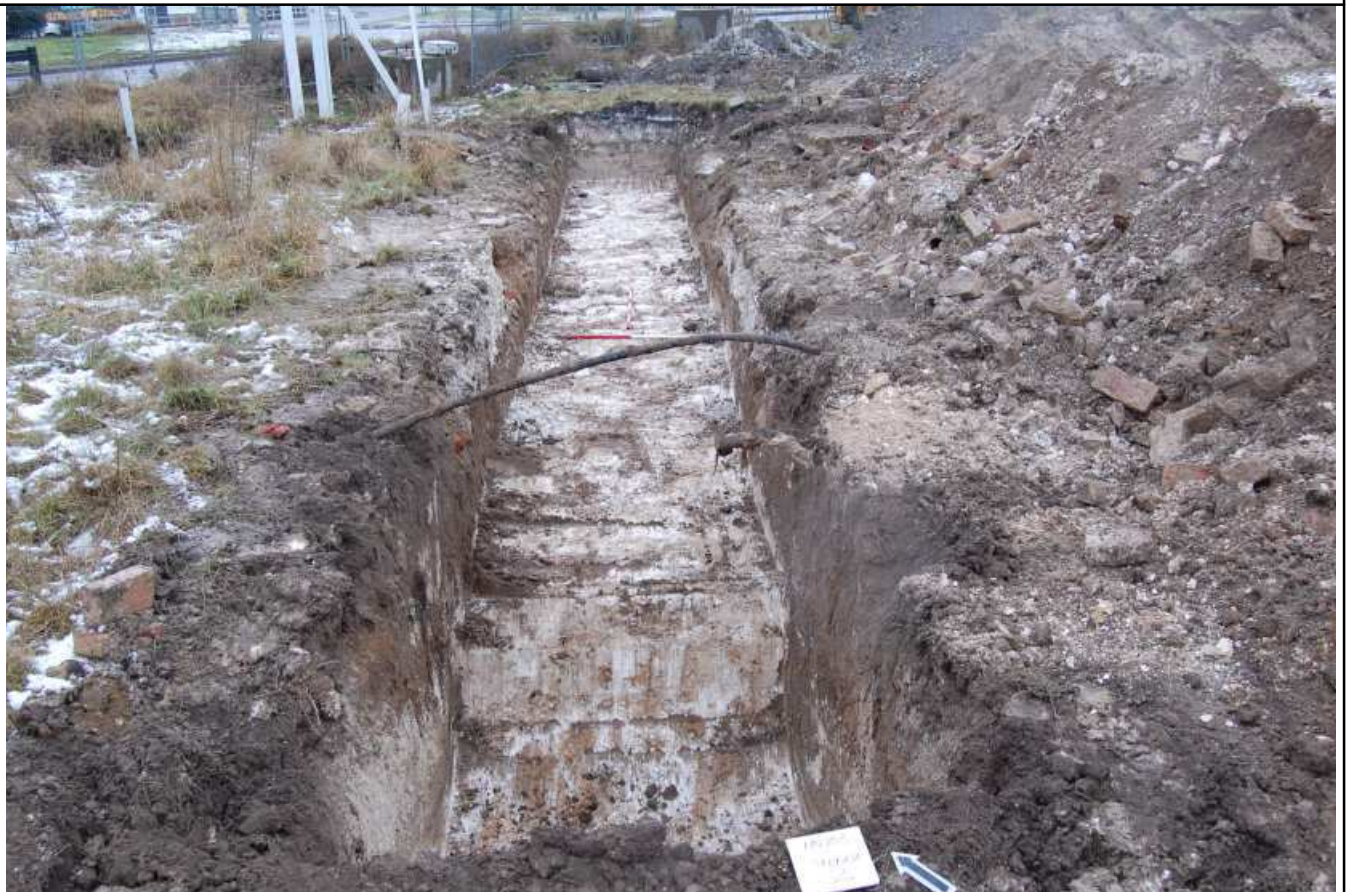
Plate 2: Trench 7, looking north-east

2.15 The stratigraphy in the trench was similar to that observed in Trench 6 and consisted of a layer of very mixed demolition overburden, 0.50m in depth, above a brown (10YR 4/3) silty clay subsoil, 0.50m in depth. Beneath this was the natural chalk, which contained patches of reddish brown (2.5 YR 4/4) silty clay, representing root activity (Plate 2).

2.16 No evidence for the presence of cremation burials was encountered and no other archaeological features, deposits or finds were present in Trench 7.

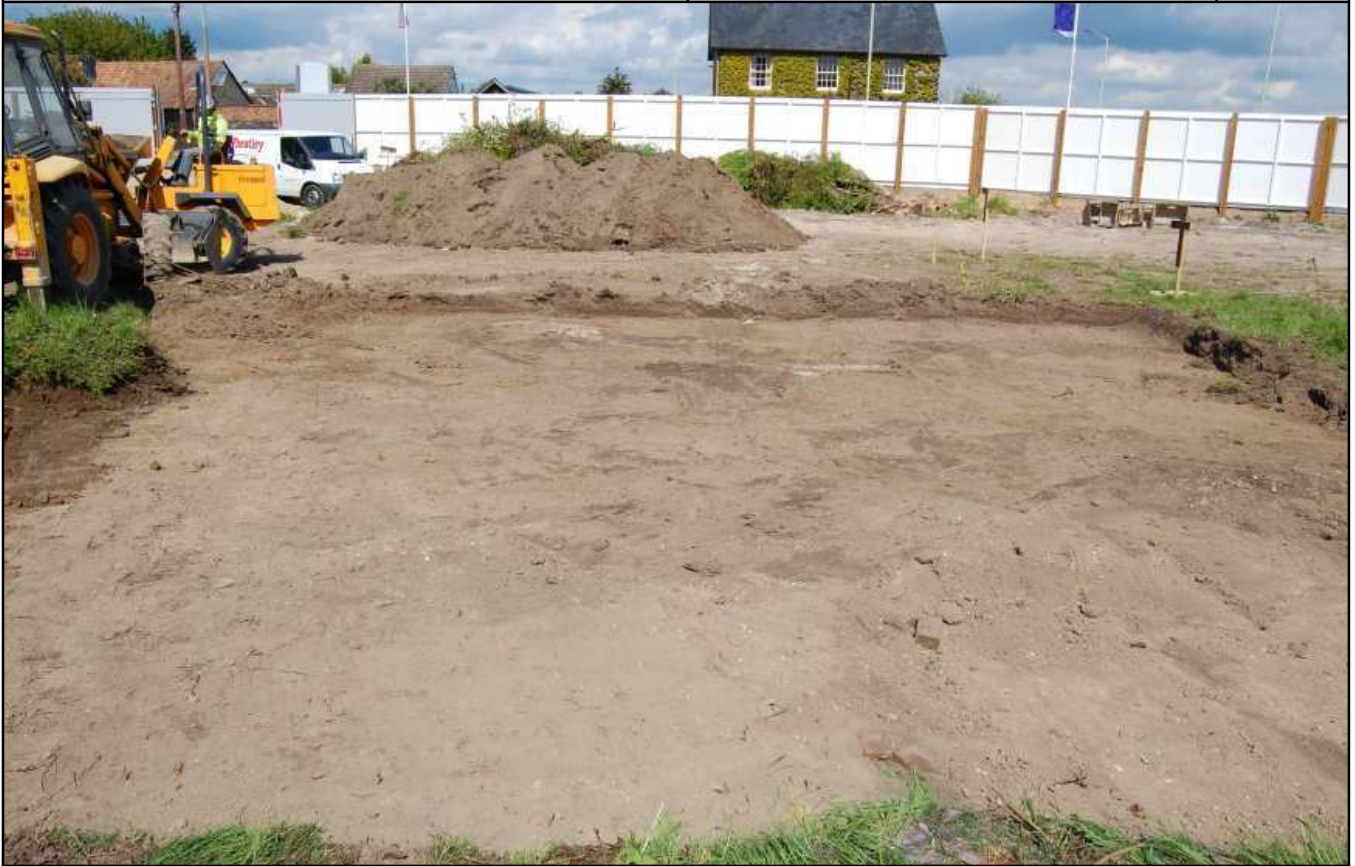
Plate 3: Topsoil stripping, southern end of site, looking north

2.18 The overburden across the southern end of the site was reduced by approximately 0.50m, revealing a subsoil layer of brown (10YR 4/3) silty clay, with occasional chalk flecks (Plate 3). Evidence for the former buildings on the site, in the form of patches of bricks and concrete and defunct cables, was also noted.

2.19 No archaeological features, deposits or finds were identified during this phase of the groundworks.

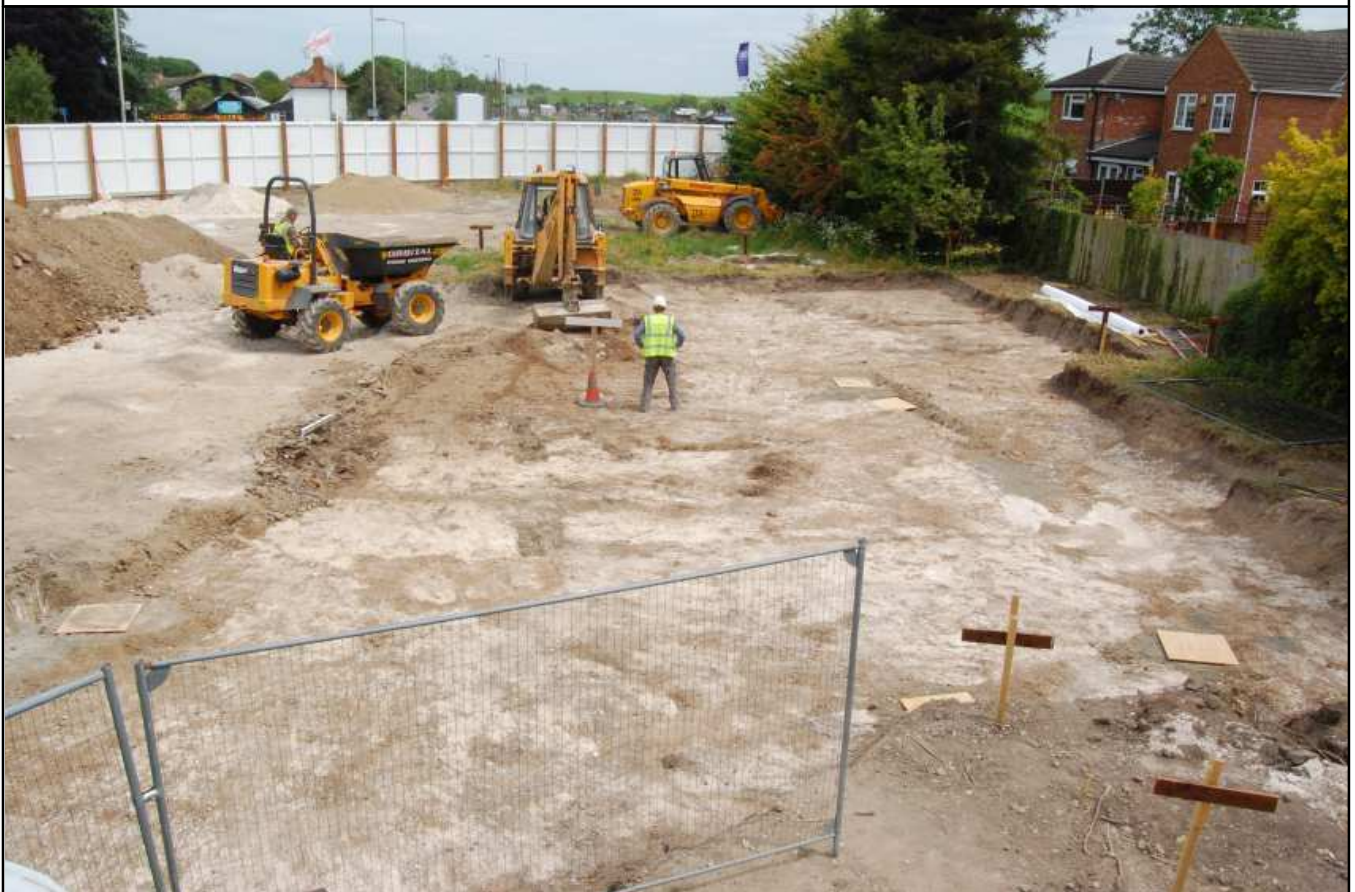
Plate 4: Ground reduction in car park area

2.20 The ground level in the area of the car park for the new development, located in the south-western corner of the site, was reduced by approximately 0.30m below the level of the topsoil strip to the clean natural chalk (Plate 4).

2.21 A feature containing a single animal burial, of fairly recent date, was observed in the centre of the area. It measured approximately 0.60m in diameter and is likely to represent the burial of a pet from one of the houses that formerly occupied the site. No other features, deposits or finds were encountered during this phase of the groundworks.

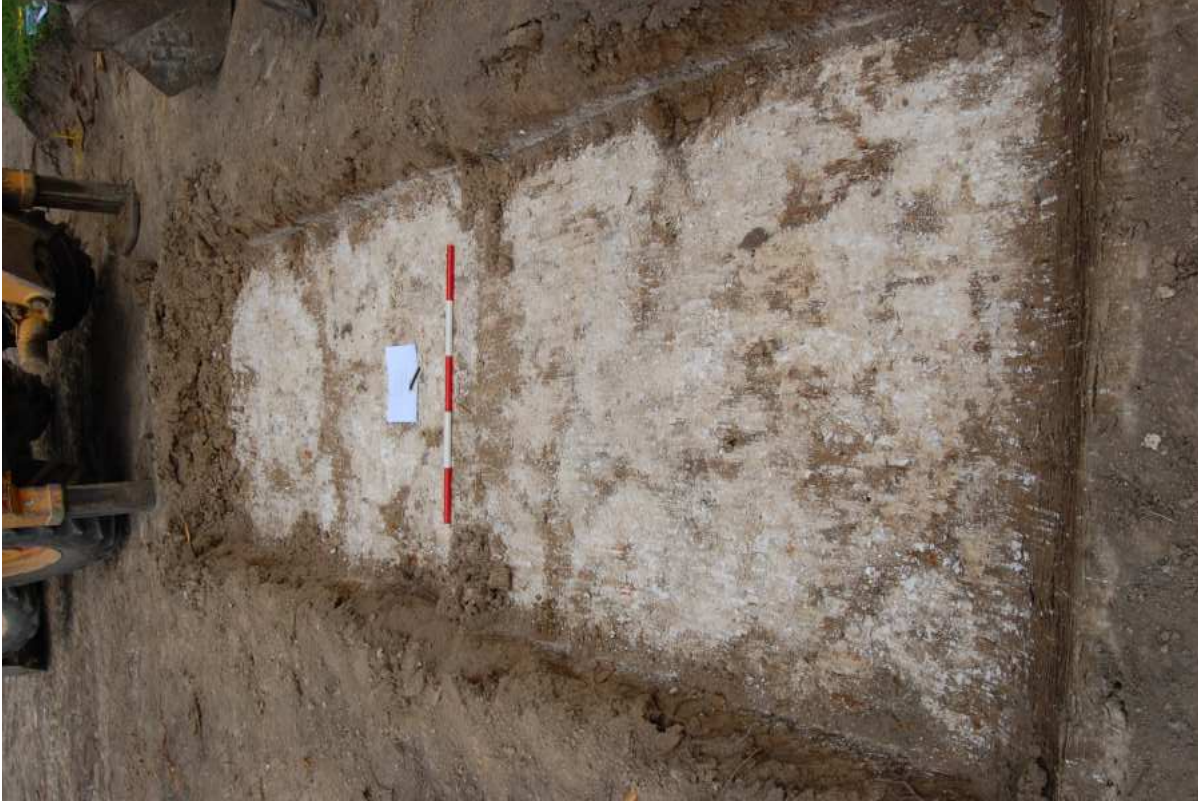
Plate 5: Soakaway 1

- Soakaway 1 was located at the rear of the car park area and measured 6m in length and 2m in width. The natural chalk was exposed at approximately 0.30m below the present surface (Plate 5).

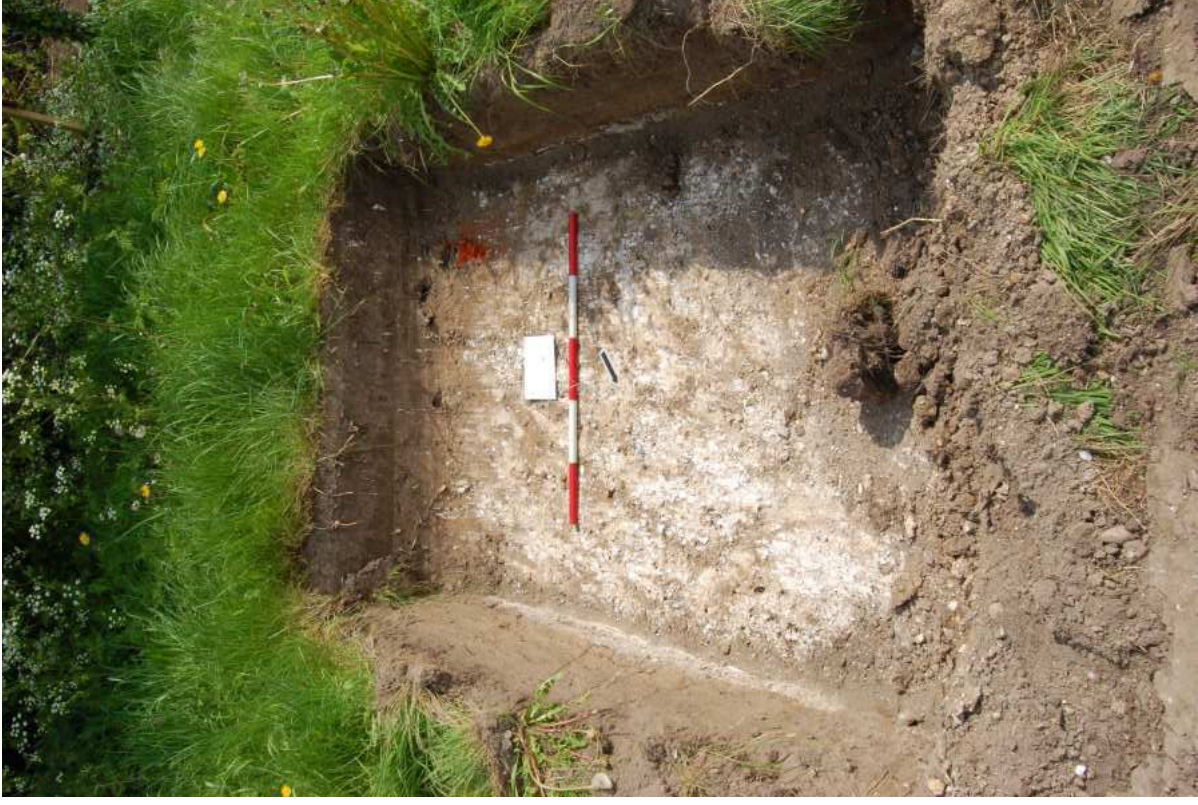
Plate 6: Soakaway 2

- Soakaway 2 was located to the south-west of Plots 13-14 and measured 4m in length and 1m in width. The natural chalk was exposed at approximately 0.50m below the present surface (Plate 6).

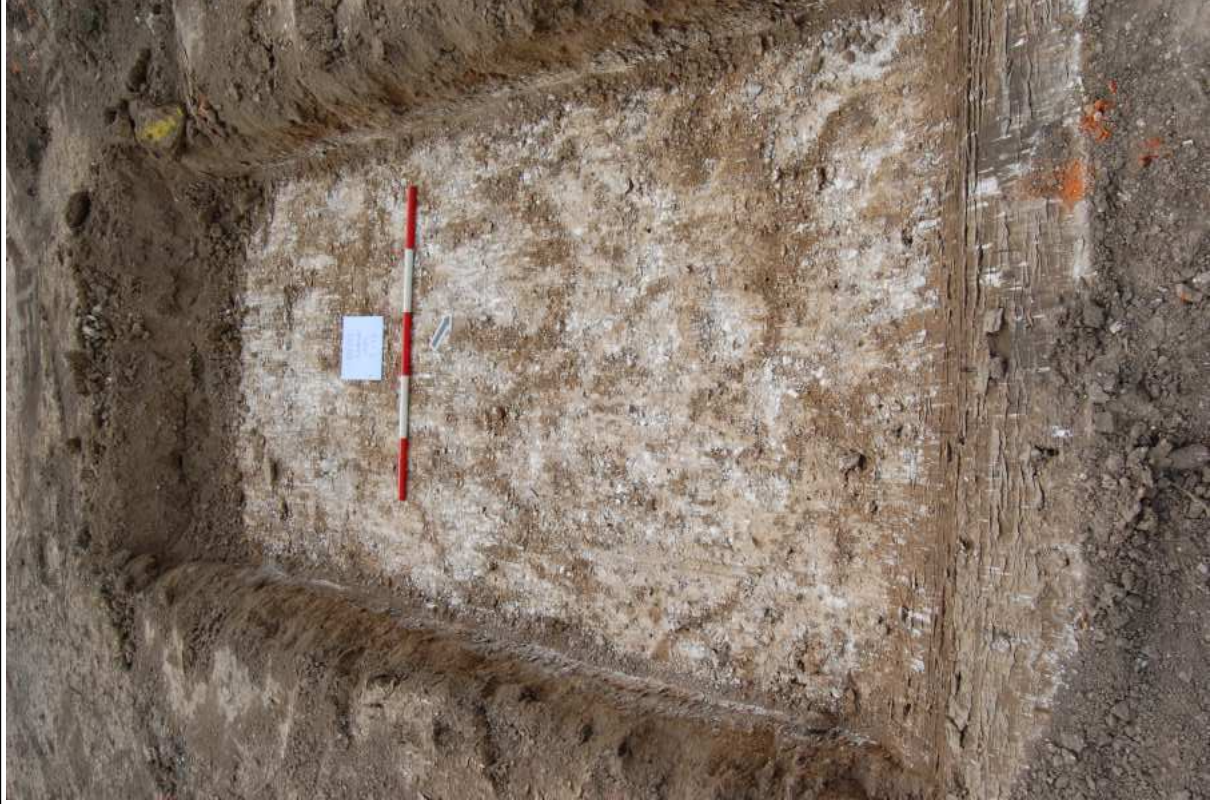
Plate 7: Soakaway 3

- Soakaway 3 was located to the south of Plots 7-12 and measured 4m in length and 2m in width. The natural chalk was exposed at approximately 0.50m below the present surface (Plate 7).

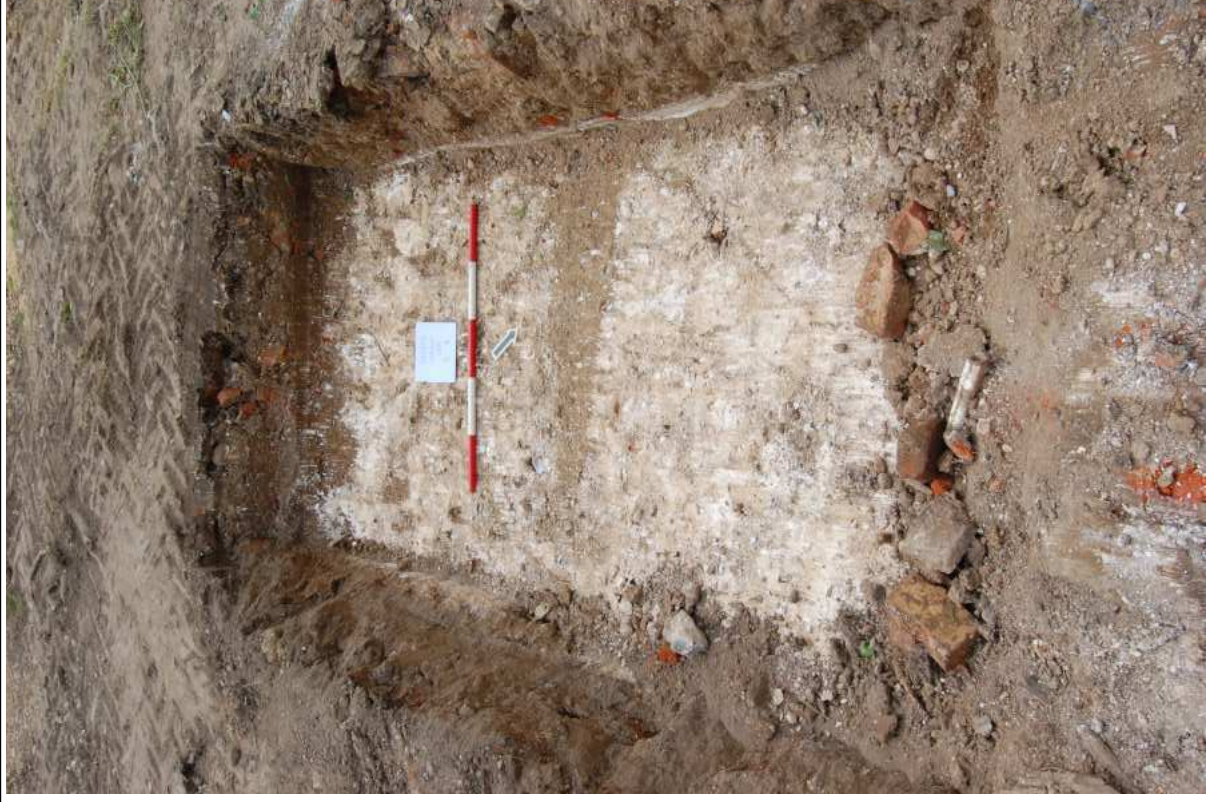
Plate 8: Soakaway 4

- Soakaway 4 was located to the south-east of Plots 3-4 and measured 6m in length and 1m in width. The natural chalk was exposed at approximately 0.50m below the present surface (Plate 8).

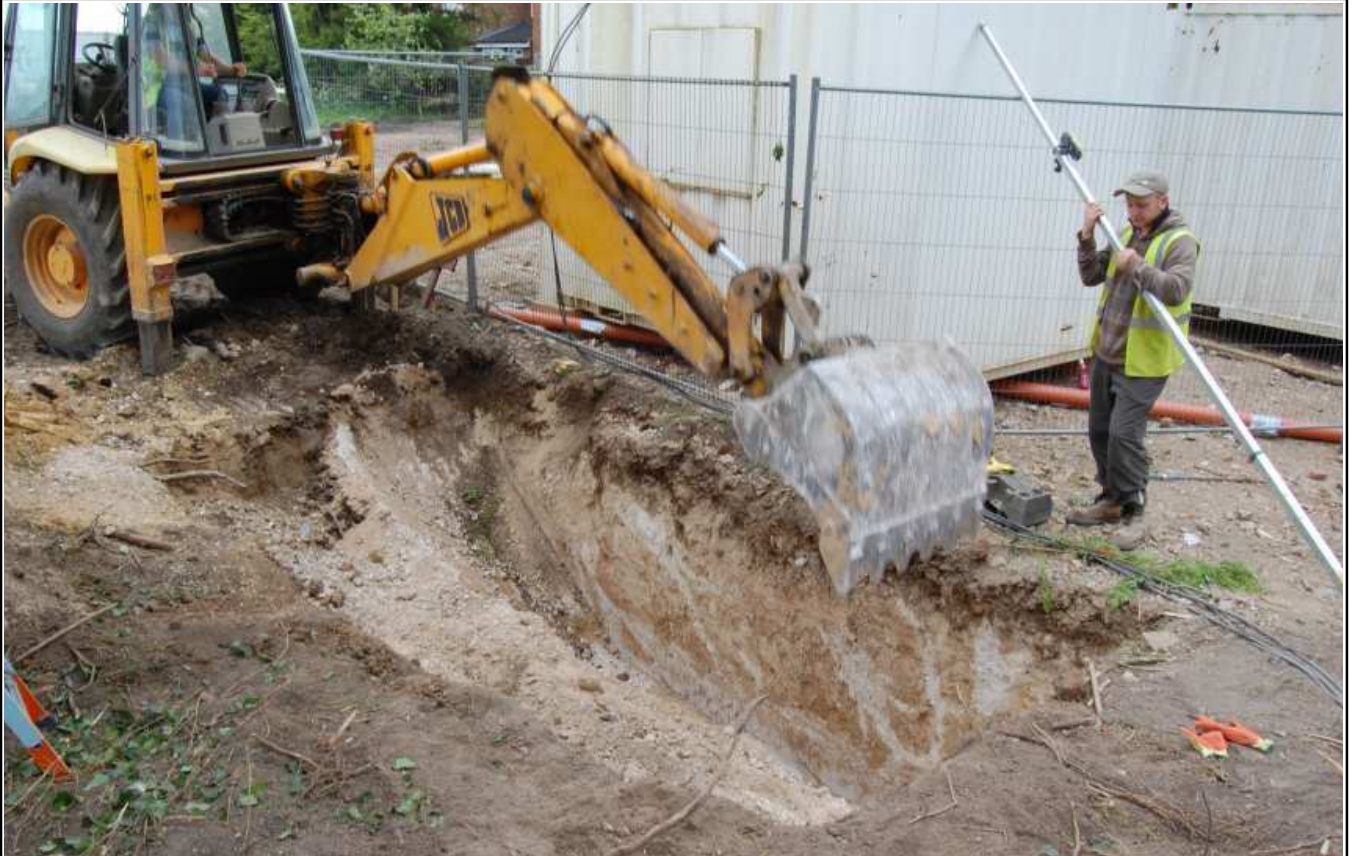
Plate 9: Soakaway 5

- Soakaway 5 was located in the car park, close to the southern boundary of the site, and measured 6.5m in length and 3m in width. The natural chalk was exposed at approximately 0.10m below the present surface (Plate 9).

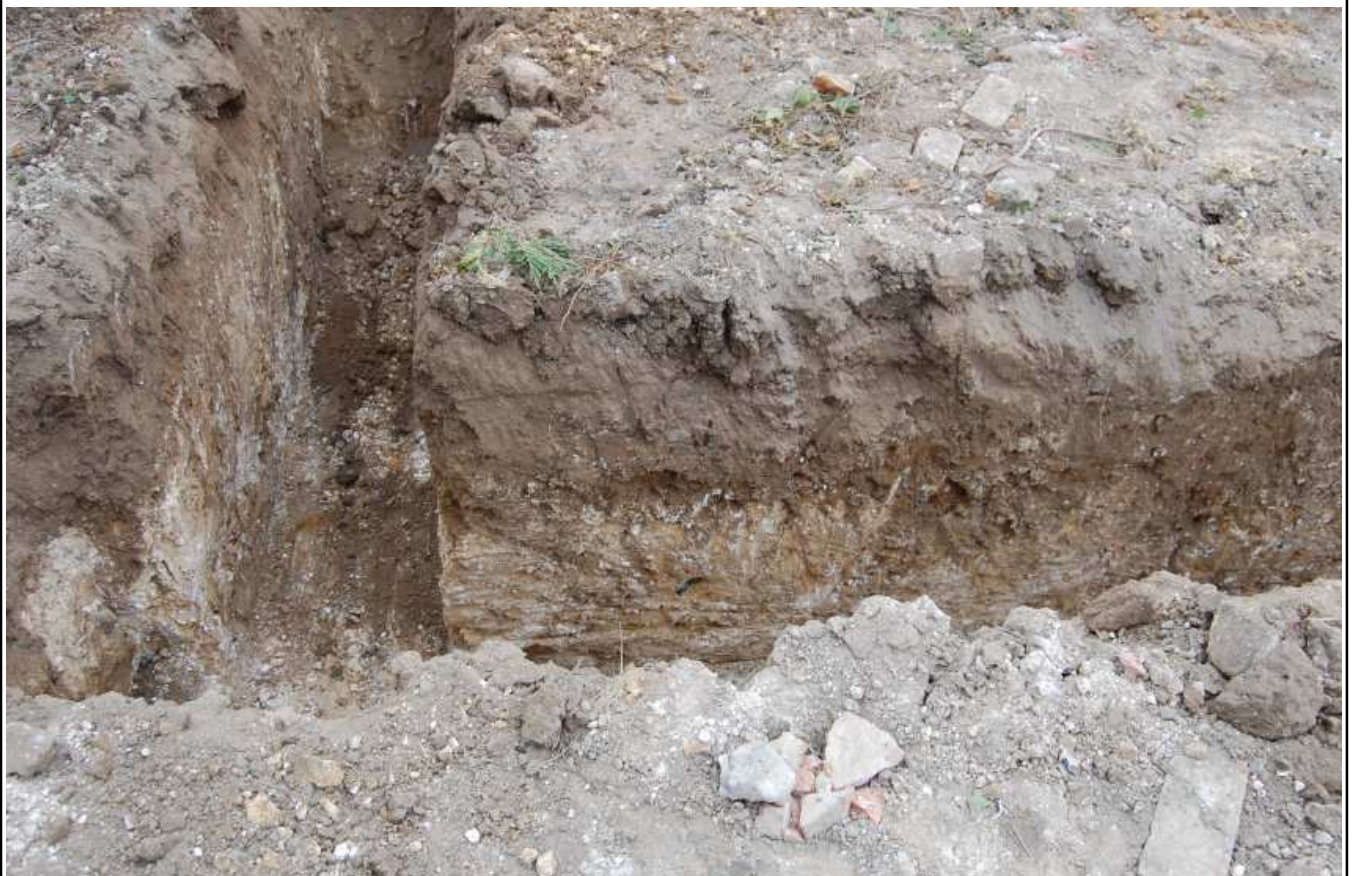
Plate 10: Sample section, footings trench Plots 13-14

2.28 The stratigraphy in the trench sections was similar across the entire site and consisted of a layer of brown (10YR 4/3) silty clay subsoil, with occasional chalk flecks and small stones, between 0.30m and 0.60m in depth above the natural chalk (Plate 10).
