JESSAMINE HOUSE,
15 High Street, Ashwell, Hertfordshire.

Project Ref: HN851
LPA Planning ref: 09/01603/1LB

Historic Building Record & Archaeological Monitoring

Report no.621

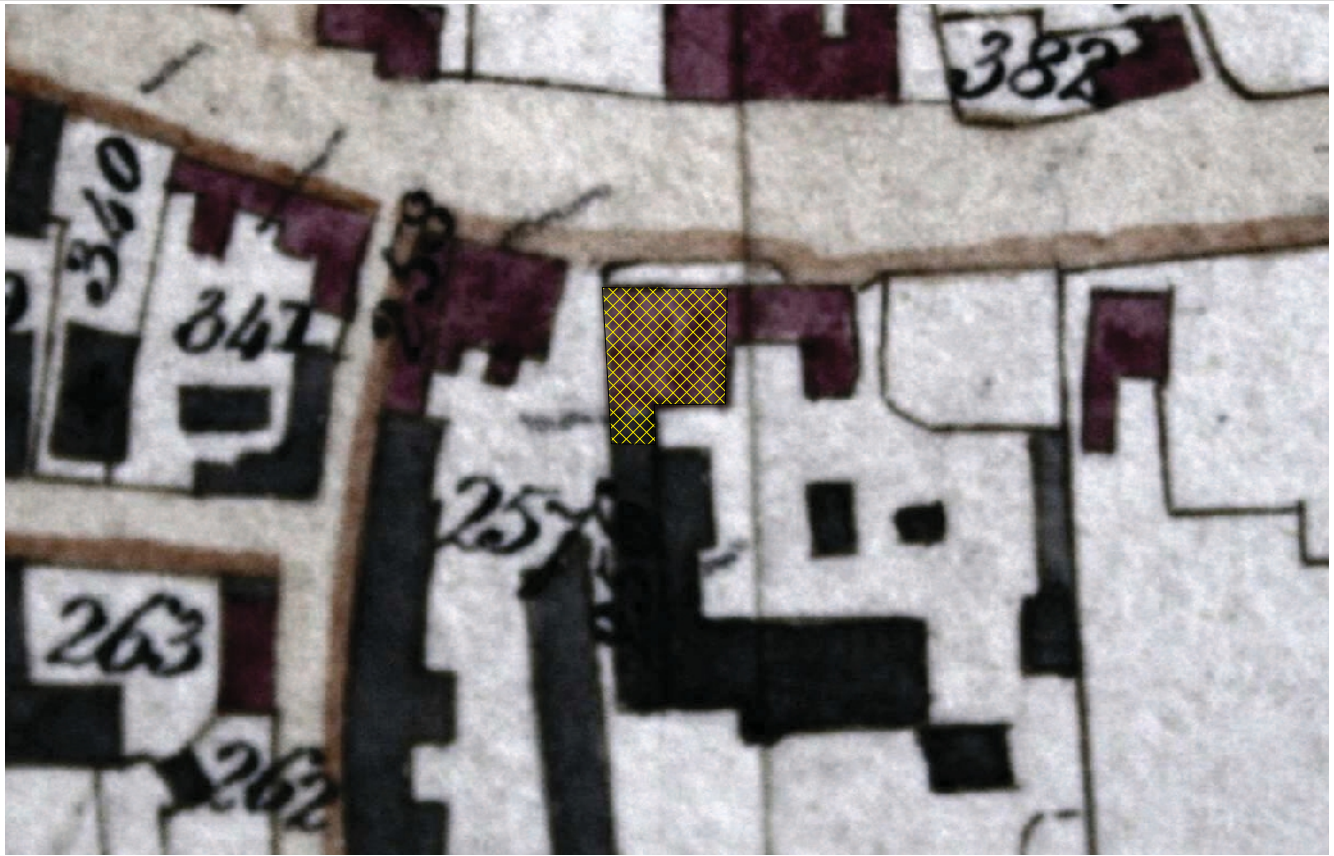
Figure 2: Extract from the Ashwell Tithe map, 1841 (HALS DSA/4/6/2)

2.8 The Tithe map of 1841 (HALS DSA4/6/2) shows the present site as Plot 255, which comprised a farmhouse fronting High Street and farm buildings to the rear (Figure 2). The property extended south to Ashwell Street. The farmhouse was in two blocks, a square block on the western side and an adjoining L-shaped block to the east. The northern range of the farm buildings adjoined the rear of the western block of the farmhouse.

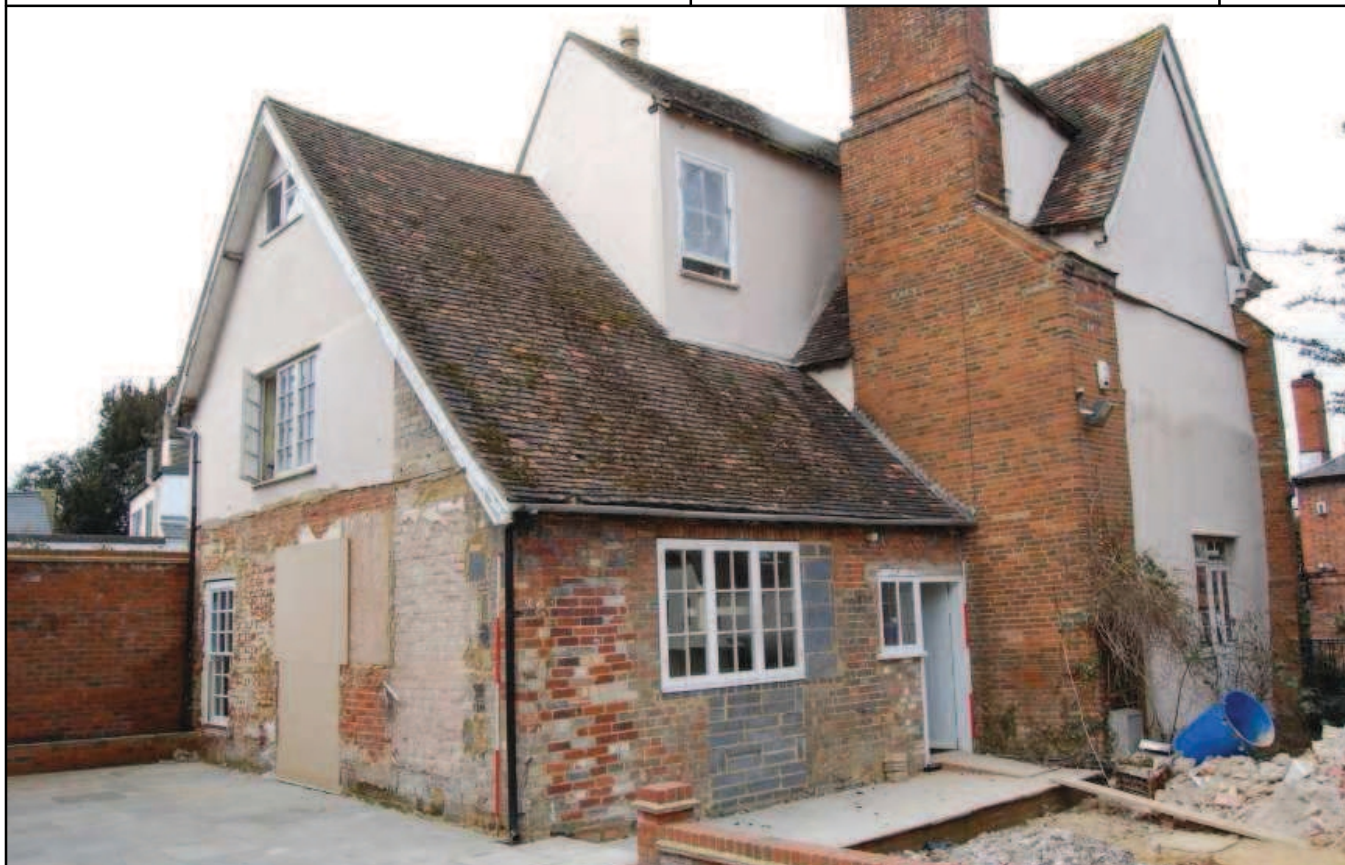
Plate 1: South and east exterior elevations

3.2 The rear (south) elevation has been stripped of its render below the first floor level following removal of a modern extension (Plate 1). Two previously blocked openings or blind windows have been re-opened and a modern sash inserted on the left side. The opening on the right is boarded and intended for a French window.

3.3 The two windows on the upper floors of the rear elevation of the rear range are also modern and due to be replaced. At first floor level, the existing window is a three light casement, each light of 8 panes, with the centre light fixed. The topmost window is a casement of two lights, with one light opening, the other with an opening quarter light.

3.4 The brickwork is original and is in Flemish bond with lime mortar. The bricks measure 8¾" x 4" x 2½" (22 x 10 x 6.5cm).

3.5 On the right hand side, beyond the second opening, is a lean-to outshut built of Cambridge white bricks, also laid in Flemish bond with lime mortar. The bricks measure 9" by 4½" by 2½" (23 x 11.5 x 6.5cm).

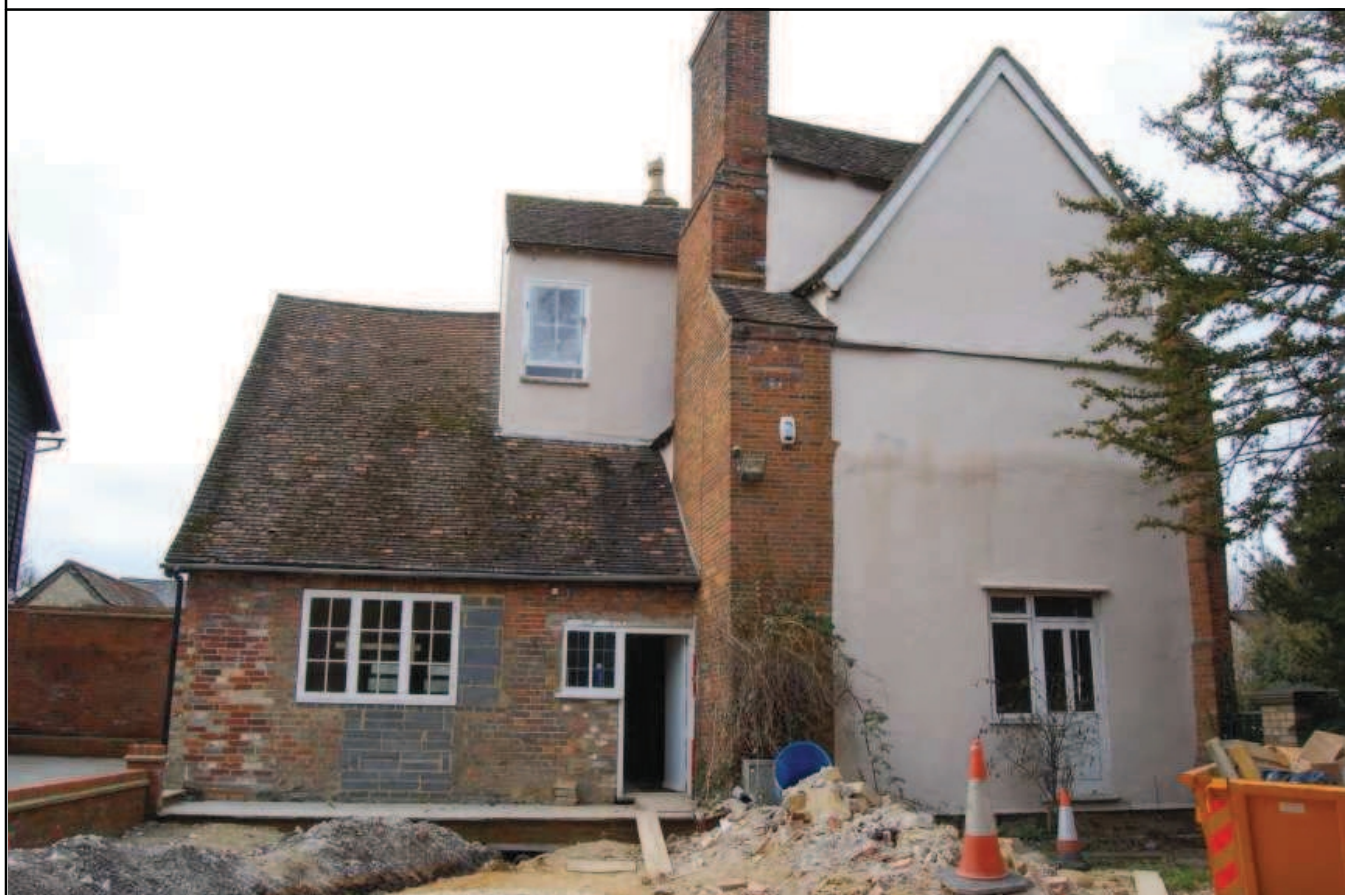
Plate 2: East exterior elevation

3.6 The east elevation of the outshut has been extensively remodelled in a variety of different brick types (Plate 2). Its original form is unclear.

3.8 A chimney stack and stair tower rise between the original rear of the building and the rear range (see Plate 2). A modern metal framed window, with a horizontal centre pivot, is located in the side elevation of the stair tower. This will be replaced.

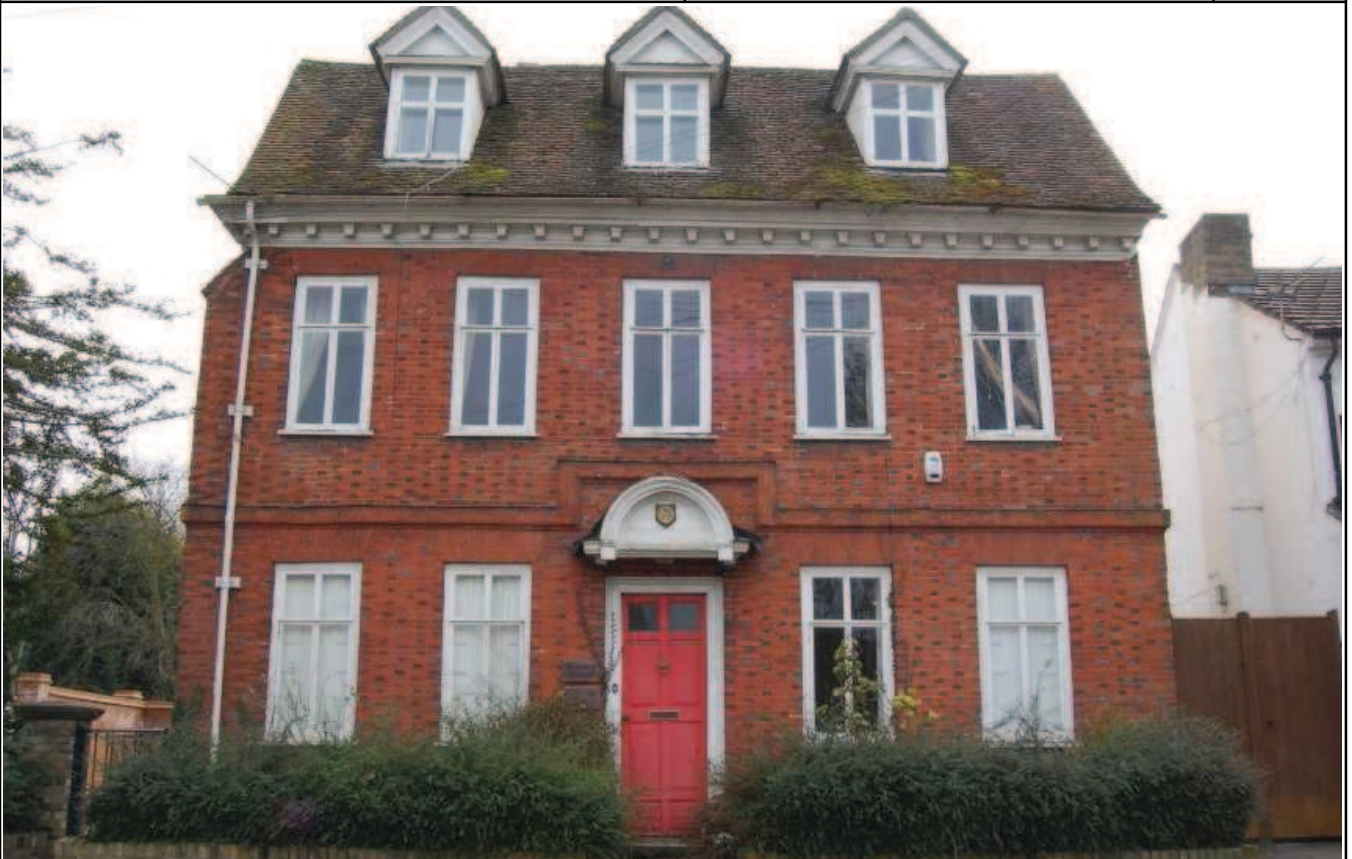
Plate 3: North exterior elevation

3.9 The front (north) elevation is as described in the listing and will not be altered by the present works (Plate 3). It is in chequered brick with a central door surmounted by a semi-circular hood. A moulded floor band in brick runs across the front and above the doorway.

3.10 There are two windows either side of the doorway on the ground floor and five windows at first floor level. Three dormer windows are set into the roof, which is tiled.

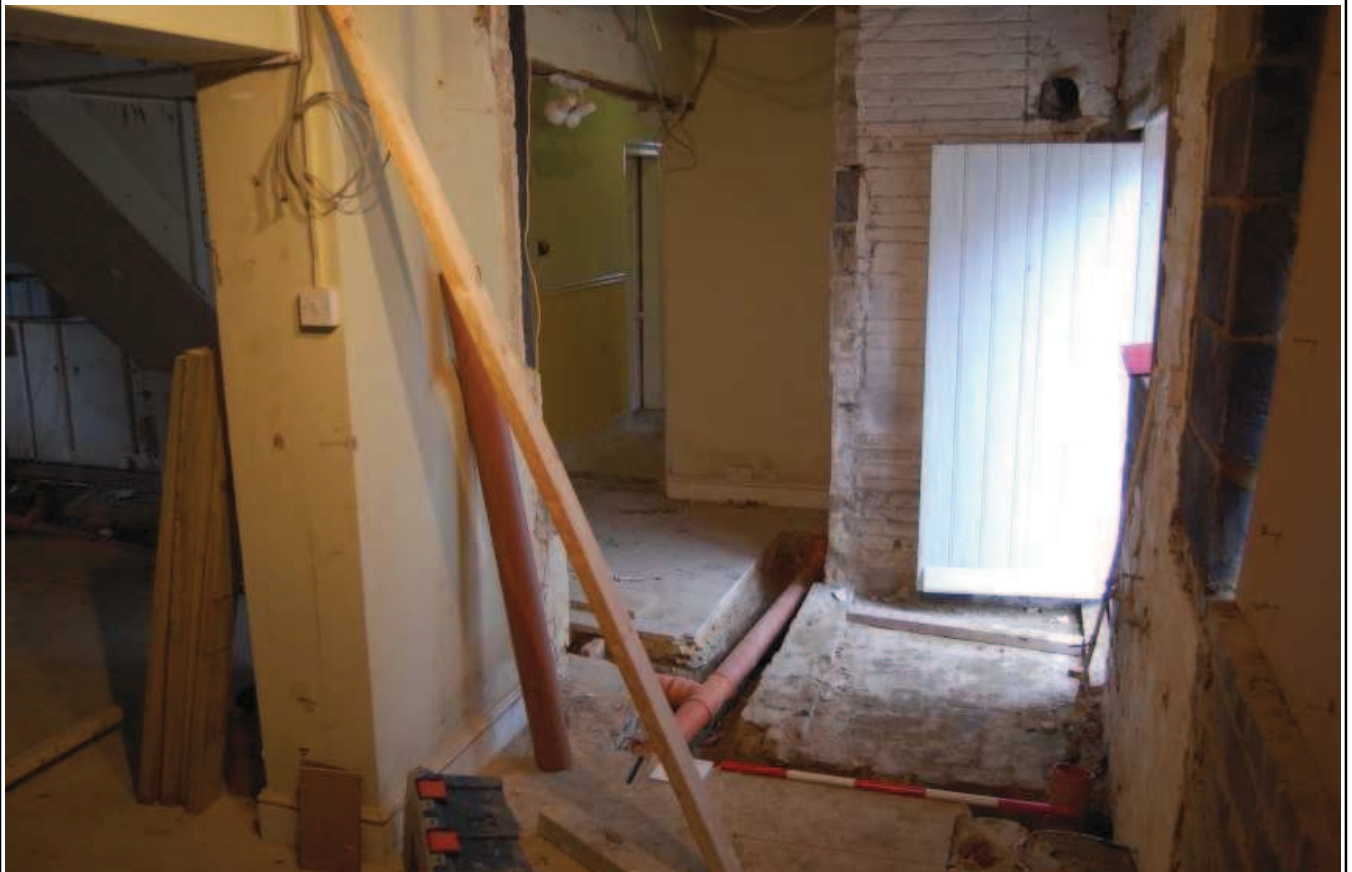
Plate 4: Interior shot, looking N showing location of walls removed

3.12 The ground floor plan shows that the layout consisted of two rooms on the front, separated by a central hall, with a large open area to the rear (Figure 4). The staircase came down into this area. A partition which ran east from the western wall, creating a smaller space at the southern end, has now been removed, as has the north internal wall to the lobby on the east and the west wall to the external recess between the lobby and the eastern front office (Figure 4; Plates 4 & 5).

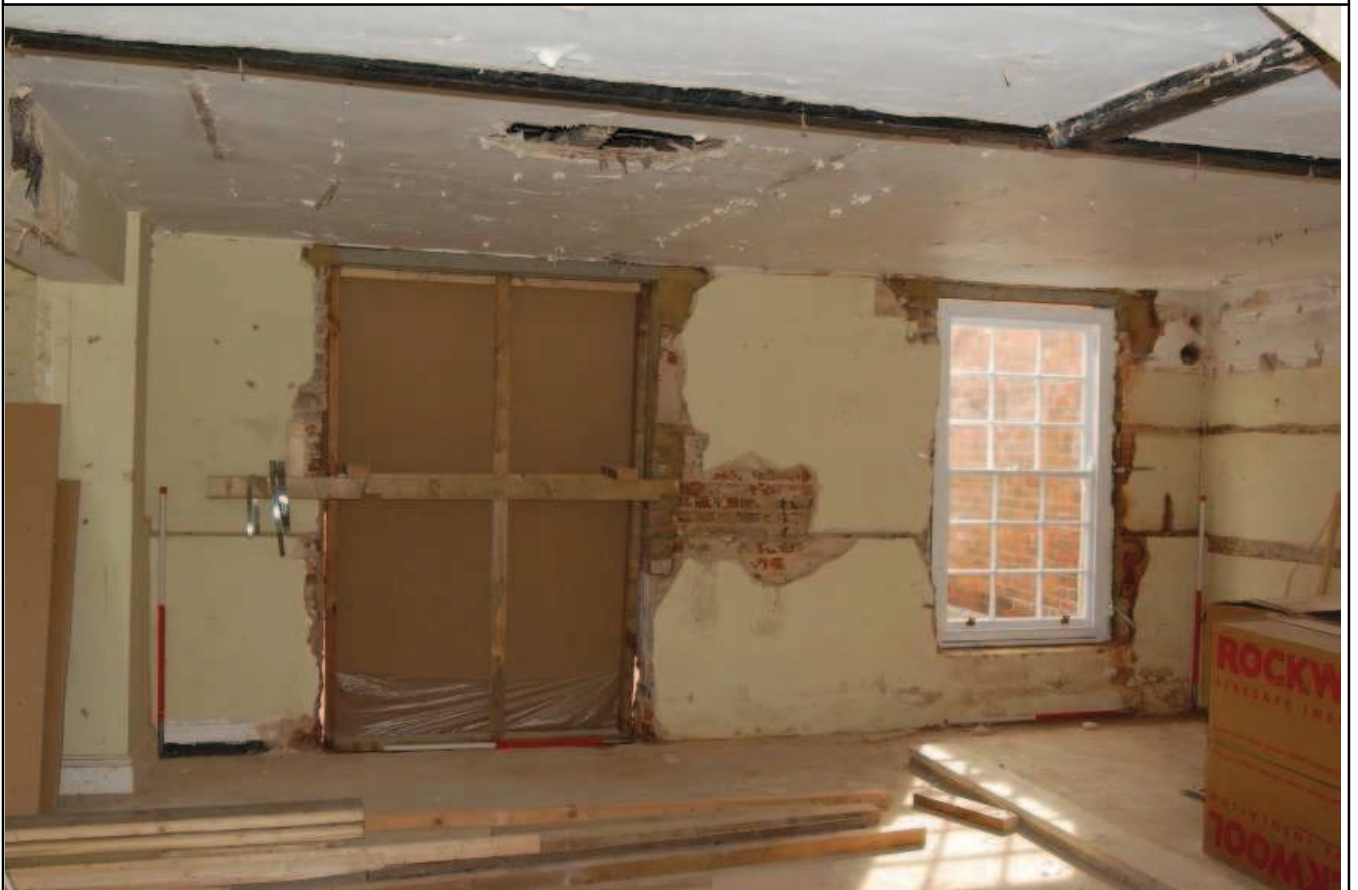
Plate 6: South interior elevation, looking south

3.13 The wall is plastered. A modern sash window, with a concrete lintel, has been inserted into a former blocked opening on the west side (Plate 6). A large opening for a French window has been created on the east side, also on the site of a former blocked opening.

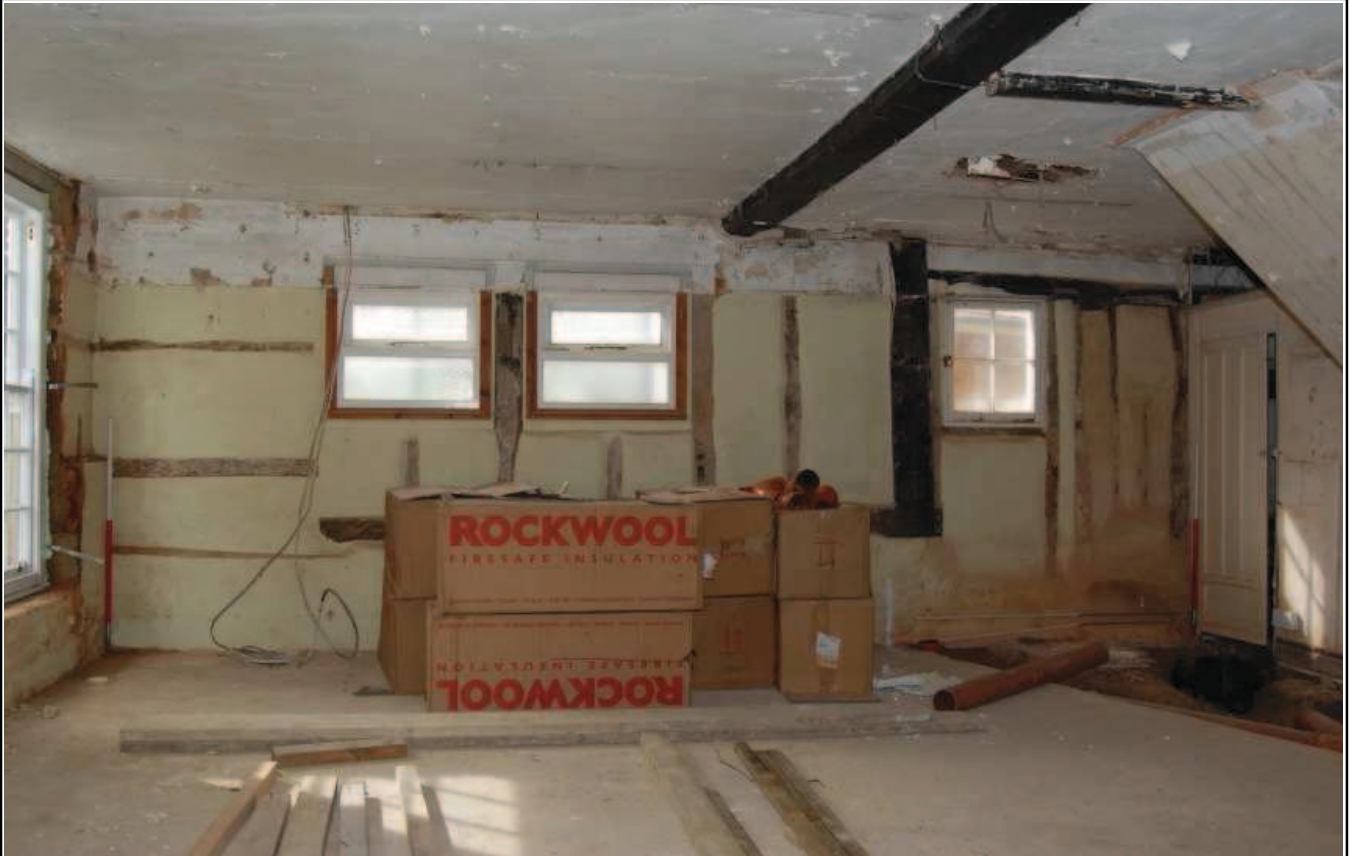
Plate 7: West interior elevation, looking west

3.14 The wall is covered in plaster, with timber studs and rails visible (Plate 7). Two small modern windows have been inserted on either of an upright stud. A small 4-light casement has been inserted in an earlier opening in the timber framing to the north.

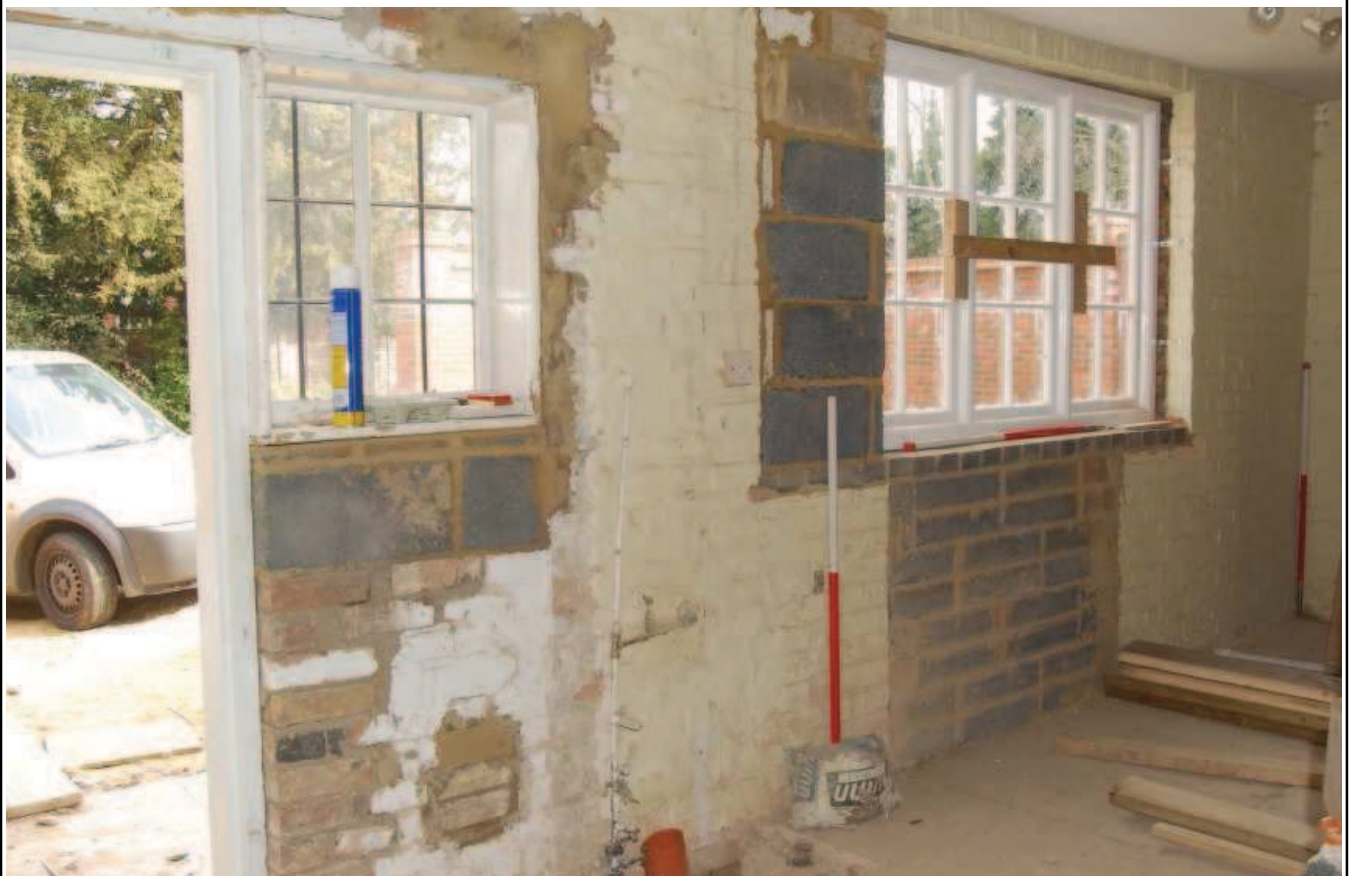
Plate 8: Former lobby & recess, east interior elevation, looking SE

3.15 The wall is in painted brick. A former French window, with adjoining side window, has been blocked and remodelled to create a new window opening (Plate 8).
