**CHURCH OF ST MARY MAGDALENE,
Westoning, Beds.**

HN856

Archaeological Monitoring Report

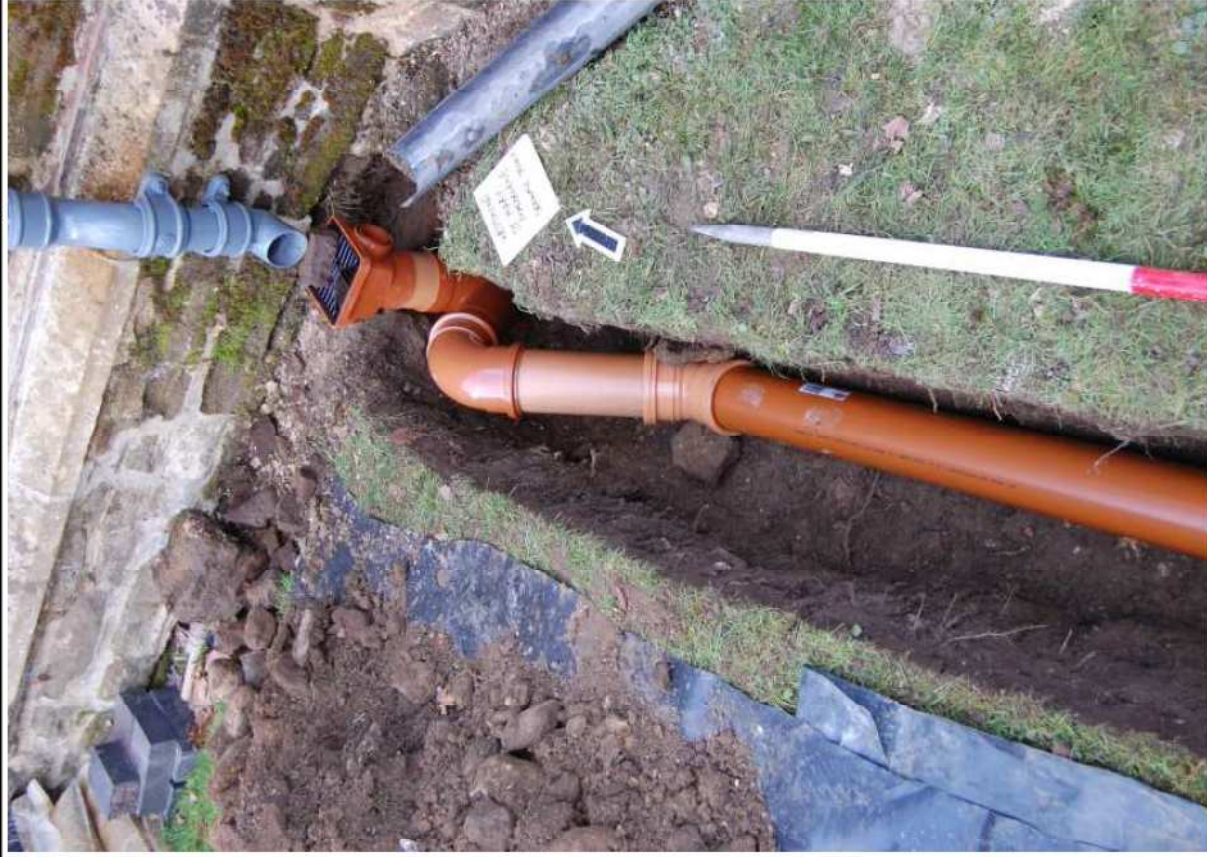
Plate 1: The N end of Tr.1, showing church wall

2.9 A drainage trench (Trench 1) had been hand excavated from the western side of the buttress on the south-eastern corner of the church (Figure 2). It ran on a north-west to south-east alignment and measured 4m long, 0.4m wide and 0.4m deep (Plate 1). The trench had been excavated and the drain laid prior to the first site visit.

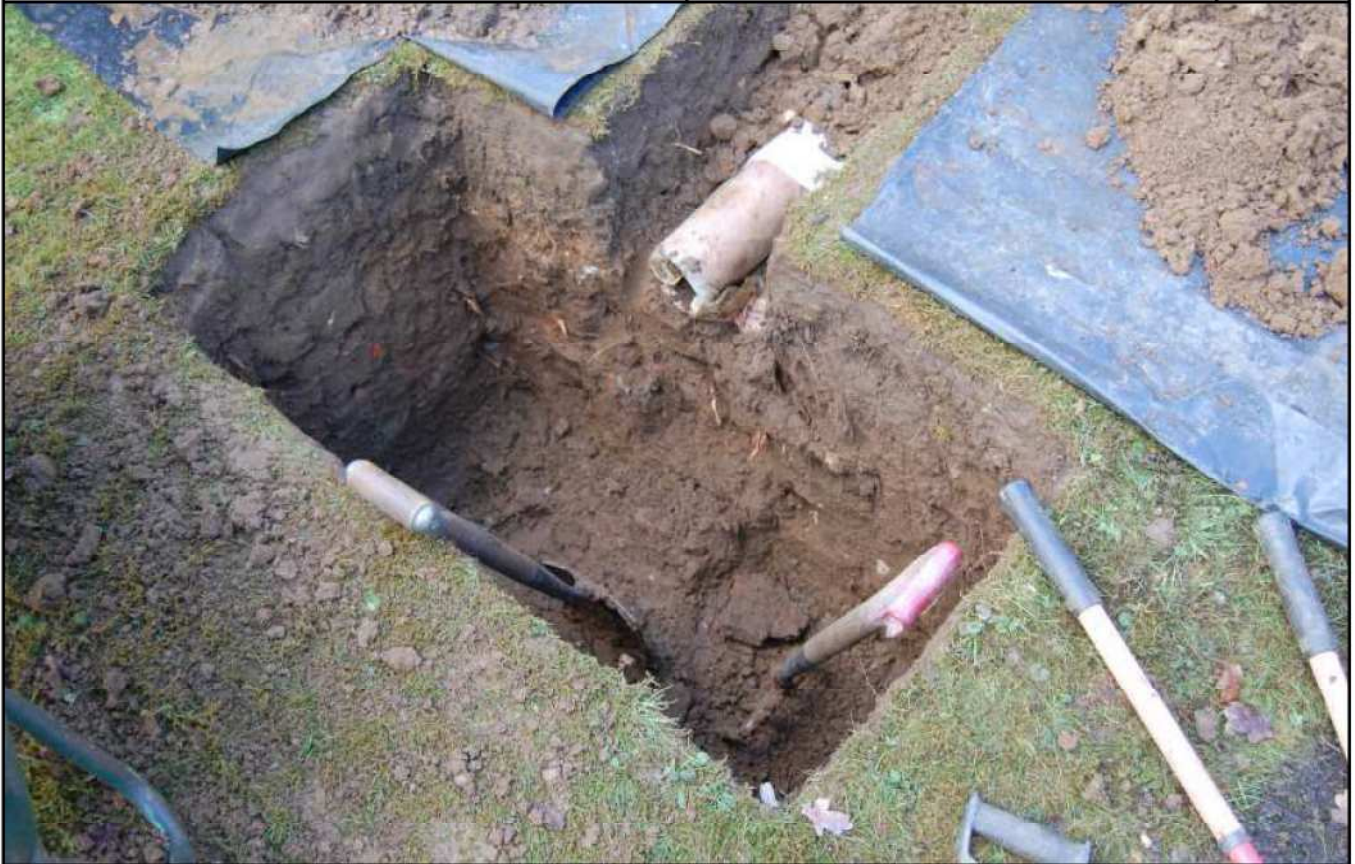
Plate 3: Trench 2, looking NW

2.11 This was located at the southern end of Trench 1 and measured 1.10m long, 0.55m wide 1m deep (Plate 3). The base of the soakaway was below the water table and water seeped into the trench during the course of the excavation.

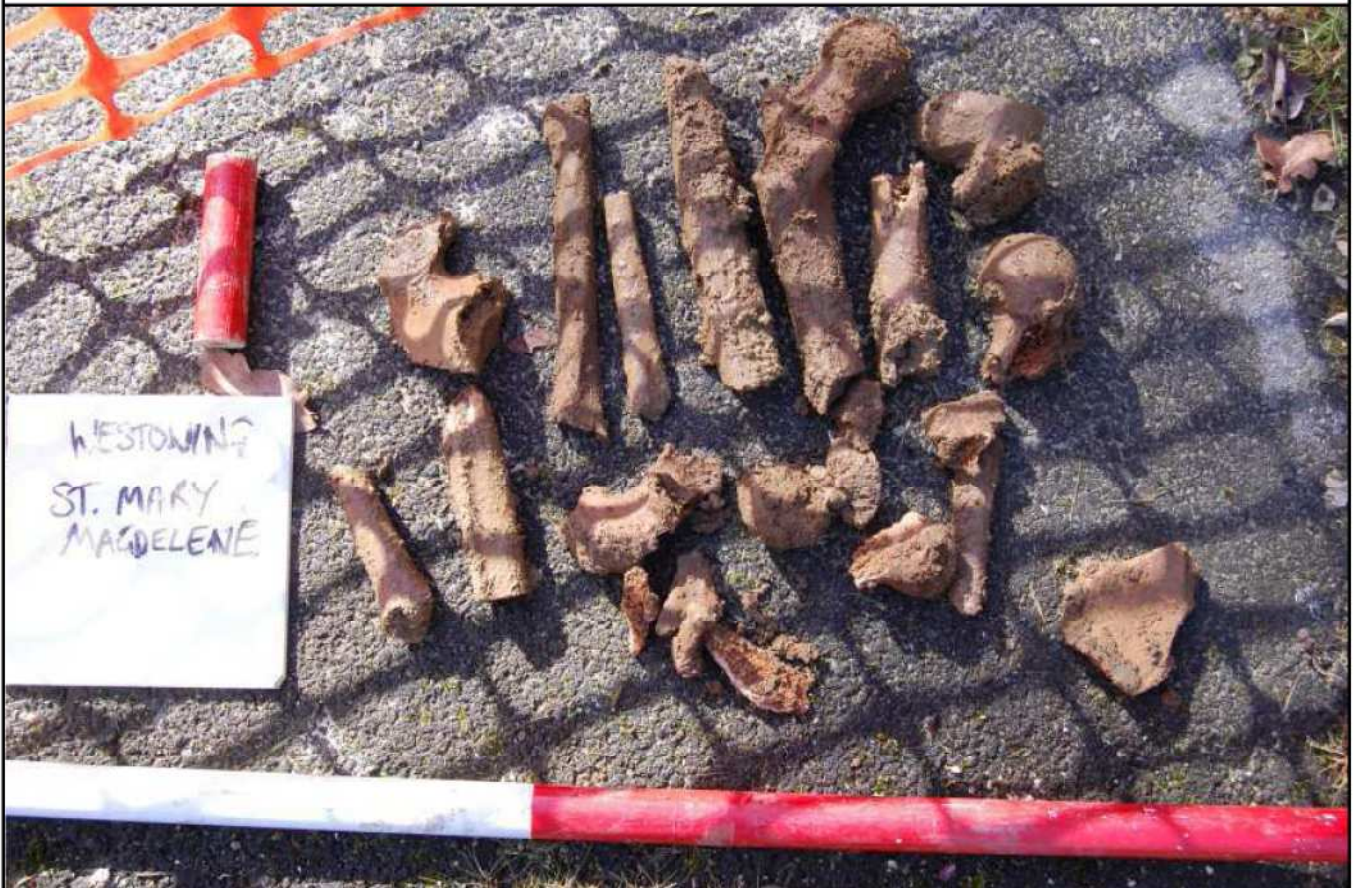
Plate 4: Skeleton 1, post-excavation

2.12 A number of disarticulated human bones (Skeleton 1) were encountered in the north-eastern end of the soakaway, at depths of between 0.60m and 1m below the present ground surface. No evidence for a grave cut, or for a coffin, was encountered and no artefacts were recovered to date the burial.

2.15 In the course of the excavation of the soakaway, a number of disarticulated human bones were unearthed throughout the trench (Skeleton 1). On-site examination of the bones showed they consisted of 2 radial fragments, a humerus, 1 ulna, 2 tibia fragments, 2 patella, a scapula fragment and a left innominate (hip bone) fragment (Plate 4). The bones were in a very poor condition, making an assessment of the age at death and sex impossible, however, fusion of the epiphyses indicates that the individual was an adult.
