**NORTH HERTS LANDFILL
Holwell, Herts.**

HN870

***ARCHAEOLOGICAL
MONITORING***

Archaeological Monitoring Report

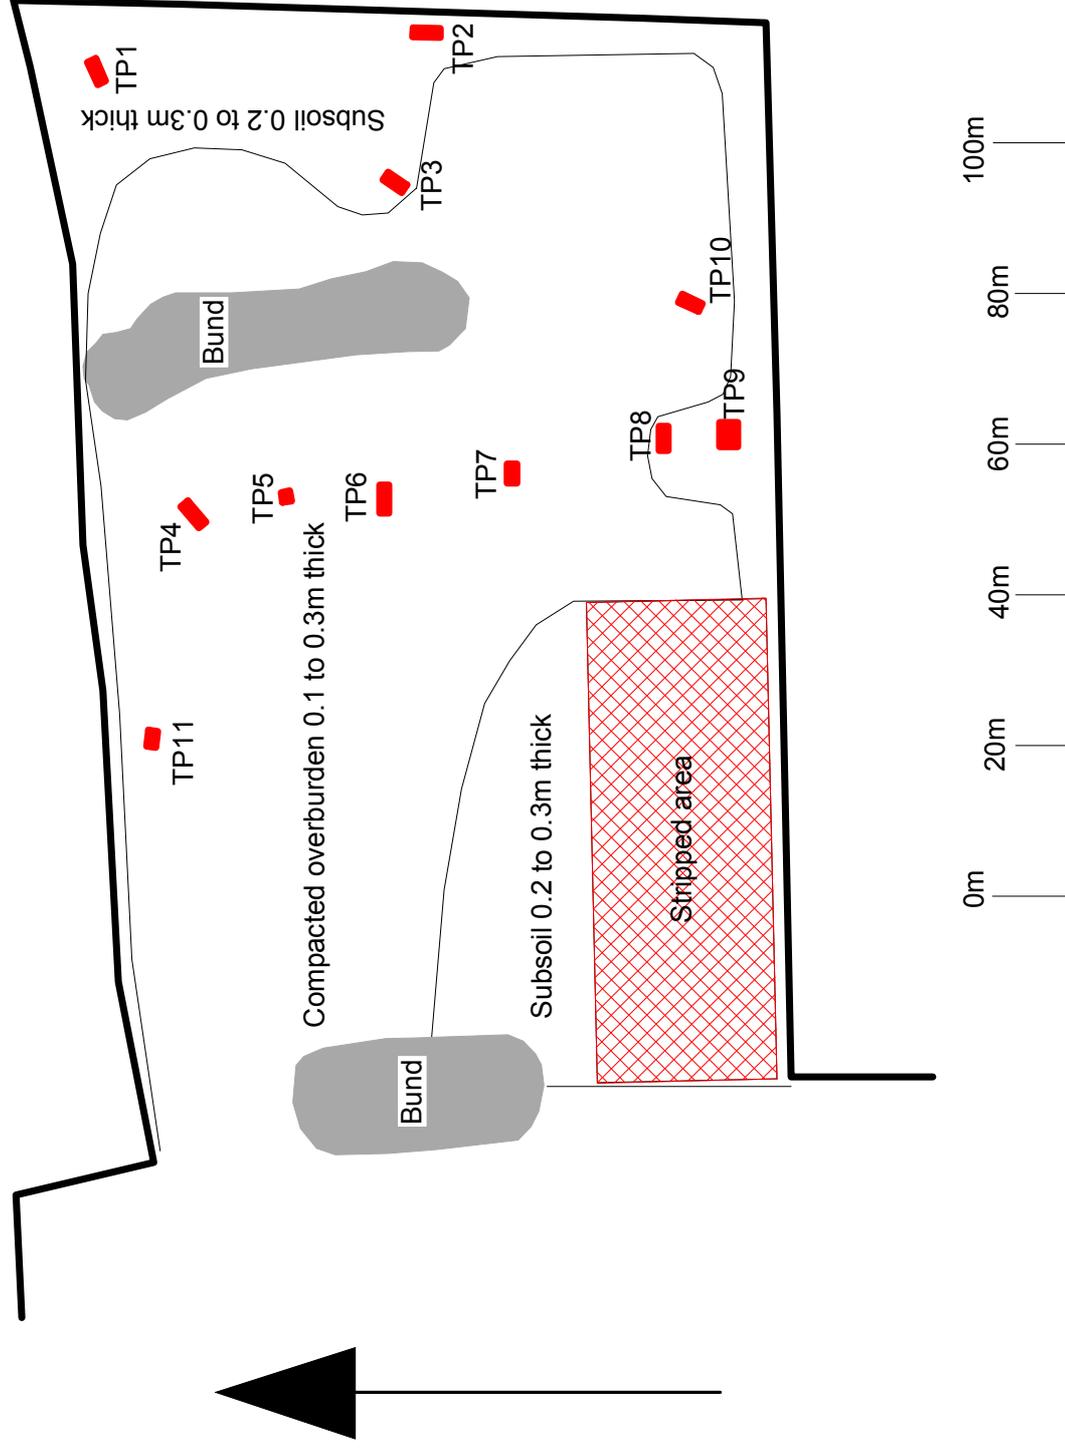
2.11 Eleven test pits were excavated across the site to assess the survival of soils, their quality and level of compaction (Figure 2). Test Pits 1 – 3 were located to the east of an existing bund; Test Pits 4 – 10 lay to the west and south of the bund; Test Pit 11 was sited towards the north-western corner, on the northern side of the vehicular access. Test Pits 2 – 10 were located on the site of spoilheaps, some of which had been in excess of 5m in height, and had recently been removed.

Plan showing the location of the Test Pits and stripped area

2.13 Following the test pitting exercise the agricultural soil specialist identified an area in the south-western corner of the field as having a suitable soil for spreading on the site as part of the reinstatement process. This comprised friable dark greyish brown silty clay subsoil, between 0.30m and 0.20m in depth. An area measuring 95.6m in length and 35.5m in width was considered sufficient to provide enough soil for spreading and was stripped down to the underlying natural chalky clay (Figure 2; Plate 12).

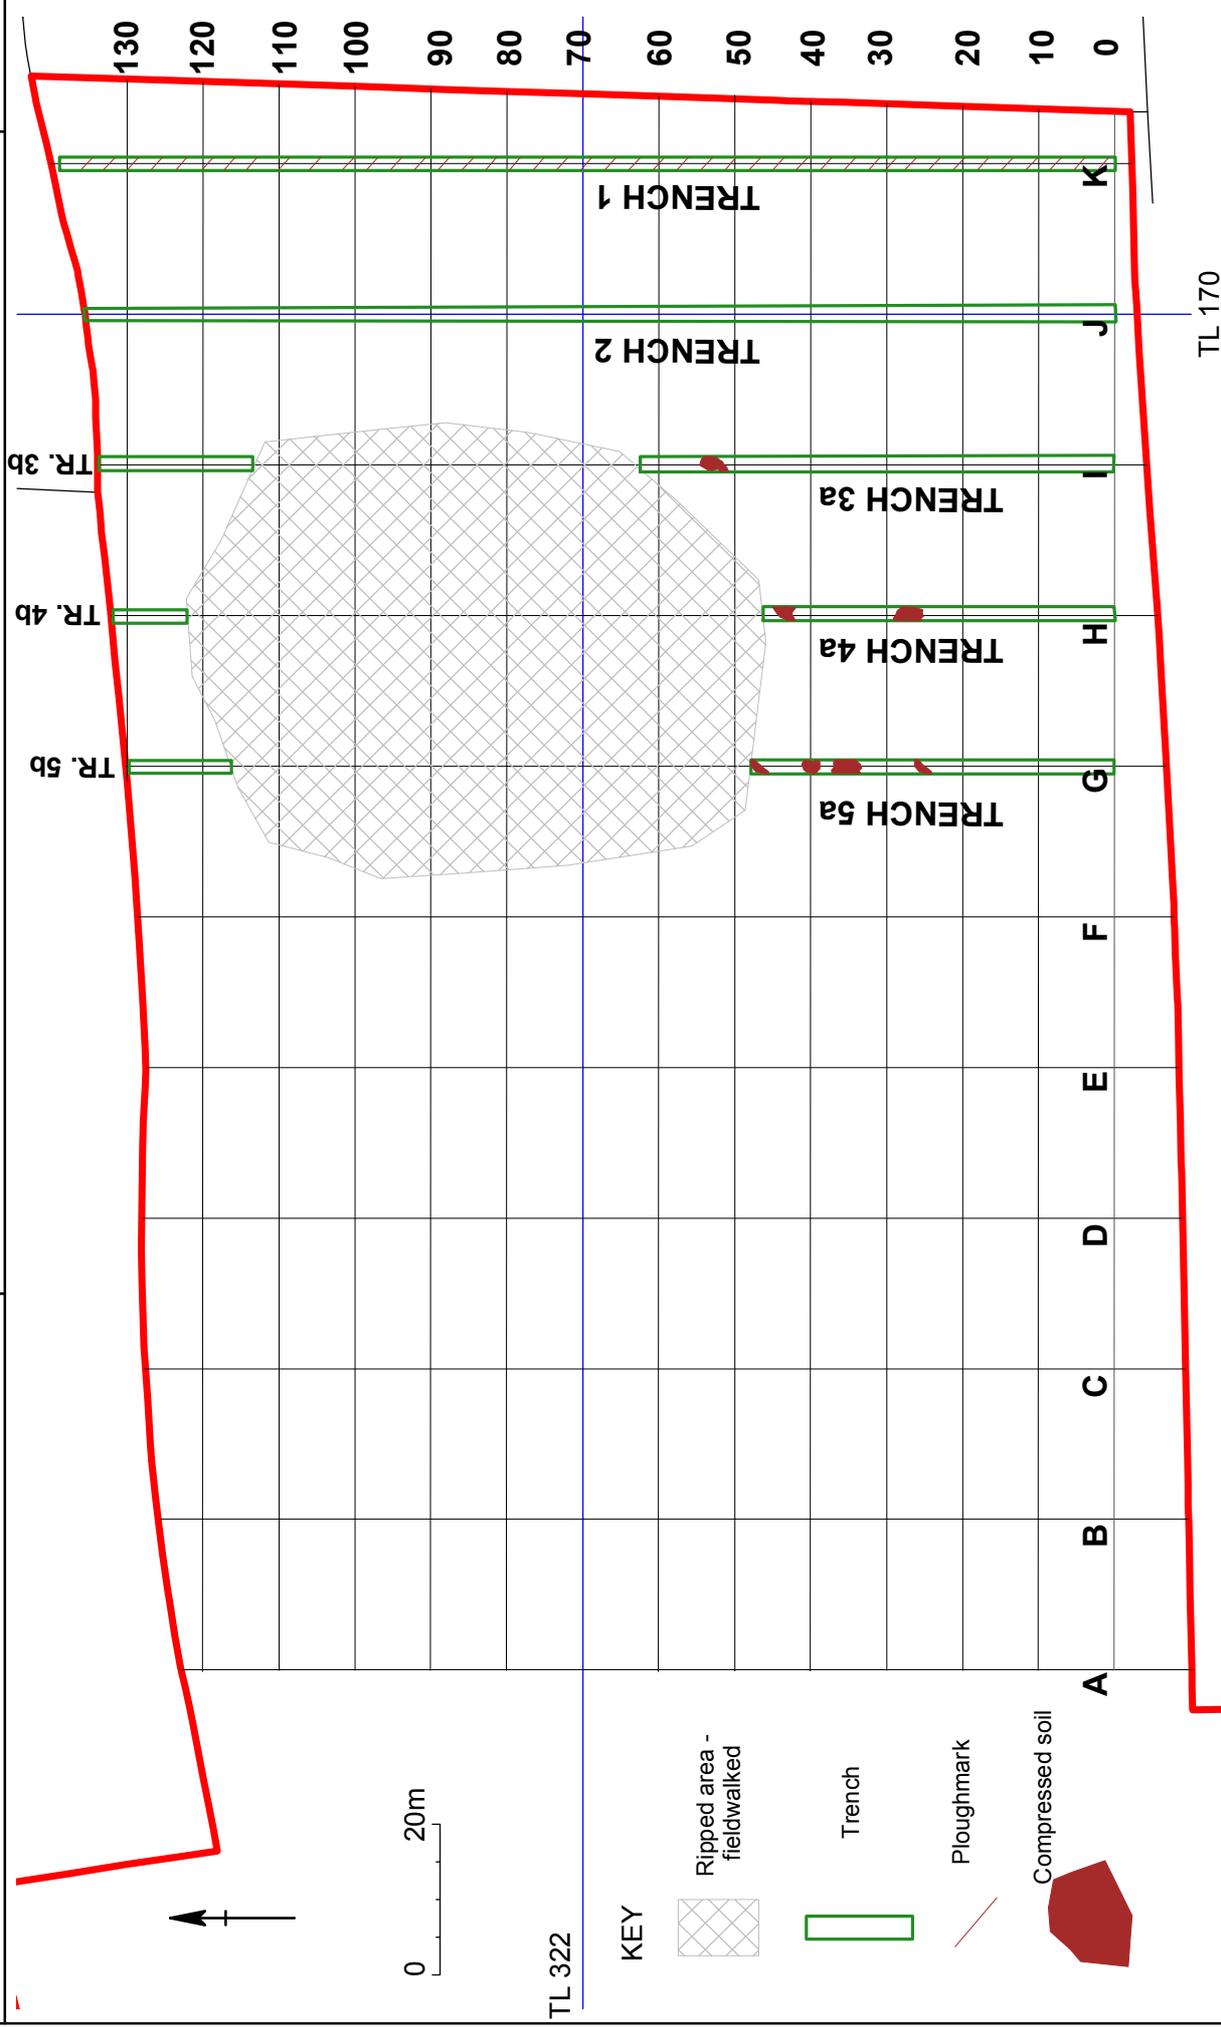
Figure 3

2.22 An area in the centre of the field, on the site of a former bund, had not been covered by soil and this was surveyed by fieldwalking (Figure 3).

2.23 The trenches measured 1.80m in width and between 0.30m and 0.40m in depth. They varied in length, with Trenches 1 and 2 at the eastern end running the entire width of the field (approximately 130m) and Trenches 3 – 5, to the west, avoiding the central ripped area (Figure 3).

2.24 Ploughmarks were noted in all trenches. These ran on a north-west to south-east alignment and were between 0.90m and 1m apart. Each measured approximately 0.15m in width and 0.15m in depth. A number of other irregular potential features were observed, particularly at the northern end of Trench 5a. Investigation demonstrated that these were modern in date and represented areas where surviving subsoils and stockpiled material had been compressed into the natural clay.

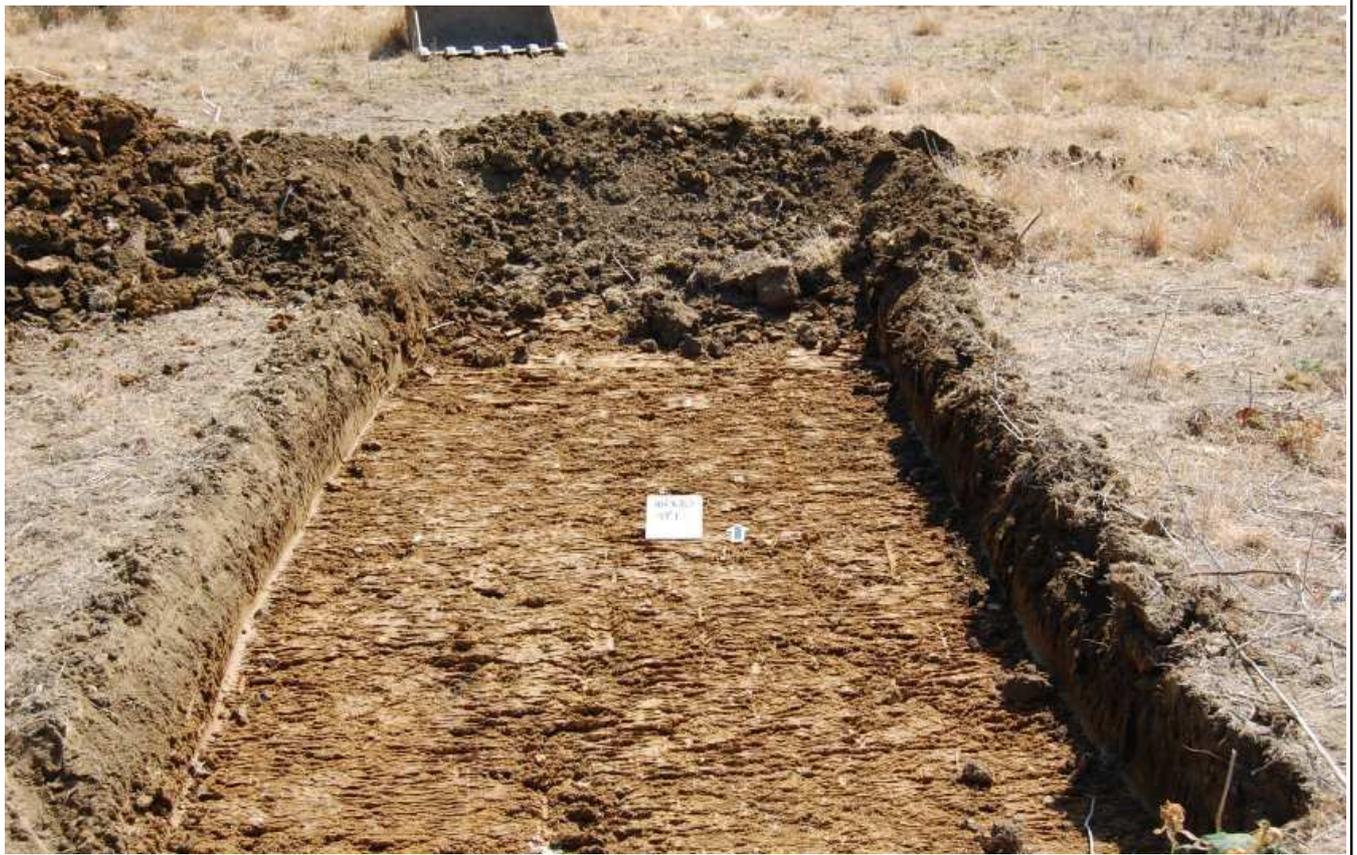
Plate 1: Test Pit 1, looking east

- **Test Pit 1** (Plate 1) was located in the north-eastern corner of the field and measured 4.95m x 1.8m x 0.32m. The stratigraphy consisted of a friable dark greyish brown silty clay subsoil, 0.20m deep, which contained CBM fragments and charcoal flecks. Below this was natural yellowish brown chalky clay, which contained occasional stones and flints. No archaeological features were observed and no artefacts were present in the spoil.

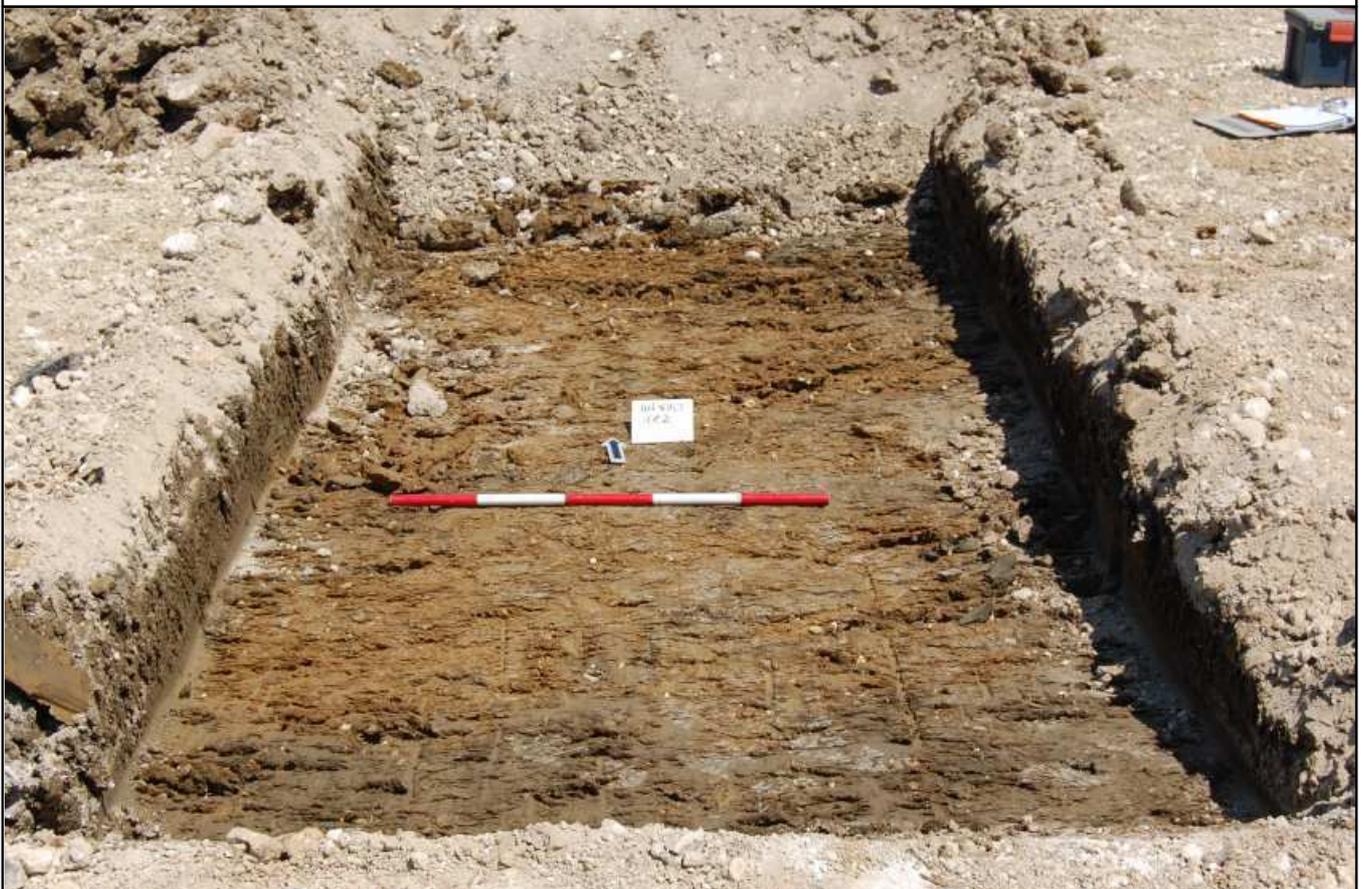
Plate 2: Test Pit 2, looking north

- **Test Pit 2** (Plate 2) was located close to the eastern field boundary, to the south of TP1, and measured 4.46m x 1.8m x 0.32m. The stratigraphy was slightly different to that observed in TP1 and consisted of a compacted layer of mixed overburden comprising stone, brick fragments, chalk lumps and charcoal, 0.09m deep, above the dark greyish brown silty clay subsoil, 0.20m deep. Below this was the natural yellowish brown chalky clay.

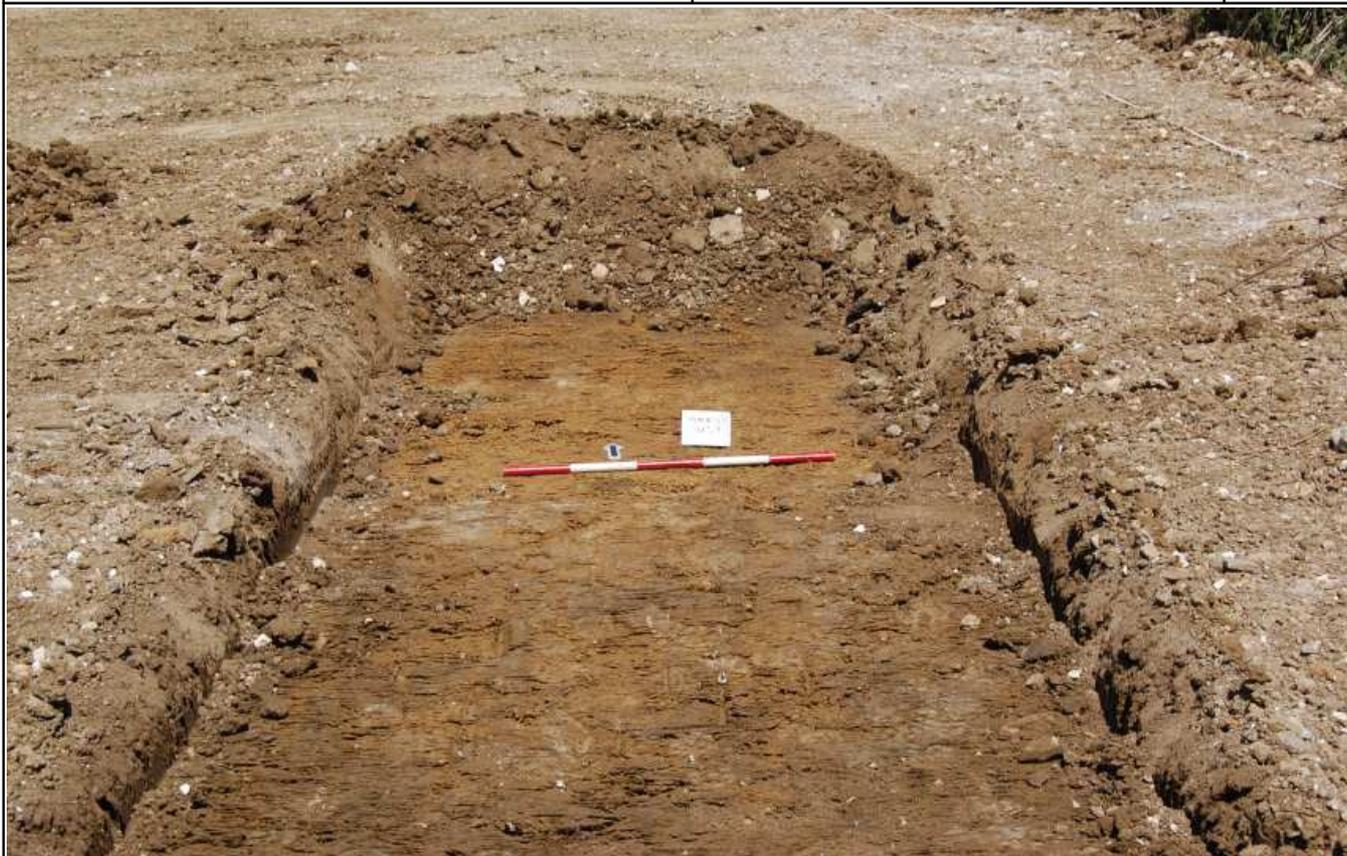
Plate 3: Test Pit 3, looking north

- **Test Pit 3** (Plate 3) was located to the west of TP2 and measured 5.40m x 1.80m x 0.32m. The stratigraphy consisted of a layer of compacted overburden, 0.12m deep, above the dark greyish brown silty clay subsoil, 0.20m deep. The natural yellowish brown chalky clay appeared at 0.32m below the present ground surface.

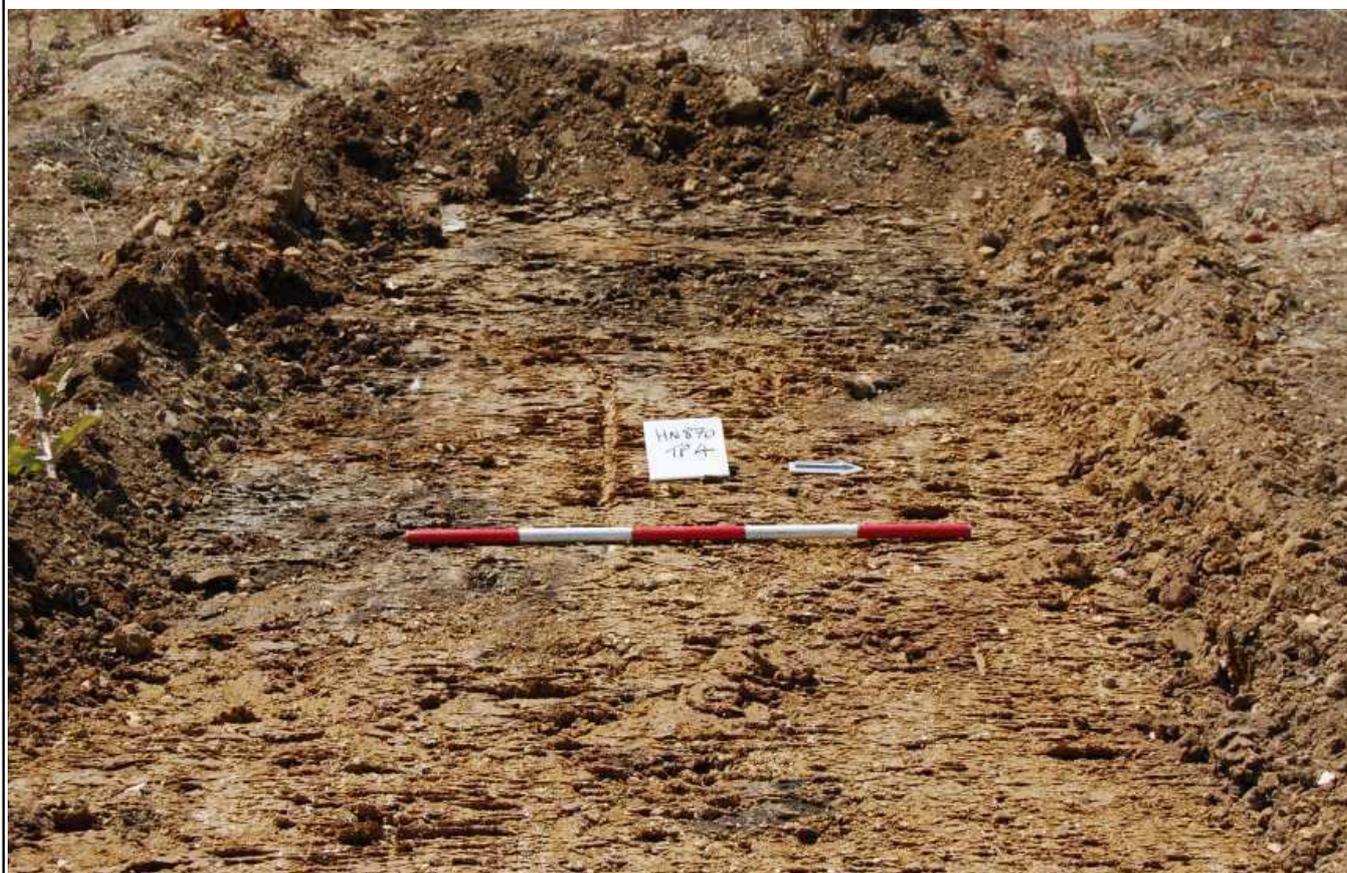
Plate 4: Test Pit 4, looking west

- **Test Pit 4** (Plate 4) was located at the northern side of the site, to the west of the existing bund and measured 5.55m x 1.80m x 0.03m. The stratigraphy consisted of a layer of compacted overburden, 0.03m deep, above the natural yellowish brown chalky clay.

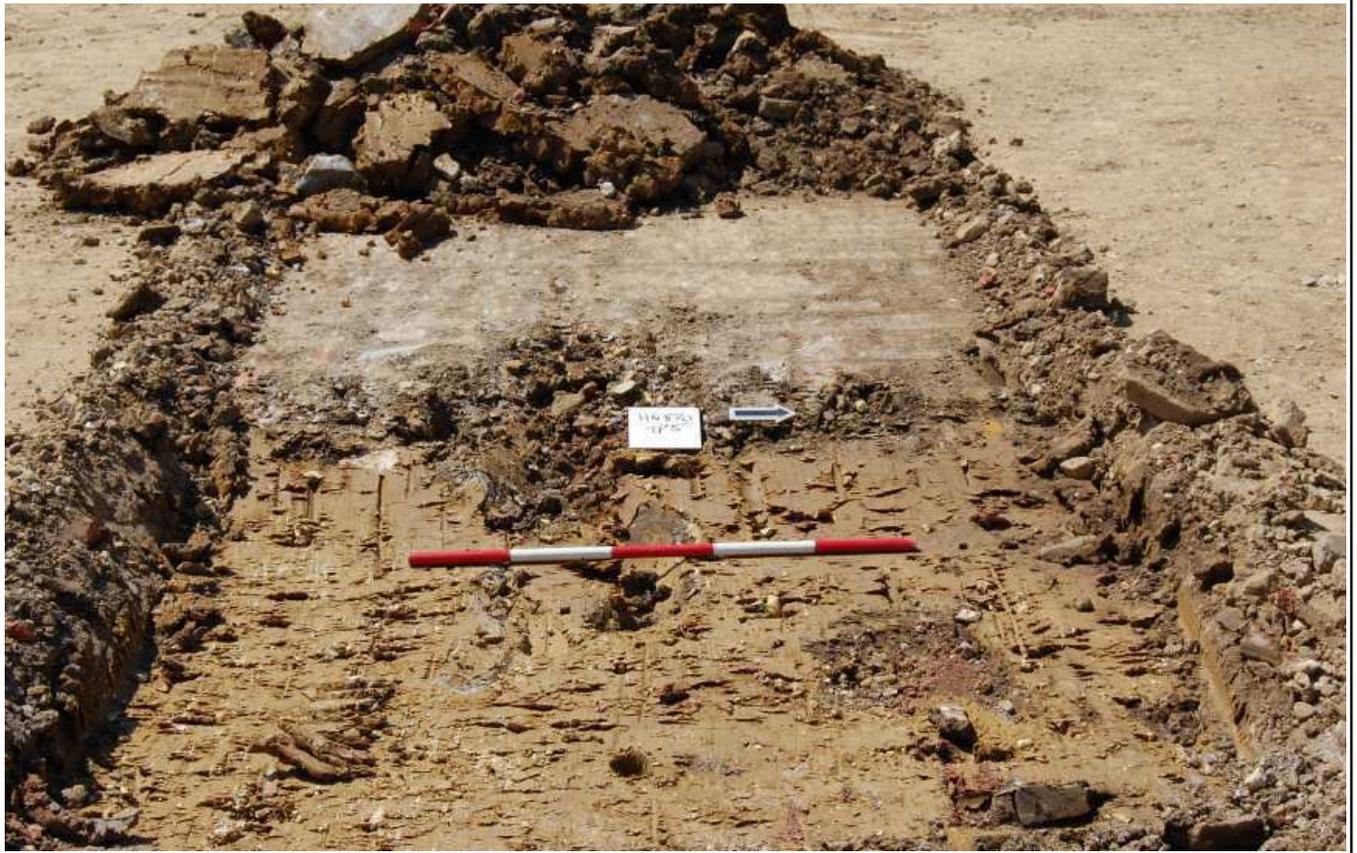
Plate 5: Test Pit 5, looking west

- **Test Pit 5** (Plate 5) was located to the south of TP 4 and measured 2.01m x 1.80m x 0.21m. The stratigraphy consisted of a layer of compacted overburden, 0.15m deep, above the natural yellowish brown chalky clay.

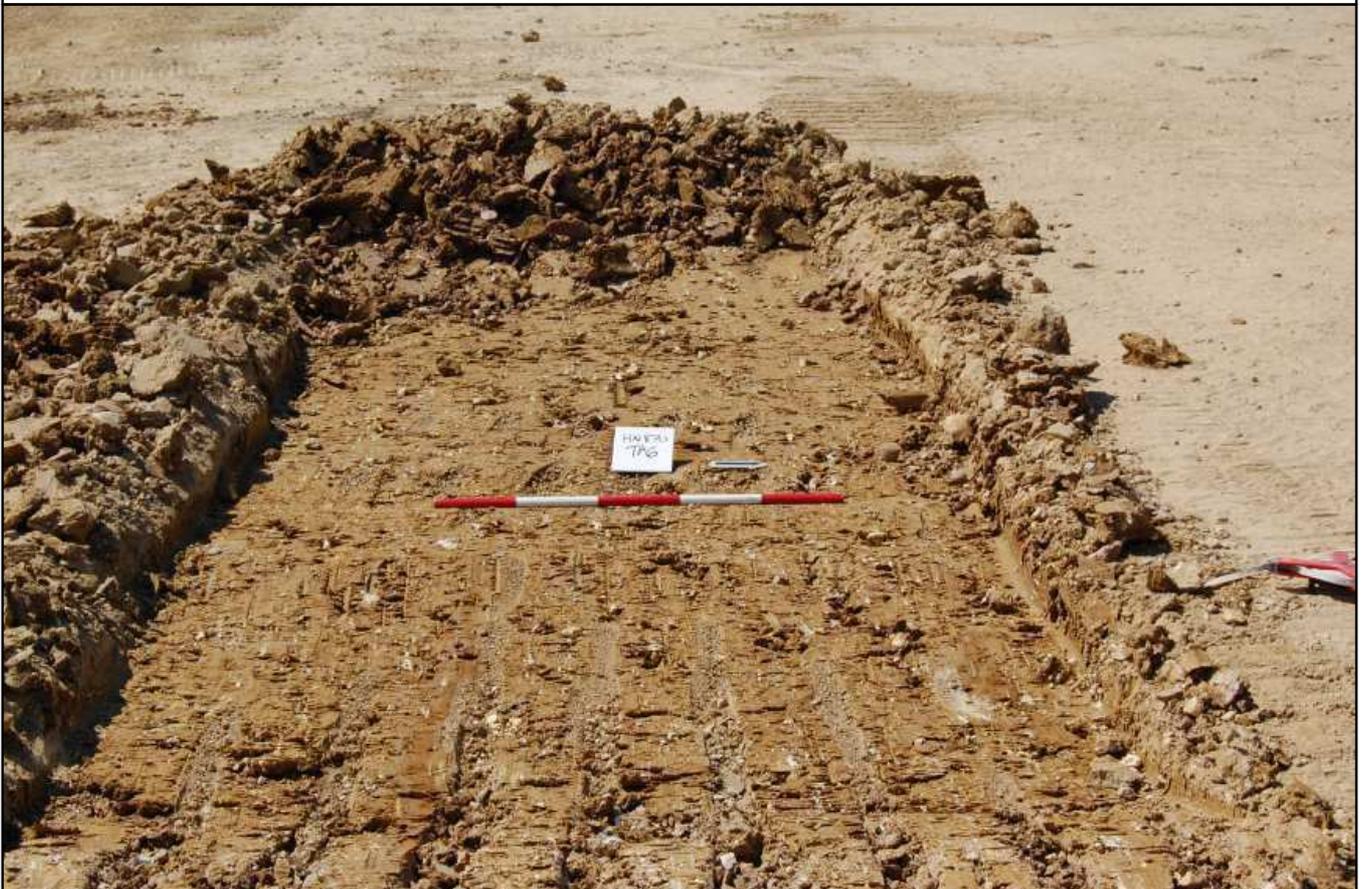
Plate 6: Test Pit 6, looking west

- **Test Pit 6** (Plate 6) was located to the south of TP5 and measured 5.56m x 1.80m x 0.16m. The surface of this test pit was so compacted that a toothed bucket was required to break the surface. The stratigraphy consisted of a layer of highly compacted overburden, 0.08m deep, above the natural yellowish brown chalky clay.

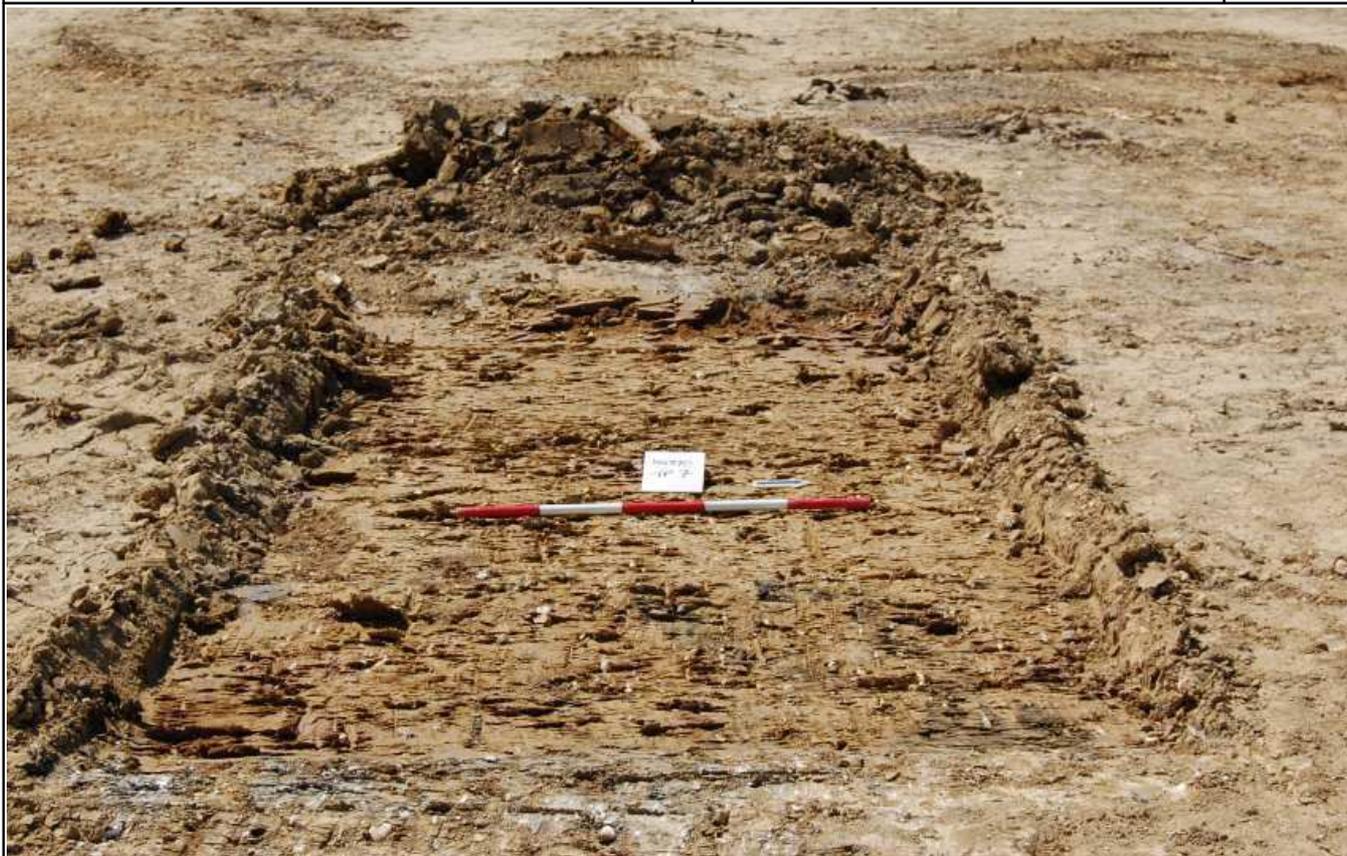
Plate 7: Test Pit 7, looking west

- **Test Pit 7** (Plate 7) was located to the south of TP6 and measured 3.90m x 1.80m x 0.10m. The stratigraphy consisted of a layer of compacted overburden, 0.08m deep, above the natural yellowish brown chalky clay.

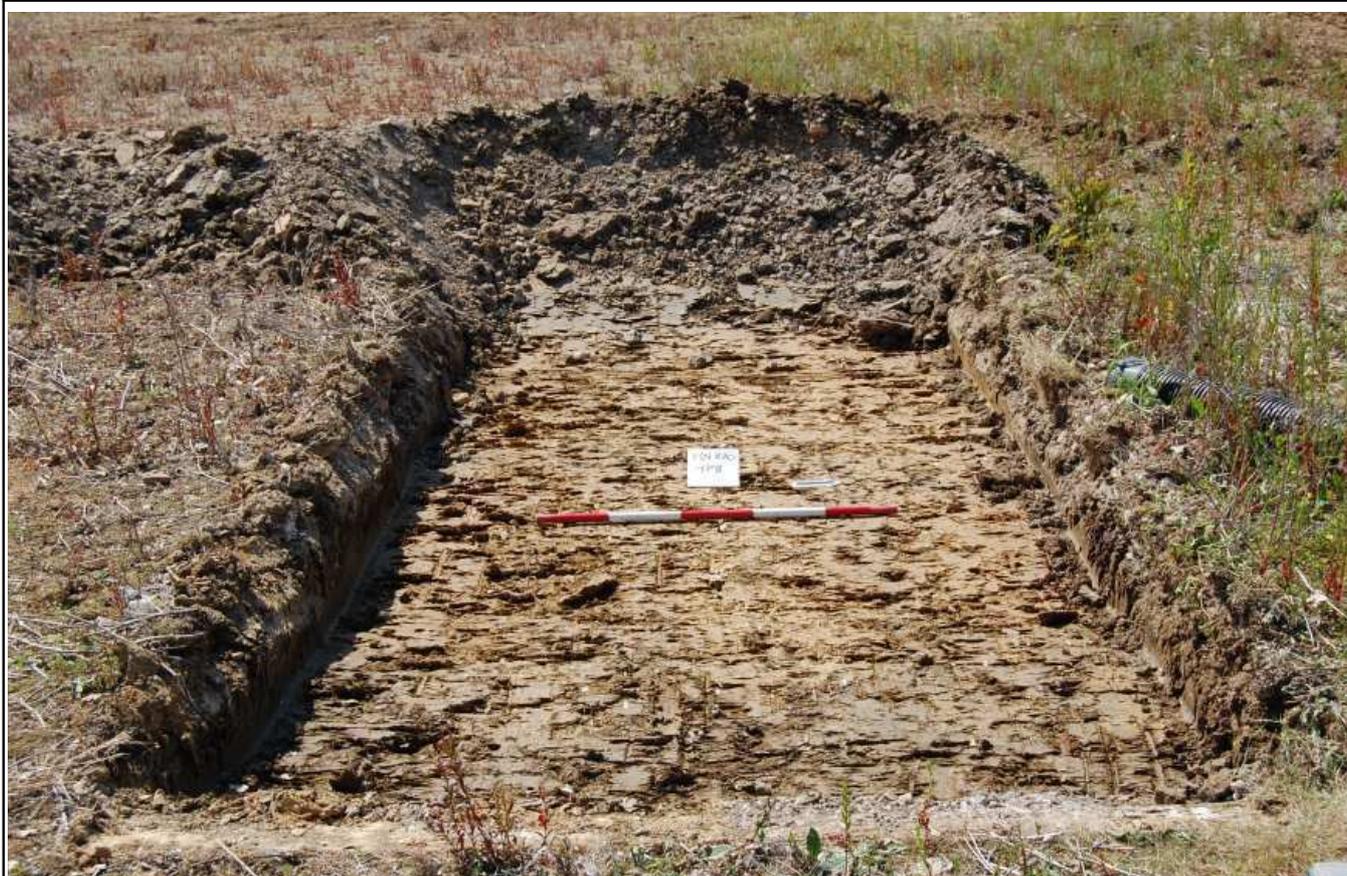
Plate 8: Test Pit 8, looking west

- **Test Pit 8** (Plate 8) was located to the south of TP 7 and measured 4.90m x 1.80m x 0.32m. The stratigraphy consisted of a layer of compacted overburden, 0.19m deep, above dark greyish brown silty clay subsoil, similar to that observed in TPs 1 – 3, 0.13m deep. The natural yellowish brown chalky clay was observed at 0.32m below the present ground surface.

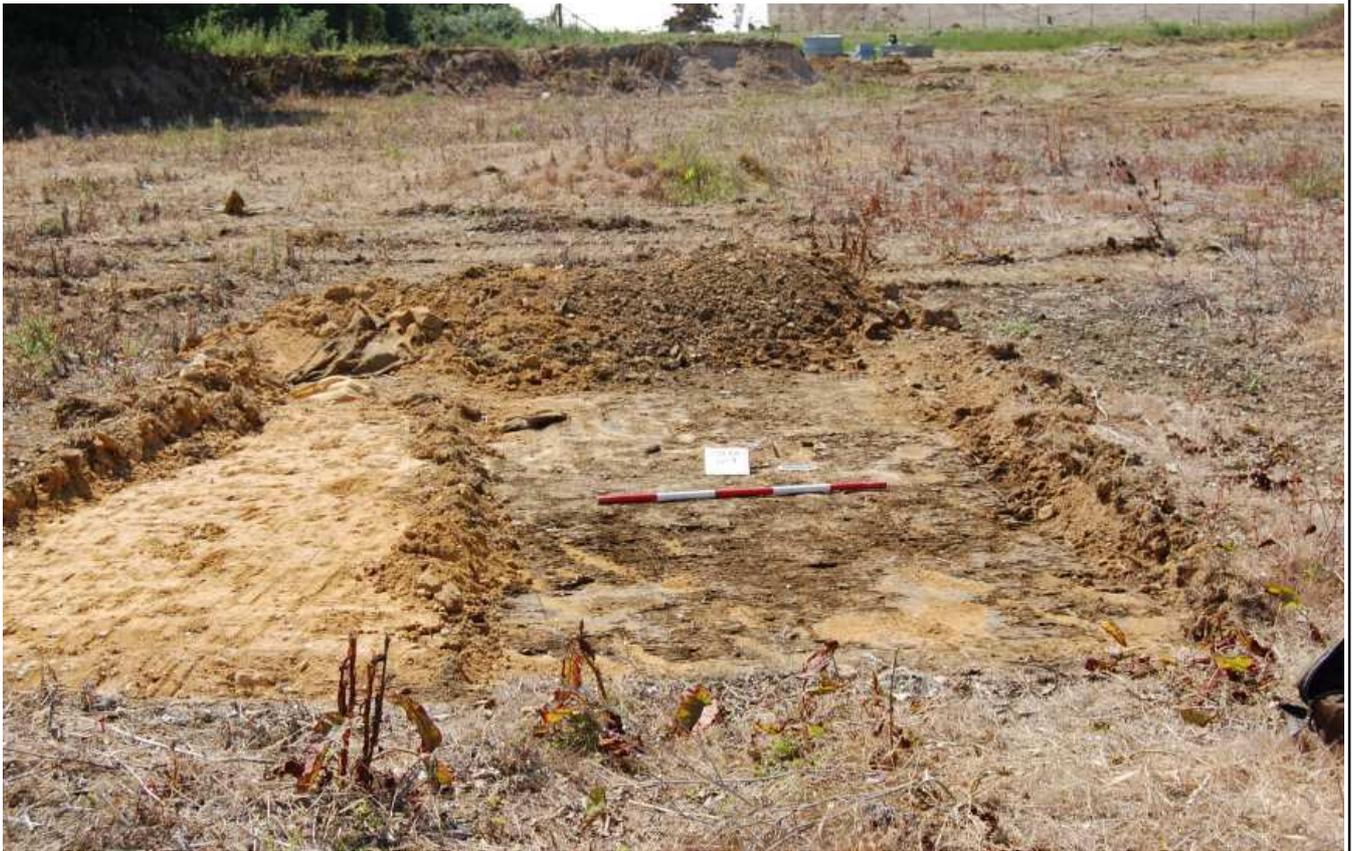
Plate 9: Test Pit 9, looking west

- **Test Pit 9** (Plate 9) was located to the south of TP8 and close to the southern boundary. It measured 4.80m x 3.60m x 0.24m. The stratigraphy consisted of a layer of sand, 0.24m deep, above a geotextile membrane. This had been laid on top of the original dark greyish brown silty clay subsoil. The natural yellowish brown chalky clay was not exposed.

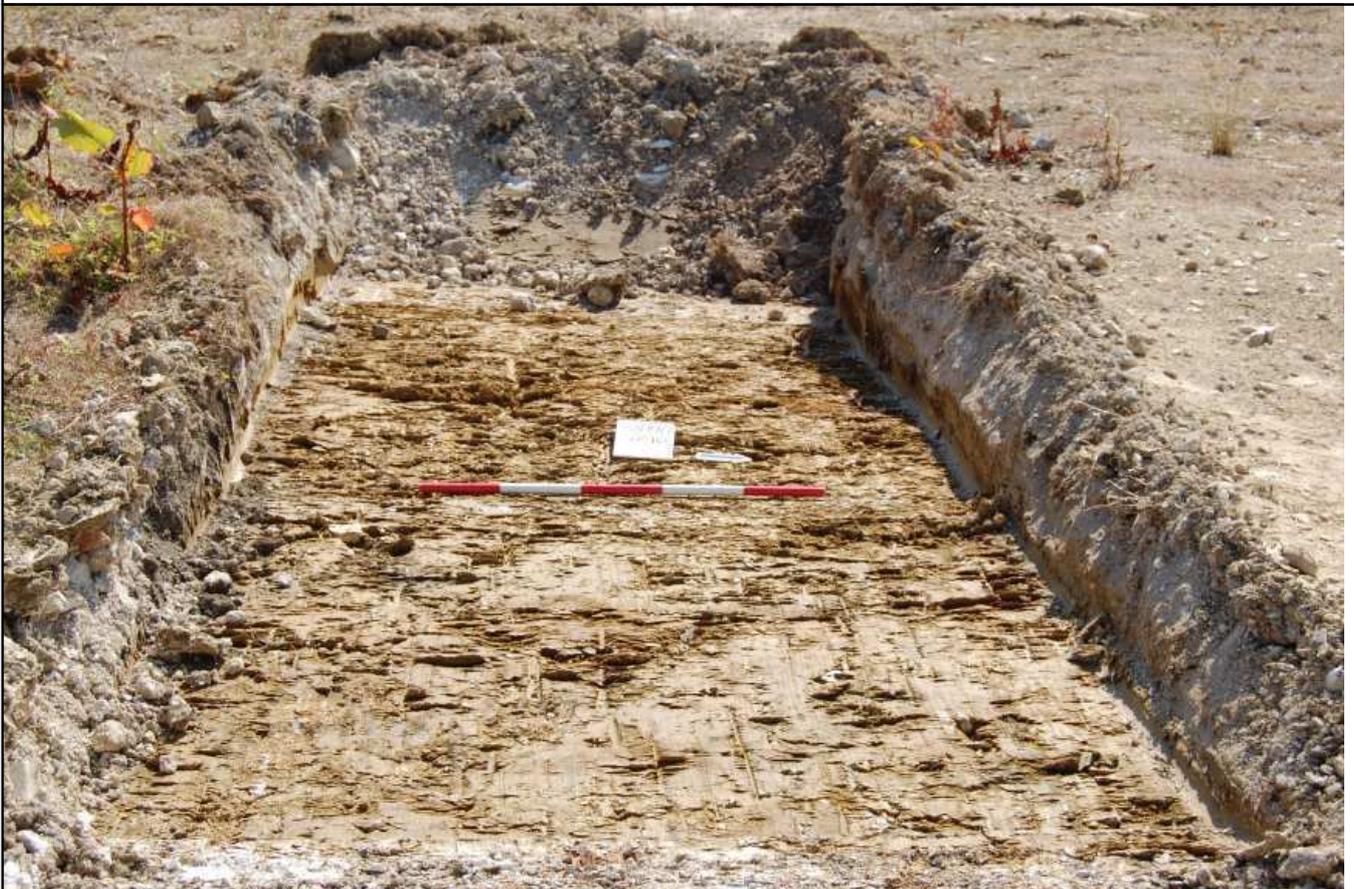
Plate 10: Test Pit 10, looking west

- **Test Pit 10** (Plate 10) was located to the east of TPs 8 and 9, close to the remains of the spoilheap that previously occupied the south-western corner of the field. The test pit measured 4.63m x 1.80m x 0.30m. The stratigraphy consisted of a layer of overburden, comprising mixture of redeposited chalk and imported topsoil, which varied in depth between 0.25m and 0.30m. This lay above the natural yellowish brown chalky clay.

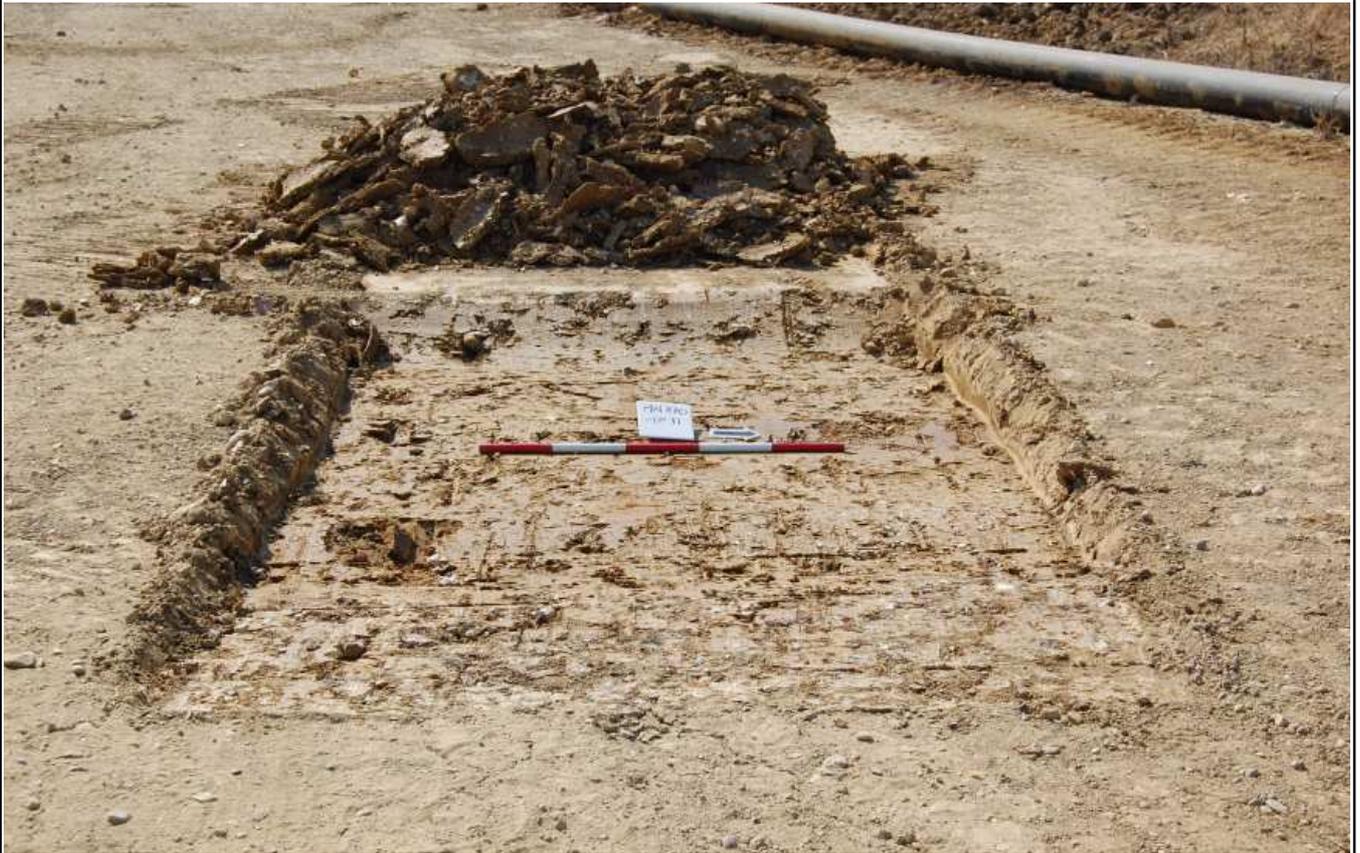
Plate 11: Test Pit 11, looking west

- **Test Pit 11** (Plate 11) was located at the northern end of the site, to the north of the present vehicle access to the field. It measured 3.20m x 1.80m x 0.12 – 0.06m. The stratigraphy consisted of a layer of compacted overburden, between 0.06m and 0.10m deep, above the natural yellowish brown chalky clay

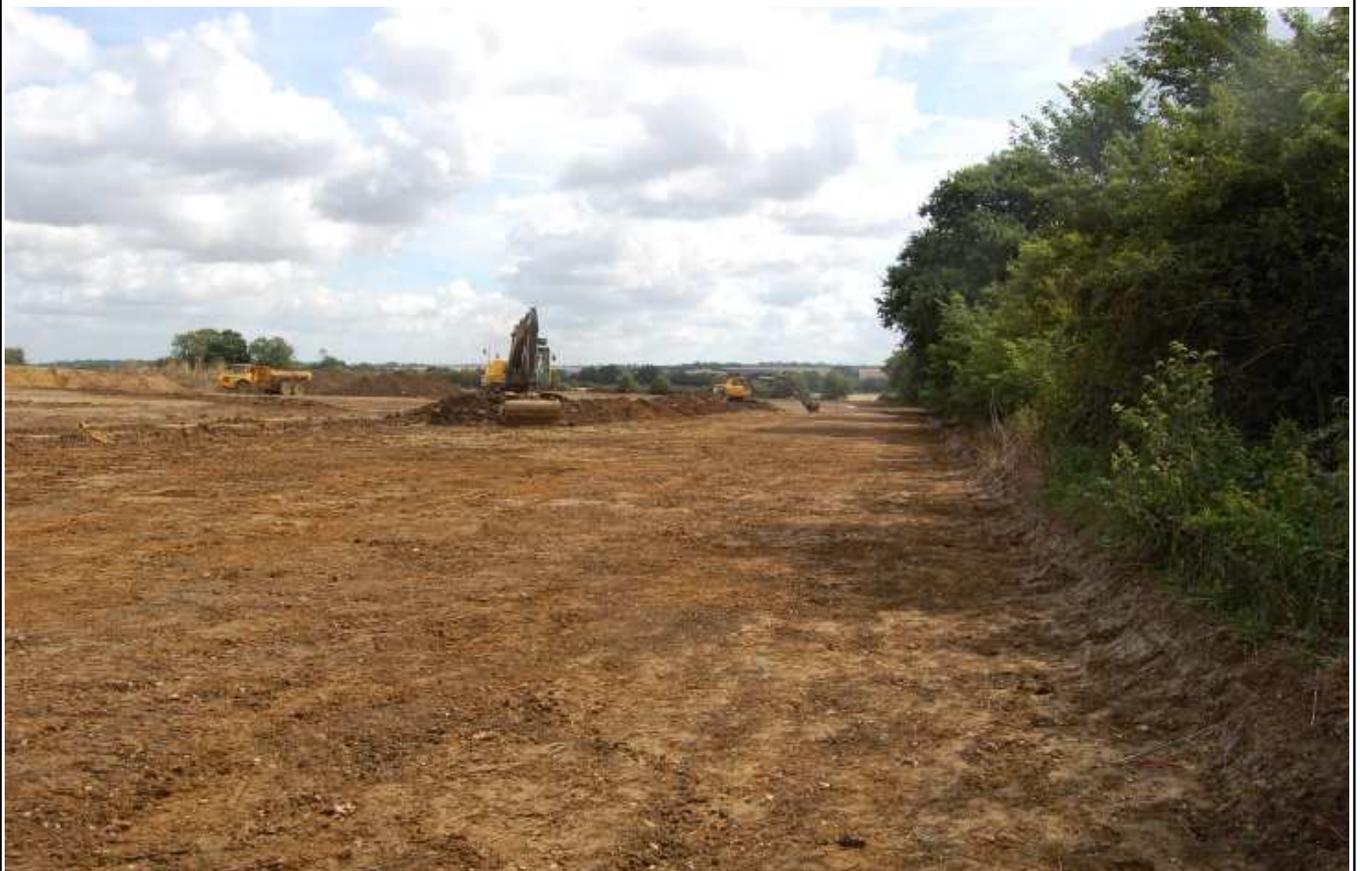
2.14 A number of plough marks, which ran on a north-west to south-east alignment, were noted cutting into the natural clay, as was a modern land drain. No evidence for archaeological features, or deposits was encountered in the stripped area and no artefacts were present in the spoil.

Plate 12: Site during stripping, looking east
