**NORTH HERTS LANDFILL
Holwell, Herts.**

HN870

***ARCHAEOLOGICAL
MONITORING***

Archaeological Monitoring Report

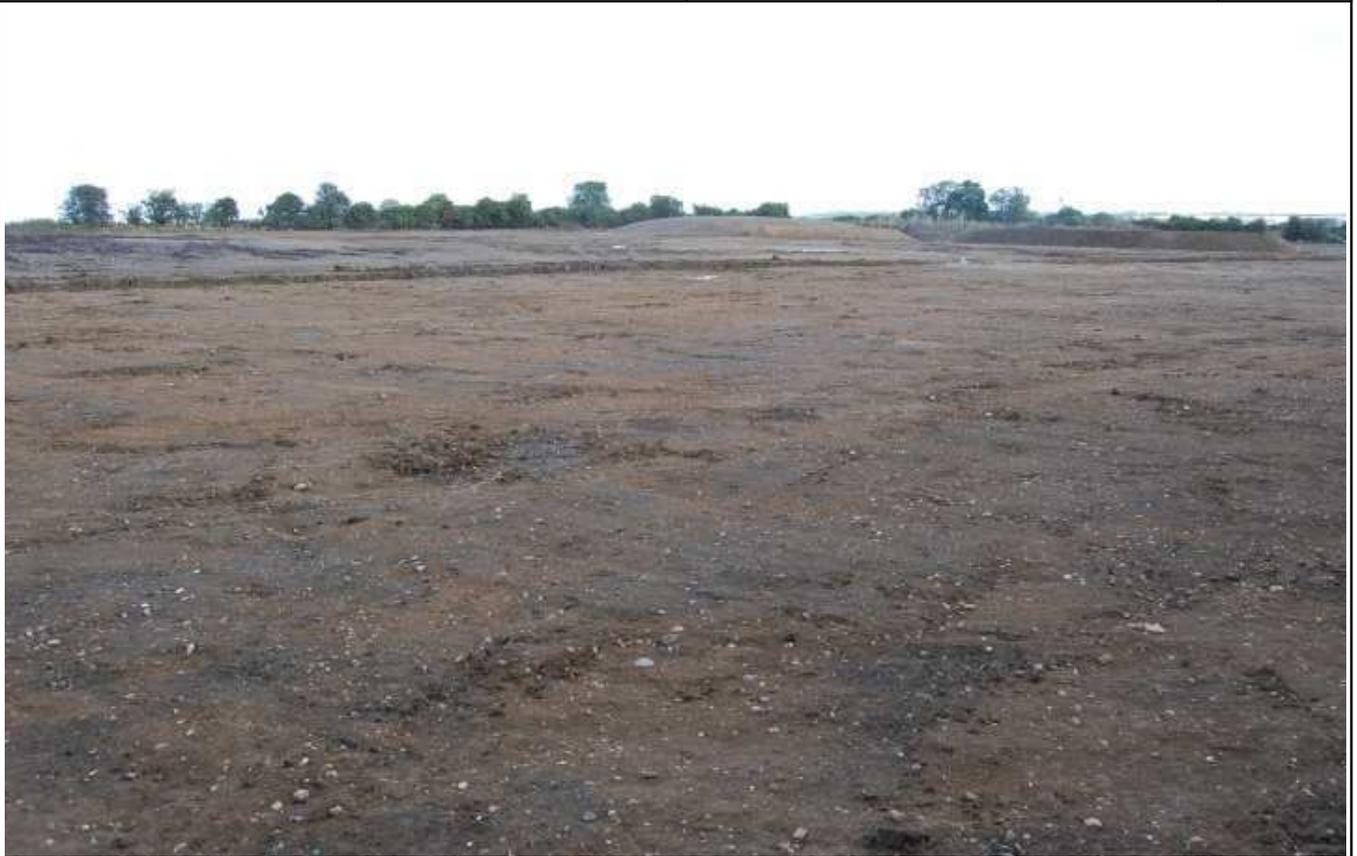
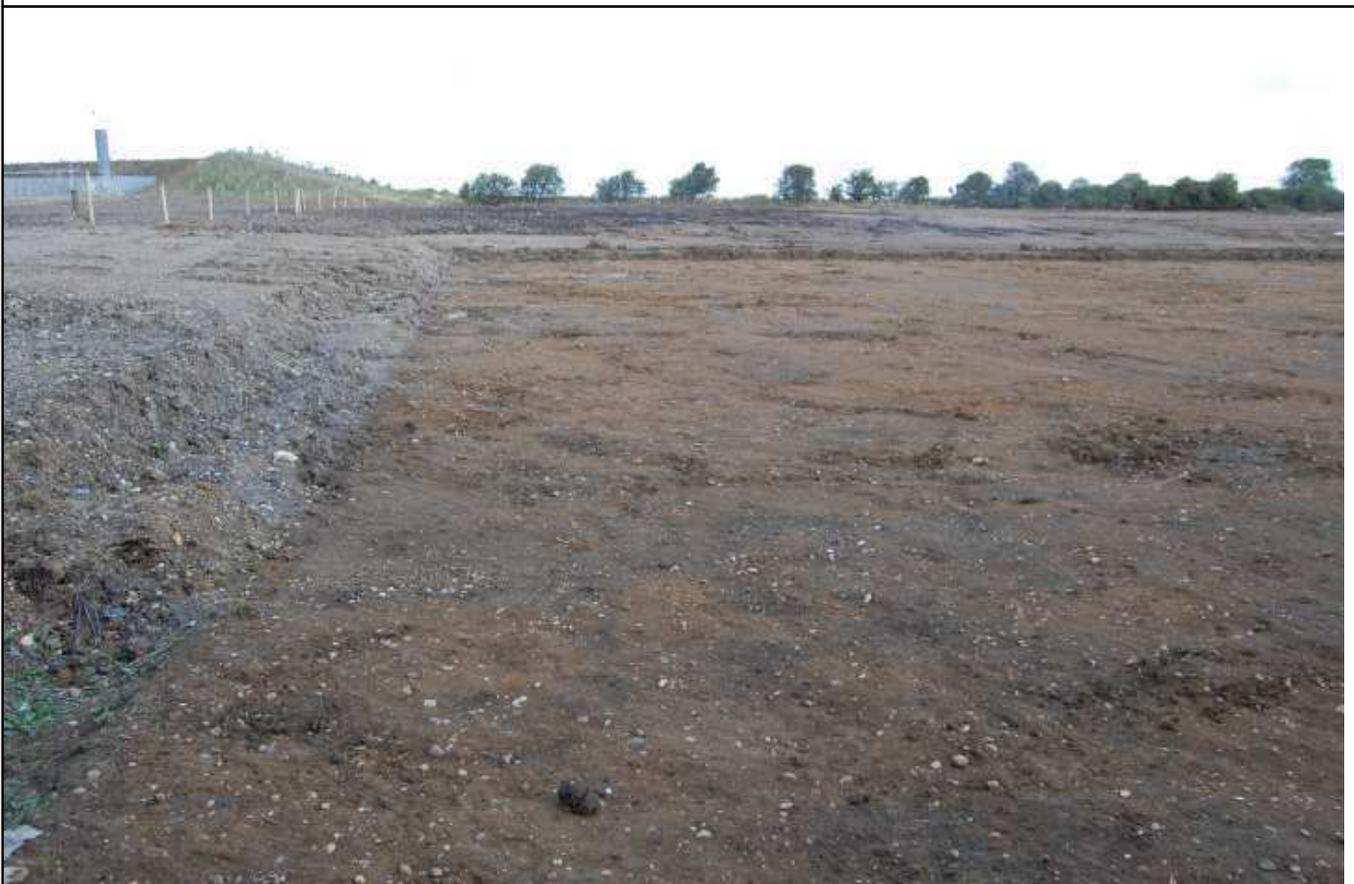
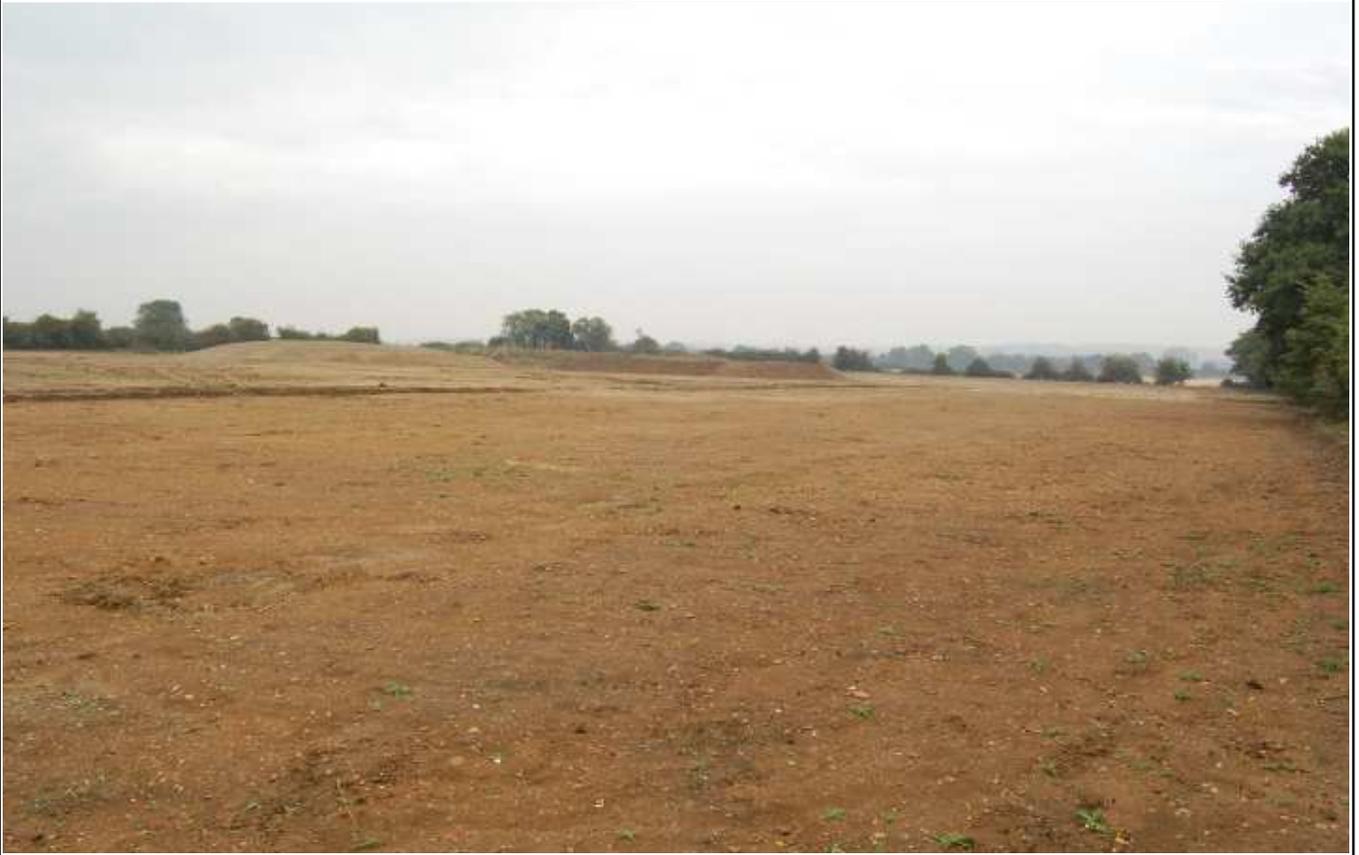
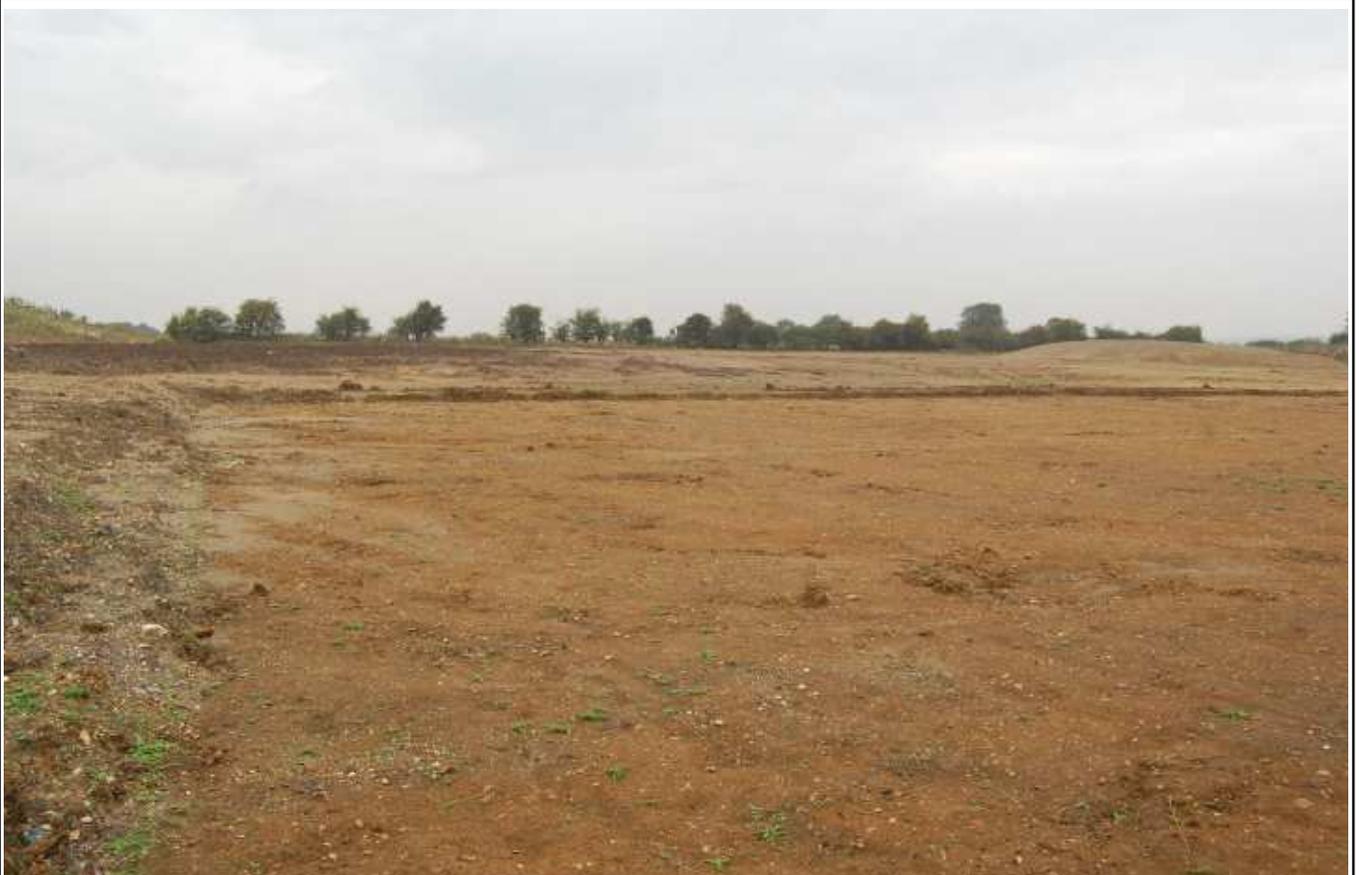
2.16 During the weathering period a number of site visits were made to walk over and inspect the exposed ground surface. Record photographs were taken from the same vantage points on each visit (Plates 13-16).

2.17 No archaeological features or deposits became apparent as a result of this exposure, though a number of further ploughmarks appeared.

Plate 13: Stripped area, 18th August, looking north-east

Plate 14: Stripped area, 18th August, looking north

Plate 15: Stripped area, 23rd September, looking north-east

Plate 16: Stripped area, 23rd September, looking north

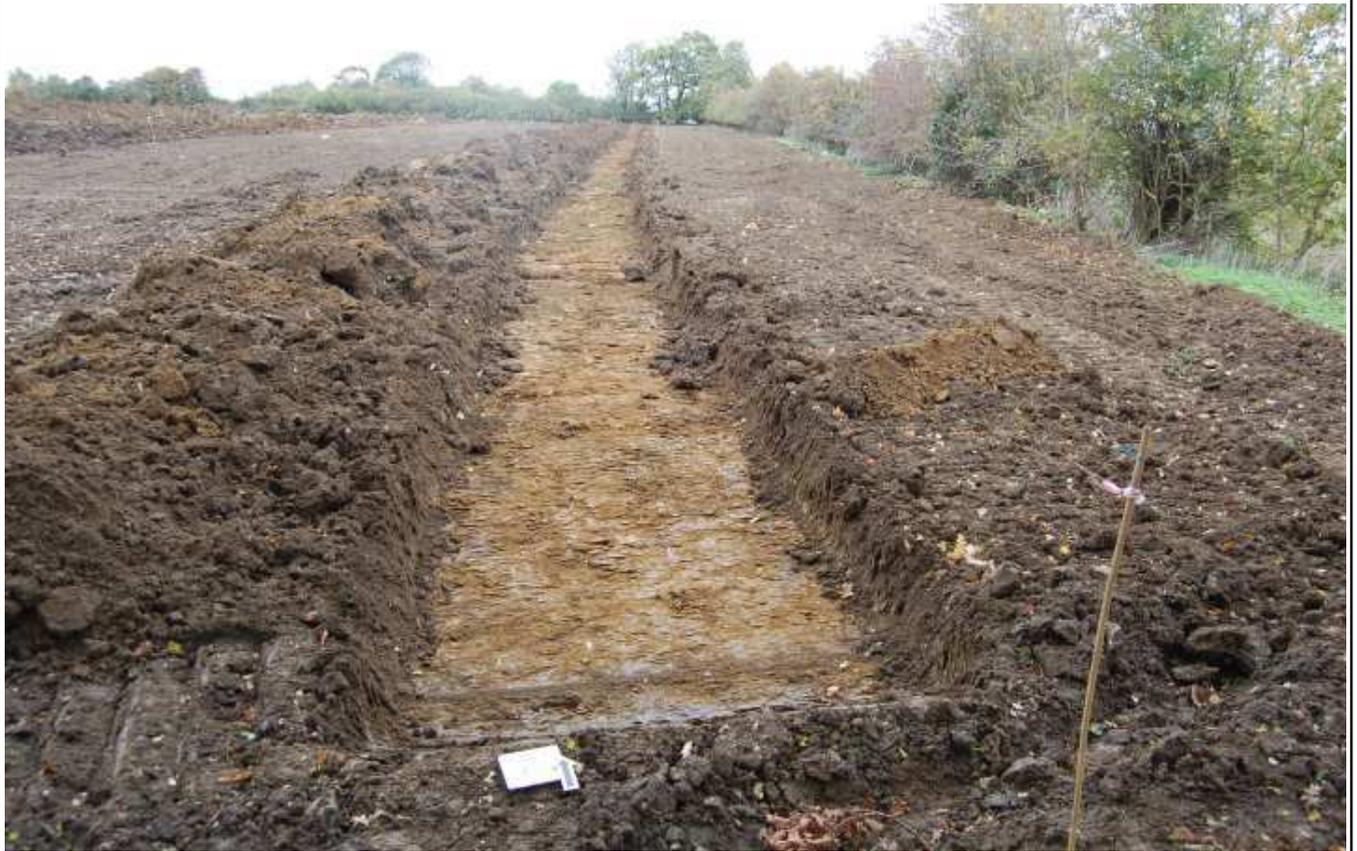
2.23 The trenches measured 1.80m in width and between 0.30m and 0.40m in depth. They varied in length, with Trenches 1 and 2 at the eastern end running the entire width of the field (approximately 130m) and Trenches 3 – 5, to the west, avoiding the central ripped area (Figure 3).

Plate 17: Trench 1, looking north

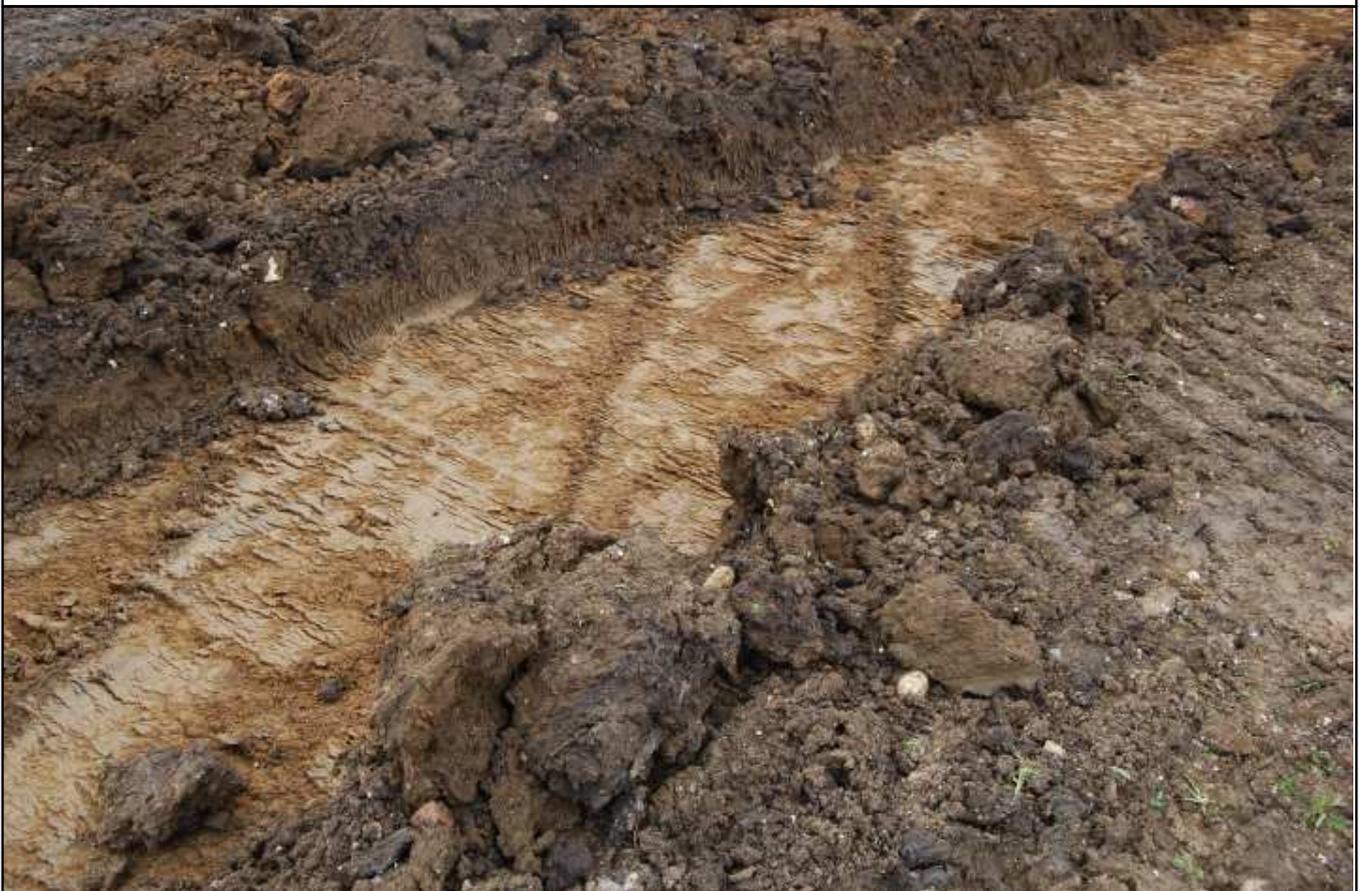
2.24 Ploughmarks were noted in all trenches. These ran on a north-west to south-east alignment and were between 0.90m and 1m apart. Each measured approximately 0.15m in width and 0.15m in depth. A number of other irregular potential features were observed, particularly at the northern end of Trench 5a. Investigation demonstrated that these were modern in date and represented areas where surviving subsoils and stockpiled material had been compressed into the natural clay.

Plate 18: Detail of ploughmarks in Trench 1
