1EW03 - Enabling Works Central

AWHe Interim Report for Archaeological Monitoring at Grove Farm – Small Dean North Embankment - Wendover - Buckinghamshire (AC210/7) Site Code: 1C19GRVAM

Document no.: 1EW03-FUS-EV-REP-CS03_CL06-009443

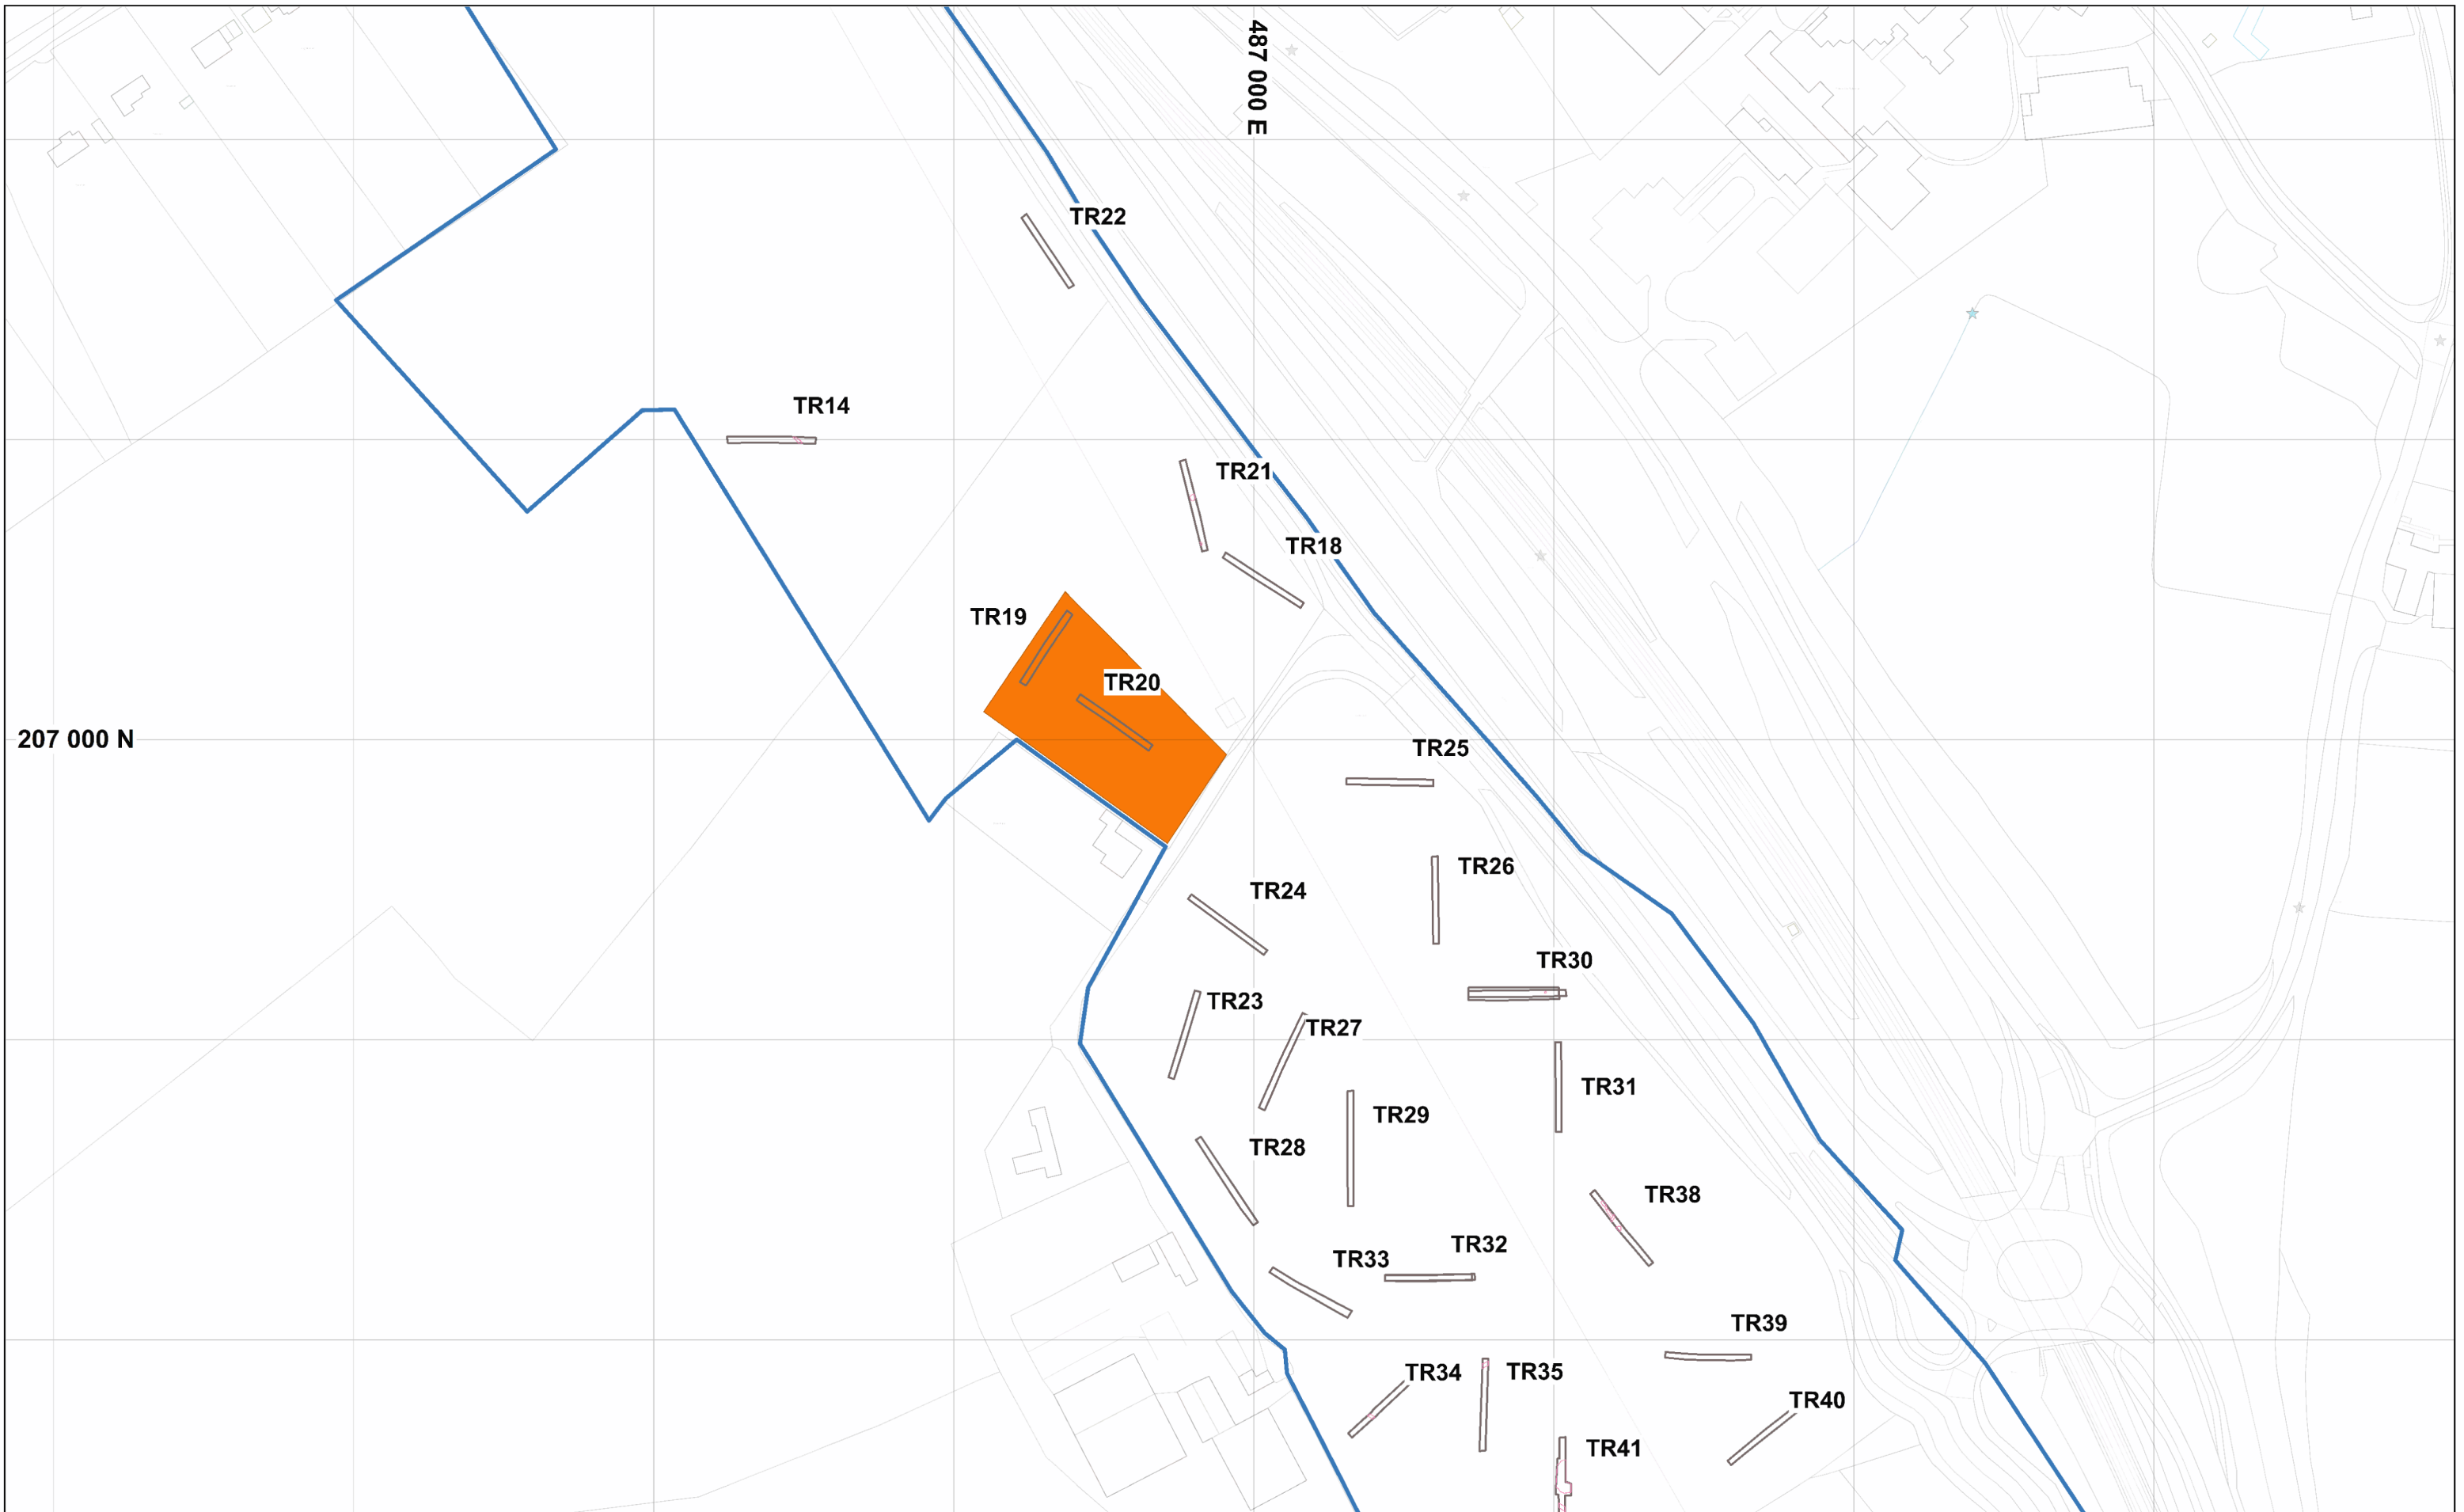
High Speed Two
Grove Farm
Figure 2. Approximate location of archaeological monitoring 2018

- 4.2.1 The natural geological horizon, or archaeological horizon was not reached during the stripping of the topsoil, which was removed to an average depth of c.0.3m (Figure 2). No features were noted cutting through the topsoil or subsoil where it was exposed, and no finds were recovered.

- Site extent
- Excavated evaluation trench
- Archaeological feature
- Archaeological monitored area, no survey data supplied, extent based on field observation

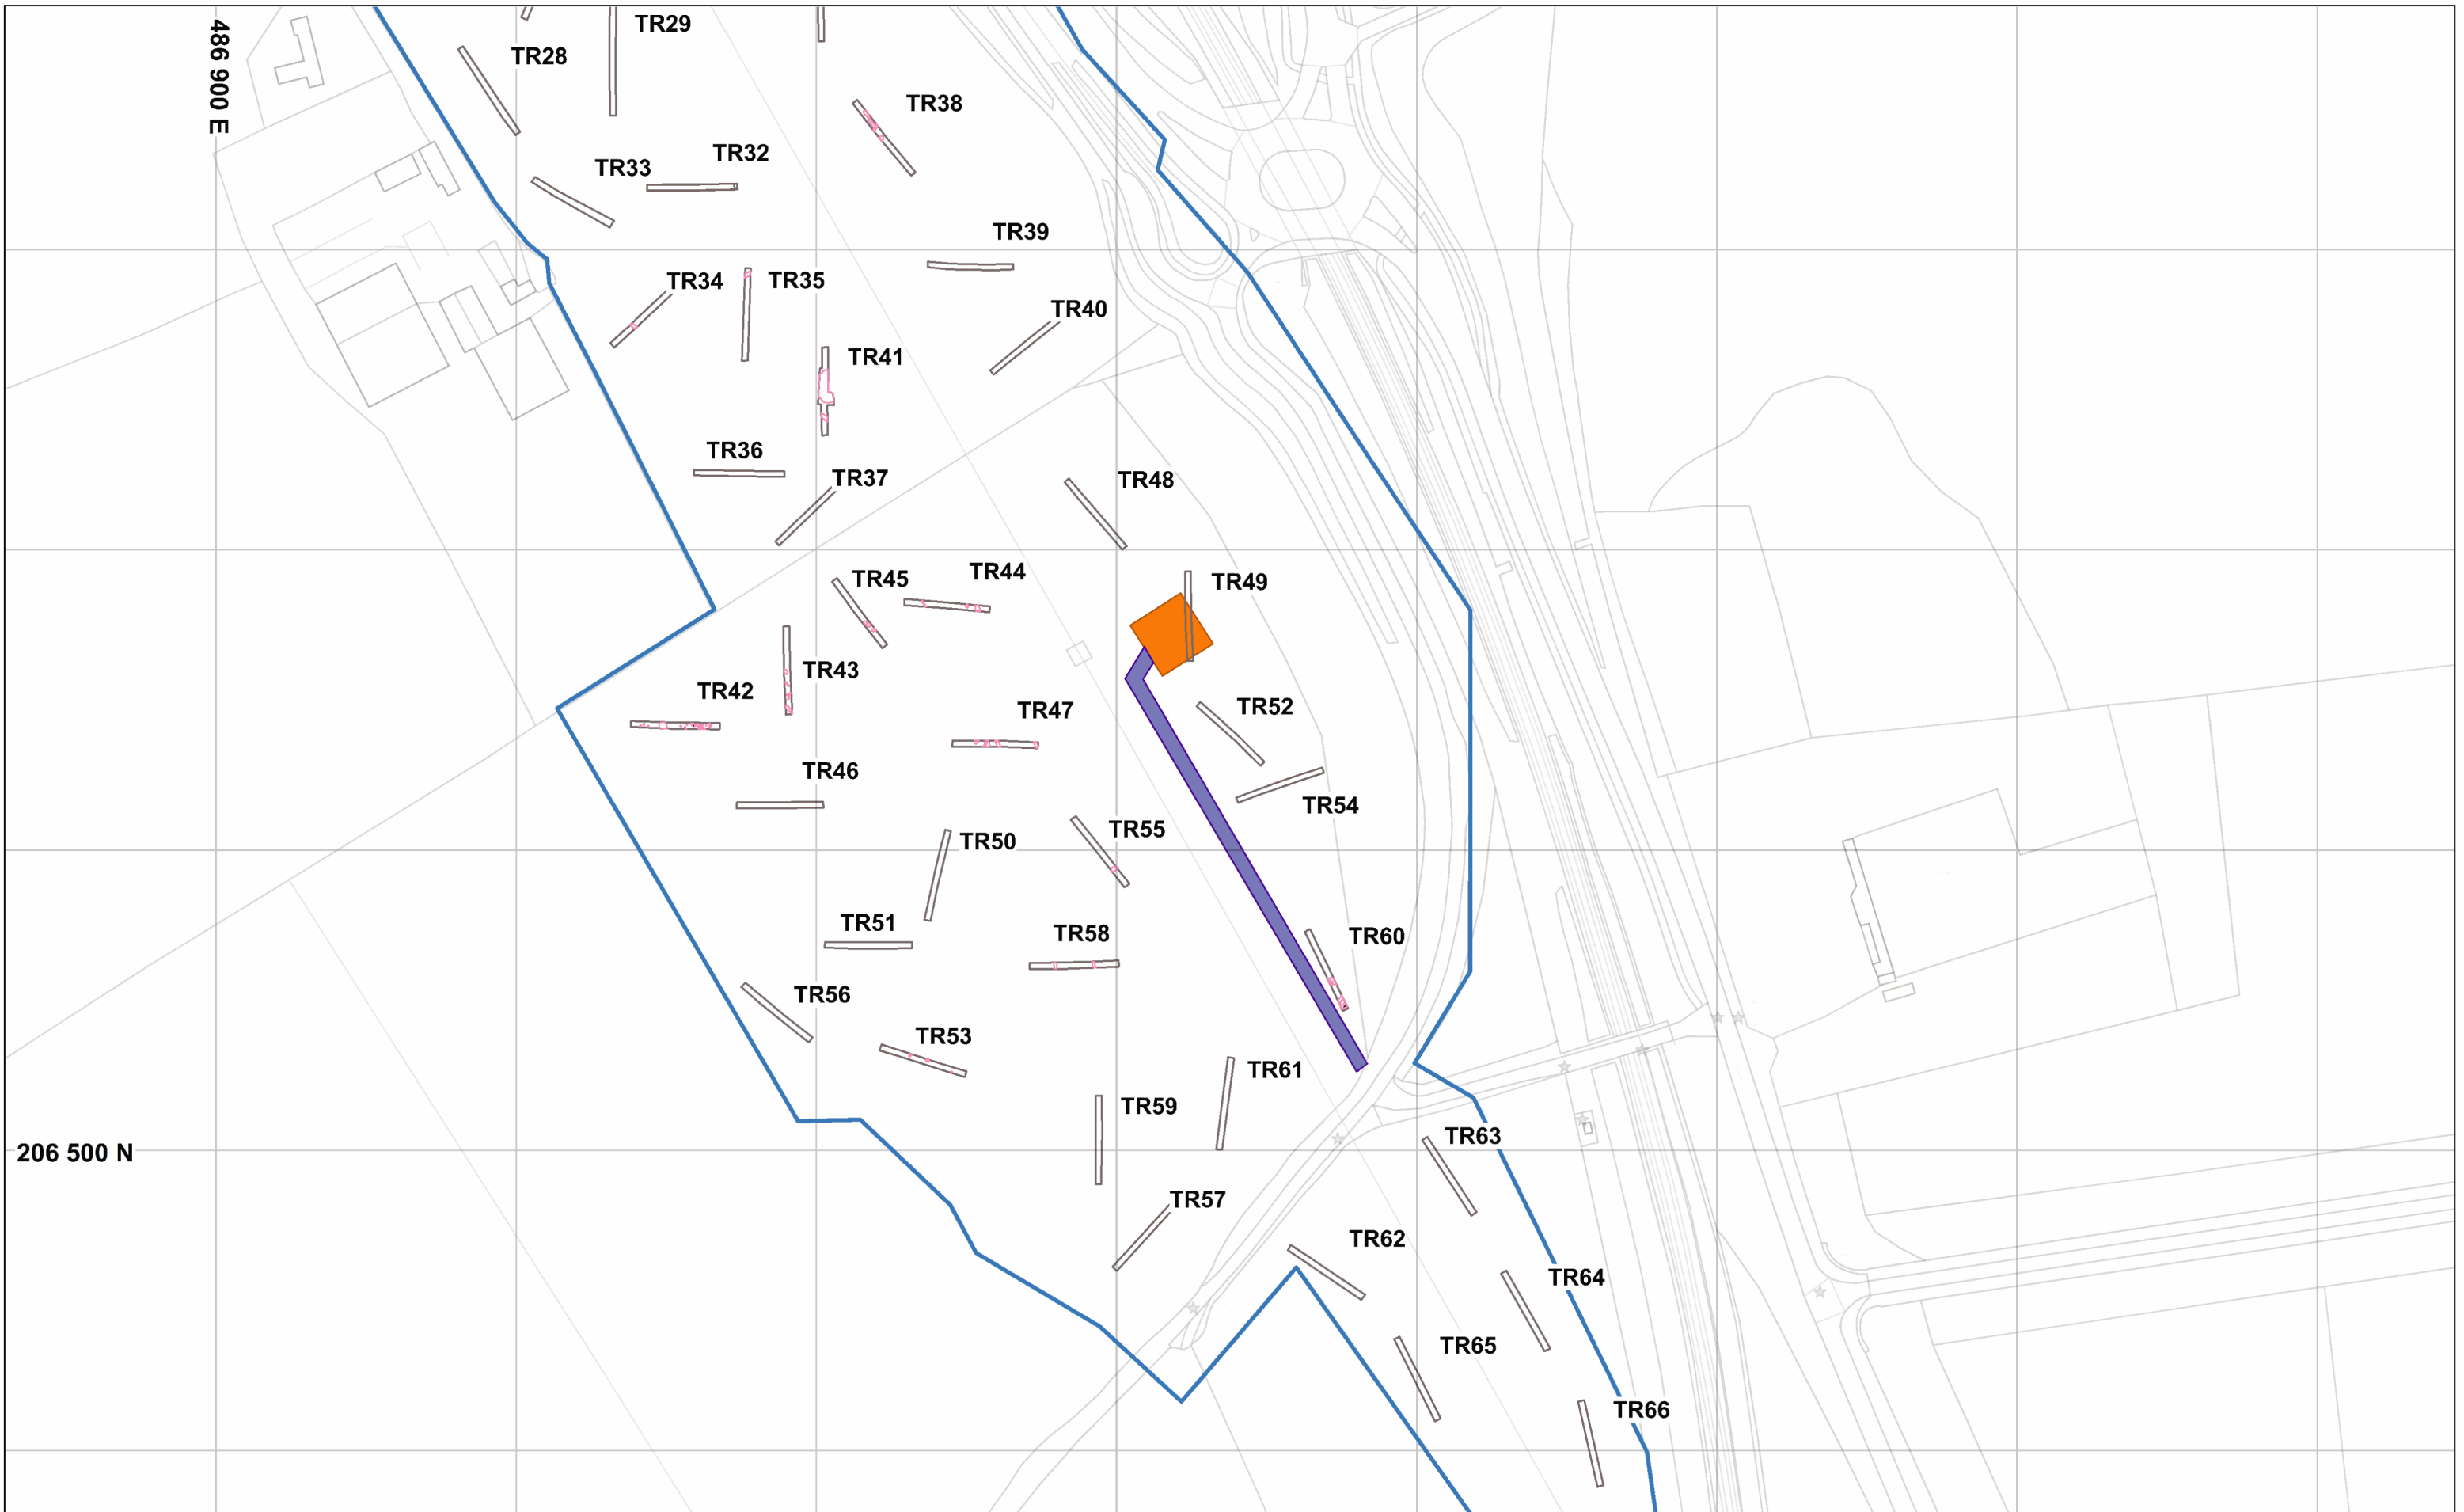
High Speed Two
Grove Farm
Figure 3. Approximate location of
archaeological monitoring 2019

- 3.1.10 The impact area of the 2019 groundworks which required monitoring encompassed c.0.14ha. The monitored pylon base area overlapped with Trench 49 which had not contained any archaeological features. The monitored area including the haul road was within an area encompassed by Trenches 44, 47, 48, 52, 54, 55, 60 and 61. Trenches 48, 52 and 54 had contained no archaeological features. Trench 44 had contained two undated northwest-southeast aligned ditches [504403] and [504405], an undated pit [504407] and an undated tree-bole [504409]. Trench 47 had contained a northwest-southeast oriented ditch [504707] dated to the Iron Age towards its eastern end, along with two further undated ditches [504705] and [504711], an undated ditch terminus and an undated pit towards the middle of the trench. Trench 55 had contained the undated southwest terminal end of a ditch [505505]. Trench 60 had contained two undated ditches, [506005] and [506031] aligned east-west and northeast-southwest respectively, along with a cluster of 8 stake-holes, these were contained within one of the ditches itself and were interpreted as being part of an east-west palisade; these features were all located towards the south end of the trench. Of these features, ditches [505505], [506005] and [506031] and the palisade in Trench 60 could have extended into the monitored area.

- Site extent
- Excavated evaluation trench
- Archaeological feature
- Archaeological monitored area, no survey data supplied, extent based on field observation, pylon base
- Haul road, no survey data supplied, extent based on field observation

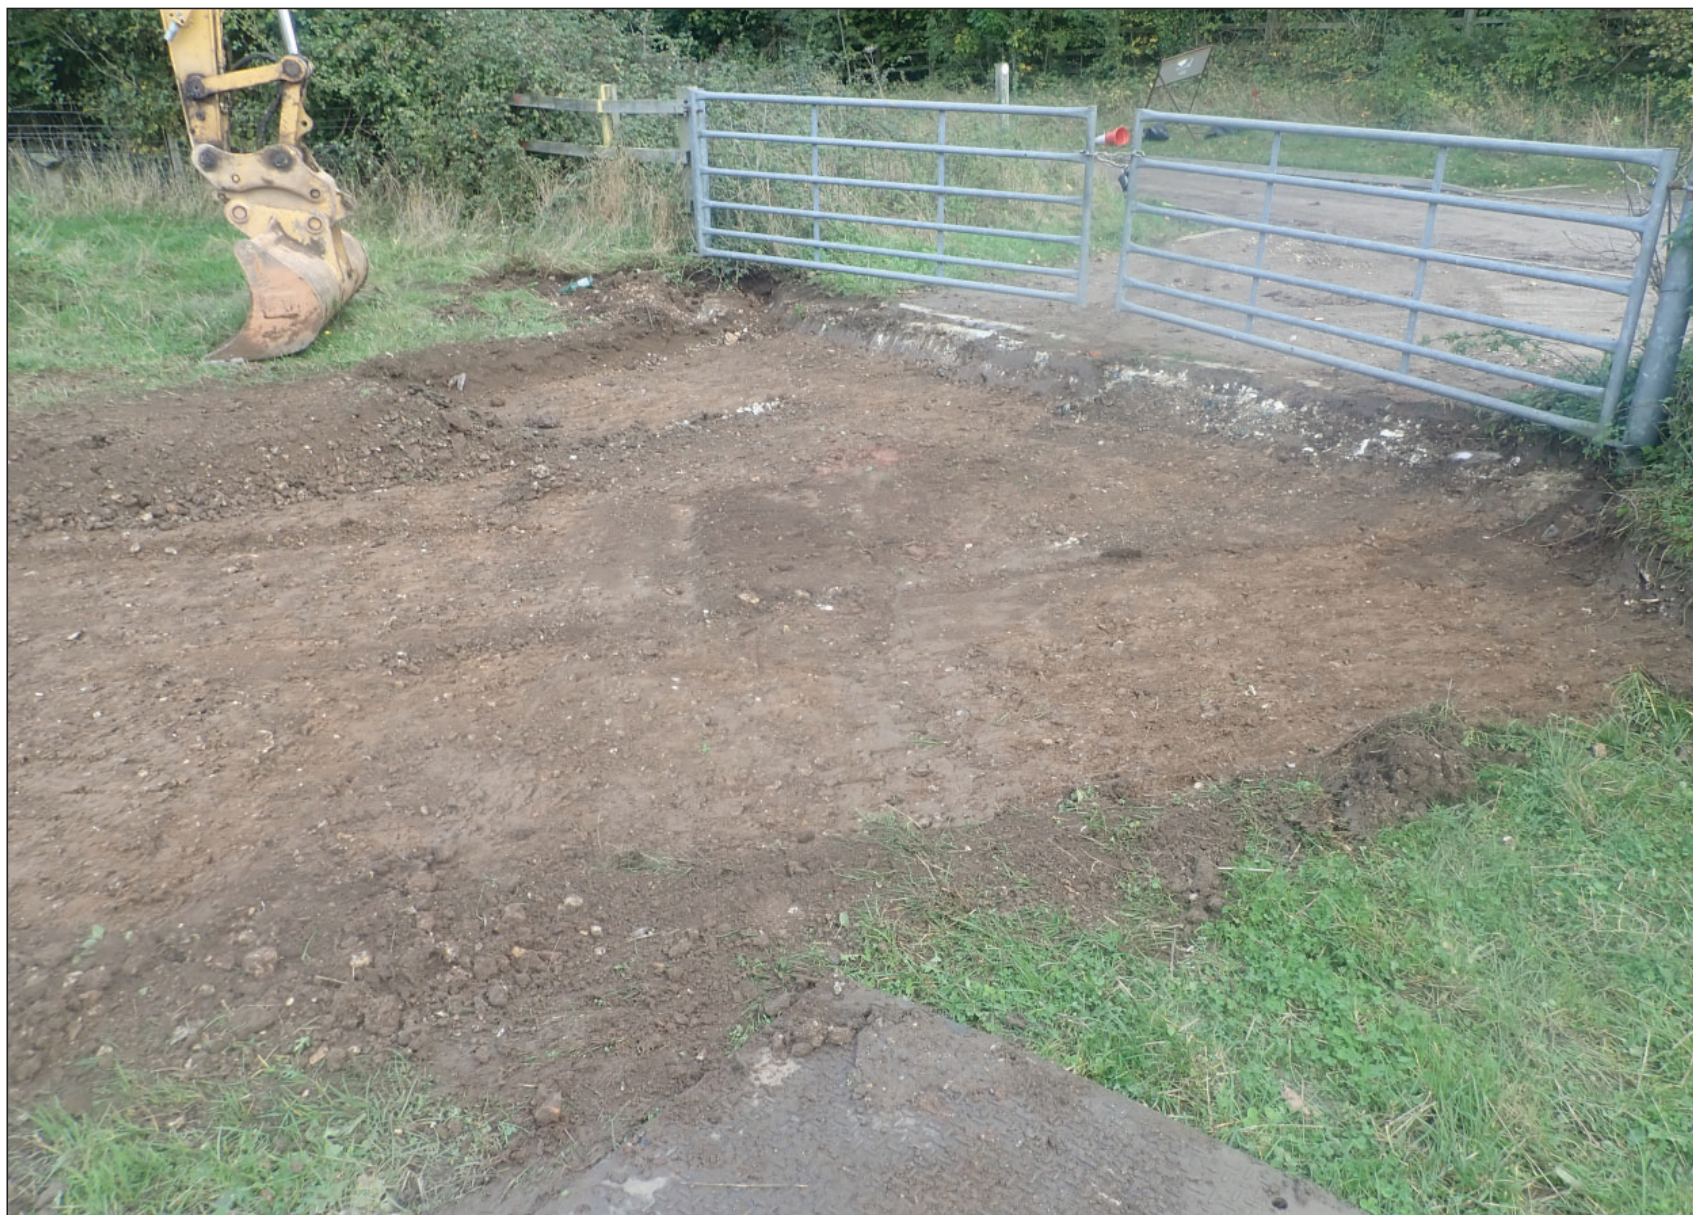
- 4.3.1 The area to be stripped and Archaeologically Monitored in 2018 and 2019 encompassed c. 0.32 ha. and c.0.14ha. No archaeological features or finds were revealed during the monitoring due to the archaeological horizon not being reached during the groundworks (Figure 2; Plates 1-3).

Plate 1 - Topsoil removal at southern extent of haul road adjacent to site entrance, looking southeast

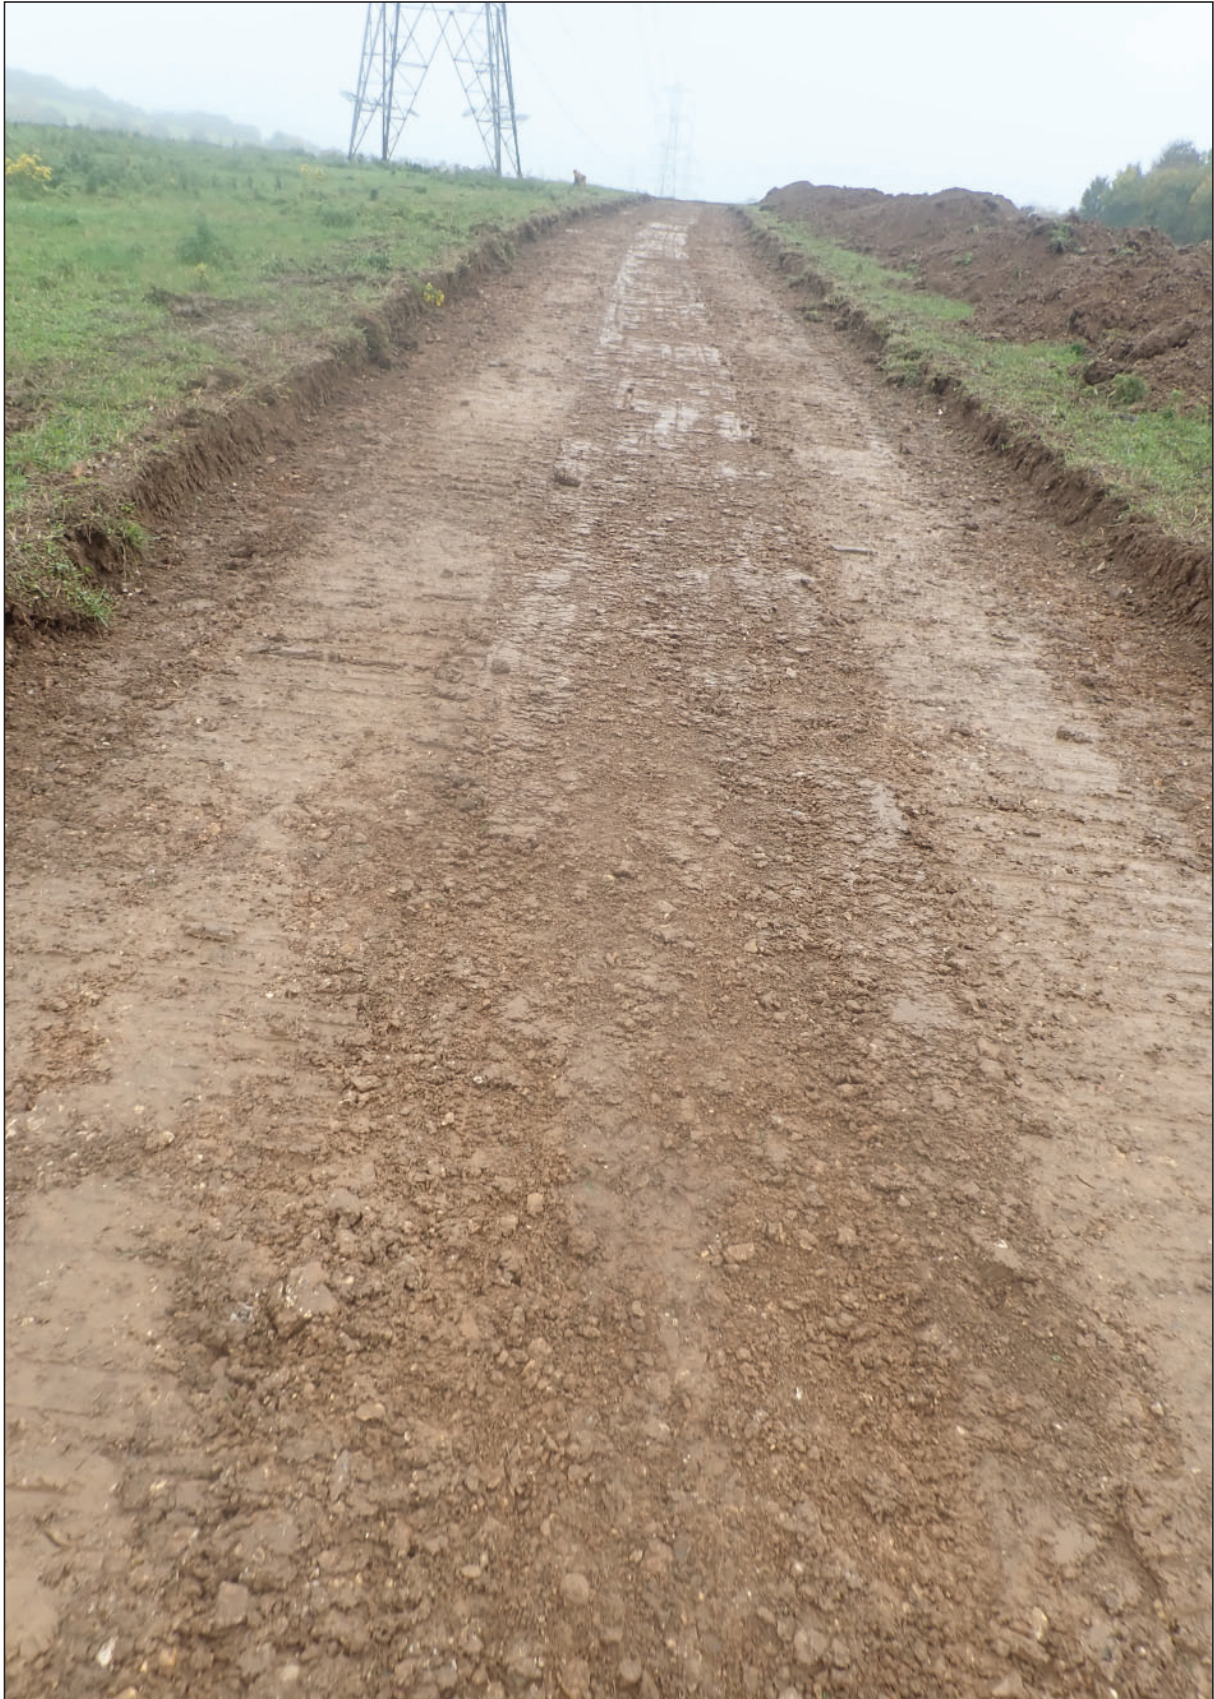
Plate 2 - Overview of haul road after topsoil removal, looking northwest

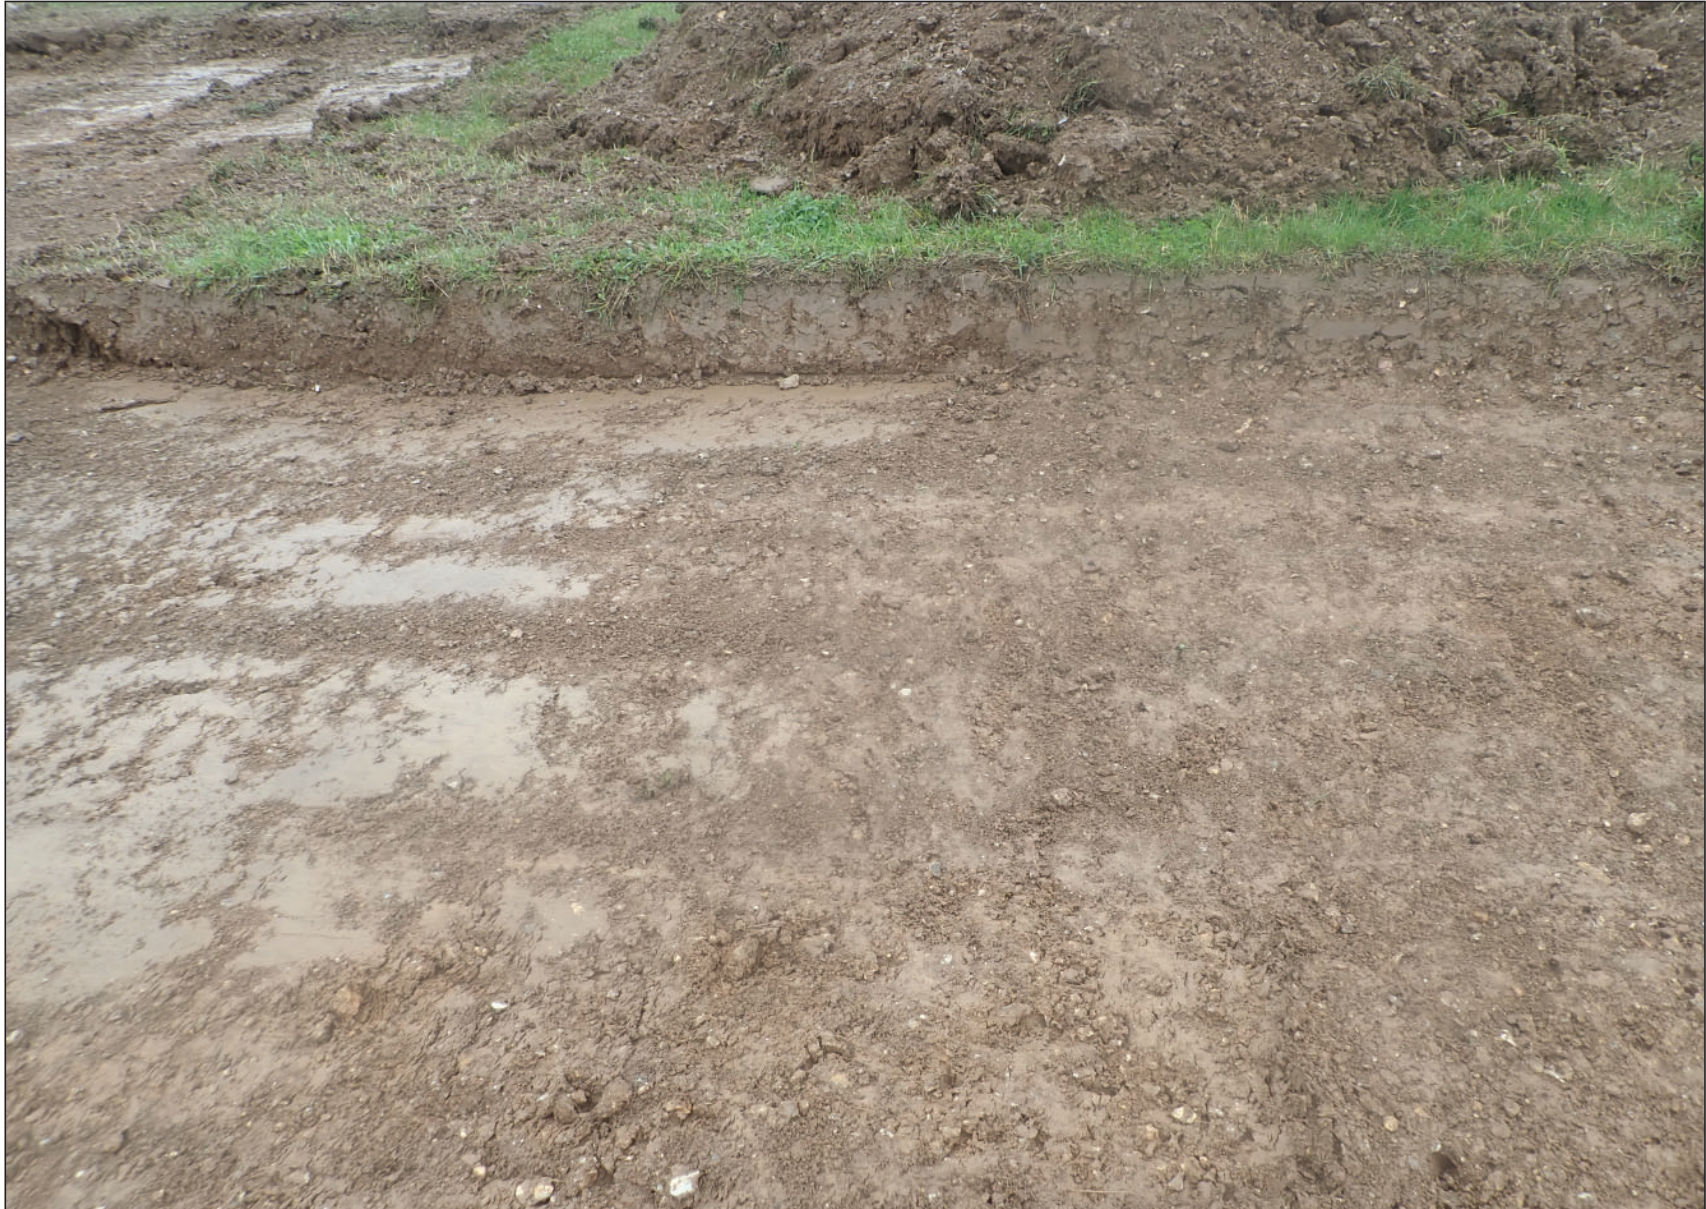
- 4.1.1 The overburden was comprised of topsoil, which was a dark grey brown friable silty clay (c. 0.3m thick) and subsoil, which was a dark brown grey silty clay with chalk and stone inclusions (0.09 – 0.46m thick). The natural geology found across the Site during the trial trenching comprised of chalk, with the lower southern slopes comprised of sandy clays with bands of flint.

Plate 3 - Representative section through haul road showing depth of topsoil removal, looking northeast
