1EW03 – Enabling Works Central AWHe C10024 Interim Report of Trial Trench Evaluation at Pipers Wood Cottages, Little Missenden Vent Shaft and Auto- Transformer Station (ATS), Buckinghamshire (AC100/11) Site Code: 1C18PIPTT

Document no.: 1EW03-FUS_IFA-EV-REP-CS02_CL04-000001

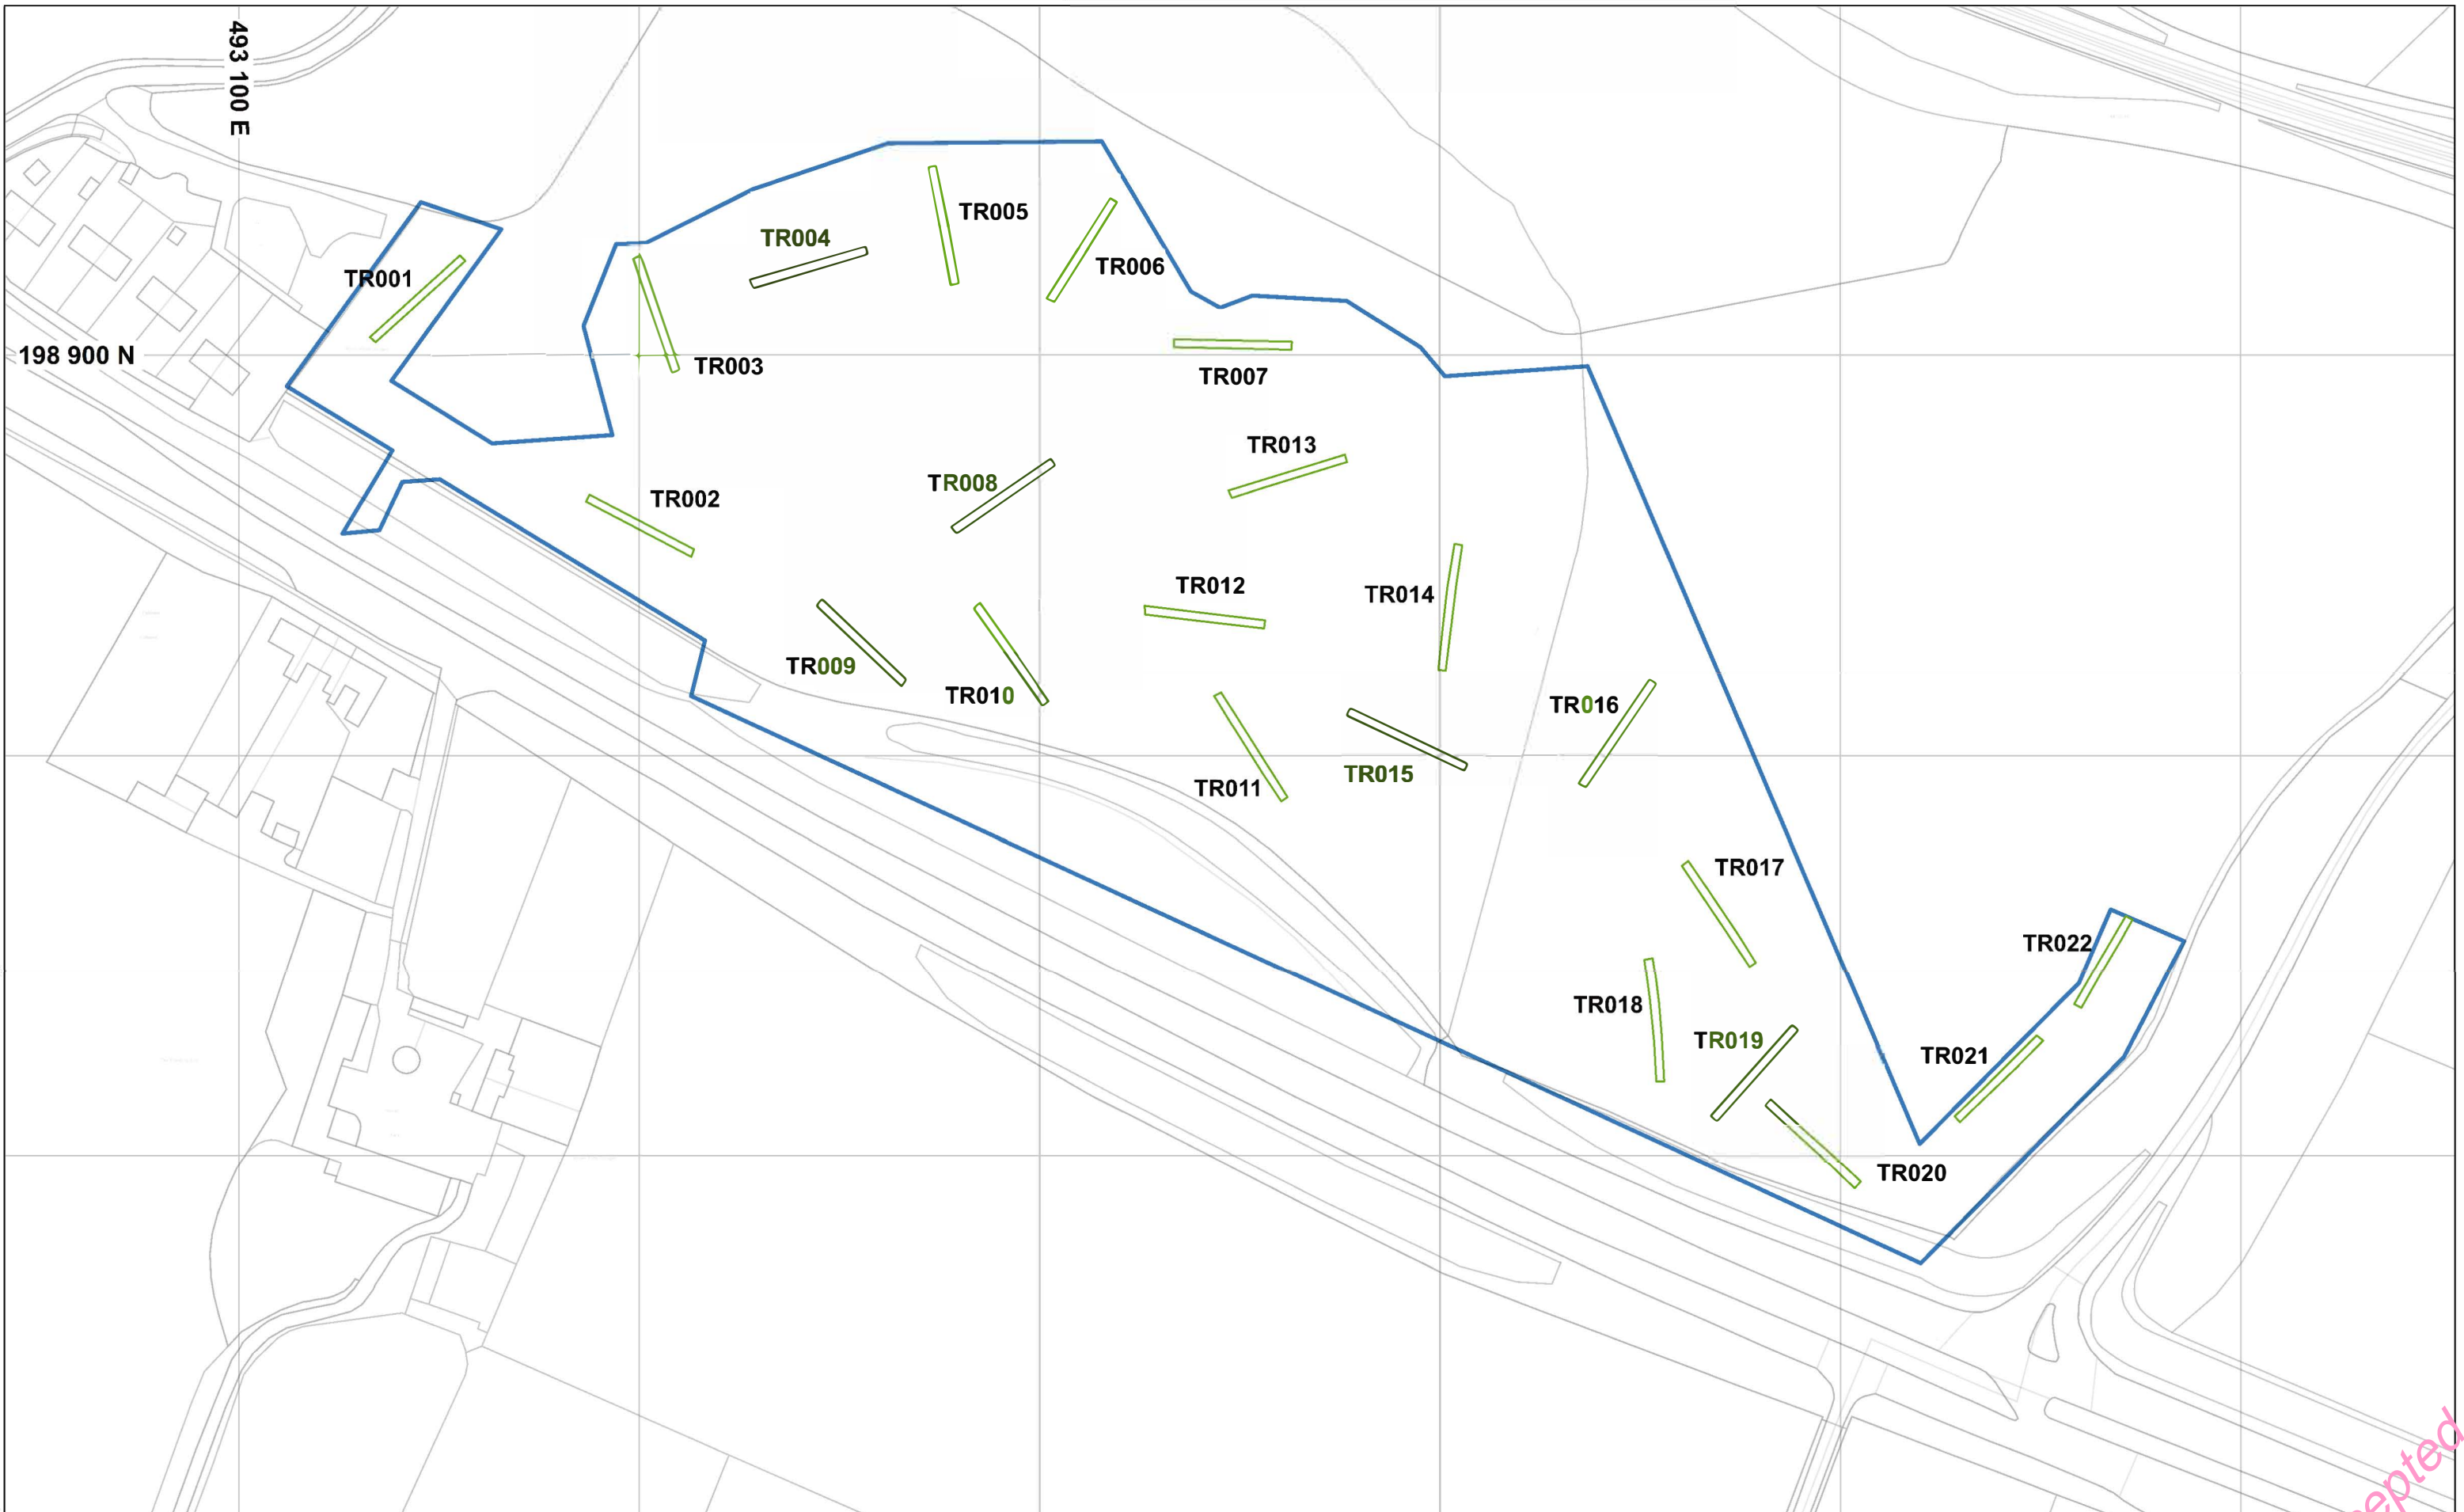
High Speed Two,
Pipers Wood Cottages
Figure 2. Overview of excavated
evaluation trenches

- 7.1.1 No archaeological remains were revealed during the trial trench evaluation, with only two undated tree throws revealed to the east of the centre of Site in Trenches 14 and 16 (Figure 2). Previously available data suggested the Site had been in agricultural use since at least the medieval period with no evidence to suggest any earlier features within the Site boundary. The results of the trial trench evaluation did not uncover evidence of agricultural use, nor evidence of occupation or exploitation of the Site from any period.
- 7.1.2 The two tree throws could represent the remnants of a wider expanse of ancient woodland within the surrounding landscape of which Keeper's Wood to the north-east of Site is also likely a remnant.

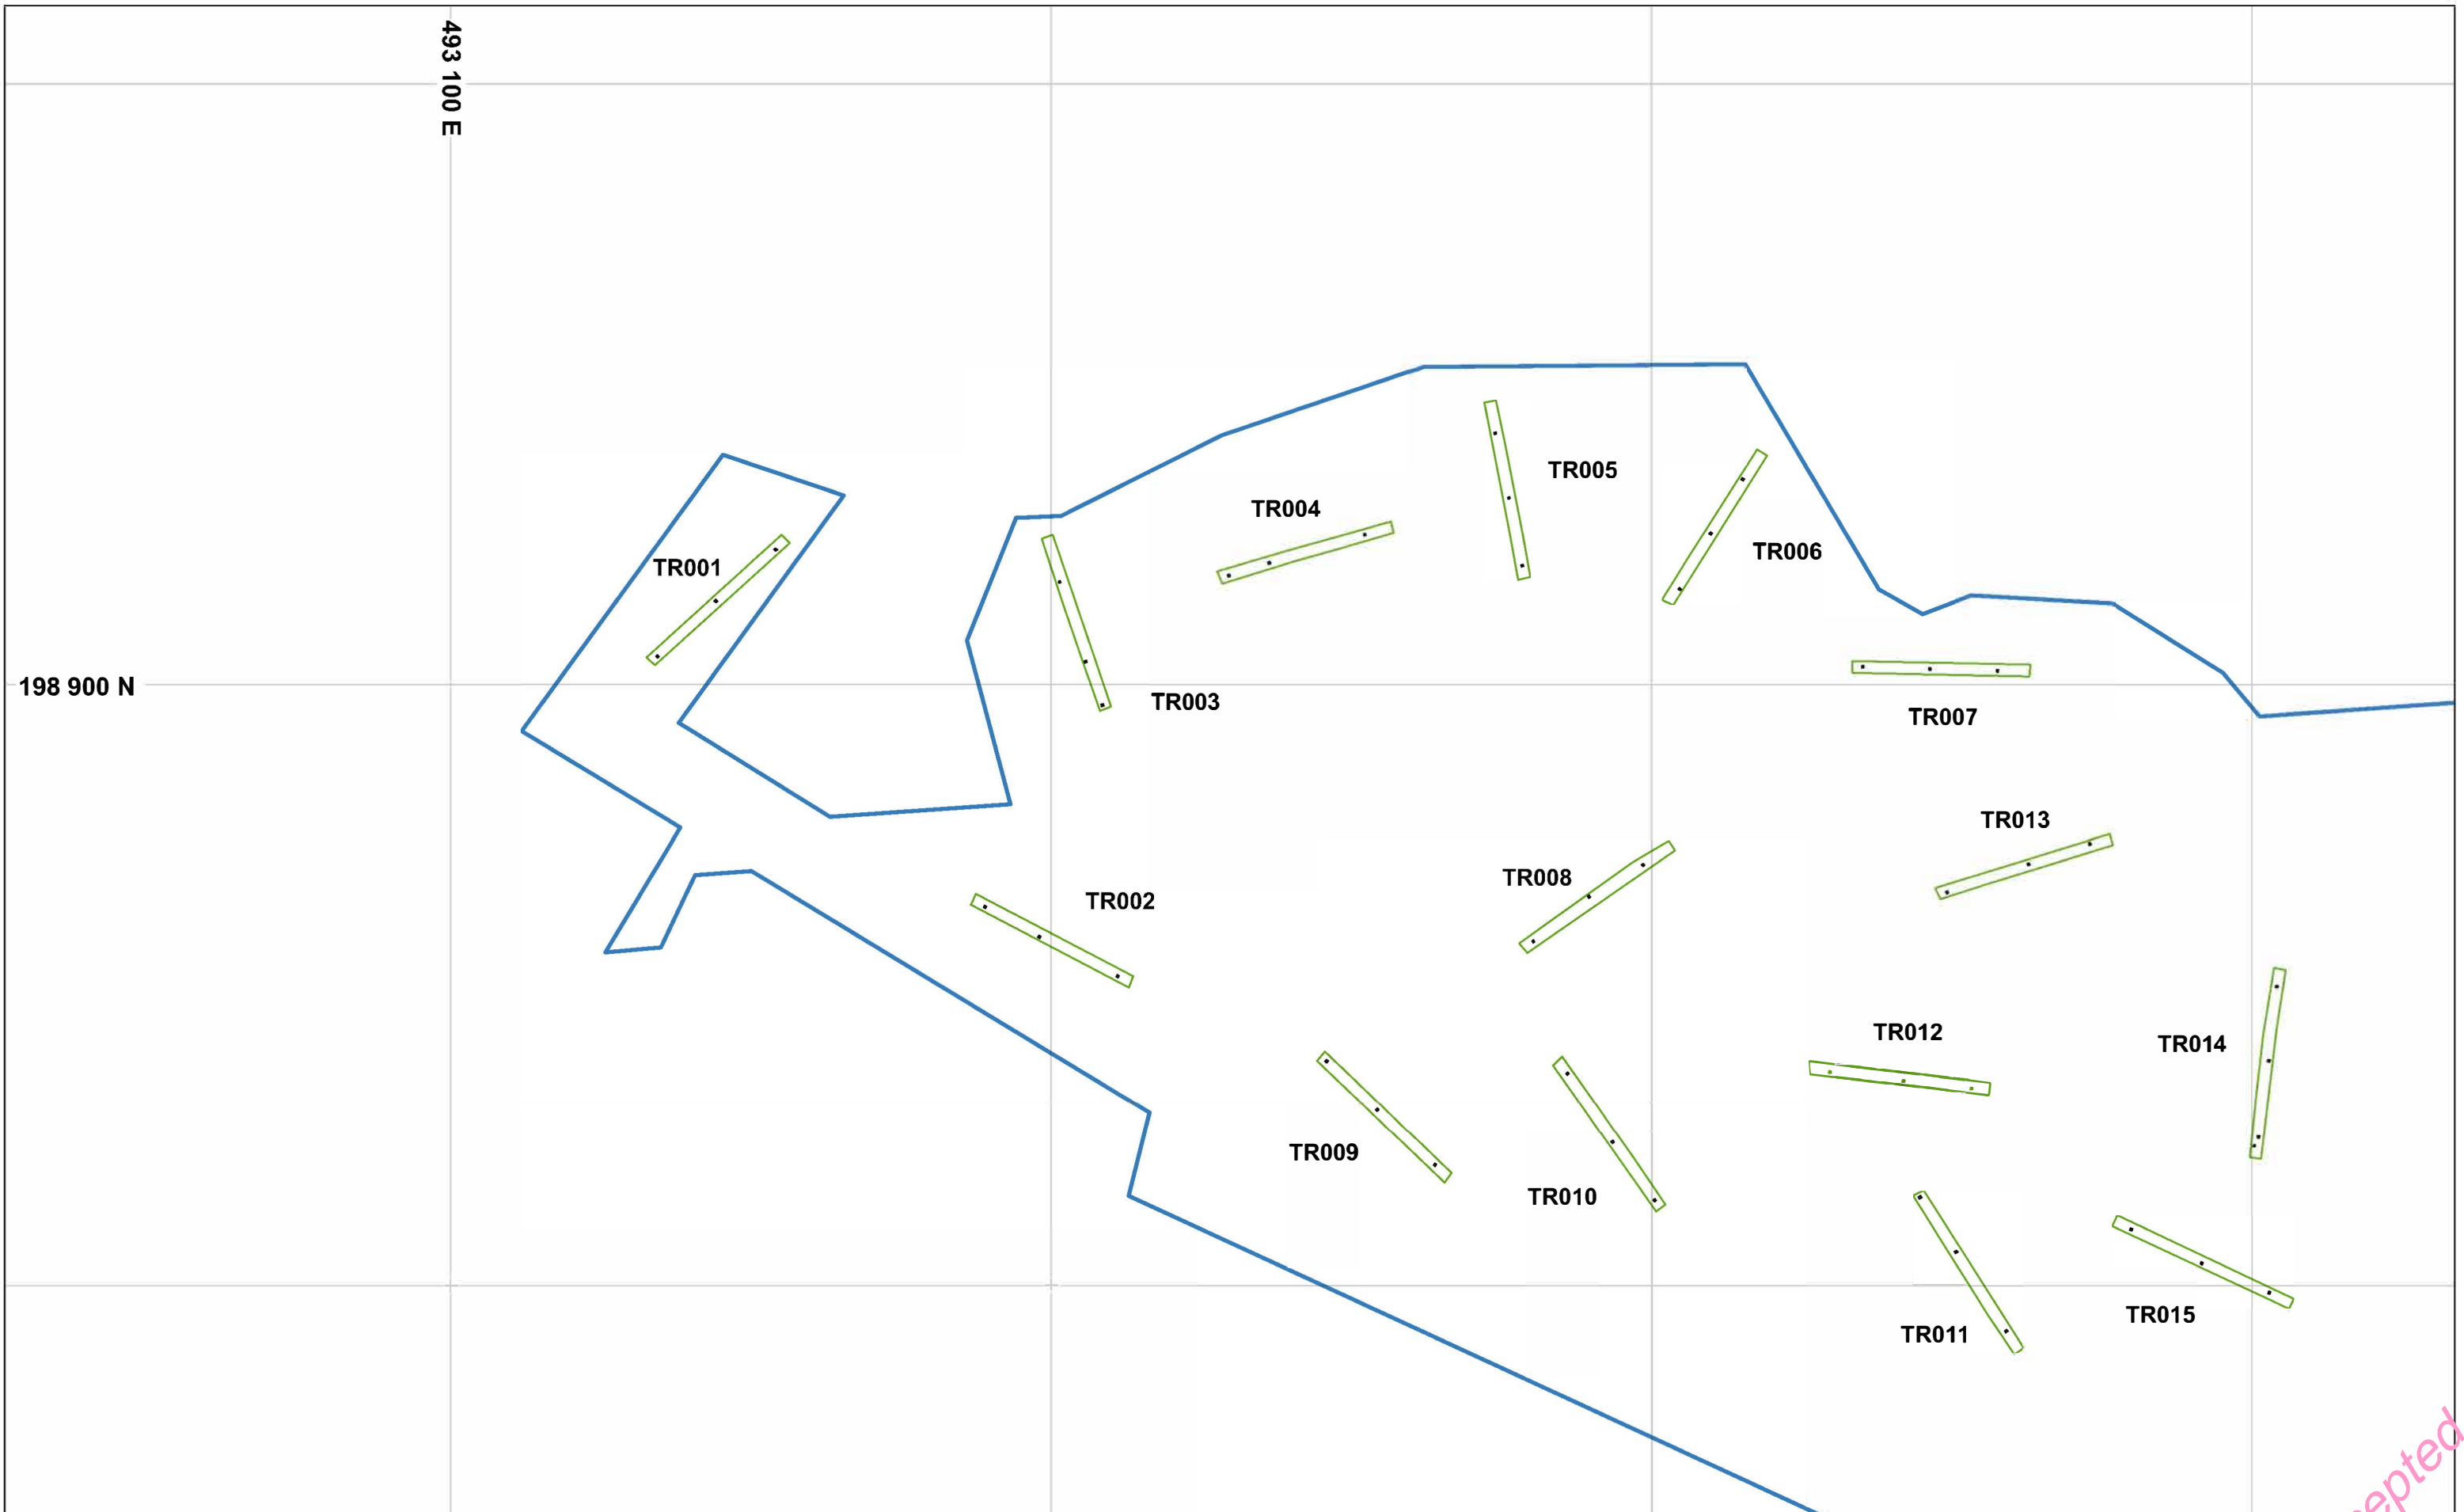
Figure 3. Overview of archaeological
features and test pits, 1 of 2

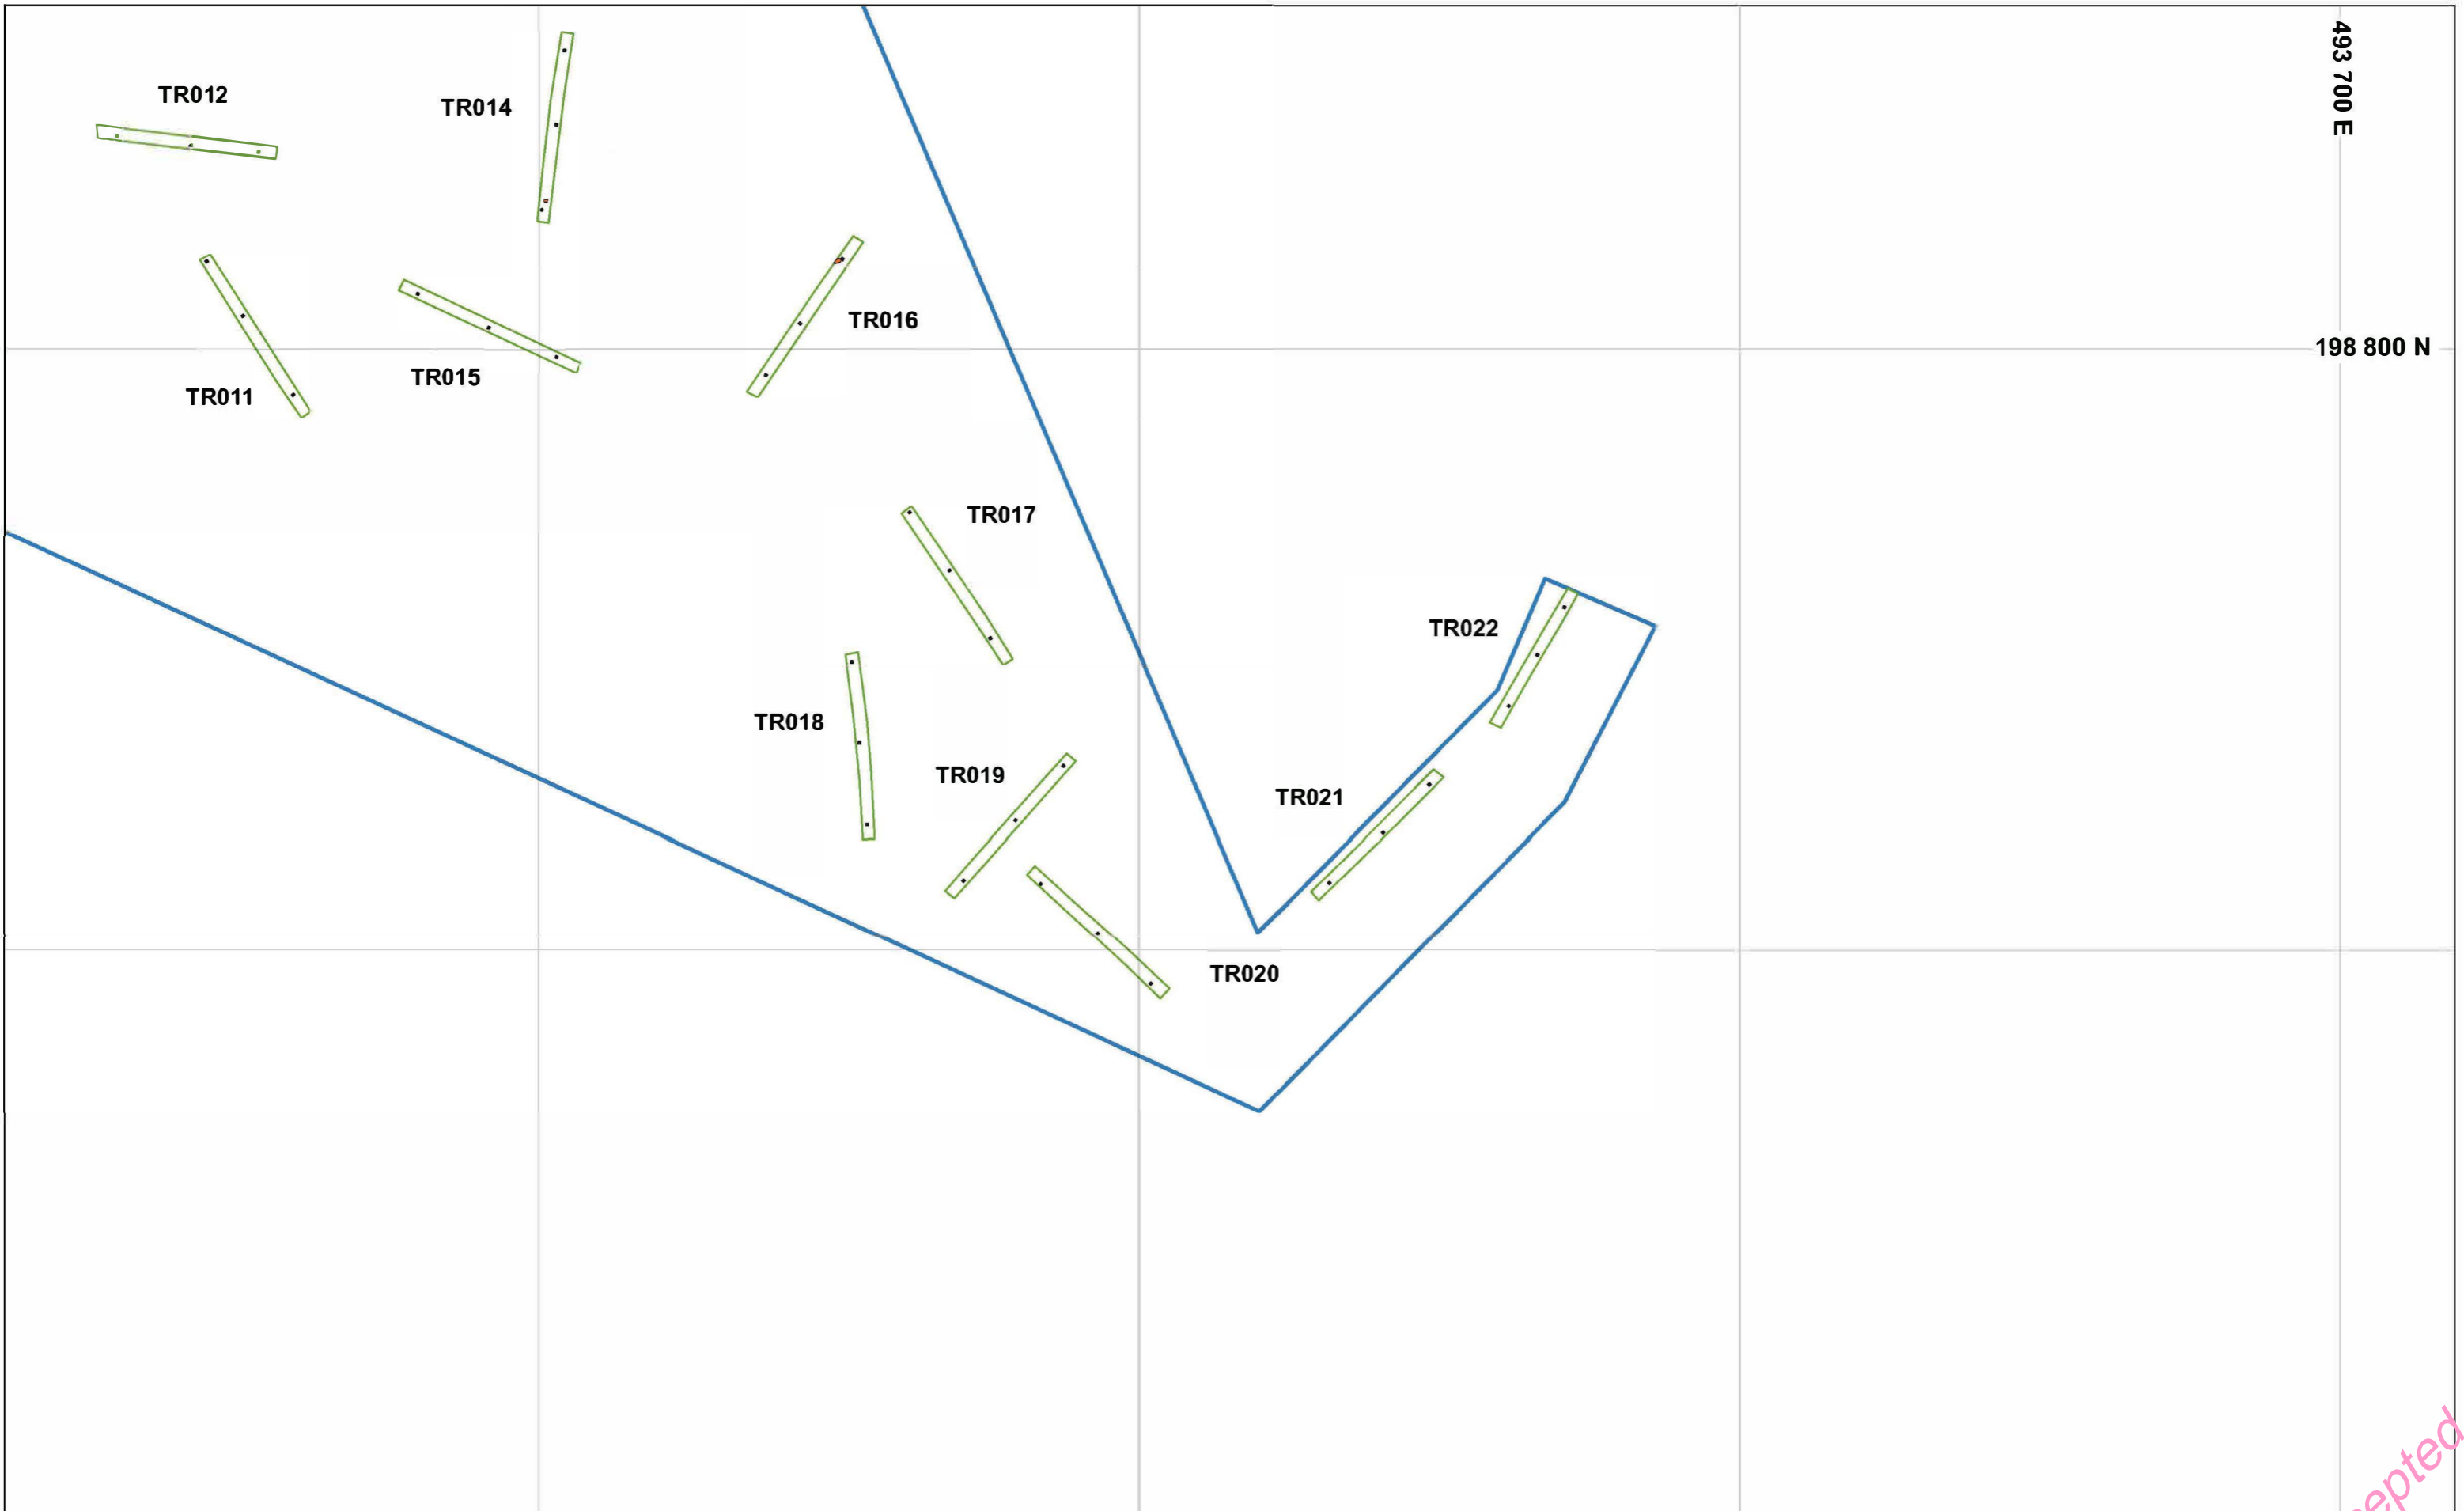
Figure 4. Overview of archaeological
features and test pits, 2 of 2

- 4.2.1 No archaeological features were uncovered during the trial trench evaluation at Pipers Wood Cottages. Two tree throws were identified in Trenches 14 and 16 to the east of the centre of Site, neither of which contained artefactual material or palaeo-environmental material suitable for sampling.
- 4.2.2 Neither of the tree throws correlated with the results of the previous geophysical survey. None of the anomalies highlighted during the geophysical survey were identified during the trial trench evaluation, and were possibly the result of variations within the natural geology.
