Sutton Archaeological Services

Evaluation Report

Packington Square Estate,

Phase 1

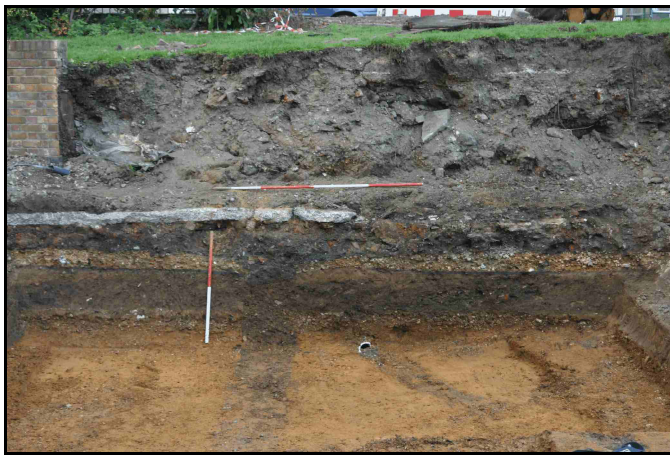
Plate 1 Trench 1: North section

Trench 1 was excavated in an area of a children's playground. The playground was in an depression, with the surrounding land sloping down to the level of the playground. The first context was the turf and topsoil on the sloping ground down to the playground. The rubberised foam covered concrete playground surface had been removed along with the playground structures. The topsoil was a friable, dark brown sandy clay [001](west: 19.625m aOD to east: 19.995m aOD and 18.96m aOD on the playground). It covered the site to a depth of c. 10cm.

Below 001 was a friable to soft, medium to dark brown sandy clay [002](west: 19.525m aOD to east: 19.895m aOD), containing 10-15% medium to large bricks and occasional large fragments of concrete. The context covered part of the trench to a depth of between 1.05m to 1.18m. It also contained fragments of glass, metal and several sherds of 20th century pottery.

A further layer of made ground lay below **005**, a soft, medium to dark brown silty clay that covered the whole of the trench area **[006]** (west: 17.855m aOD to east: 17.825m aOD). This context contained moderate small to large flint pebbles and occasional large brick fragments to a depth of 41cm.

Trench 1: the area had been truncated down to the sand and gravel, and a children's paddling pool was built in the area when the flats were first built. The pool later went out of use and the ground was built up, landscaped and a children's playground constructed. The gravel was located at about 17.42m aOD.

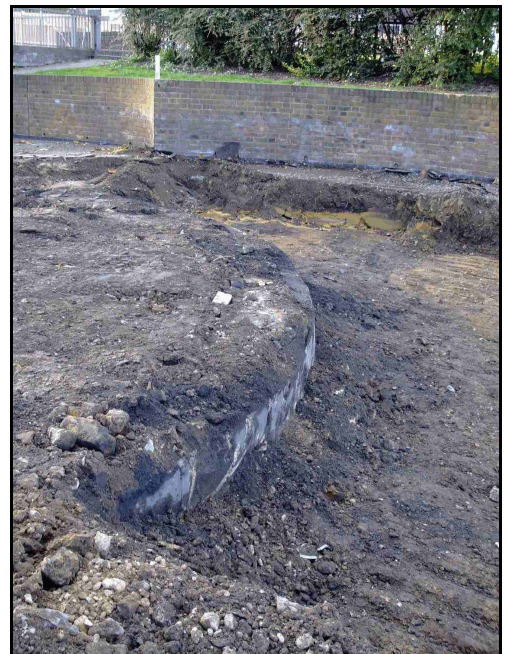
Plate 2 Paddling pool

On the western side of the trench the remains of a concrete paddling pool were revealed **[007]**(top: 18.285m aOD). The depth of the pool side was 28cm to a blue mosaic surface, with a total depth of 1.10m.

The paddling pool had been built directly into the natural sand and gravel **[008]** (west: 17.445m aOD to east: 17.415m aOD, and 17.185m aOD below the pool). The natural was a loose, yellowish brown silty coarse sand, containing 50-60% fine to large flint pebbles.

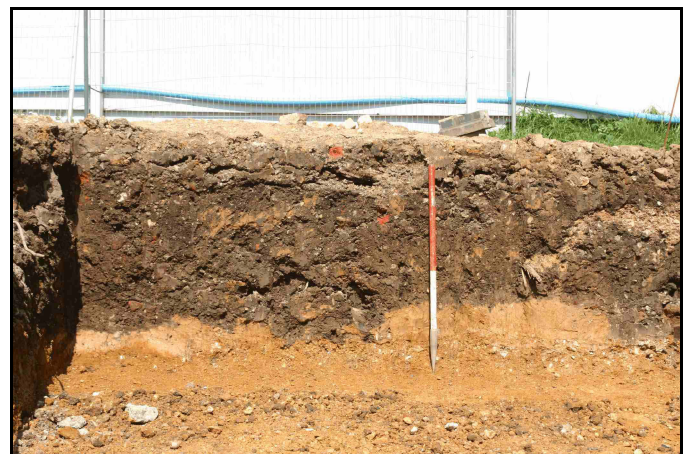
Plate 6 Trench 3: north section

The remaining overburden was also removed under archaeological supervision. It was a friable, medium to dark brown sandy clay [**016**](south 18.728m aOD to north: 18.755m aOD), containing 10-15% medium to large bricks and occasional large fragments of concrete and small to large flint pebbles. The context covered the whole trench to a depth of between 78cm to 95cm. It also contained fragments of glass, metal and sherds of 20th century pottery.

The stone walls were built on a clay context, a light orangish brown clay [019](south 17.81m aOD to north: 17.83m aOD) , containing very occasional small to medium flint pebbles.

Below the clay was the natural sand and gravel, a loose, light orangish brown silty coarse sand, containing 30-40% very fine to large flint pebbles [020](south 17.68m aOD to north: 17.73m aOD).

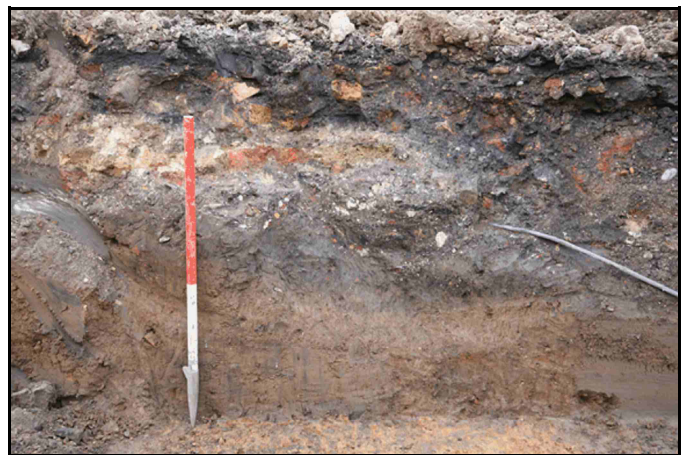
Plate 8 Trench 4: south section

The first context was either a made ground deposit or demolition debris from the previous builds that stood on the site. It was a friable to soft, dark brown sandy clay [021](west: 18.72m aOD to east: 18.845m aOD), containing 25-35% medium to large bricks and occasional fragments of concrete and white mortar. The context covered the trench to a depth of between 67cm to 76cm. It also contained fragments of glass, metal and several sherds of 19th century pottery.

A subsoil context lay below context 021, the only place in the Phase I site where this was found. It was a very soft, medium brown silty clay [022](west: 17.96m aOD to east: 18.17m aOD), containing occasional small to medium flint pebbles. The context contained sherds of late Medieval and Post Medieval pottery as well as clay pipe bowls of 18th and 19th century date. The depth of the context was between 33cm to 41cm.

The final context was the natural sand and gravel, a loose, light orangish brown silty coarse sand [023](west: 17.63m aOD to east: 17.76m aOD), containing 25-30% very fine to large flint pebbles.

Trench 4: below the 19th century levels, were the remains of the original subsoil, the only location on the site where this was found. The natural sand and gravel lay below at about 17.70m aOD. No signs of any earlier occupation were found.
