Sutton Archaeological Services

Evaluation Report

Packington Square Estate,

Phase 2

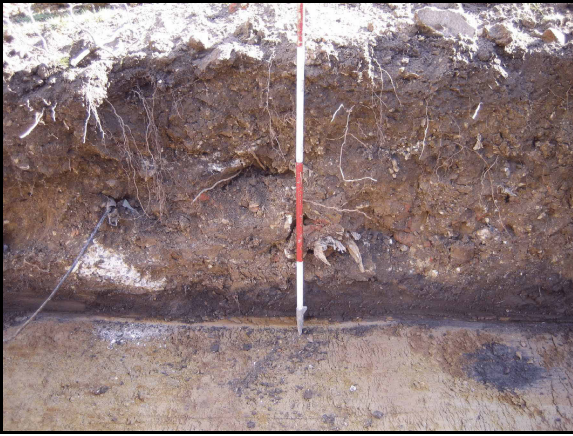
Plate 1 Trench 5: south section

Trench 5 was 15m x 2m and situated in the northern part of the estate, surrounded on three sides by blocks of flats. It was excavated immediately to the south of a children's playground, being aligned west to east. The playground area was in a depression, with part of the trench area sloping down to the level of the playground. The first context was a friable, orangish to dark brown clayey silt [024](west: 19.47m aOD to east: 18.68m aOD), containing 10-15% medium to large bricks and occasional large fragments of concrete. It covered the trench to a depth of between 0.65m to 1.20m.

Below 024, in the western part of the trench was what looked like an old 19th century garden type soil, a friable to soft, very dark brown clayey silt [025](west: 18.27m aOD to east: 18.13m aOD), containing moderate small to medium flint pebbles, fragments of 19th century pottery and clay pipe stems. At the western end of the trench, the context was 0.51m deep, reducing to almost nothing in the central part of the trench. The eastern part of the context having been truncated during the development of the 1960's council flats.

The natural sand lay beneath both contexts **024** and **025** and was a loose, olive to orangish brown medium sand, containing 20-30% fine to large flint pebbles (west: 17.75m aOD to east: 18.06m aOD).

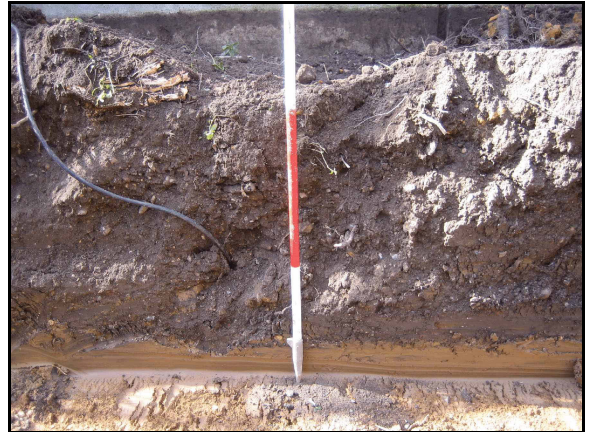
Plate 2 Trench 6: west section

Trench 6 was 15m x 2m and excavated in the gardens of the ground floor flats in block 554 to 576 and was aligned north to south. The first context was a friable, medium to dark brown clayey silt [**027**](north: 19.11m aOD to south: 19.03m aOD), containing occasional medium to large bricks and fragments of concrete. It covered the trench to a depth of between 0.98m to 1.17m.

The natural sand lay beneath both context **027** and was a friable, olive to orangish brown medium sand, containing 20-30% fine to large flint pebbles (north: 17.94m aOD to south: 18.05m aOD).

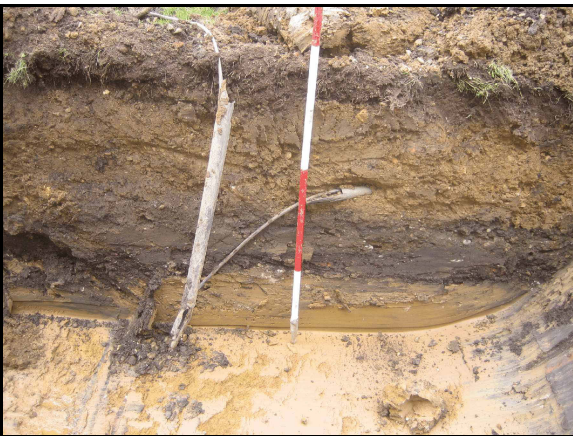
Plate 3 Trench 7: south section

Trench 7 was 15m x 2m and was the northerly of the five trenches and was in an area bounded on one side by Prebend Street. It was excavated immediately to the south of a children's playground, being aligned west to east. The first context was a made ground deposit, probably laid down during the landscaping of the area. It was a friable, orangish brown silty sand [**029**](west: 19.33m aOD to east: 19.49m aOD), containing 20-30% small to large flint pebbles. It covered the trench to a depth of between 0.89m to 0.99m.

A further deposit of made ground lay below **029**. It was a very soft, dark brown to black silty clay [**030**](west: 18.54m aOD to east: 18.50m aOD), containing frequent small to large flint pebbles and medium to large brick fragments. All of the brick in context **030** were of 19th century date which probably came from the demolished 19th century houses that once occupied the southern side of Prebend Street. It covered the trench to a depth of between 0.89m to 0.99m.

Below the made ground was the natural sand and gravel, a loose, light orangish brown silty coarse sand, containing 30-40% very fine to large flint pebbles [**031**](south 18.10m aOD to north: 17.89m aOD).
