Evaluation Report

1177-79 Newham Way

East Ham, London, E6

J G PERRY: May 2005

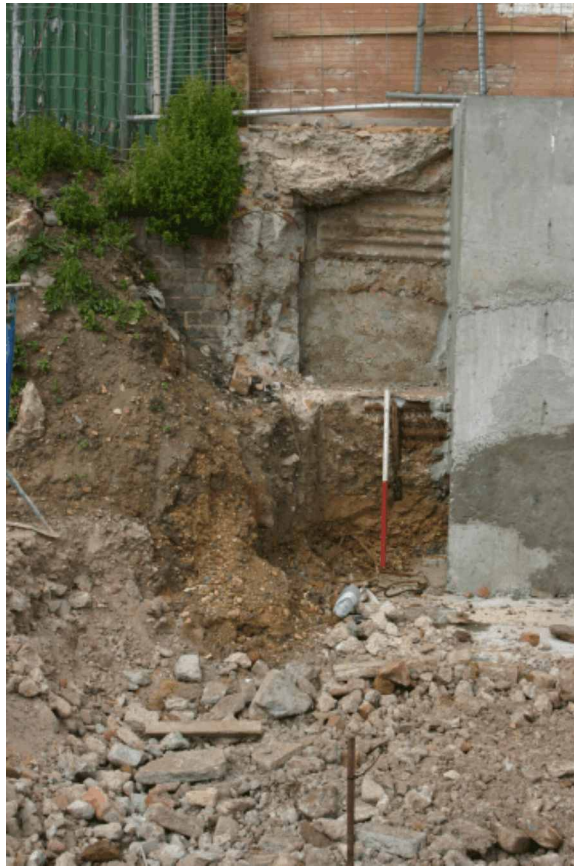
Plate 1 Truncated deposits
at the rear of the site

The area of trench 1, and probably the whole site, had been truncated by about 2m when the previous garage was constructed. An examination of the bank (plate 1) to the rear gardens of the houses fronting onto Roman Way, showed that about 50cm of the natural had been removed in this process.

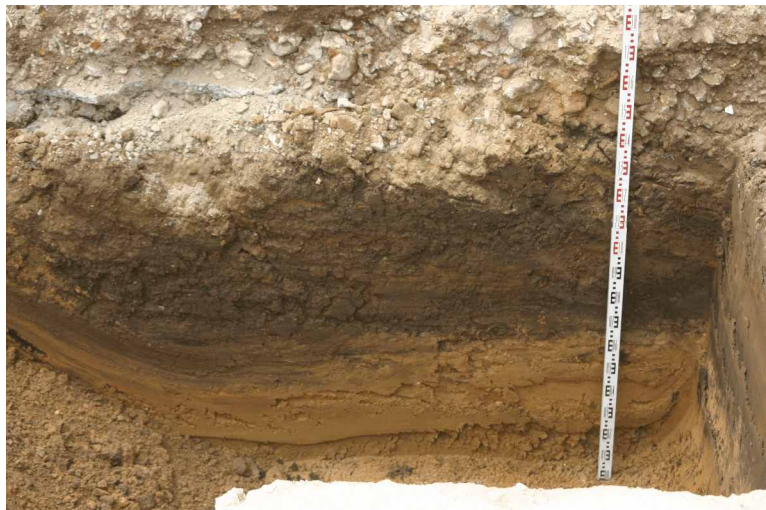
Plate 2 Trench 2: part of the west section

Trench 2 was in the western part of the site and oriented north to south. Because of the restricted area in which the excavator had to manoeuvre, the trench was excavated in two halves. The northern part was excavated first and then back filled, before the southern part was excavated and later backfilled. Using this method, a small area in the centre of the trench could not be fully examined.

In trench 2 were the remains of a gravel terrace to the river Thames. Abutting the terrace was an alluvial deposit probably laid down by the Thames over a considerable period of time. This most likely represents a marshy area along the margins of the Thames 2½km to the south. Several archaeological excavations on the other side of the A13, Newham Way, revealed waterlogged Bronze Age track ways across this marshy area. The alluvial deposit in trench 2 was extremely dry with no trace of any track way or Prehistoric finds. We recovered pottery dating from the 19th century at the top of the deposit, close to its interface with context **004** above.
