# MORWELLHAM QUAY HIGHWAYS WORKS, GULWORTHY, DEVON

Results of historic building recording and archaeological  
monitoring and recording

Historic England Scheduled Monument Consent reference:  
S00241283 (conditions g-i)

Report No: ACD2117/3/0

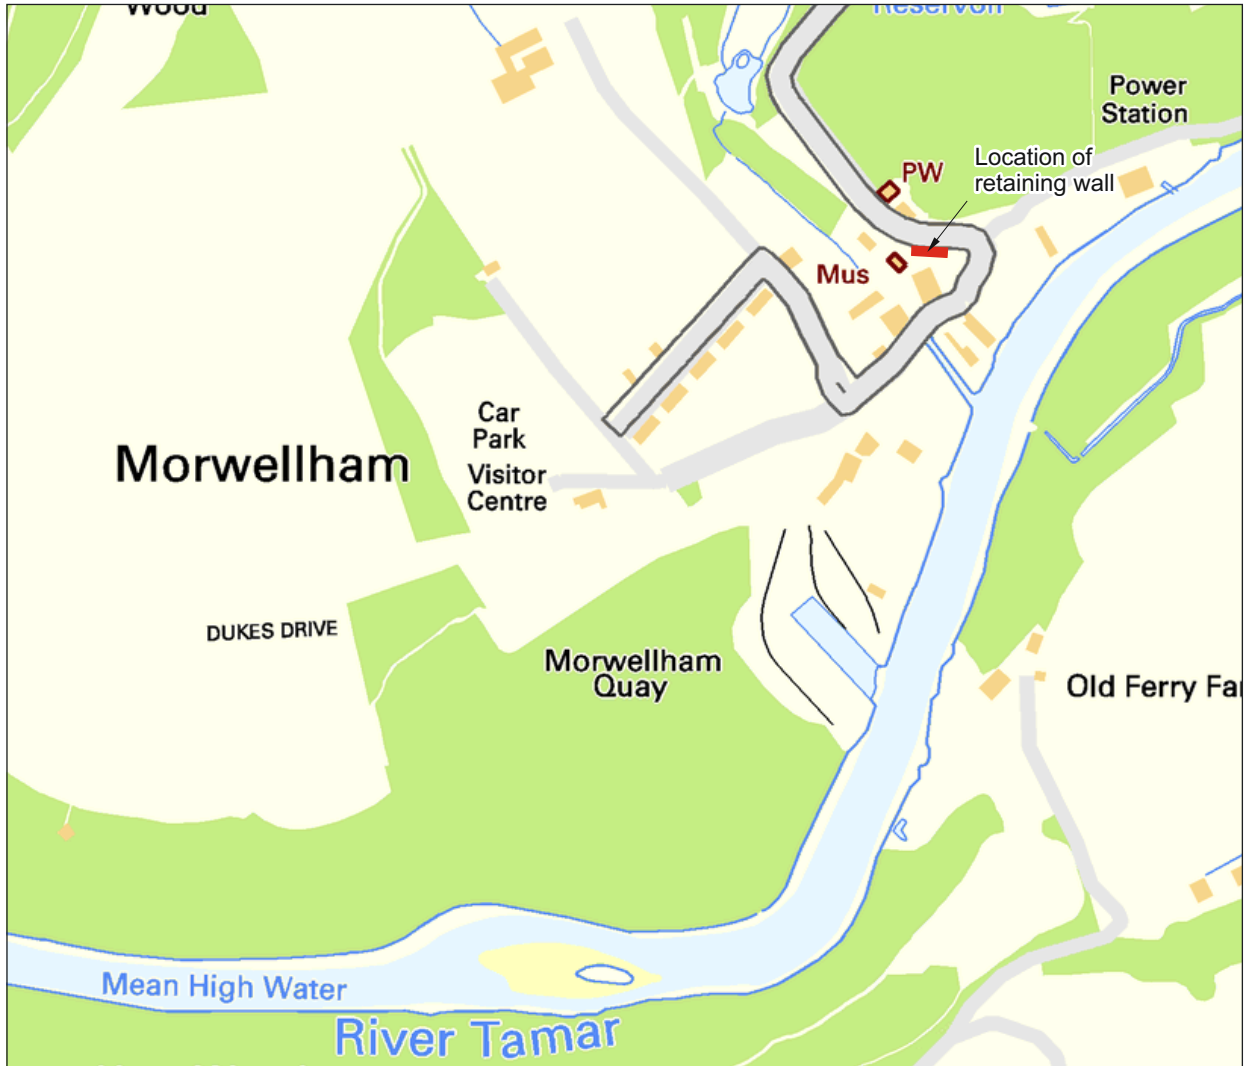
Fig. 2: Plan of monitored works

### 6.7 **Retaining wall repair groundworks** (Fig. 2; Plate 1)

Following the initial monitoring of geotechnical investigations, the groundworks for the retaining wall repairs comprised the excavation of five footings trenches. These were approximately 2m long and 1m wide for four new buttresses, and a trench measuring 4m by 1.5m for a set of new steps. The trenches were excavated in the grass-covered plot to the south of the highway retaining wall.

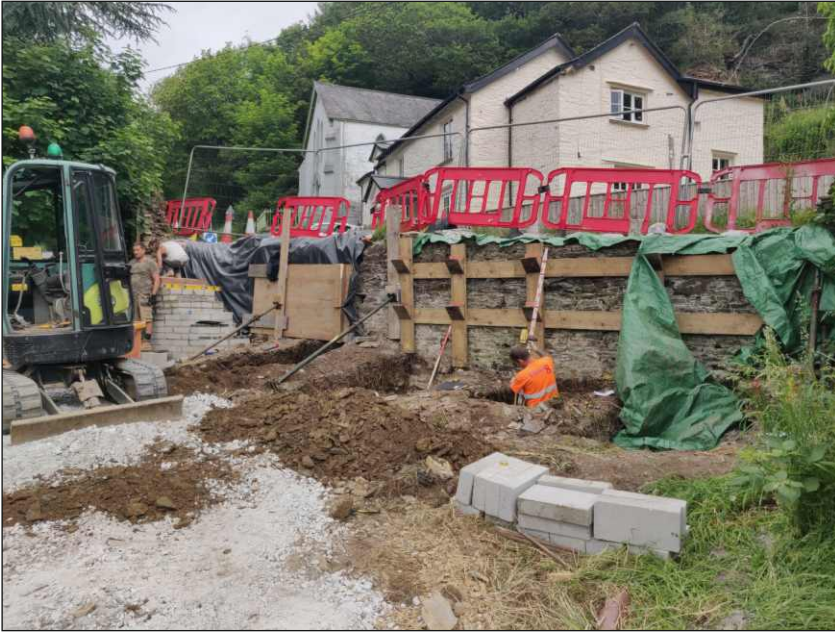
Plate 1: General working view during construction groundworks. Looking north

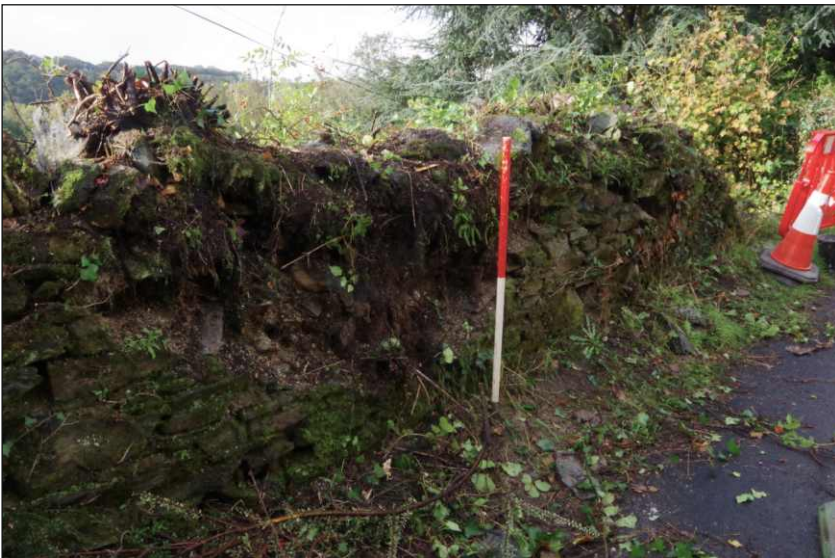
- 5.1 The faces of the retaining wall are constructed of rubble local slates, laid in rough courses and bonded with an off-white lime mortar (Plate 2). The parapet has been topped with stones set on their ends creating a rough crenulation, but only a few remain *in situ*; others have moved but remain on top of the wall with the remainder missing altogether. The wall projects forward slightly of the outbuilding to the east, and at its east end it returns at an angle to meet the corner of the structure. The two lengths of masonry are not structurally connected. This short return was retained as part of the works. During the dismantling of the wall, it was observed that the structure contained a rubble core, and both this and the facework on the north, highway elevation, had been damaged by deep root penetration. Much of the stonework was very loose, and a section of the facework on the north elevation had collapsed exposing the core. On the south face there are traces of repointing and remnants of white paint, mainly surviving at the base of the lower revetment section. At the east end at ground level a ceramic drainpipe passes through the wall. This terminates in a brick-lined sump attached to the wall.

- 5.2 No features were visible in the base of the collapsed portion of the parapet wall. The boundary wall to Tamarisk Cottage to the west has a clean face against the position of the collapsed wall, which may represent evidence for a former opening. Alternatively, this may indicate that the boundary wall to Tamarisk Cottage (on its north and east sides) is a continuous feature, and a separate structure from the collapsed retaining wall.

Plate 2: Pre-commencement view of retaining wall parapet showing collapse of the face (left of scale) and surviving capping (right). Looking southwest (scale 1m)

Other than the retaining wall as a probable former structural element (and with some surviving paint on the lower courses), there was no visible evidence for the former buildings recorded on historic maps in this location south of the highway. The wall retained no associated architectural detailing (such as evidence for a roof or divisions) and had probably been at least partially rebuilt with a new parapet after the building went out of use.

In view of the difference in height between the highway and the current field it seems unlikely that the break in the adjacent boundary wall represents an opening; rather this is interpreted as evidence that the collapsed section of retaining wall was structurally distinct from the upstanding boundary of Tamarisk Cottage.

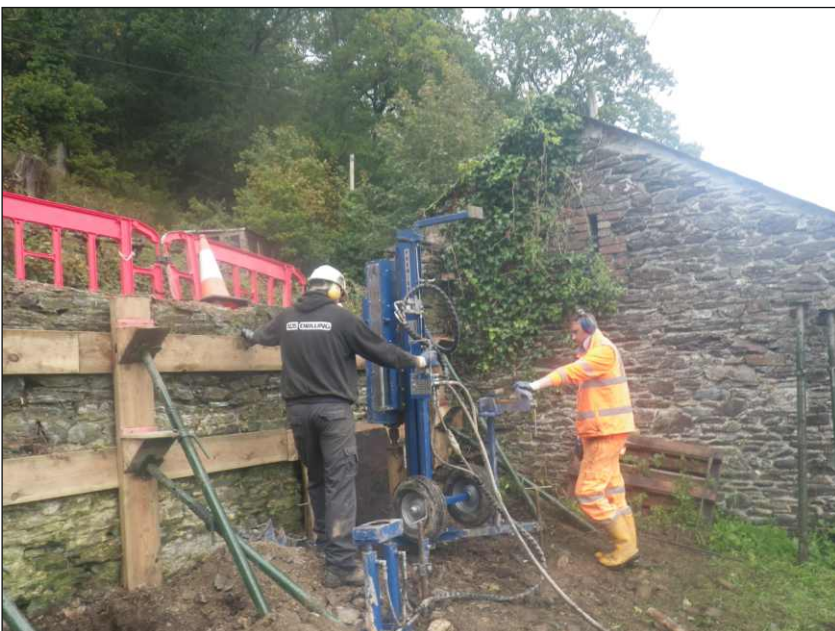
The monitored geotechnical investigations comprised the excavation of a test pit and four window samples. The location of these is shown on Fig. 2.

Plate 3: Working view during geotechnical investigations, looking northeast

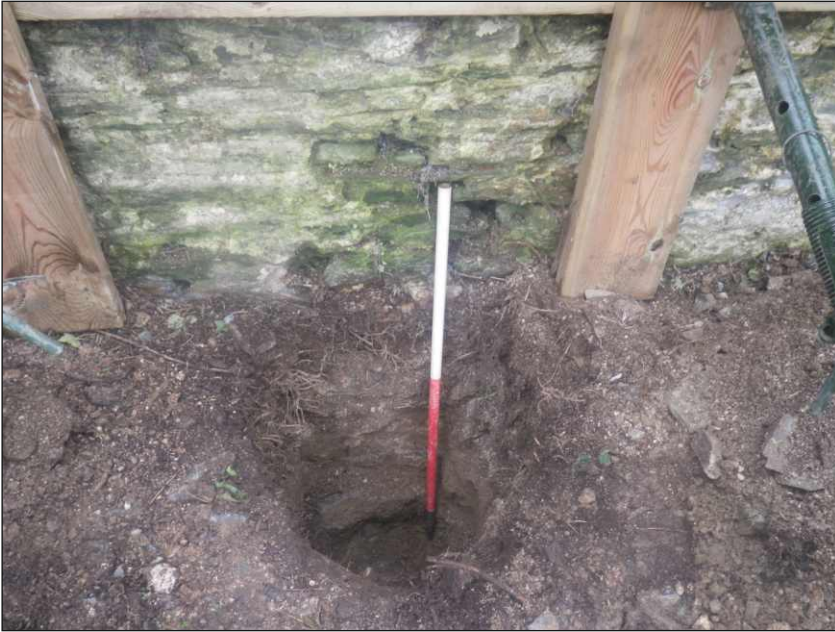
The test pit measured 0.30m wide by 0.40m long and was excavated to a depth of 0.90m below existing levels. The following stratigraphic sequence was exposed:

- 0-0.18m topsoil consisting of mid-brown loamy-sand with rare sub-angular slate inclusions;
- 0.18-0.46m made ground consisting of mid grey-brown loamy-sand with common sub-angular slate and rare brick and very small lime mortar fragments;
- 0.46-0.52m lens of gravel; and
- 0.52m+ slate bedrock.

Plate 4: View of geotechnical test pit with the retaining wall to the rear. Looking northeast (scale 1m)

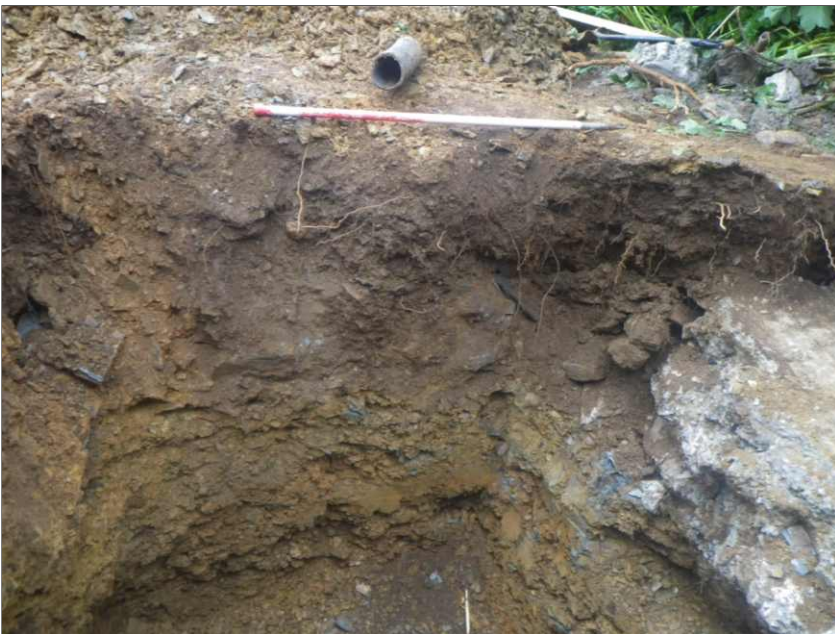
Pit F102 was partially exposed in the footings trench excavated for the new set of steps. The pit measured 2.26m across by 0.91m deep with steeply sloping sides and a flattish base. It contained a single fill (103) composed of mid yellowish brown silty clay, from which four pieces of iron were recovered.

- 7.1 Four iron bars were recovered from context 103, fill of pit F102. One bar appears to be complete at a length of 800mm. It has a flattened rectangular cross-section, c. 32mm by 12mm, along most of its length. At each end the bar narrows and the cross-section becomes circular, at one end for a length of c. 40mm and the other end, for c. 75mm. Two of the other bars are similar but slightly shorter at 730mm and 750mm, apparently because one of the narrowed ends is missing. The fourth bar has the same cross-section but is a broken fragment with a length of 360mm. The bars are perhaps iron railing components. They are made from cast iron and are therefore very likely to be of 18th or 19th century date.

Plate 5: Pit F102, view to southeast (scale 1m)

The groundworks exposed two features within the five excavated trenches. Pit F102, which was partially exposed in the trench excavated for the new steps, had an uncertain function. Nevertheless, based on the sections of recovered 18th to 19th century iron bar, it is likely to be broadly contemporary with the historic use of the quay and may simply have been a rubbish pit.

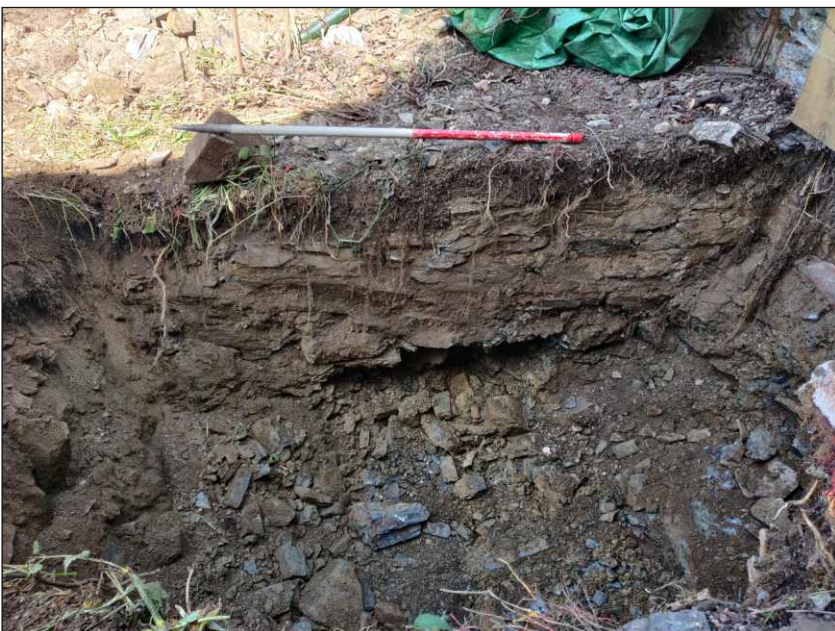
Wall S105 was exposed in the sections of two of the buttress footings trenches. The wall, which extended perpendicular to the highway retaining wall between the two footings trenches, measured 1.2m wide and was constructed on the natural subsoil to a height of 0.57m. It was constructed of six courses of lime mortar bonded unfaced slate blocks and rubble. It appeared to be keyed into the retaining wall with the highway and shared a consistent construction style. No associated surfaces were exposed.

Plate 6: Wall S105, view to northwest (scale 1m)

Wall F105 may represent an element of the previous building range that is represented on the Ordnance Survey 25-inch maps of 1885 and 1906 or earlier buildings identified in Cynthia Gaskell-Brown's 1977 survey. Although no evidence for it as a scar in the retaining wall above was visible, as it was keyed into the lower courses of the retaining wall, it is likely that it was contemporary at least with this portion.
