**Tow Law Auction Mart,  
Tow Law, County Durham**

**archaeological recording, July 2005**

**Report 1326**  
August 2005

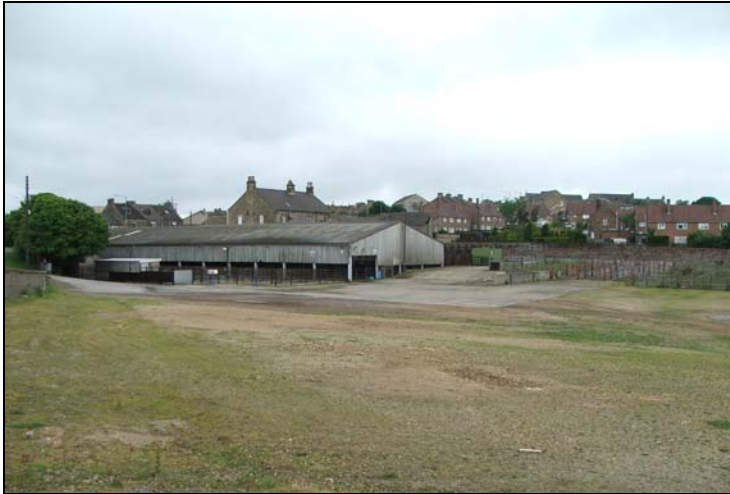
**Figure 4**  
General view of the mart, showing open parking areas, pens and sheds. The pub is visible above the recent portal-frame sheds: looking NW

- 3.2 The site lies in a shallow depression, at the head of the valley of the river Deerness (Figure 4). This runs eastwards away from the town; to the south is Church Lane, which lies alongside the line of the railway that once served the ironworks and the coke ovens. At the time of the survey, the mart was still in use for the sale of livestock; the public house and the other buildings were empty and disused. A little under half of the site is open ground used for parking; this lies at the east and south. The buildings are at the west end of the site, on the High Street. The central part of the site is surfaced with concrete, and covered with steel pens for cattle and sheep, a system of raceways and gates, and a cattle crush. At the north-east corner of the site is a small area of rough pasture.

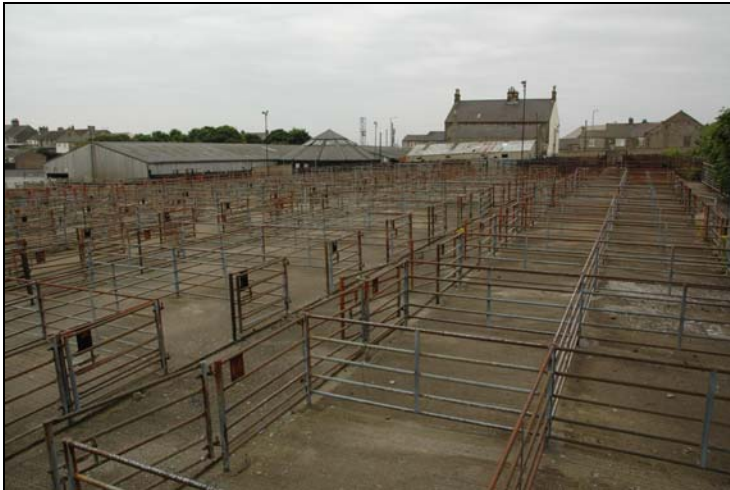
**Figure 5**  
View of the buildings from the east end of the sheep pens: W

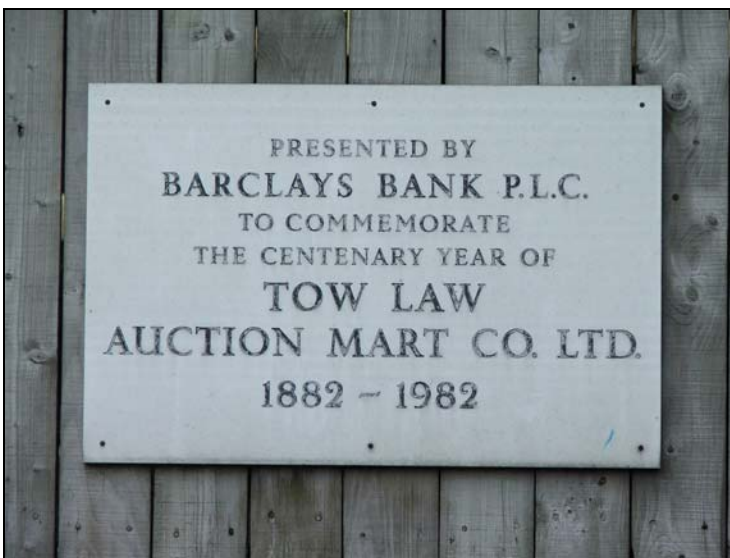
**Figure 6**  
Plaque on the north wall of the large southern shed, beside the ring: S

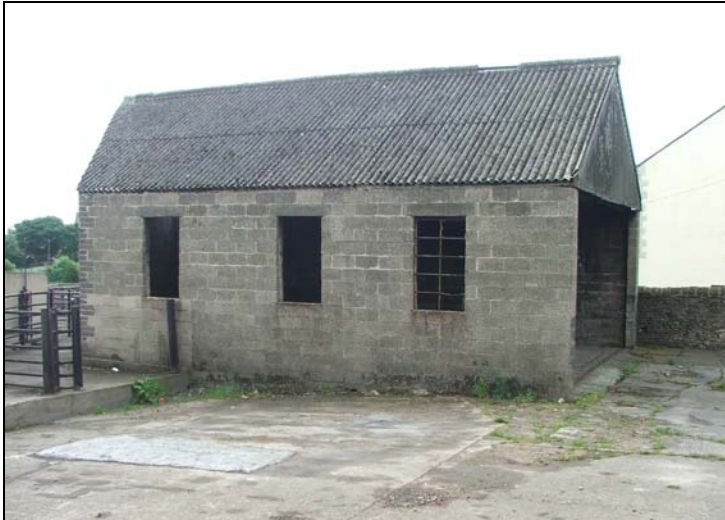
**Figure 7**  
Former coal depot  
building at the north end  
of the site: S

- 3.3 At the northern end of the site is a large open-fronted shed formerly used as a coal depot (Figure 7). It is built of concrete blocks and has a steep-pitched roof of corrugated asbestos cement sheets. The Cattle Mart pub lies at a lower level immediately south of this, and behind it is a stone storage building (Figures 8, 9 & 10). It was formerly attached to a longer building on its east face, now reduced to a low cement-rendered shed that has been used for storage and for public lavatories (Figure 10). The old building was inaccessible, so its interior has only been inspected from outside. The retaining wall between the pub and the old coal depot is all that remains of a long structure first shown on the second edition Ordnance Survey map. This is assumed to have been a storage or service building. The auction ring lies south-east of the pub (Figures 18 & 19); it is flanked on the west and south by recently-erected portal-frame sheds filled with steel cattle pens. In the north-west corner of the western shed is a small corrugated iron pay office (Figure 27).

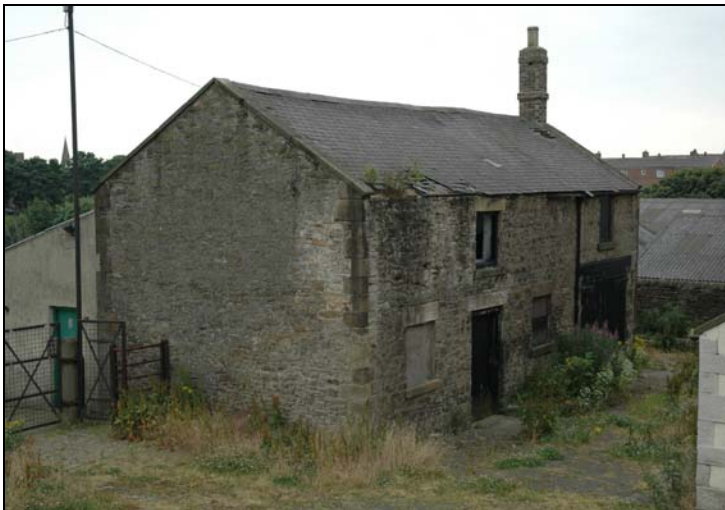
**Figure 8**  
Store and stable / garage  
building at the rear of  
the pub: SE

- 4.6 The smaller building at the rear is built of sandstone rubble, with dressed stone in the quoins, sills and lintels (Figure 8). The low-pitched roof is slated and there is a tall brick chimney in the south gable. There are no openings in the north, east and south walls; however, as the majority of the east wall is covered by a later concrete shed, some features may be hidden from view. The building has four bays. At the north there is a three-bay room on the ground floor that may have been used as a stable; it has a central door and two windows. The room above this has a single central window. The fourth bay, at the south end of the building, has a large vehicle door with a softwood lintel; there is a central window above.

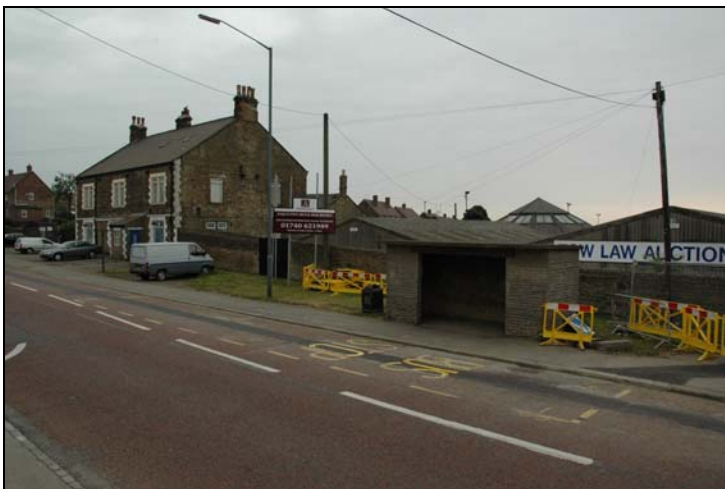
**Figure 9**  
Pub, sheds and the roof  
of the auction ring, seen  
from the opposite side  
of the High Street: NE

- 4.1 The Cattle Mart, formerly known as the Cattle Mart Hotel, is a large building of two storeys, typical both of its period and location (Figures 9-11). It is built of coursed sandstone with projecting quoins; the north and east walls are rendered, and the roof is slated. Some external additions can be seen at the rear. The building has been altered internally in recent years but the old plan can be detected from surviving sections of internal walls. A sketch plan and section of the building is shown in Figure 2. Originally the building had a flat façade of three bays; the door was placed off-centre, and had a broad chamfered opening which is now hidden by a later porch (Figure 12). The windows have slightly-projecting quoins and lintels, which are painted white. The ground-floor windows have been widened, and the masonry between them shows the effect of this change.

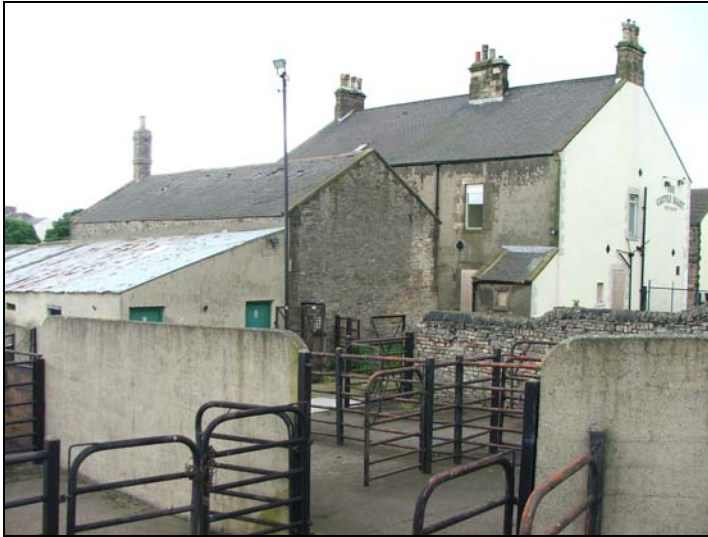
**Figure 10**  
Pub, store building and  
sheds seen from the  
northern pens: SW

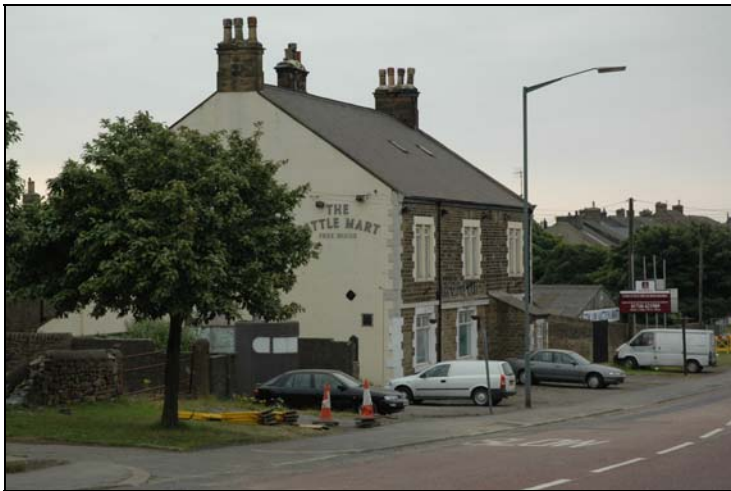
**Figure 11**  
The Cattle Mart pub:  
SE

- 4.2 On the ground floor the front rooms have been joined to form a single large bar (Figure 13); this was formerly three separate rooms and a passage (Figure 14) running through to the staircase and the rear of the building. There are two large parlour dining or bar rooms at the rear, and the kitchen (Figure 15) stands at the middle of the north end. These rooms are served by chimney stacks in the gable walls and near the middle of the central bay. A scullery and a projecting porch lie at the north-east corner; the main passage also extends into a rear porch. Relatively recent additions on either side of the passage and porch house the lavatories (Figure 11).

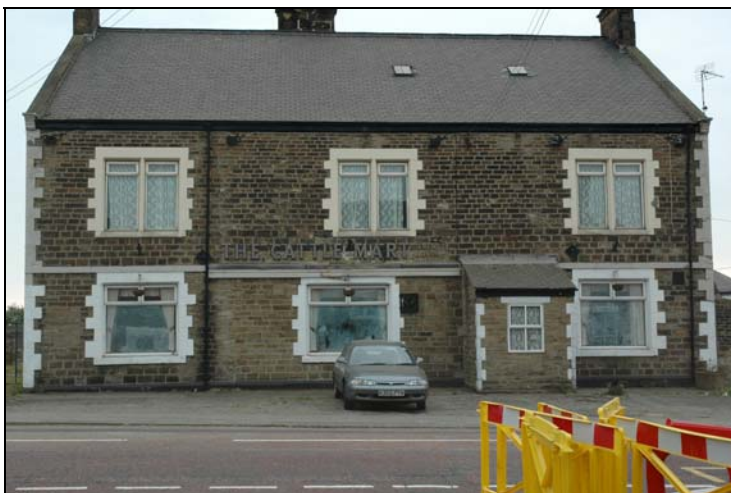
**Figure 12**  
The front of the pub.  
Alterations to the  
ground floor windows  
are apparent left of the  
later porch: E

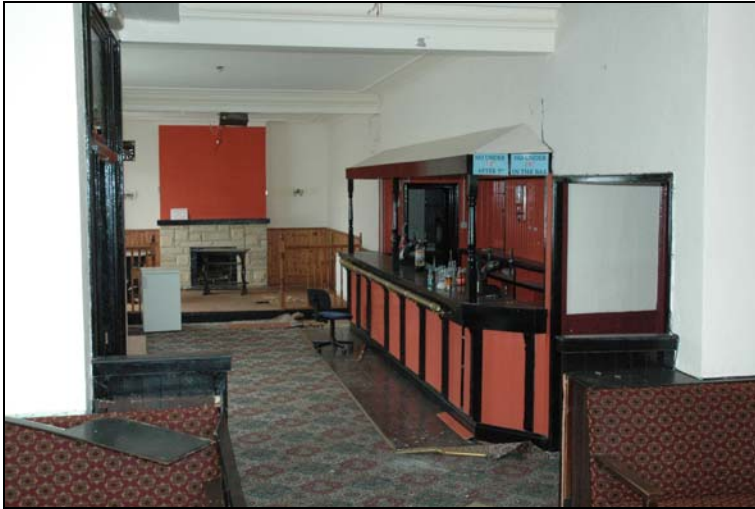
**Figure 13**  
View along the bar.  
Former wall lines are  
visible as boxed-in  
joists on the ceiling:  
N

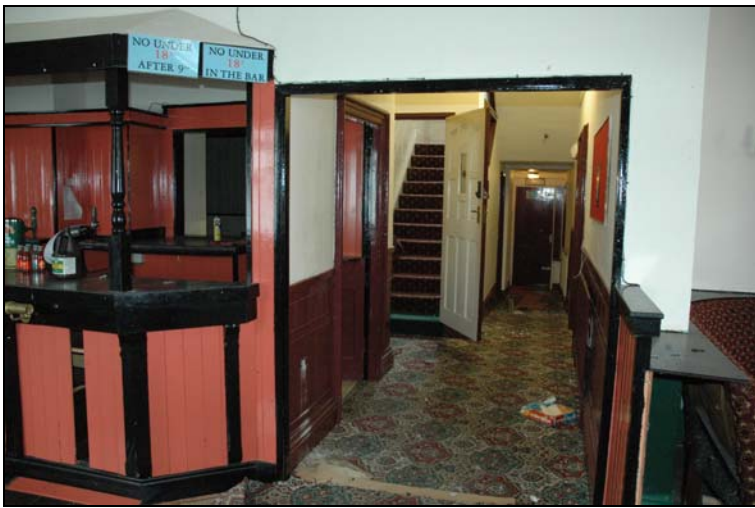
**Figure 14**  
The passage, looking  
towards the staircase  
and the lavatories: E

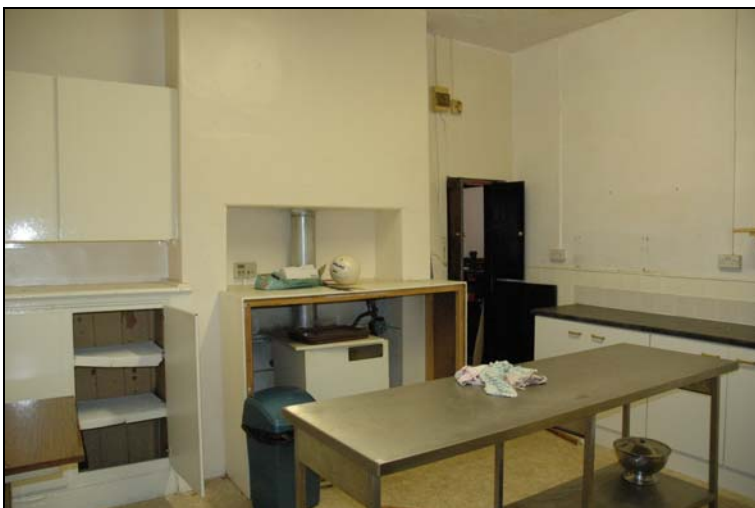
**Figure 15**  
The kitchen, showing  
the large fireplace in  
the S wall: SW

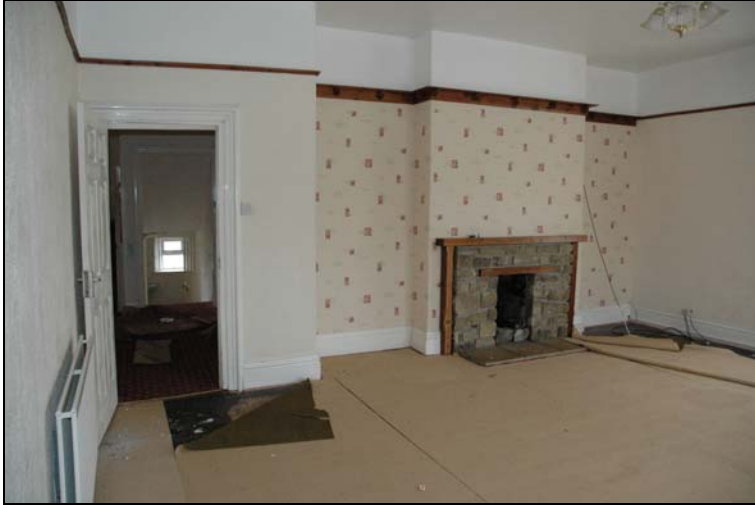
**Figure 16**  
First-floor sitting room at the south-west corner of the building: SE

the front of the building, and has a hatch at the front. Above, the stairs rise to a half-landing that serves a mezzanine-level lavatory above the back porch. On the first floor there were formerly three bedrooms at the front and three at the rear; these have been subdivided to provide a larger bathroom at the north end of the central corridor, and a box-room in the middle front room. All of the bedrooms are large; the biggest, at the south-west corner, was most recently the sitting room of the manager's flat (Figure 16).

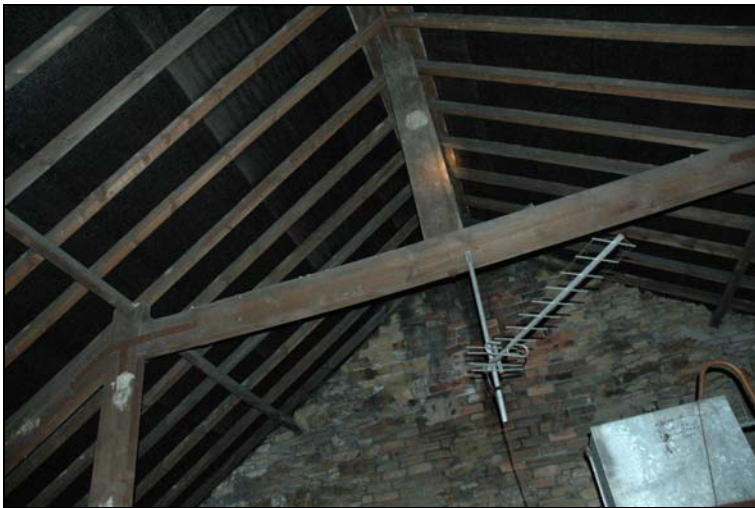
**Figure 17**  
The roof truss near the north end of the building. The truncated principal rafters, queen posts and collar beam are connected by iron straps: N

- 4.4 The attic contained two small bedrooms lit by skylights, with two cupboards at the south-east side. An opening in the north wall of the largest room allowed a view of the roof truss, which is shown in Figure 17. It has a pair of queen posts supporting a collar and truncated principal rafters that carry two purlins; a third is notched into the top of the queen-posts, and the lighter ridge-piece is carried on a slender post rising from the collar. The trusses are softwood, and the individual timbers are connected with iron bolts and straps; the roof is boarded and covered with slate.

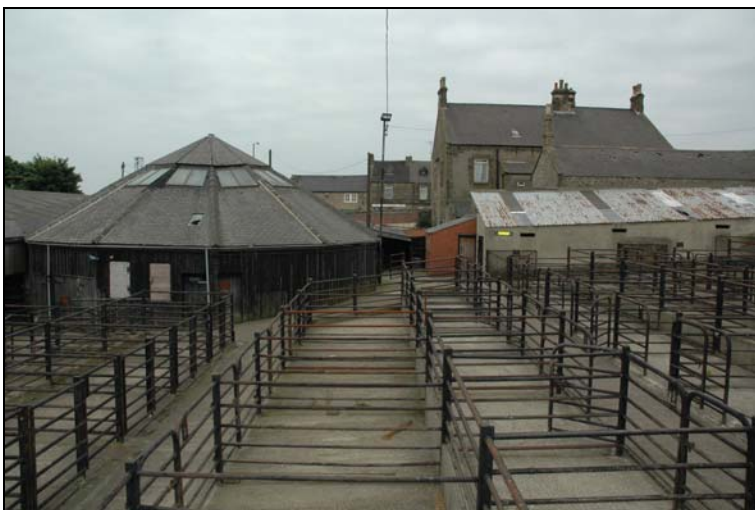
**Figure 18**  
The auction ring, with the pub and other buildings behind: W

- 5.1 The sale ring, which is the central feature of the mart, is a 12-sided wooden building with a conical slate roof (Figures 18 & 19). It is lit by a ring of large skylights; a number of small windows in the walls having all been closed up (Figure 20). The west side of the building is now overlapped by the westernmost portal-frame shed, to provide sheltered access to the sale ring from the covered yards to the west and south (Figure 21). This side houses the steel weighbridge (Figure 22) with internal and external doors, secured by a steel sliding door in the shed. The inner door gives access to the concrete-floored ring, which is surrounded by twelve trimmed roundwood posts that support the roof (Figure 23). Outside these there are three tiers of green-painted wooden benches, separated from the ring by a wood and steel fence (Figures 24 & 26). A fourth row of benches is fixed to the inside of the fence on the north and south sides of the ring.

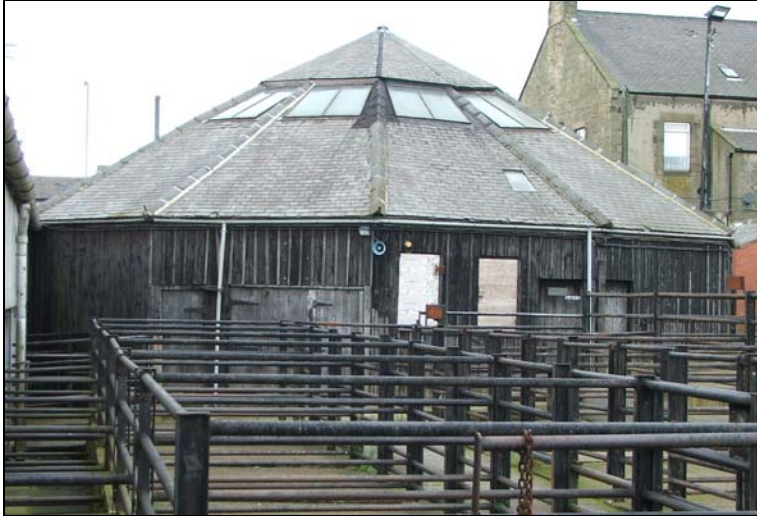
**Figure 19**  
The auction ring,  
showing the doors  
for buyers (right)  
and auctioneers: W

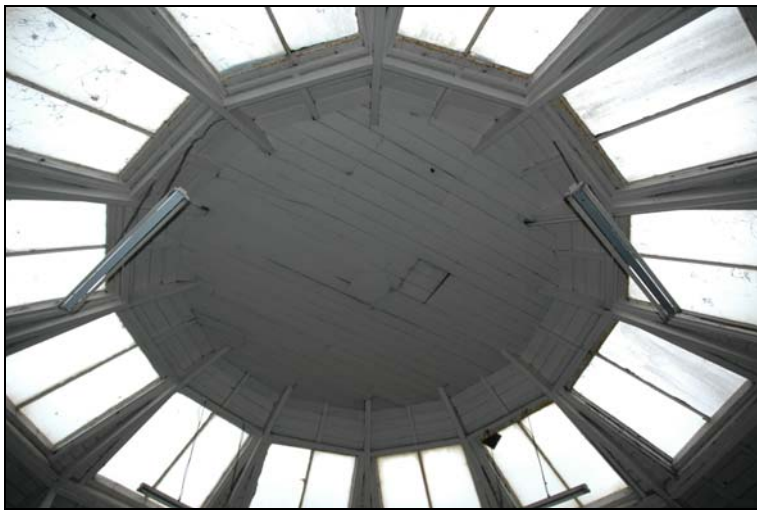
**Figure 20**  
View of the roof of  
the ring

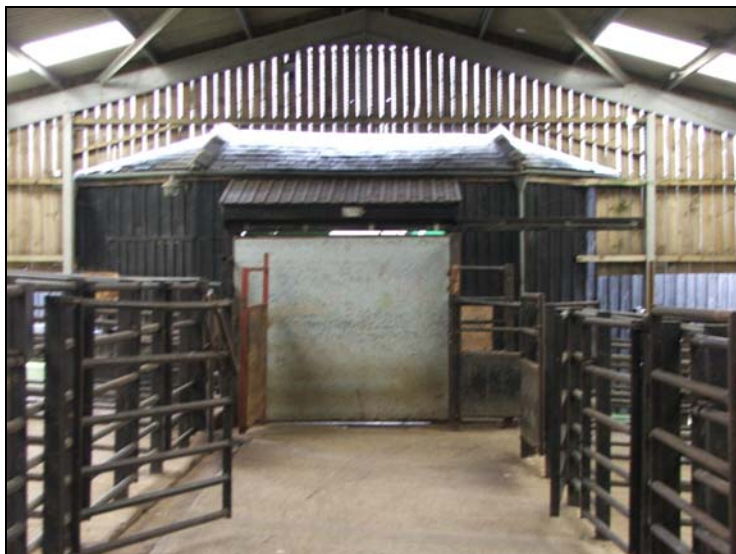
**Figure 21**  
The west side of the  
ring, inside a recent  
shed. The steel door  
covers the end of the  
weighbridge: E

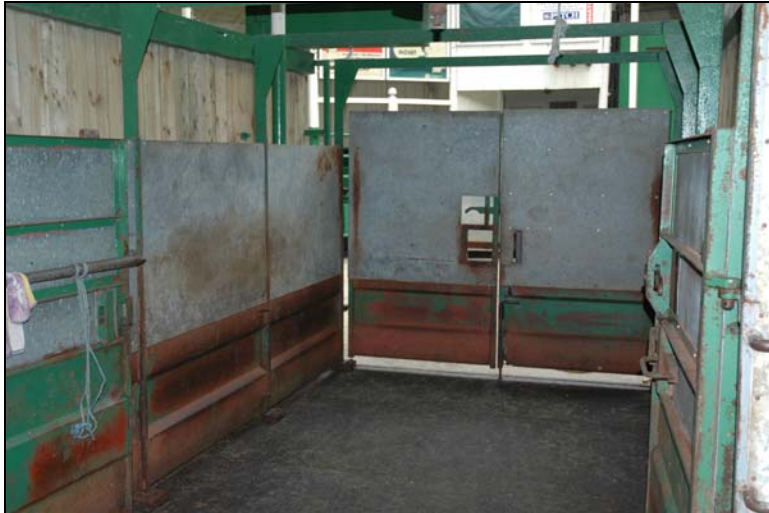
**Figure 22**  
Interior of the weighbridge, seen from the pens: W

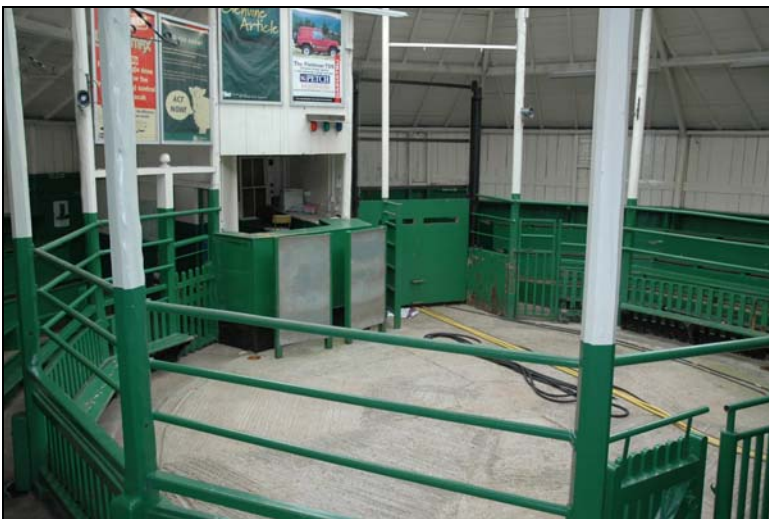
**Figure 23**  
The auction ring, showing the auctioneer's box and the exit gate: SE

- 5.2 At the opposite side of the ring from the weighbridge is the auctioneer's box (Figure 23). This has a raised floor and a wooden counter, with a sliding door to an entrance passage on the north side (Figure 25). Three metal screens on the floor in front of the box provide refuges for the auctioneer's assistants; inside the box are connections and controls for lights and the public address system. The marks of the auctioneer's hammer are clearly visible on the counter at the north-west corner.

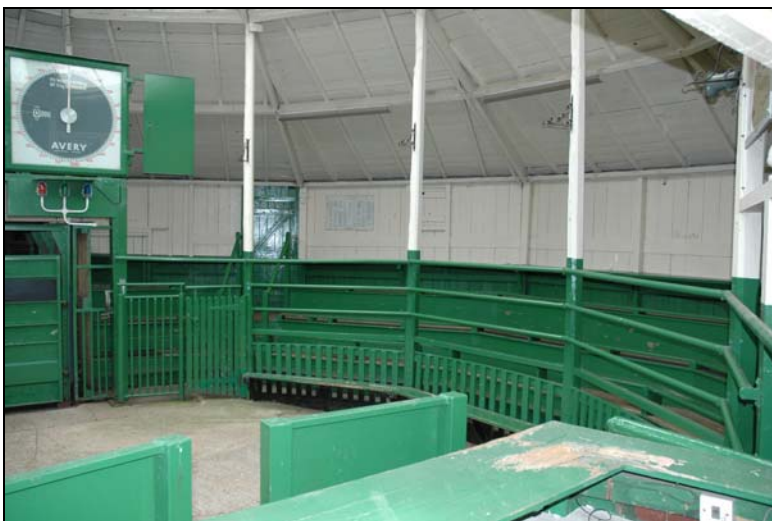
**Figure 24**  
Seating on the north side of the ring: NW

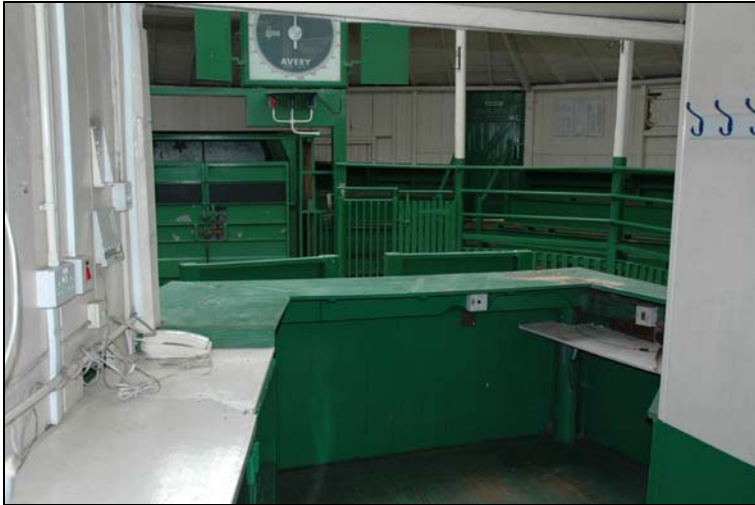
**Figure 25**  
View of the ring from  
the back of the  
auctioneer's box: W

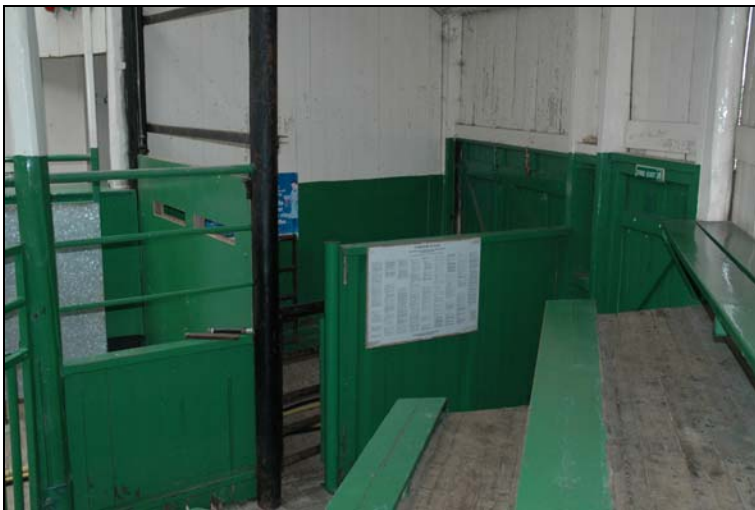
**Figure 26**  
The exit from the  
ring to the raceways.  
The sliding door with  
the viewing slits  
slides vertically in  
the black frame: N

- 5.3 Immediately south of the box is the exit door, which runs vertically in a steel frame (Figure 26). This has slits to allow the operator to see the animals in the ring before opening the shutter. At the back, wooden doors allow access to the outdoor pens and the crush, east of the ring.

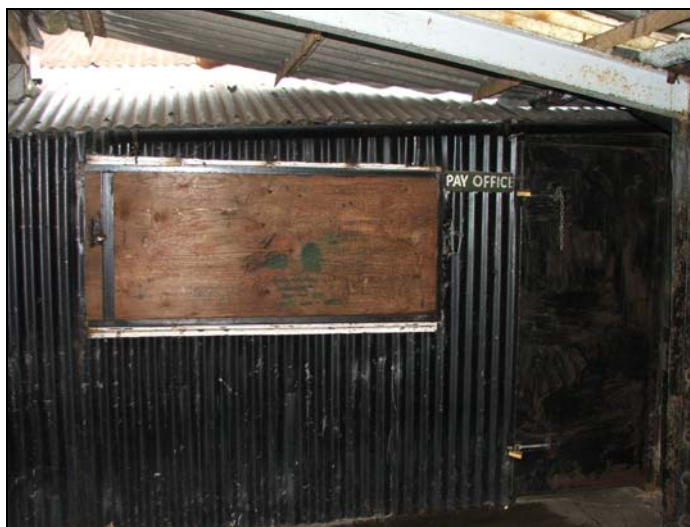
**Figure 27**  
The pay office at the  
north-west corner of  
the pens west of the  
ring: W

- 5.4 The last component of the group is the pay office, housed in a small black-painted corrugated iron shed at the north-west corner of the pens on the west of the ring. This is windowless, and was inaccessible when the site was surveyed.
