**Coronation Street, South Shields,  
Tyne and Wear**

**archaeological evaluation**

**Report 1396**

February 2006

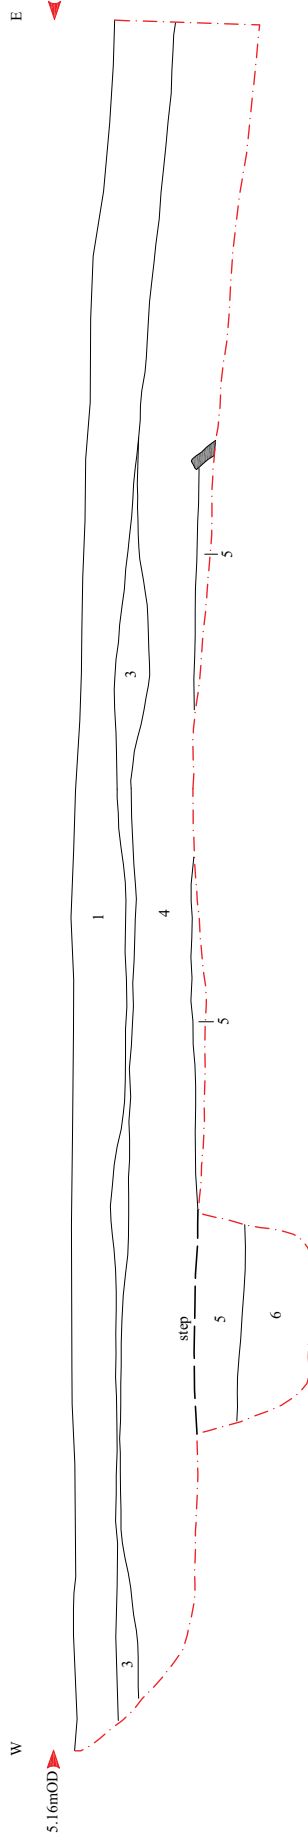
### Section 1, Trench 1

- 5.3 Grey silty clay [6] was reached at a depth of 1.8m bgl. This contained disarticulated human bone and fragments of grave furniture. Above this was a 0.46m deep layer of re-deposited grey silty sand [5] containing disarticulated human bone (see Section 7 below). Immediately above this, at a depth of 1.1m bgl, was made ground consisting of a deposit of grey silty sand [4] measuring 0.7m deep, containing brick rubble and mortar. Above this was a 0.2m layer of red crushed brick [3]. A 0.9m-thick layer of yellow gravel [2] was identified at the southwest corner of the trench at a depth of 0.4m bgl. This is probably bunding from the construction of the nearby sewage pumping station (Figure 5). Immediately above this layer and the crushed brick [3] was a 0.4m-deep layer of topsoil [1]. No archaeological features were identified in this trench; however a number of unstratified gravestone fragments were recovered (Figure 6).

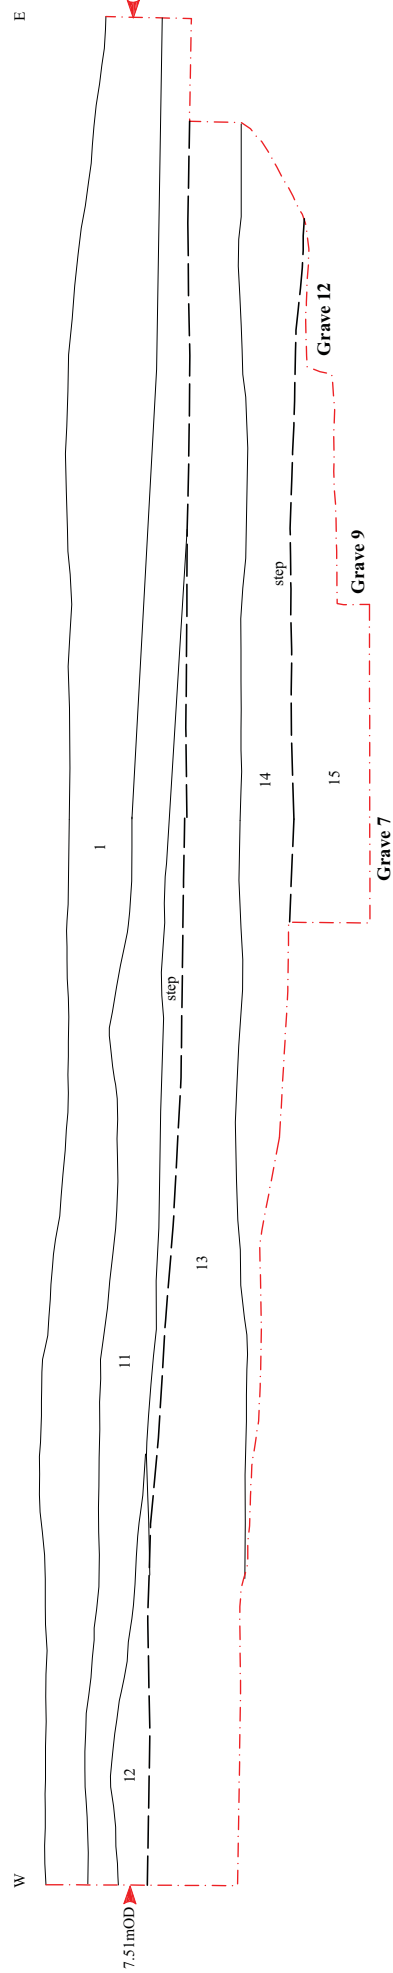
### Section 2, Trench 3

- 5.7 Natural subsoil consisting of a lens of orange-yellow sand [46] was revealed at a depth of 2m bgl (6m OD) at the centre of the trench. Above the natural was a 0.4m depth of grey silty sand [15] containing disarticulated human bone, glass, metal and pottery. Fourteen rectangular graves cut this layer; all were aligned approximately east-west. The graves were cleaned and recorded by hand but were not excavated. Articulated skeletons were identified in four of the graves. The human remains were in a good state of preservation. Although no coffins could be identified, a number of nails were recovered (see Section 6.16 below).

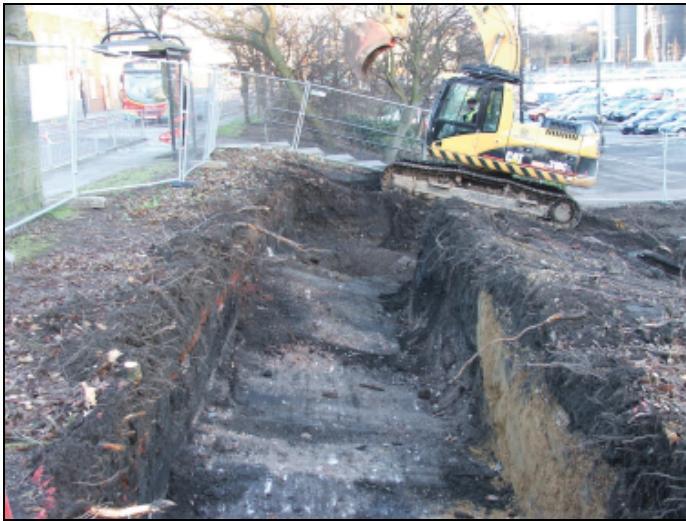
**Figure 5**  
Made ground in Trench 1  
(looking east)

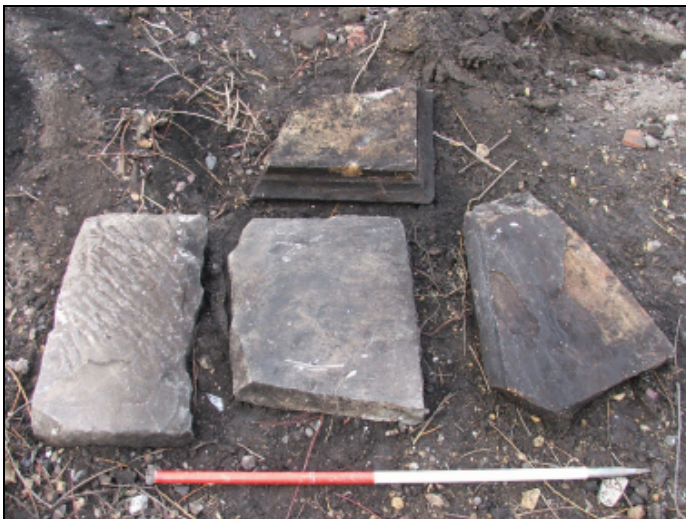
- 6.23 One tombstone was recovered from Trench 1 in three separate pieces. This was a 0.1m thick slab with a bevelled upper edge. It was made of fine quality yellow sandstone which exhibited significant blackening from pollution on its upper surface. The bases of four broken headstones were recovered, three of which had tooled panels at the bottom which would have been buried in the earth to give stability. One headstone top was retrieved from Trench 3 in three pieces, with an upper chamfered edge. None of the stones bore inscriptions.

- 6.24 The condition of the stones suggests that they had been deliberately discarded, probably when the graveyard was cleared of monuments. It is significant that none of the stones were inscribed and that mainly bases were recovered.

**Figure 6**  
Gravestone fragments  
recovered from Trench 1

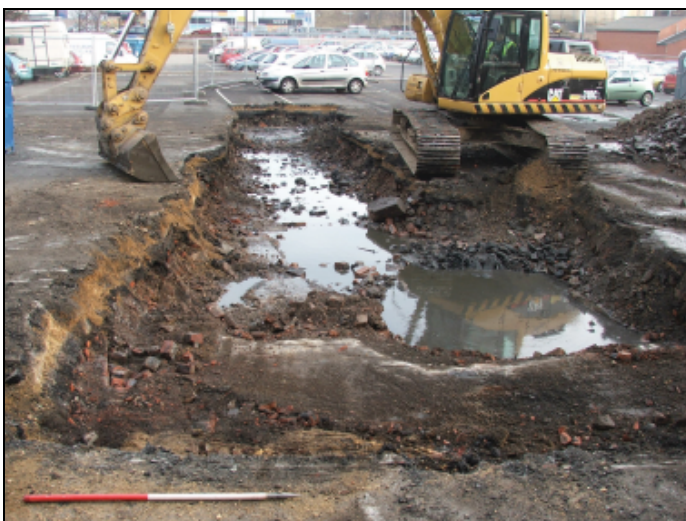
- 5.5 The concrete foundations [9] of a substantial structure were encountered at a depth of 0.7m bgl. These consisted of two rows of concrete slabs with fixed steel girders, running northeast to southwest across the trench. A concrete surface [10] was encountered at a depth of 0.45m bgl at the western end of Trench 2 (Figure 7). Immediately above and between these foundations was a loose deposit of brick rubble [8] of unknown depth, above which was a 0.25m depth of tarmac [7] forming the surface of the car park. No archaeological deposits or finds were found in this trench.

- 5.14 The deposits in Trench 2 were consistent with the foundations of a large industrial structure, probably connected to the gas works. Ground conditions meant it was not possible to determine whether earlier deposits survived beneath these foundations.

**Figure 7**  
Concrete foundations in  
Trench 2 (looking east)

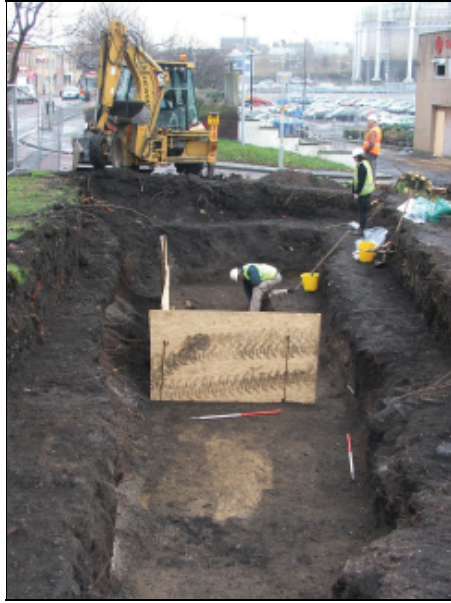
- 5.6 This trench was 18m long, 4m wide at the west end and 7m wide at the east end, with stepped sides (Figure 8). The trench was excavated to a depth of 3m bgl at the eastern end. Trench 3 was situated at the northwest corner of the proposed development area, 40m to the west of Trench 1.

**Figure 8**  
Working shot of Trench 3,  
looking east towards the  
sewage pumping station

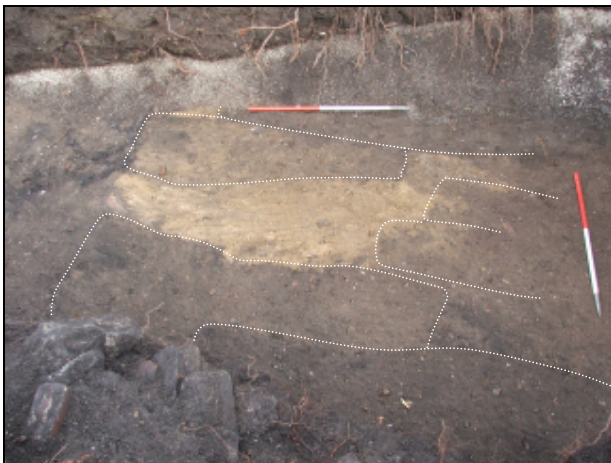
been truncated on the north side by a modern service pipe trench [F16] of unknown depth, which ran along the northern edge of Trench 3 (Figure 9). Grave 3 [F25] was 0.5m south of Grave 1 and measured 1.7m by 0.6m. This was filled with brown silty sand [24] and cut on the southeast corner by Grave 4 [F23]. Grave 4 measured 1.9m by 0.5m and ran into the southern baulk of Trench 3. It was also filled with brown silty sand [22]. Grave 5 [F29] was at the centre of the trench and measured 1.5m by 0.6m. The eastern end of this grave was not visible, as the grave fill [28] was indistinguishable from the surrounding material [15]. Grave 6 [F27] measured 1.2m by 0.5m and cut the north side of Grave 5. Like Grave 5, the eastern end of this grave could not be identified as the grave fill [26] was indistinguishable from the surrounding material.

**Figure 9**  
Grave cuts in Trench 3 with  
the service pipe trench  
behind (looking north)

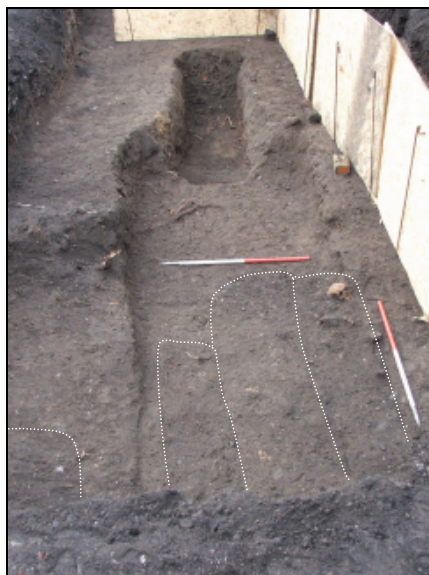
- 5.9 Towards the eastern end of Trench 3 the depth of graveyard soil [15] increased and was excavated to a depth of 3m bgl. Although graves were present in this area, the material filling the graves was indistinguishable, in places, from the surrounding soil. The cut of Grave 7 [F45] could only be identified in section at the centre of the trench; it measured 1.2m in length. The grave contained grey silty sand [44] and human remains consisting of the left side of a torso and the right side of a damaged skull. Grave 7 was truncated on the south side by Grave 8 [F43], which measured 1.2m in length and was filled by grey silty sand [42]. This grave was also only visible in section. Grave 9 [F41] was identified through the presence of a human skeleton, of which only the skull and right shoulder were exposed [40]. Grave 9 was cut by another burial, Grave 10 [F39], on the south side. Grave 10 and was filled by grey silty sand [38] and was identified by the presence of a skull, which protruded from the trench section.

**Figure 10**  
Graves at the east end of  
Trench 3 (looking west)
