ARCHAEOLOGICAL
SERVICES
DURHAM UNIVERSITY

Morpeth Flood Alleviation Scheme
Morpeth
Northumberland

geophysical survey

report 2919
June 2012

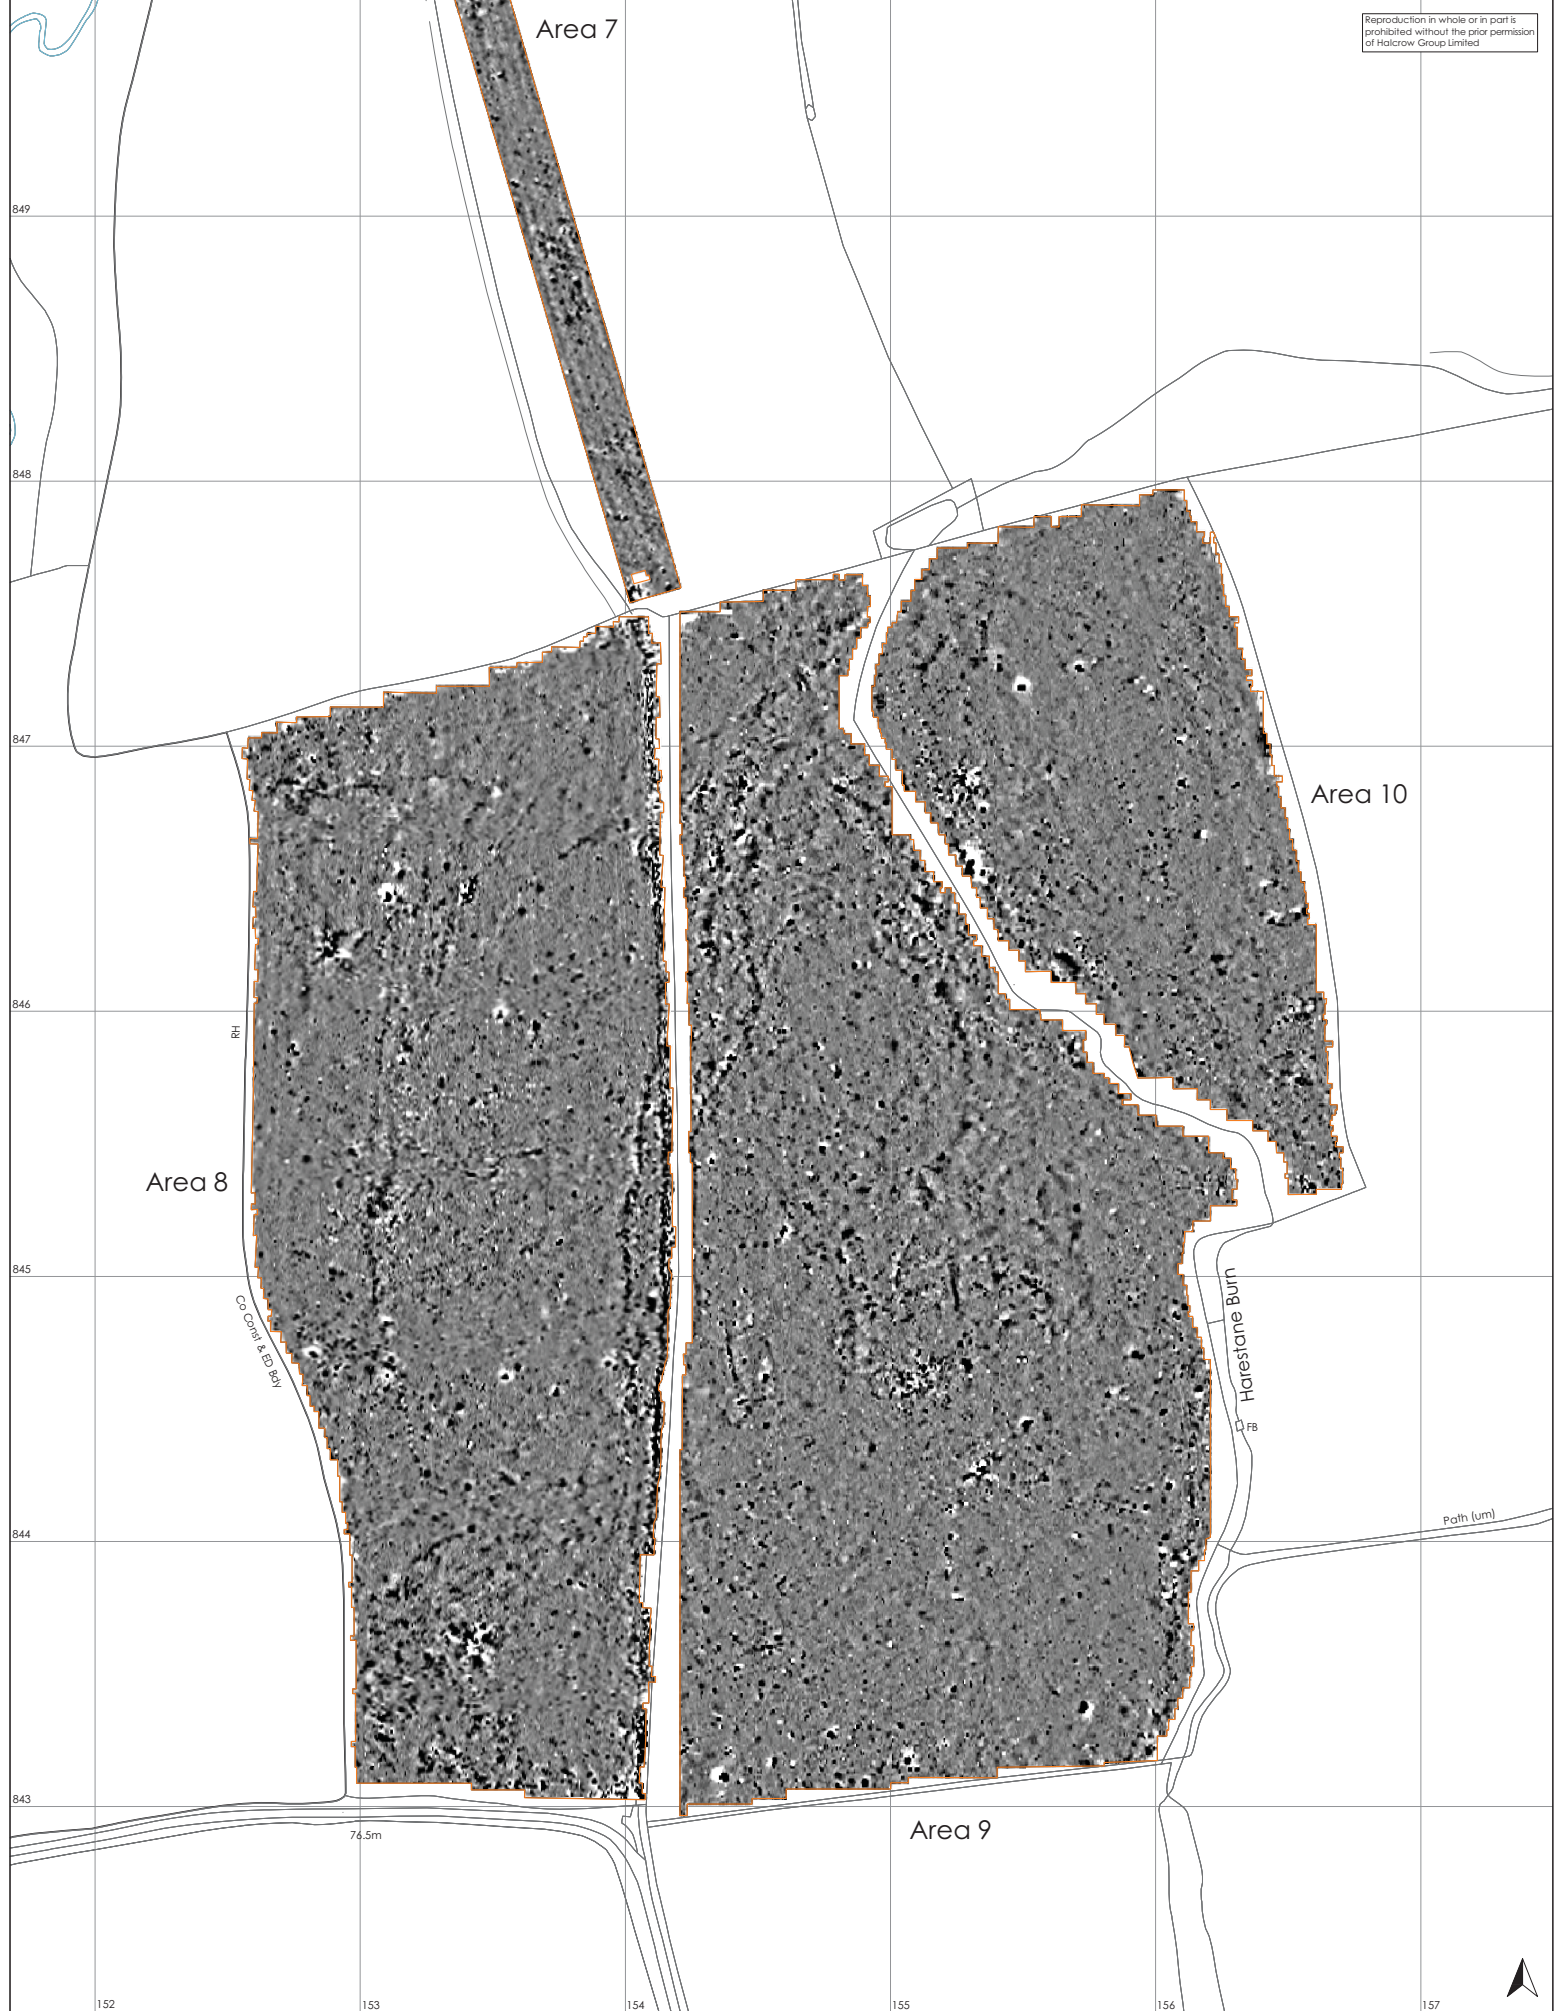
Morpeth Flood Alleviation Scheme
Morpeth
Northumberland
geophysical survey
report 2919
Figure 4: Geophysical surveys south
(Areas 7-10)

- 5.30 Several, often diffuse, linear and curvilinear positive magnetic anomalies have been detected in this area. These could possibly reflect anthropogenic soil-filled features, such as enclosure ditches and pits.
- 5.31 A narrow band of strong dipolar magnetic anomalies has been detected along the eastern edge of the survey area. This reflects an existing farm track. A curvilinear anomaly has been detected just to the west of this, which could reflect a former course of the track, or a former field boundary.
- 5.32 A north/south aligned 'texture' across the area reflects the modern plough regime; tramlines have been detected in the data as pairs of narrow linear negative magnetic anomalies.

- 5.33 As in Area 8 to the west, several positive magnetic anomalies have been detected which could reflect soil-filled features in this area.
- 5.34 A number of the anomalies appear likely to be anthropogenic due to their more regular nature. At least two potential small rectilinear enclosures have been identified as well as several sub-circular anomalies which could reflect ring-ditches.

- 5.35 A very weak texture in the data reflects the current plough direction.
- 5.36 A former field boundary is shown by OS maps of the area, aligned broadly east/west across the centre of the area; this has not been identified in the data.

- 5.37 Positive magnetic anomalies with similar characteristics to those identified in Areas 8 and 9 have also been detected in this area. These are also likely to reflect soil-filled features, however, as in the other areas the exact nature and origin of these features remains unclear. At least one potential rectilinear enclosure may have been detected and two possible small ring-ditches.
- 5.38 As in Areas 8 and 9 the modern plough regime can be identified as a weak 'texture' in the data.

- 5.8 Geoplot v.3 software was used to process the geophysical data and to produce both continuous tone greyscale images and trace plots of the raw (minimally processed) data. The greyscale images and interpretations are presented in Figures 2–8; the trace plots are provided in Figure 9. In the greyscale images, positive magnetic anomalies are displayed as dark grey and negative magnetic anomalies as light grey. Palette bars relate the greyscale intensities to anomaly values in nanoTesla.
- 5.9 The following basic processing functions have been applied to each dataset:
