Howarth Litchfield Partnership for Durham University Estates and Buildings

Master's House Palace Green Durham

archaeological excavation

report 2955 December 2012

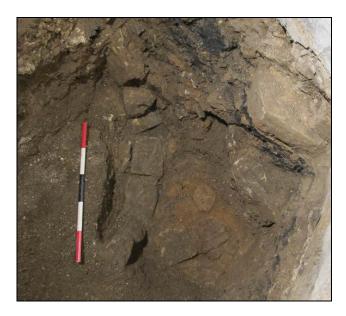
Figure 5: The north-west end of Trench A showing curving wall [F11] & floor [F12], looking west

- 5.3 An unmortared curving stone wall [F11: 0.8m by 0.15m by 0.5 deep] constructed of rectangular masonry of variable size was partly exposed in the trench (Figure 5). Abutting this wall was a layer of orange sandy clay [13] that contained six sherds of 12th-13th century pottery, a horseshoe nail, animal and fish bone, and a fragment of lead. Behind the back wall of the recess, a substantial mortared stone wall was seen to be standing on this layer. This wall [F10] was built of roughly rectangular stones of variable sizes (Figure 7). It is possible that it is a continuation of the stone wall visible in the stairwell. Abutting this and overlying the sandy clay layer [13] was a fragmented stone surface [F12: 30mm thick]. This was overlain by a layer of firm grey-brown silt clay [16: 50mm-80mm thick]. This material contained 12 sherds of 14th-15th century pottery, animal and fish bone and three iron objects. Overlying this was a 0.2m-thick layer of mottled orange and grey-brown loam [9] that contained two large sandstone blocks [F15: approx. 0.6 by 0.4m by 0.12m thick], 22 sherds of 13th -15th century pottery, fish and animal bone, oyster shell and a small piece of post-medieval glass. Directly over this was a stone floor [F14: 0.45m by 0.65m by 0.18m thick] set in a brown silt clay matrix (Figure 6). Above this at the south end of the trench was a layer of laminated deposits [8: 0.2m thick] containing 14th-15th century pottery, animal bone and oyster shell. These layers were below a flagstone surface [F5] on which the brick foundation [F6] to the recess had been built.

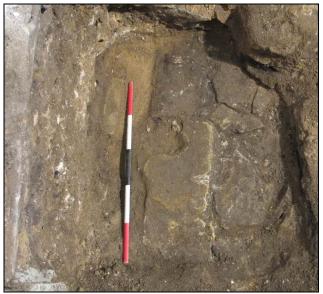
Figure 6: Stone floor [F14] in the south-west part of Trench A, looking east

- 5.4 At the north end of the trench, the stone floor [F14] was covered by a layer of crushed mortar [17], probably laid as a levelling deposit; three fragments of animal bone were recovered from this layer. A compact very dark brown sandy silt [3:

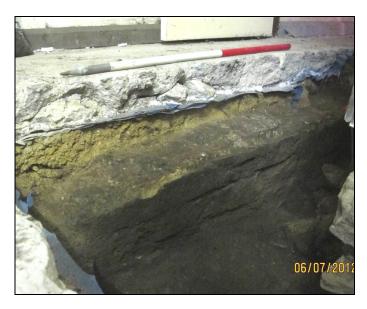
Figure 8: Stone Wall [F115] in Trench B, looking west

- 5.7 At the south-west edge of the excavated area a substantial section of well-made stone wall was partly exposed [F115: 2.26m long]. The wall runs north-east southwest and its upper surface is approximately 0.16m below the concrete floor of the kitchen. Four courses of mortar-bonded faced sandstone blocks were exposed (Figure 8). This wall is similar to another isolated section seen in a service trench just outside the gate to the garden of the Master's House (Archaeological Services 2012a, 12; Area 11, F231). These may form part of the structure of the Owen Gate (4.5, above). Abutting this wall was a layer of dark grey-brown sandy silt [121: unexcavated]. Stone and mortar inclusions in this deposit suggest that this layer might be contemporary with layer [207] in a recess in Area C, a short distance to the north-east. At the west side of the trench this layer was overlain by grey-brown sandy clay [117: 0.14m thick] that contained occasional angular stone, brick fragments, two sherds of medieval pottery and a fragment of medieval window glass. Overlying this was dark brown clay [114: 0.24m thick] that contained two fragments of stone floor tile, 13th-15th century pottery, animal and fish bone, a large sharpening / whetstone, a nail fragment and clay tobacco pipe fragments. Above this layer was a dark grey silt [109: 70mm thick] that contained a single sherd of 12th-13th century pottery. This deposit was below a thin layer of coarse yellow sand and crushed stone [108: 70mm thick]; three sherds of medieval pottery were recovered from this layer. Above this was a soft sandy clay [107: 50mm thick] which formed the bedding for a flagstone surface [F111: 50mm thick]. A U-profile foundation trench cut this layer [F116: 2.64m by 0.32m by 0.25m deep] (Figure 10). Within this was a mortared wall [F124] of medium-sized irregular sandstone blocks. The backfill of the trench [118] contained stone, brick, tile and mortar, as well as late medieval pottery, animal bone and clay pipe fragments. Brick foundations [F105] had been inserted later on the east and west sides of the stone wall. These were built from hand-made bricks (230 mm by 70mm by 100mm), probably of 19thcentury date.

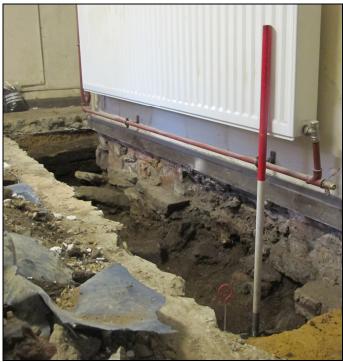
Figure 9: Trench B, north-east facing section, looking southwest

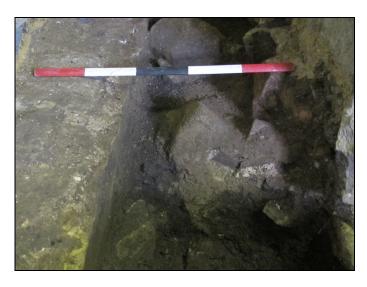
Figure 10: Trench B, section 3, showing wall foundation cut [F116], looking north-west

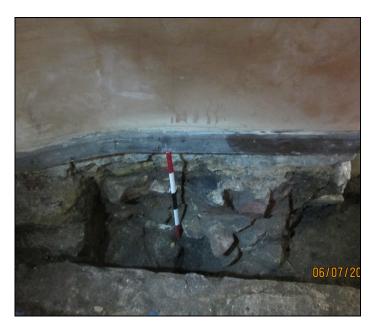
Figure 11: South facing section in Trench B, looking north

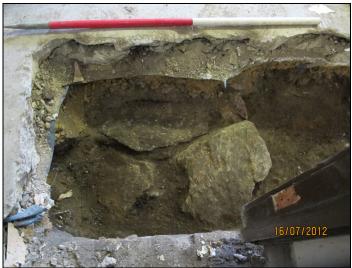
Figure 12: East end of Trench B showing stone floor [F122], looking east

- 5.8 At the base of the north-east end of the trench a layer of mottled yellow sandy clay [112: unexcavated] was found. This underlay the remains of a stone floor [F122: unexcavated (Figure 12)]. This was found at a depth of 0.35m below the present floor and consisted of roughly cut flags measuring 60-80mm thick. This stone floor was covered with a deposit of brown silty clay [106: 0.15m thick] that contained stone and coal fragments, a sherd of 13th-14th century pottery and a clay pipe fragment. This layer was directly under the brick foundation of the chimney stack

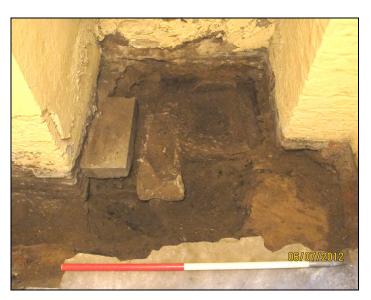
Figure 13: Reused architectural fragments [F206] in Trench C, looking south-east

- 5.12 Two reused architectural fragments [F206] abutted the stone foundation (Figure 13). One was a thick slab, roughly square, with a shallow circular depression at its centre; one edge was chamfered. The second was rectangular in shape and measured 0.62m by 0.24m by 70mm thick. The bonding mortar included brick fragments. A layer of black silt [210: 80mm thick] containing post-medieval pottery, animal bone, glass and clay pipe overlay these stones. A bone object, possibly used in manuscript preparation or printing, was also recovered from this layer. The deposit was overlain by bedding [204] for a flagstone floor [F213 (Figure 14)]. This floor resembles the surface in the wine cellar at the rear of the building, north of Area A. A repair to this floor [203] was cut by the foundation trench [F201: 1.4m by 1.1m by 0.35m deep] for the brick chimney; this was irregularly shaped in plan and profile. The chimney stack's foundation [F212] was five courses of hand-made bricks bonded with cement. A stone block [F205] abutting this foundation was overlain by a backfill deposit of dark brown friable silt [208] that contained frequent inclusions of stone, mortar, cinder and coal fragments. Finds recovered from this deposit included two sherds of post-medieval pottery, post-17th-century window glass, animal bone and clay pipe fragments. A thin layer of fine brown silt [200] overlay the backfill; this may derive from the overlying crushed brick and stone sub-base [202: 0.1m thick] for the concrete floor [211: 0.1m thick].

- 6.27 A piece of worked, partly banded hard sandstone was found re-used in context [F206], possibly as floor levelling material. The large, sub-rectangular stone is 610mm x 598mm max dimensions, and 75mm-125mm thick. It has two original and two broken edges. All original surfaces have been roughly dressed, and the underside is fairly flat. The top has the remains of a broken lip, 60mm wide and surviving to a depth of about 20mm, running along one edge. The edge at right angles to this is slightly chamfered. In the centre of the top is a circular depression, 50mm deep and 200mm in diameter, with a vestigial channel 90mm long by about 5mm deep leading from it. The channel is truncated by a broken edge in the stone. Though broken, the stone has an unfinished appearance. Its date and function are unknown.

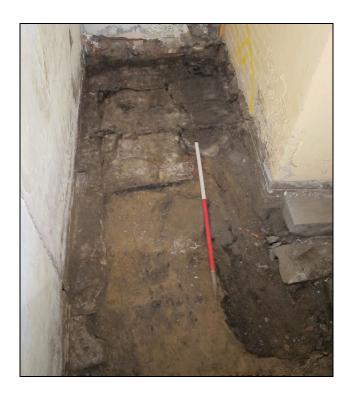
Figure 14: Floor [F213] in Trench C, looking north-east
