# **Eccup to East Rigton Water Main, West Yorkshire**

## **geophysical surveys**

**Report 1425**

April 2006

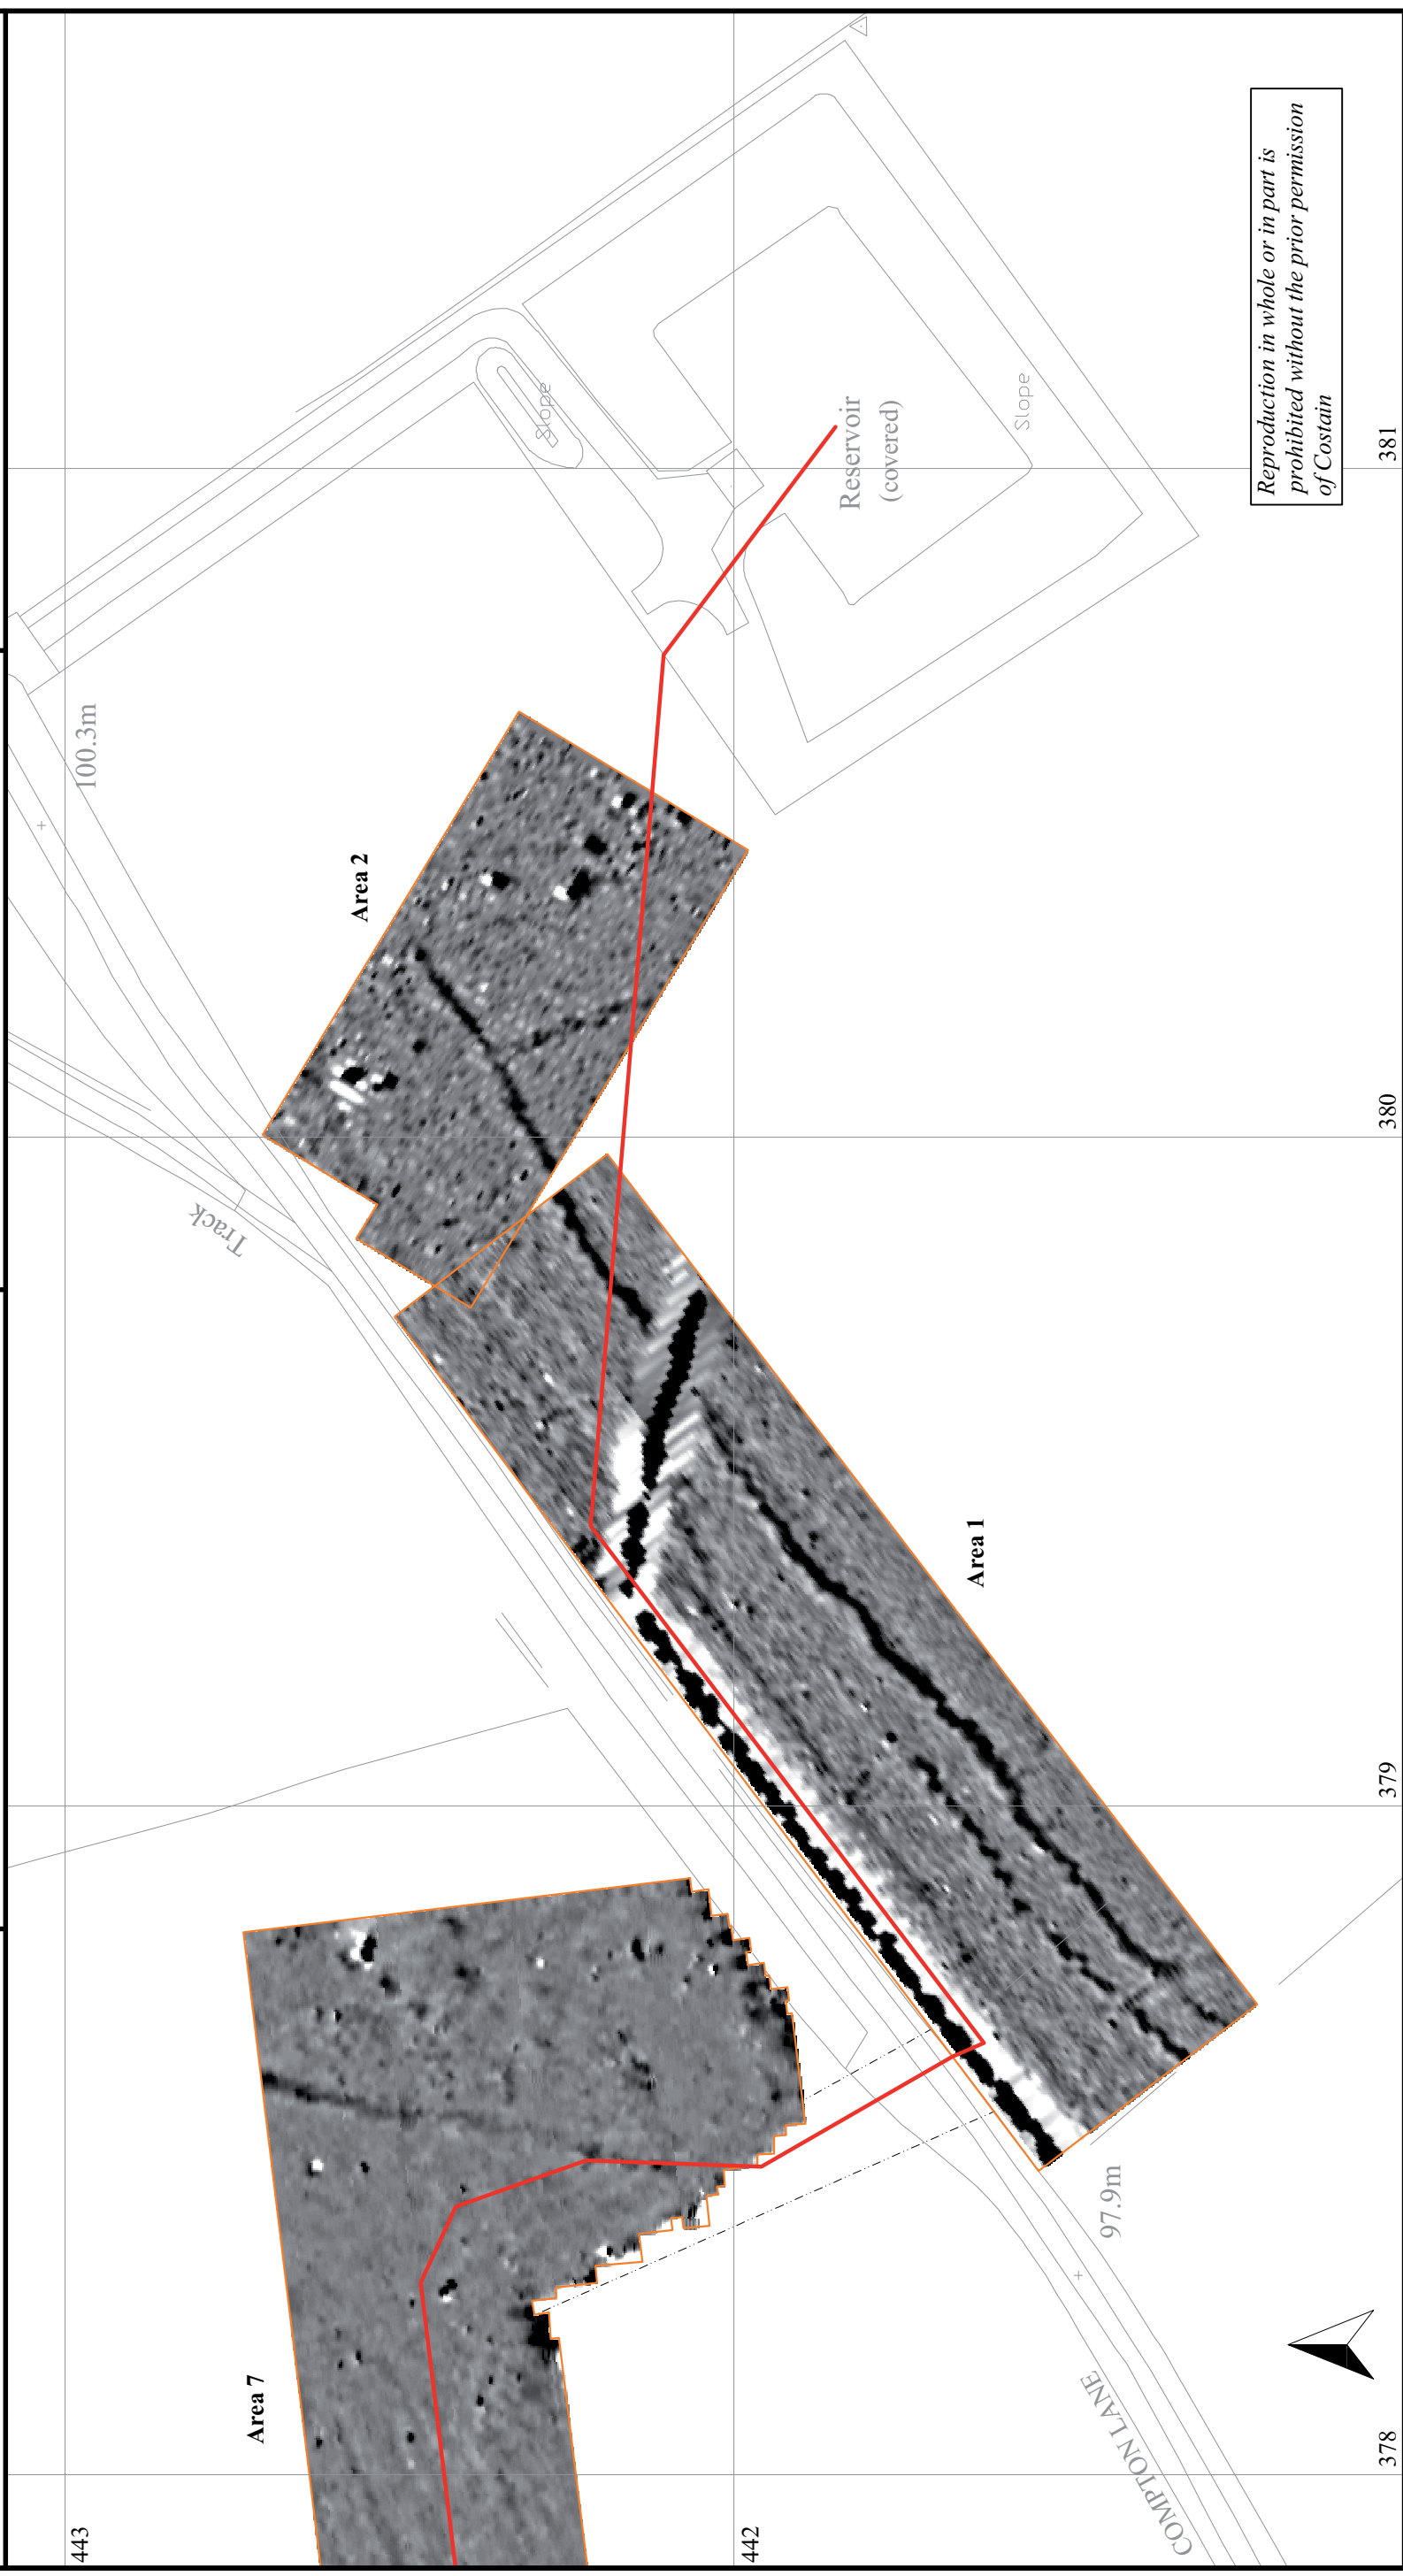
Figure 2

Areas 1 and 2, geophysical surveys

- 4.14 A chain of dipolar magnetic anomalies traverses the area, almost certainly reflecting a ferrous pipe. This is probably related to the present reservoir complex; indeed part of its course corresponds to the proposed route for the new pipe.
- 4.15 Several linear positive magnetic anomalies were also detected here. These are indicative of soil-filled features and may represent former field systems.

- 4.16 A linear positive magnetic anomaly detected in Area 1 continues into this area. It is associated with another, perpendicular, positive magnetic linear anomaly and both may reflect former field boundaries.

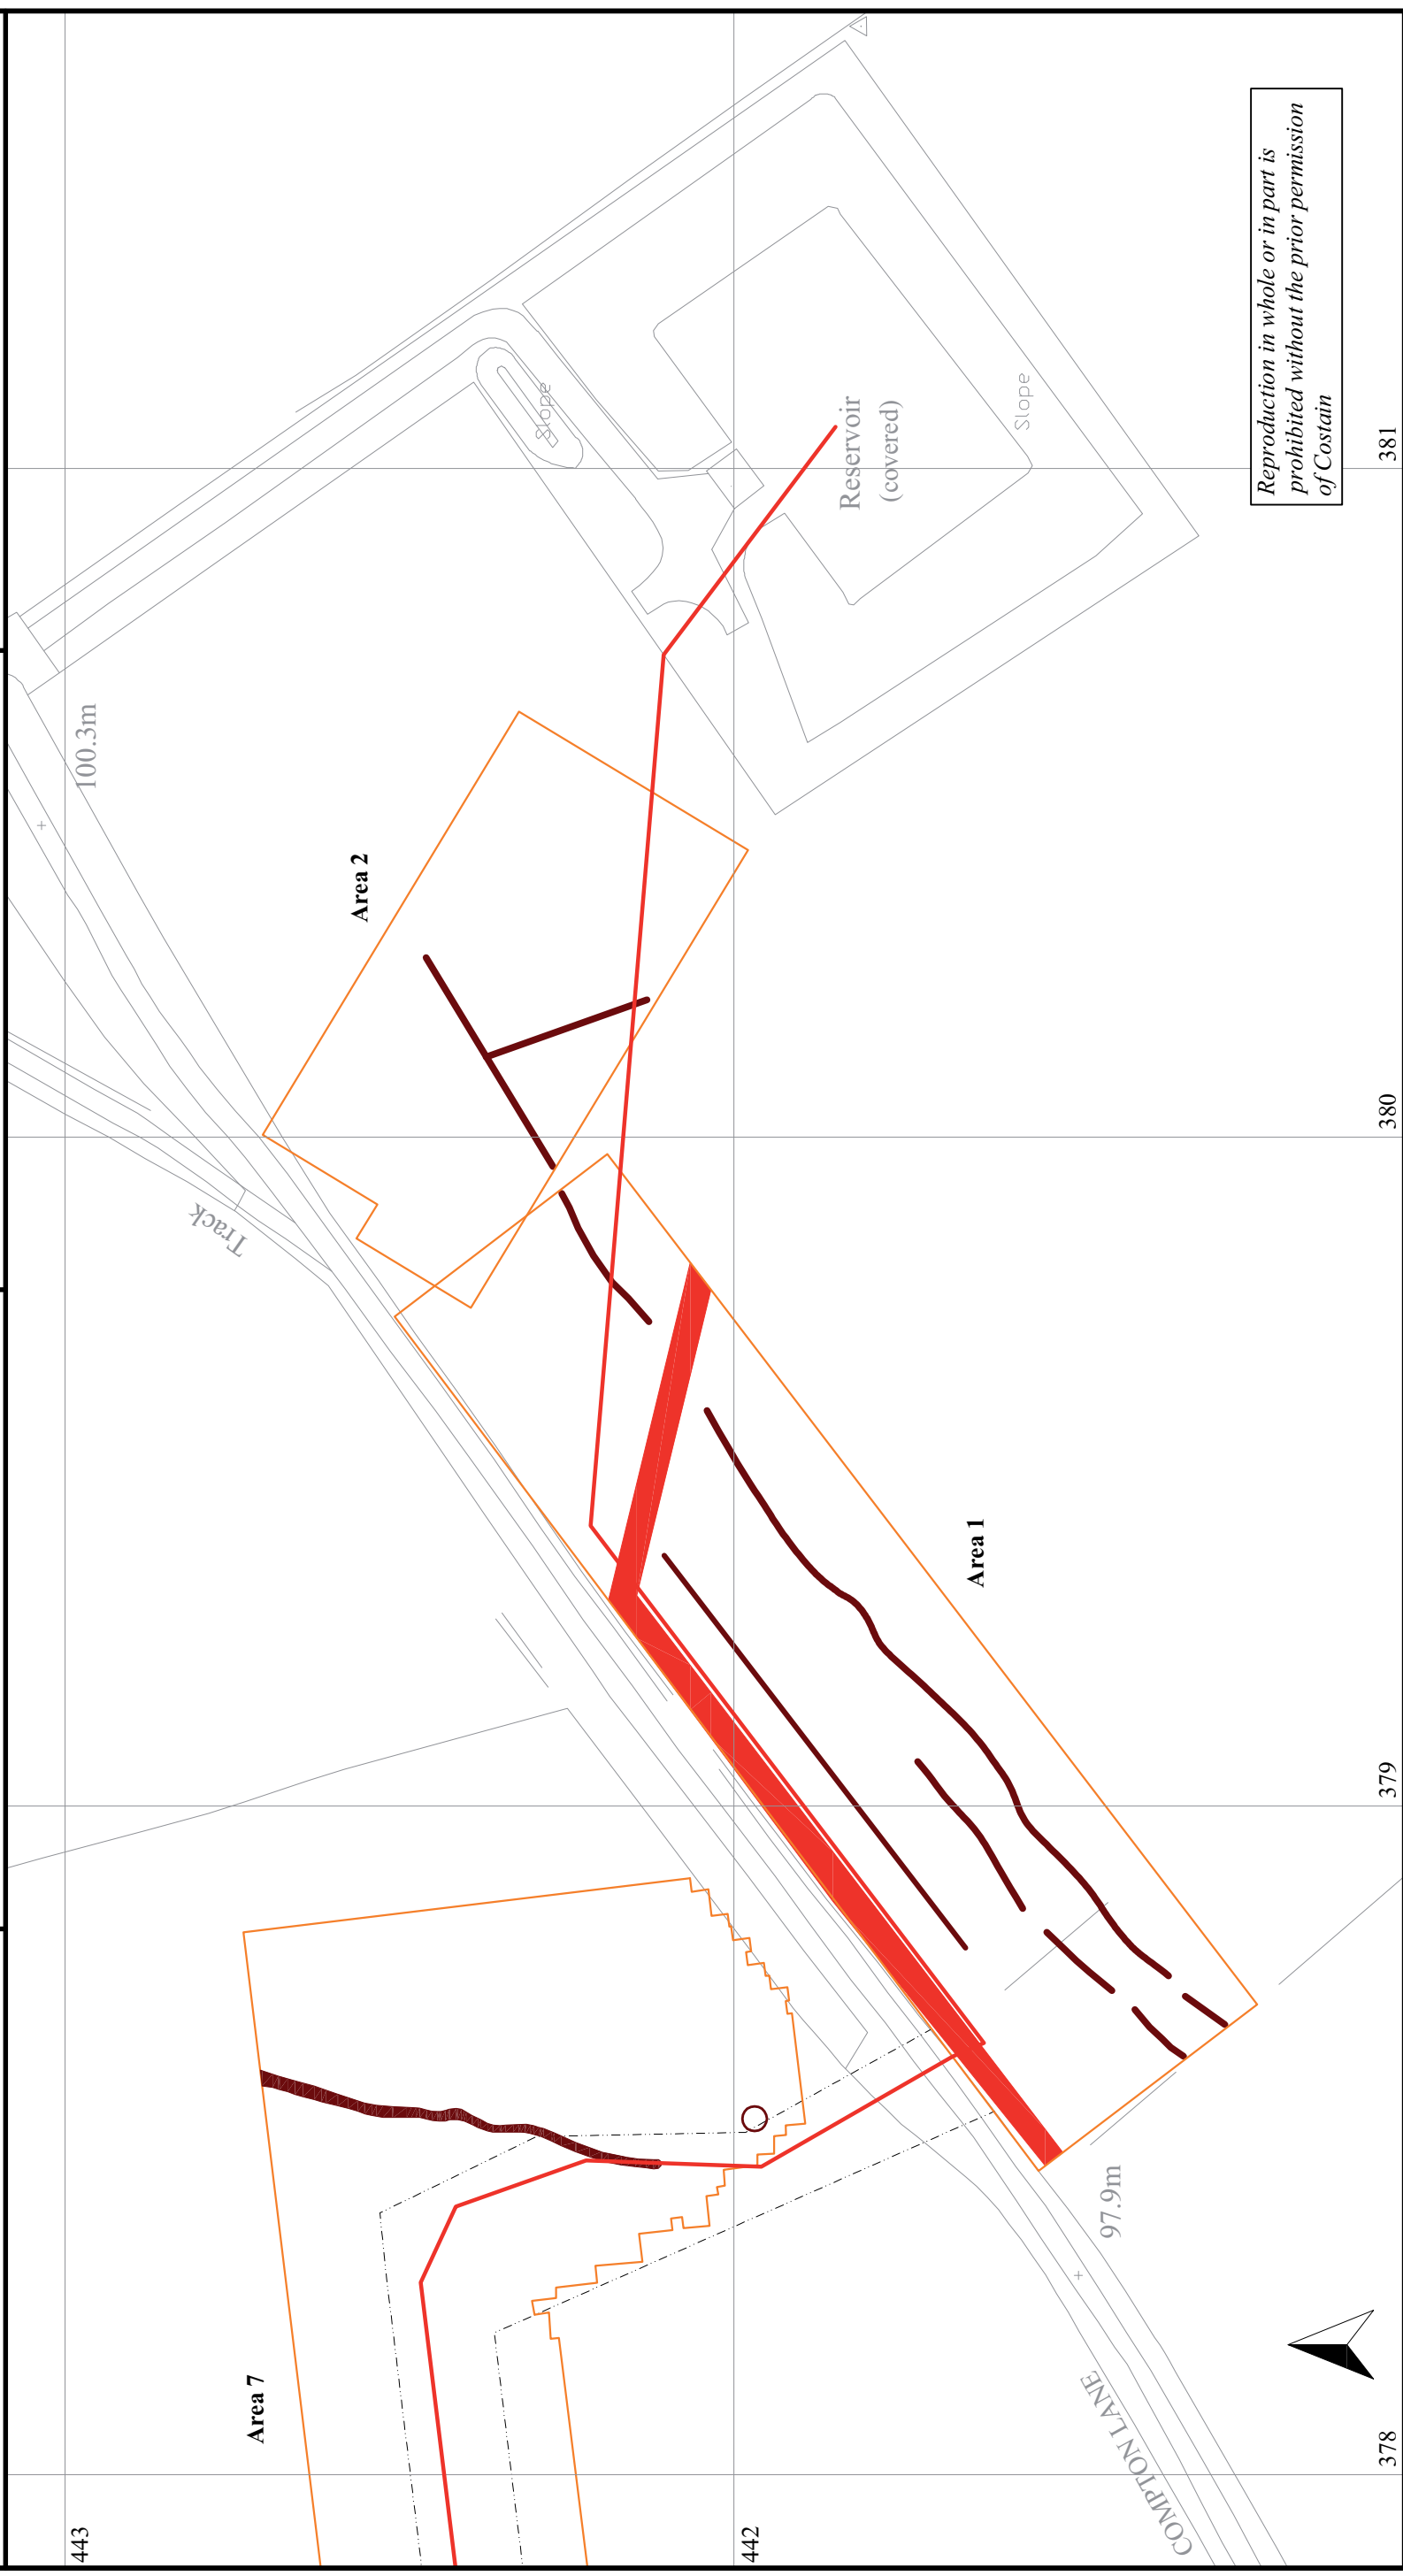
Figure 4

Areas 1 and 2, archaeological interpretation

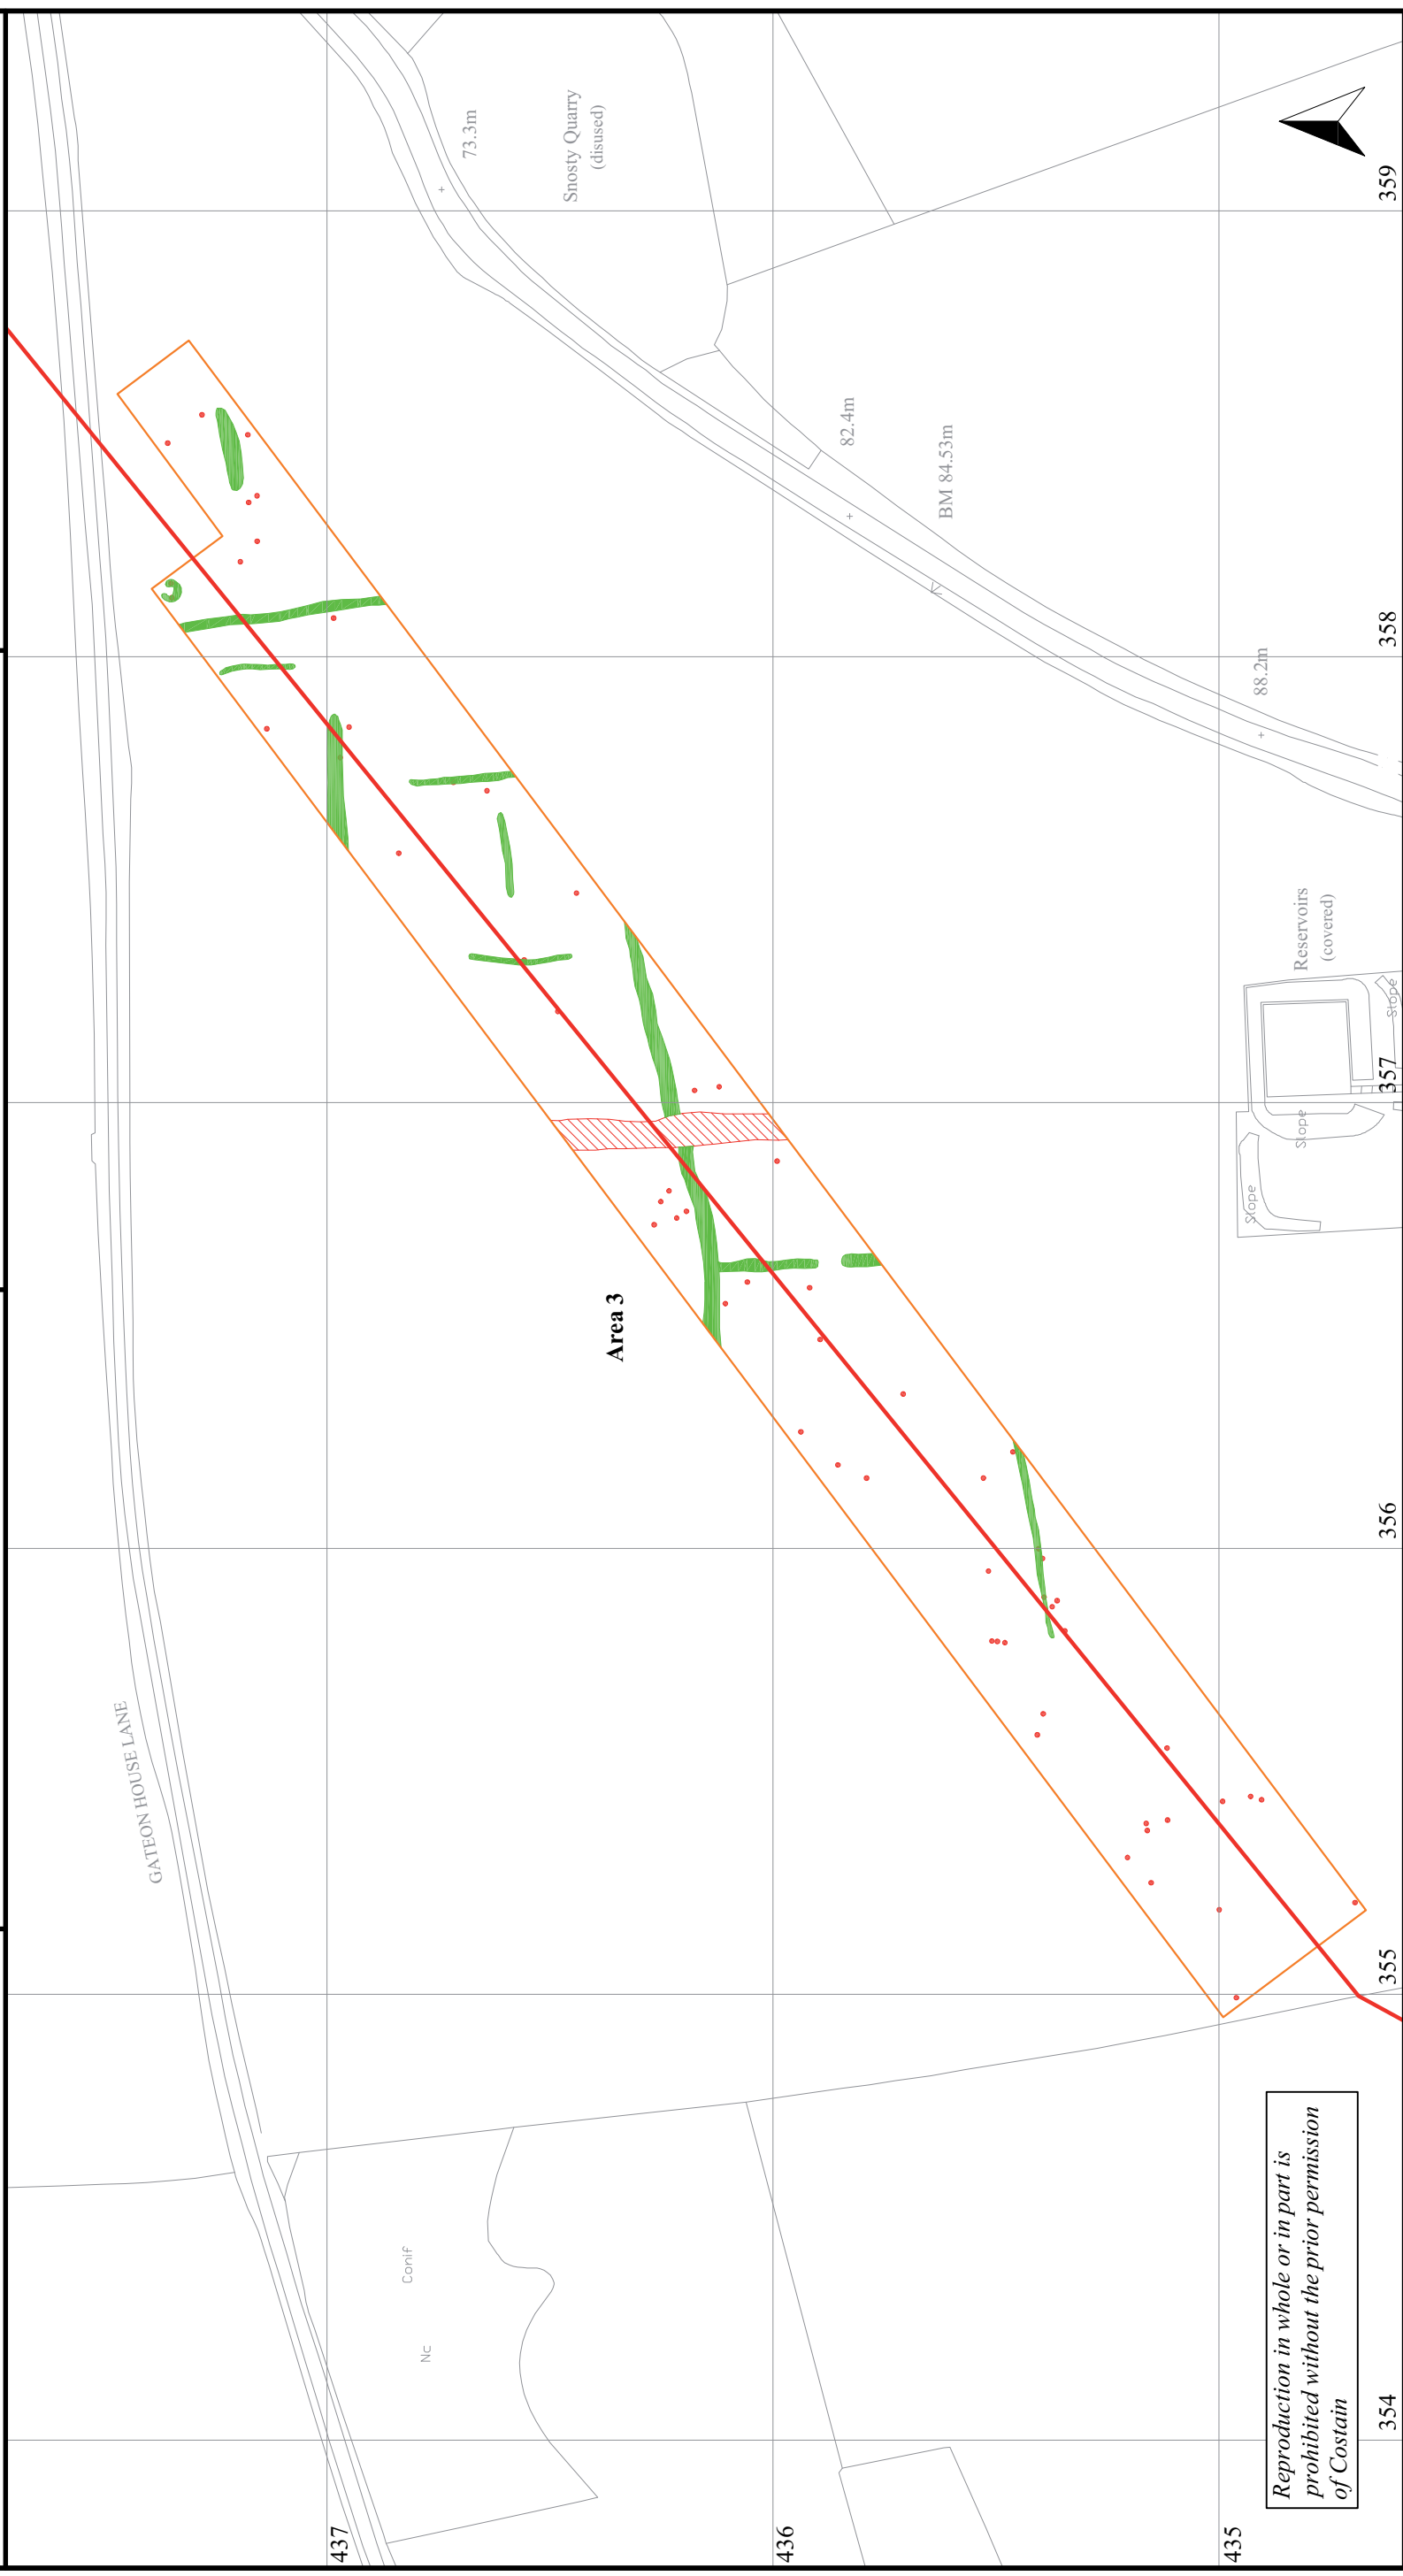
**Eccup to East Rigton Water Main,  
West Yorkshire  
geophysical surveys  
Report 1425  
Figure 6  
Area 3, geophysical interpretation**

- 4.17 A chain of dipolar magnetic anomalies detected here almost certainly reflects a ferrous pipe traversing the area; this appears likely to be associated with the existing reservoirs to the south, next to Whin Hill House.
- 4.18 A number of linear positive magnetic anomalies were detected across this survey area. The majority of these appear to reflect former field boundaries, while others may represent other soil-filled ditches.
- 4.19 A magnetic 'texture' was detected across the western part of the survey area; this almost certainly reflects the current plough direction.

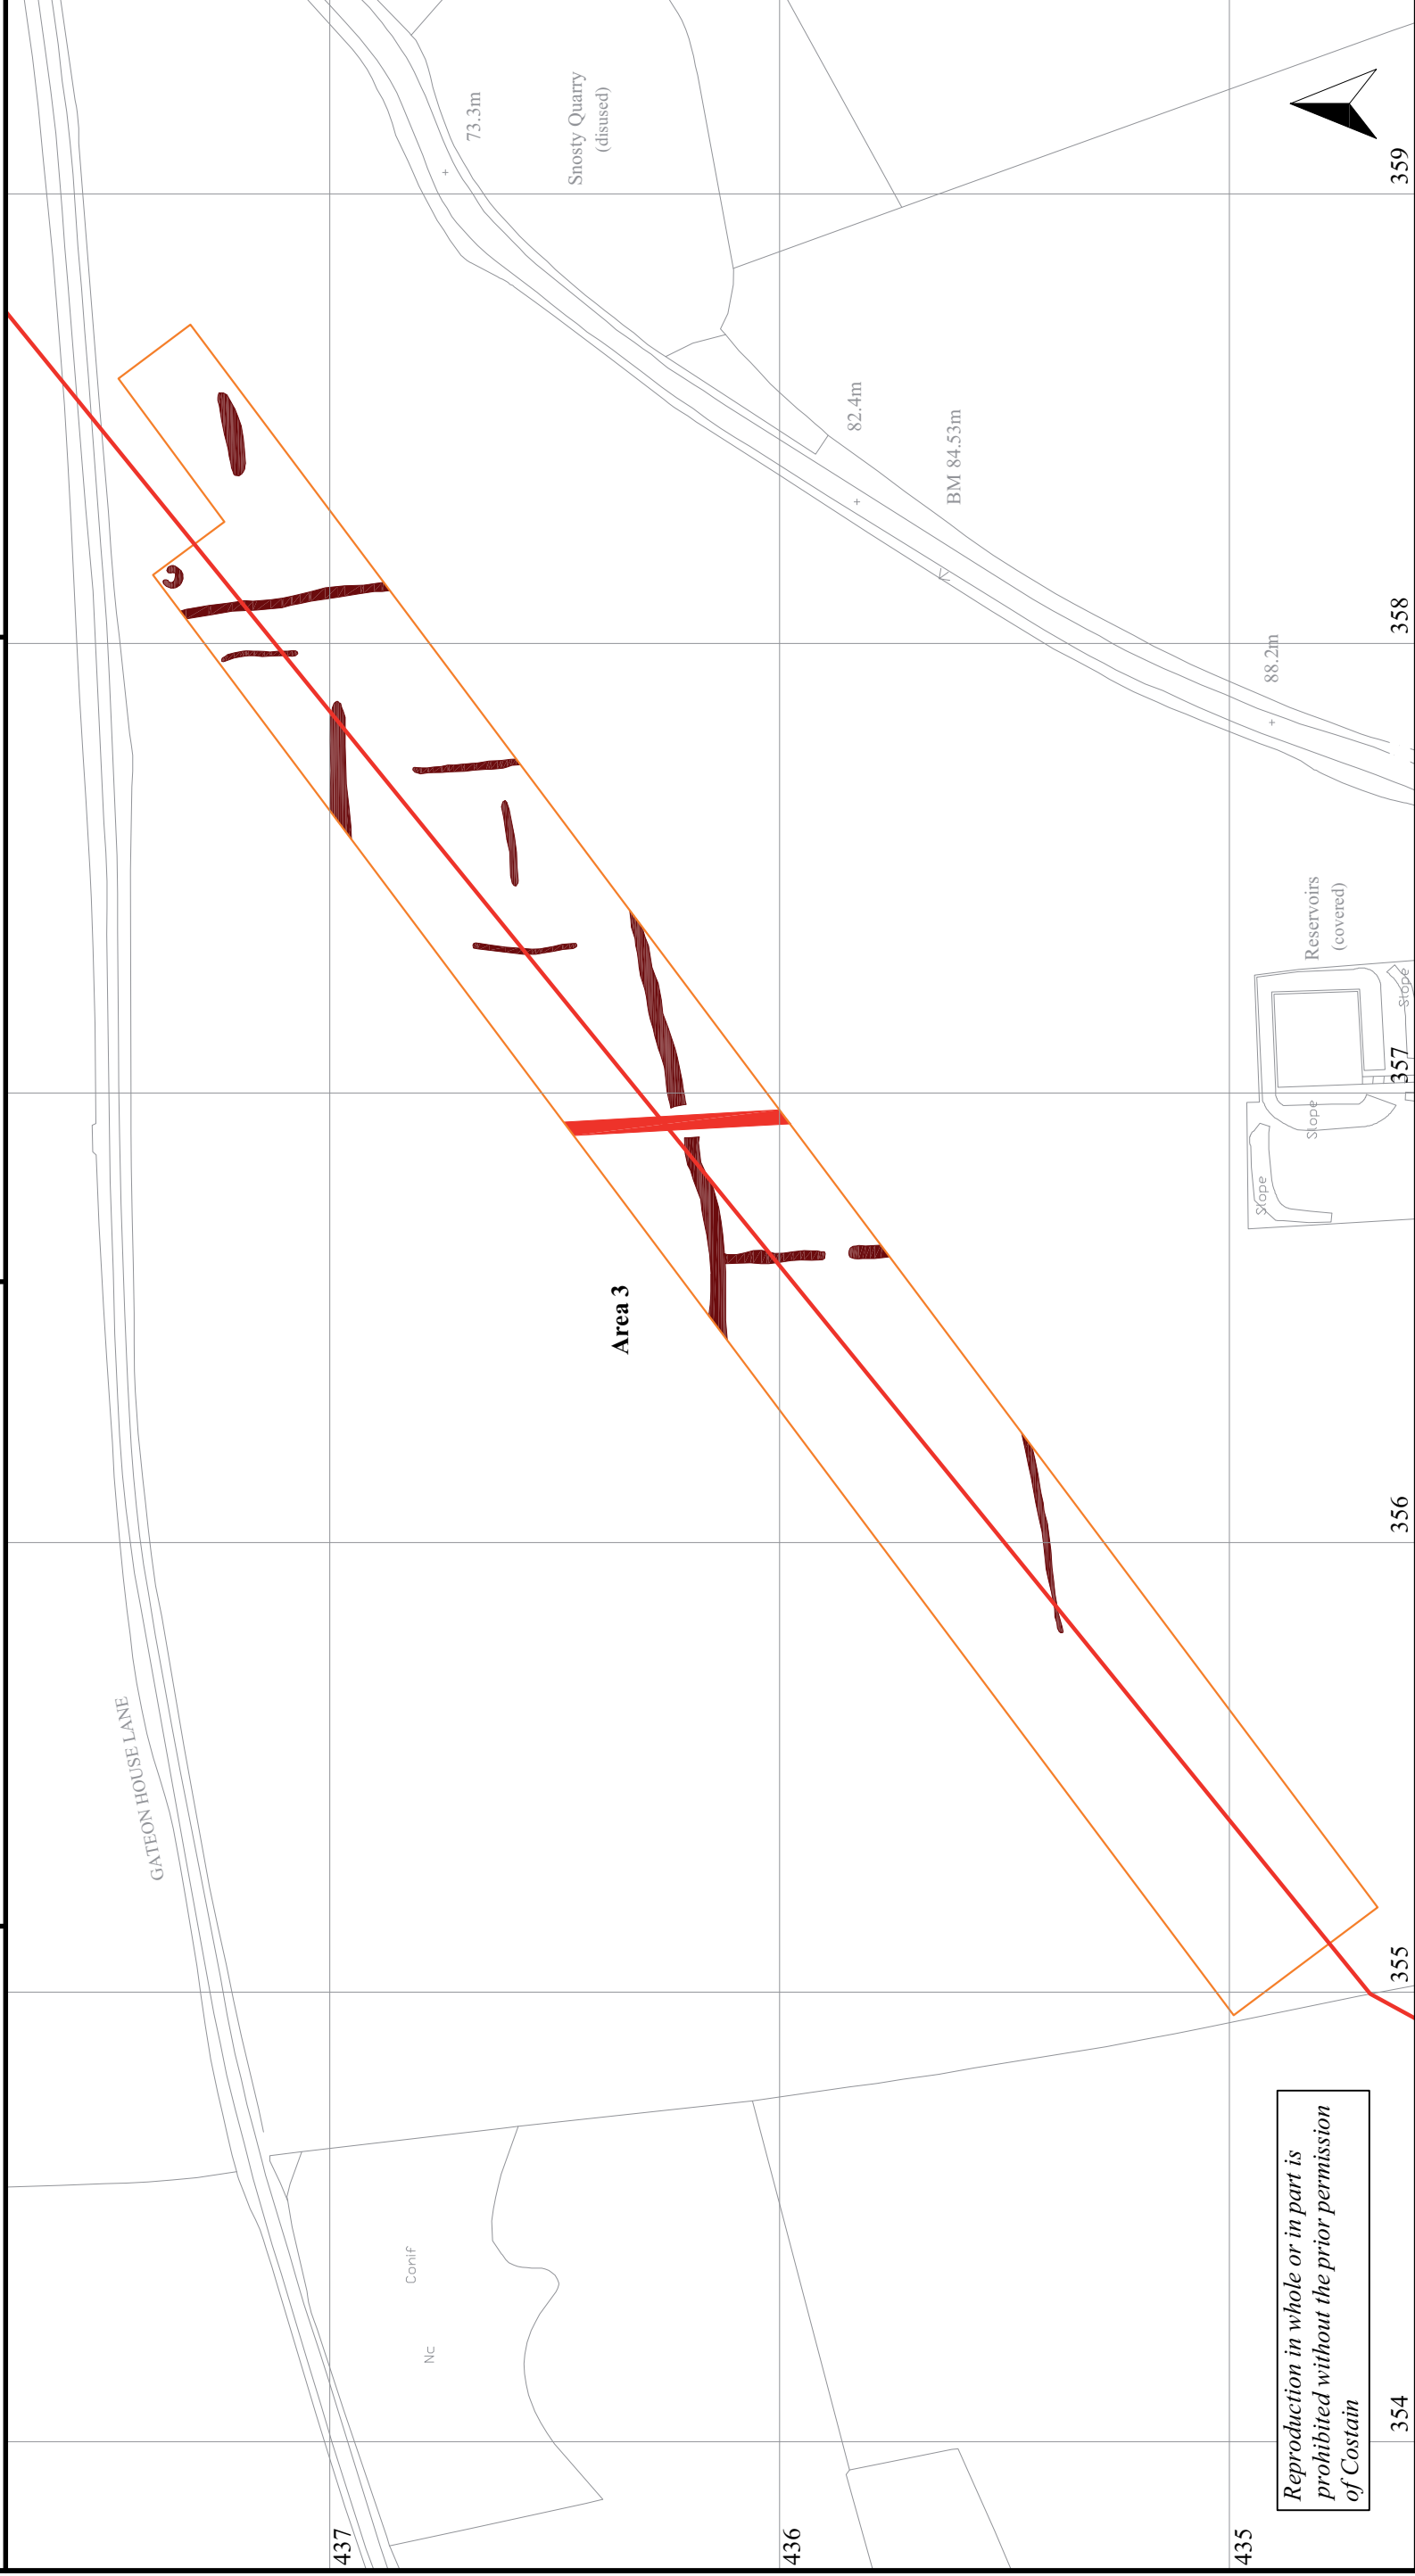
Eccup to East Rigton Water Main,  
West Yorkshire  
geophysical surveys  
Report 1425  
Figure 7  
Area 3, archaeological interpretation

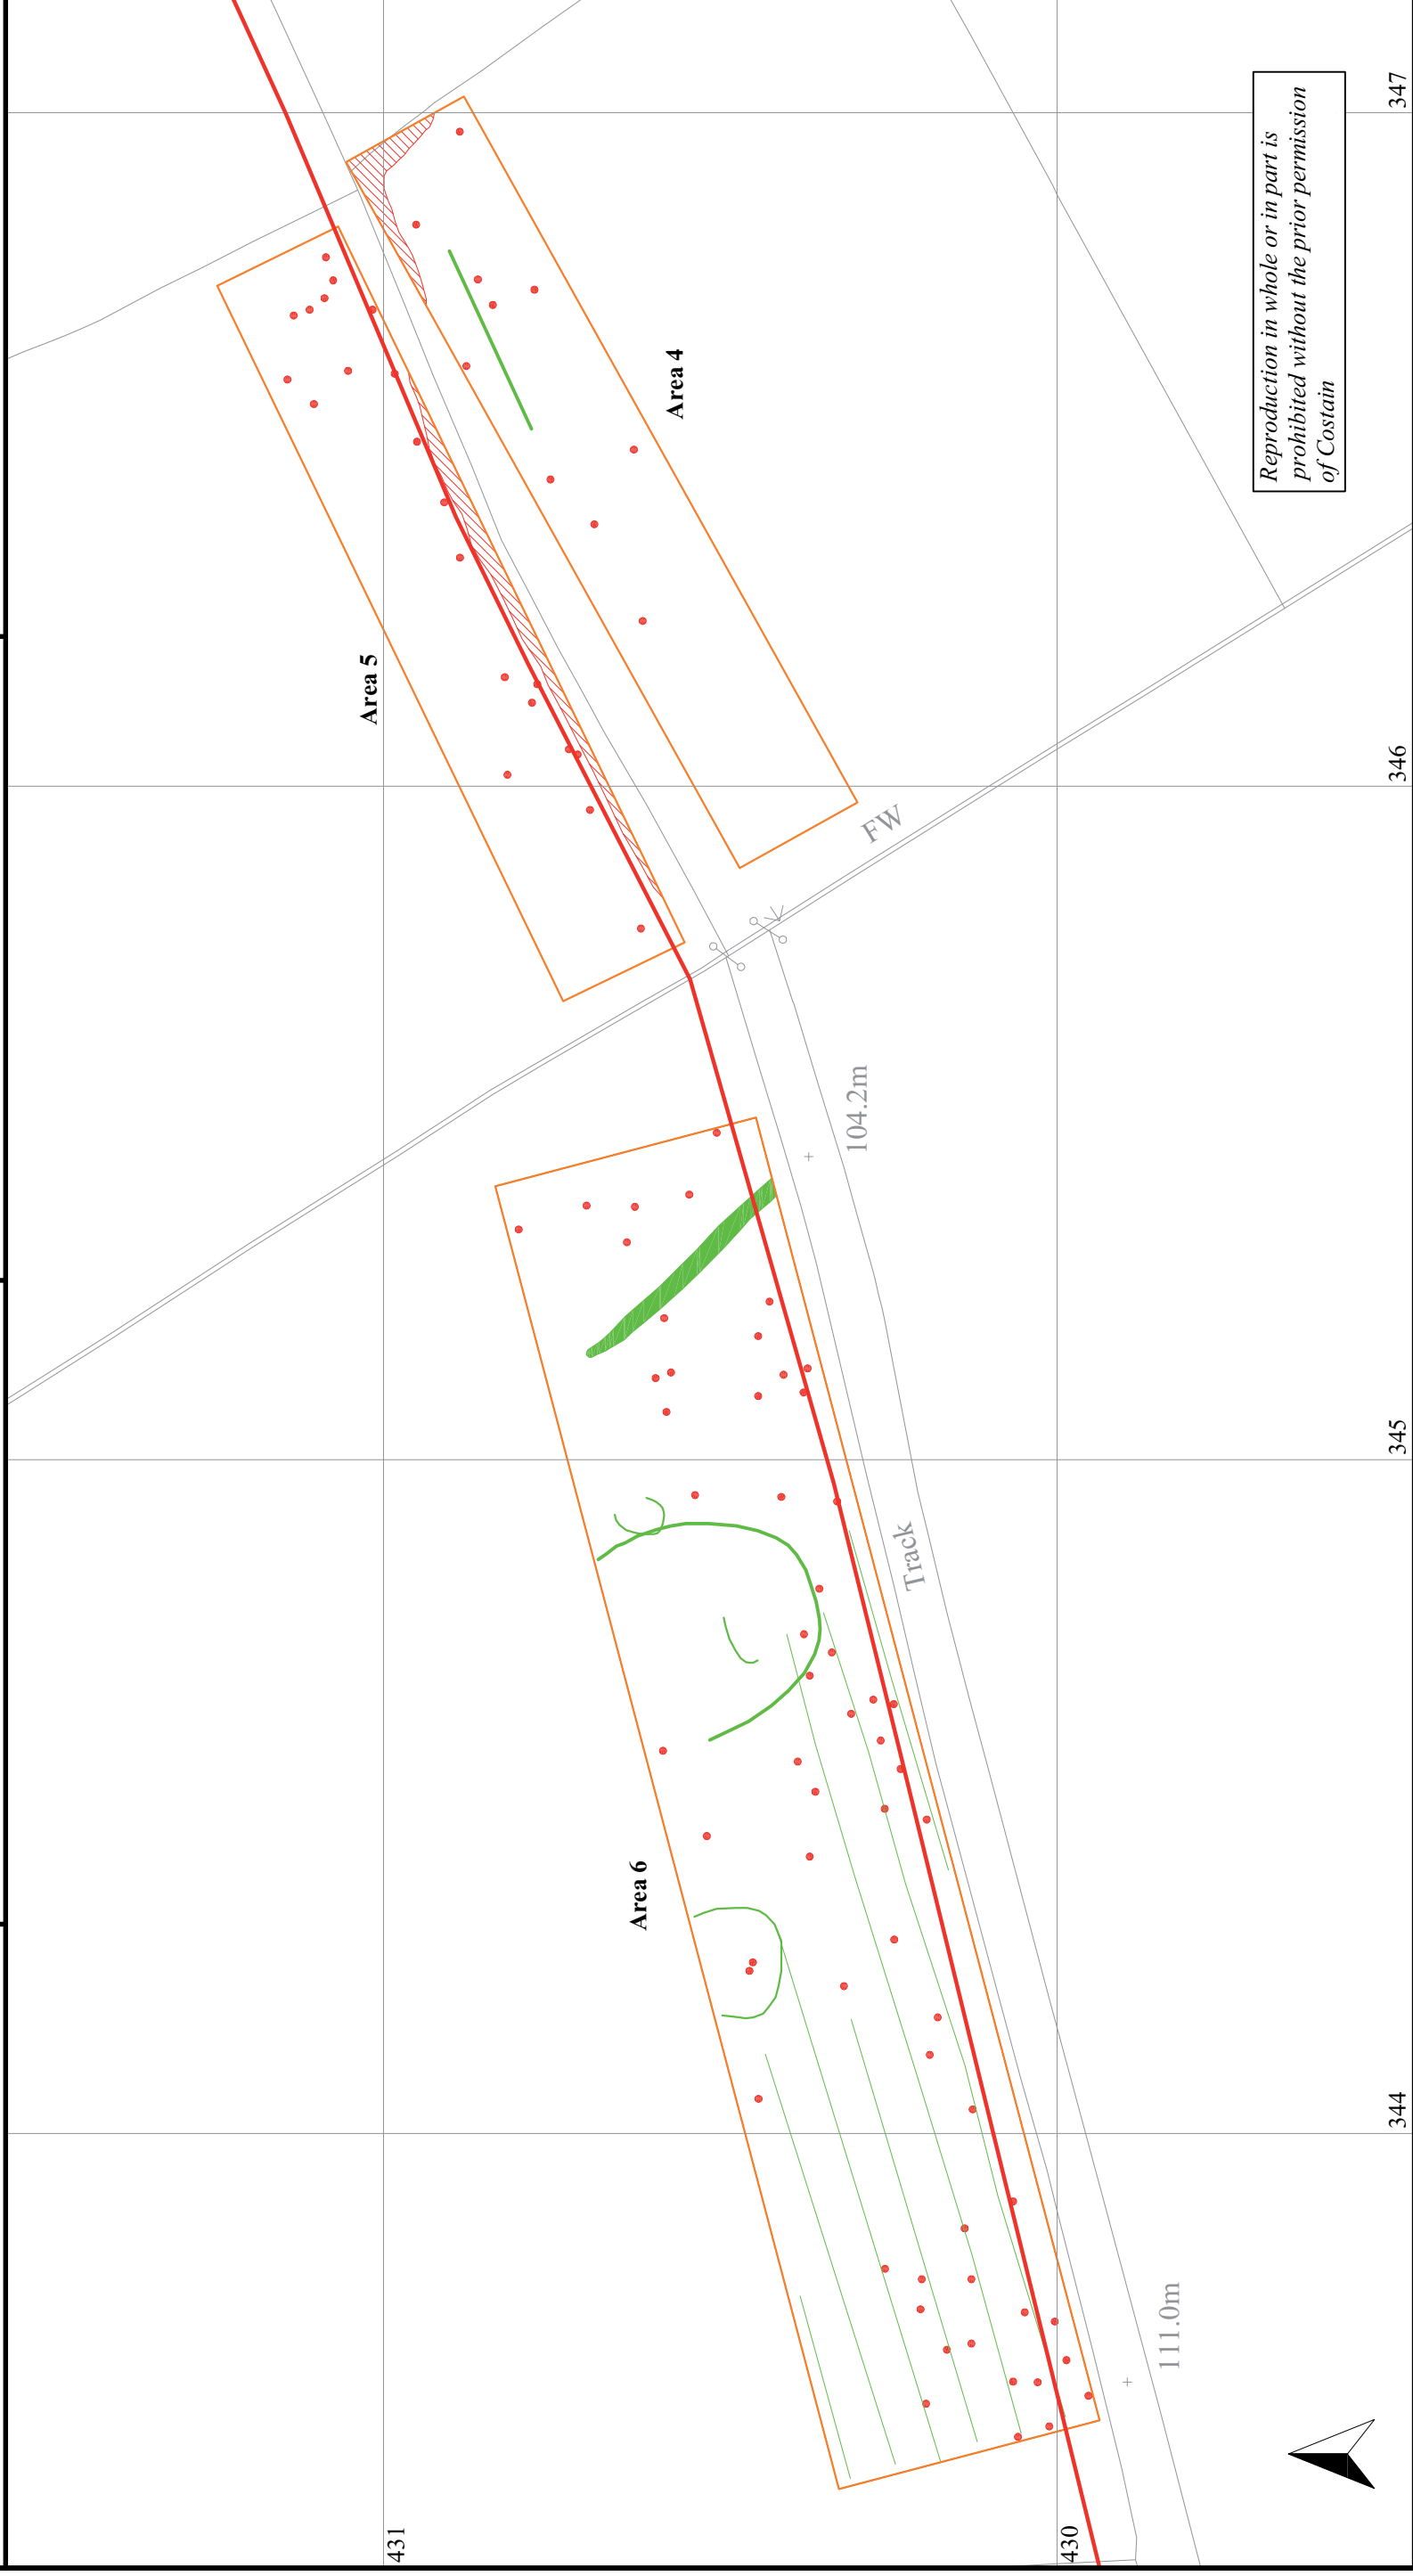
Eccup to East Rigton Water Main,  
West Yorkshire  
geophysical surveys  
Report 1425  
Figure 9  
Areas 4, 5 and 6, geophysical interpretation

- 4.20 One feature of potential archaeological interest was detected in these two areas, which were located either side of a wire fence. A weak and diffuse positive magnetic anomaly parallel to and south of the fence may reflect a soil-filled ditch feature. The only other anomalies detected reflect the existing fence, a gate and near-surface ferrous litter.

- 4.21 A linear positive magnetic anomaly was detected towards the eastern end of the survey area. This may reflect a soil-filled feature such as a former field boundary or ditch.
- 4.22 An extremely weak curvilinear positive magnetic anomaly detected in the central part of the area is likely to reflect the remains of a soil-filled feature, possibly an enclosure ditch. Additional weak curvilinear anomalies could reflect the remains of other ditch features.
- 4.23 Parallel, positive magnetic linear anomalies traverse the survey area in an east-west direction, spaced at approximately 6-8m intervals. These are likely to reflect the presence of land drains in this boggy pasture area.
