on behalf of Environment Agency

West Coldside Morpeth Flood Alleviation Scheme Northumberland

geophysical survey

report 3030 November 2012

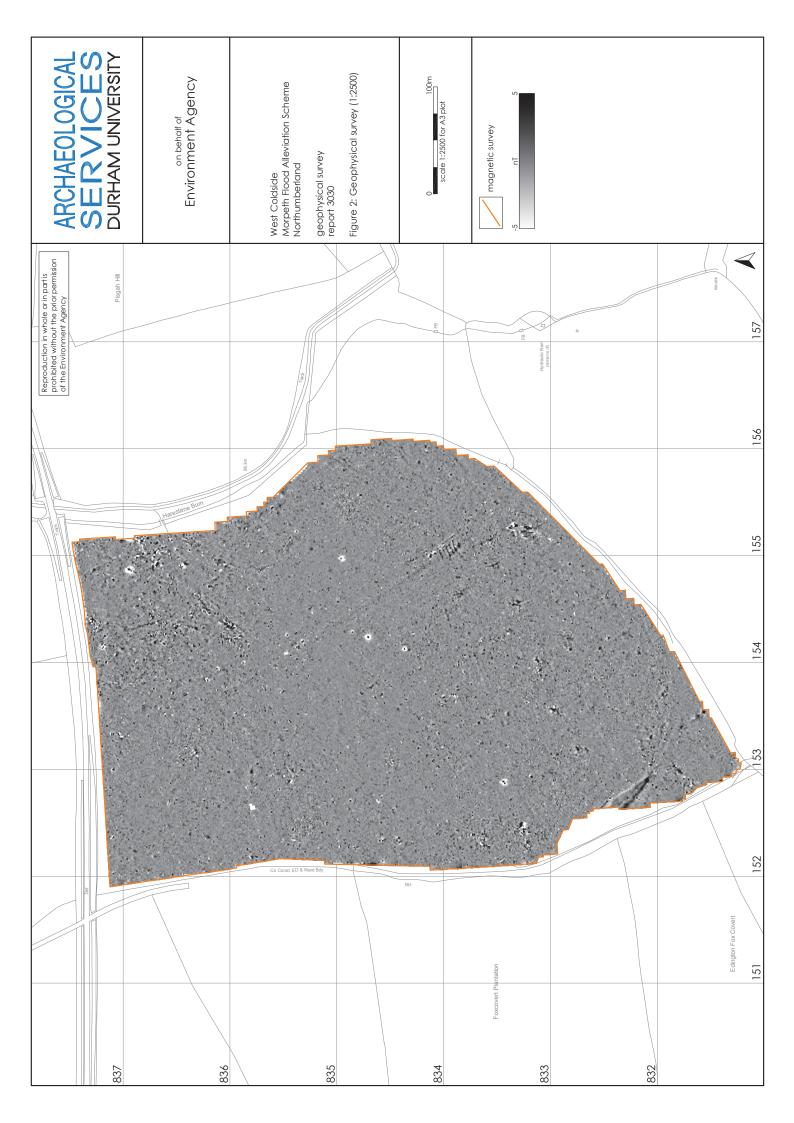
- 5.8 Geoplot v.3 software was used to process the geophysical data and to produce a continuous tone greyscale image. The greyscale image and interpretations are presented in Figures 2–5. In the greyscale image, positive magnetic anomalies are displayed as dark grey and negative magnetic anomalies as light grey. A palette bar relates the greyscale intensities to anomaly values in nanoTesla.
- 5.9 The following basic processing functions have been applied to the geomagnetic data:

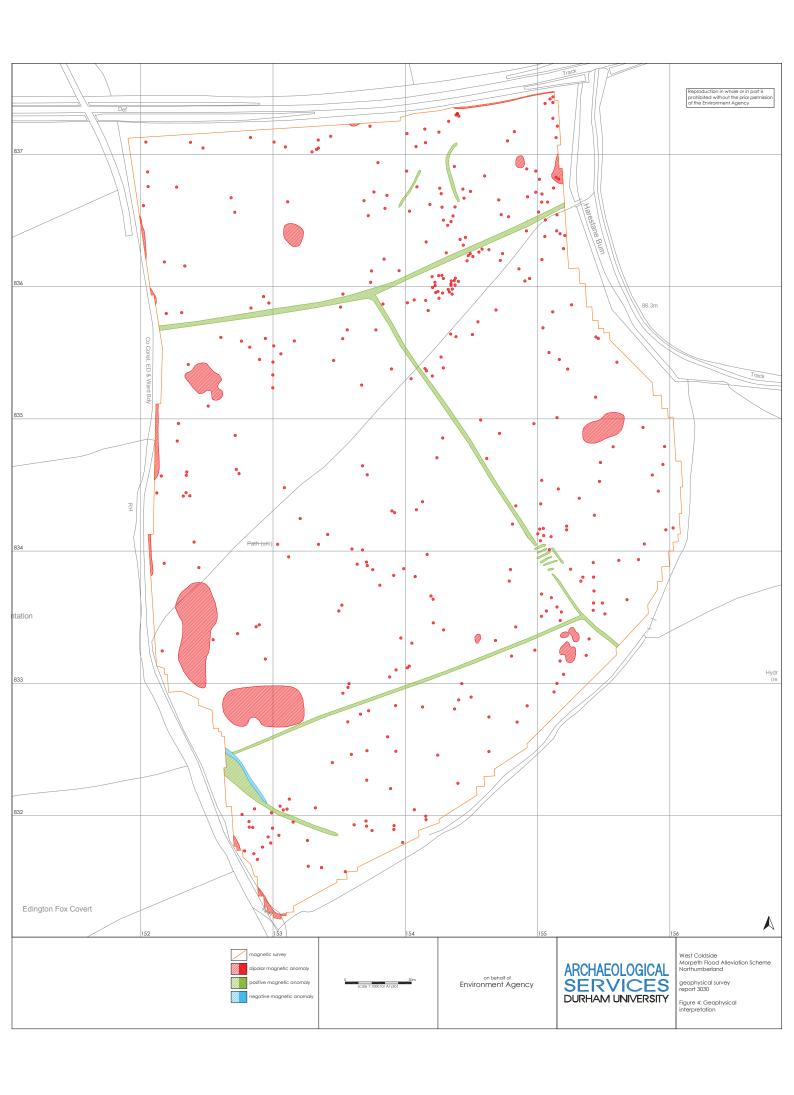
5.10 A colour-coded geophysical interpretation plan is provided. Three types of geomagnetic anomaly have been distinguished in the data:

positive magnetic regions of anomalously high or positive magnetic field

gradient, which may be associated with high magnetic susceptibility soil-filled structures such as pits and ditches

negative magnetic regions of anomalously low or negative magnetic field

gradient, which may correspond to features of low magnetic susceptibility such as wall footings and other concentrations

of sedimentary rock or voids

dipolar magnetic paired positive-negative magnetic anomalies, which typically

reflect ferrous or fired materials (including fences and service

pipes) and/or fired structures such as kilns or hearths

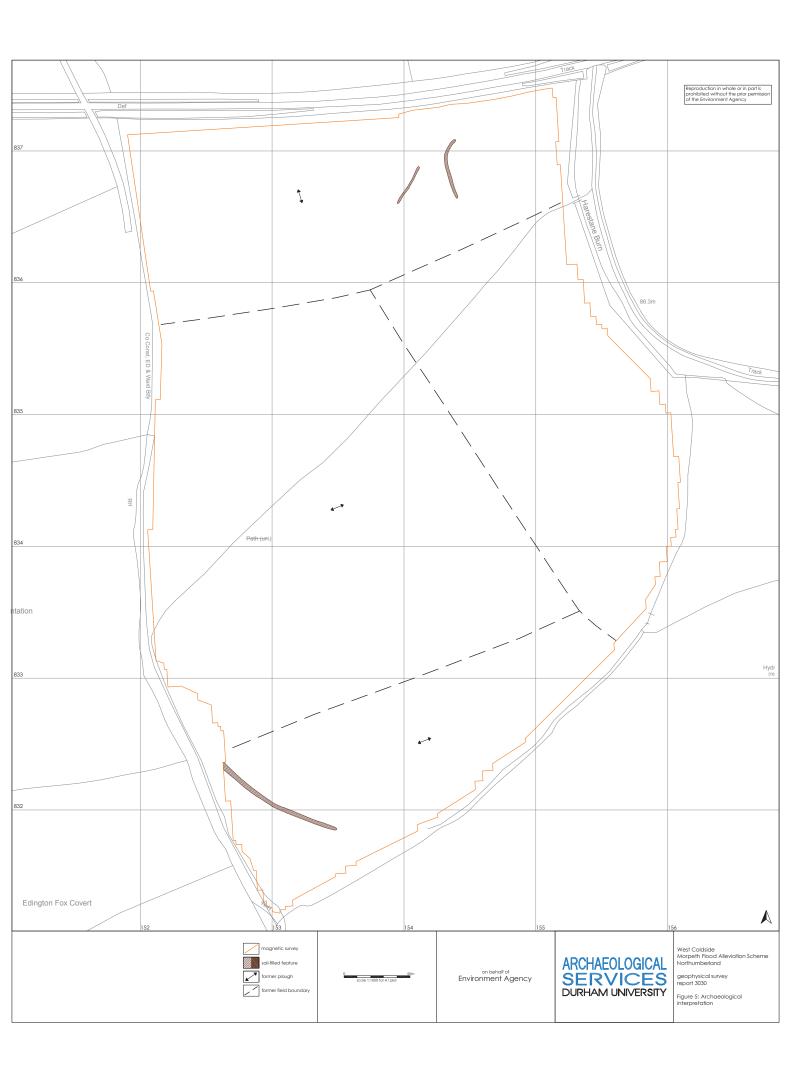
- 5.11 A colour-coded archaeological interpretation plan is provided.
- 5.12 Three weak linear positive magnetic anomalies have been detected, which broadly correspond to the locations of former field boundaries as shown by OS editions from the 1850s to the 1970s. The area is also shown as being woodland on several of the OS map editions. This may account for the magnetic 'noise' detected across the survey area.

- 5.13 A series of weak positive magnetic striations have been detected across the survey area. This almost certainly reflects a former ploughing regime.

- 5.14 A number of other weak and ephemeral positive magnetic anomalies have been detected. These could reflect the truncated remains of soil-filled features. Although possibly anthropogenic, the origin of these potential features is undetermined.

- 5.15 The only other anomalies detected here are small, discrete dipolar magnetic anomalies. These almost certainly reflect items of near-surface ferrous and/or fired debris, such as horseshoes and brick fragments.
