ARCHAEOLOGICAL
SERVICES
DURHAM UNIVERSITY

Force Crag Mine
Allerdale
Cumbria

archaeological monitoring

report 3150
April 2013

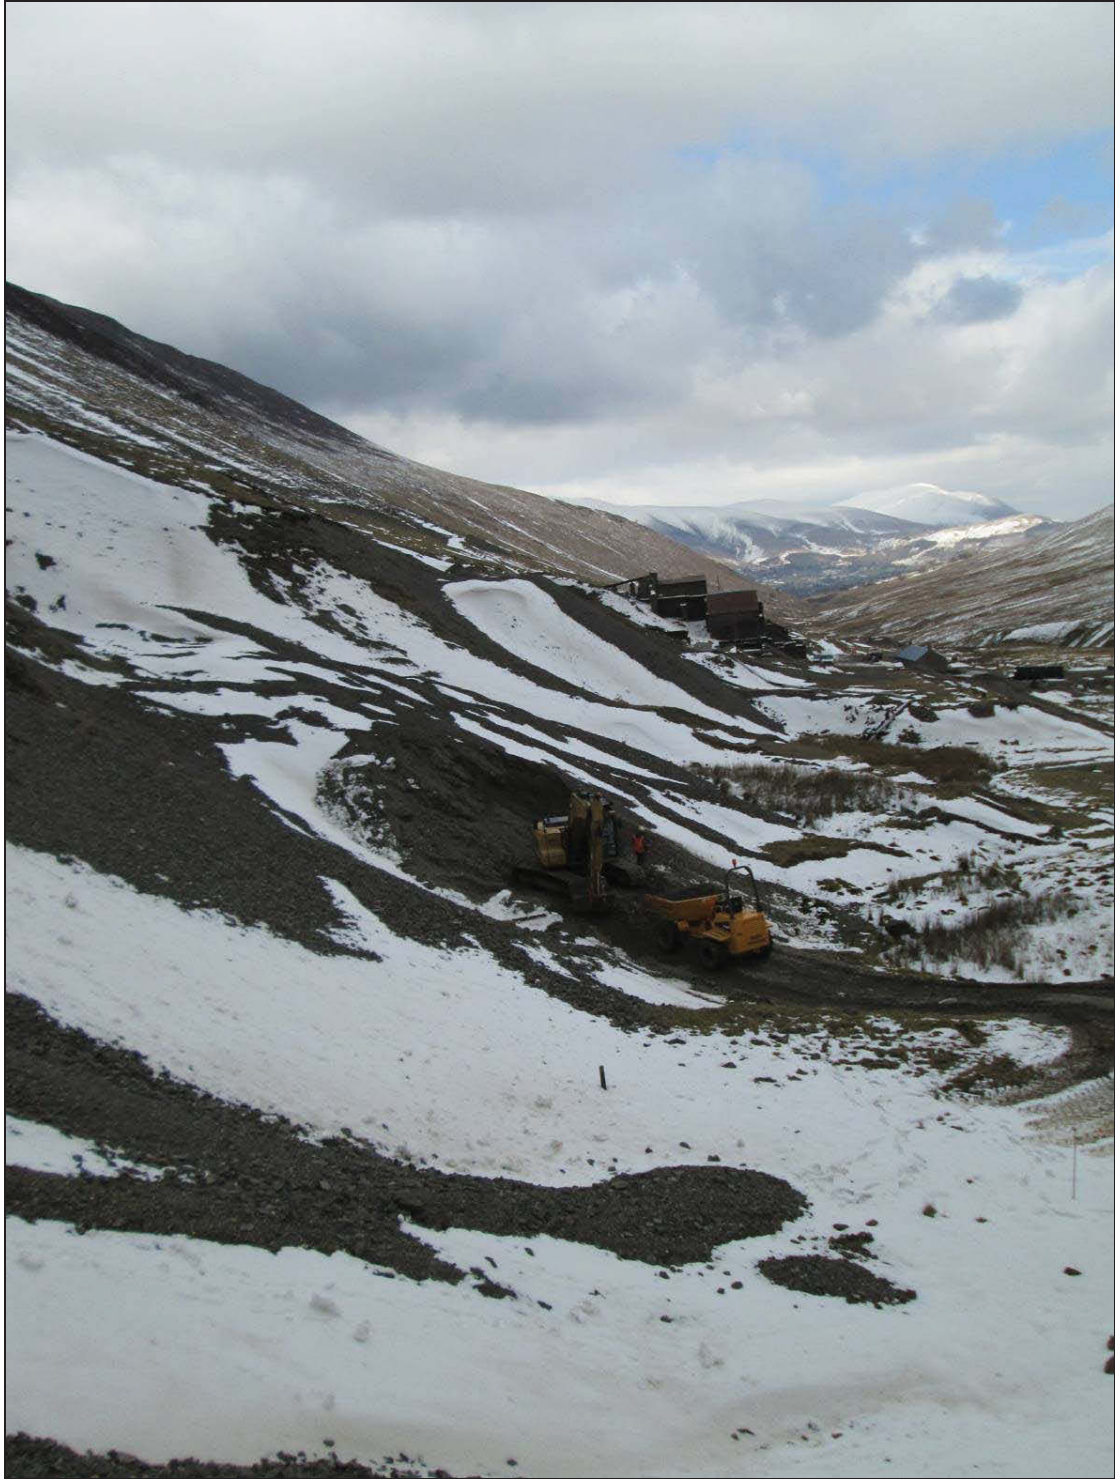
Figure 3: The site with the mill in the background and the roadstone quarry in the foreground, looking east

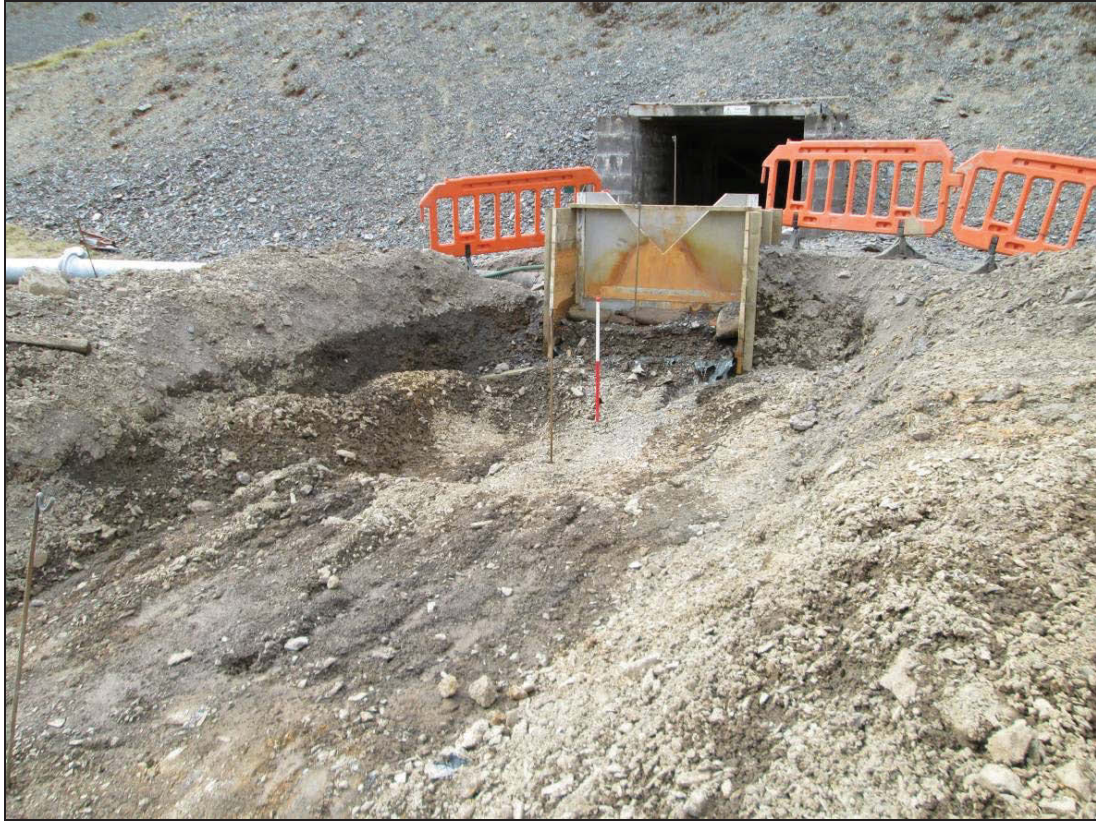
Figure 4: Chamber 1, looking north

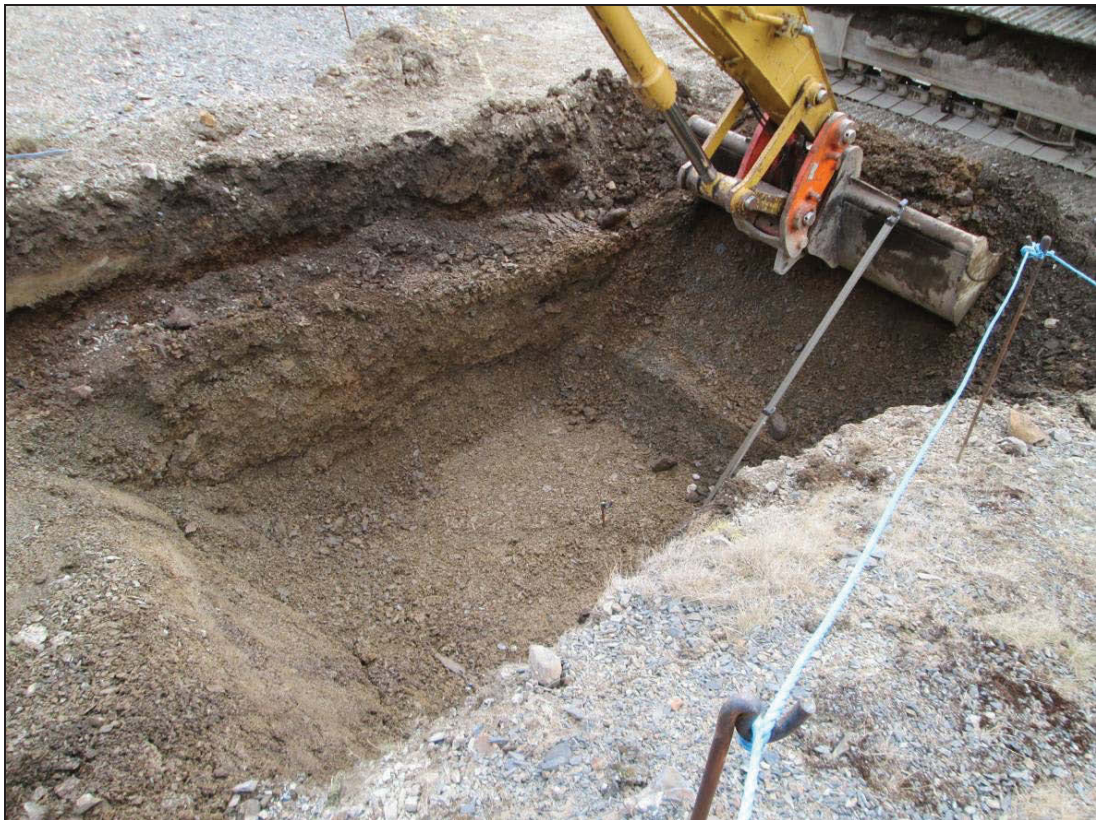
- 5.5 Chamber 2 was situated at the base of the main erosion scar, just to the north of the main track from Braithwaite leading west to the roadstone quarries. The chamber was located in order to prevent damage to existing spoil heaps not eroded by the flood damage within the scar.
- 5.6 The excavation for the chamber was 4m wide by 4m long and 1.4m deep. The deposits noted were loose shale to 0.40m deep, beneath which was mixed sandy silts in gravel and shale to the extent of the dig depth. No archaeological remains were noted during the excavation.

Figure 5: Chamber 2, looking south-east

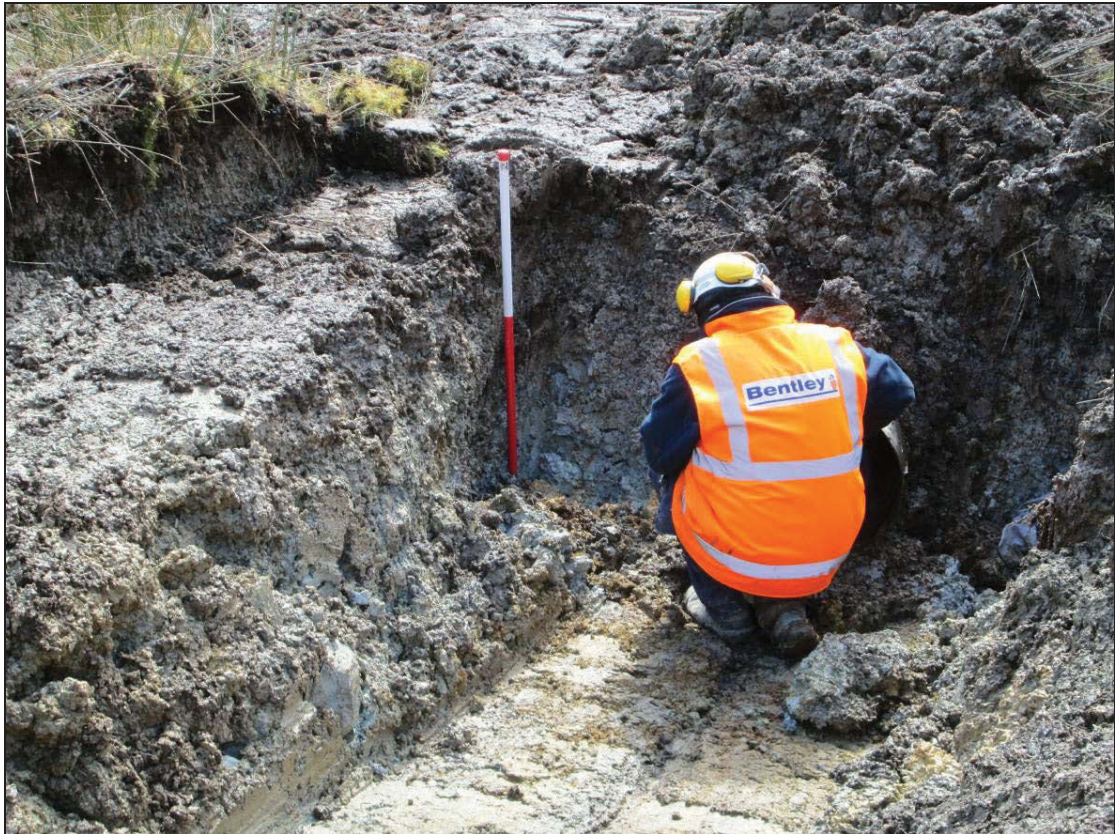
- 5.7 Chamber 3 was situated on the south side of the main track, connecting to Chamber 2 by a stretch of piping cut through the track surface. The chamber was cut to the west of an extant spoil heap, through ground thought to be relatively untouched by industrial activity.
- 5.8 The excavation for the chamber was 3m wide by 4.5m long and 1.7m deep, through wet mixed silts, clays and gravels, topped with rough turf and topsoil approximately 0.2m thick. No archaeological remains were noted during the excavation.

Figure 6: Excavating Chamber 3, looking north

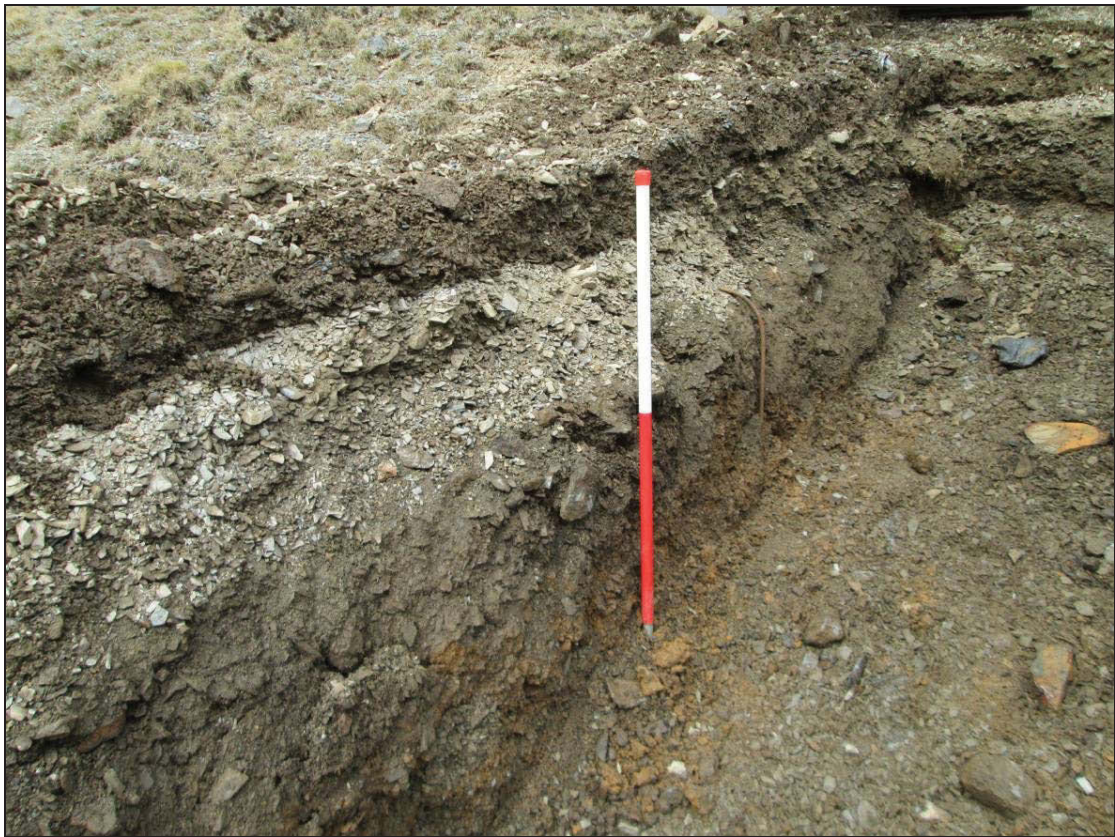
- 5.9 The outflow from the 1967 Level 1 entrance scored a deep gulley down the hillside during periods of flooding, cutting through a pre-1967 tramway at its northern extent and spoil heaps between the Mill and machinery platforms for the aerial ropeway to the south-west.

- 5.10 The main pipe cut was approximately 70m in length and ran the course of the main gulley through the slope to the west of the Mill. The gulley was initially filled with stone from the quarry to the west of the site to allow the 21 tonne excavator to track up and down the slope: the pipe cut was then excavated 1m down from the surface between Chambers 1 and 2: where excavations of this depth cut into original surface material, the pipe cutting was monitored.

- 5.11 No strata of archaeological significance was revealed during the course of the pipe cut excavation: iron and wood debris was recovered from the hillwash material, but no *in situ* deposits or remains were observed, barring cut-off cast iron piping; the past flooding from the Level 1 entrance may have removed the archaeological material in its entirety within the path of the water outflow.

Figure 7: Example section of the pipe trench cut

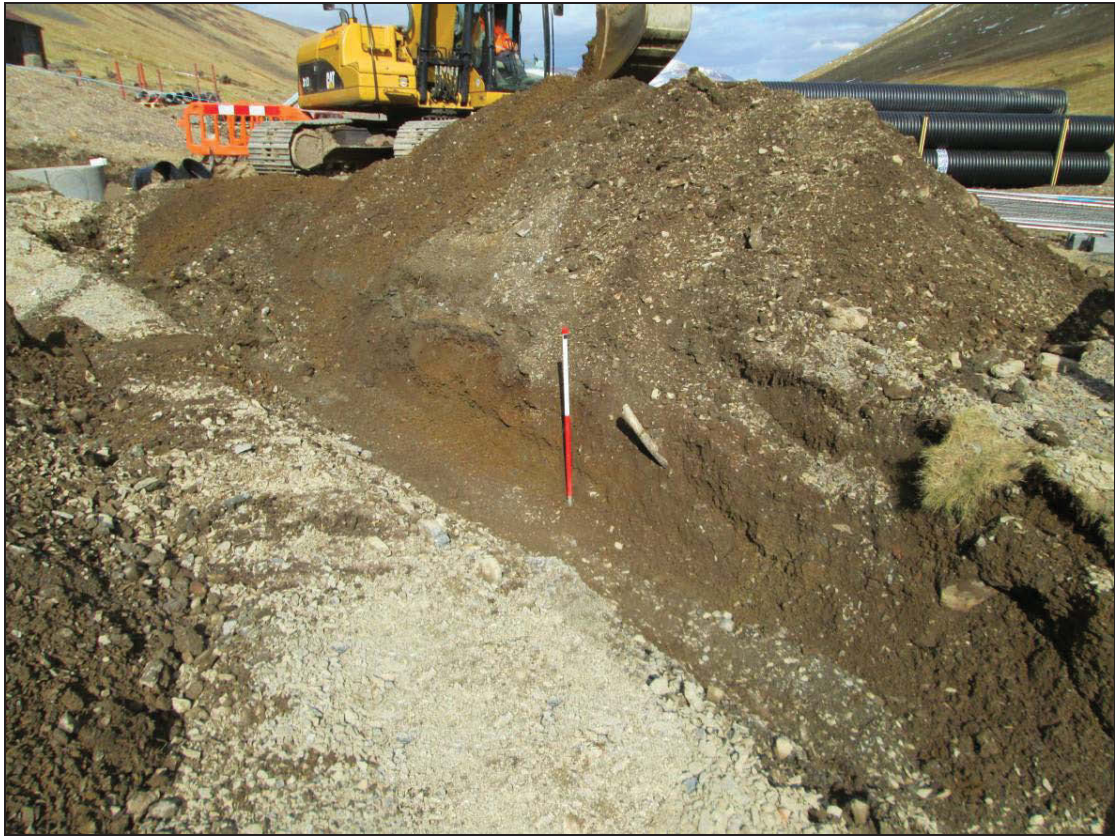
- 5.12 A trench was cut across Track 1, joining Chambers 2 and 3. The trench was 1.8m wide and 12m long. The trench was excavated to 0.8m deep: the upper 0.2m comprised compacted stones and gravel, forming the surface of the track, with loose scree below. Beyond the presence of a lead water pipe, no archaeological deposits were observed.

Figure 8: Section across road (Track 1), looking east

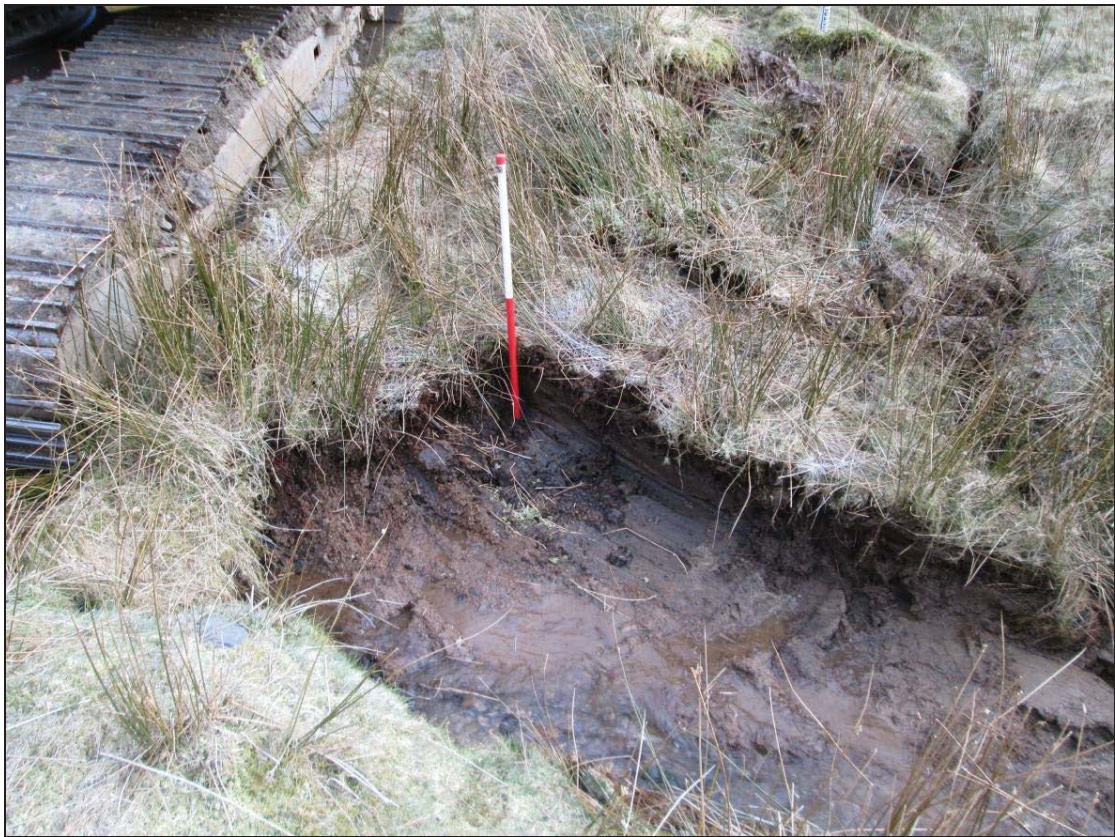
- 5.13 The lower pipe cut was excavated to the west of standing spoil heaps through ground thought to be untouched, sloping down to the Coledale Beck.

- 5.14 The excavation measured approximately 21m long and between 1.2-1.8m wide, and ran from Chamber 3 down to a northern branch of the Coledale Beck. The trench was excavated to 0.9m deep, with mixed sandy clays at 0.6m deep covered by a wet silty turf and topsoil. The southern end of the pipe drained into a gabion basket, and was built around with rocks to help the outlet blend into the surroundings. No significant archaeological features or deposits were uncovered during the excavation of the trench.

Figure 9: Excavation for the gabion basket

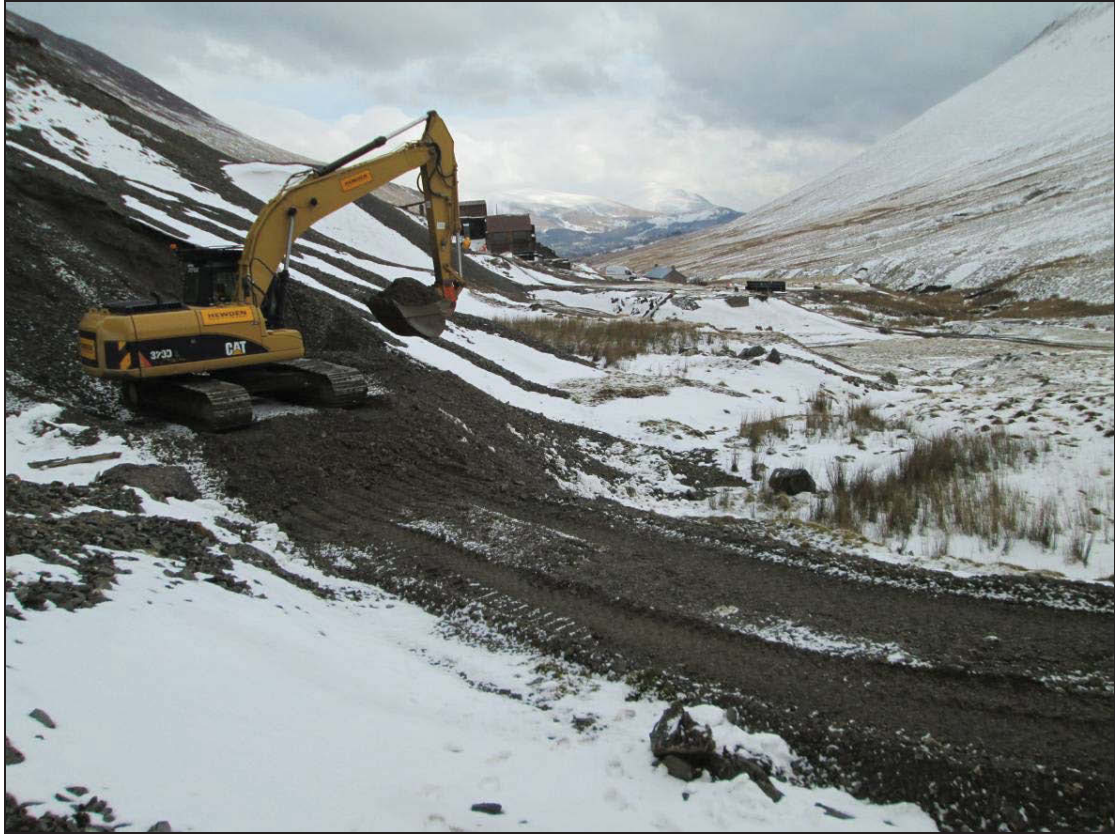
- 5.15 The old roadstone quarry at the western end of the site was used for backfill material, with at least 350 tonnes of material being transported from the quarry area to the main landscaping site. The material used was hillwash collected at the base of a large gully, originating as material washed down from the crags, spoil heaps and hillsides.
- 5.16 During the removal of the material, wooden sleepers were uncovered, presumably having washed down from the levels above. No extant building remains or *in situ* archaeological deposits were uncovered. Once the necessary material was removed, the area was graded and shelved to allow for natural weathering to blend away the excavation scar.

Figure 10: The roadstone quarry in the foreground, looking east
