St Botolph's Chapel  
Frosterley  
County Durham

archaeological excavation

report 3679  
May 2015

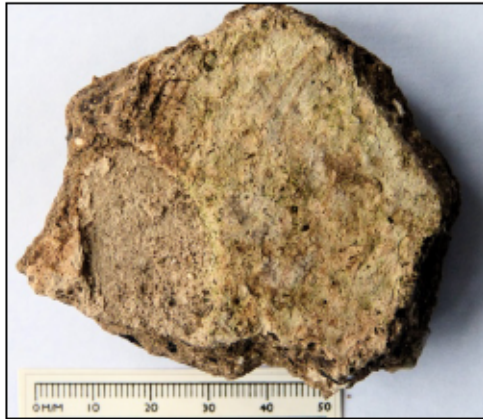
**Plate 1: Faint red curved lines on fragment from [62].**

- 7.46 Fragments from [70 and 88] show evidence of two different colour schemes or overpainting. The piece from [70] has bright orange/red paint which has been covered with a further top coat, painted white (Plate 2). A small piece from [88] was painted red and then later re-coated and painted white with a black stripe (Plate 3). Apart from this stripe, there is no evidence for the type of decorative schemes in use.

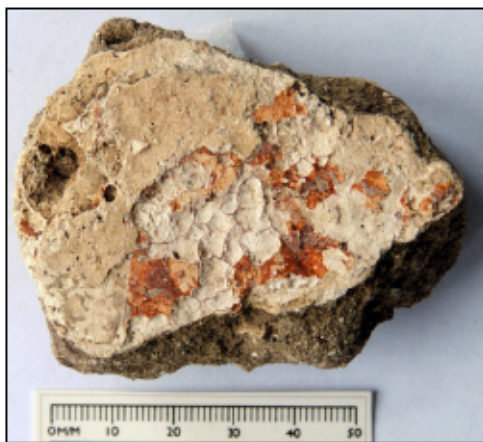
**Plate 2: Orange/red overpainted with white from [70]**

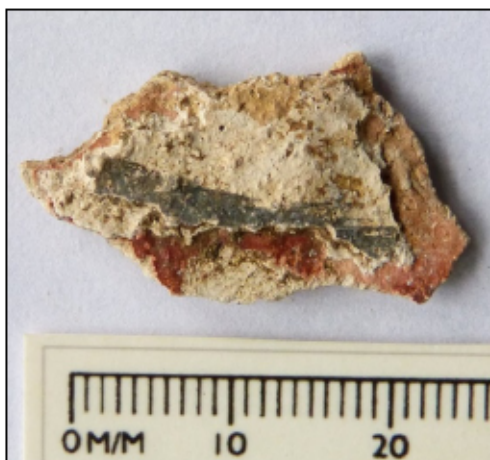
**Plate 3: Red overpainted with white with black stripe from [88]**

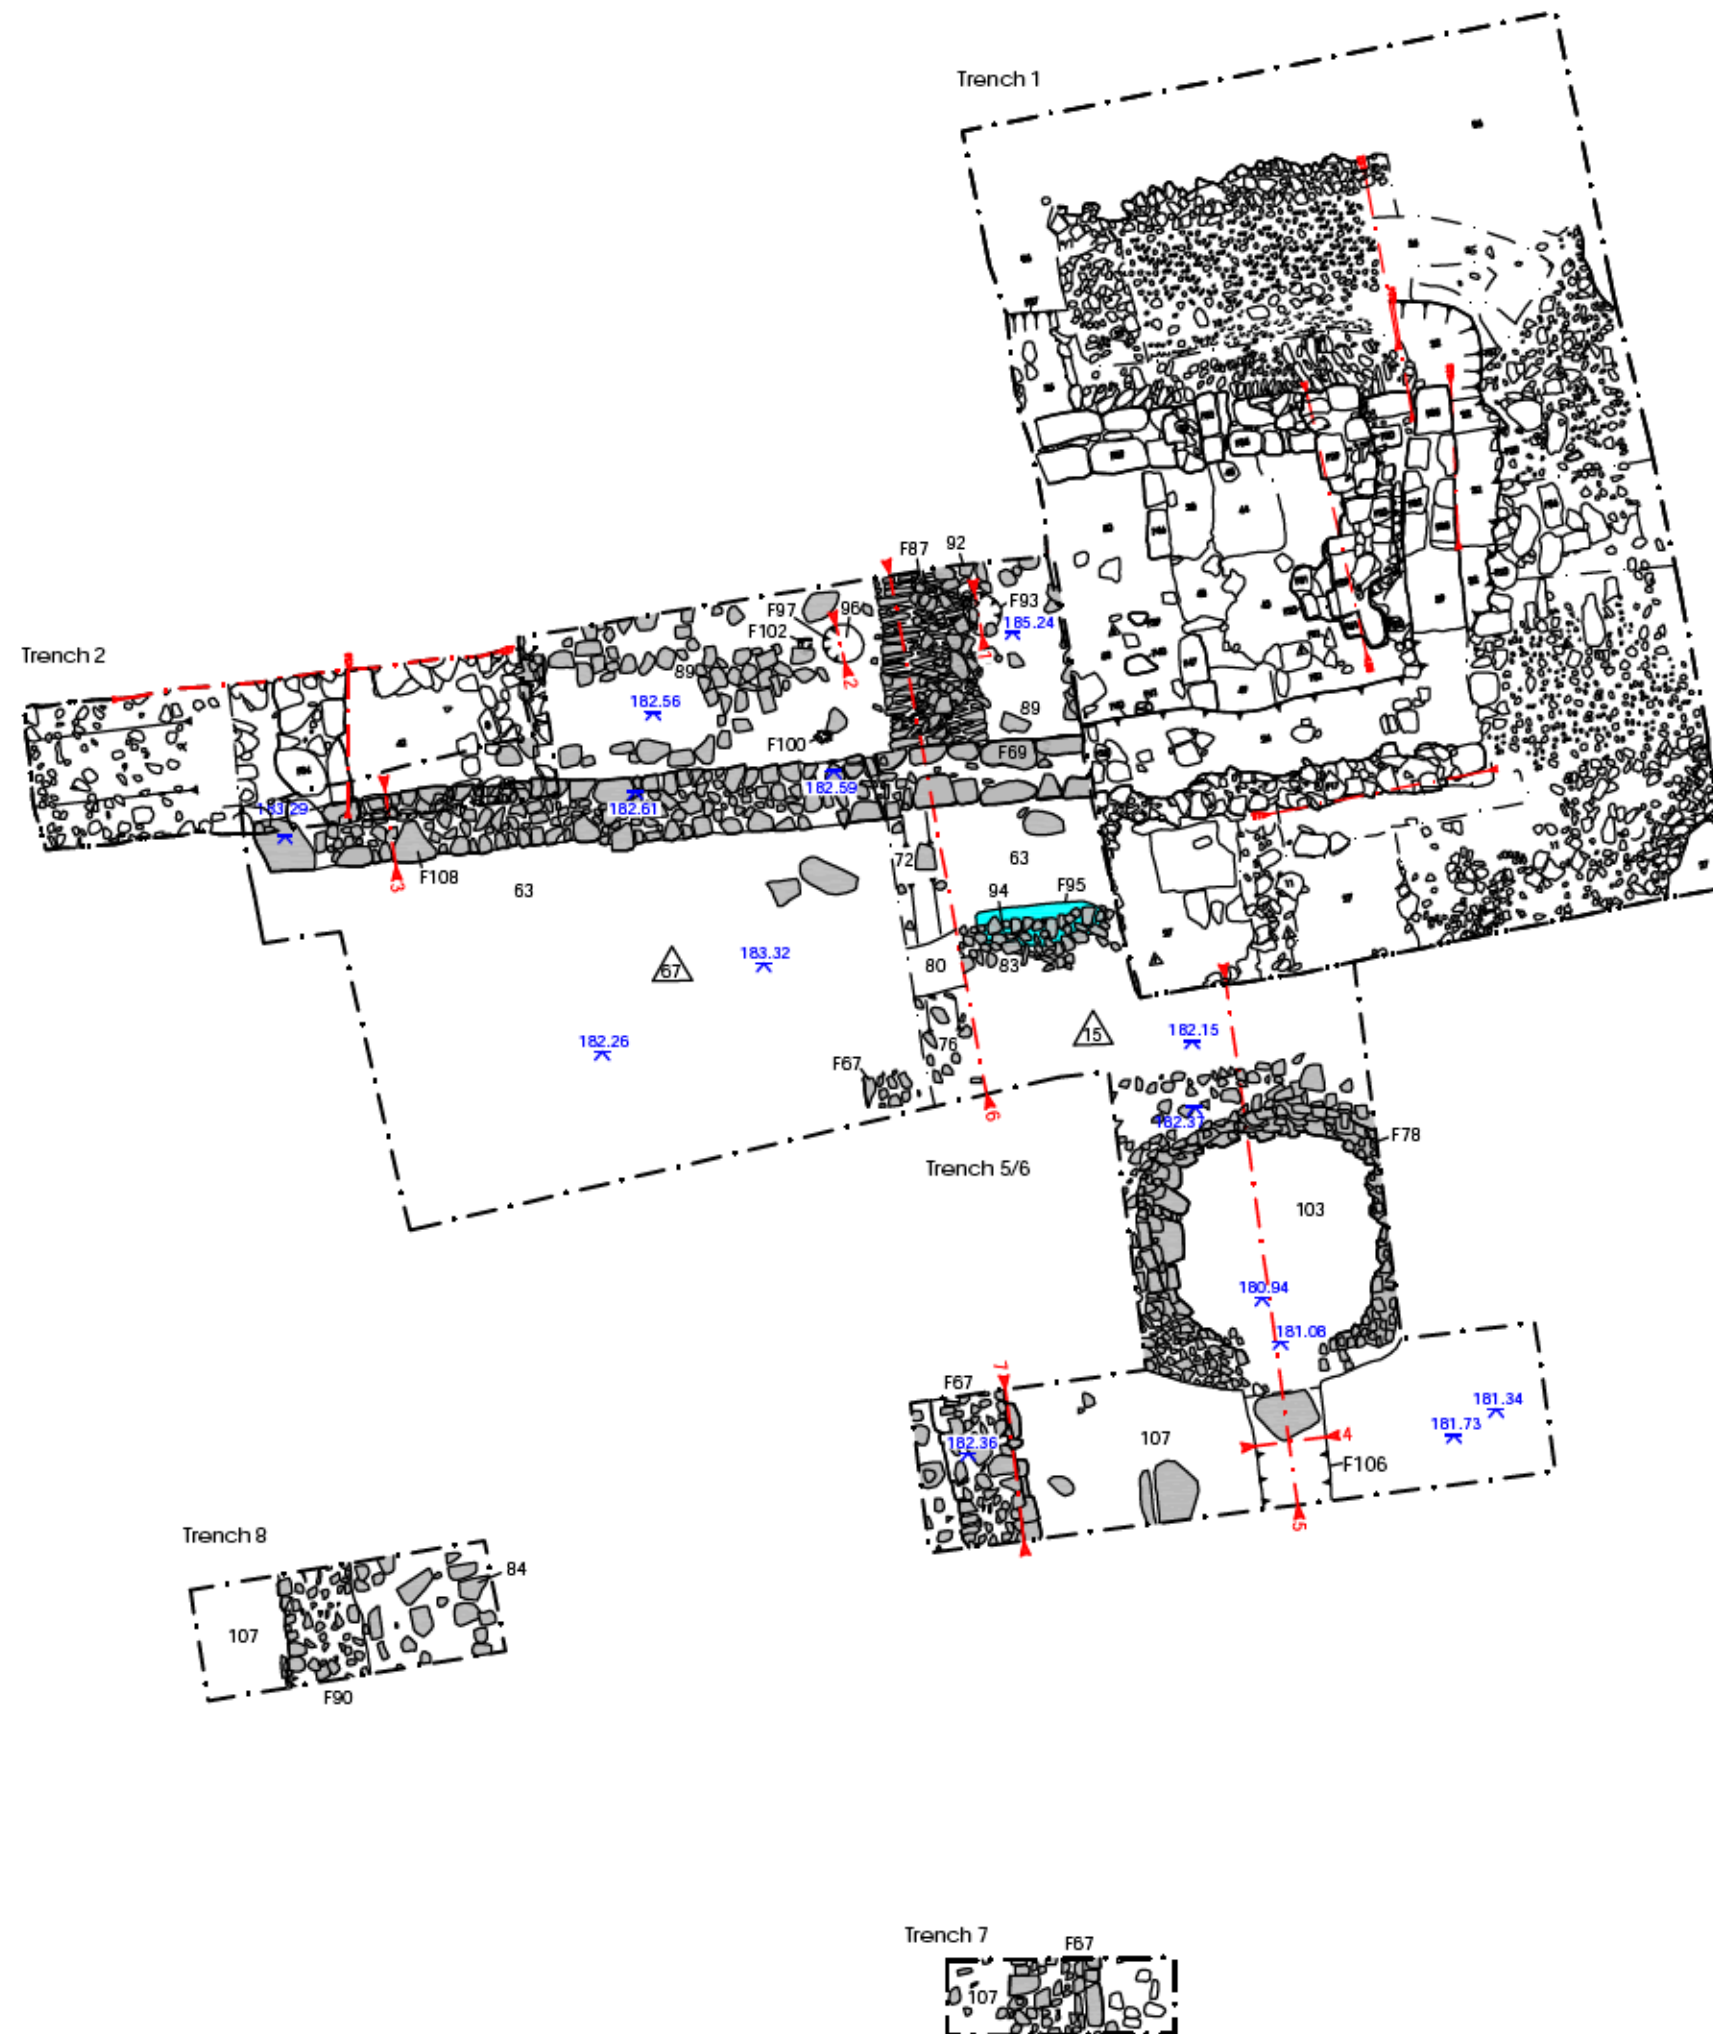
Figure 3: Trench plan

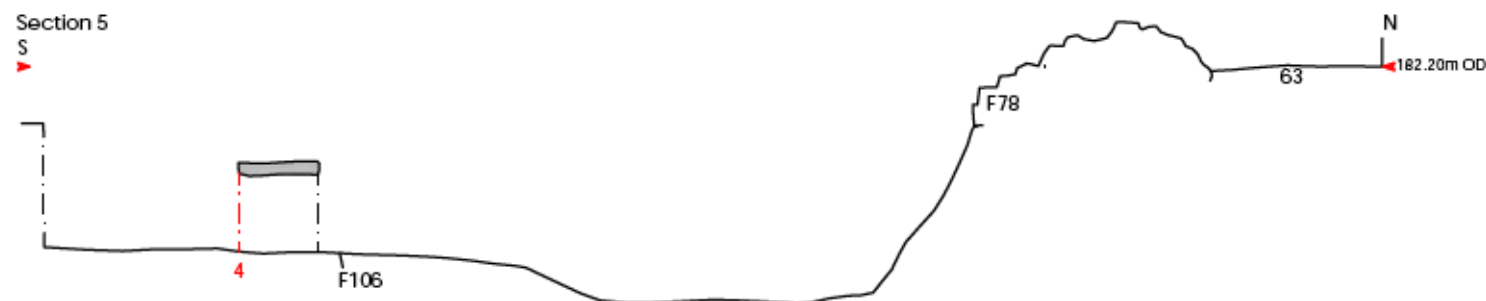
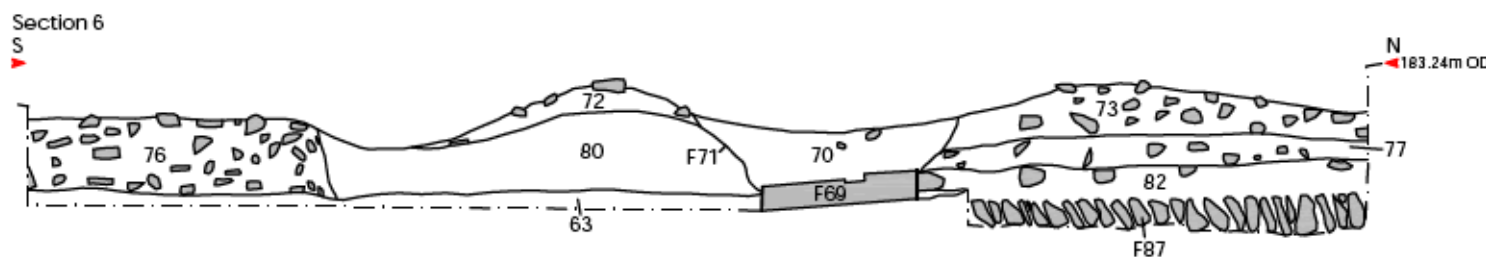
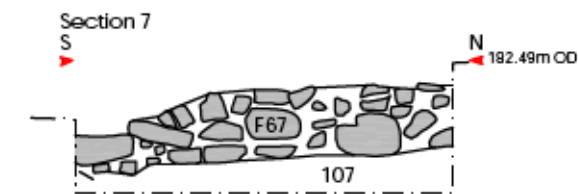
Figure 4: Sections

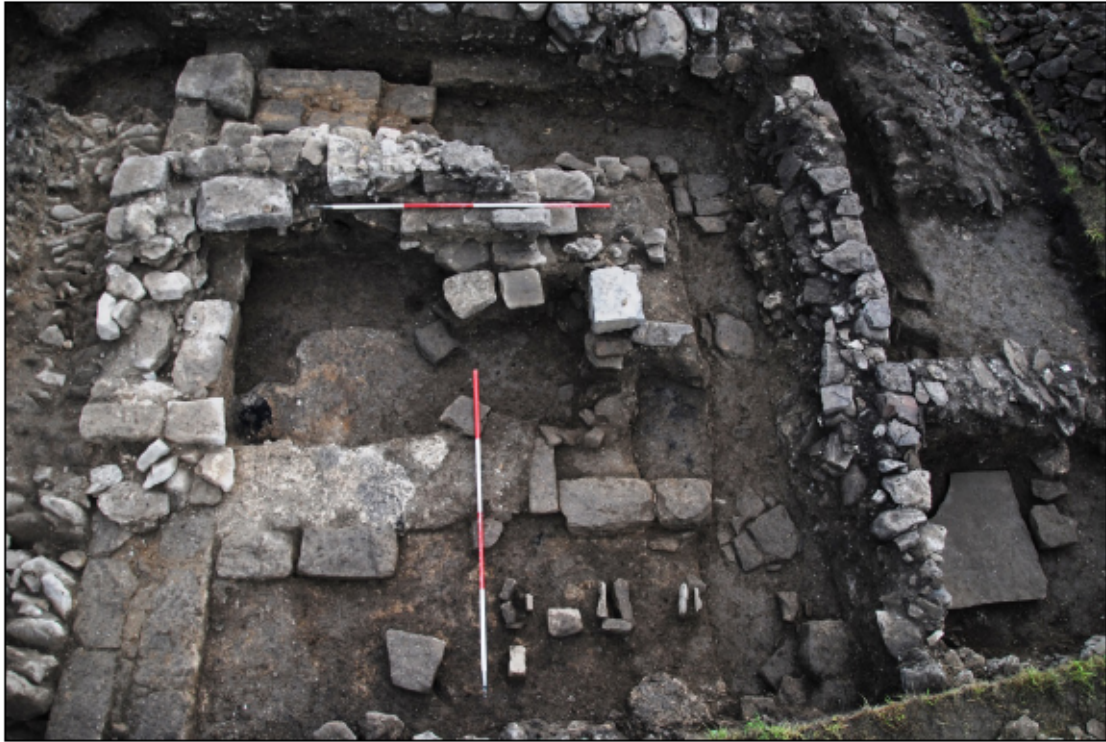
Figure 5: Trench 1, 2013, east end of the chapel, looking east

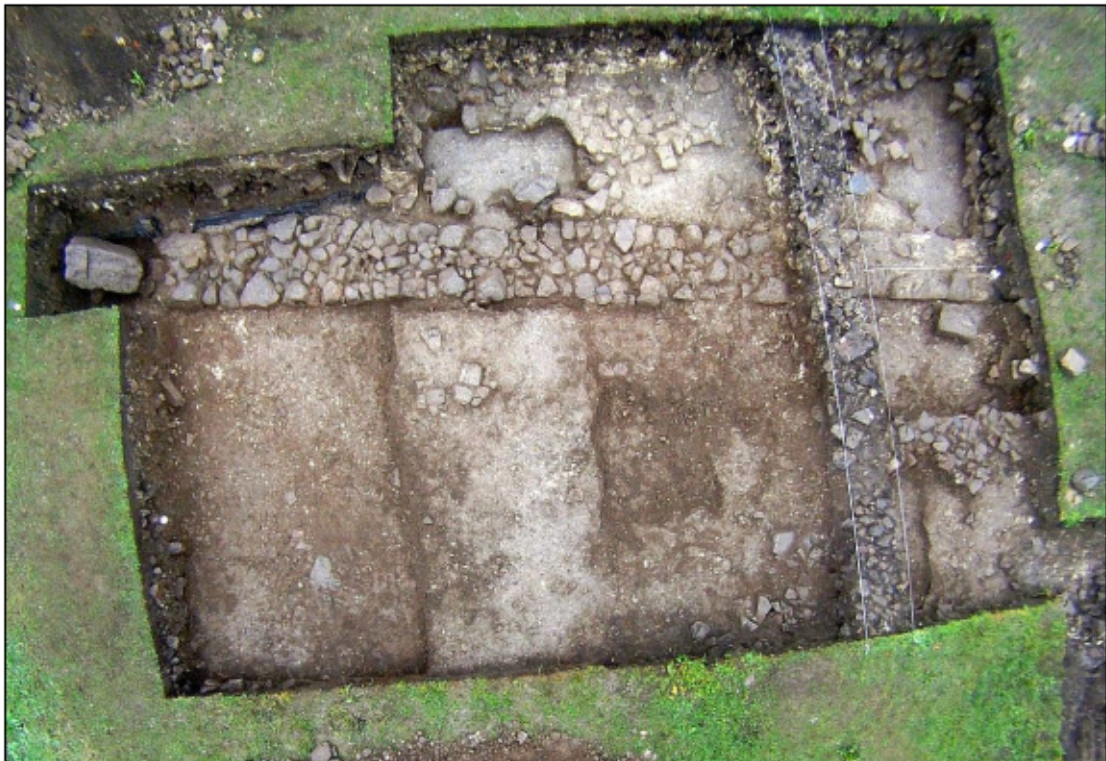
Figure 6: Trench 5, 2014, south wall of the chapel, looking north (Photograph by Steven Eastmead 2014)

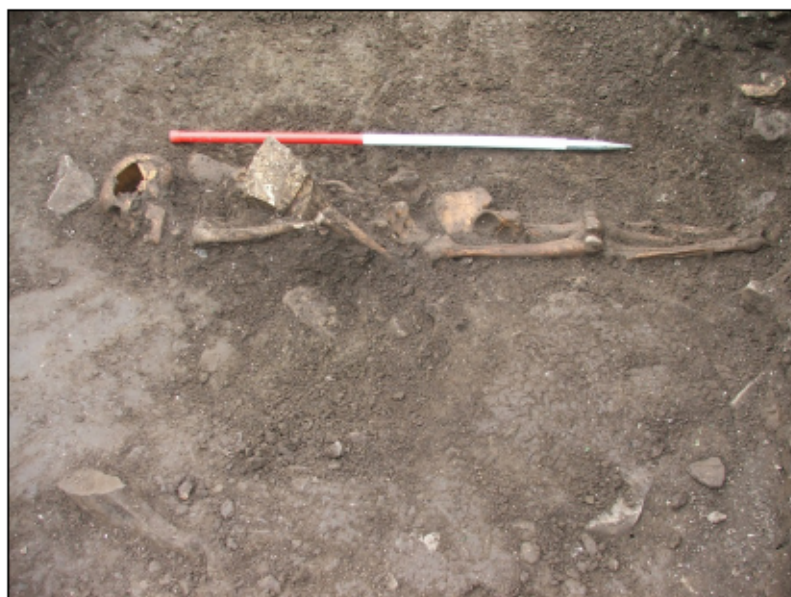
Figure 7: Trench 5, burial SK1, looking north

- 6.1 A skeleton (SK 1) was uncovered in context [94]. The skeleton was not lifted, although a single loose fragment of bone was recovered. The bone has been radiocarbon dated to 779-1013 cal AD (95.4% probability), indicating a late Anglo-Saxon date.

- 6.6 The skeleton is a male. Aspects of the pelvis displaying strong male traits were clearly visible in the photographs. These include a narrow left greater sciatic notch (also noted to be narrow on the skeleton context form), and a broad sacral body associated with narrow alae (Mays and Cox 2000). The left side of the mandible is also clearly visible in the photographs. This has a broad and fairly upright ramus, both features typical of male individuals. The mental eminence (chin) was probably square, but the right half of the mentum was buried in the soil, so it is difficult to be

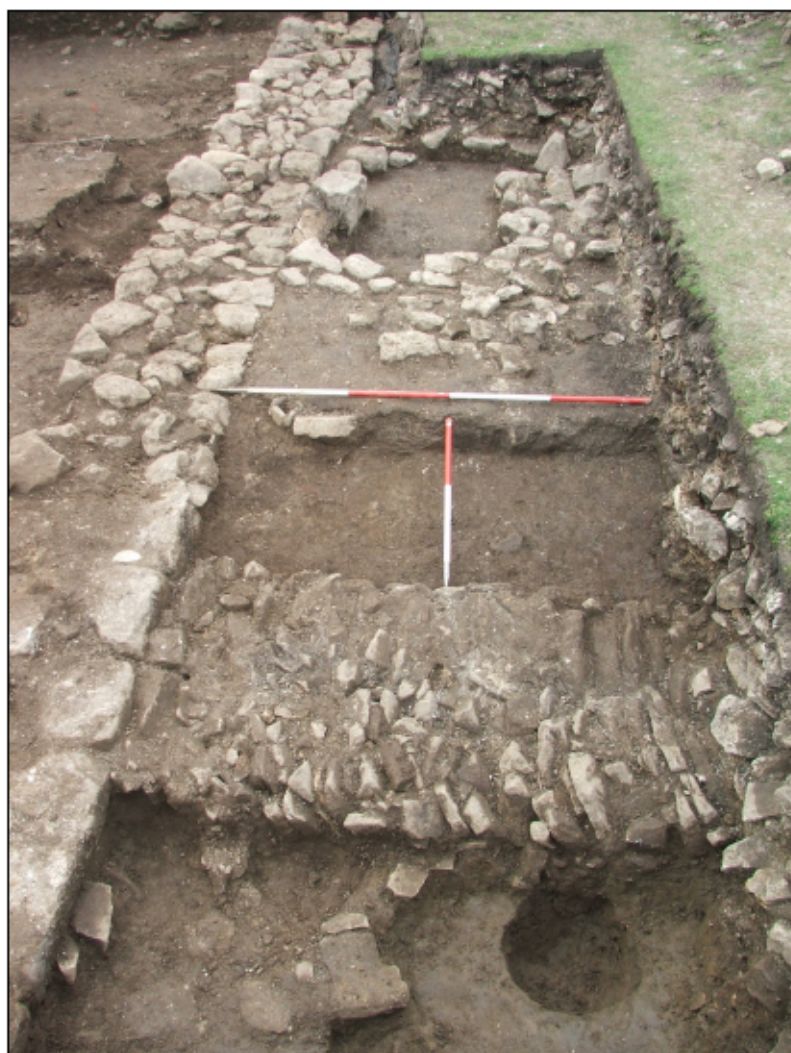
Figure 8: Trench 5, south part of the chapel, looking west

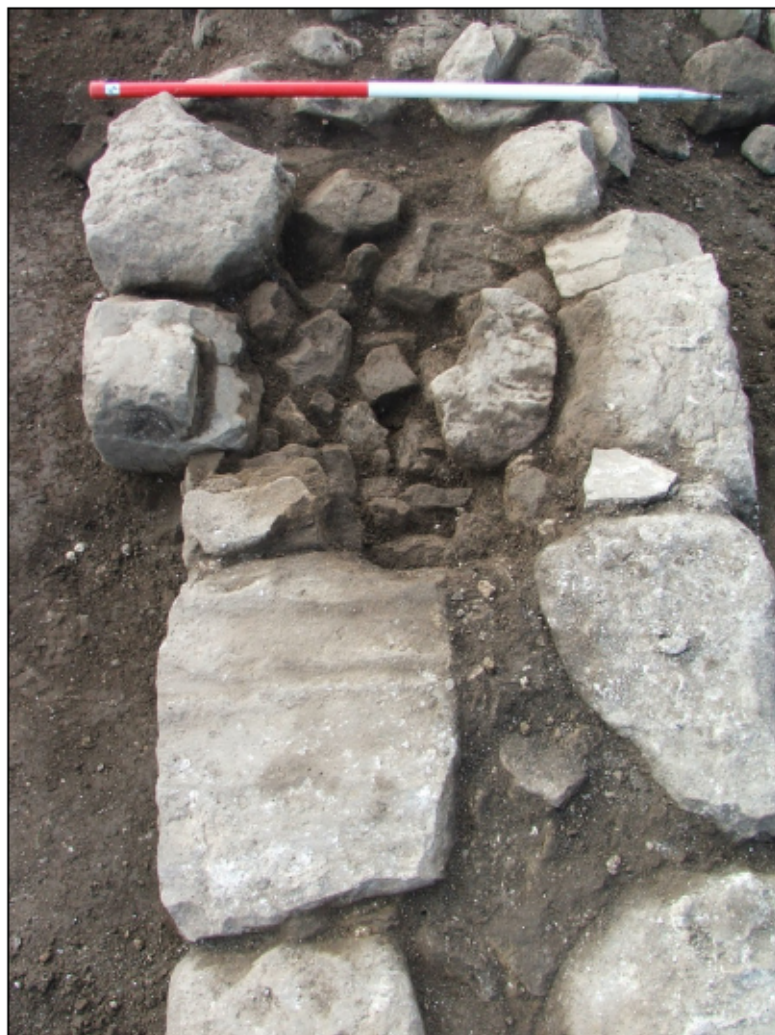
Figure 9: Trench 5,  
interface between walls  
F69 and F108, looking  
west

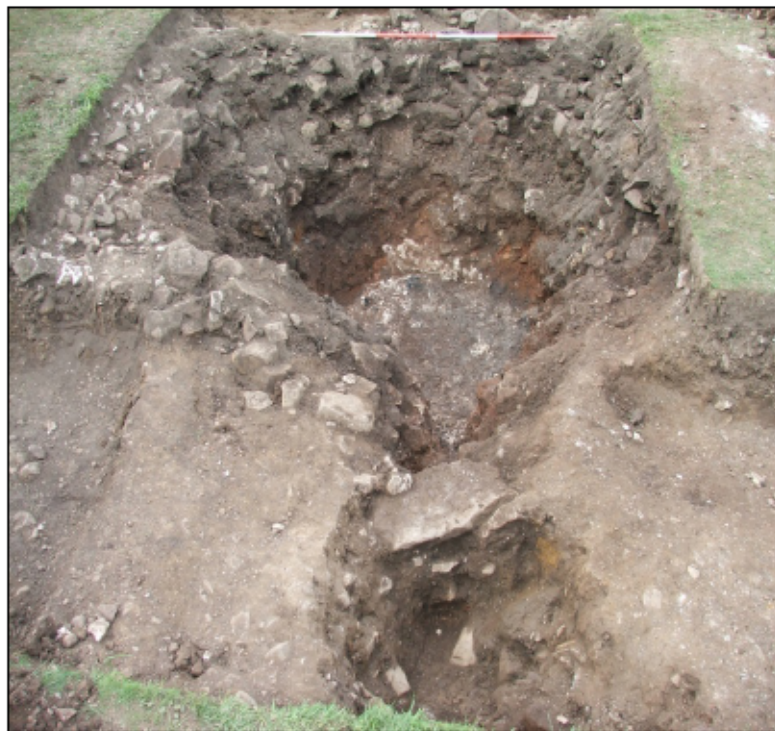
Figure 10: Trench 6, kiln  
pit F78 with stokehole  
F106 to south, looking  
north

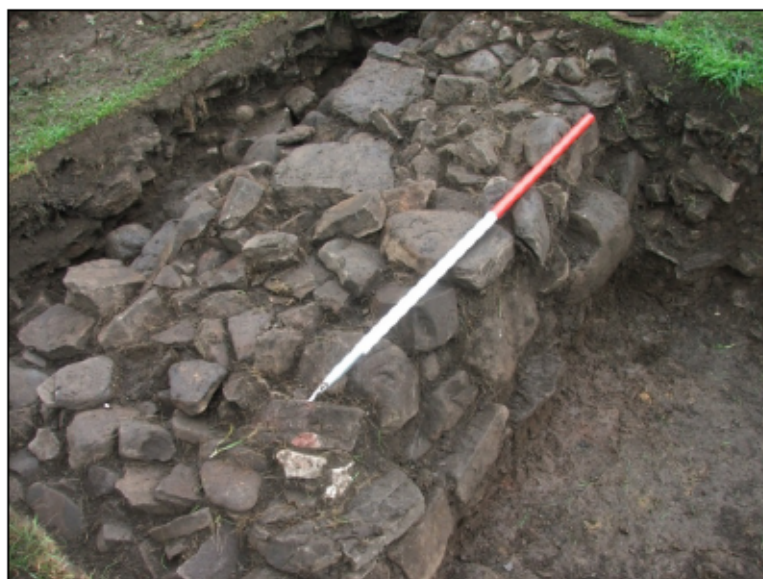
Figure 11: Trench 6,  
wall F67, looking north

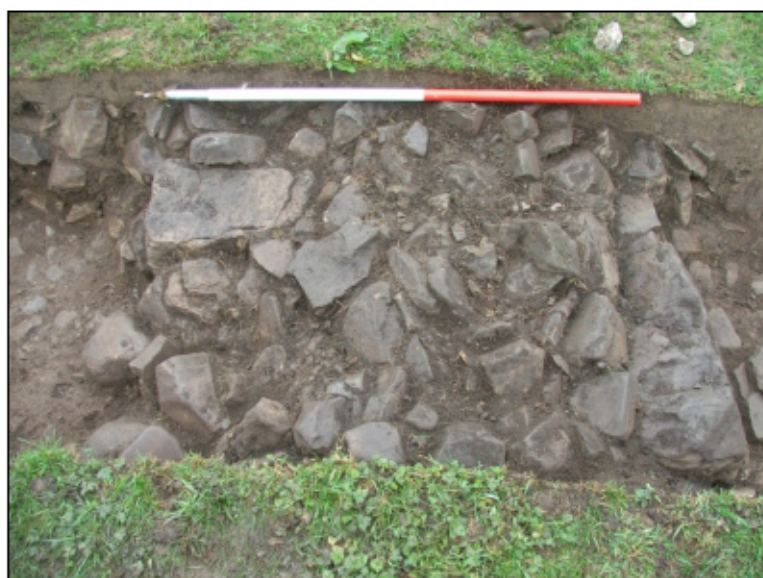
Figure 12: Trench 7,  
wall F67, looking north

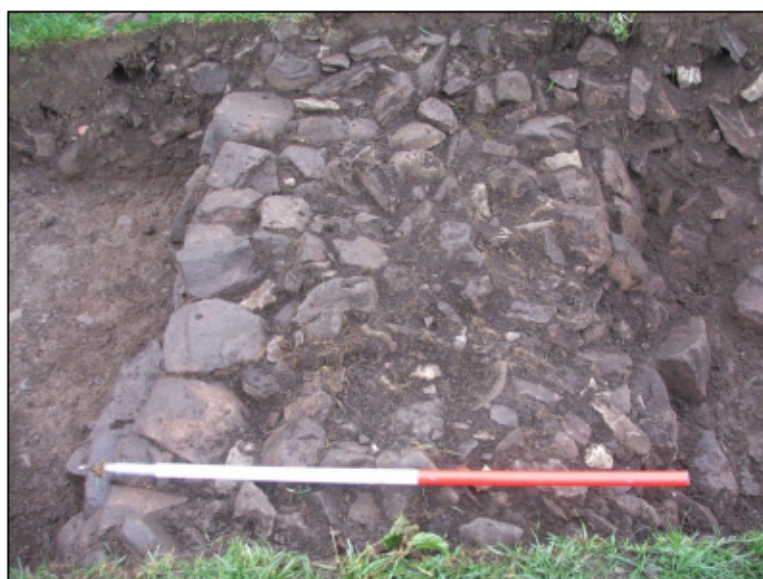
Figure 13: Trench 8,  
wall F90, looking north

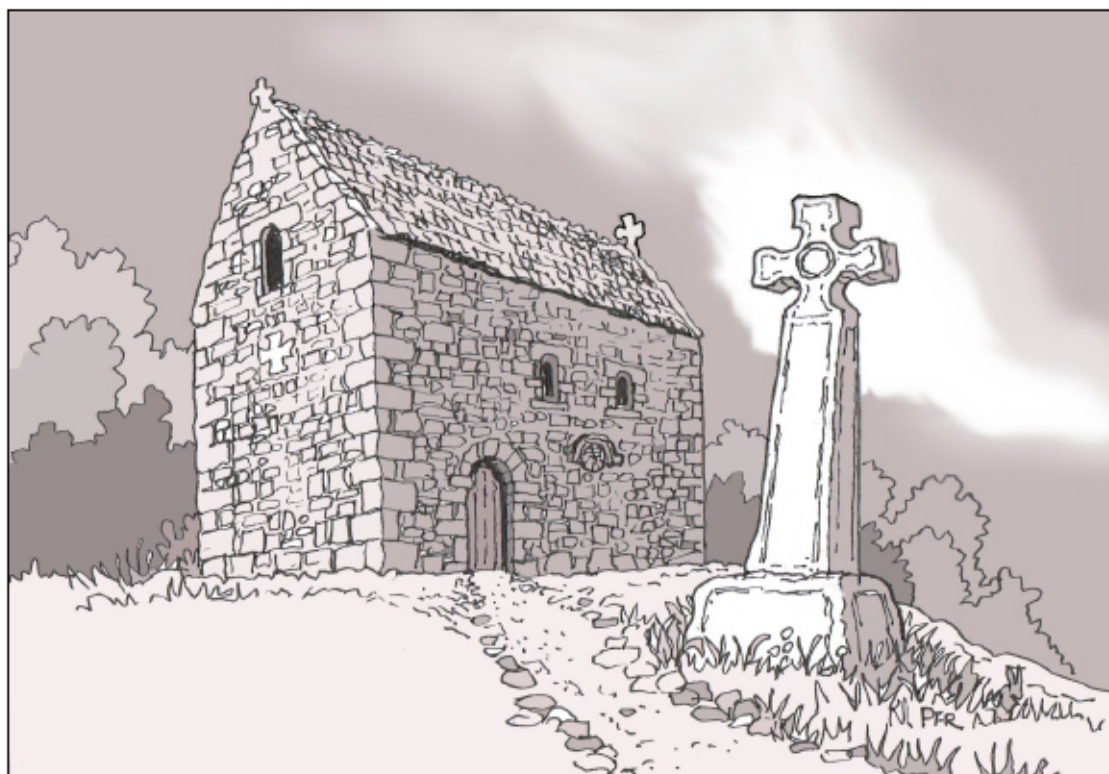
Figure 14: Possible reconstruction of the chapel, by Peter Ryder
