on behalf of Northumbrian Water

Low Lane Maltby Stockton-on-Tees

archaeological monitoring

report 3986 February 2016

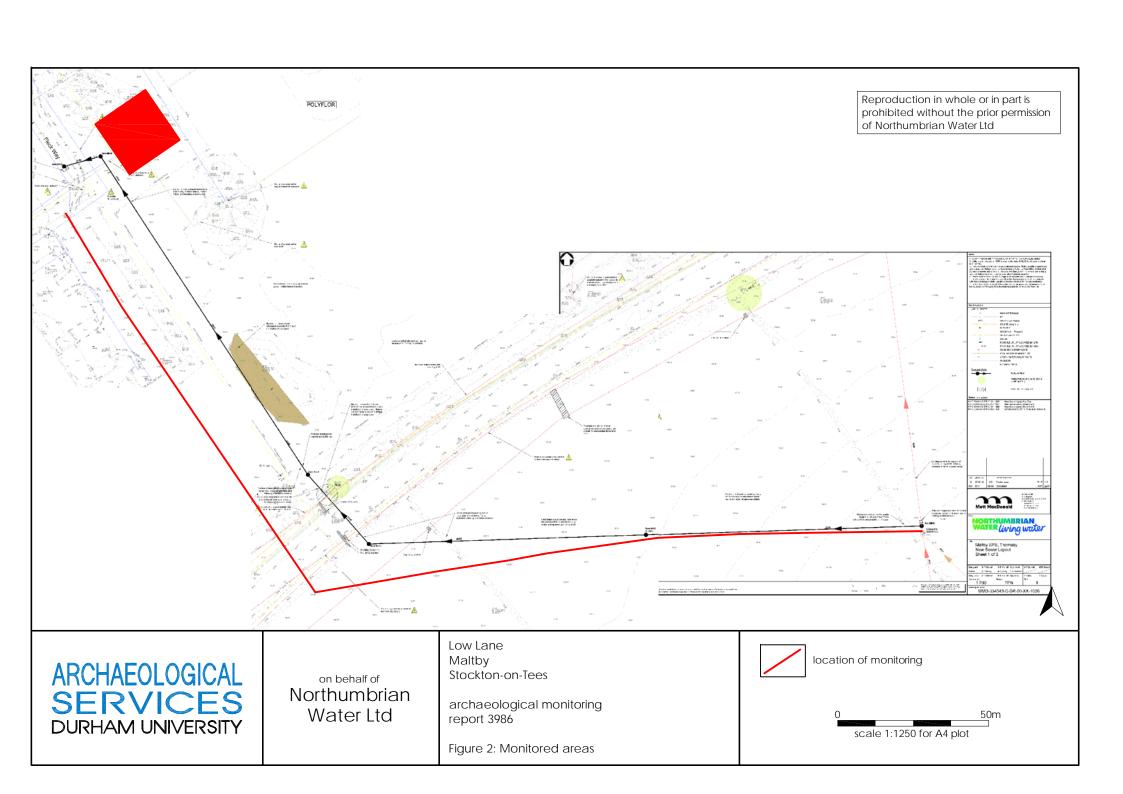
5.1 The works to be monitored comprised a topsoil strip for a site compound measuring approximately 20m by 20m and the excavation of a 340m x 1m trench to a maximum depth of 5m below ground level (Figure 2) for a sewer pipe. Excavations were undertaken using a 360° backhoe excavator equipped with a toothless bucket under constant archaeological supervision.

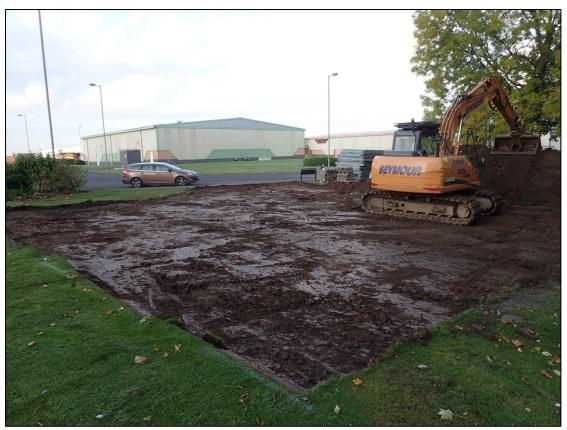
Figure 3: Topsoil strip for site compound, looking north-west

5.2 A topsoil strip was monitored over this area. Natural subsoil, a red-brown sandy clay [7], was identified between 0.2m and 0.3m below the ground surface. Overlying this was modern topsoil and turf [6: 0.2m to 0.3m thick], containing brick and plastic. No archaeological features were identified and no artefacts recovered.

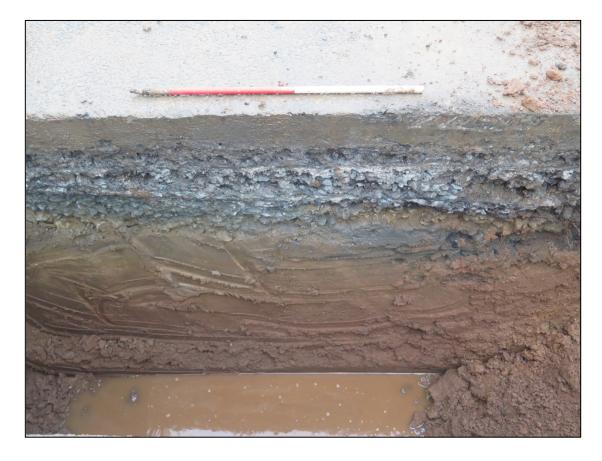
Figure 4: Section through pipe trench across Low Lane, looking west

- The pipe trench crossed the B1380 Low Lane road and the grass verge either side of the road. In this area, the natural subsoil [4] was identified at approximately 0.6m below the ground surface. Cutting the natural subsoil was the trench for a modern service pipe [F10: 1m wide, 1.5m deep]; animal bone was recovered from the fill of this trench [11].

- 5.5 Cutting the natural subsoil beneath the road was an amorphous pit. The pit [F8: 0.4m long by 0.2m wide, 0.1m deep] was located on the north side of the carriageway and was filled with a grey-brown clay [9] containing 19th-century pottery. Overlying the pit and the natural subsoil was a concrete road deck [13: 0.28m thick], with tarmac above it [12: 0.3m thick].

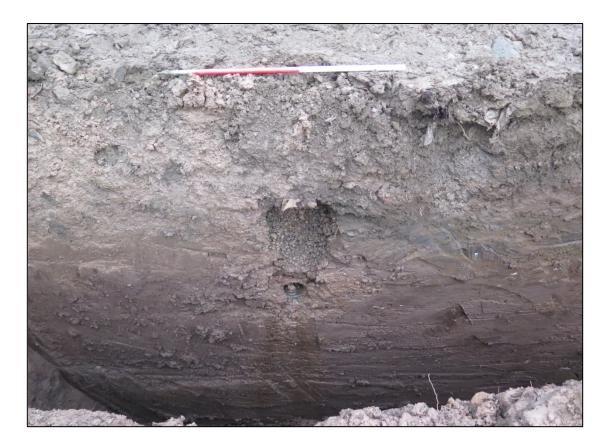
Figure 5: Trench section, in field south of Low Lane, looking north

- To the south of the B1380 Low Lane the pipe trench crossed two agricultural fields. Here the natural subsoil [4] was overlain by a humic grey-brown agricultural topsoil [14: 0.25m thick].
